Hazardous Building Materials (HAZMAT) Survey

Parramatta East Public School Upgrade  
30-32 Brabyn Street, Parramatta NSW

Prepared for  
NSW Department of Education  
School Infrastructure

Project 214531.01  
4 March 2025

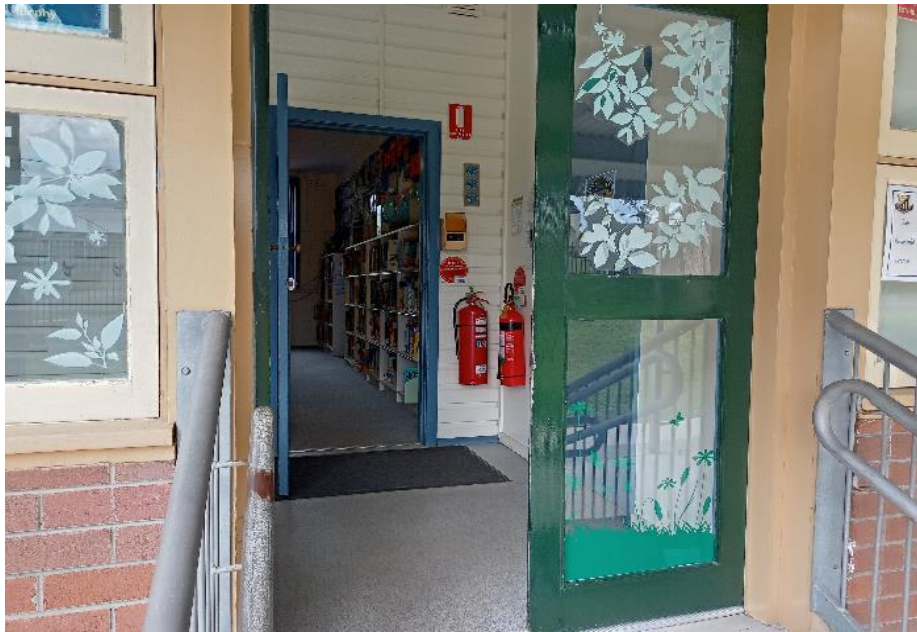
Photograph 37: B00A, exterior, doors, green paint, lead paint identified.

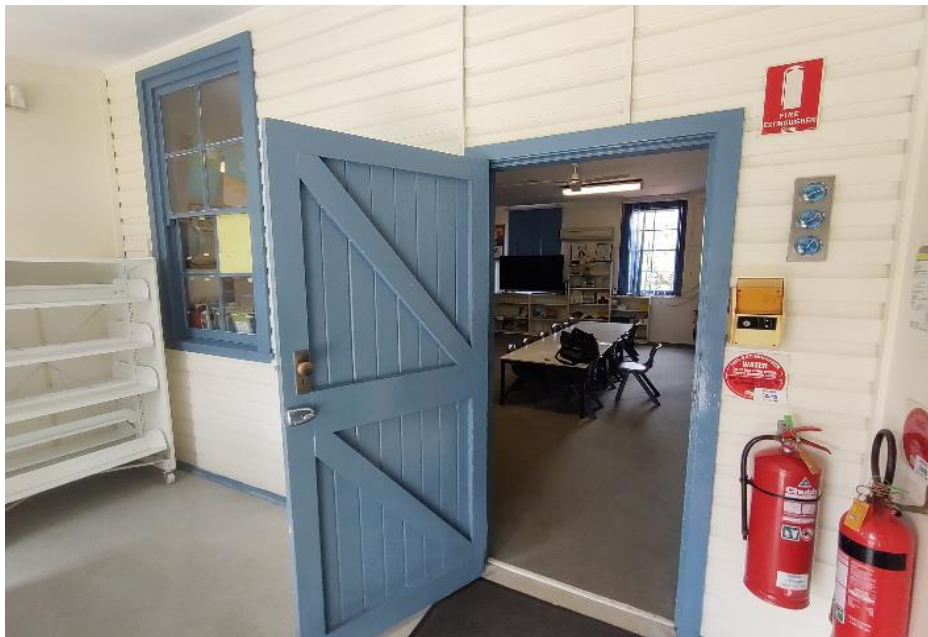
Photograph 38: B00A, interior, doors / windows, blue paint, lead paint identified.

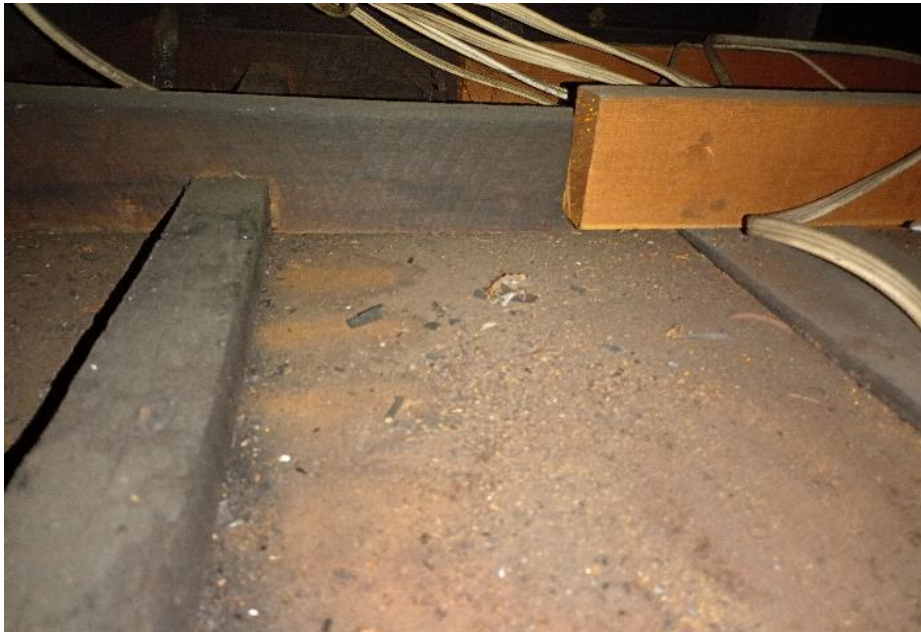
Photograph 39: B00A, AR0003, ceiling cavity, settled dust / debris, contains lead.

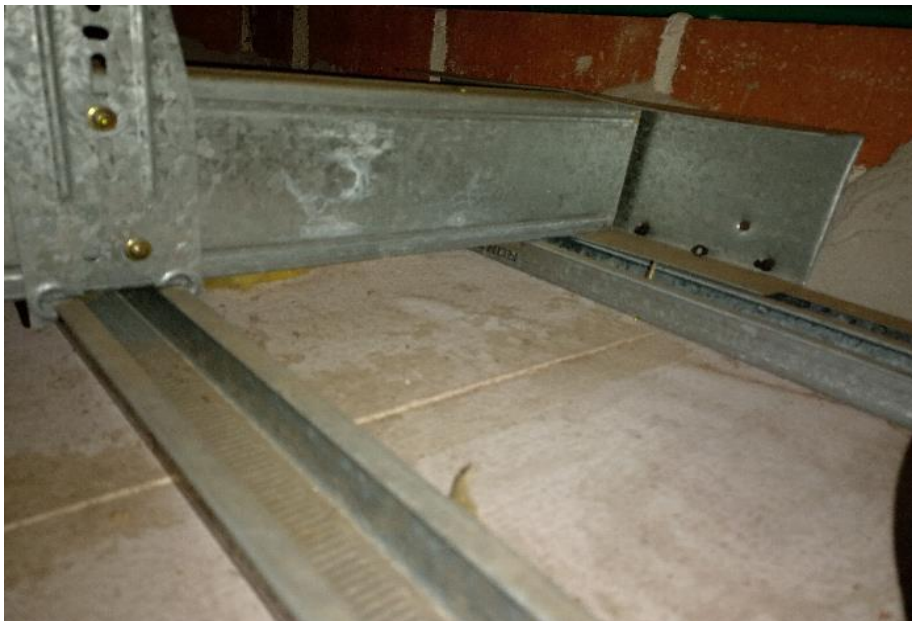
Photograph 40: B00Q, QR0003, ceiling cavity, settled dust & debris, contains lead.

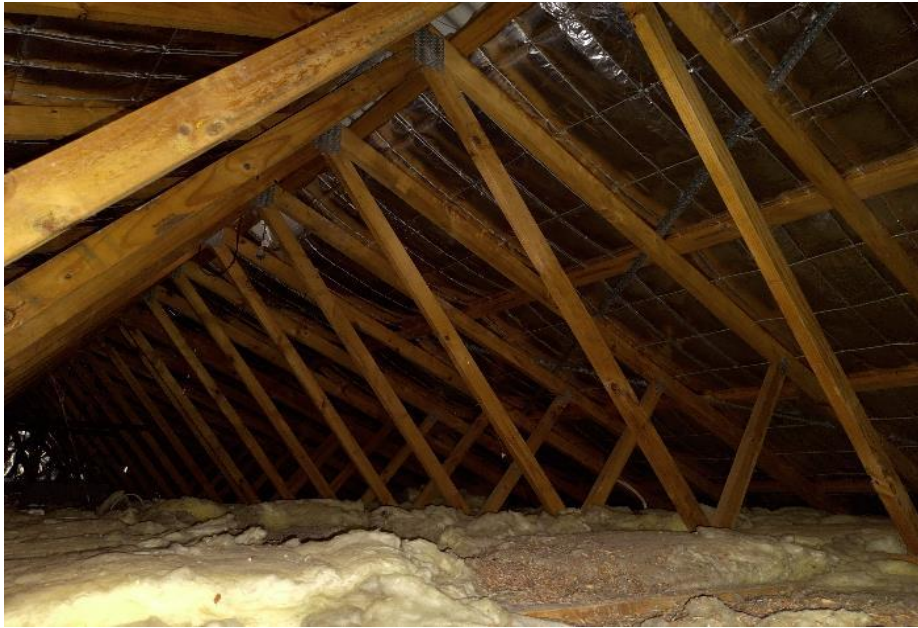
Photograph 41: B00A, ceiling cavity, sarking and insulation batts, suspected SMF.

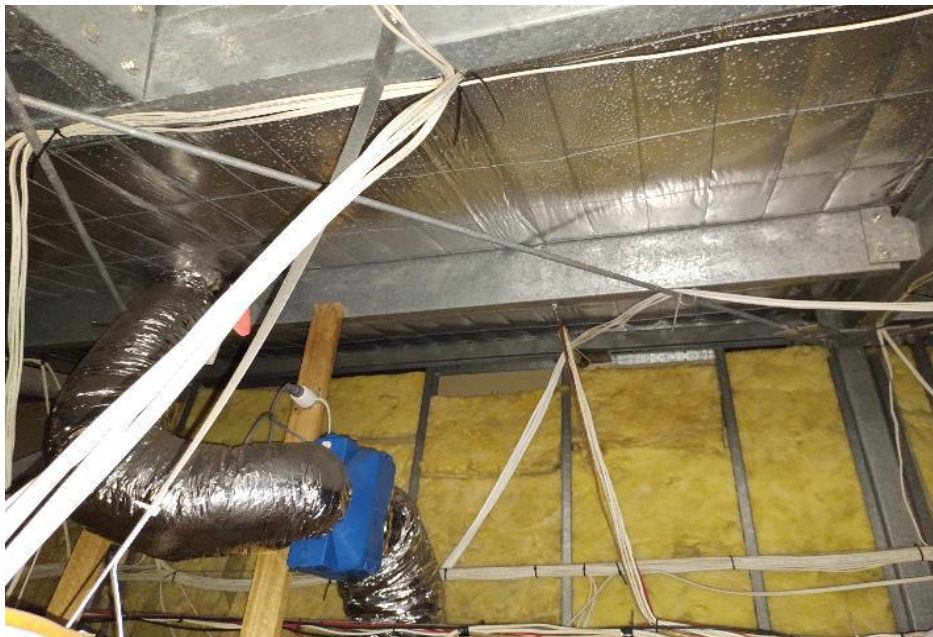
Photograph 42: B00Q, ceiling cavity, insulation batts, sarking and AC ducting, suspected SMF.

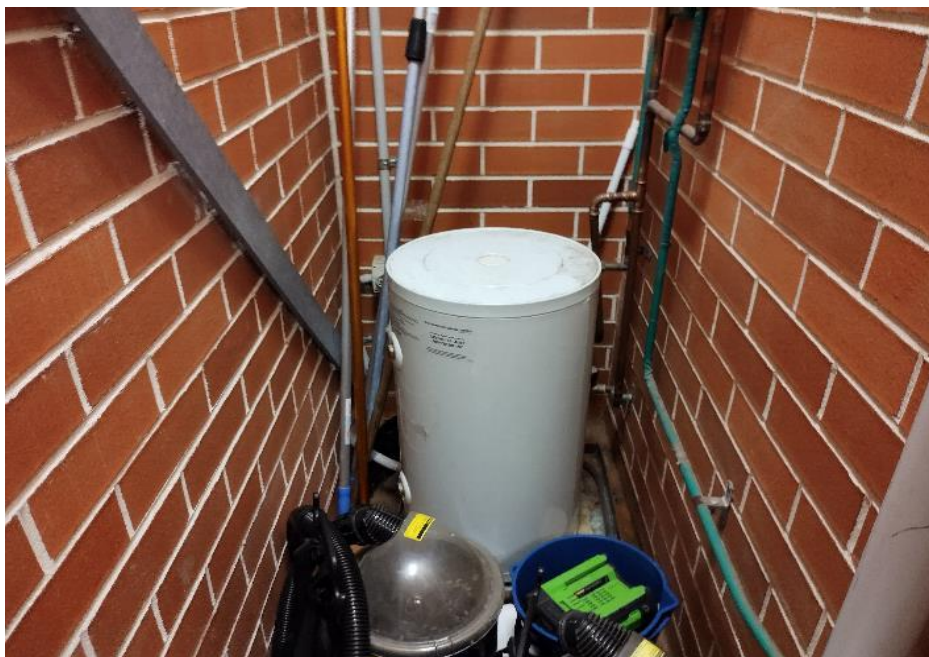
Photograph 43: B00Q, QR0012, hot water unit, internal insulation, suspected SMF.

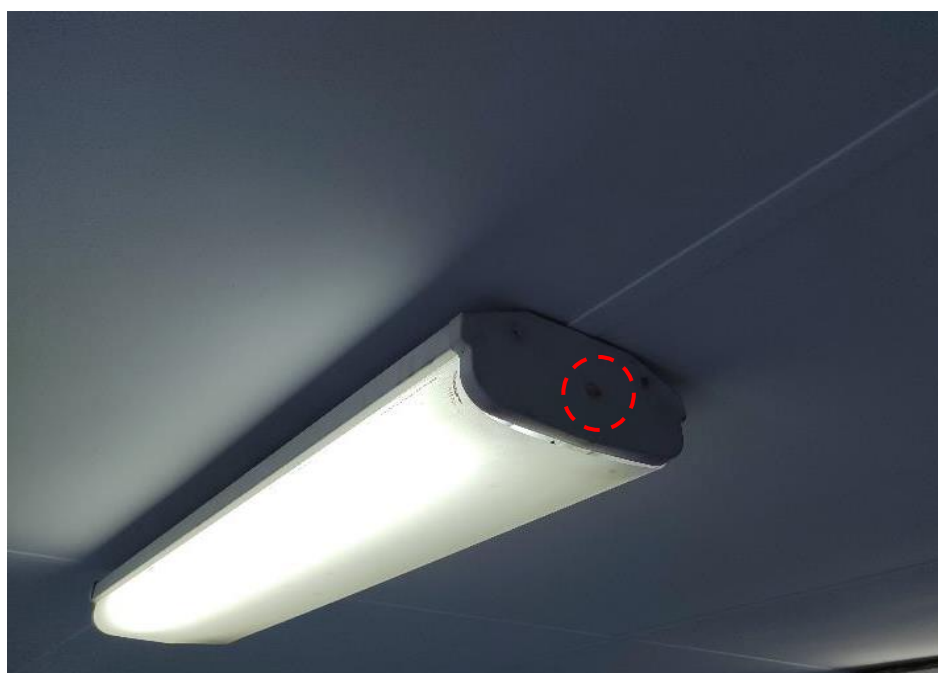
Photograph 44: Buildings in general, fluorescent light fittings, internal components, insulating oil, nil PCB (suspected).
