Hazardous Materials Survey Report

New High School for Medowie - 6 Abundance Road, Medowie NSW 2318

Prepared for: NSW Department of Education

A101024.0124.00 Medowie HBM1 v2f | Date: 23 January 2025

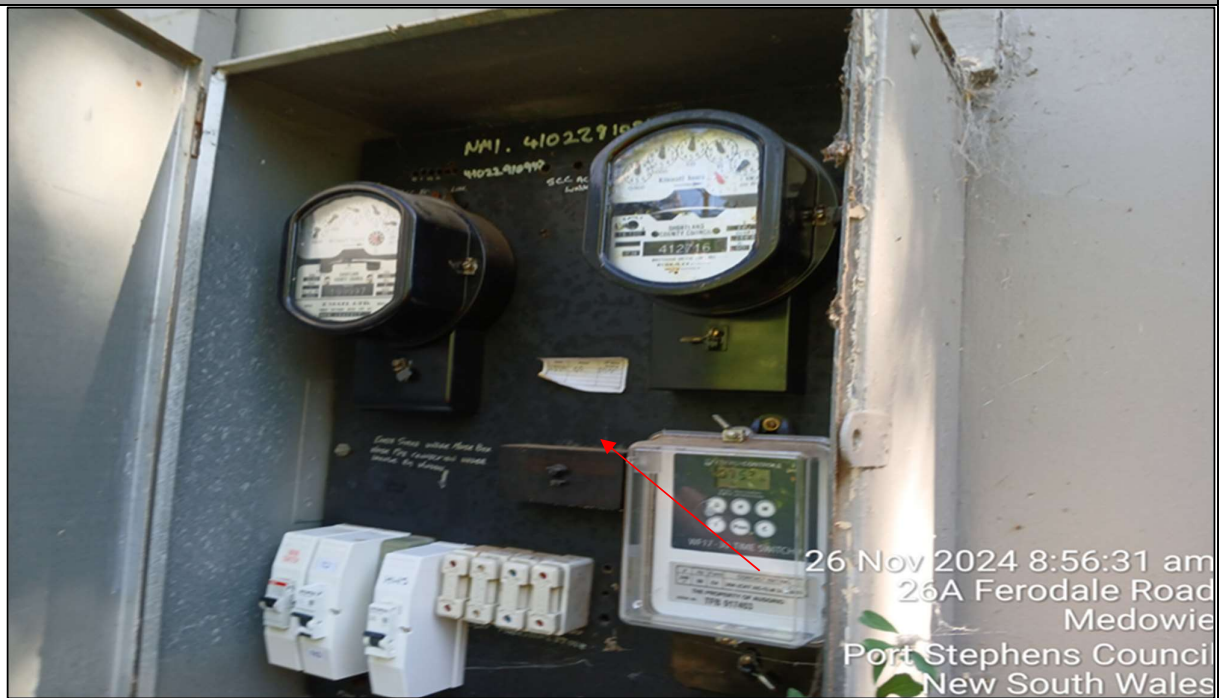
Photograph 2. Electrical backing board, assumed asbestos containing materials

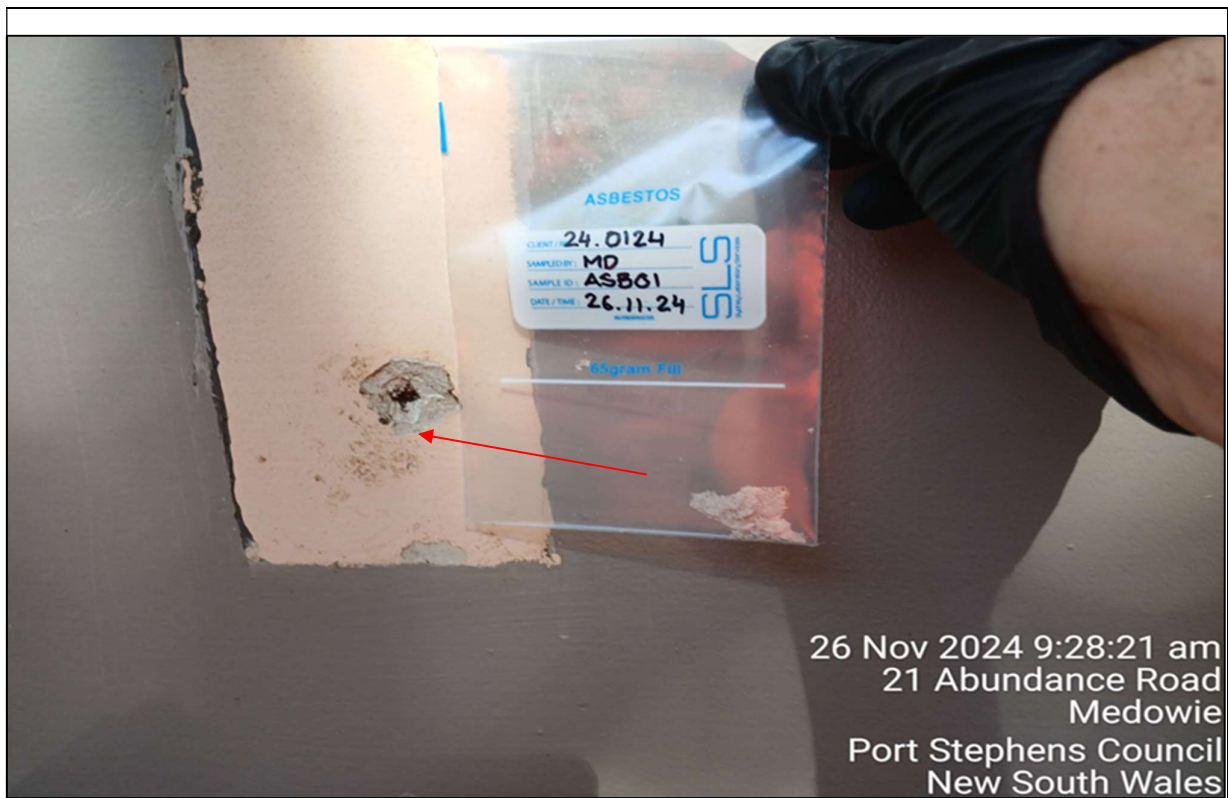
Location	Material	Risk score	Recommendation
Residential building, external ground floor, walls, throughout, Flat fibrous cement sheeting (FFCS)	Chrysotile Asbestos Detected (ASB01)	Medium	Remove prior to refurbishment or demolition. Air monitoring is not compulsory, but it is recommended during and after the removal. Asbestos waste must be disposed as hazardous special asbestos waste to an authorised asbestos waste facility. For further information refer to the SafeWork NSW Code of Practice: How to Safely Remove Asbestos (2022).
Residential building, external, gable ends, FFCS	Chrysotile and Amosite Asbestos Detected (ASB02)	Low	Remove prior to refurbishment or demolition. Air monitoring is not compulsory, but it is recommended during and after the removal. Asbestos waste must be disposed as hazardous special asbestos waste to an authorised asbestos waste facility. For further information refer to the SafeWork NSW Code of Practice: How to Safely Remove Asbestos (2022).

Photograph 3. External, Walls throughout (ASB01) Chrysotile asbestos detected

Risk score	Hazmat material	Recommended Action
Low	Non-Friable Asbestos	Remove prior to refurbishment or demolition. If the amount of non-friable asbestos containing material is greater than 10 square metres (m ²), removal must be performed by a Class A or Class B licensed asbestos removal contractor who must notify SafeWork Australia.
Medium	Non-Friable Asbestos	Remove external walls (represented by positive sample ASB02) and gable ends (positive sample ASB01) prior to refurbishment or demolition. If the amount of non-friable asbestos containing material is greater than 10 square metres (m ²), removal must be performed by a Class A or Class B licensed asbestos removal contractor who must notify SafeWork Australia. Air monitoring is not compulsory, but it is recommended during and after the removal. Asbestos waste must be disposed as hazardous special asbestos waste to an authorized asbestos waste facility. Clearance is required following the removal of greater than 10 square metres (m ²) of non-friable asbestos containing material

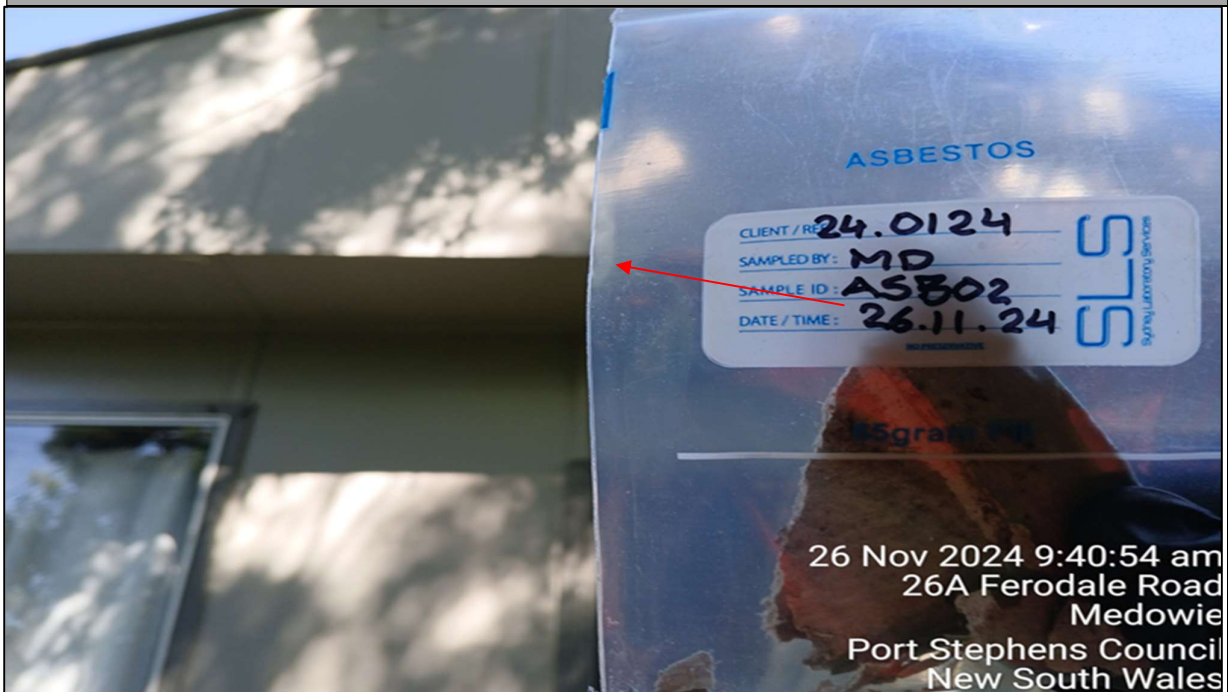
Photograph 4. External, gable ends, throughout (ASB02), Chrysotile and Amosite asbestos detected

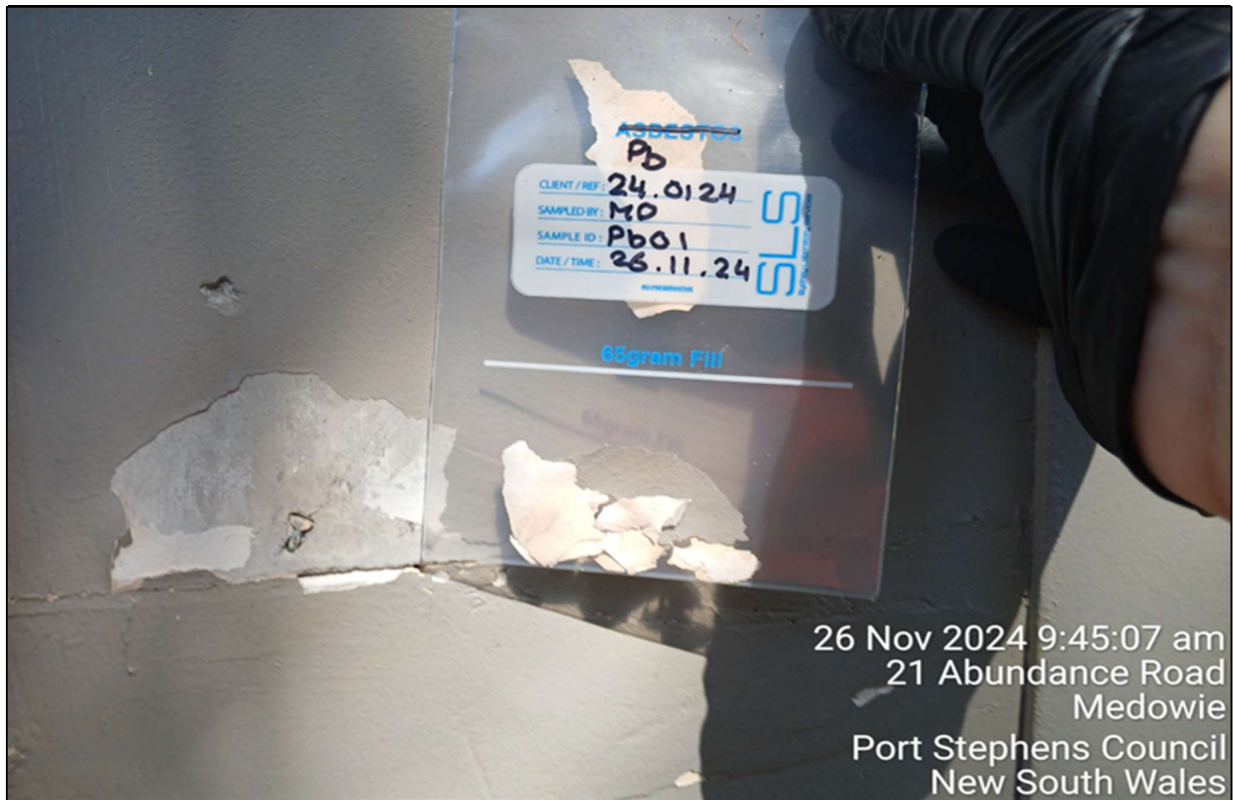
Photograph 5 External, throughout. (Pb01) Lead content below 0.1% (w/w Lead)

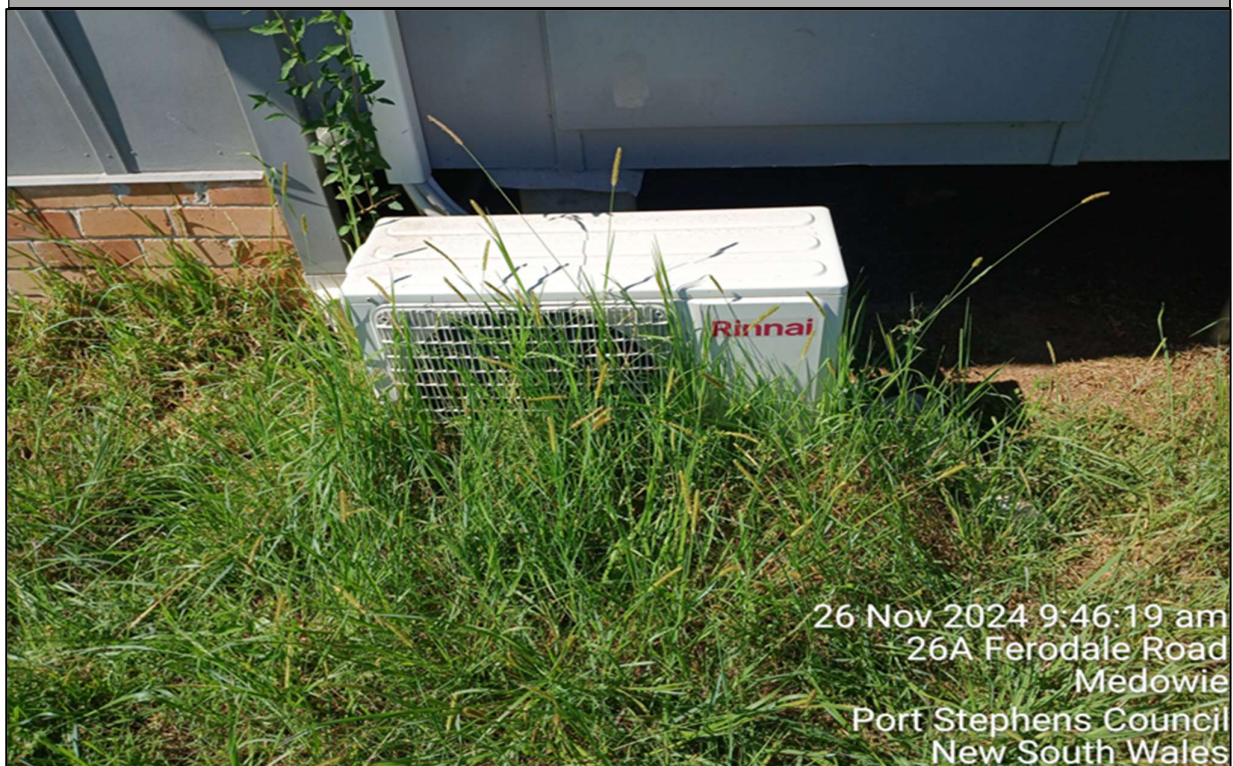
Photograph 6. Air conditioning unit, Insulation, assumed to contain SMF

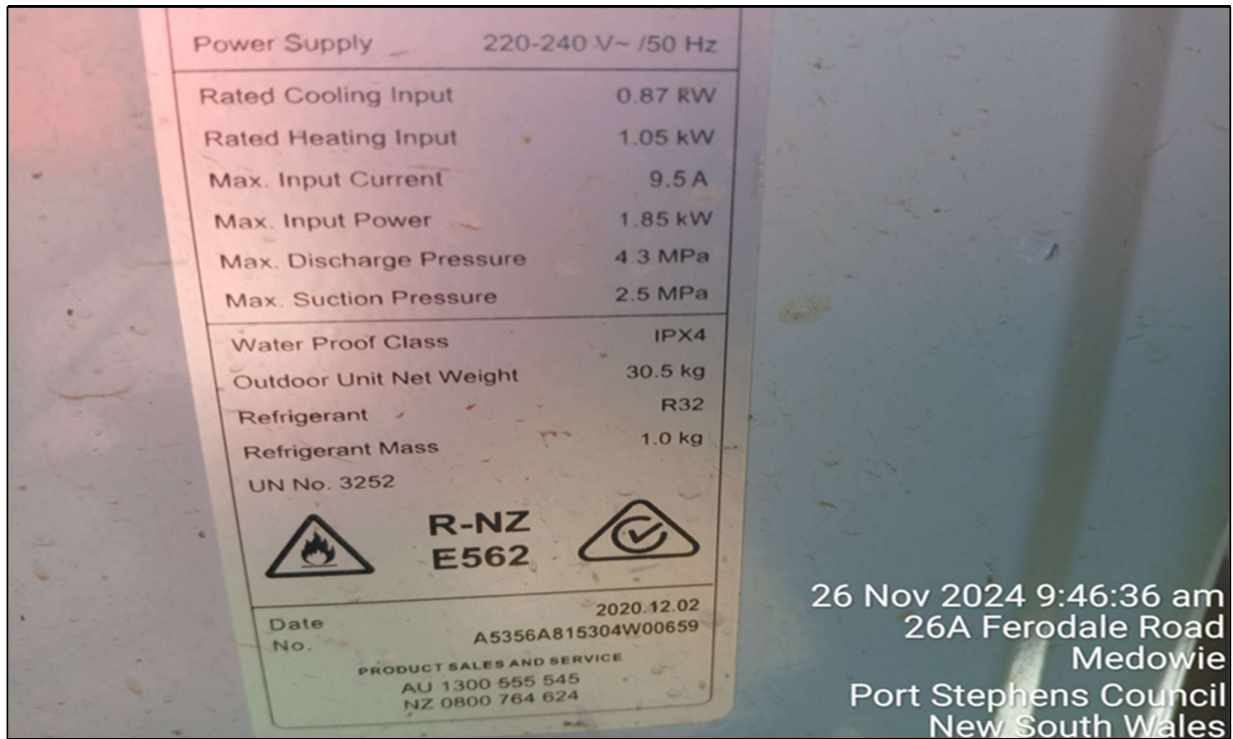
Photograph 7. External, residence, Airconditioning unit, refrigerant R32 not classified as ozone depleting substance.

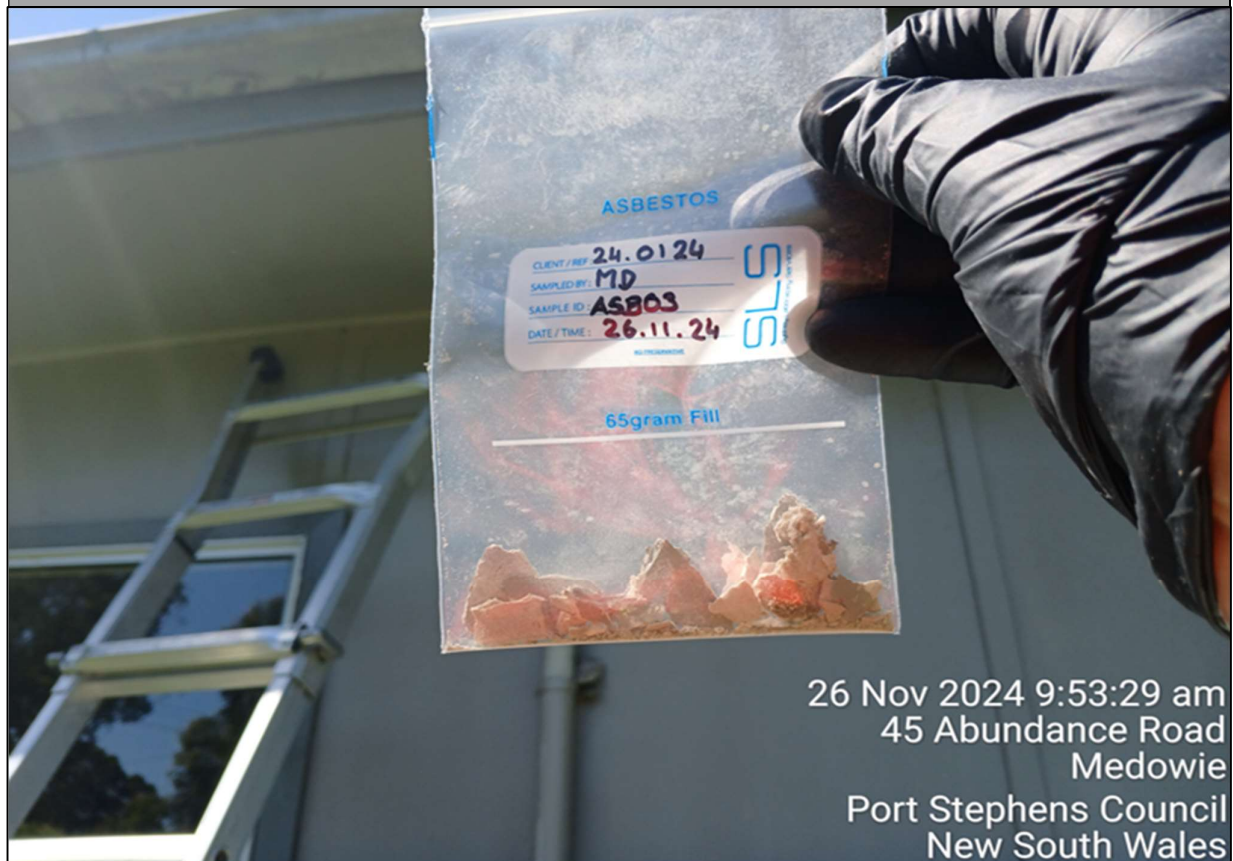
Photograph 8. Eaves, throughout (ASB03) No asbestos detected.

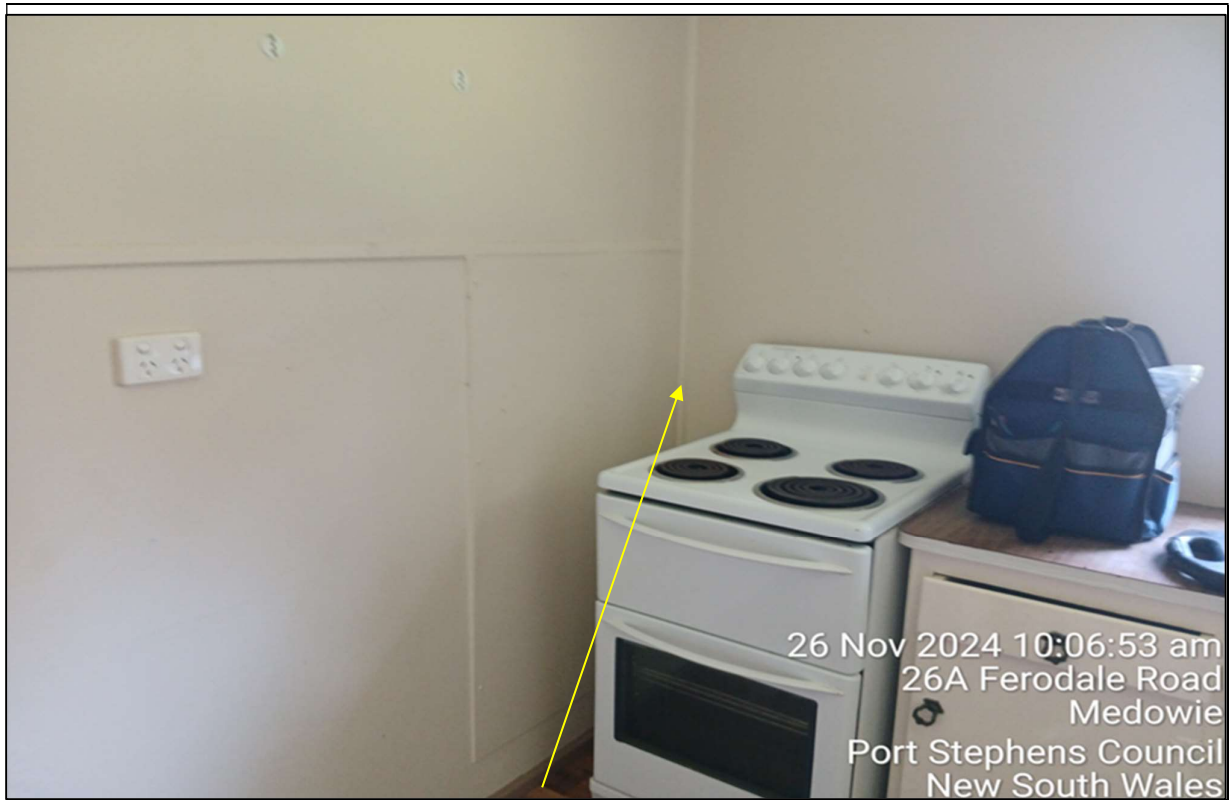
Internal	Ground floor	Kitchen, sheeting adjacent oven	Flat fibrous cement sheeting	Asbestos	2	m2	9	ASB04	No asbestos detected.	Non friable	Accessible	Good	Negligible	No asbestos detected. No further action required.
Internal	Ground floor	Ceiling cavity	Insulation batts	Asbestos	80	m2	10	ASB05	No asbestos detected.	Non friable	Accessible	Good	Negligible	No asbestos detected. No further action required.
Internal	Ground floor	Ceiling cavity	Insulation batts	Synthetic Mineral Fibres	80	m2	10	ASB05	Synthetic Mineral Fibres Detected	N/A	Non-accessible	Good	Low	Maintain in current condition if to remain in-situ. Remove in accordance with The National Code of Practice for the Safe Use of Synthetic Mineral Fibres [NOHSC:2006(1990)].
Internal	Ground floor	Bathroom, walls	Flat fibrous cement sheeting	Asbestos	10	m2	11	ASB06	No asbestos detected.	Non friable	Accessible	Good	Negligible	No asbestos detected. No further action required.

Photograph 9. Kitchen, sheeting adjacent oven (ASB04). No asbestos detected.

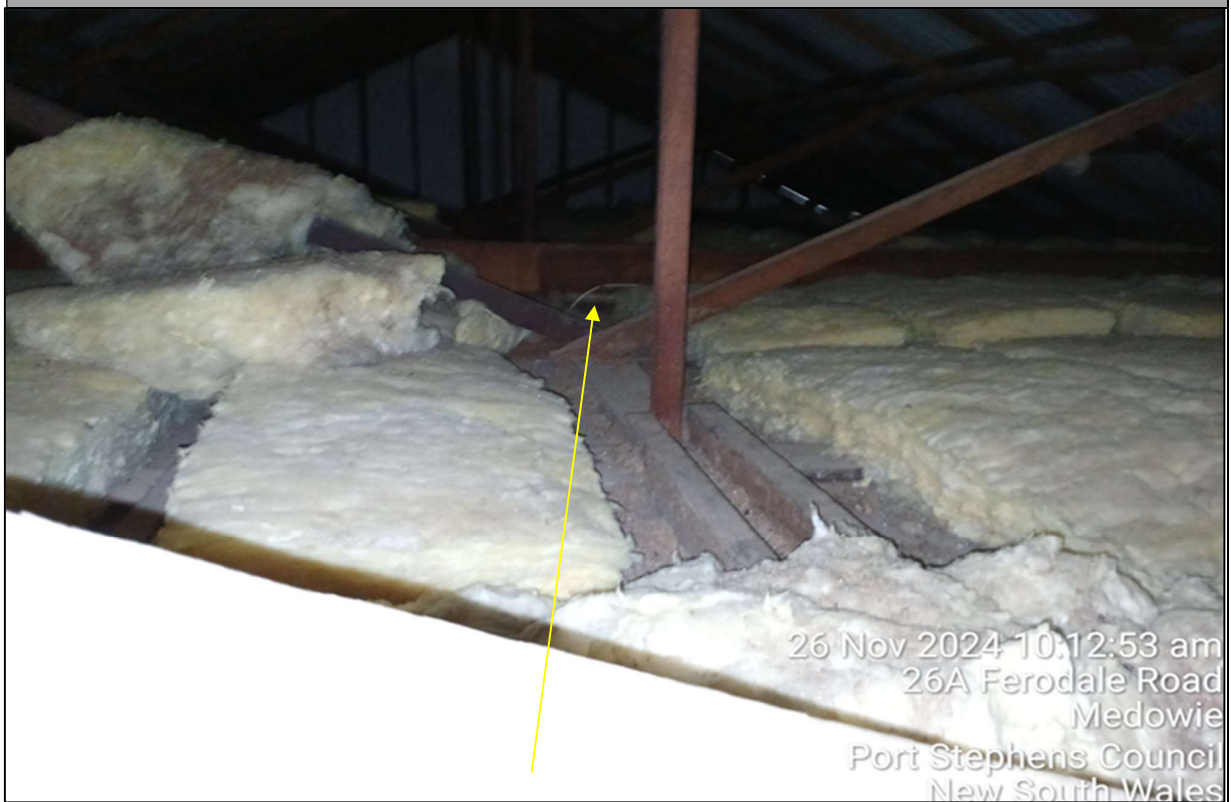
Location	Material	Risk score	Recommendation
Residential building, internal, ground floor, ceiling cavity, insulation batts	SMF fibres detected (ASB05)	Low	Encapsulate exposed sections under controlled SMF conditions and remove in accordance with The National Code of Practice for the Safe Use of Synthetic Mineral Fibres [NOHSC:2006(1990)]

Photograph 10. Ceiling cavity, Insulation batts, (ASB05) SMF Detected

Risk score	Hazmat material	Recommended Action
Low	Non-Friable SMF	Remove ceiling cavity insulation batts (sampled as ASB05) prior to refurbishment or demolition as a preventive action to minimise the generation of fibres and dust during refurbishment or demolition works. A hazardous materials removal contractor can perform the removal. SafeWork Australia does not need to be notified. Air monitoring is not necessary. The material can be disposed as a general waste construction. Clearance is not required. For further information refer to the NSW SafeWork information guide on the safe management of synthetic mineral fibres (SMF) – glass wool and Rockwool.

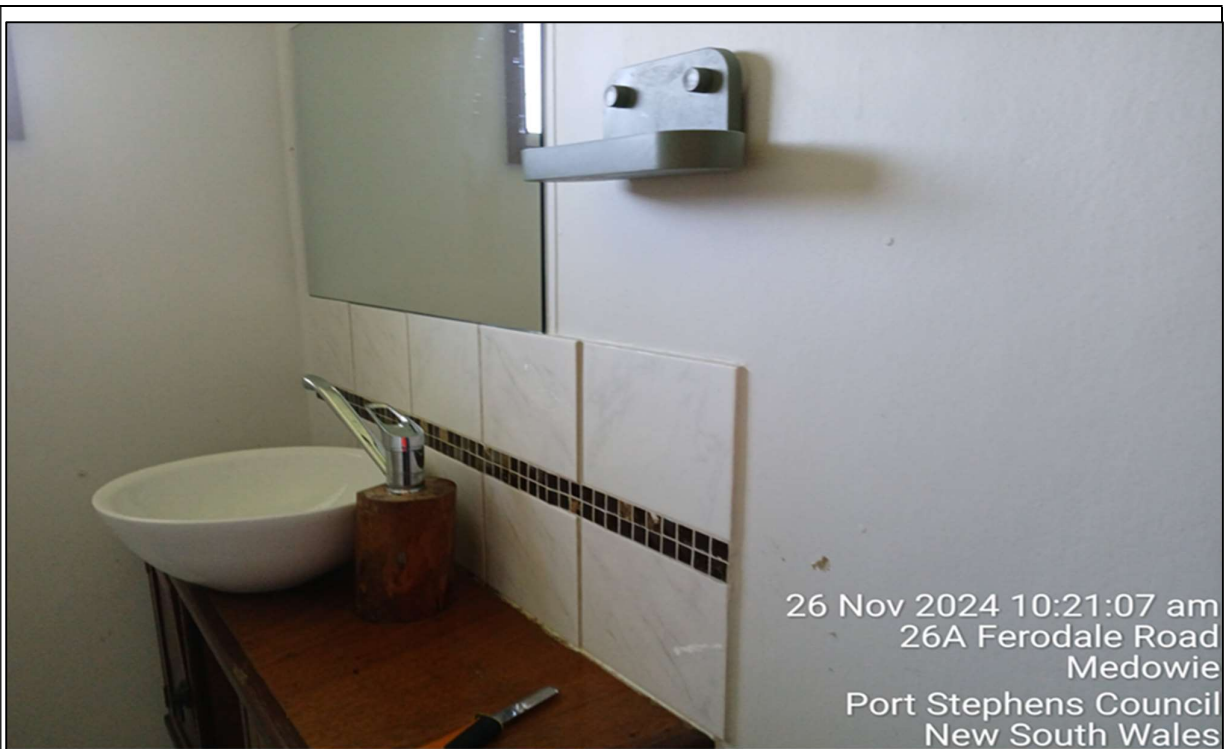
Photograph 11. Bathroom, walls. (ASB06). No asbestos detected

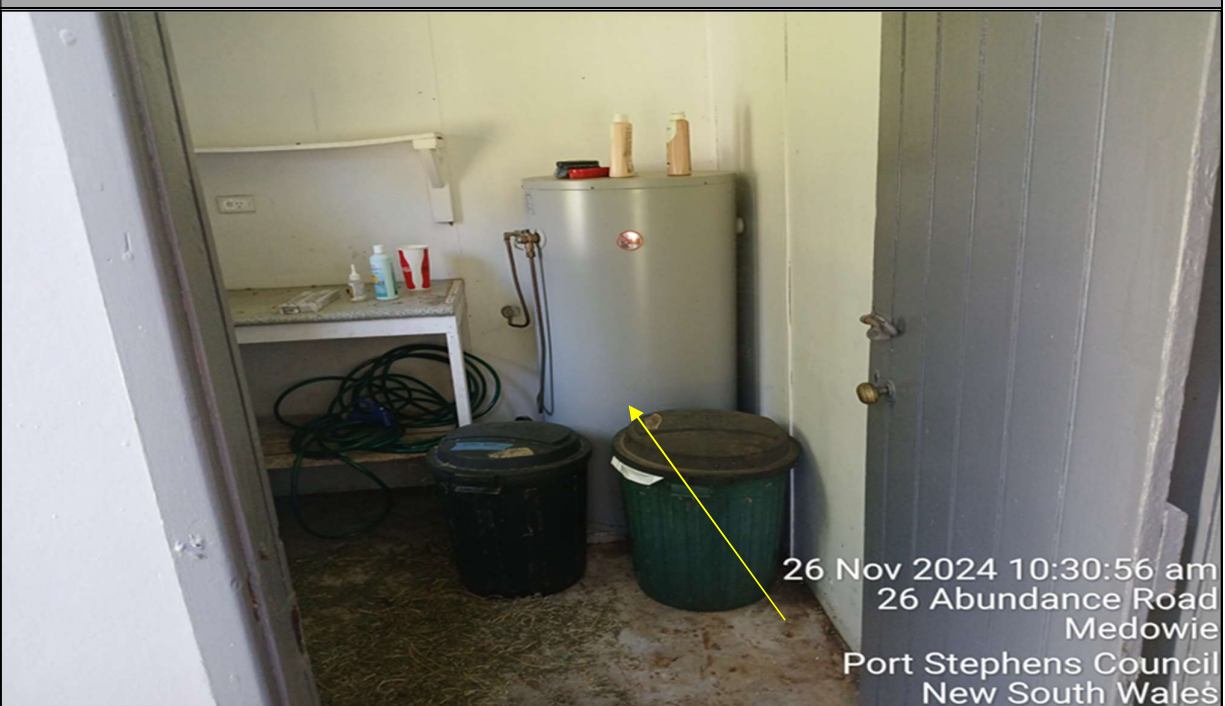
Photograph 12. Laundry, Hot water system unit insulation. assumed to contain synthetic mineral fibres

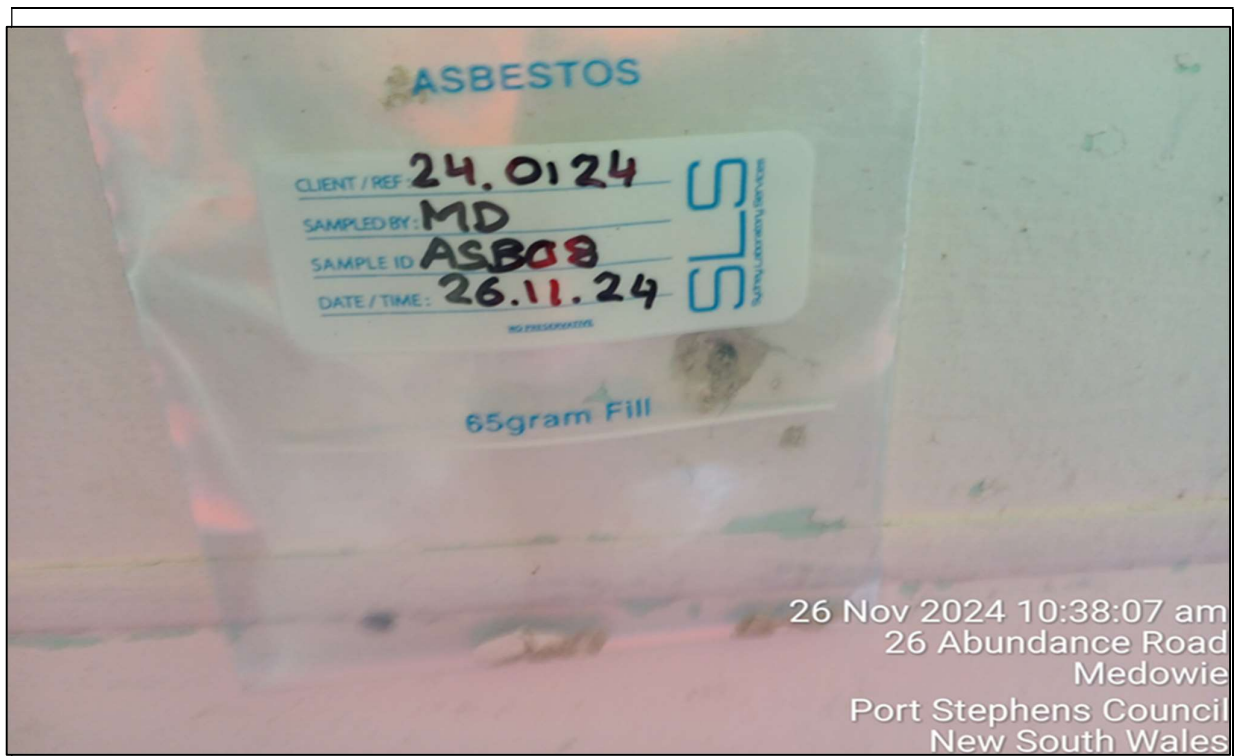
Photograph 13. Laundry, walls. (ASB08) No asbestos detected.

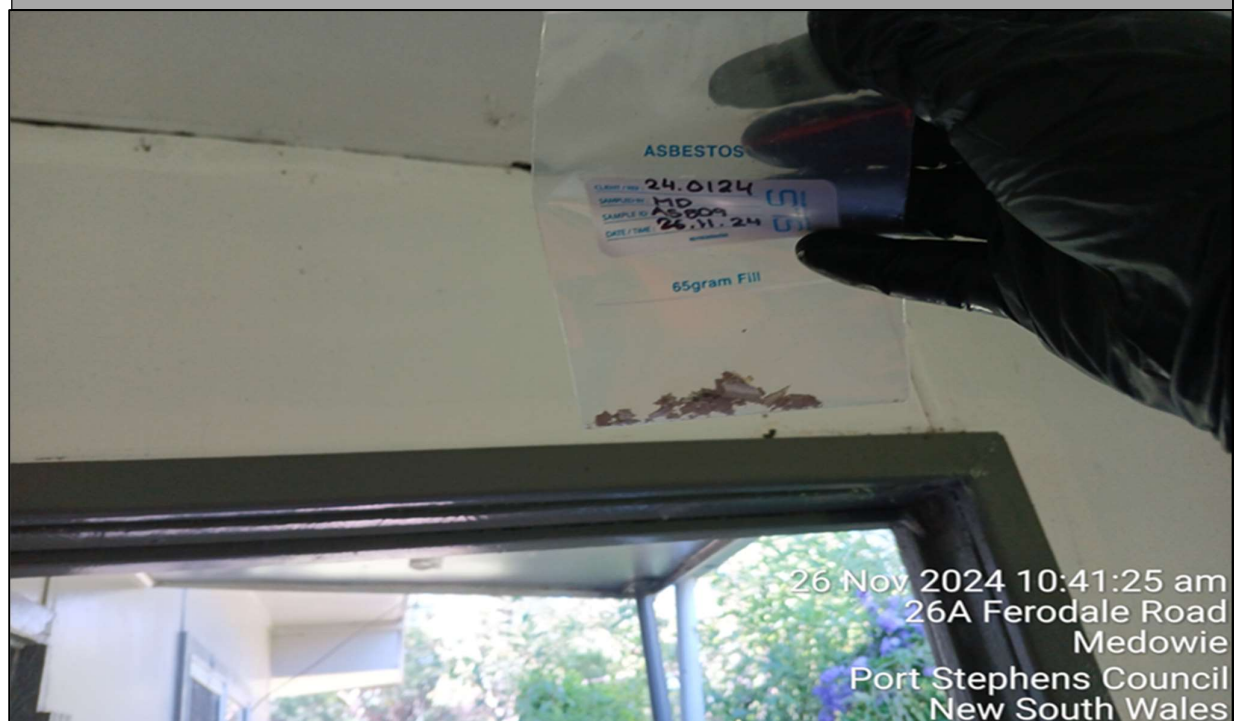
Photograph 14. Laundry, ceiling. (ASB09) No asbestos detected.

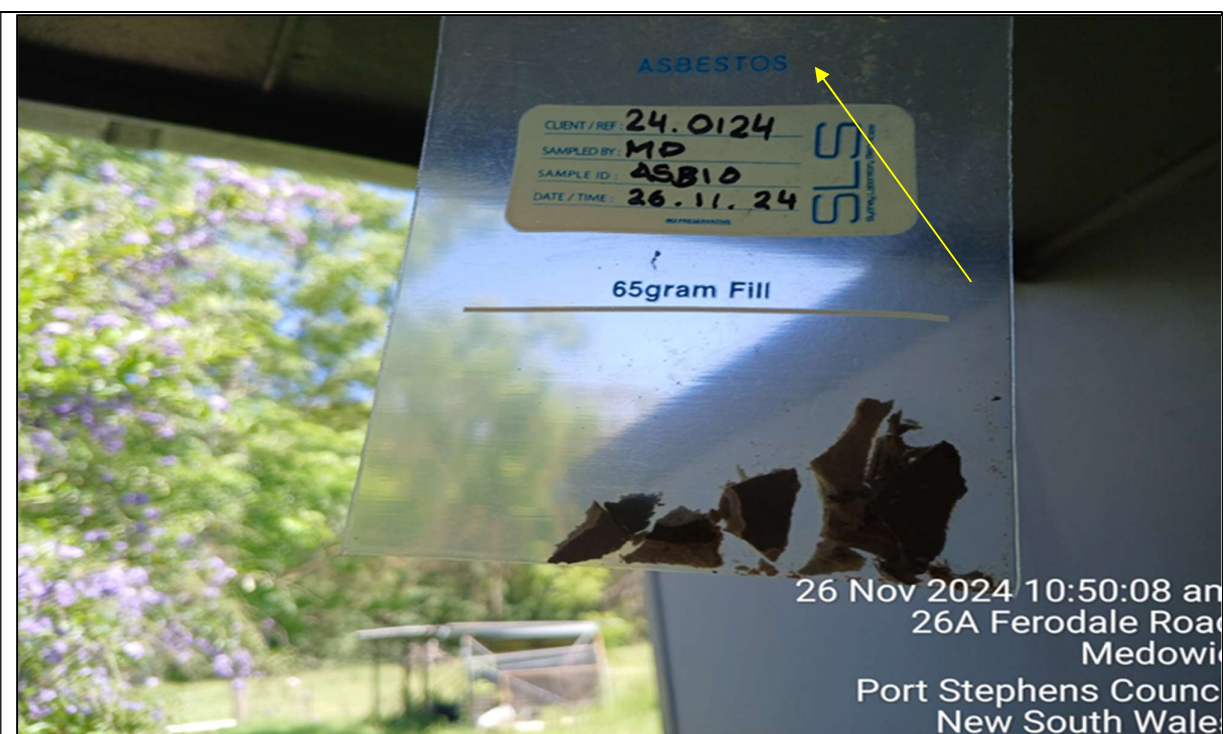
External	Ground floor	Rear access, ceiling lining	Flat fibrous cement sheeting	Asbestos	2	m2	15	ASB10	No asbestos detected.	Non friable	Accessible	Good	Negligible	No asbestos detected. No further action required.
External	Ground floor	Northern aspect	Air conditioning unit, Insulation	Synthetic Mineral Fibres	1	Unit	6	-	Assumed to contain synthetic mineral fibres	N/A	Non-accessible	Good	Negligible	Maintain in current condition if to remain in-situ. Remove in accordance with The National Code of Practice for the Safe Use of Synthetic Mineral Fibres [NOHSC:2006(1990)].
External	Ground floor	Residence, stand alone shed	Air conditioning unit, Insulation	Synthetic Mineral Fibres	1	Unit	17	-	Asumed to contain synthetic mineral fibres	N/A	Non-accessible	Good	Negligible	Maintain in current condition if to remain in-situ. Remove in accordance with The National Code of Practice for the Safe Use of Synthetic Mineral Fibres [NOHSC:2006(1990)].

Photograph 15. Rear access, ceiling lining (ASB11) No asbestos detected.

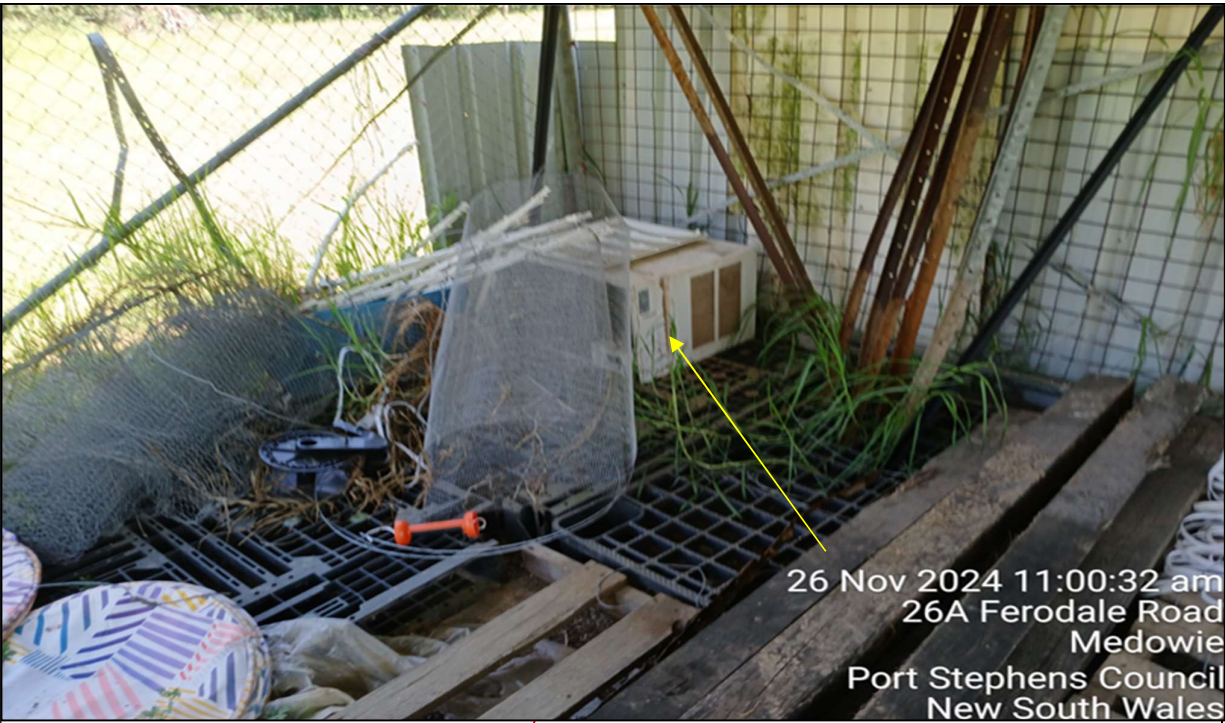
Photograph 17. Air conditioning unit (R22). Insulation assumed to contain synthetic mineral fibres

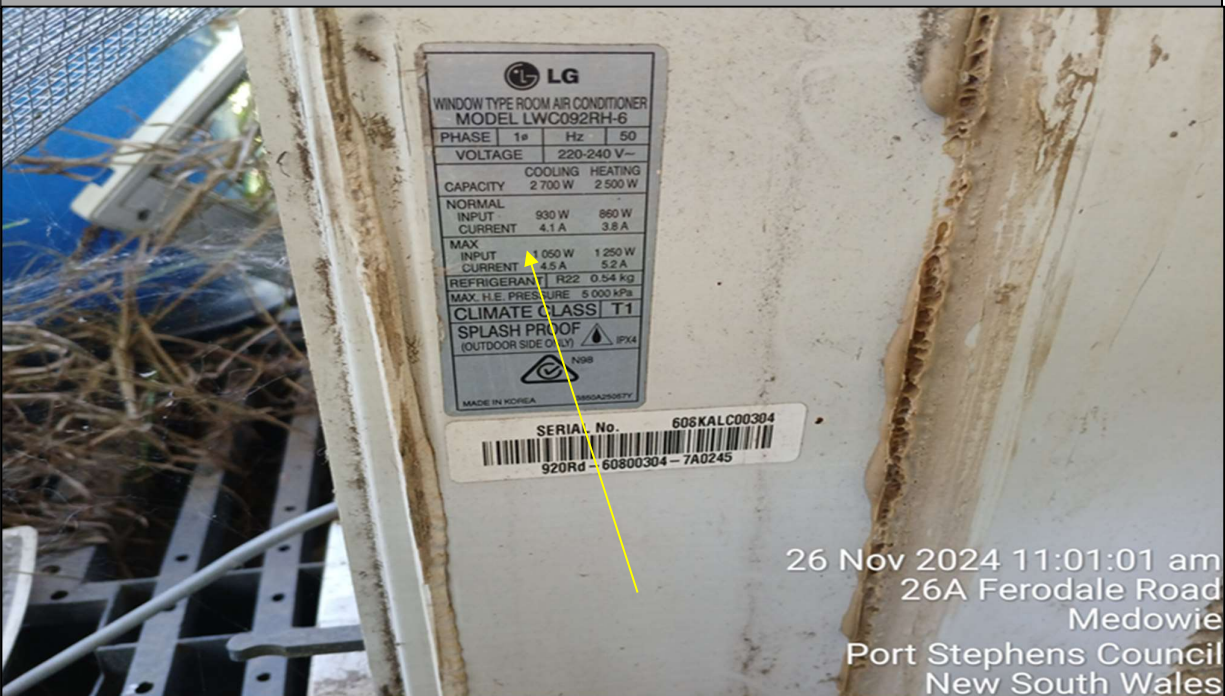
Location	Material	Risk score	Recommendation
Exterior, shed adjacent residential building decommissioned air-conditioning unit	Name plate, R22	Low	ODS in a system observed to be in sound condition and effectively sealed. No activity being conducted in the immediate area with the potential to disturb the material. Environmental risk is negligible if left undisturbed. ODS are to be removed and disposed of in accordance with the Australia and New Zealand Refrigerant Handling Code of Practice 2007 Part 1 – Self-Contained Low Charge System and the Australia New Zealand Refrigerant Handling Code of Practice 2007 Part 2 – Systems Other than Self-Contained Low Charge System.

Photograph 18. Air conditioning unit, (R22) ozone depleting substances

Risk score	Hazmat material	Recommended Action
Low	ODS	R22 ODS in a system observed to be in sound condition and effectively sealed. No activity being conducted in the immediate area with the potential to disturb the material. Environmental risk is negligible if left undisturbed. ODS are to be removed and disposed of in accordance with the Australia and New Zealand Refrigerant Handling Code of Practice 2007 Part 1 – Self-Contained Low Charge System and the Australia New Zealand Refrigerant Handling Code of Practice 2007 Part 2 – Systems Other than Self-Contained Low Charge System.

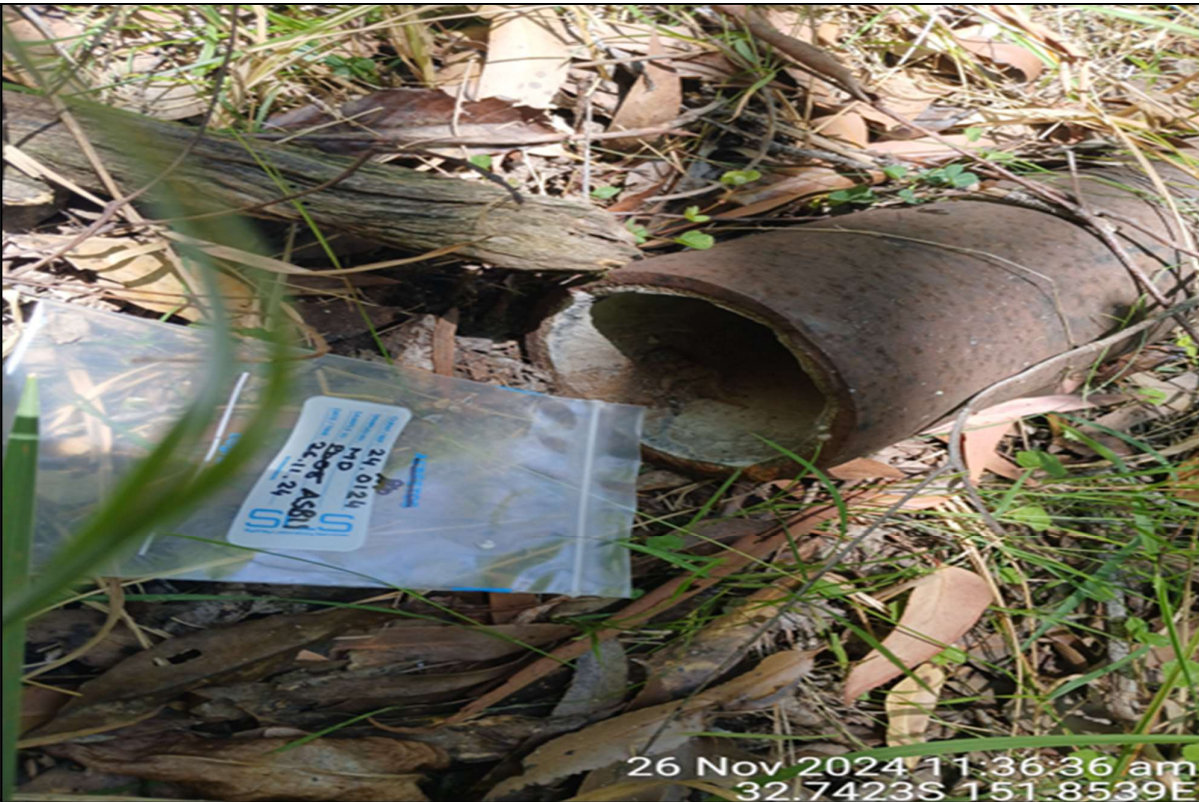
Photograph 19. "32.74236S 1518539E", Pipe lining (ASB11). No asbestos detected.
