# Hazardous Building Materials Assessment

**Lismore South Public School – Flood  
Recovery Rebuild**

NSW Department of Education

04 June 2025

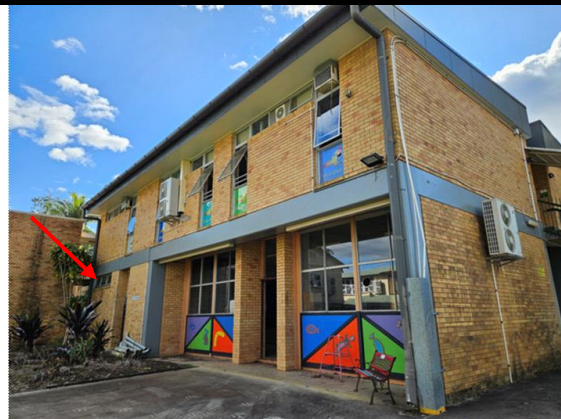
| Consultant | | | Location / Description | | | | | | | | | | Risk Assessment | | | | | | | | | | | |
|---|---|---|---|---|---|---|---|---|---|---|---|---|---|---|---|---|---|---|---|---|---|---|---|--|
| 18-Jul-24 | | GHD | B00A - Library | GF | External | Sealant / Adhesives | All windows to ground floor south wall | South wall | Putty | Unsealed | Refer to B00A-A06 | Chrysotile Detected | Non-friable | Poor | High | Very high | Removal | Labels required (not affixed or not sufficient) | 6 | Item | Quantity estimate based on number of individual windows. | | | |

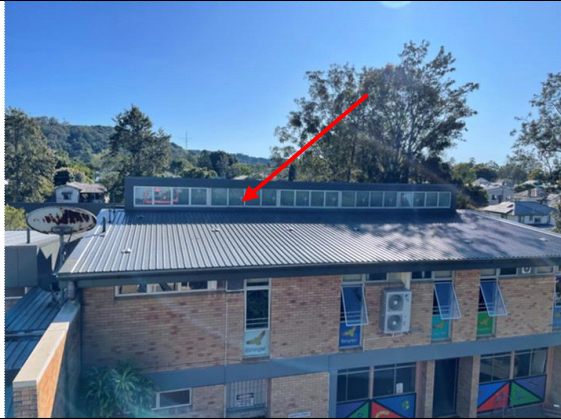
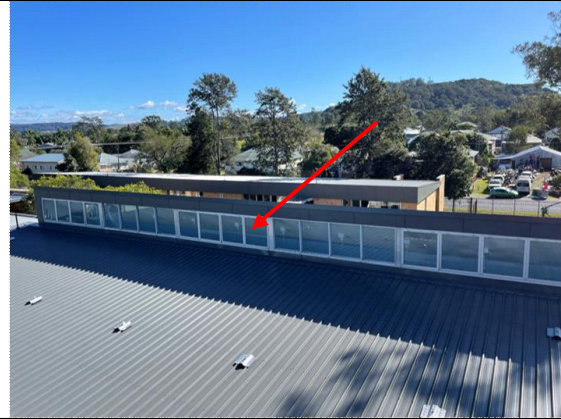
| Consultant | | | Location / Description | | | | | | | | | | Risk Assessment | | | | | | | | | | | |
|---|---|---|---|---|---|---|---|---|---|---|---|---|---|---|---|---|---|---|---|---|---|---|---|--|
| 18-Jul-24 | | GHD | B00A - Library | 01 | External | Sealant / Adhesives | All windows to skylight on roof | Southern aspect | Putty | Unsealed | Refer to B00A-A06 | Chrysotile Detected | Non-friable | Poor | High | Very high | Removal | Labels required (not affixed or not sufficient) | 20 | Item | Quantity estimate based on number of individual windows. | | | |

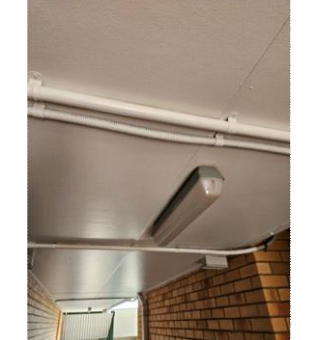
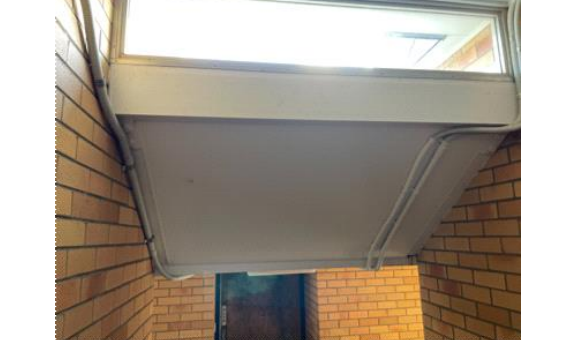
| Consultant | | | Location / Description | | | | | | | | | | Risk Assessment | | | | | | | | | | | |
|---|---|---|---|---|---|---|---|---|---|---|---|---|---|---|---|---|---|---|---|---|---|---|---|--|
| 18-Jul-24 | | GHD | B00A - Movement | 01 | External | Flat cement product | Ceiling linings to walkway to western aspect of B00A | Ceiling linings throughout walkway areas including B00A entryway | Lining | Sealed | Refer to B00H-A06 | Chrysotile & Amosite Detected | Non-friable | Good | High | Very high | Removal | Labels required (not affixed or not sufficient) | 75 | m2 | | | | |

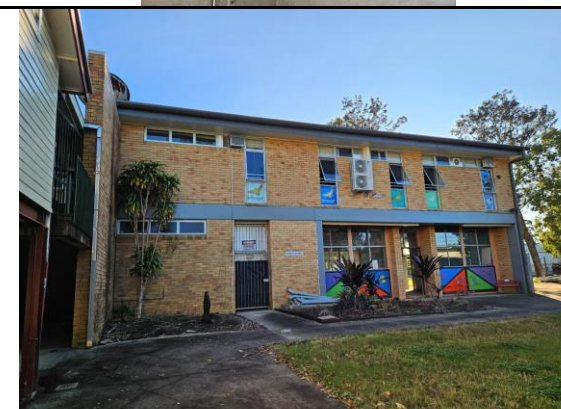
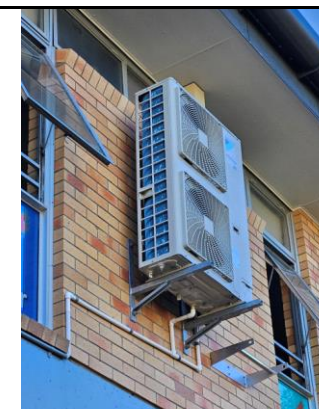
| Inspection date | Reinspection Date | Consultant and Surveyor Reference | Building Ref | Floor | Room or Space | Material description | Primary location | Secondary location | Application | Surface treatment | Sample identification | Laboratory results | Friability | Material condition | Likelihood of disturbance | Risk | Control method | Labelling | Estimated quantity | Units | Comments | Photograph reference | | Photograph reference | |
|---|---|---|---|---|---|---|---|---|---|---|---|---|---|---|---|---|---|---|---|---|---|---|--|---|--|
| 18-Jul-24 | | GHD | B00A | 01 | External | Thermal insulation | Air conditioning units | Southern wall and northern wall | Insulation | - | Assumed | Presumed to contain SMF until proven otherwise | N/A | Good | High | Very high | Removal | N/A | 3 | Item | Air-conditioning units throughout B00A | | | | |

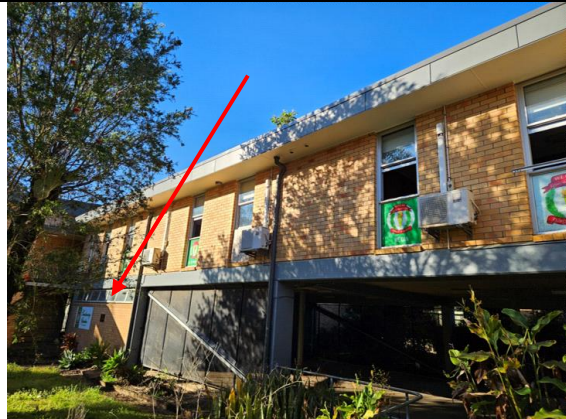
| Consultant | | | Location / Description | | | | | | | | | | Risk Assessment | | | | | | | | | | | |
|---|---|---|---|---|---|---|---|---|---|---|---|---|---|---|---|---|---|---|---|---|---|---|---|--|
| 18-Jul-24 | | GHD | B00B - Administration | GF | External | Sealant / Adhesives | Window putty between glass and window frame within rectangular windows | Student toilets - south and north wall | Putty | Unsealed | Refer to B00A-A06 | Chrysotile Detected | Non-friable | Fair | High | Very high | Removal | Labels required (not affixed or not sufficient) | 14 | Item | Quantity estimate based on number of individual windows. | | | |

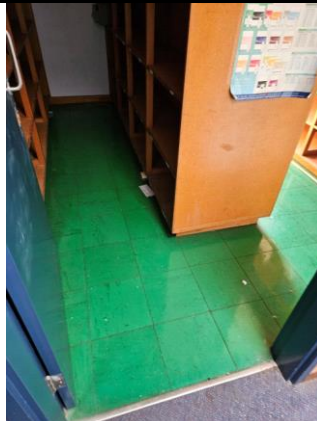
| Consultant | | | Location / Description | | | | | | | | | | Risk Assessment | | | | | | | | | | | |
|---|---|---|---|---|---|---|---|---|---|---|---|---|---|---|---|---|---|---|---|---|---|---|---|--|
| 18-Jul-24 | | GHD | B00B - Storeroom | 01 | Internal | Floor tiles | Green vinyl floor tiles - General storeroom | Floor | Lining | Sealed | B00B-A02 | Chrysotile Detected | Non-friable | Good | High | Very high | Removal | Labels required (not affixed or not sufficient) | 15 | m2 | | | | |

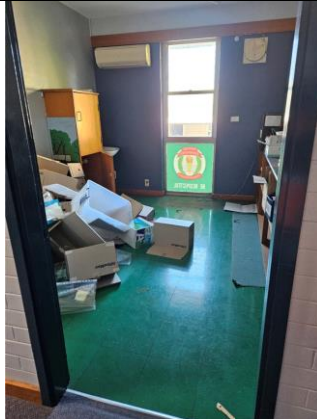
| Consultant | | | Location / Description | | | | | | | | | | Risk Assessment | | | | | | | | | | | |
|---|---|---|---|---|---|---|---|---|---|---|---|---|---|---|---|---|---|---|---|---|---|---|---|--|
| 18-Jul-24 | | GHD | B00B - Photocopy room | 01 | Internal | Floor tiles | Green vinyl floor tiles - photocopy room | Floor | Lining | Sealed | Refer to B00B-A02 | Chrysotile Detected | Non-friable | Good | High | Very high | Removal | Labels required (not affixed or not sufficient) | 12 | m2 | | | | |

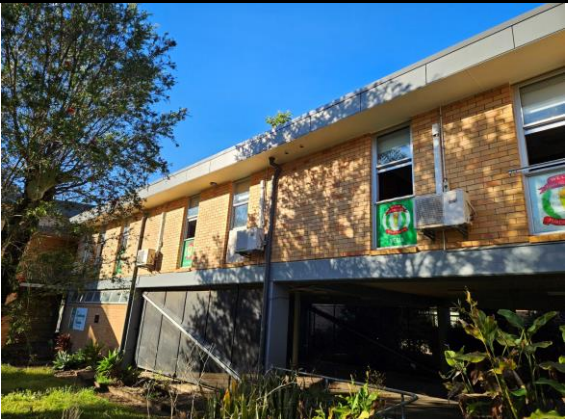
| Inspection date | Reinspection Date | Consultant and Surveyor Reference | Building Ref | Floor | Room or Space | Material description | Primary location | Secondary location | Application | Surface treatment | Sample identification | Laboratory results | Friability | Material condition | Likelihood of disturbance | Risk | Control method | Labelling | Estimated quantity | Units | Comments | Photograph reference | Photograph reference |
|---|---|---|---|---|---|---|---|---|---|---|---|---|---|---|---|---|---|---|---|---|---|---|---|
| 18-Jul-24 | | GHD | B00B - Administration | 01 | External | Thermal insulation | Southern wall | Air conditioners | Insulation | Sealed | Assumed | Presumed to contain SMF until proven otherwise | Non-friable | Good | High | Very high | Removal | Not required | 8 | Item | | | |

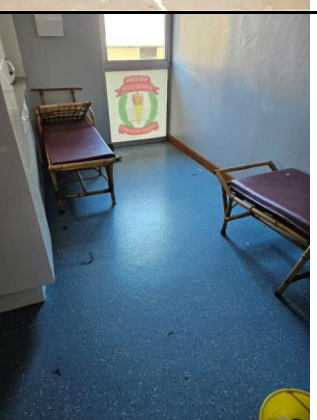
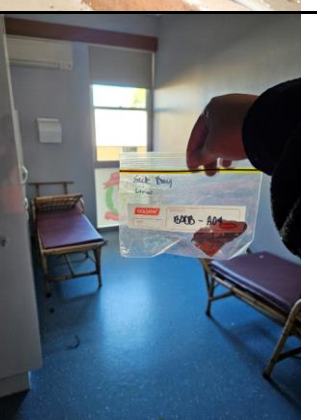
| Inspection date | Reinspection Date | Consultant and Surveyor Reference | Building Ref | Floor | Room or Space | Material description | Primary location | Secondary location | Application | Surface treatment | Sample identification | Laboratory results | Friability | Material condition | Likelihood of disturbance | Risk | Control method | Labelling | Estimated quantity | Units | Comments | Photograph reference | Photograph reference |
|---|---|---|---|---|---|---|---|---|---|---|---|---|---|---|---|---|---|---|---|---|---|---|---|
| 18-Jul-24 | | GHD | B00B - Sick Bay | 01 | Internal | Floor sheeting | Floors | Throughout | Lining | Sealed | B00B-A04 | SMF Detected | Non-friable | Good | High | Very high | Removal | Not required | 8 | m2 | | | |

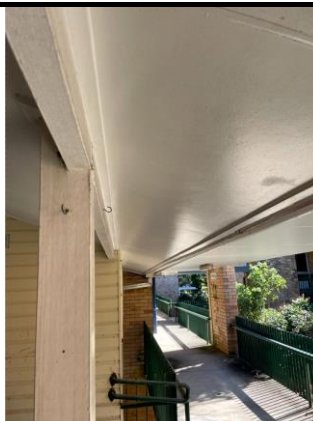
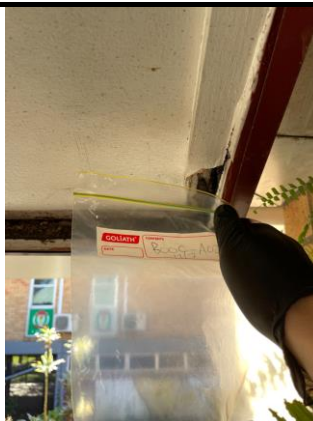
| Consultant | | | Location / Description | | | | | | | | | | Risk Assessment | | | | | | | | | | | |
|---|---|---|---|---|---|---|---|---|---|---|---|---|---|---|---|---|---|---|---|---|---|---|---|--|
| 17-Jul-24 | | GHD | B00C - Movement | 01 | External | Flat cement product | Walkway to northern aspect of B00C | Ceiling lining | Lining | Sealed | B00C-A02 | Chrysotile Detected | Non-friable | Good | High | Very high | Removal | Labels required (not affixed or not sufficient) | 35 | m2 | | | | |

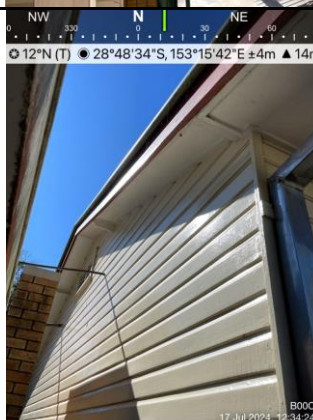
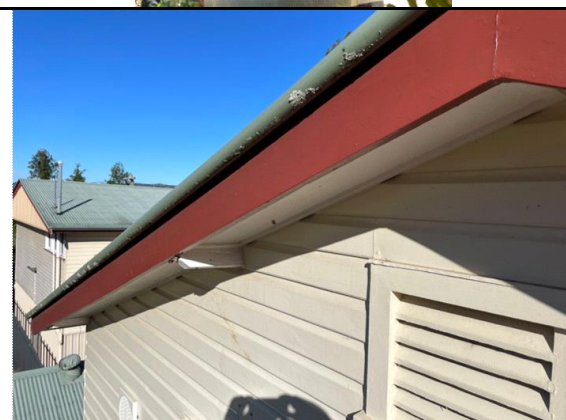
| Consultant | | | Location / Description | | | | | | | | | | Risk Assessment | | | | | | | | | | | |
|---|---|---|---|---|---|---|---|---|---|---|---|---|---|---|---|---|---|---|---|---|---|---|---|--|
| 17-Jul-24 | | GHD | B00C | Roof | External | Flat cement product | Eaves | All aspects of B00C | Lining | Sealed | B00C-A06 | Chrysotile Detected | Non-friable | Good | High | Very high | Removal | Labels required (not affixed or not sufficient) | 55 | m2 | | | | |

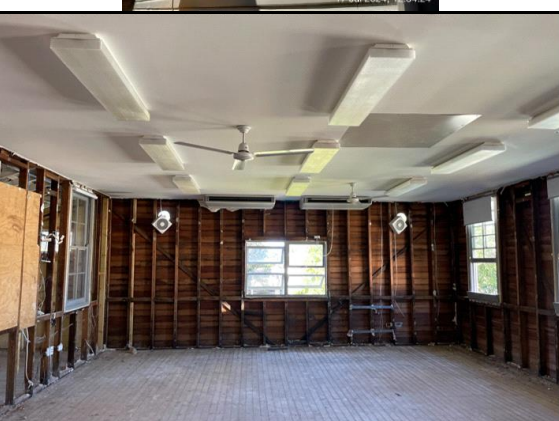
| Consultant | | | Location / Description | | | | | | | | | | Risk Assessment | | | | | | | | | | | |
|---|---|---|---|---|---|---|---|---|---|---|---|---|---|---|---|---|---|---|---|---|---|---|---|--|
| 18-Jul-24 | | GHD | B00C | 01 | Internal | Debris | Dust main classroom | Floor | Dust | Unsealed | B00C-AD01 | Chrysotile Detected | Friable | Poor | High | Very high | Removal | N/A | <1 | m3 | Chrysotile asbestos detected as loose fibres in dust to floor - Recommend access restricted as soon as practicable | | | |

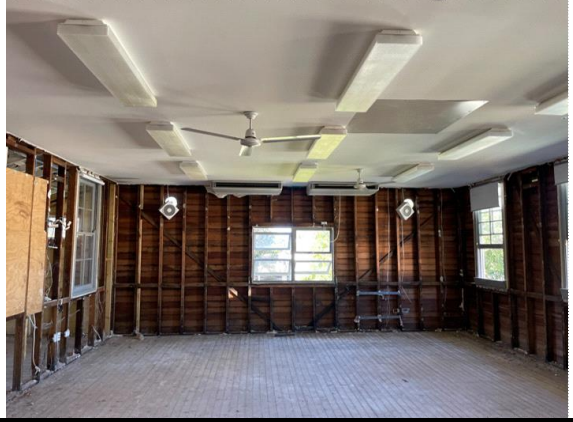
| Inspection date | Reinspection Date | Consultant and Surveyor Reference | Building Ref | Floor | Room or Space | Material description | Primary location | Secondary location | Application | Surface treatment | Sample identification | Laboratory results | Friability | Material condition | Likelihood of disturbance | Risk | Control method | Labelling | Estimated quantity | Units | Comments | Photograph reference | Photograph reference |
|---|---|---|---|---|---|---|---|---|---|---|---|---|---|---|---|---|---|---|---|---|---|---|---|
| 17-Jul-24 | | GHD | B00C | 01 | Internal | Paint | Floors | Throughout internal areas of B00C | Dust | - | B00C-LD01 | Calculated 17.80mg/m2 (1600 µg lead) | N/A | Poor | High | - | Removal | N/A | <1 | m3 | | | |

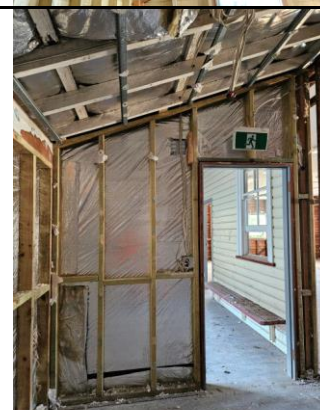
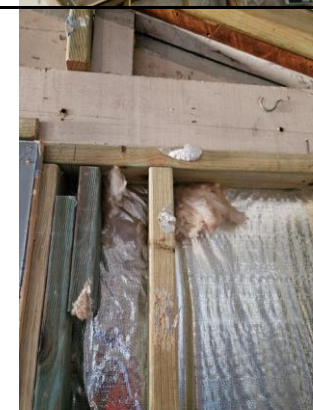
| Inspection date | Reinspection Date | Consultant and Surveyor Reference | Building Ref | Floor | Room or Space | Material description | Primary location | Secondary location | Application | Surface treatment | Sample identification | Laboratory results | Friability | Material condition | Likelihood of disturbance | Risk | Control method | Labelling | Estimated quantity | Units | Comments | Photograph reference | Photograph reference | |
|---|---|---|---|---|---|---|---|---|---|---|---|---|---|---|---|---|---|---|---|---|---|---|---|---|
| 17-Jul-24 | | GHD | B00C | 01 | Internal | Thermal insulation | Walls | All aspects | Insulation | Unsealed | Assumed | Presumed to contain SMF until proven otherwise | N/A | Poor | High | Very high | Removal | Not required | 45 | m2 | | | | |

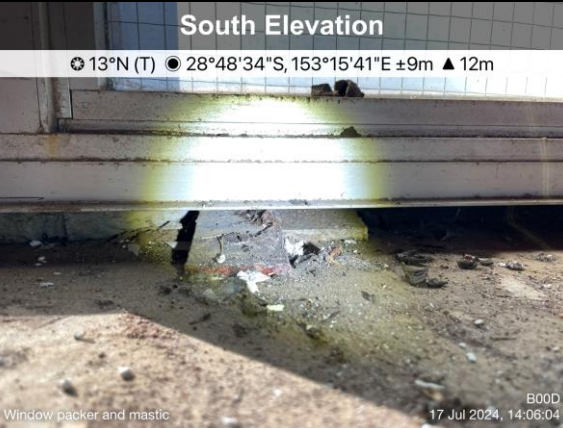
| Consultant | | | Location / Description | | | | | | | | | | Risk Assessment | | | | | | | | | | | |
|---|---|---|---|---|---|---|---|---|---|---|---|---|---|---|---|---|---|---|---|---|---|---|---|--|
| 17-Jul-24 | | GHD | B00D - Classrooms (room reference R1003, R1006, R1007) | 01 | External | Flat cement product | Window to northern and southern aspects of B00D | All aspect | Lining | Unsealed | B00D-A04 | Chrysotile Detected | Non-friable | Fair | High | Very high | Removal | Not required | 6 | Item | Quantity estimate based on presence of packers per window.<br><br>ACM sheet frgment packers present to all window surrounds present in B00D. | | | |

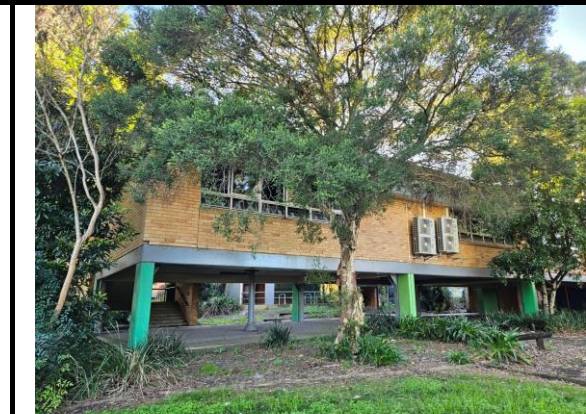
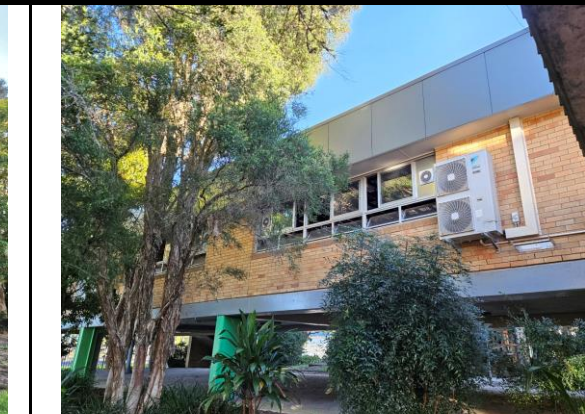
| Inspection date | Reinspection Date | Consultant and Surveyor Reference | Building Ref | Floor | Room or Space | Material description | Primary location | Secondary location | Application | Surface treatment | Sample identification | Laboratory results | Friability | Material condition | Likelihood of disturbance | Risk | Control method | Labelling | Estimated quantity | Units | Comments | Photograph reference | Photograph reference |
|---|---|---|---|---|---|---|---|---|---|---|---|---|---|---|---|---|---|---|---|---|---|---|---|
| 17/724 | | GHD | B00D - General Learning | 01 | External | Thermal insulation | Southern wall | Air conditioning units | Insulation | - | Assumed | Presumed to contain SMF until proven otherwise | N/A | Good | High | Very high | Removal | Not required | 3 | Item | | | |

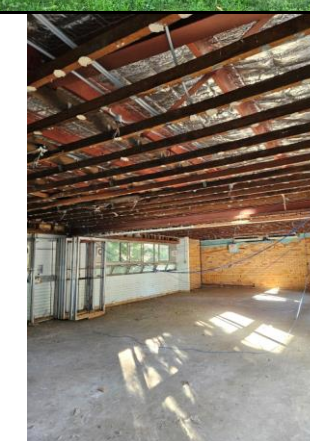
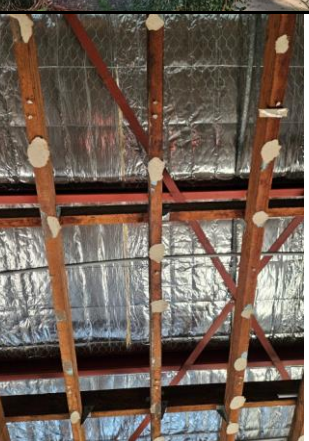
| Inspection date | Reinspection Date | Consultant and Surveyor Reference | Building Ref | Floor | Room or Space | Material description | Primary location | Secondary location | Application | Surface treatment | Sample identification | Laboratory results | Friability | Material condition | Likelihood of disturbance | Risk | Control method | Labelling | Estimated quantity | Units | Comments | Photograph reference | Photograph reference |
|---|---|---|---|---|---|---|---|---|---|---|---|---|---|---|---|---|---|---|---|---|---|---|---|
| 17/724 | | GHD | B00D - Classrooms | Roof | Internal | Thermal insulation | Roof cavity | All aspects | Insulation | - | Assumed | Presumed to contain SMF until proven otherwise | N/A | Good | High | Very high | Removal | Not required | 67 | m2 | | | |

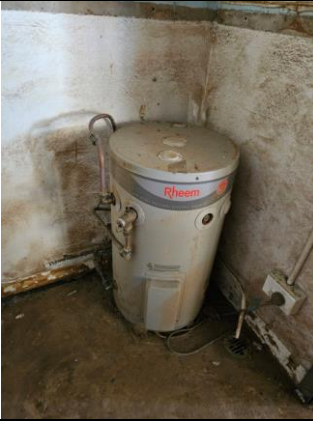
| Inspection date | Reinspection Date | Consultant and Surveyor Reference | Building Ref | Floor | Room or Space | Material description | Primary location | Secondary location | Application | Surface treatment | Sample identification | Laboratory results | Friability | Material condition | Likelihood of disturbance | Risk | Control method | Labelling | Estimated quantity | Units | Comments | Photograph reference | Photograph reference | |
|---|---|---|---|---|---|---|---|---|---|---|---|---|---|---|---|---|---|---|---|---|---|---|---|--|
| 17-Jul-24 | | GHD | B00H - Canteen | GF | External | Thermal insulation | Store room | Hot water heater | Insulation | Sealed | Assumed | Presumed to contain SMF until proven otherwise | N/A | Good | High | Very high | Removal | Not required | 1 | Item | | | | |

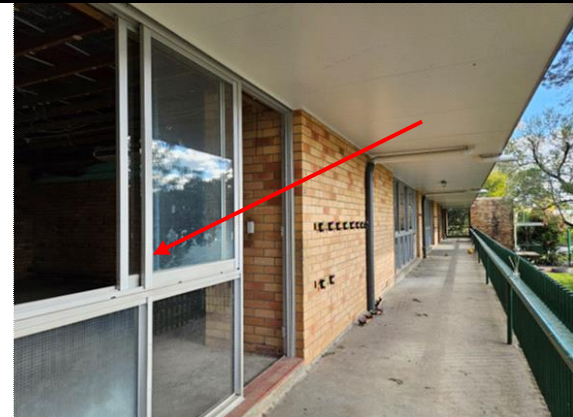
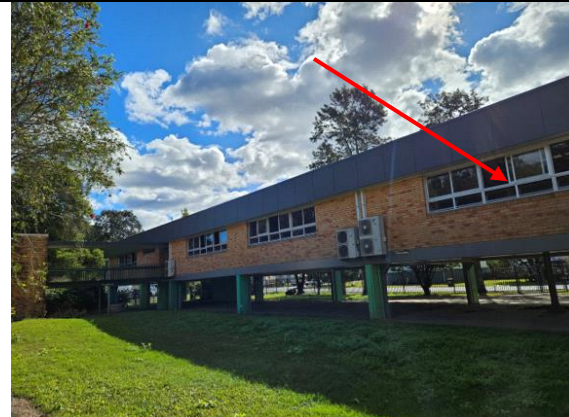
| Consultant | | | Location / Description | | | | | | | | | | Risk Assessment | | | | | | | | | | | |
|---|---|---|---|---|---|---|---|---|---|---|---|---|---|---|---|---|---|---|---|---|---|---|---|--|
| 18-Jul-24 | | GHD | B00F - Classrooms | 01 | External | Sealant / Adhesives | Window putty between glass and frame within windows to classrooms | Window to northern and southern aspects of B00F | Window putty | Unsealed | Refer to B00D-A01 | Chrysotile Detected | Non-friable | Poor | Very high | Very high | Removal | Labels required (not affixed or not sufficient) | 11 | Item | Quantity estimate based on per window.<br><br>Positive asbestos indentification applicable to all windows present in B00F | | | |

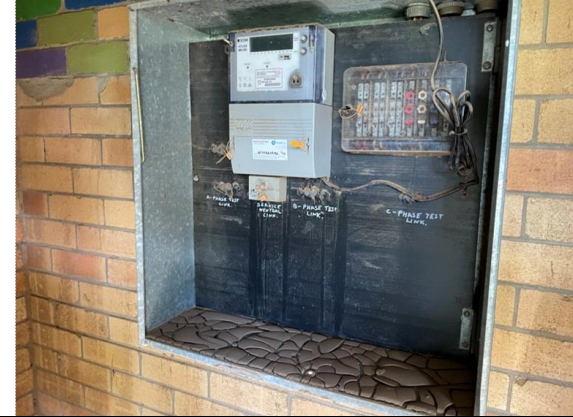
| Consultant | | | Location / Description | | | | | | | | | | Risk Assessment | | | | | | | | | | | |
|---|---|---|---|---|---|---|---|---|---|---|---|---|---|---|---|---|---|---|---|---|---|---|---|--|
| 18-Jul-24 | | GHD | B00F - Classrooms | GF | Internal | Asbestos boards – insulating board in cores & linings | Distribution boards | Ground floor electrical room | Backing board within cabinet | Unsealed | refer to B00F-A05 | Chrysotile Detected | Non-friable | Fair | High | Very high | Removal | Labels required (not affixed or not sufficient) | 2 | m2 | | | | |

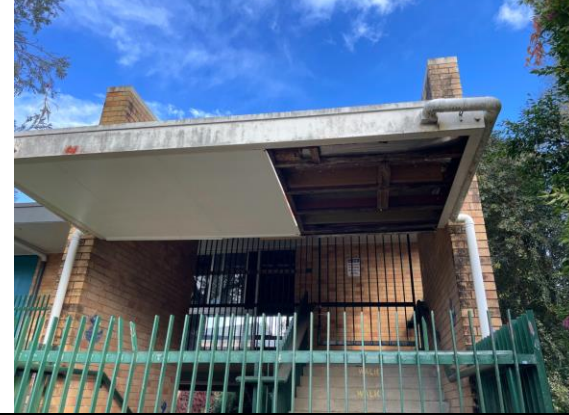
| Consultant | | | Location / Description | | | | | | | | | | Risk Assessment | | | | | | | | | | | |
|---|---|---|---|---|---|---|---|---|---|---|---|---|---|---|---|---|---|---|---|---|---|---|---|--|
| 18-Jul-24 | | GHD | B00F - Movement | 01 | External | Flat cement product | Awning lining | Sheet to B00F western stairway | Lining | Sealed | Movement 6-A01 | Chrysotile & Amosite Detected | Non-friable | Poor | High | Very high | Removal | Labels required (not affixed or not sufficient) | 15 | m2 | | | | |

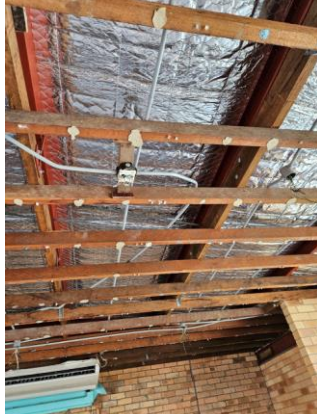
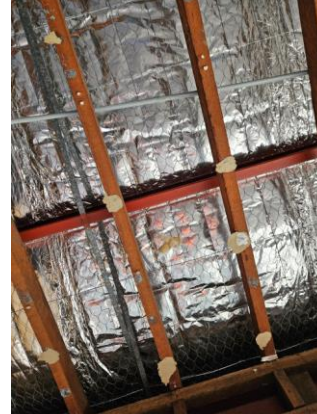
| Inspection date | Reinspection Date | Consultant and Surveyor Reference | Building Ref | Floor | Room or Space | Material description | Primary location | Secondary location | Application | Surface treatment | Sample identification | Laboratory results | Friability | Material condition | Likelihood of disturbance | Risk | Control method | Labelling | Estimated quantity | Units | Comments | Photograph reference | Photograph reference |
|---|---|---|---|---|---|---|---|---|---|---|---|---|---|---|---|---|---|---|---|---|---|---|---|
| 18-Jul-24 | | GHD | B00F - Classrooms | 01 | Internal | Thermal insulation | Ceiling | Fixed to underside of roof throughout B00F | Foil backed insulation | - | Assumed | Presumed to contain SMF until proven otherwise | N/A | Good | High | Very high | Removal | N/A | 130 | m2 | | | |

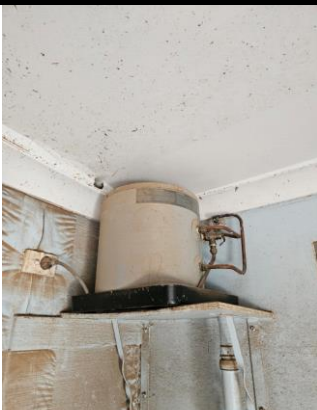
| Inspection date | Reinspection Date | Consultant and Surveyor Reference | Building Ref | Floor | Room or Space | Material description | Primary location | Secondary location | Application | Surface treatment | Sample identification | Laboratory results | Friability | Material condition | Likelihood of disturbance | Risk | Control method | Labelling | Estimated quantity | Units | Comments | Photograph reference | Photograph reference |
|---|---|---|---|---|---|---|---|---|---|---|---|---|---|---|---|---|---|---|---|---|---|---|---|
| 17-Jul-24 | | GHD | B00G-Toilet Block | GF | Internal | Thermal insulation | Disabled toilet | Hot water heater | Insulation | Sealed | Assumed | Presumed to contain SMF until proven otherwise | N/A | Good | High | High | Removal | Not required | 1 | Item | | | |

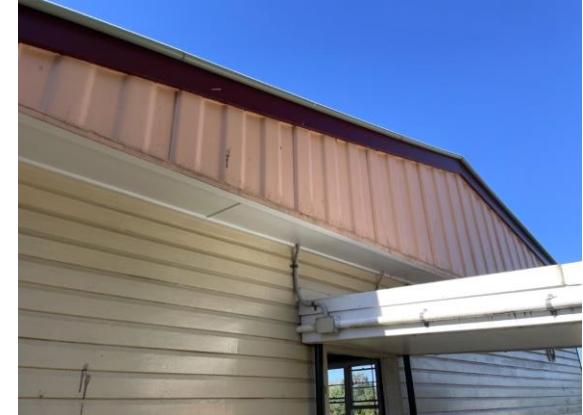
| Consultant | | | Location / Description | | | | | | | | | | Risk Assessment | | | | | | | | | | | |
|---|---|---|---|---|---|---|---|---|---|---|---|---|---|---|---|---|---|---|---|---|---|---|---|--|
| 17-Jul-24 | | GHD | B00H | 01 | External | Flat cement product | Ceiling to entryway | Walkway/movement area ceiling | Lining | Sealed | B00H-A06 | Chrysotile & Amosite Detected | Non-friable | Fair | High | Very high | Removal | Labels required (not affixed or not sufficient) | 12 | m2 | | | | |

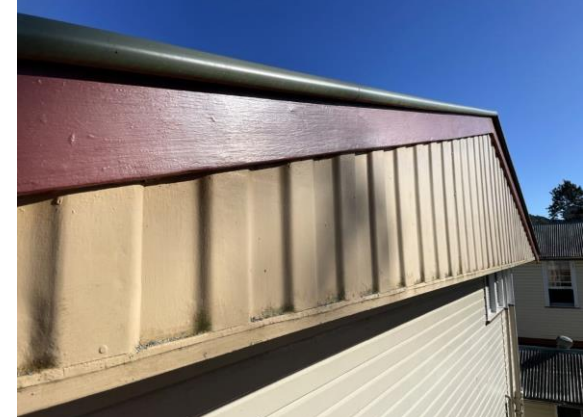
| Consultant | | | Location / Description | | | | | | | | | | Risk Assessment | | | | | | | | | | | |
|---|---|---|---|---|---|---|---|---|---|---|---|---|---|---|---|---|---|---|---|---|---|---|---|--|
| 17-Jul-24 | | GHD | B00H - General Learning | Roof | External | Flat cement product | Gable ends | All aspects | Lining | Sealed | B00H-A07 | Chrysotile & Amosite Detected | Non-friable | Fair | Very high | Very high | Removal | Labels required (not affixed or not sufficient) | 20 | m2 | | | | |

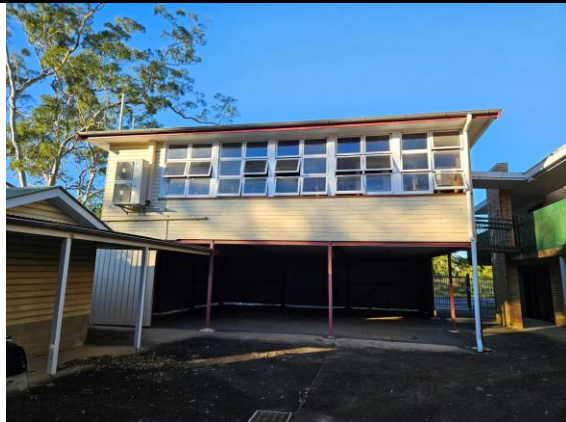
| Inspection date | Reinspection Date | Consultant and Surveyor Reference | Building Ref | Floor | Room or Space | Material description | Primary location | Secondary location | Application | Surface treatment | Sample identification | Laboratory results | Friability | Material condition | Likelihood of disturbance | Risk | Control method | Labelling | Estimated quantity | Units | Comments | Photograph reference | Photograph reference |
|---|---|---|---|---|---|---|---|---|---|---|---|---|---|---|---|---|---|---|---|---|---|---|---|
| 17-Jul-24 | | GHD | B00H - General Learning | GF | External | Thermal insulation | Northern wall | Air conditioning unit | Insulation | Sealed | Assumed | Presumed to contain SMF until proven otherwise | N/A | Good | High | Very high | Removal | N/A | 1 | Item | | | |

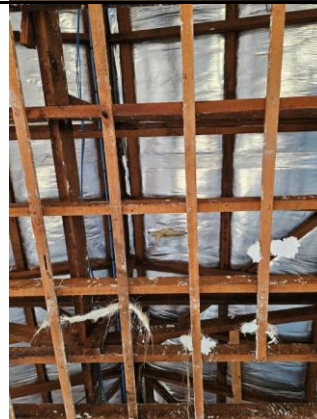
| Inspection date | Reinspection Date | Consultant and Surveyor Reference | Building Ref | Floor | Room or Space | Material description | Primary location | Secondary location | Application | Surface treatment | Sample identification | Laboratory results | Friability | Material condition | Likelihood of disturbance | Risk | Control method | Labelling | Estimated quantity | Units | Comments | Photograph reference | Photograph reference |
|---|---|---|---|---|---|---|---|---|---|---|---|---|---|---|---|---|---|---|---|---|---|---|---|
| 17-Jul-24 | | GHD | B00H - Classrooms | Roof | Internal | Thermal insulation | Roof cavity | Fixed to underside of roof | Foil backed insulation | Sealed | Assumed | Presumed to contain SMF until proven otherwise | N/A | Good | High | Very high | Removal | N/A | 150 | m2 | | | |

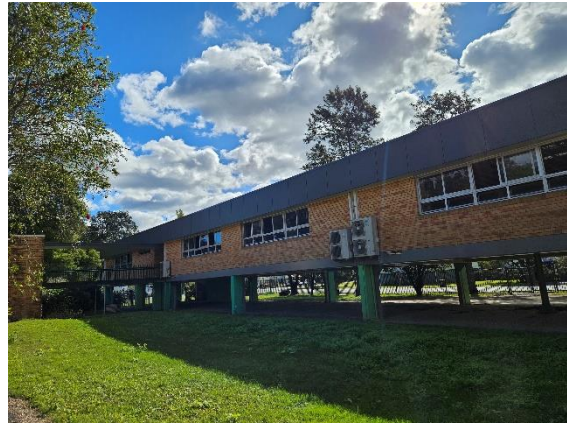
Photograph 14: Building B00F external area (Asbestos detected in window putty)

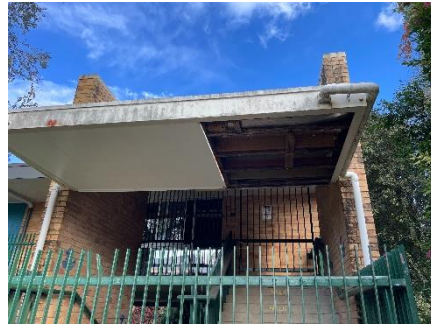
Photograph 20: Damaged ceiling lining to B00F stairway/movement area (Asbestos detected in flat cement sheet ceiling lining)
