# Scope of Works for Hazmat Remediation and Demolition

Willyama High School, Broken Hill, NSW, 2880

**Report No.:** 31174 - R02

**Site visit and assessment** - 4<sup>th</sup> June 2024

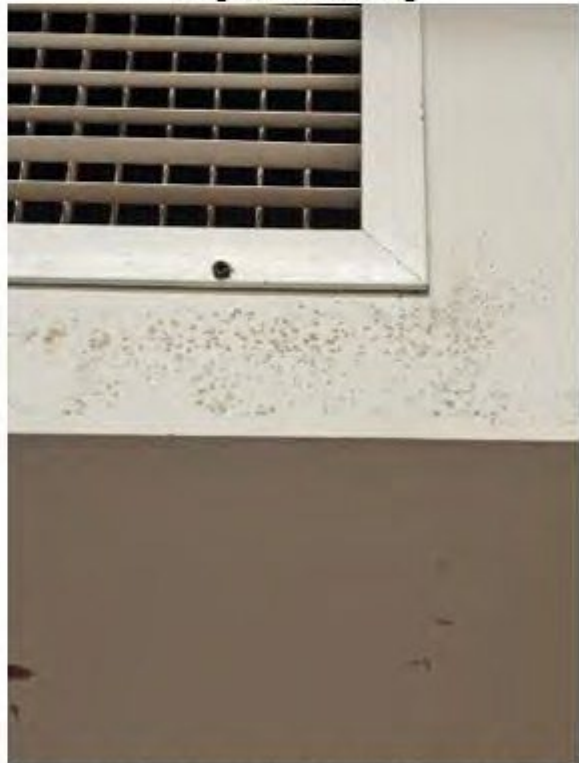
Image 6: Mould nearby air-conditioning duct

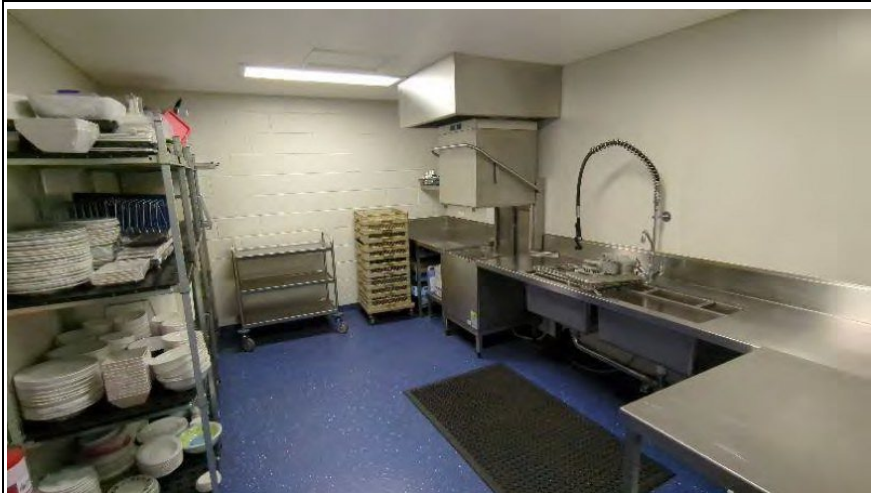
<p>B00A-R0W35 - Storeroom</p>	Masonry walls, plasterboard ceiling and vinyl floor sheeting.	<p>No signs of visual mould growth or water damage were noted.</p> <p>Refer to index photos 128 - 131</p> <p>Condition 3</p>

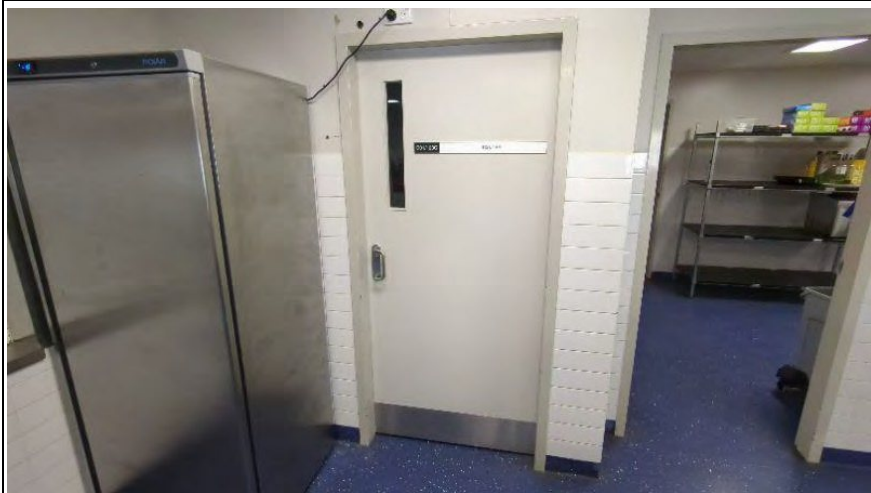
<p>B00A-R0W36 - Pantry</p>		<p>No access Assumed mould growth</p>

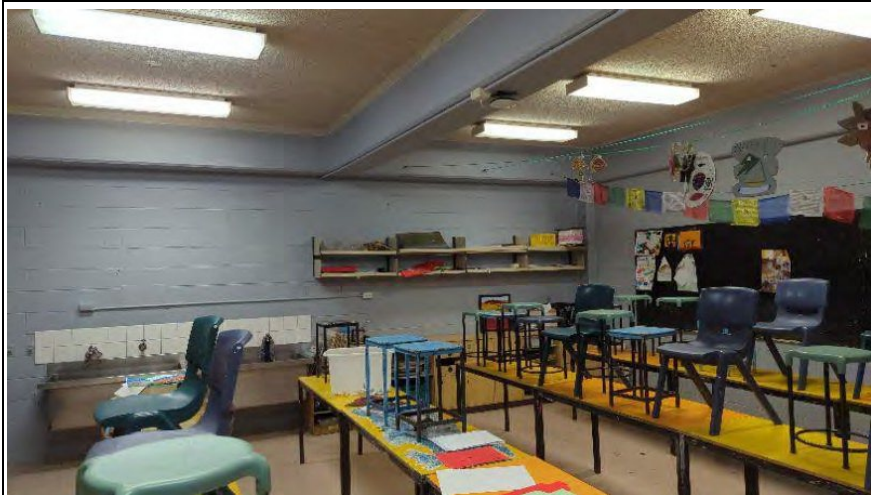
<p>B00A-R0W18 - Art LS</p>	Masonry walls, concrete floor and sprayed coating (vermiculite) ceiling	<p>Suspected visual mould growth was noted to masonry walls, concrete floor, plasterboard ceiling and all contents.</p> <p>Refer to index photos 157 - 163</p> <p>Condition 3</p>

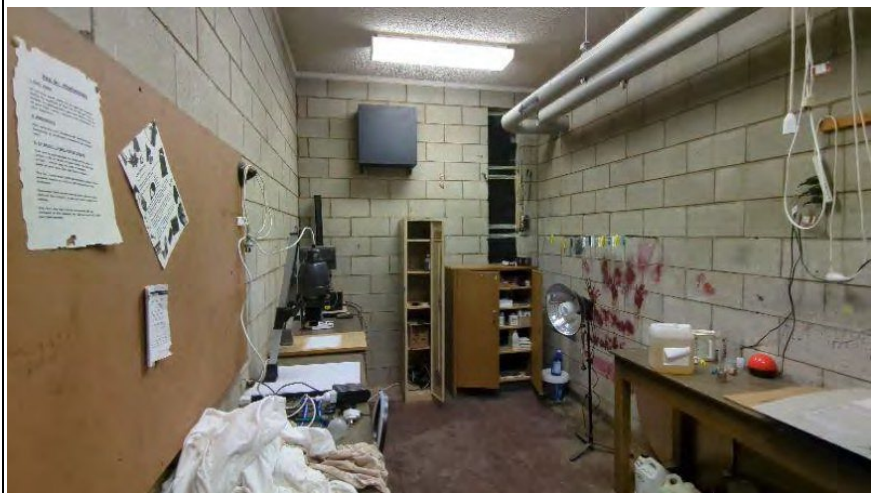
<p>B00A-R0W08 - Dark Room</p>	Masonry walls, concrete floor and sprayed coating (vermiculite) ceiling.	<p>Suspected visual mould growth was noted chipboard entrance archway.</p> <p>Refer to index photos 167 - 170</p> <p>Condition 3</p>

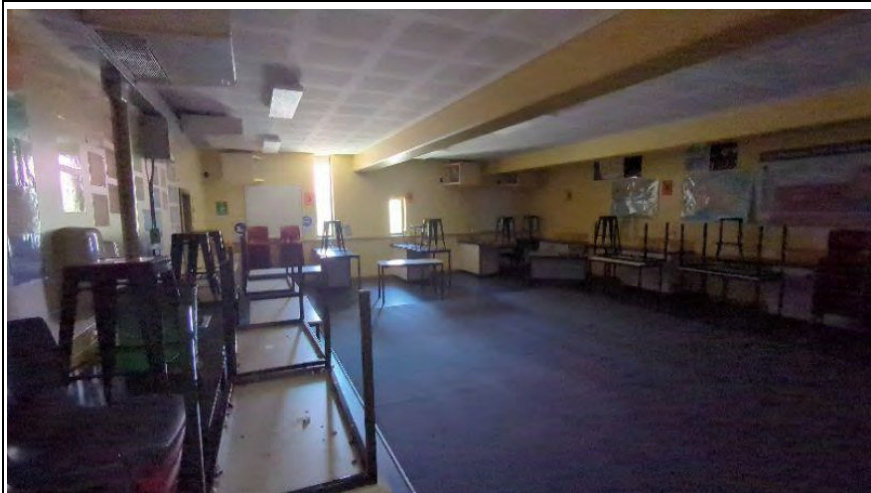
<p>B00A-R1E22 - Science L.S</p>	Plasterboard walls, perforated plasterboard ceiling and carpet over concrete.	No signs of visual mould growth or water damage were noted. Condition 3
  <p>B00A-R1E21 - Preparation</p>	Plasterboard walls, perforated plasterboard ceiling and carpet over concrete.	No signs of visual mould growth were noted. Evaporative water stains were noted to vinyl floor sheeting. Refer to index photos 188-193 Condition 3

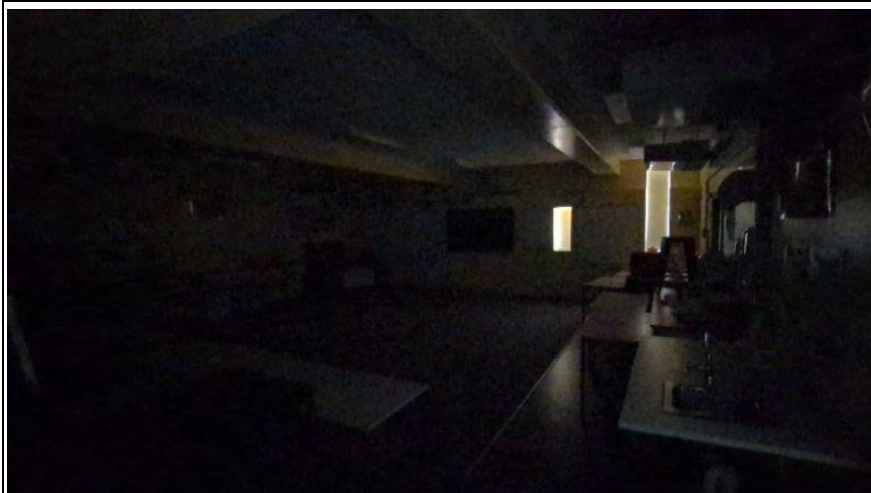
<p>B00A-R1E20 - Science L.S</p>	Plasterboard walls, perforated plasterboard ceiling and carpet over concrete.	No signs of visual mould growth were noted. Evaporative water stains were noted to table tops. Refer to index photo 194 Condition 3

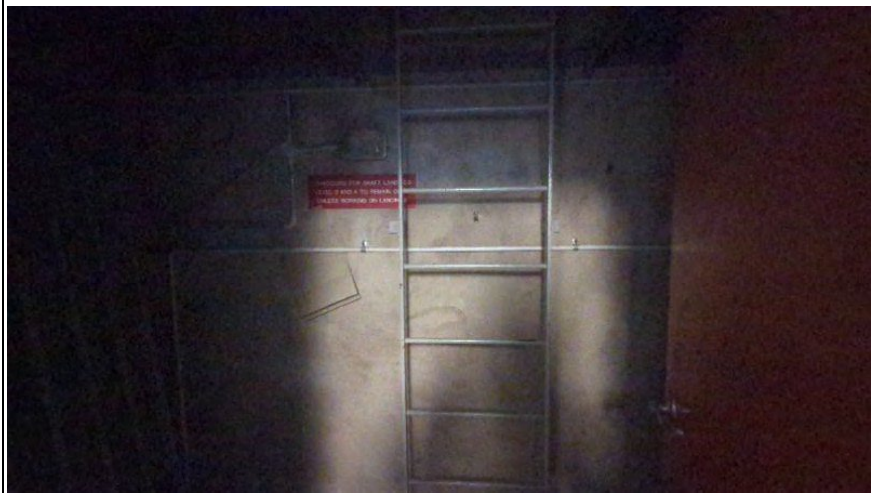
<p>B00A-R1E13 Plant</p>	Concrete walls, concrete floor and concrete ceiling.	Suspected visual mould growth noted to hardwood door and architraves. Refer to index photo 196 Condition 3

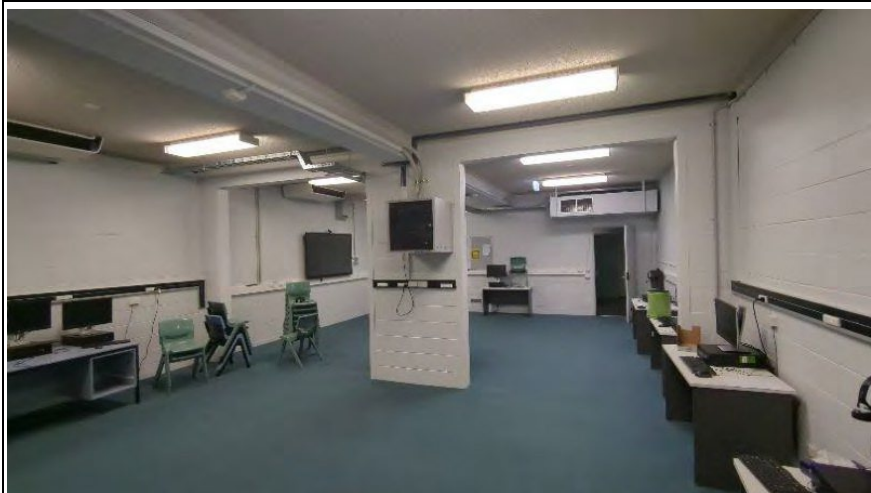
<p>B00A-R1E12 Computer learning space</p>	Masonry walls, carpet over concrete and sprayed coating (vermiculite) ceiling.	<p>No signs of visual mould growth were noted. Water stains were noted to carpet.</p> <p>Refer to index photos 197 - 200</p> <p>Condition 3</p>

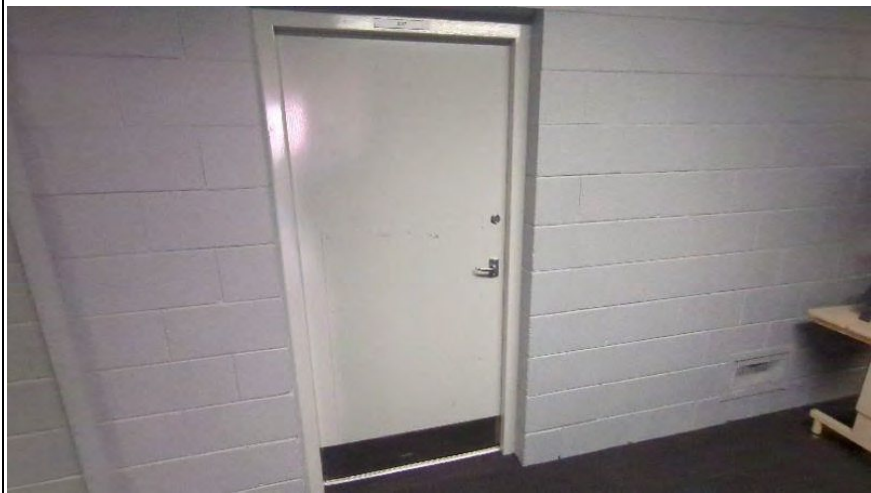
<p>B00A-R1E14 General LS</p>	Masonry walls, perforated plasterboard ceiling and carpet over concrete.	<p>Traces of suspected visual mould growth were noted to carpet.</p> <p>Condition 3</p>

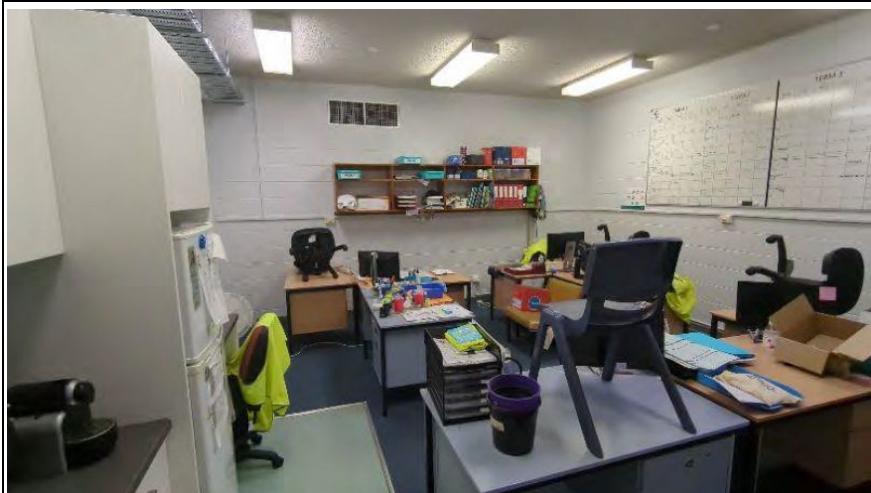
<p>B00A-R1E10 Staff study</p>	Masonry walls, vinyl floor sheeting and sprayed coating (vermiculite) ceiling.	Suspected visual mould growth was noted to vinyl floor sheeting and fridge. Refer to index photos 202 - 204 Condition 3

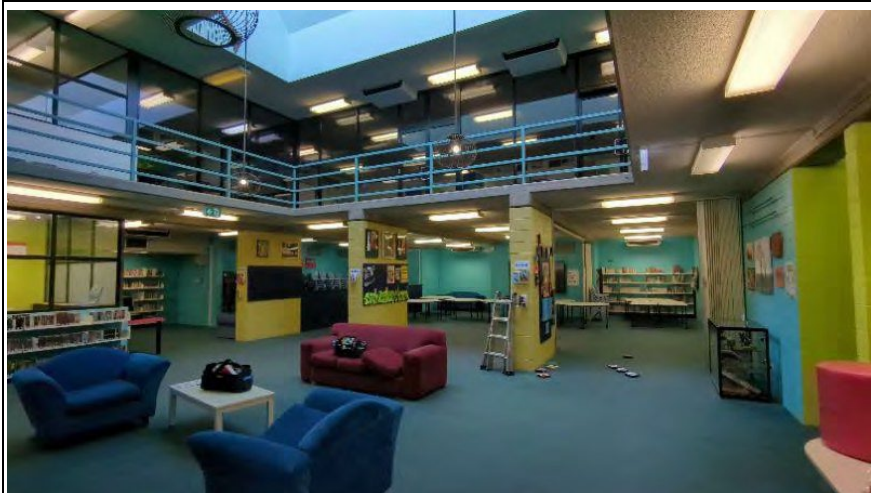
<p>B00A-R1N05 - Library</p>	Masonry walls, carpet over concrete and sprayed coating (vermiculite) ceiling.	<p>Suspected visual mould growth was noted to carpet floor and porous couches.</p> <p>Refer to index photos 218 - 225</p> <p>Condition 3</p>

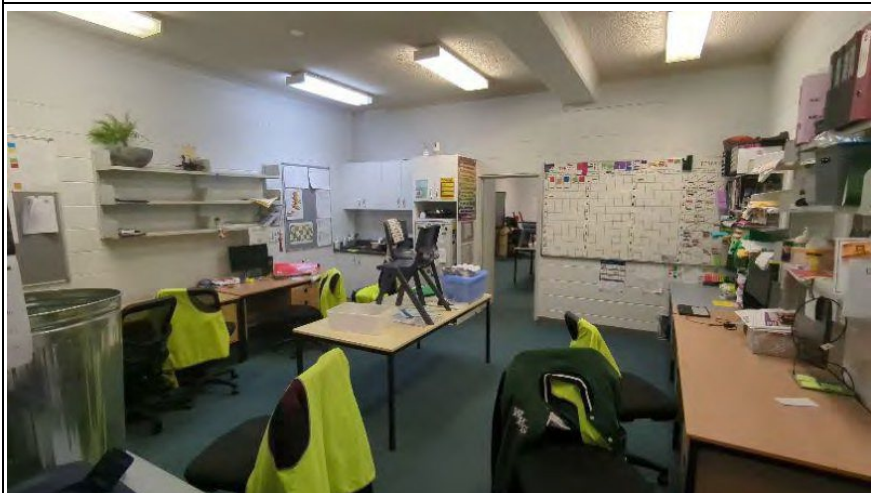
<p>B00A-R1W23 - Staff Study</p>	<p>Masonry walls, carpet over concrete and sprayed coating (vermiculite) ceiling.</p>	<p>Suspected visual mould growth was noted to the carpet floor and porous contents.</p> <p>Refer to index photos 230 - 238</p> <p>Condition 3</p>

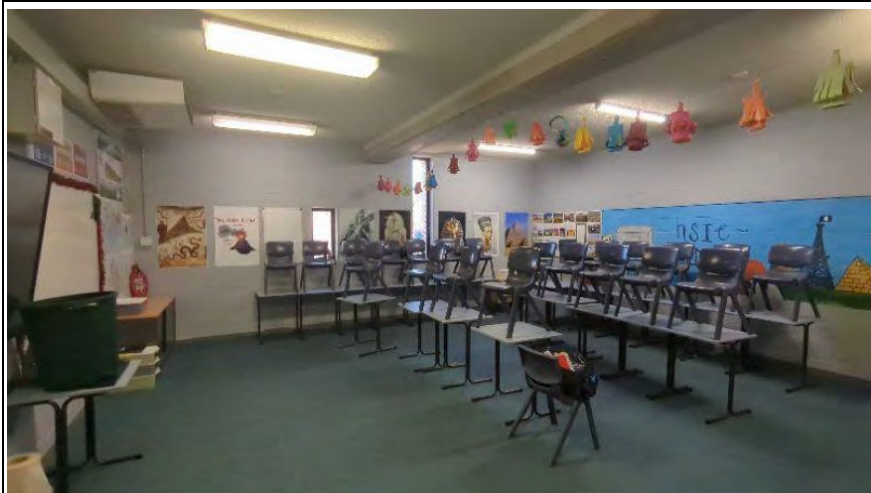
<p>B00A-R1W20 - General L.S</p>	Masonry walls, carpet over concrete and sprayed coating (vermiculite) ceiling.	<p>Suspected visual mould growth was noted to carpet floor.</p> <p>Refer to index photos 268 - 270</p> <p>Condition 3</p>

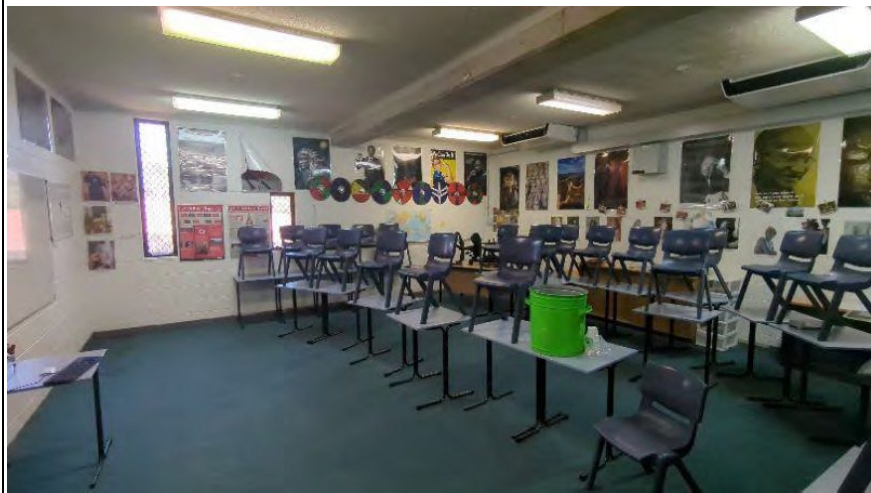
<p>B00A-R1W19 - General L.S</p>	Masonry walls, carpet over concrete and sprayed coating (vermiculite) ceiling.	<p>Traces of suspected visual mould growth was noted to the carpet floor.</p> <p>Refer to index photos 271 - 275</p> <p>Condition 3</p>

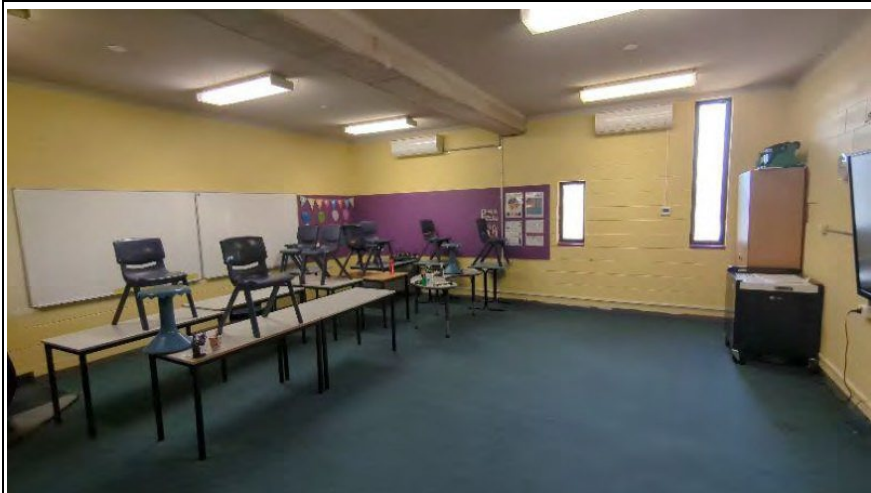
<p>B00A-R1W13 - General L.S</p>	Masonry walls, carpet over concrete and sprayed coating (vermiculite) ceiling.	<p>Suspected visual mould growth was noted to carpet floor.</p> <p>Refer to index photos 294 - 297</p> <p>Condition 3</p>

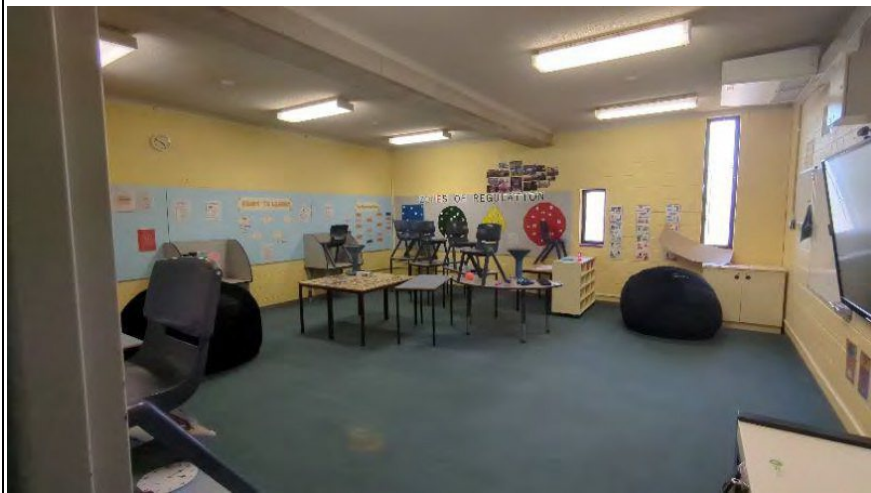
<p>B00A-R1W12 - General L.S</p>	Masonry walls, carpet over concrete and sprayed coating (vermiculite) ceiling.	<p>Suspected visual mould growth was noted to carpet floor.</p> <p>Refer to index photos 298 - 304</p> <p>Condition 3</p>

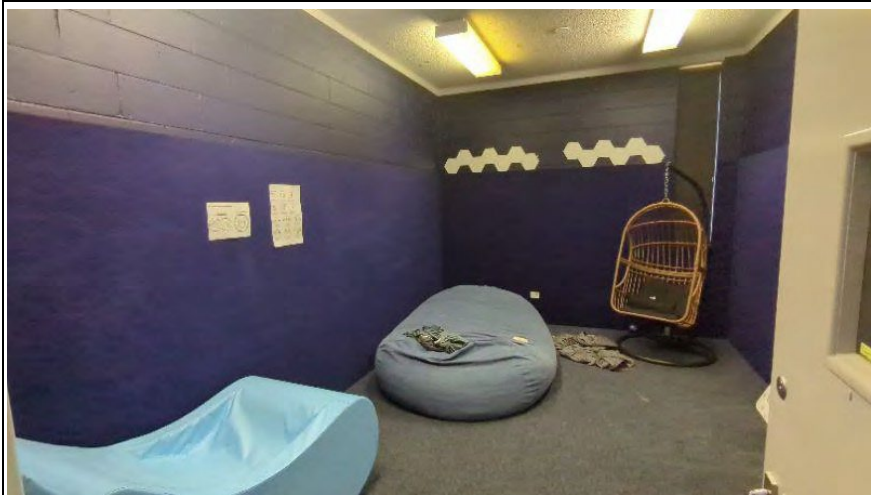
<p>B00A-R109 - Sensory Zone</p>	Masonry walls, carpet over concrete and sprayed coating (vermiculite) ceiling.	<p>Suspected visual mould growth was noted to carpet floor and porous contents.</p> <p>Refer to index photos 308 - 309</p> <p>Condition 3</p>

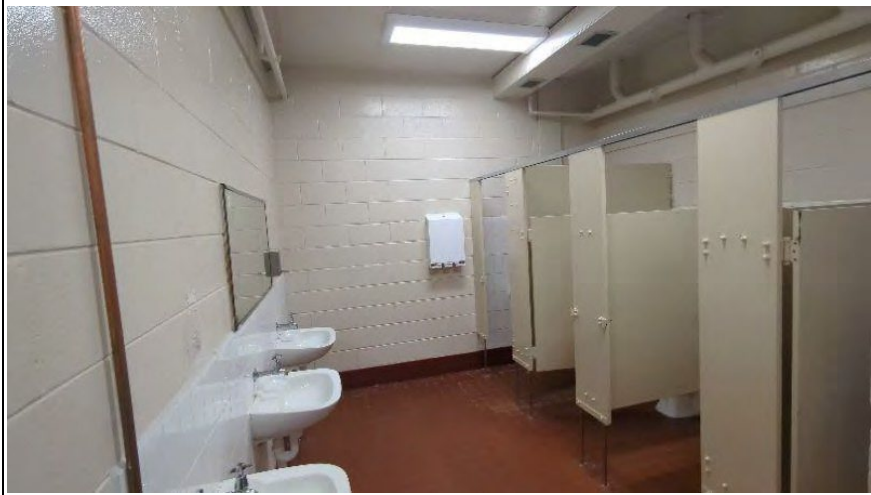
<p>B00A-R1W07 - Girl's Toilet</p>	Concrete ceiling, masonry walls and ceramic floor tiles.	<p>No signs of visible mould growth were noted.</p> <p>Evaporative water stains were noted to ceramic floor</p> <p>Condition 3</p>

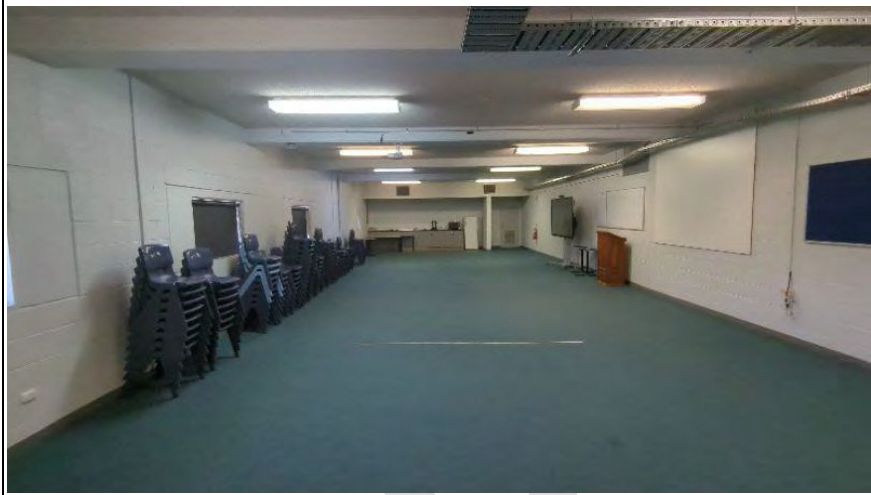
<p>B00A-R1N01 - Staff</p>	Masonry walls, carpet over concrete and sprayed coating (vermiculite) ceiling.	Suspected visual mould growth was noted to carpet floors. Refer to index photos 312 - 316 Condition 3

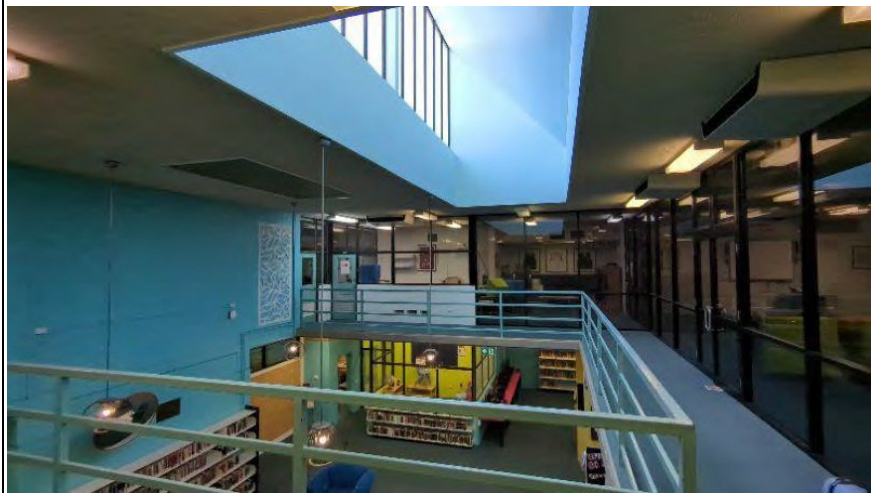
<p>B00A-R2N05 - Library Mezzanine</p>	Plasterboard walls and carpet over concrete.	<p>No signs of visual mould growth. Liquid stains noted to carpet.</p> <p>Refer to index photos 319</p> <p>Condition 3</p>

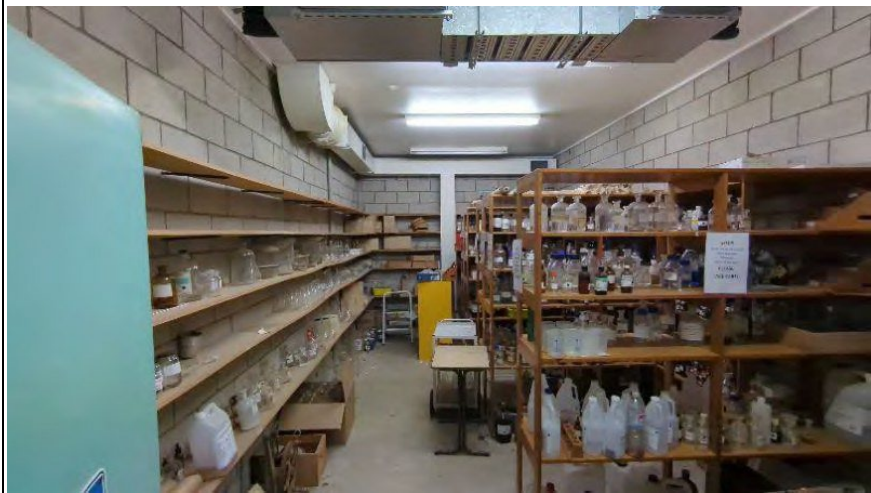
<p>B00A-R2E12 - App Store</p>	Masonry walls, concrete floor and fibre cement ceiling.	No signs of visual mould growth or water damage were noted. Condition 3 *Hazardous Chemicals Present*

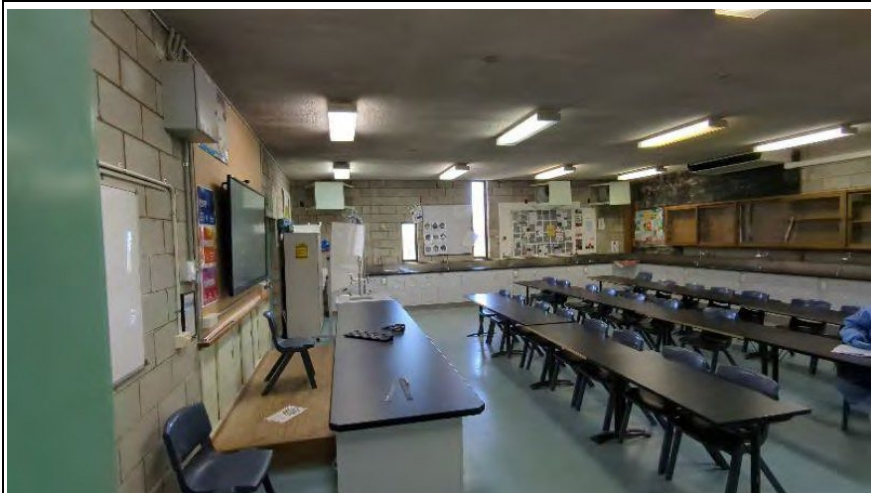
<p>B00A-R2E01 - Lab L.S</p>	Masonry walls, vinyl floor sheeting and sprayed coating (vermiculite) ceiling.	<p>No signs of visual mould growth were noted to building materials or contents. However, suspected visual mould growth was noted to paper towel in water trough.</p> <p>Refer to index photo 326 Condition 3</p>

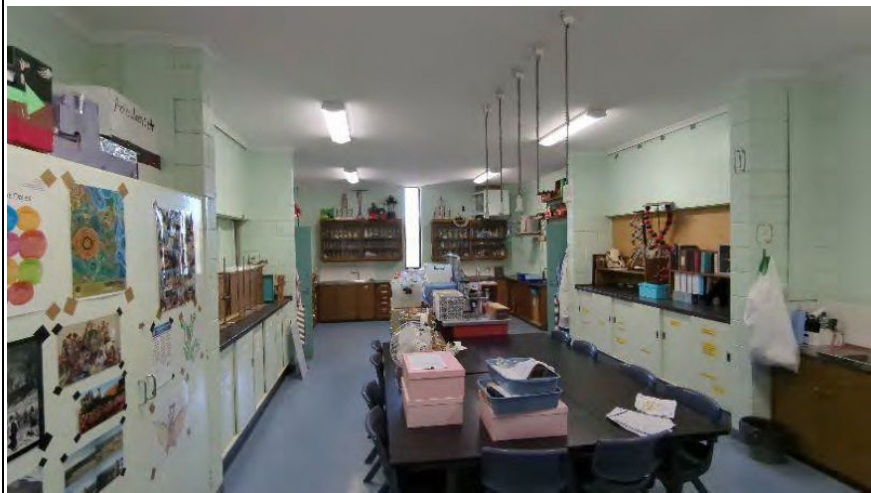
<p>B00A-R2E02 - Preparation</p>	Masonry walls, vinyl floor sheeting, plasterboard ceiling.	<p>No signs of visual mould growth were noted. Signs of water damage (in the form of swelling) were noted to the hardwood cupboards.</p> <p>Condition 3</p>

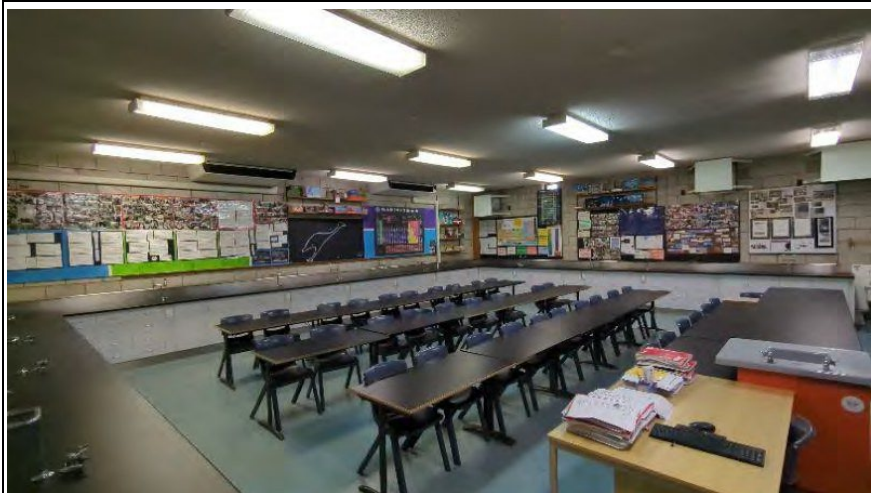
<p>B00A-R2E03 - Lab</p>	Masonry walls, vinyl floor sheeting and sprayed coating (vermiculite) ceiling.	<p>Suspected visual mould growth was noted to the plush in corner tap. No signs of visual mould growth or water damage were noted to building materials.</p> <p>Refer to index photos 327 - 328</p> <p>Condition 3</p>

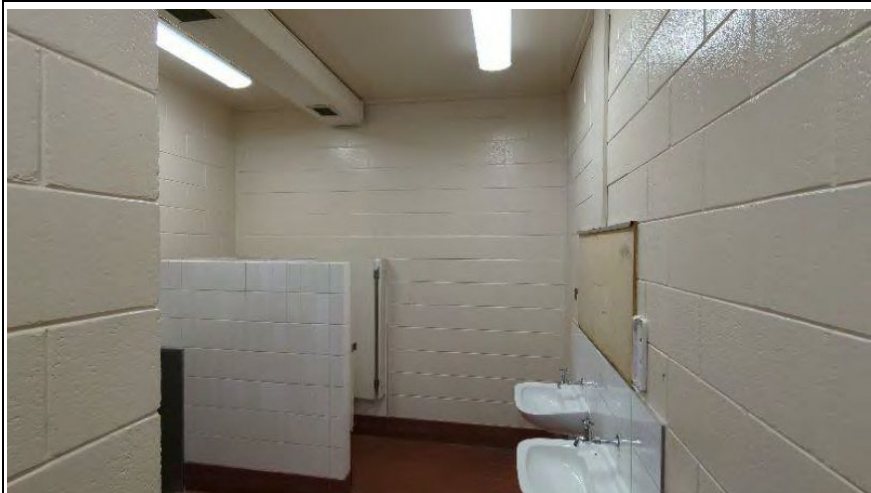
<p>B00A-R2E05 - Boys Toilet</p>	Masonry walls, ceramic floor tiles and concrete ceiling,	<p>No signs of visual mould growth were noted. Signs of water damage were noted to plywood sheet covering mirror and evaporative water stains were noted to ceramic floor tiles.</p> <p>Condition 3</p>

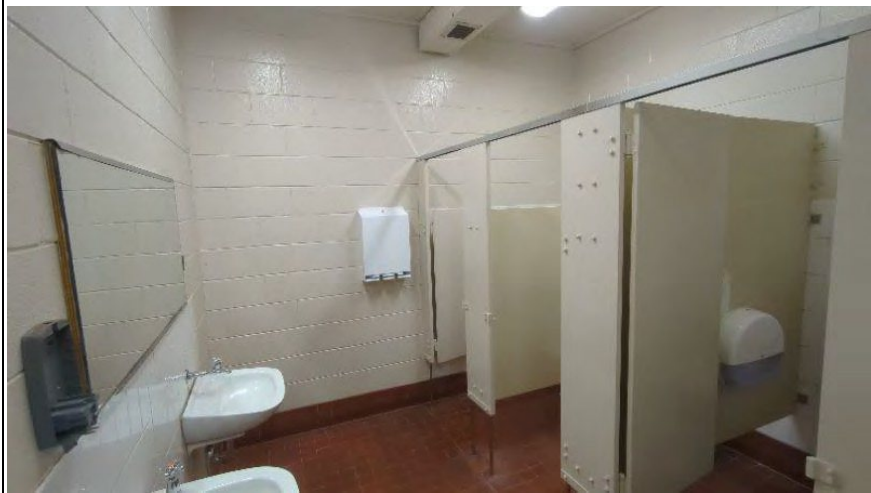
<p>B00A-R2E04 - Girls toilet</p>	Masonry walls, ceramic floor tiles and concrete ceiling,	<p>No signs of visual mould growth were noted. Evaporative water stains were noted to ceramic floor tiles.</p> <p>Condition 3</p>

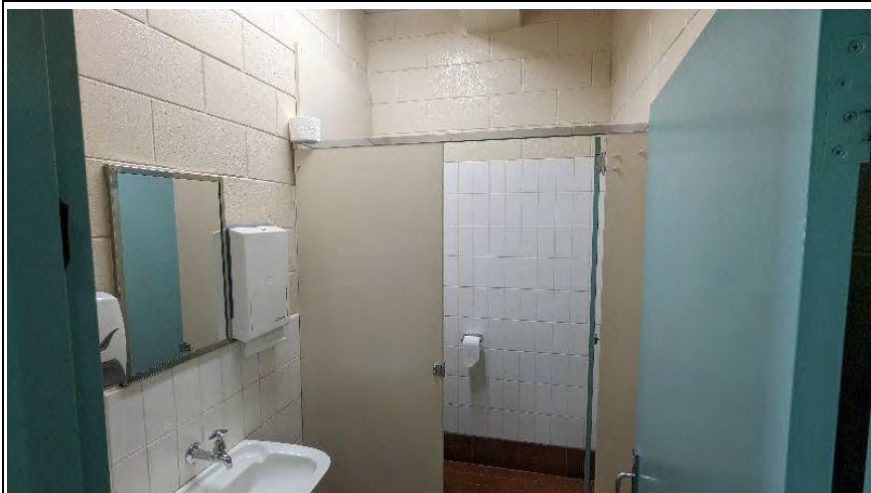
<p>B00A-R2E06 - Staff Toilet</p>	Masonry walls, ceramic floor tiles and concrete ceiling,	No signs of visual mould growth were noted. Evaporative water stains were noted to ceramic floor tiles. Condition 3

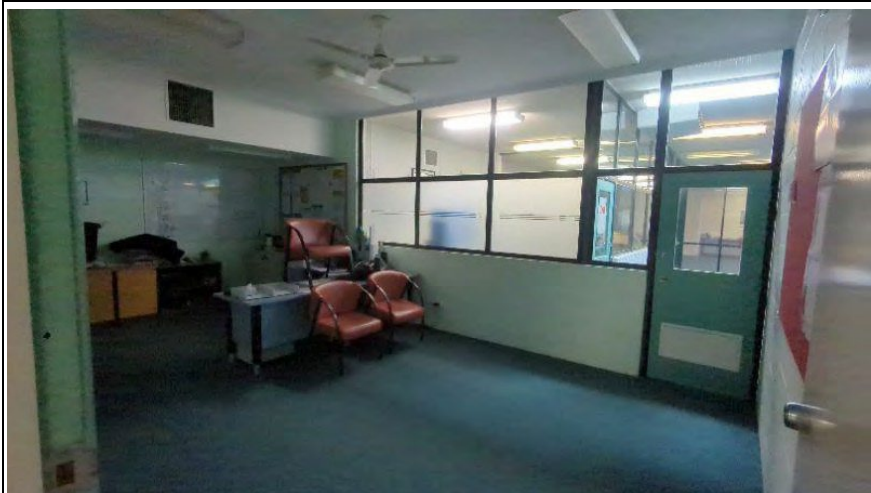
<p>B00A-R2N11 - Workroom</p>	Plasterboard walls, carpet over concrete and sprayed coating (vermiculite) ceiling.	<p>No signs of visual mould growth were noted. Signs of water ingress (in the form of brown staining) was noted to the cornice.</p> <p>Refer to index photos 335-336 Condition 3</p>

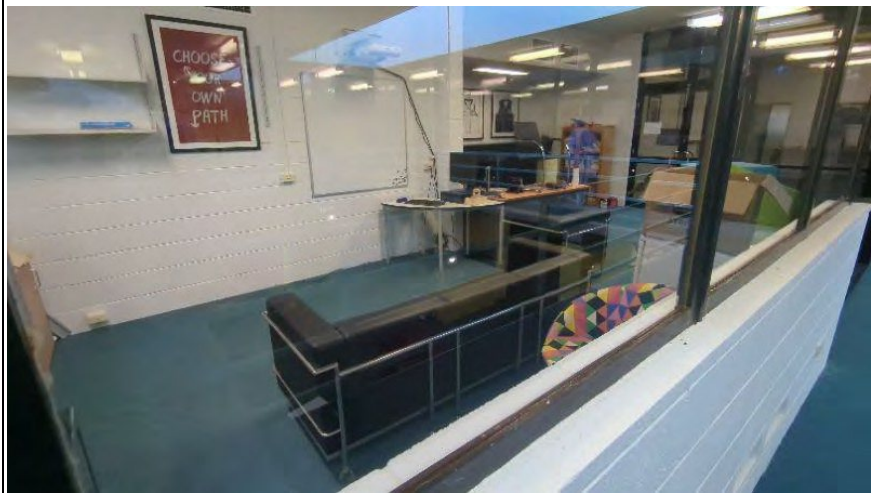
<p>B00A-R2N12 - Workroom</p>	Masonry walls, carpet over concrete and plasterboard ceiling.	<p>Trades of suspected visual mould growth were noted to the carpet floor.</p> <p>Refer to index photos 338-340 Condition 3</p>

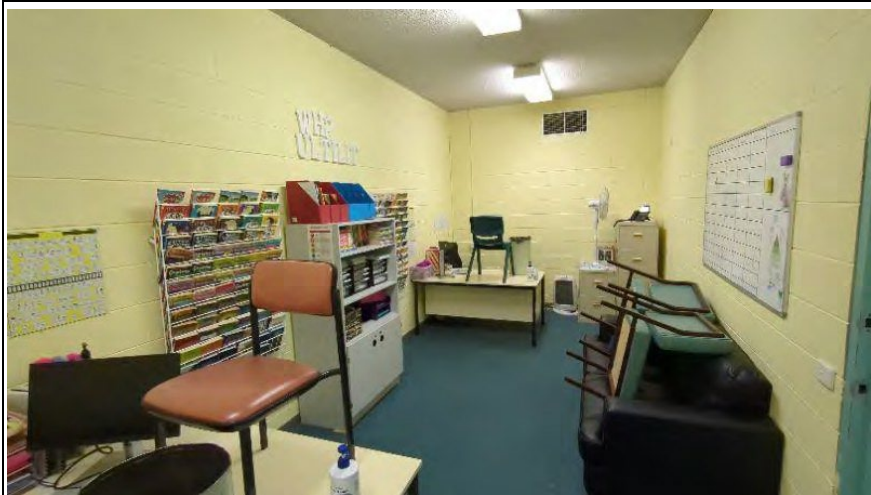
<p>B00A-R2W15 - Staff Study</p>	Masonry walls, carpet over concrete and sprayed coating (vermiculite) ceiling.	<p>Suspected visual mould growth was noted within cabinetry beneath sink.</p> <p>Refer to index photos 342</p> <p>Condition 3</p>

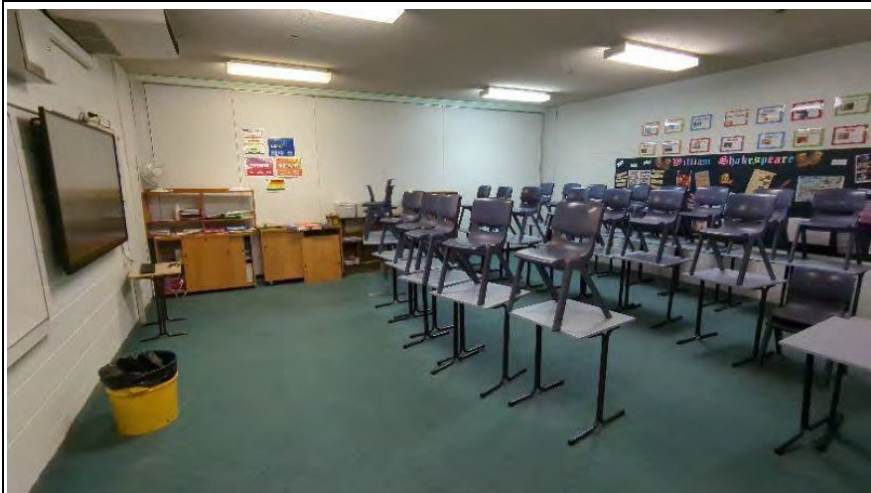
<p>B00A-R2W16 General L.S</p>	Masonry walls, carpet over concrete and sprayed coating (vermiculite) ceiling.	Traces of suspected visual mould growth were noted to carpet. Refer to index photos 344. Condition 3

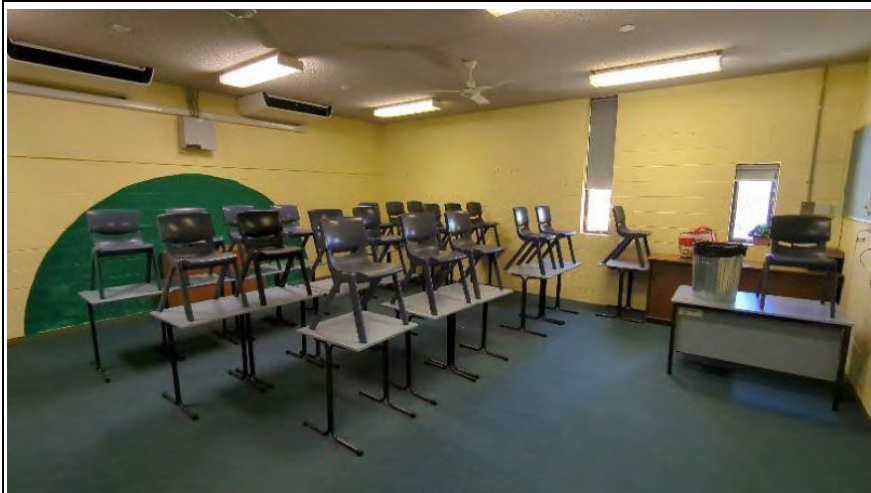
<p>B00A-R2W10 - General L.S</p>	Masonry walls, carpet over concrete and sprayed coating (vermiculite) ceiling.	<p>No signs of visual mould growth were noted. Water damage (in the form of leaching) was noted to ceiling and upper sections of masonry wall. Refer to index photos 347</p> <p>Condition 3</p>

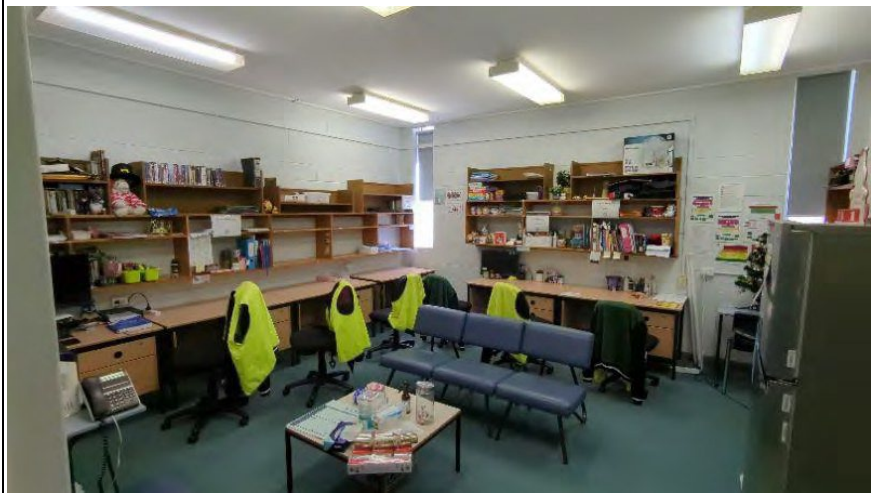
<p>B00A-R2W07 Staff Study</p>	Masonry walls, carpet over concrete and plasterboard ceiling.	Suspected visual mould growth was noted to porous contents. Refer to index photos 348 - 352 Condition 3
