# Pre-Demolition Hazardous Building Materials Survey – Former Sydney Fish Markets

Infrastructure NSW

JBS&G 64782 | 175,847 (Rev A)

19 May 2026

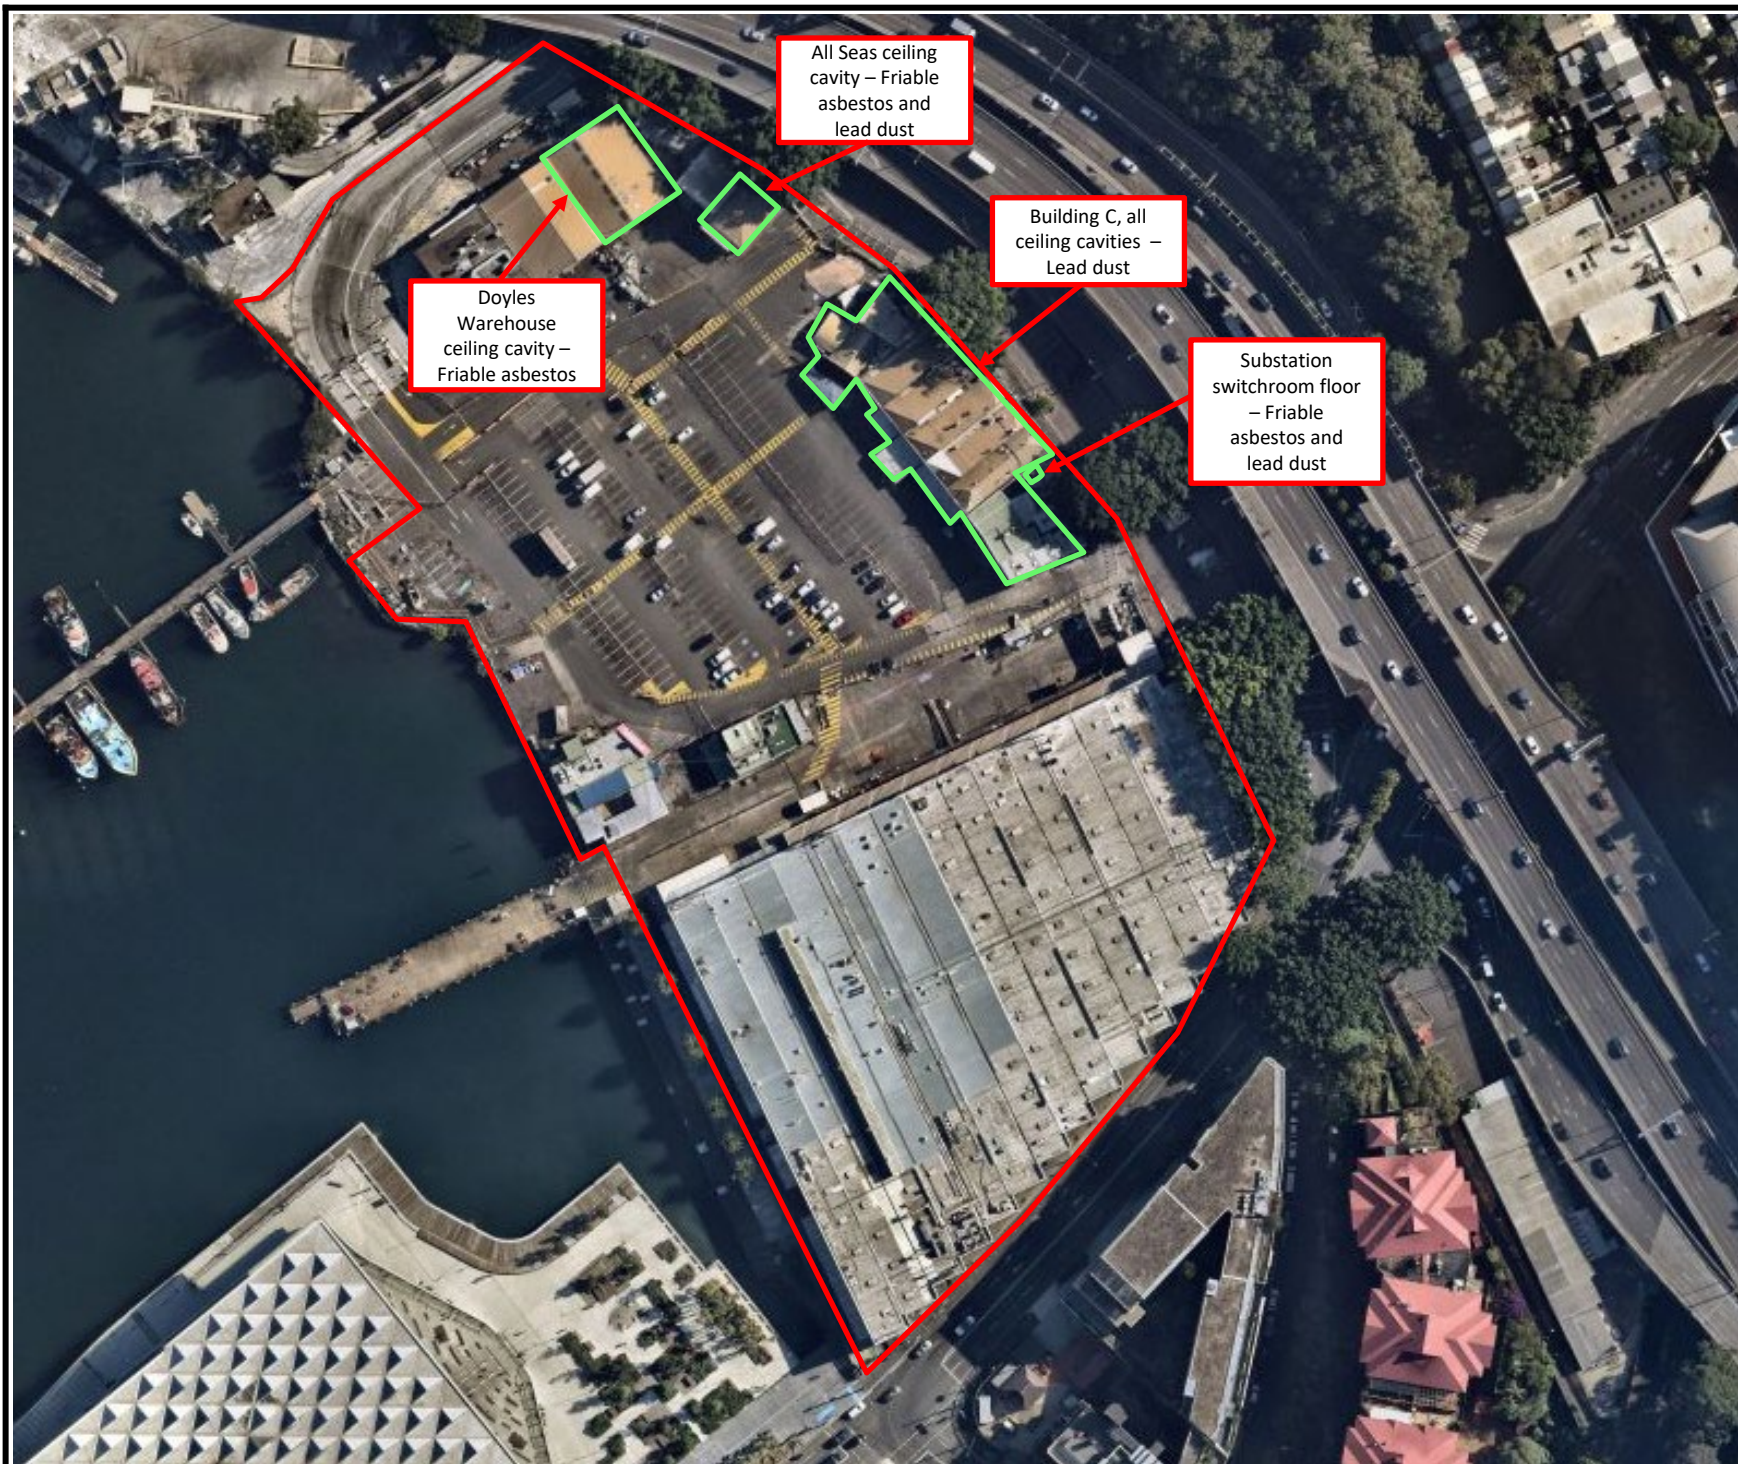
- Approximate Site Boundary
- Recommended Restricted Access Locations

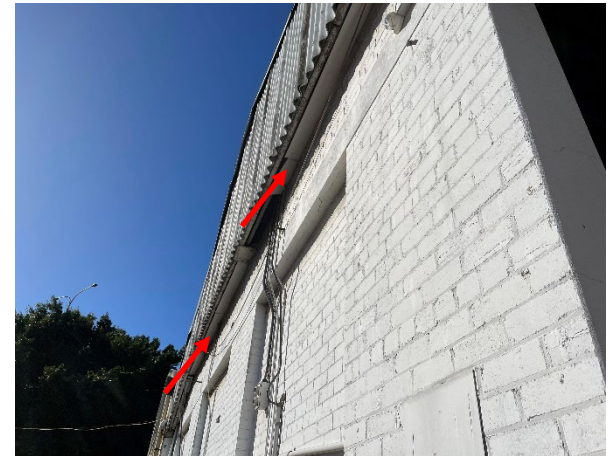
Photo 6: External, Box Recycling Warehouse north eaves – asbestos containing fibre cement sheeting

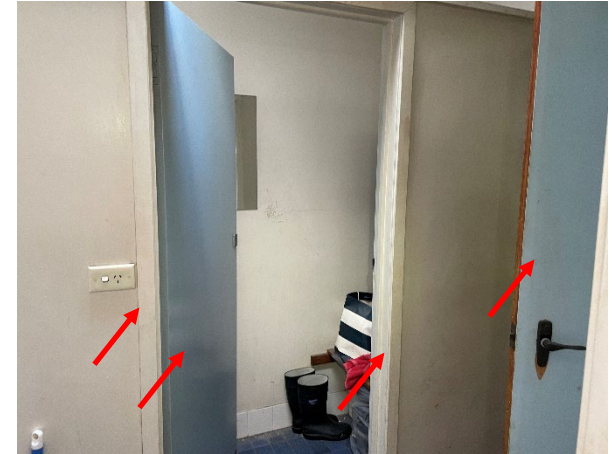
Photo 21: Internal, Doyle's Warehouse, bathroom door and door frame – lead based blue paint with white overcoat

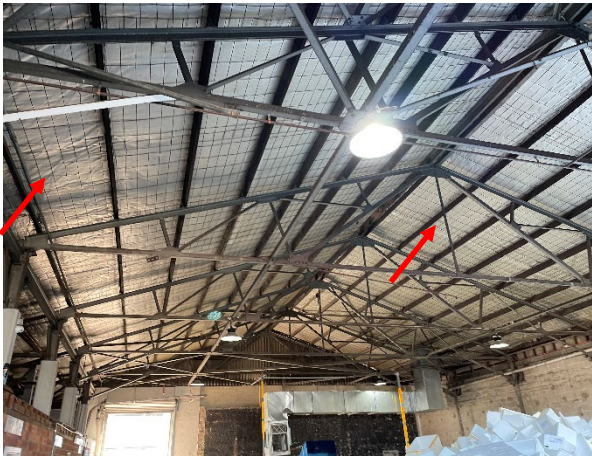
Photo 22: Internal, Box Recycling Warehouse, underside of roof – assumed SMF sarking

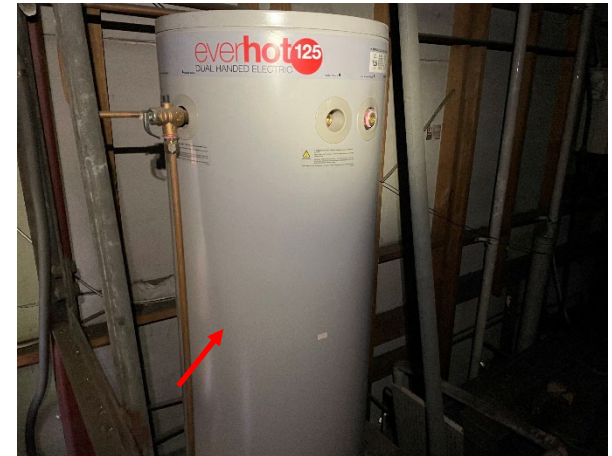
Photo 24: Internal, Doyle's Warehouse ceiling cavity, hot water heater – assumed SMF insulation core

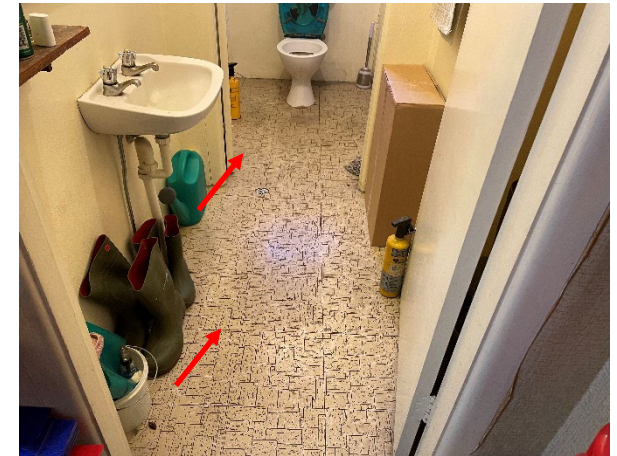
Photo 30: Internal, Net & Tackle, level 1 bathroom floor – asbestos-containing grey vinyl tiles

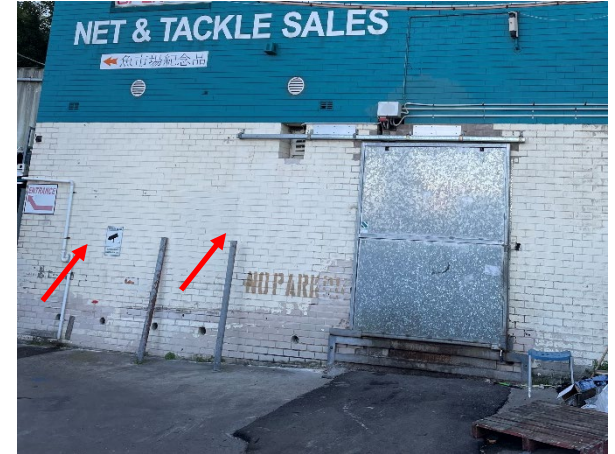
Photo 33: External, Net & Tackle, brick walls – lead based cream paint

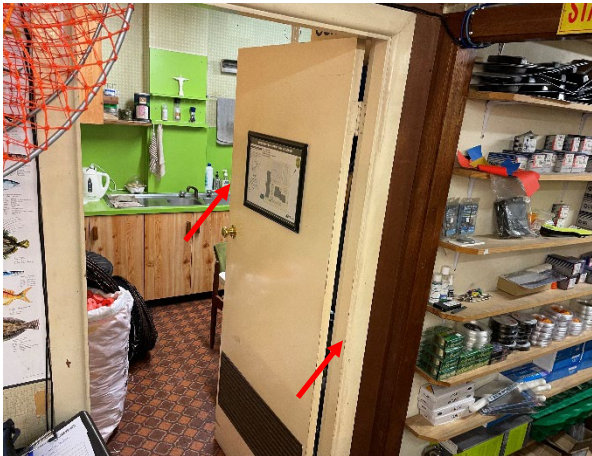
Photo 34: Internal, Net & Tackle, door frame – lead based cream paint

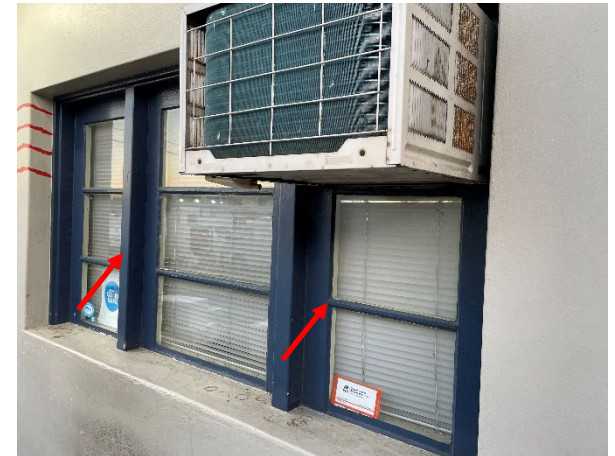
Photo 36: External, All Seas, window frame – lead based blue paint

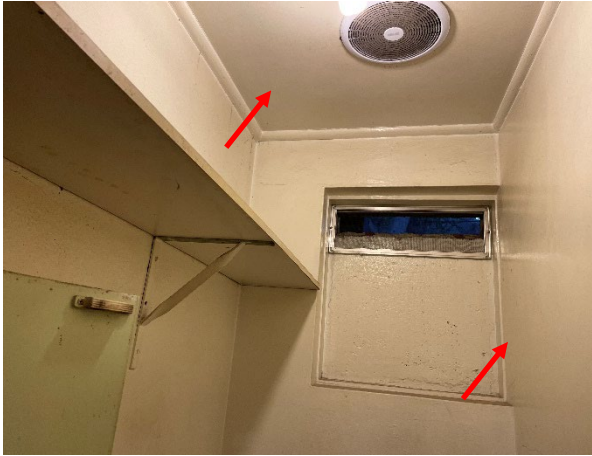
Photo 37: Internal, All Seas, bathroom walls and ceiling – assumed lead containing cream paint

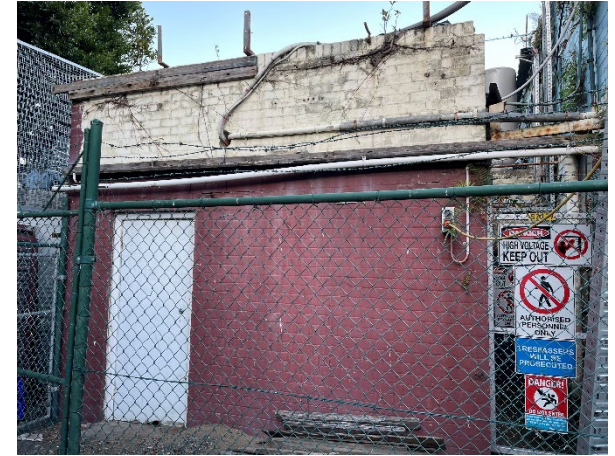
Photo 45: Inaccessible secondary main switch room and electrical substation

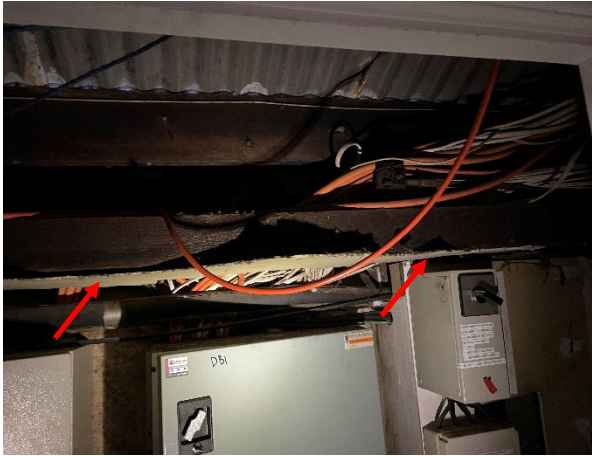
Photo 49: Internal, Get Fish security office electrical cupboard, ceiling liner – asbestos containing fibre cement sheet

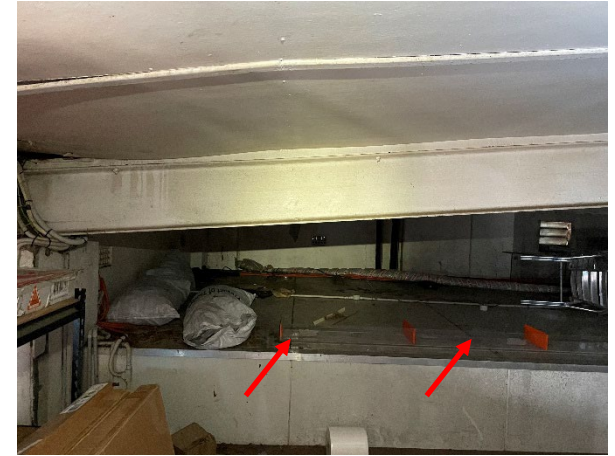
Photo 51: Internal, Sea Emperor above new cool room, ceiling cavity – elevated lead concentrations within settled dust

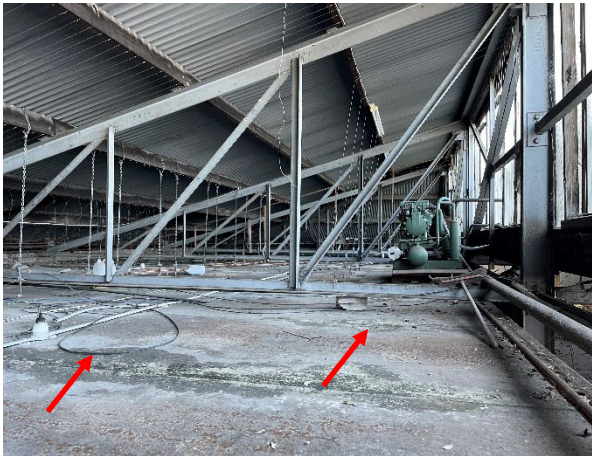
Photo 52: Internal, Poulos Bros above cool room, ceiling cavity – elevated lead concentrations within settled dust

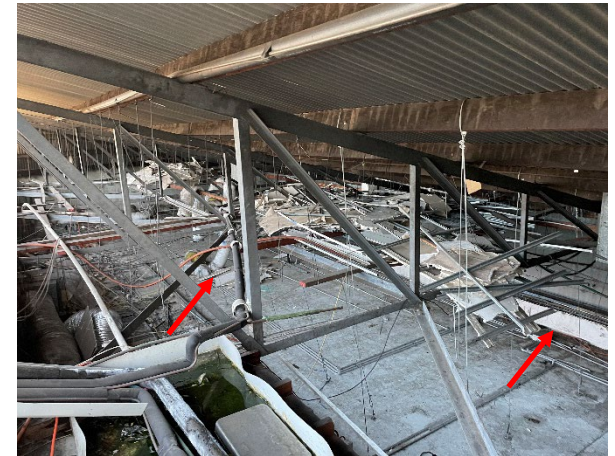
Photo 54: Internal, Get Fish, ceiling cavity accessed via storeroom – elevated lead concentrations within settled dust

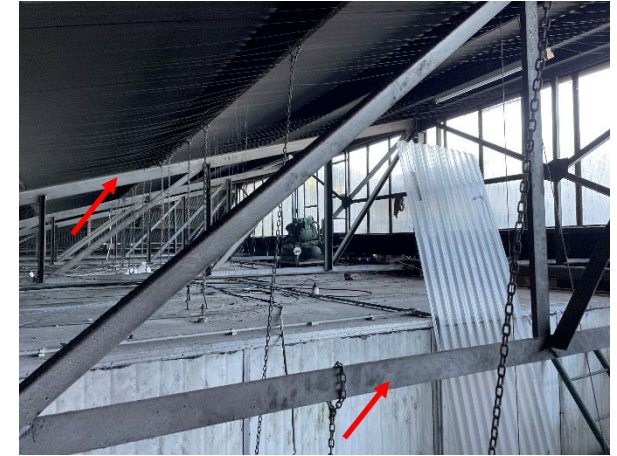
Photo 57: Internal, Poulos Bros ceiling cavity, metal framework to saw tooth roof – lead based grey paint

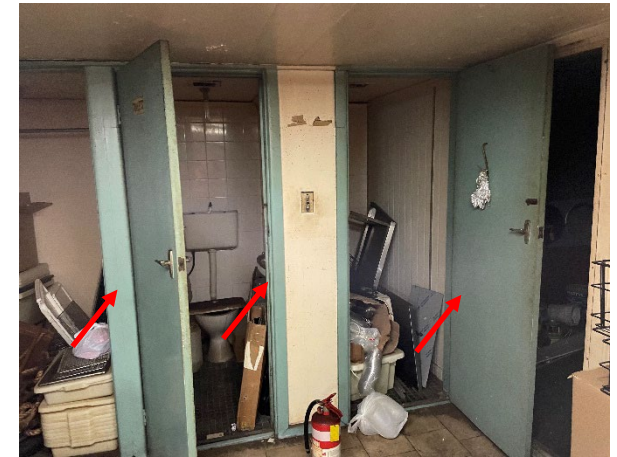
Photo 60: Internal, Salty Squid Level 1, bathroom door and door frame – lead based aqua paint

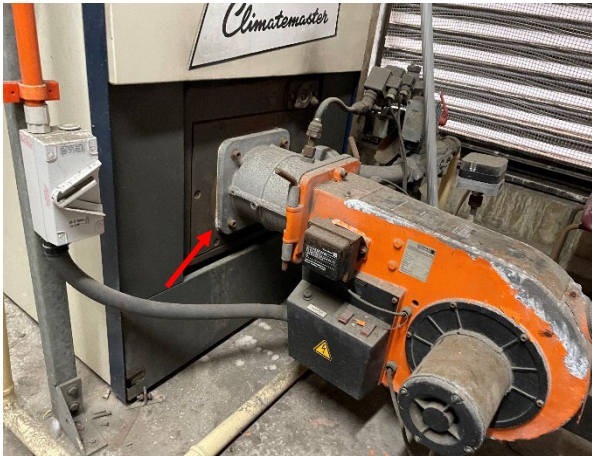
Photo 67: Internal level 1 air conditioning plantroom No. 1, boiler room, Boiler number 2 (north unit) – asbestos containing gasket

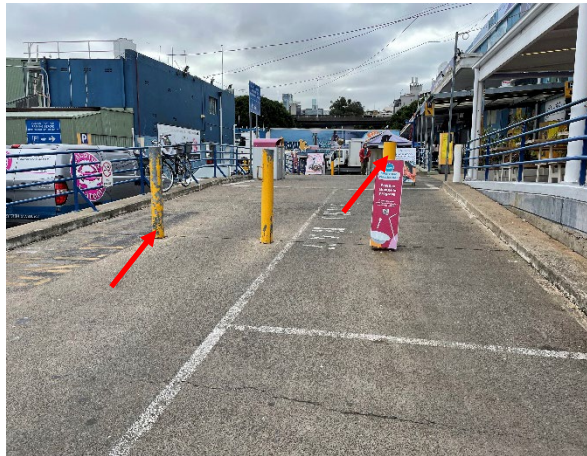
Photo 68: External, traffic bollards – lead based yellow paint

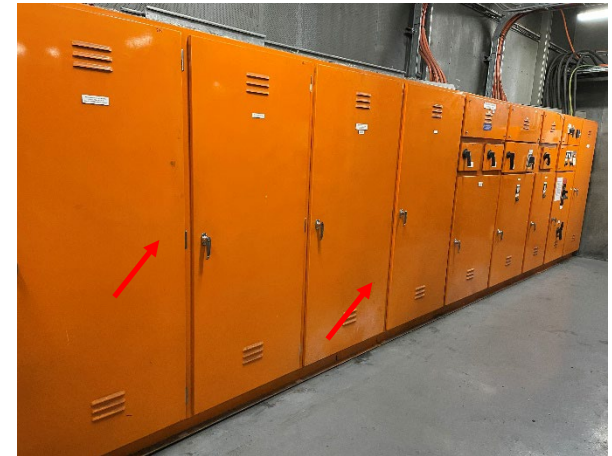
Photo 69: Internal and external, throughout, electrical distribution cupboards and boxes – lead based orange paint

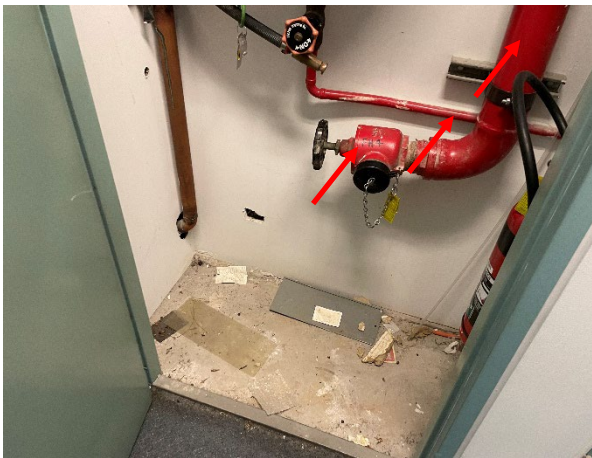
Photo 70: Internal and external, fire suppression system throughout, pipes and hydrants – lead based red paint

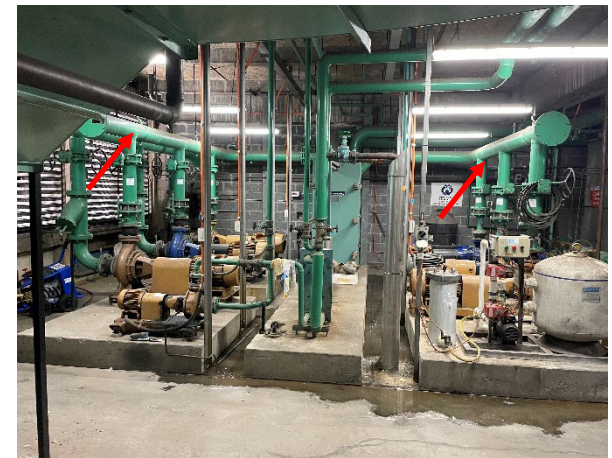
Photo 72: Internal, level 1 plantroom 1, water service lines to water filtration system – lead based green paint

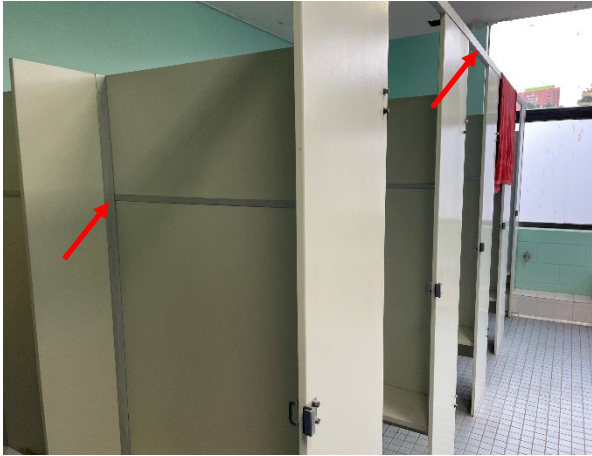
Photo 73: Internal, level 1 northeast staff bathroom, frame to cubical dividers – lead based grey paint

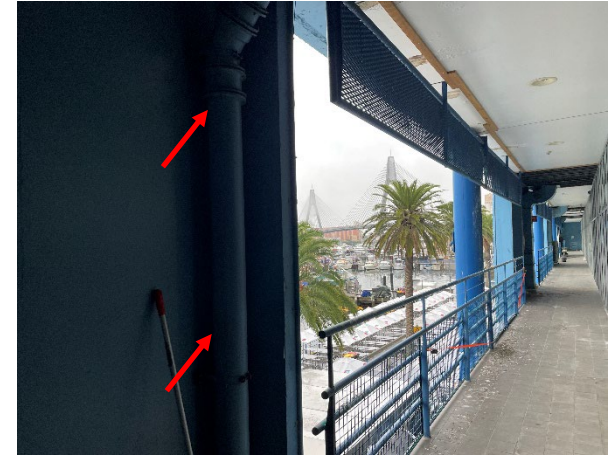
Photo 75: External, level 1 west balcony, cast iron pipework – lead based light blue paint

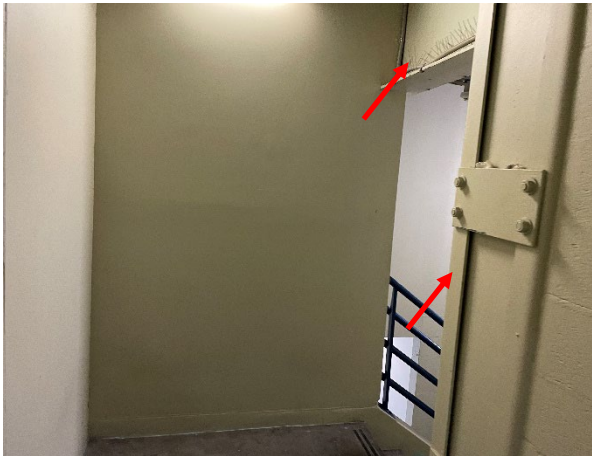
Photo 76: Internal, west central stairwell, I beam and metal frame – lead based cream paint with light blue undercoat

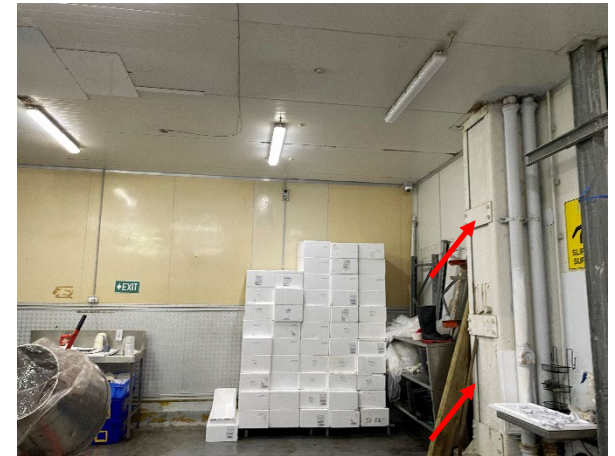
Photo 78: Internal ground floor, Claudio's and Musumeci cool room, structural columns – lead based cream paint

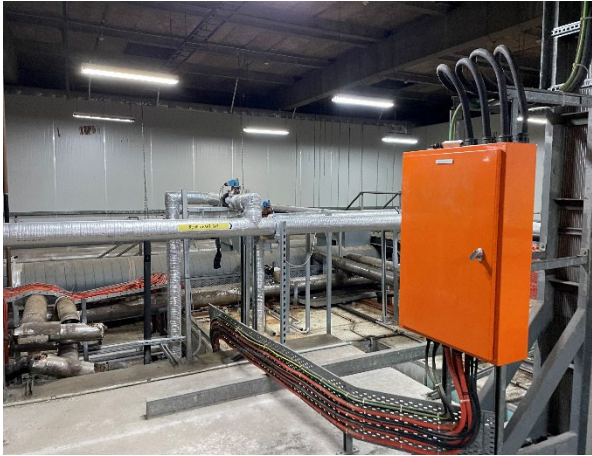
Photo 79: Internal, throughout plant rooms and ceiling cavities, pipework – assumed SMF insulation

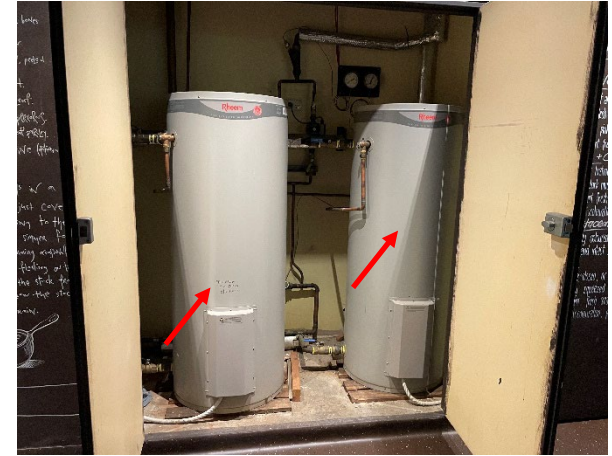
Photo 81: Internal, throughout plant room and tenancies, tanked hot water heater – assumed SMF insulation core

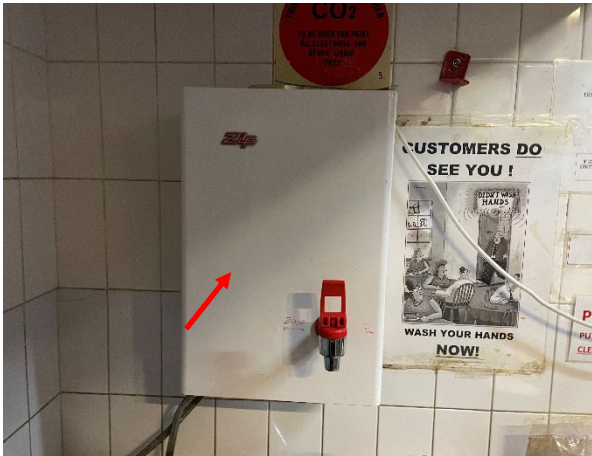
Photo 82: Internal, throughout kitchenettes, Zipp instant boil – assumed SMF insulation core

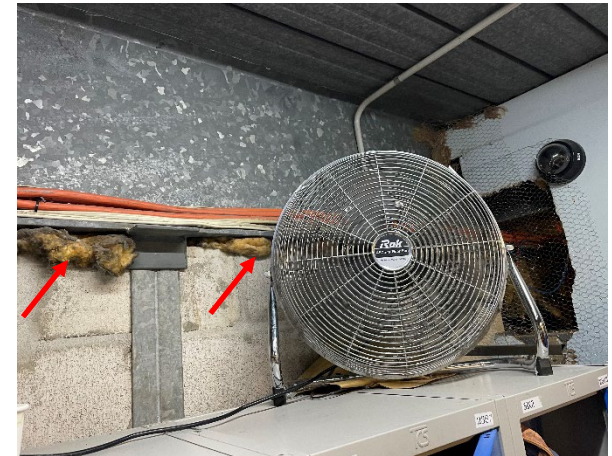
Photo 84: Internal, Peters Sydney Fish Market, wall cavity – assumed SMF insulation batts

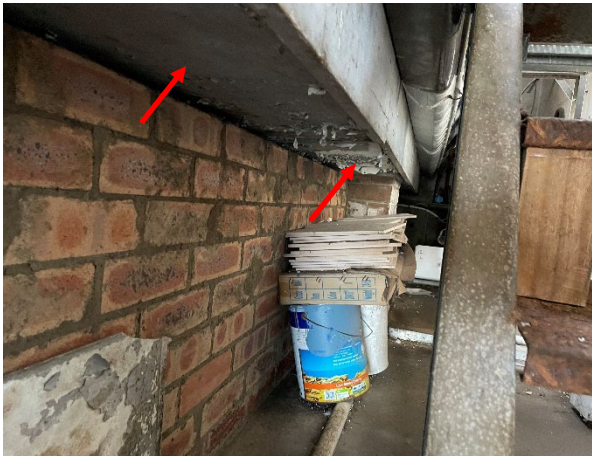
Photo 88: Internal, level 1 storeroom, original eaves (partially removed) – asbestos containing fibre cement sheeting

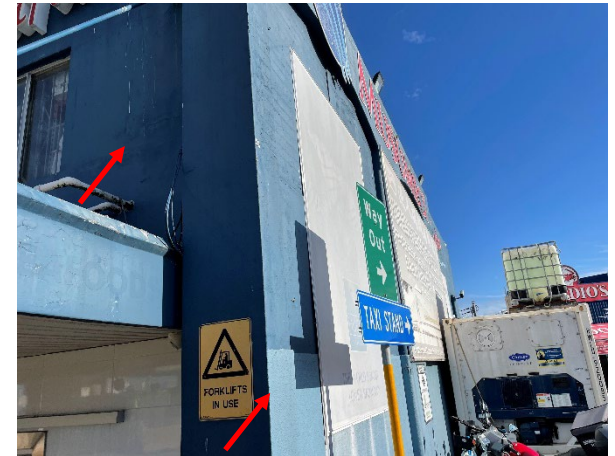
Photo 90: External, wall – lead based blue paint

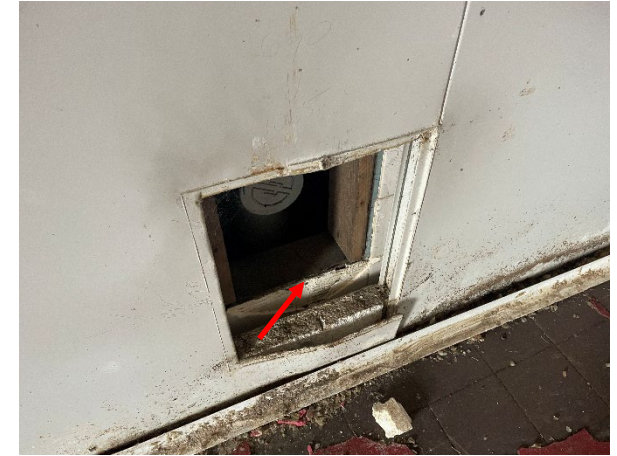
Photo 105: Internal, Doyles Warehouse – ground level central south cool room, behind wall tiles – asbestos containing fibre cement sheeting

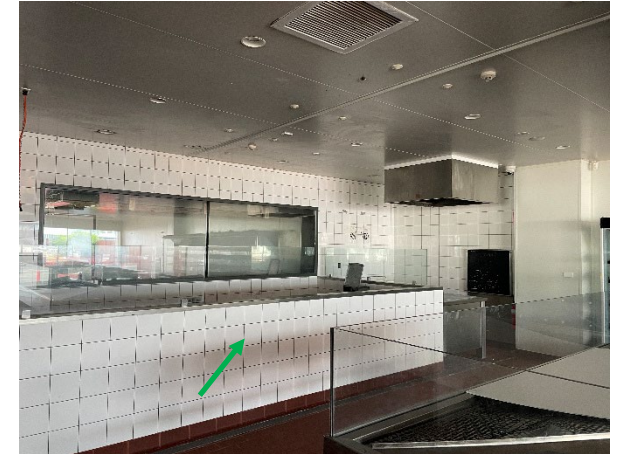
Photo 111: Vic's Meats, internal, ground floor, butchers' area, behind white tiled walls – non-asbestos containing fibre cement sheeting

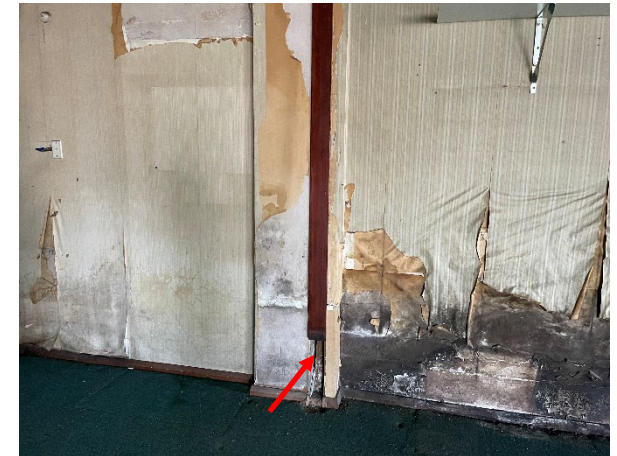
Photo 114: Net and Tackle, internal, level 1, south wall, formwork – asbestos containing fibre cement debris

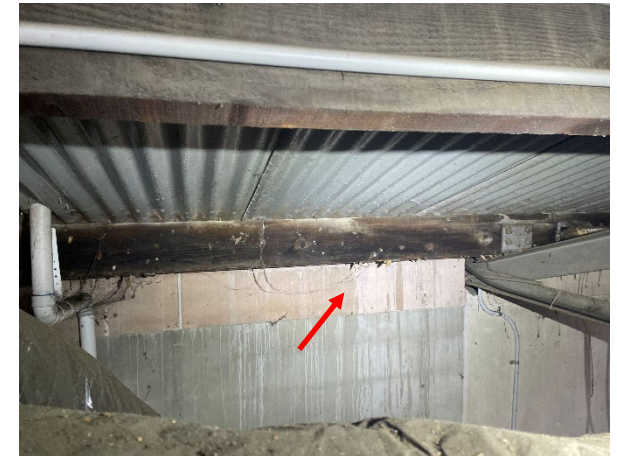
Photo 120: Poulos Bros, internal, cool room, ceiling cavity, infill panel adjacent top of cool room wall – asbestos containing fibre cement sheeting

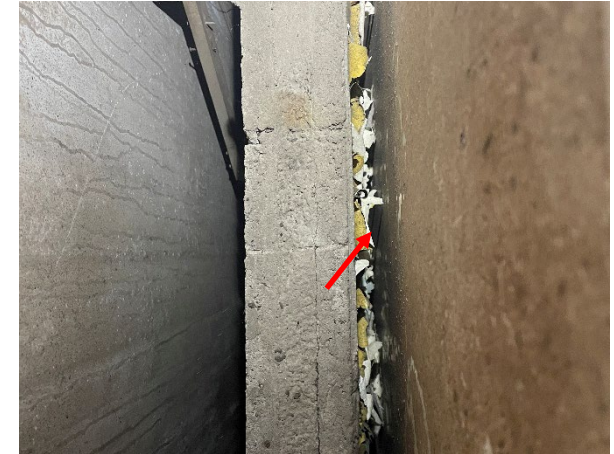
Photo 123: Poulos Bros, internal, ceiling cavity, original brick walls – lead based cream paint

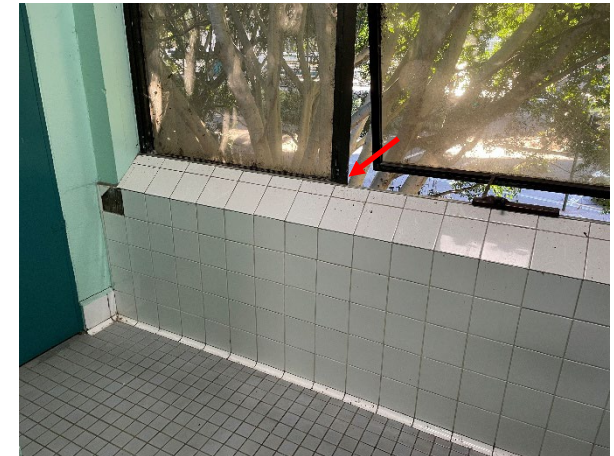
Photo 126: Main Market, external, level 1, north east men's and women's bathroom, windows (assumed to be present to all external windows) – asbestos containing window mastic

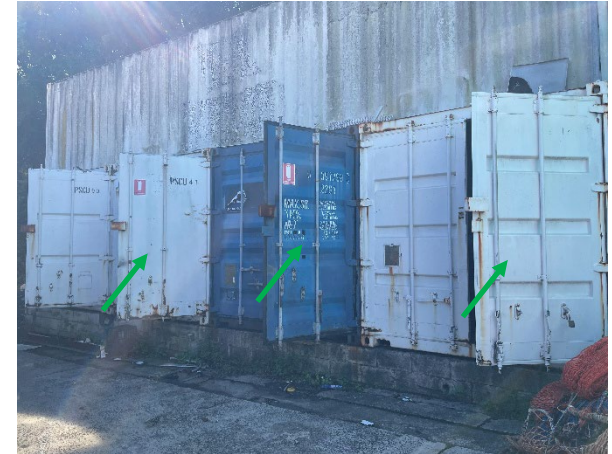
Photo 135: External, northern portion of site, adjacent All Seas, two white and one blue shipping containers – non-lead based white and blue paints
