# ARBORICULTURAL IMPACT ASSESSMENT TREE PROTECTION SPECIFICATION

**Former Sydney Fish Market**  
**56-60 Pyrmont Bridge Road, PYRMONT**

Prepared for: INFRASTRUCTURE NSW (iNSW)

15<sup>th</sup> May 2026

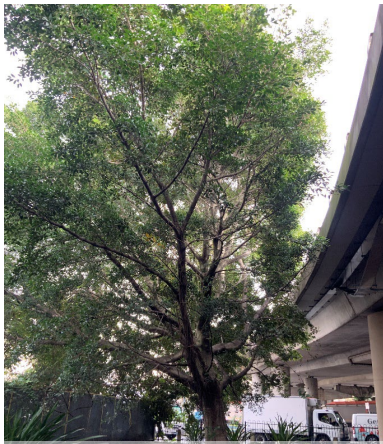
**Plate 1:** Showing Tree 26

Trees 26 and 27 were identified as *Ficus microcarpa* var. 'hilli' (Hills Weeping Fig) and are located at the northern end of the site. Tree 27 is in fair health with a reduced crown density of 50-75%. The trees are in fair structural condition with minor bark inclusions present at a number of branch junctions. The crowns of the trees extend over the roofline of the adjacent building. Trees 26 and 27 have a medium (15-40 years) Useful Life Expectancy (ULE) and have been allocated a Retention Value of *Consider for Retention*.

| Tree No. | Species | DBH (mm) | Height (m) | Crown Spread (mR) | Health Rating | Structural Condition Rating | Comments | Age Class | ULE (years) | L/Sign | Retention Value | NRZ (mR) | SRZ (mR) |
|---|---|---|---|---|---|---|---|---|---|---|---|---|---|
| 26 | <i>Ficus microcarpa</i> var. 'hillii' (Hills Weeping Fig) | 650 | 12 | 10 | Good | Fair | Limited clearance due to over-pass. Large number of surface roots. Wound(s), various stages of decay. Branch inclusions, minor. | Mature | 15-40 | High | Consider for Retention | 7.80 | 2.9 |

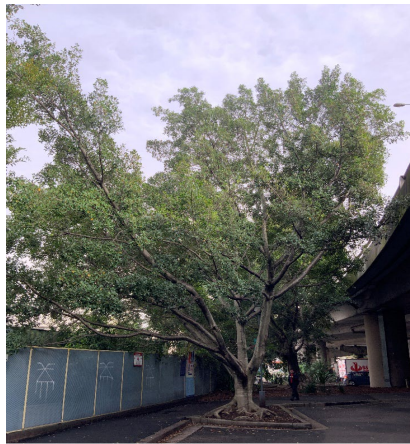
**Plate 2:** Showing Tree 27

| Tree No. | Species | DBH (mm) | Height (m) | Crown Spread (mR) | Health Rating | Structural Condition Rating | Comments | Age Class | ULE (years) | L/Sign | Retention Value | NRZ (mR) | SRZ (mR) |
|---|---|---|---|---|---|---|---|---|---|---|---|---|---|
| 27 | <i>Ficus microcarpa</i> var. 'hillii' (Hills Weeping Fig) | 650 | 11 | 8 | Fair | Fair | Crown density 50-75%. Limited clearance due to over-pass. Large number of surface roots. Asymmetric root plate. Crossing branches. Significant damage to pavement. Small (<25mmø), in low volumes. Mechanical damage to exposed surface roots. Bark inclusion(s), minor. Structures within SRZ. Wound(s), various stages of decay. | Mature | 15-40 | High | Consider for Retention | 7.80 | 2.9 |

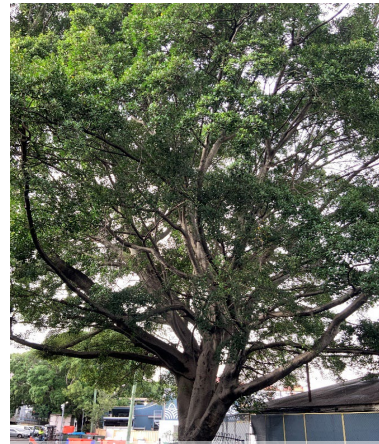
**Plate 3:** Showing Tree 28

Trees 28 and 29 were identified as *Ficus microcarpa* var. 'hilli' (Hills Weeping Fig). Tree 28 is located at the north end of the site with Tree 29 located in the centre of the site. They are in poor structural condition as they have developed highly asymmetric root plates between the adjacent building and kerb. The basal flare and buttress of the trees are roots causing extensive lifting and damage to the pavement and are overgrowing the kerb. It is not possible to accurately determine the extent to which the adjacent building footings (to the west) and kerb (to the east) are contributing to the structural support of the root plates. Trees 28 and 29 have a short (5-15 years) ULE and have been allocated a Retention Value of *Consider for Retention*.

| Tree No. | Species | DBH (mm) | Height (m) | Crown Spread (mR) | Health Rating | Structural Condition Rating | Comments | Age Class | ULE (years) | L/Sign | Retention Value | NRZ (mR) | SRZ (mR) |
|---|---|---|---|---|---|---|---|---|---|---|---|---|---|
| 28 | <i>Ficus microcarpa</i> var. 'hillii' (Hills Weeping Fig) | 1500 | 18 | 15 | Good | Poor | Limited clearance due to over-pass. Large number of surface roots. Asymmetric root plate. Crossing branches. Significant damage to pavement. Small (<25mmø), medium (25-75mmø) & large (>75mmø) deadwood in low volumes. Mechanical damage to exposed surface roots. Bark inclusion(s), minor. Structures within SRZ. Wound(s), various stages of decay. | Mature | 5-15 | High | Consider for Retention | 15.00 | 4.1 |

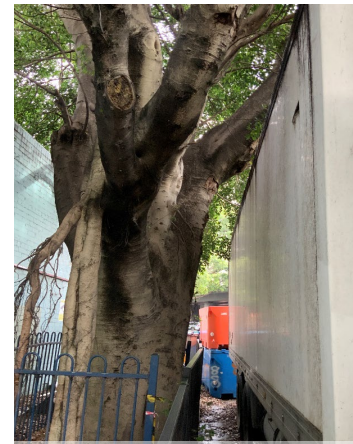
**Plate 4:** Showing Tree 29

| Tree No. | Species | DBH (mm) | Height (m) | Crown Spread (mR) | Health Rating | Structural Condition Rating | Comments | Age Class | ULE (years) | L/Sign | Retention Value | NRZ (mR) | SRZ (mR) |
|---|---|---|---|---|---|---|---|---|---|---|---|---|---|
| 29 | <i>Ficus microcarpa</i> var. 'hillii' (Hills Weeping Fig) | 1200 | 18 | 15 | Good | Poor | Limited clearance due to over-pass. Large number of surface roots. Asymmetric root plate. Crossing branches. Significant damage to pavement. Crown extends over building. Wound(s), various stages of decay. Major bark inclusion | Mature | 5-15 | High | Consider for Retention | 14.40 | 3.7 |

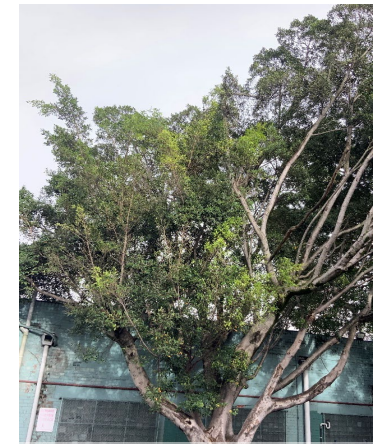
**Plate 5:** Showing Tree 30

Tree 30 was identified as *Ficus microcarpa* var. 'hilli' (Hills Weeping Fig) and is located in the centre of the site. It is in fair health with a reduced crown density of 25-50%. The tree is in poor structural condition with a number of large sunburn and vehicle impact wounds with decay present. Tree 30 has a transient (<5 years) ULE and has been allocated a Retention Value of *Priority for Removal*.

| Tree No. | Species | DBH (mm) | Height (m) | Crown Spread (mR) | Health Rating | Structural Condition Rating | Comments | Age Class | ULE (years) | L/Sign | Retention Value | NRZ (mR) | SRZ (mR) |
|---|---|---|---|---|---|---|---|---|---|---|---|---|---|
| 30 | <i>Ficus microcarpa</i> var. 'hilli' (Hills Weeping Fig) | 900 | 17 | 10 | Fair | Poor | Crown density 25-50%. Adjacent tree removed exposing crown with resultant sunburn. Wound(s), various stages of decay. Asymmetric root plate. Asymmetric crown. Significant damage to pavement. Small (<25mmø) & medium (25-75mmø) deadwood in moderate volumes. Partially suppressed. | Mature | <5 | High | Priority for Removal | 10.80 | 3.3 |

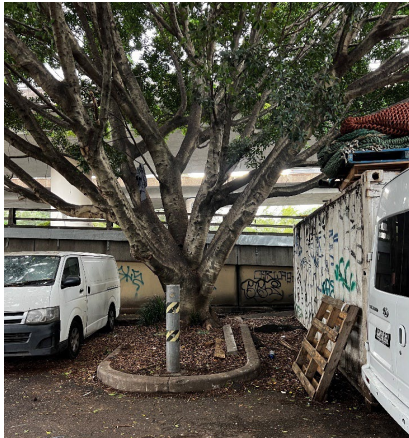
**Plate 6:** Showing Tree 31

Tree 31 was identified as *Ficus microcarpa* var. 'hilli' (Hills Weeping Fig) and is located in the centre of the site and adjacent to the Western Distributor ramp. It is in fair structural condition due to the presence of a major co-dominant bark inclusion. The tree has an extensive network of surface roots which are lifting adjacent kerbs and pavements. Tree 31 has a medium (15-40 years) ULE and has been allocated a Retention Value of *Consider for Retention*.

| Tree No. | Species | DBH (mm) | Height (m) | Crown Spread (mR) | Health Rating | Structural Condition Rating | Comments | Age Class | ULE (years) | L/Sign | Retention Value | NRZ (mR) | SRZ (mR) |
|---|---|---|---|---|---|---|---|---|---|---|---|---|---|
| 31 | <i>Ficus microcarpa</i> var. 'hilli' (Hills Weeping Fig) | 850 | 16 | 10 | Good | Fair | Surface roots. Mechanical damage to branches. Small (<25mmø) & medium (25-75mmø) deadwood in low volumes. Partially suppressed. Co-dominant inclusions, major. Structures within SRZ. | Mature | 15-40 | High | Consider for Retention | 10.20 | 3.2 |

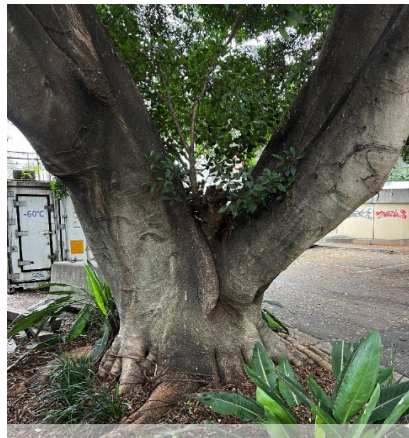
Tree 32 was identified as *Ficus microcarpa* var. 'hilli' (Hills Weeping Fig) and is located in the centre of the site. The tree is in poor structural condition due to the presence of a major co-dominant bark inclusion which is considered a significant structural defect. Tree 32 has a short (5-15 years) ULE and has been allocated a Retention Value of *Consider for Retention*.

| Tree No. | Species | DBH (mm) | Height (m) | Crown Spread (mR) | Health Rating | Structural Condition Rating | Comments | Age Class | ULE (years) | L/Sign | Retention Value | NRZ (mR) | SRZ (mR) |
|---|---|---|---|---|---|---|---|---|---|---|---|---|---|
| 32 | <i>Ficus microcarpa</i> var. 'hilli' (Hills Weeping Fig) | 1000 | 16 | 10 | Good | Poor | Mechanical damage to branches from adjacent structures. Crown over hanging building. Small (<25mmø) & medium (25-75mmø) deadwood in low volumes. Co-dominant inclusions, major. Wound(s), various stages of decay. Trunk cavity(s), minor. Structures within SRZ. | Mature | 5-15 | High | Consider for Retention | 12.00 | 3.4 |

**Plate 7:** Showing Tree 32 – co-dominant inclusion

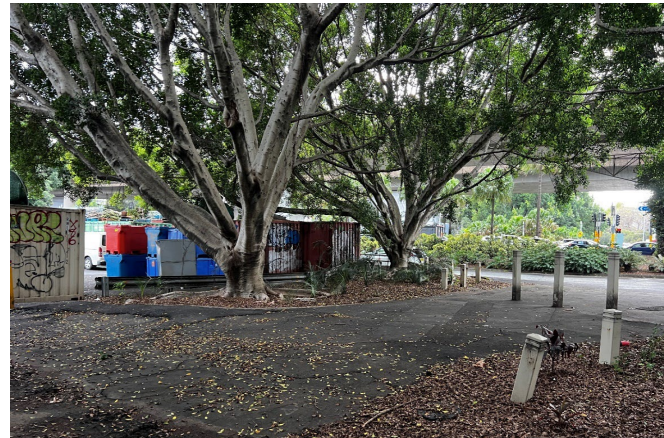
**Plate 8:** Showing Tree 33 (right) & Tree 34 (left)

Tree 33 was identified as *Ficus microcarpa* var. 'hilli' (Hills Weeping Fig) and is located at the southern end of the site and adjacent to the Western Distributor ramp. The tree is in poor structural condition due to the presence of a major co-dominant bark inclusion which is considered a significant structural defect. Tree 33 has a short (5-15 years) ULE and has been allocated a Retention Value of *Consider for Retention*.

Trees 34-36 were identified as *Ficus microcarpa* var. 'hilli' (Hills Weeping Fig) and are located at the southern end of the site and are growing as a group resulting in partial crown suppression. The trees are in fair to poor structural condition due to the presence of bark inclusions. The crowns of the trees extend over the roofline of the adjacent building. Trees 34-36 have a short (5-15 years) ULE and have been allocated a Retention Value of *Consider for Retention*.

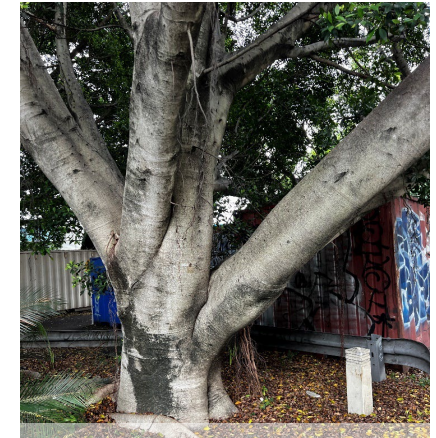
**Plate 9:** Showing Tree 3 – co-dominant inclusion

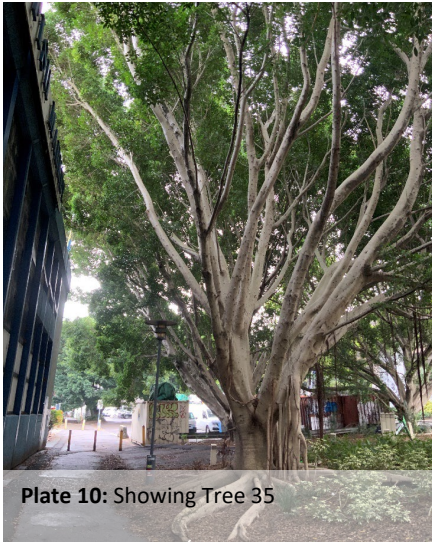
**Plate 10:** Showing Tree 35

| Tree No. | Species | DBH (mm) | Height (m) | Crown Spread (mR) | Health Rating | Structural Condition Rating | Comments | Age Class | ULE (years) | L/Sign | Retention Value | NRZ (mR) | SRZ (mR) |
|---|---|---|---|---|---|---|---|---|---|---|---|---|---|
| 35 | <i>Ficus microcarpa</i> var. 'hilli' (Hills Weeping Fig) | 1000 | 18 | 12 | Good | Fair | Asymmetric crown spread. Partially suppressed. Mechanical damage to exposed surface roots. Co-dominant inclusions, major. Bark inclusion(s), major. Crown conflict with adjacent structures. | Mature | 5-15 | High | Consider for Retention | 12.00 | 3.4 |

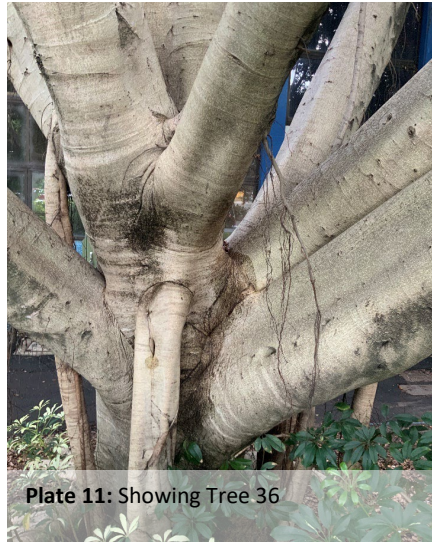
**Plate 11:** Showing Tree 36

| Tree No. | Species | DBH (mm) | Height (m) | Crown Spread (mR) | Health Rating | Structural Condition Rating | Comments | Age Class | ULE (years) | L/Sign | Retention Value | NRZ (mR) | SRZ (mR) |
|---|---|---|---|---|---|---|---|---|---|---|---|---|---|
| 36 | <i>Ficus microcarpa</i> var. 'hilli' (Hills Weeping Fig) | 1000 | 17 | 12 | Good | Fair | Asymmetric crown spread. Partially suppressed. Mechanical damage to exposed surface roots. Co-dominant inclusions, major. Bark inclusion(s), major. Crown conflict with adjacent structures. | Mature | 5-15 | High | Consider for Retention | 12.00 | 3.4 |

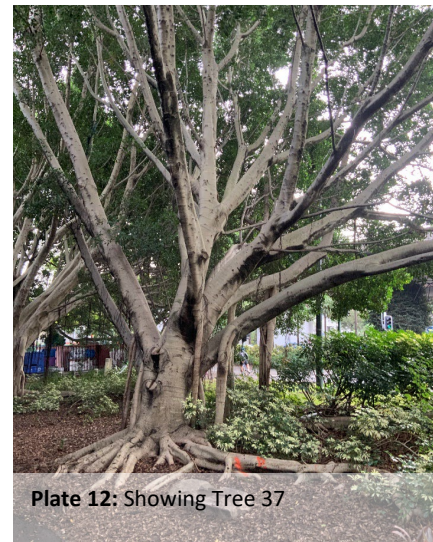
**Plate 12:** Showing Tree 37

Tree 37 was identified as *Ficus microcarpa* var. 'hilli' (Hills Weeping Fig) and is located at the southern end of the site. The tree is in fair health and fair structural condition with a reduced crown density of 50-75% and a major co-dominant bark inclusion. The crown of the tree extends over the roofline of the adjacent building. Tree 37 has a short (5-15 years) ULE and has been allocated a Retention Value of *Consider for Retention*.

| Tree No. | Species | DBH (mm) | Height (m) | Crown Spread (mR) | Health Rating | Structural Condition Rating | Comments | Age Class | ULE (years) | L/Sign | Retention Value | NRZ (mR) | SRZ (mR) |
|---|---|---|---|---|---|---|---|---|---|---|---|---|---|
| 37 | <i>Ficus microcarpa</i> var. 'hilli' (Hills Weeping Fig) | 700 | 14 | 12 | Fair | Fair | Crown density 50-75%. Mechanical damage to exposed surface roots. Co-dominant inclusions, major. Bark inclusion(s), major. Crown conflict with adjacent structures. | Mature | 5-15 | High | Consider for Retention | 8.40 | 3.0 |

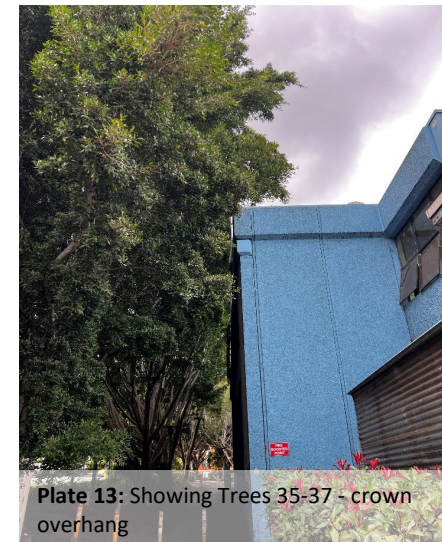
**Plate 13:** Showing Trees 35-37 - crown overhang

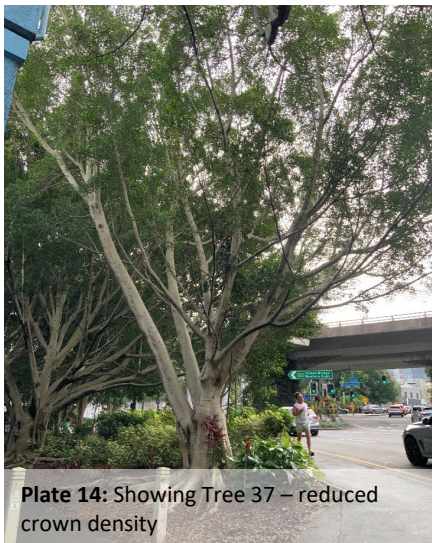
**Plate 14:** Showing Tree 37 - reduced crown density

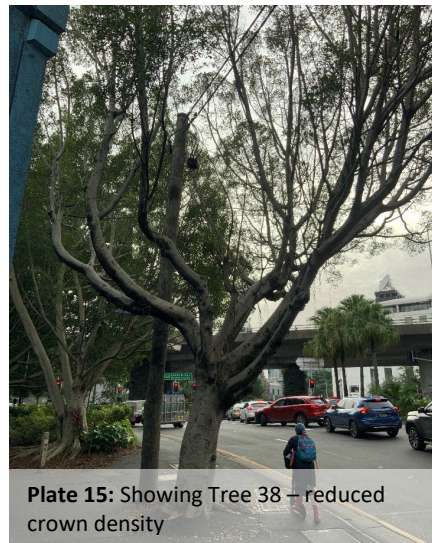
Trees 38 and 39 were identified as *Ficus microcarpa* var. 'hilli' (Hills Weeping Fig) and are in poor health with a reduced crown density of 25-50%. The trees are in fair structural condition as they have been subject to repeated high sided vehicle impacts and the resultant wounds are in various stages of decay. Trees 38 and 39 have a transient (<5 years) ULE and have been allocated a Retention Value of *Priority for Removal*.

| Tree No. | Species | DBH (mm) | Height (m) | Crown Spread (mR) | Health Rating | Structural Condition Rating | Comments | Age Class | ULE (years) | L/Sign | Retention Value | NRZ (mR) | SRZ (mR) |
|---|---|---|---|---|---|---|---|---|---|---|---|---|---|
| 38 | <i>Ficus microcarpa</i> var. 'hilli' (Hills Weeping Fig) | 600 | 14 | 12 | Poor | Fair | Crown density 25-50%. Pruned/lopped for powerline clearance. Wound(s), various stages of decay. | Mature | <5 | High | Priority for Removal | 7.20 | 2.8 |

**Plate 15:** Showing Tree 38 - reduced crown density

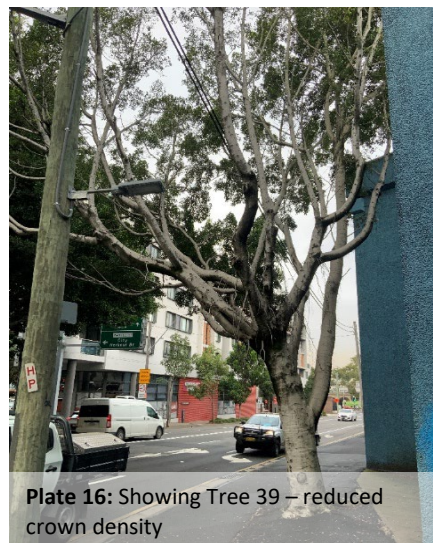
| Tree No. | Species | DBH (mm) | Height (m) | Crown Spread (mR) | Health Rating | Structural Condition Rating | Comments | Age Class | ULE (years) | L/Sign | Retention Value | NRZ (mR) | SRZ (mR) |
|---|---|---|---|---|---|---|---|---|---|---|---|---|---|
| 39 | <i>Ficus microcarpa</i> var. 'hilli' (Hills Weeping Fig) | 600 | 14 | 12 | Poor | Fair | Crown density 25-50%. Pruned/lopped for powerline clearance. Wound(s), advanced stages of decay. | Mature | <5 | High | Priority for Removal | 7.20 | 2.8 |

**Plate 16:** Showing Tree 39 - reduced crown density

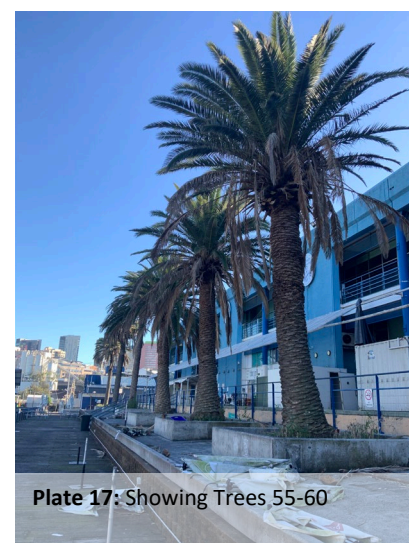
**Plate 17:** Showing Trees 55-60

Trees 55-60 are a group of six (6) *Phoenix canariensis* (Canary Island Date Palm) located in small masonry planters within the former outdoor dining area. Trees 55-60 have a medium (15-40 years) ULE and have been allocated a Retention Value of *Consider for Retention*.

2.2.14 *Phoenix canariensis* (Canary Island Date Palm) is an exotic palm species which was introduced to Australia in the late 1800s. It is historically associated with commemorative plantations and civic landscapes established during the late nineteenth and early twentieth centuries (including the Inter-war Period). The trees are not visible in aerial imagery from 1943 and are unlikely to be culturally significant specimens. New plantings of this species are generally avoided due to its propensity to self-seed and become weedy, its susceptibility to *Fusarium oxysporum* f. sp. *canariensis*, and its tendency to provide attractive habitat for vermin.
