Report on  
Geotechnical Investigation

Proposed Perisher View Ski Lodge  
Lot 1, DP1192372, Perisher Valley, NSW

Project 94499.00  
June 2020

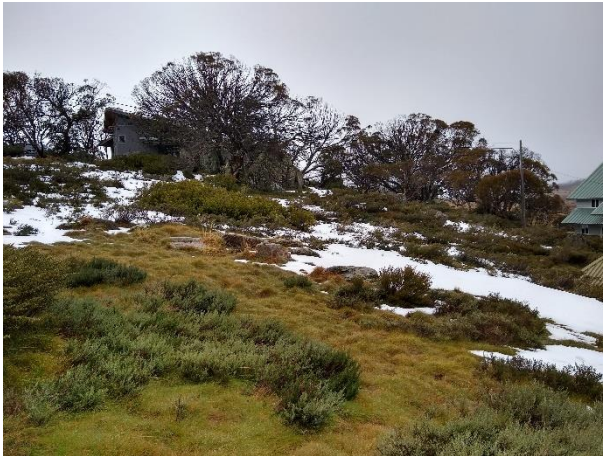
**Figure 2: View north across Lot 1.**

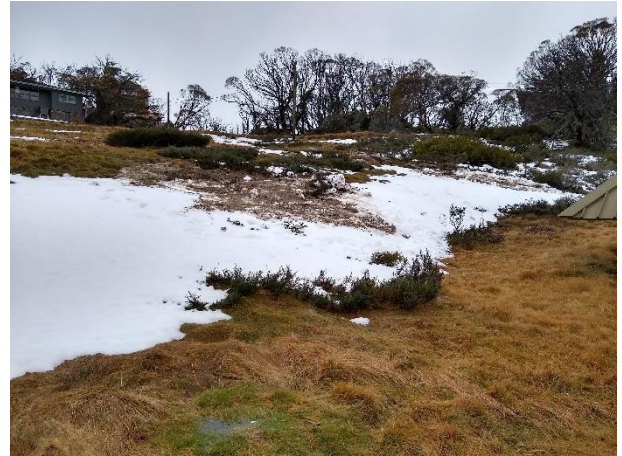
**Figure 3: View north-west diagonally from south-east corner of Lot 1.**

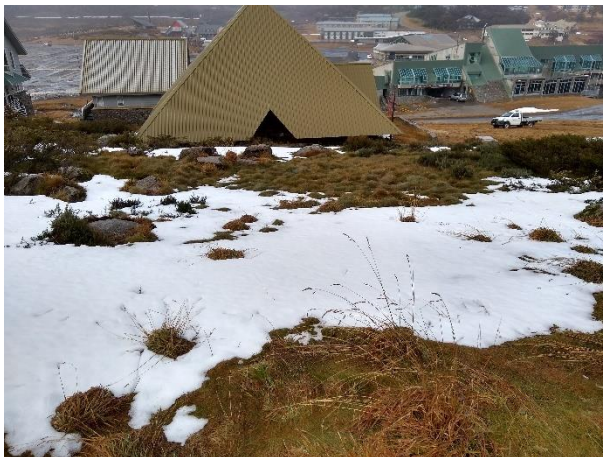
**Figure 4: View south-east toward the church outside Lot 1 rear boundary.**

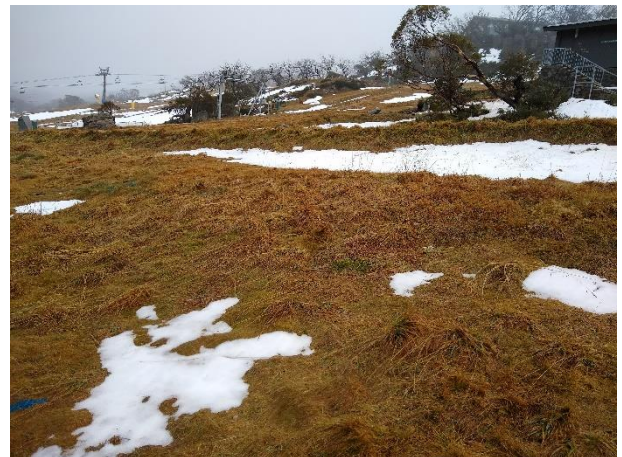
**Figure 5: View west across upslope portion of Lot 1 adjacent to Burramys Road.**
