## **Sundowner Snowmaking & Associated Works Thredbo NSW**

Geotechnical Investigation

Our ref: 6653-G1  
6 October 2021

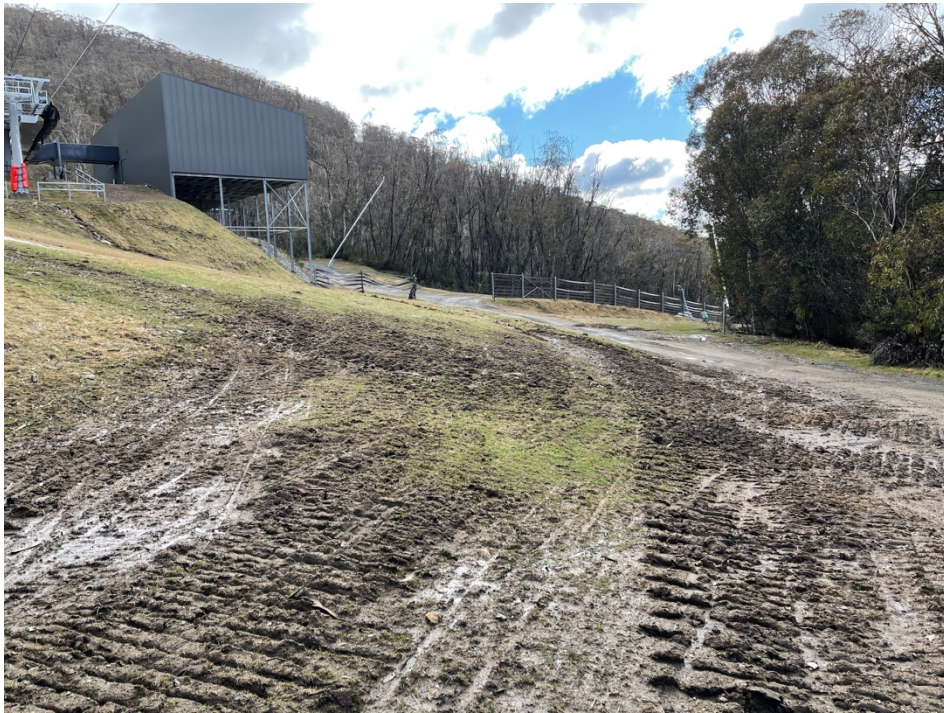
**Photo 1**

View of connection to recent Friday Flat Snowmaking replacement looking east. Ground surface slopes up to the northwest at about 8-10°.

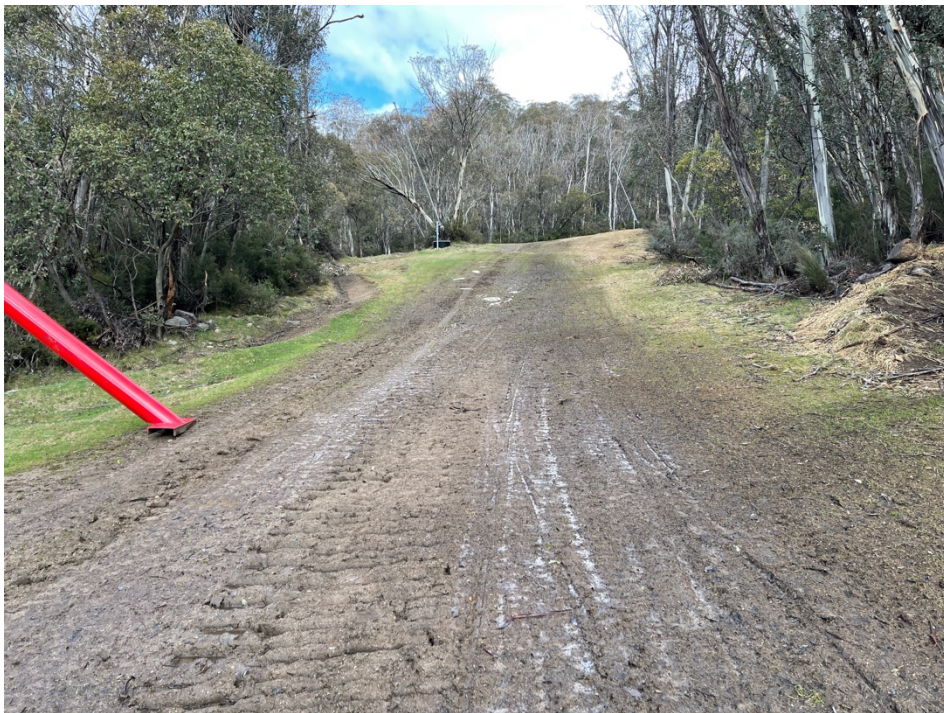
**Photo 2**

View looking west, taken from position east of TP1. Ground surface slopes up to the northwest at about 8-10°.

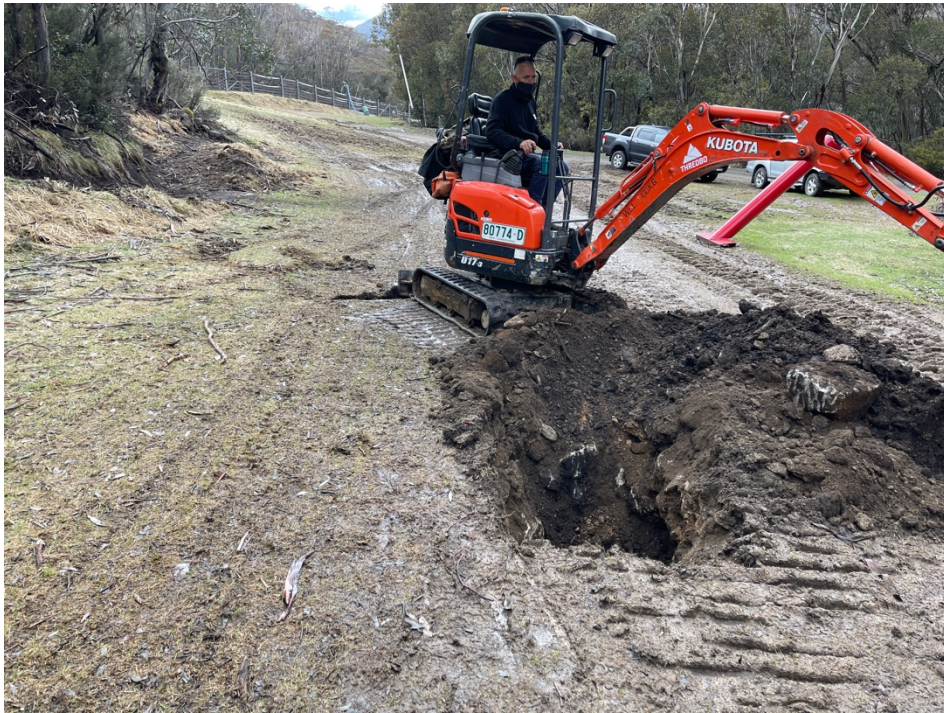
**Photo 3**  
View of TP1, looking east

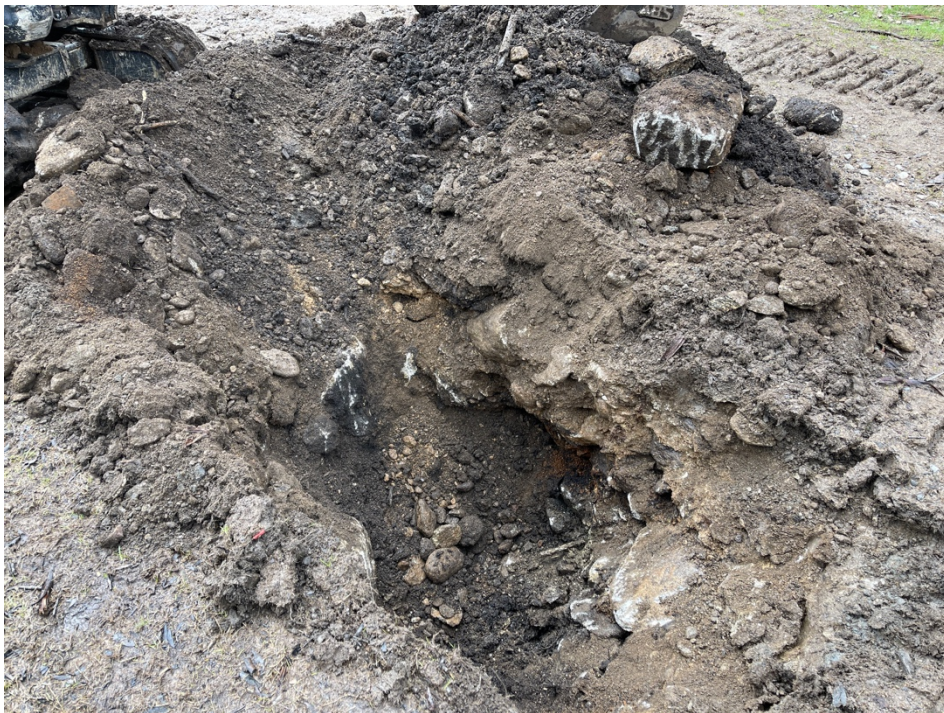
**Photo 4**  
Closeup view of TP1.

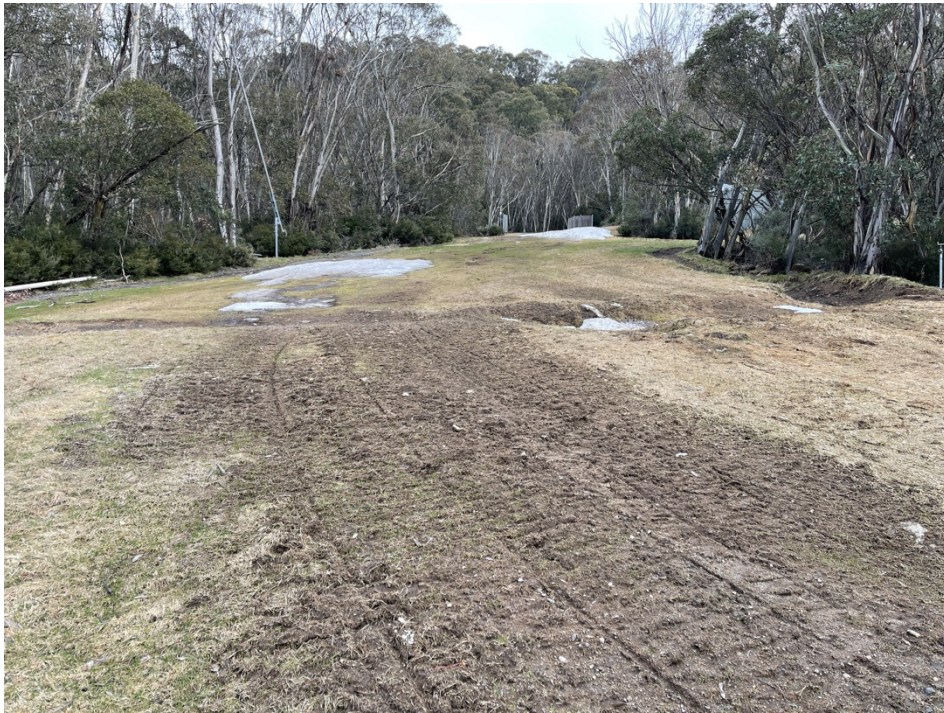
**Photo 5**

View from near TP2  
looking northwest.  
Ground surface  
slopes up to the  
northwest at about  
5-8°.

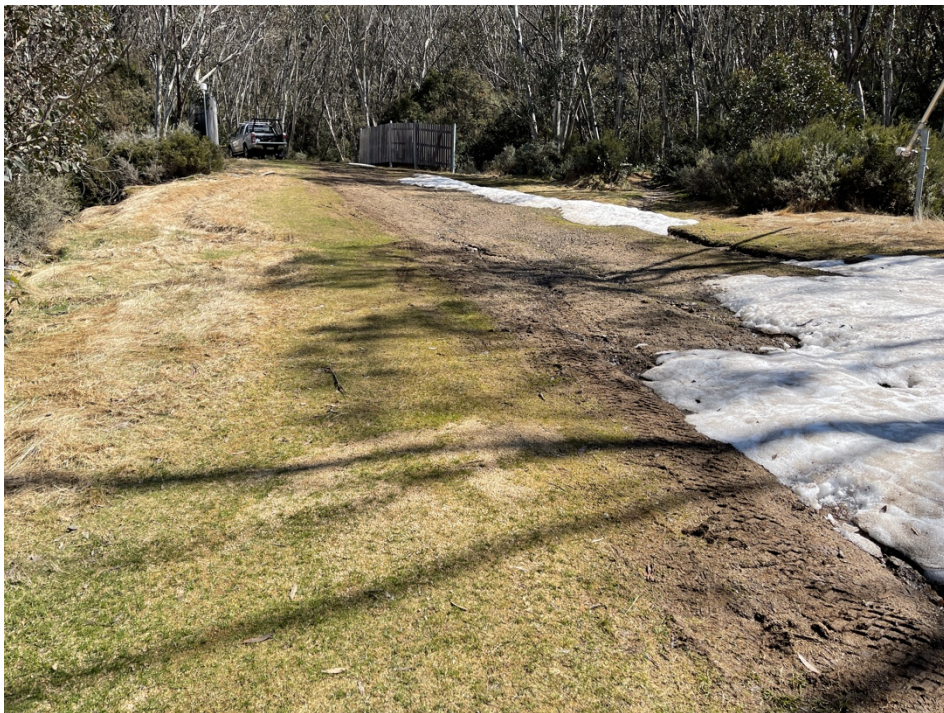
**Photo 8**  
View from near TP3  
looking northwest  
towards culvert over  
creek. Ground  
surface slopes up to  
northwest at about  
5-8°.

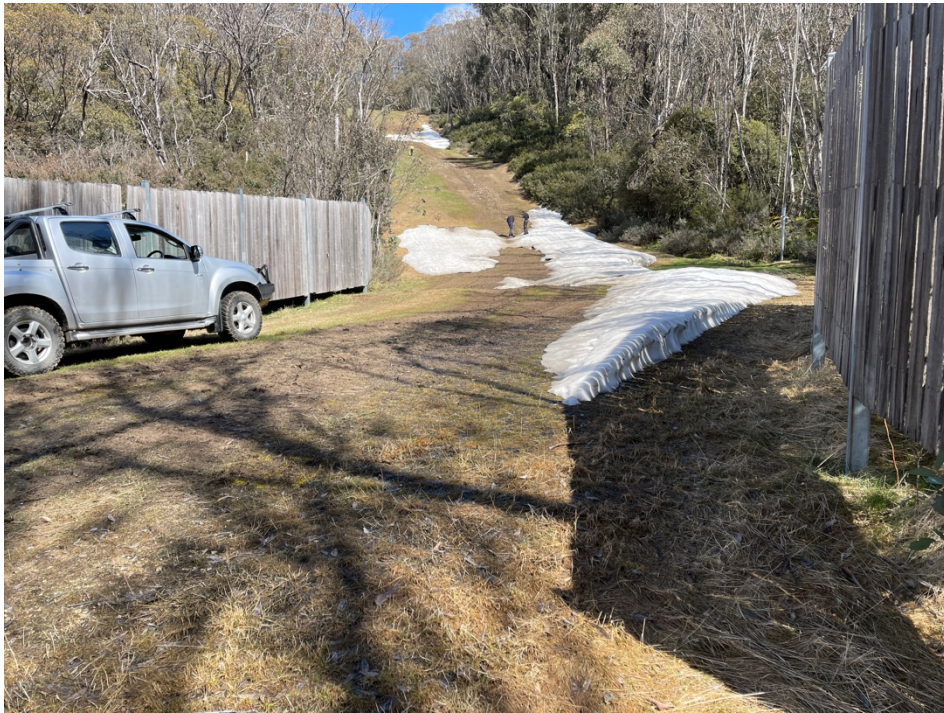
**Photo 9**

View from culvert looking west. Ground surface slopes down to creek at about 25-35°, culvert has been placed over creek and filled over including approaches to form ski run, locally slopes up to the west at about 5-8°.

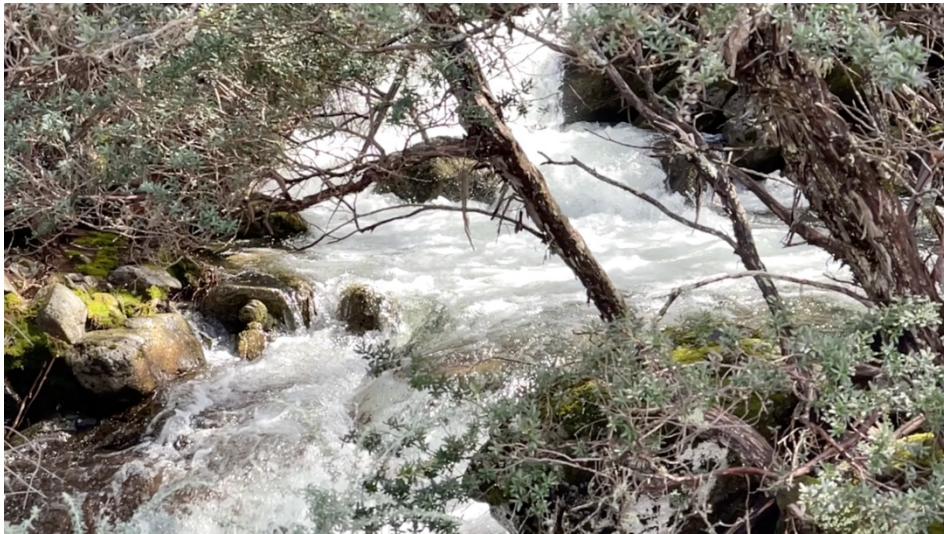
**Photo 10**

View of creek under culvert, heavy flow at time of investigation.

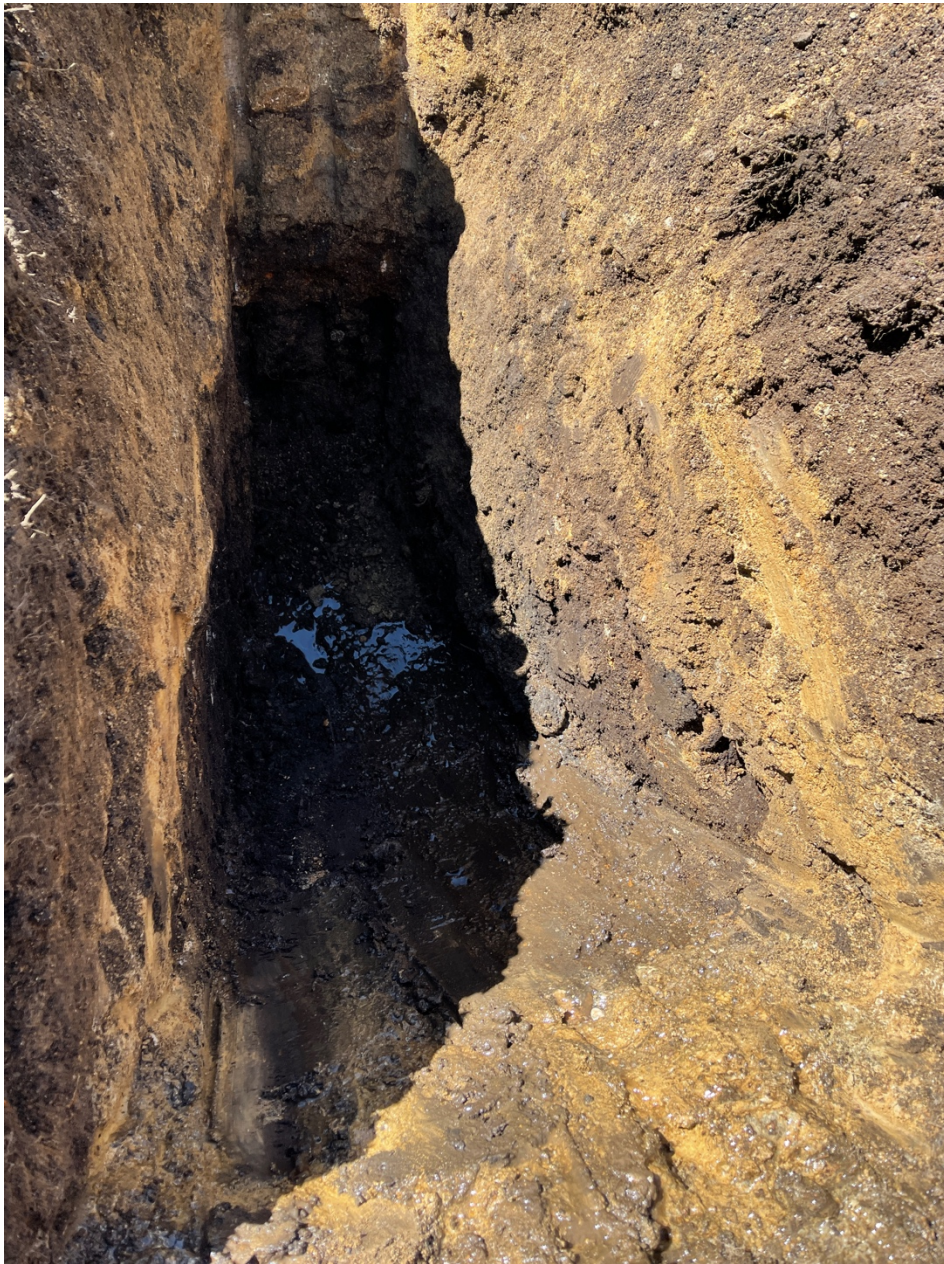
**Photo 11**

View of TP4 – water  
in base is surface  
water from snow  
melt.

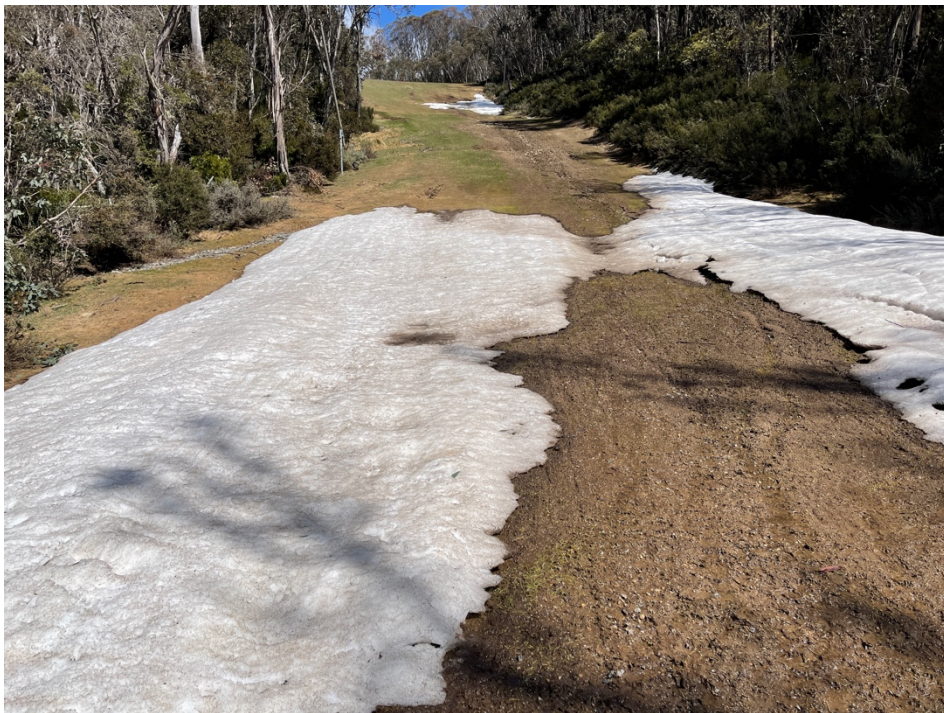
**Photo 13**  
View from west of  
TP4 looking west.  
Ground slopes up to  
west at 10-15°.

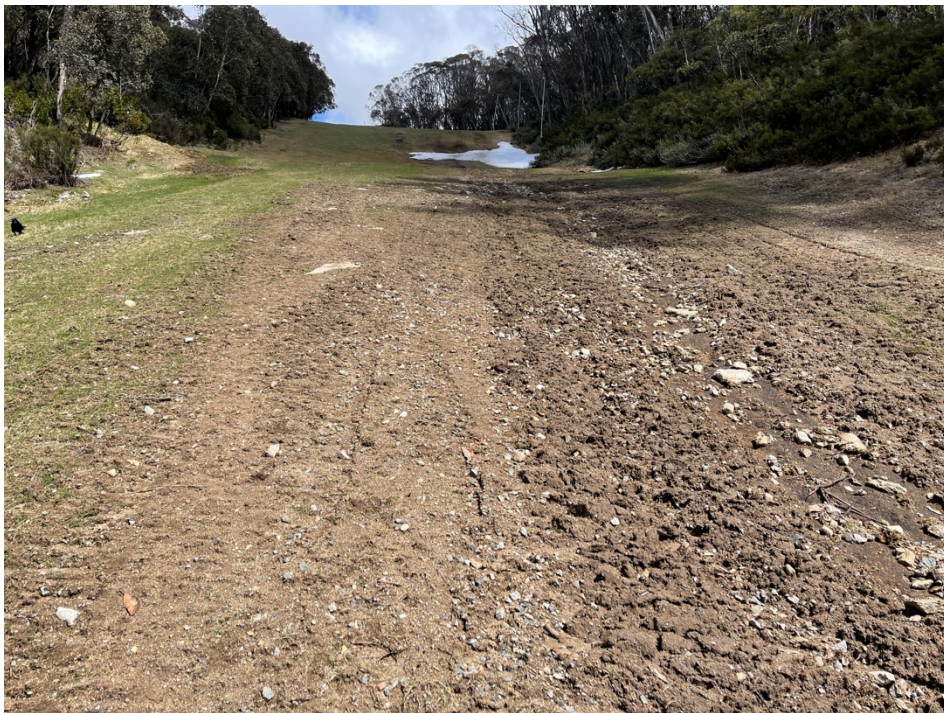
**Photo 16**  
View from west of  
TP5 looking  
southwest. Ground  
slopes up to the  
west/southwest at  
about 15°.

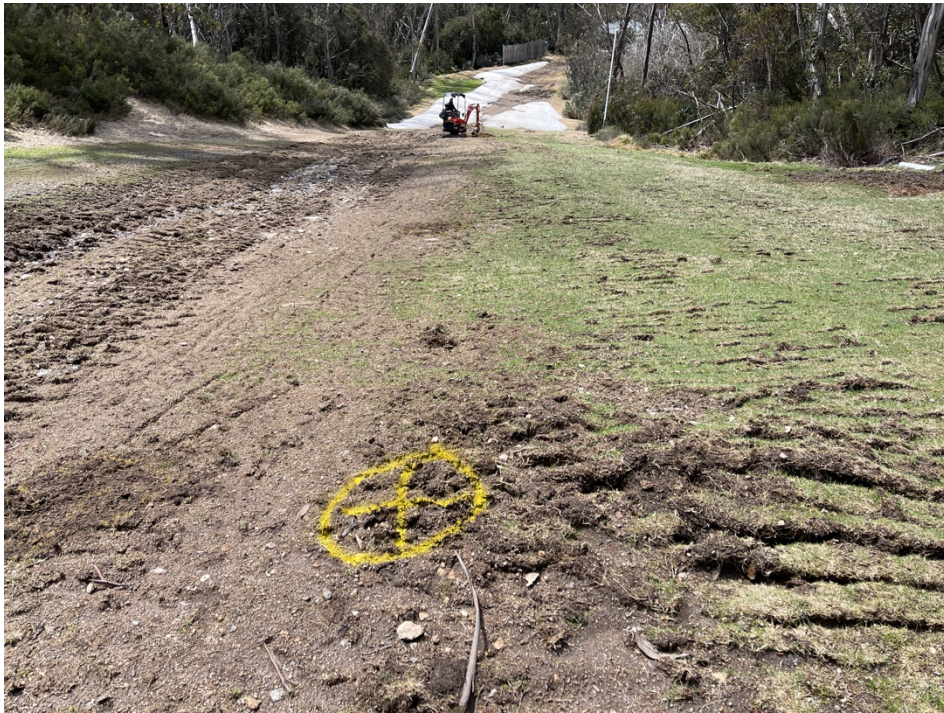
**Photo 17**

View from proposed TP6 looking northeast to TP5. Ground surface slopes up to the west/southwest at about 15°.

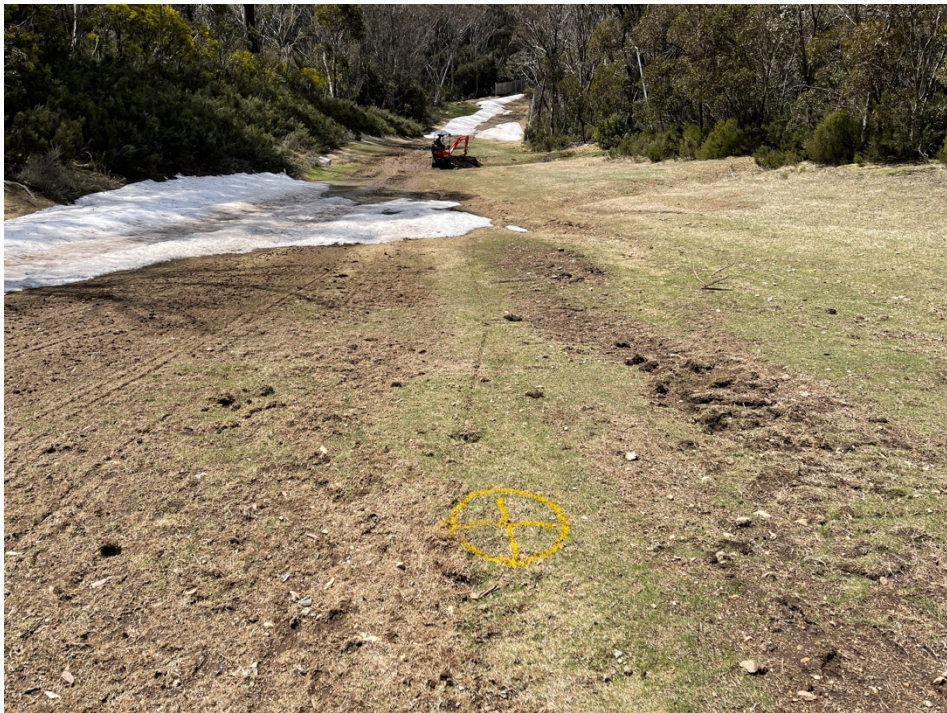
**Photo 20**  
View from proposed  
TP7 looking  
northeast to TP6.  
Ground surface  
slopes up to the  
west/southwest at  
about 15°.

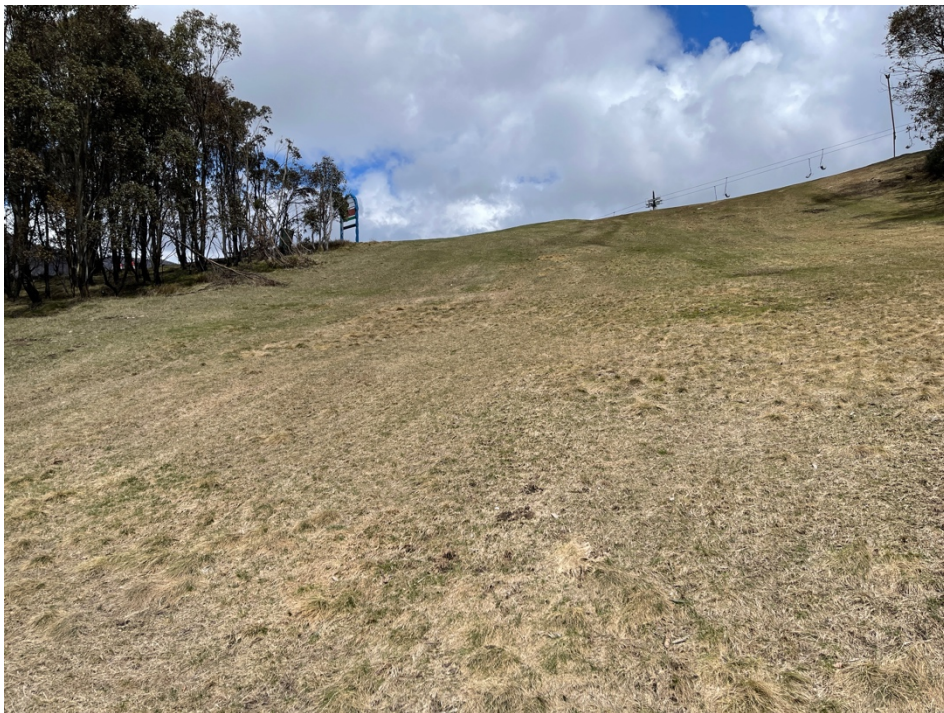
**Photo 23**  
View from TP8  
looking southwest.  
Ground slopes up to  
the west at about  
10–15°.

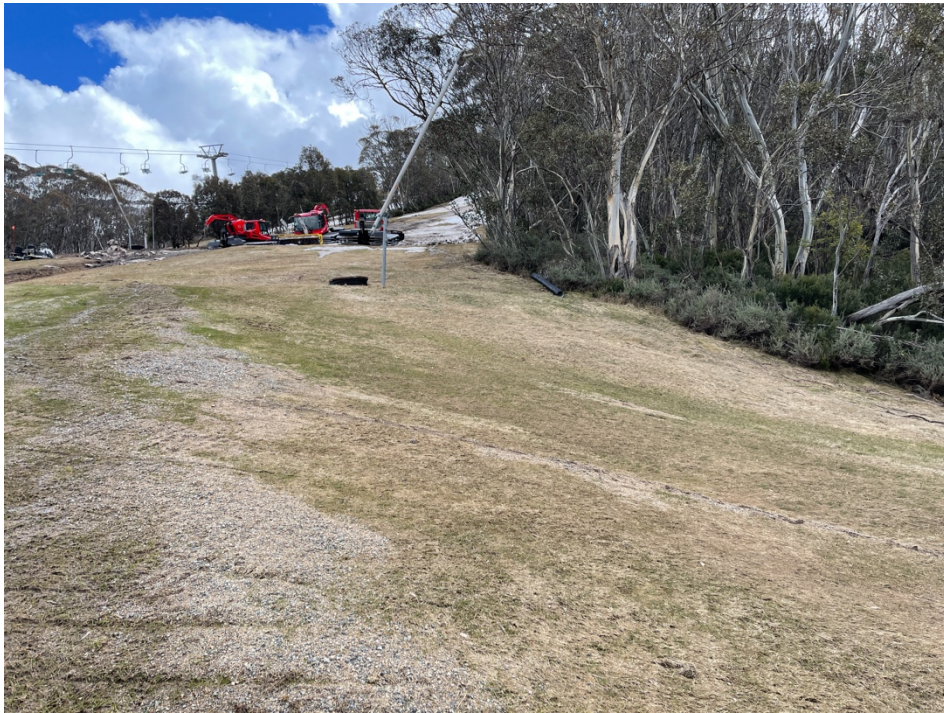
**Photo 27**

View from TP9  
looking northwest.  
TP located on  
shoulder of  
northwest trending  
ridgeline that slopes  
up to the northwest  
at less than about  
10°.

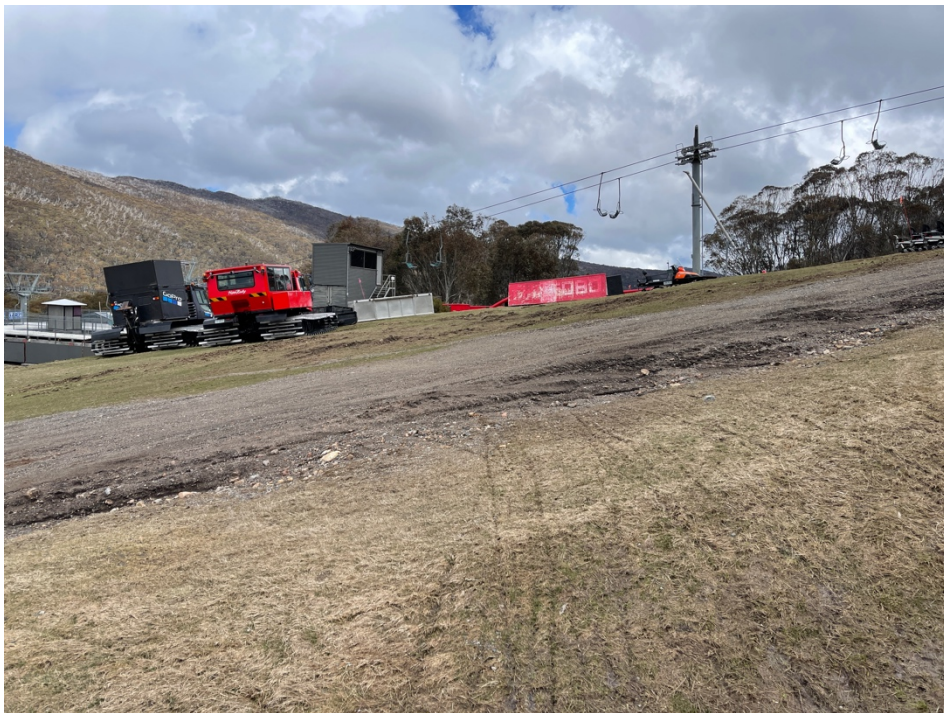
**Photo 28**

View from TP9  
looking southwest.

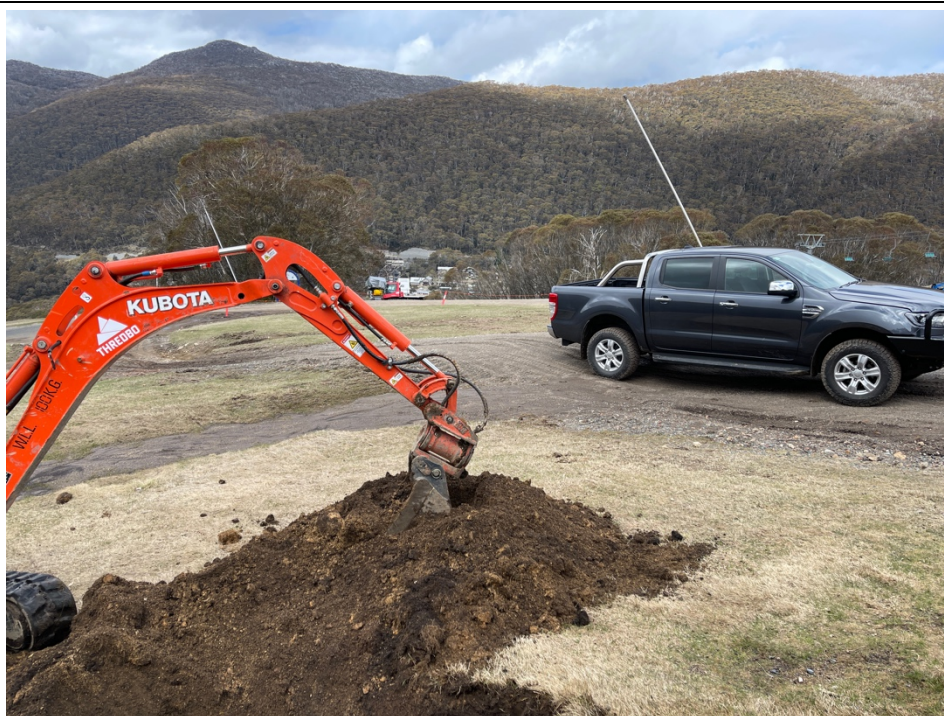
**Photo 29**

View at TP9 looking south.
