EVT / Kosciuszko Thredbo Pty Ltd

Sundowner Snowmaking & Associated Works Thredbo NSW

Geotechnical Investigation

Our ref: 6653-G1
6 October 2021

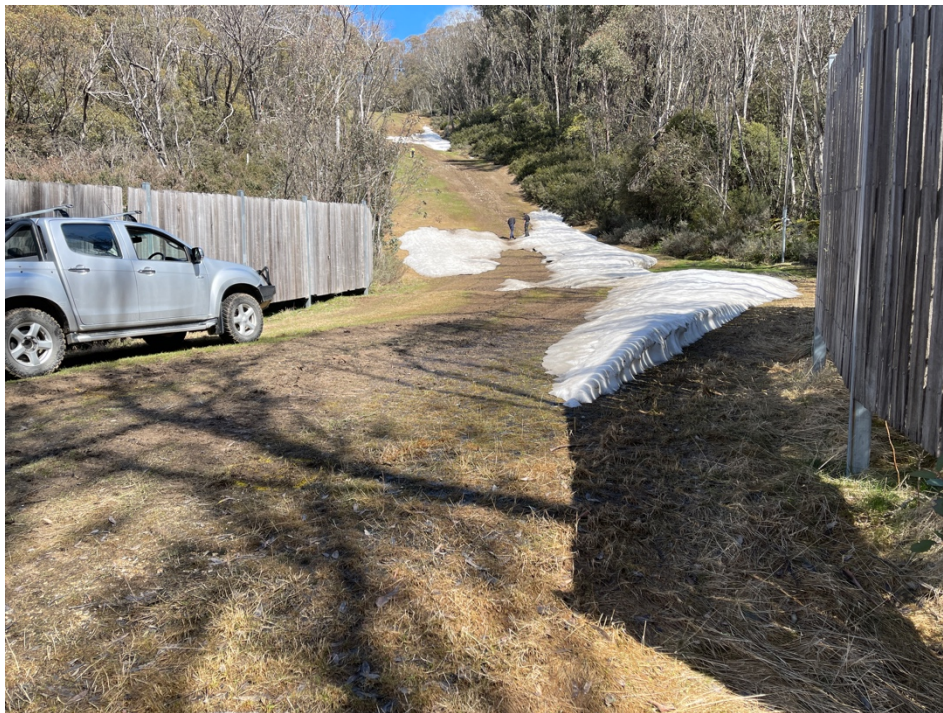
Photo 9

View from culvert looking west. Ground surface slopes down to creek at about 25-35°, culvert has been placed over creek and filled over including approaches to form ski run, locally slopes up to the west at about 5-8°.

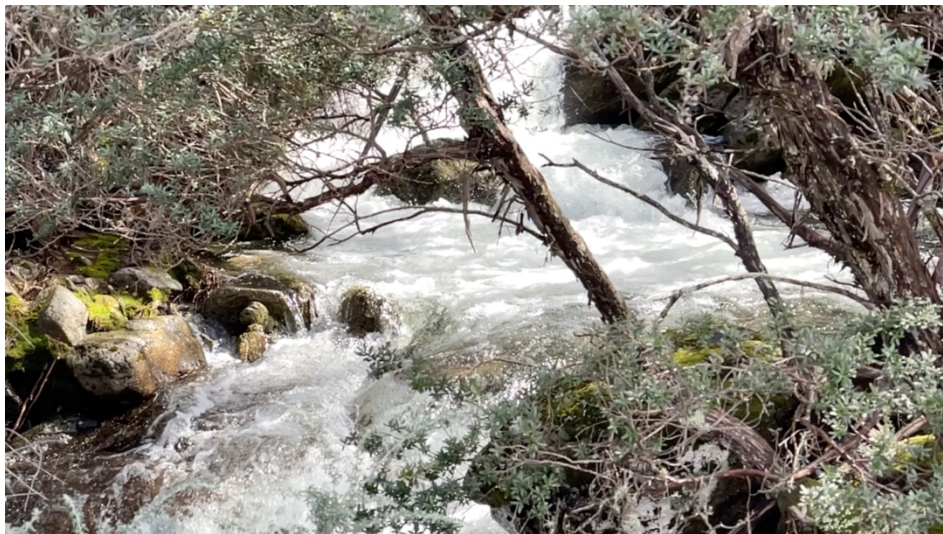
Photo 10

View of creek under culvert, heavy flow at time of investigation.

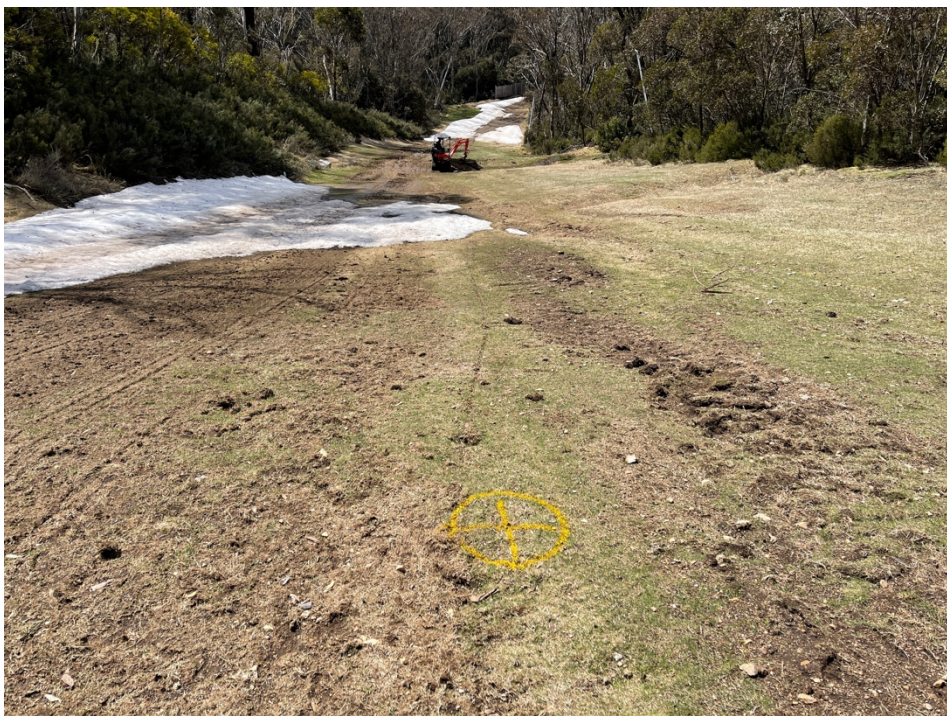
Photo 20

View from proposed TP7 looking northeast to TP6. Ground surface slopes up to the west/southwest at about 15°.

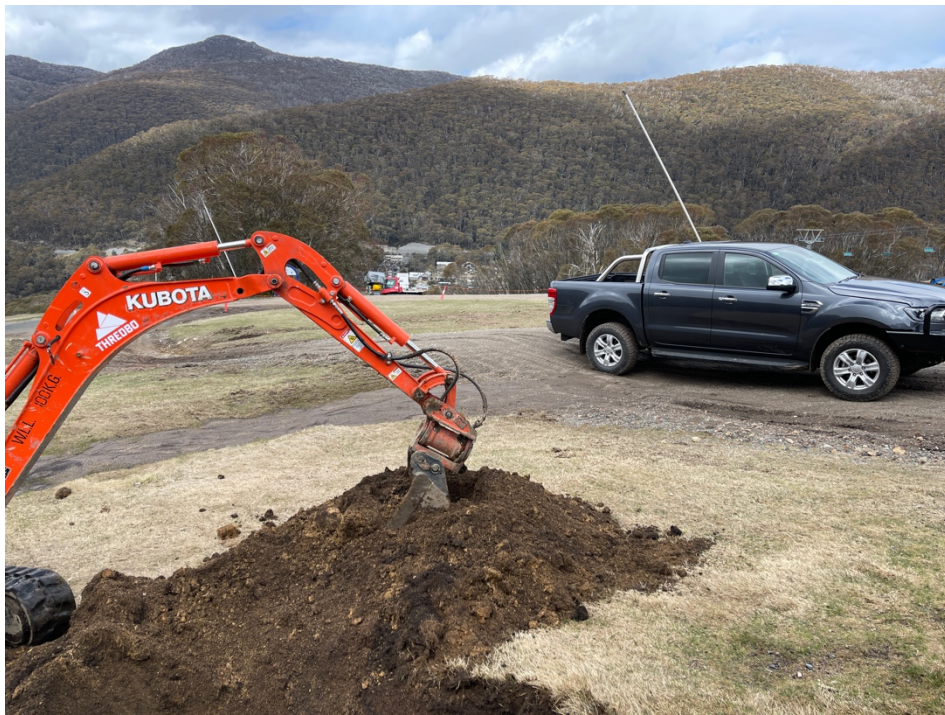
Photo 29

View at TP9 looking south.
