EVT / Kosciuszko Thredbo Pty Ltd

Sundowner Snowmaking & Associated Works Thredbo NSW

Geotechnical Investigation

Our ref: 6653-G1
6 October 2021

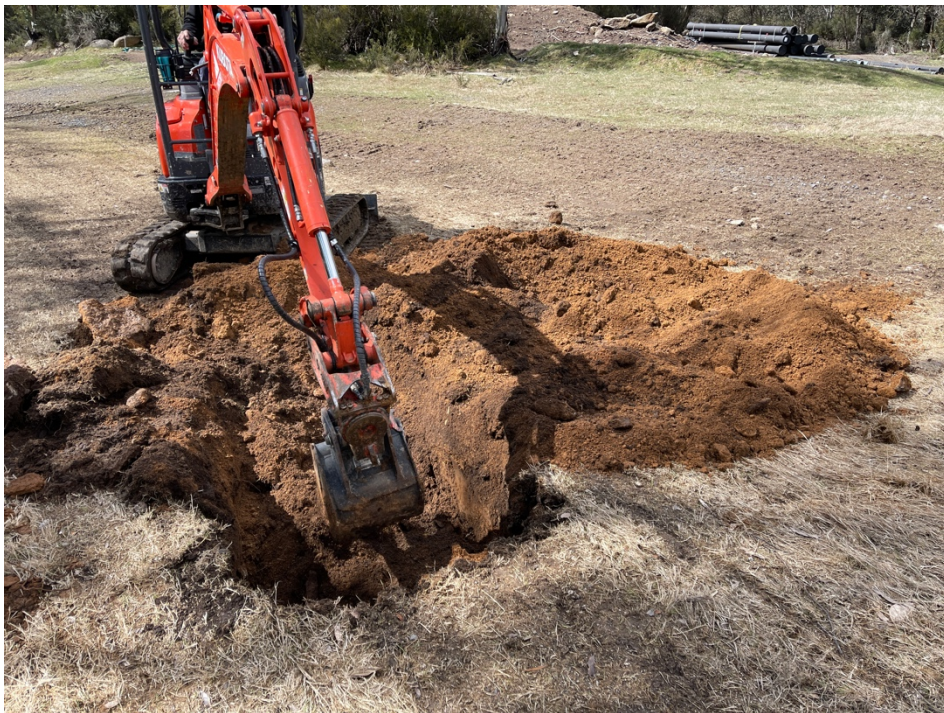
Photo 6

View of TP2.

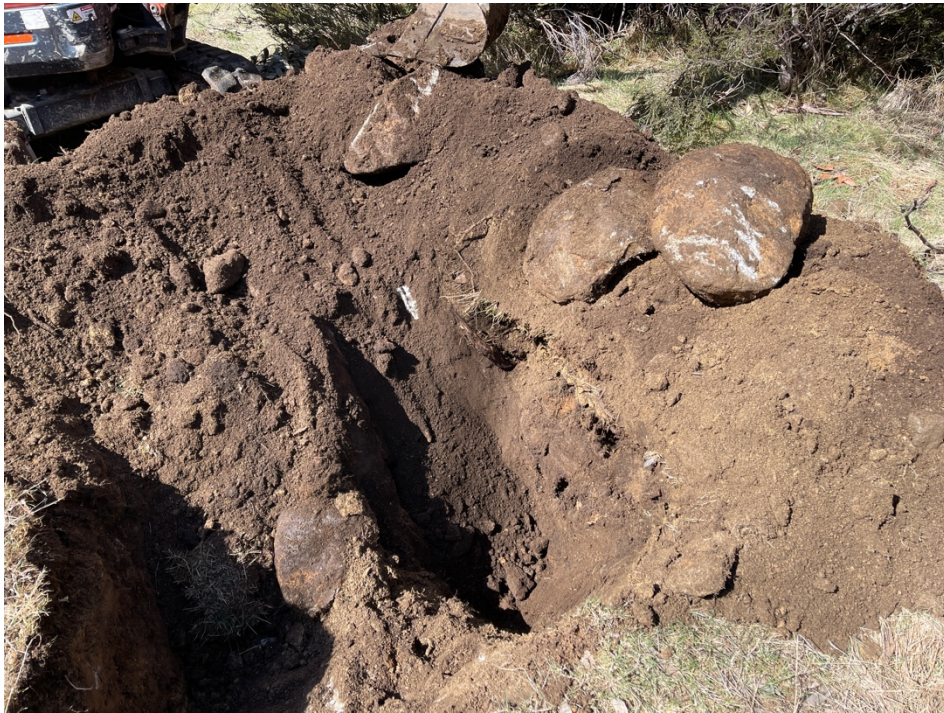
Photo 7
View of TP3.

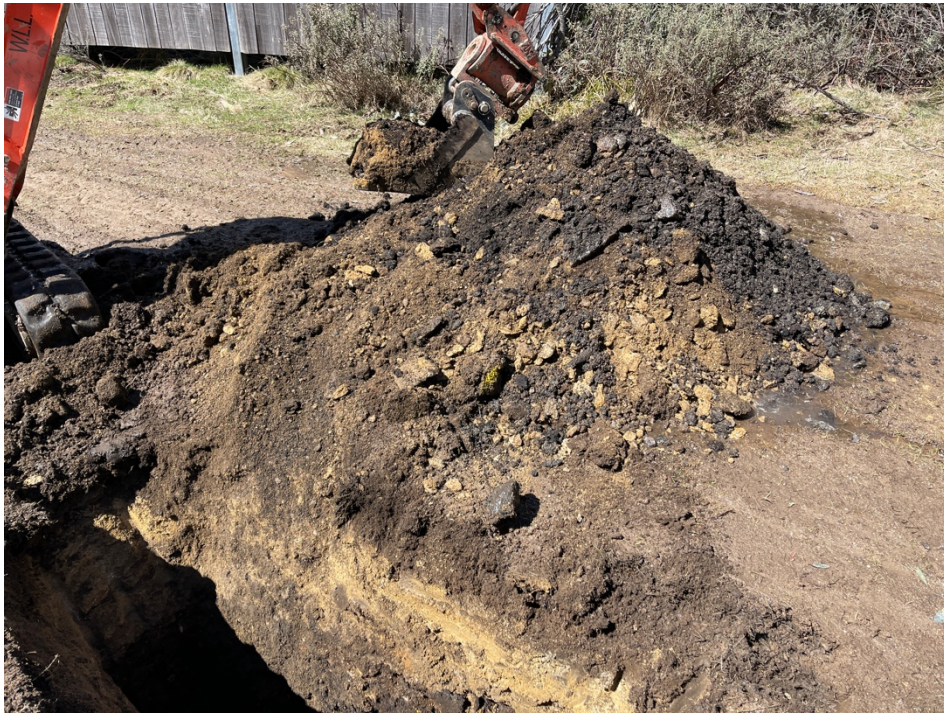
Photo 12
View of TP4.

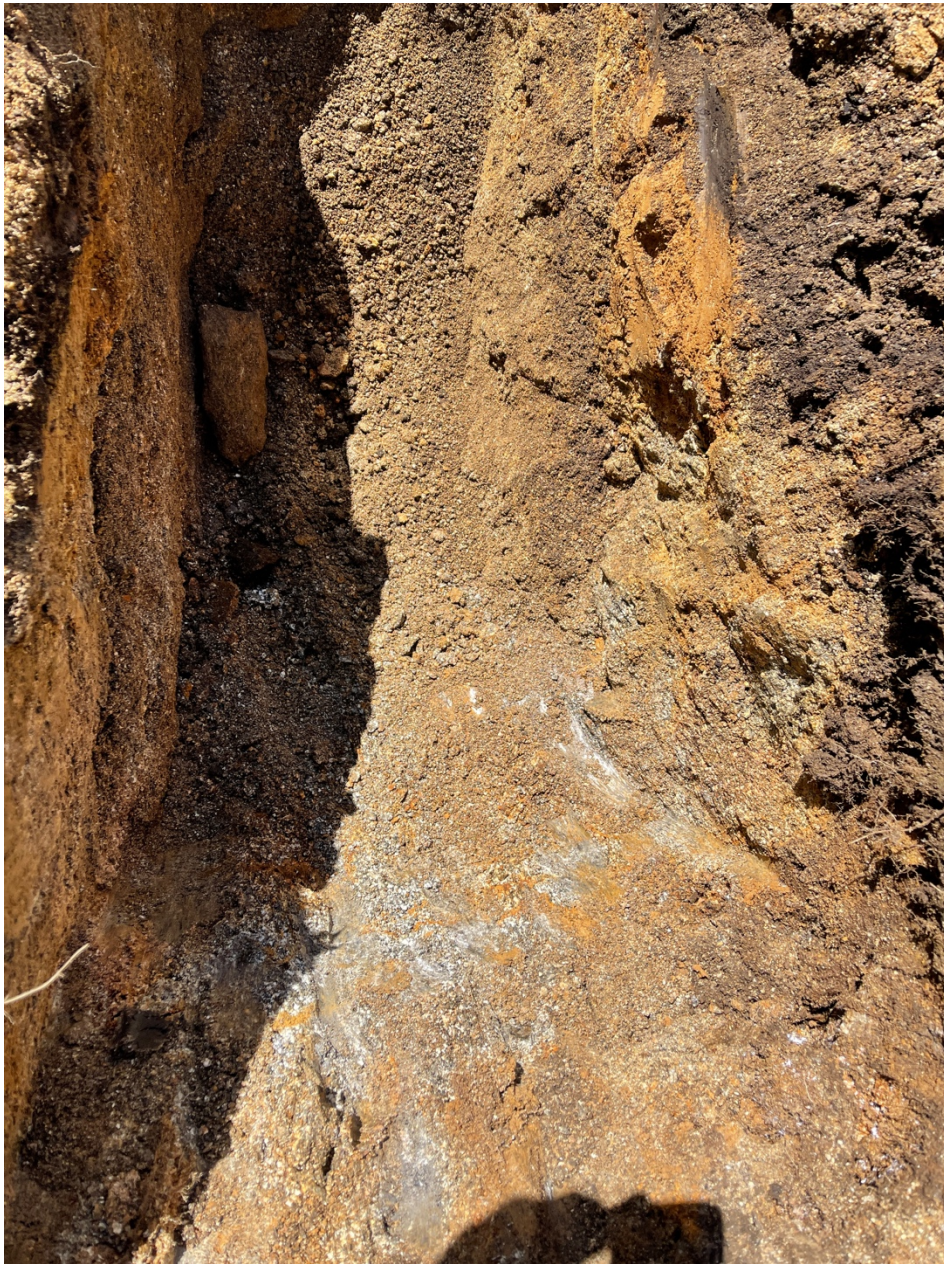
Photo 14

View of TP5.

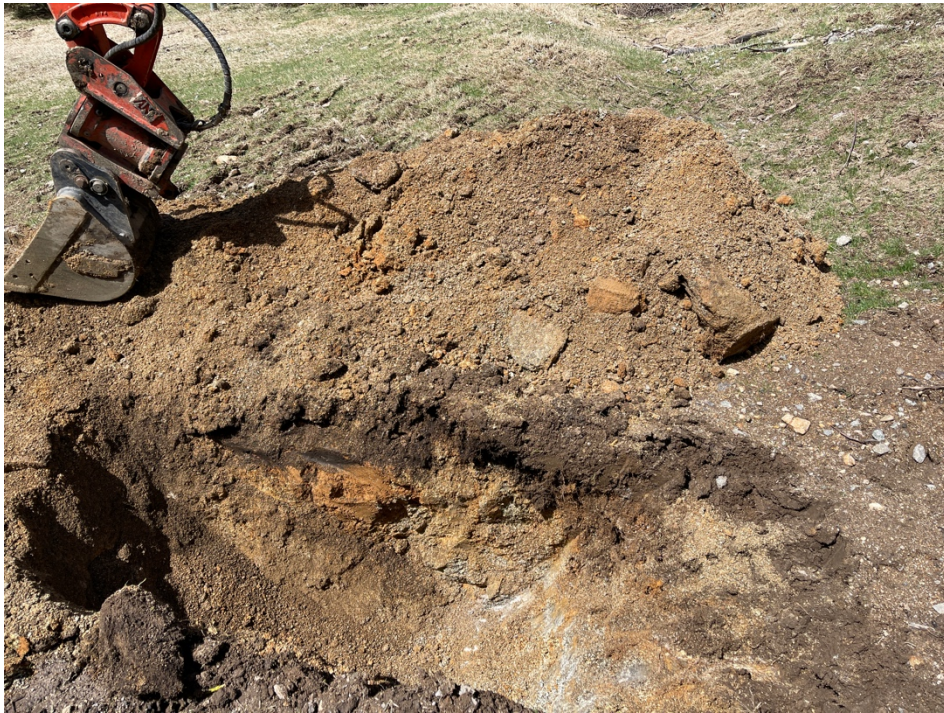
Photo 15
View of TP5.

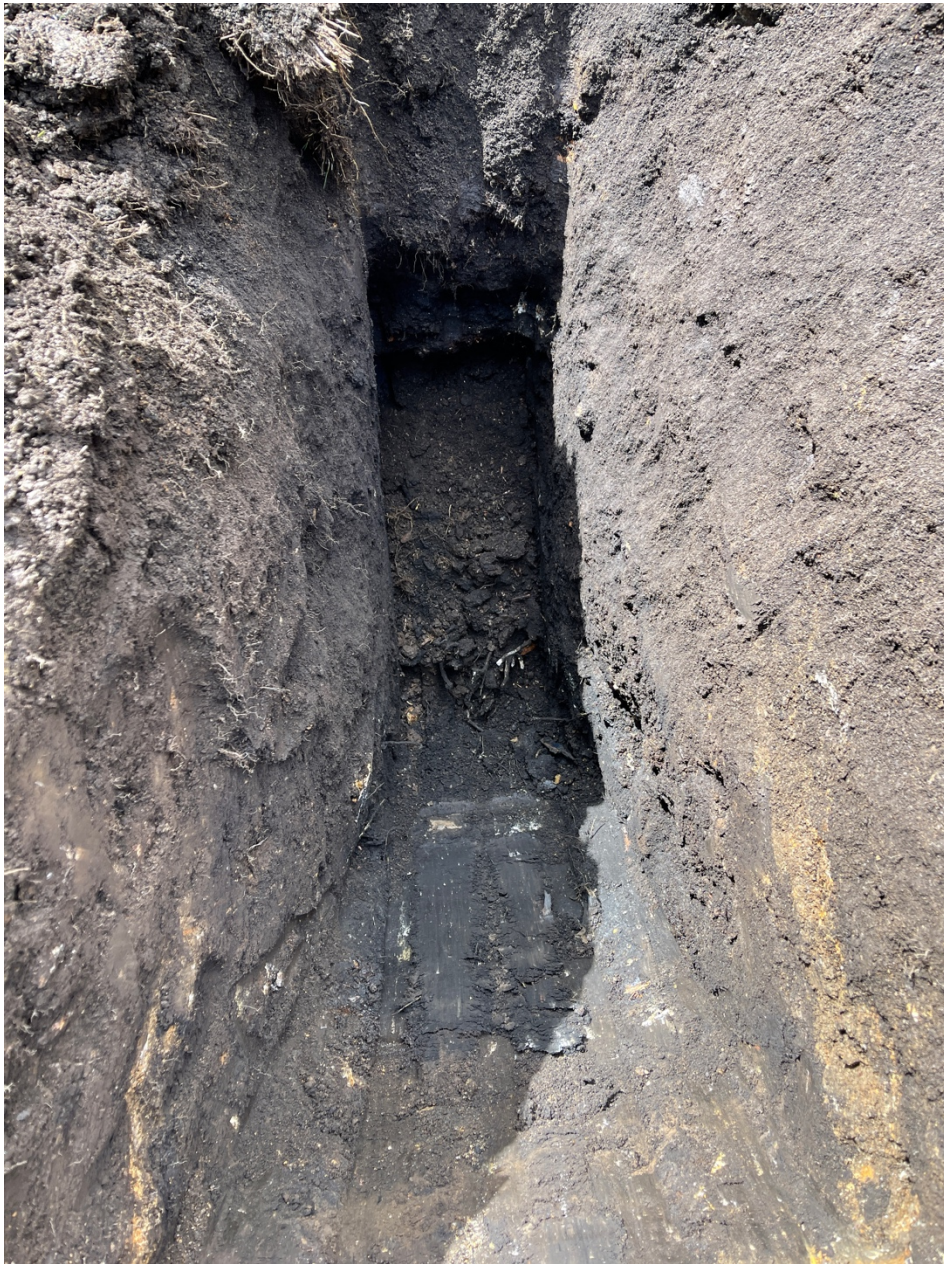
Photo 18

View of TP6.

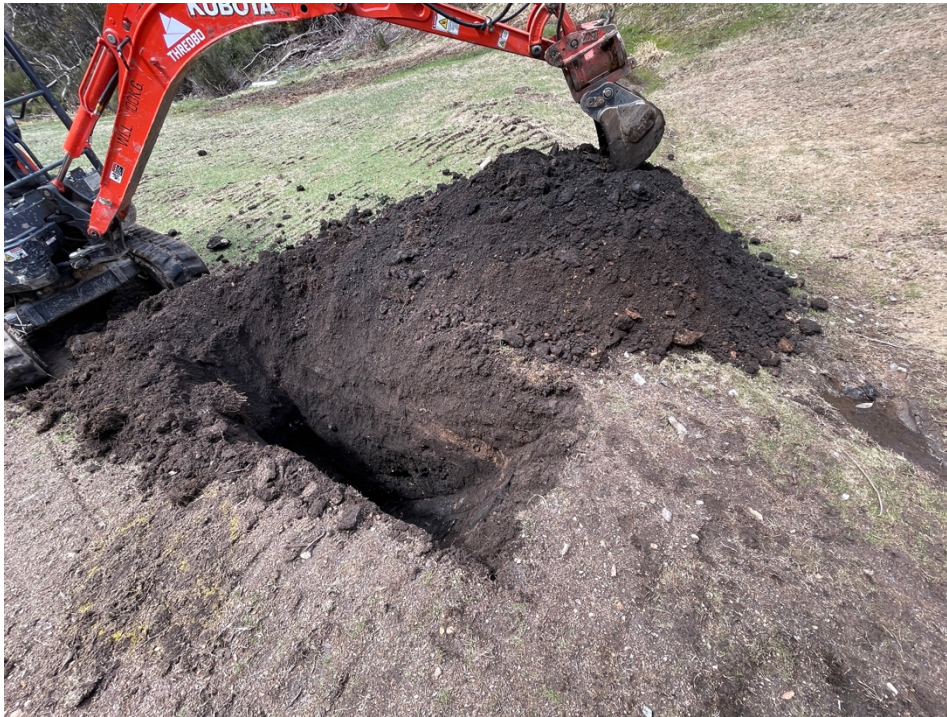
Photo 19
View of TP6.

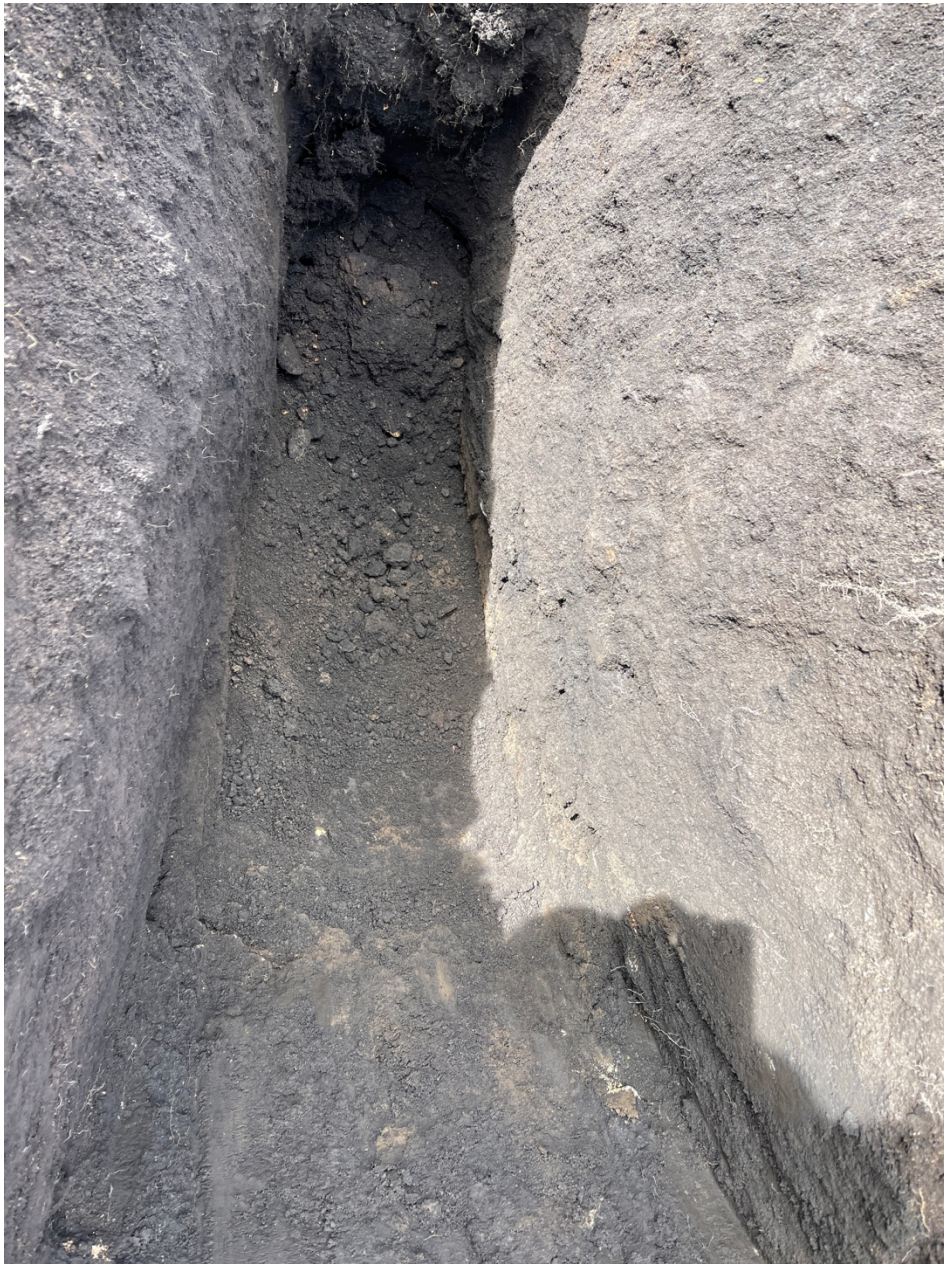
Photo 21

View of TP7.

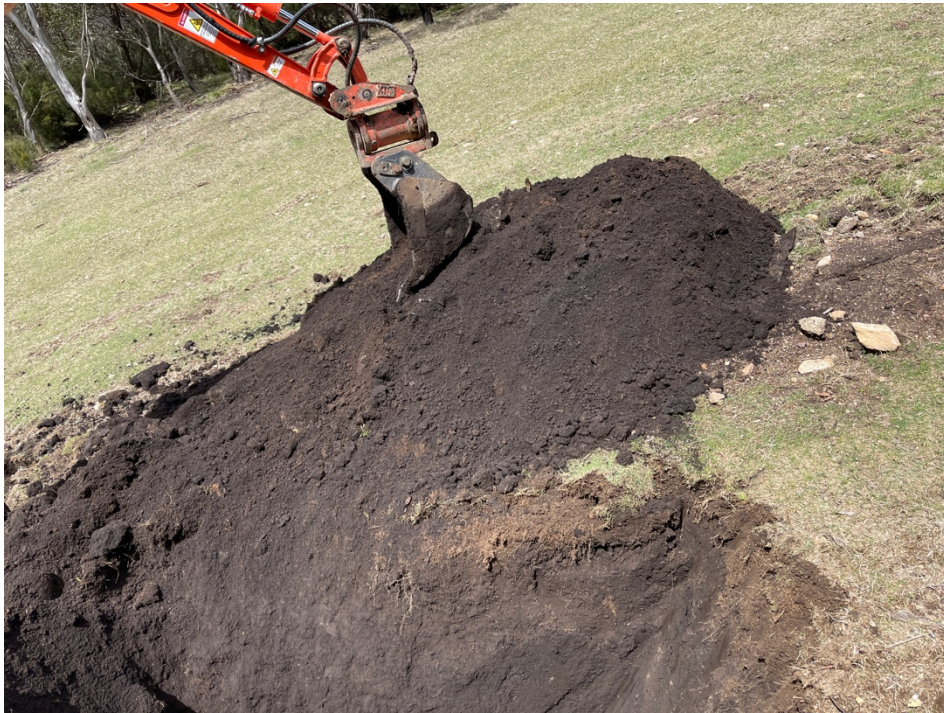
Photo 22
View of TP7.

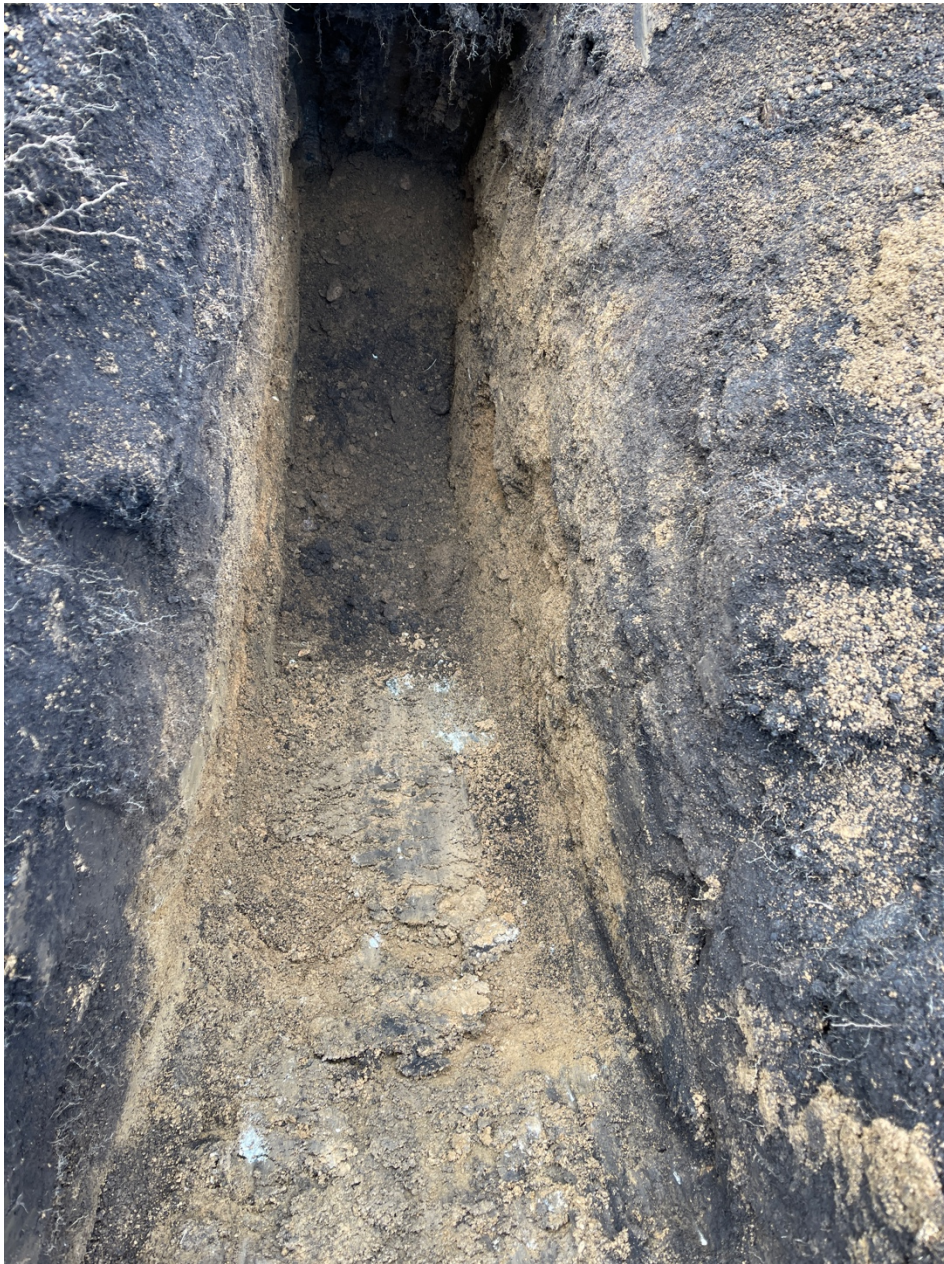
Photo 24

View of TP8

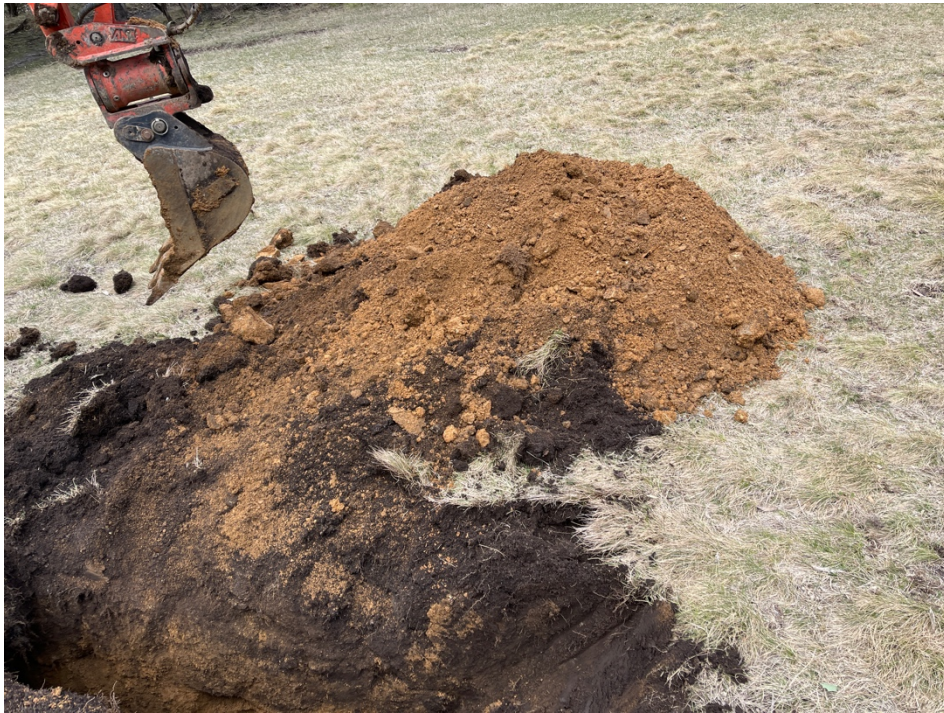
Photo 25
View of TP8

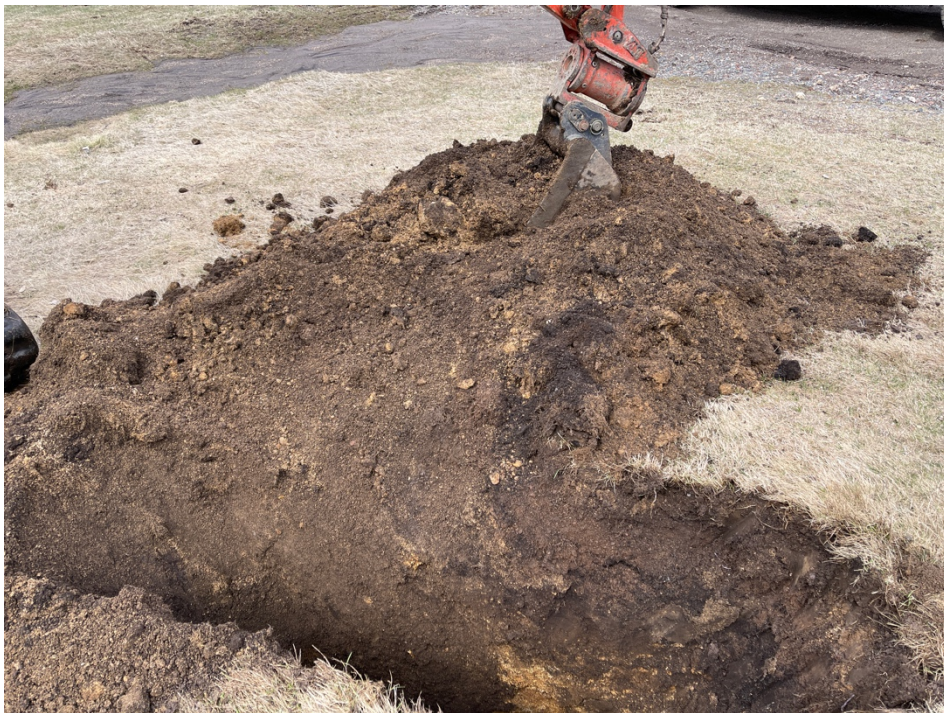
Photo 26
View of TP9
