EVT / Kosciuszko Thredbo Pty Ltd

## **Thredboland and Freeriders Beginner Zone Project Friday Flat, Thredbo NSW**

Geotechnical Investigation

Our ref: 6751-G1 Rev 3  
27 June 2022

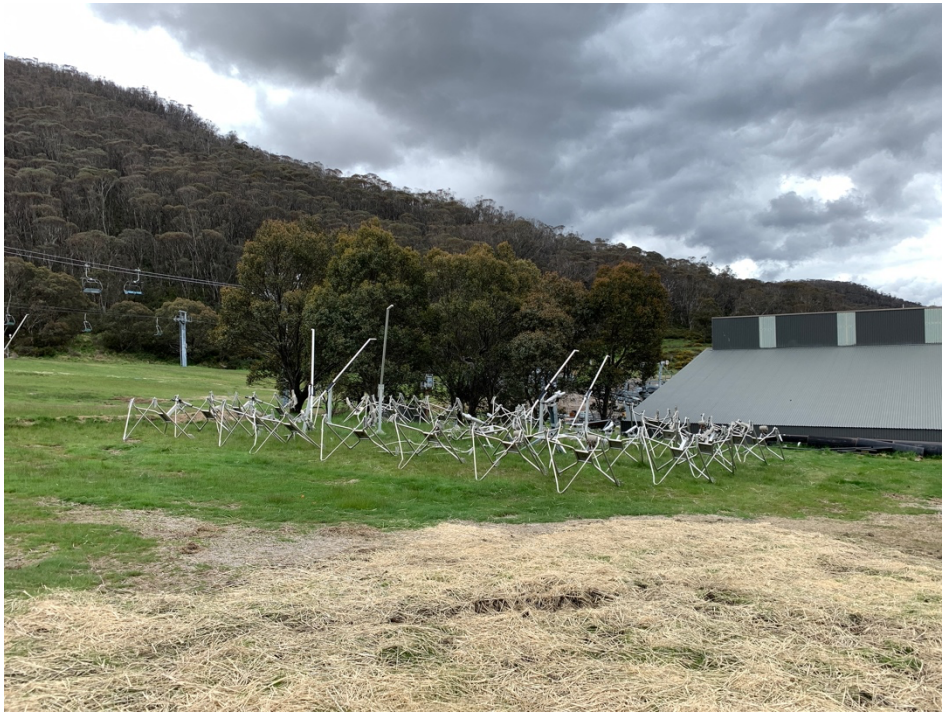
**Photo 1**  
Overview of existing  
site condition

At the time of investigation, the Site was generally grassed and used for facilities storage. Soft ground was encountered to the south of the Site which appeared to be filled / disturbed ground likely associated with recent snowmaking trenching works. No signs of granite outcrops were observed during the site walkover.

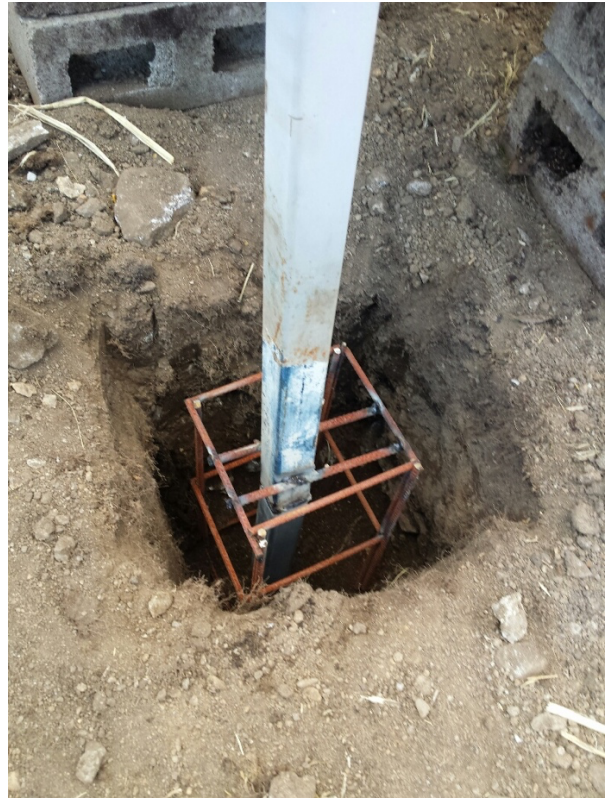
The footings for the operators’ huts comprise short concrete piers nominal 580mm deep by 300mm diameter. Due to the small size of the hut, footing loads are anticipated to be small. The proposed footings are suitable provided that the base of the piers is founded in firm or better clays or medium dense or better sands and an allowable bearing pressure of not more than 100kPa is required.

Typical footing excavation for Operators Hut
