# Geotechnical Investigation Report

Project  
**Preliminary Geotechnical Report**  
**30 Diggings Terrace, Thredbo NSW**

Prepared for  
**Hidali P/L c/o Belvedere Constructions Pty Ltd**

Report No  
**13526-GR-1-1 Rev E**

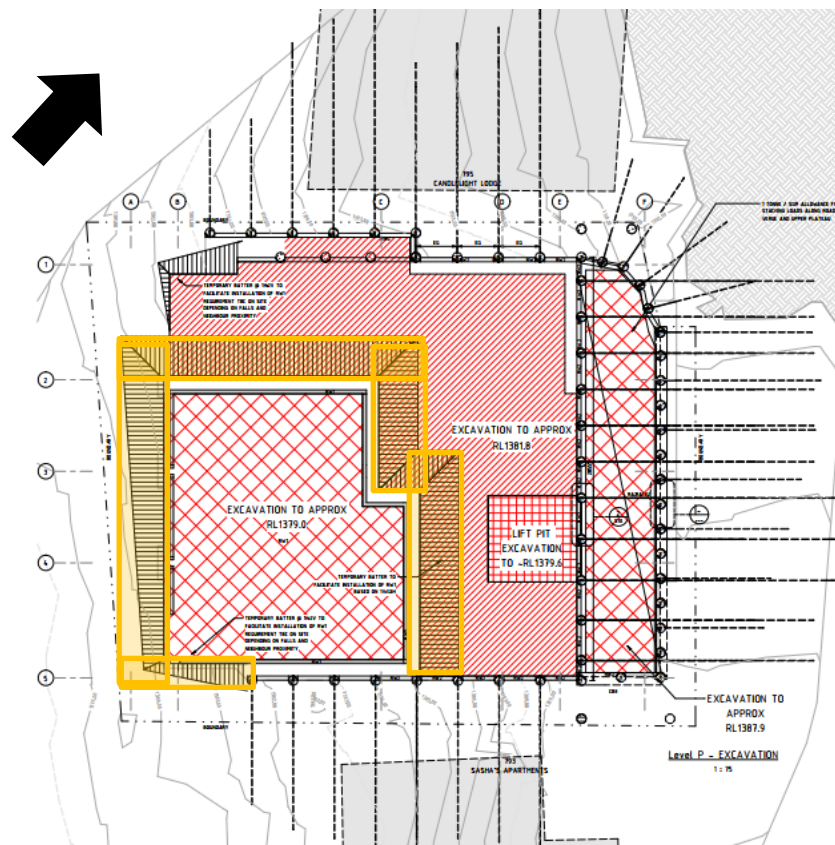
**Figure 4: Excavation plan (by PMI) showing the locations where unsupported cuts may be feasible in yellow**

Based on the proposed basement excavation setbacks, temporary and permanent unsupported batter slopes within highly weathered granodiorite may be feasible on the southern, eastern and western boundaries of the lowest cellar basement level (see Figure 4).

Temporary batters within highly weathered granodiorite can be excavated to a maximum batter slope of 1H:1V, provided they are above the water table or within dewatered ground, and not exposed for longer than three

In the areas where temporary batter slopes are not feasible, a suitably designed shoring system is recommended. Anchored contiguous piled walls are recommended. Weep holes or drains (e.g. vertical drains) must be provided behind shotcrete to avoid build-up of hydrostatic pressure in the overburden soils and rock mass. For the southernmost retaining wall with RP2 piles (see Appendix B), the contiguous bored pile wall will need pile spacings no more than 150mm due to the presence of fill material at the edge of Diggings Terrace. Subject to approval, temporary ground anchors are recommended to control wall deflections. Retaining Wall RW2, being in less weathered granodiorite can be permitted to have wider spaced piles. To avoid later complications in removing walings, it is suggested a “one temporary anchor per pile” approach to avoid a need for walings is considered. Use of a capping beam may still be prudent. The lower basement/cellar cut is anticipated to be feasible by unsupported steeply battered rock cut. This must be verified by further deep geotechnical investigation post-demolition prior to further construction.

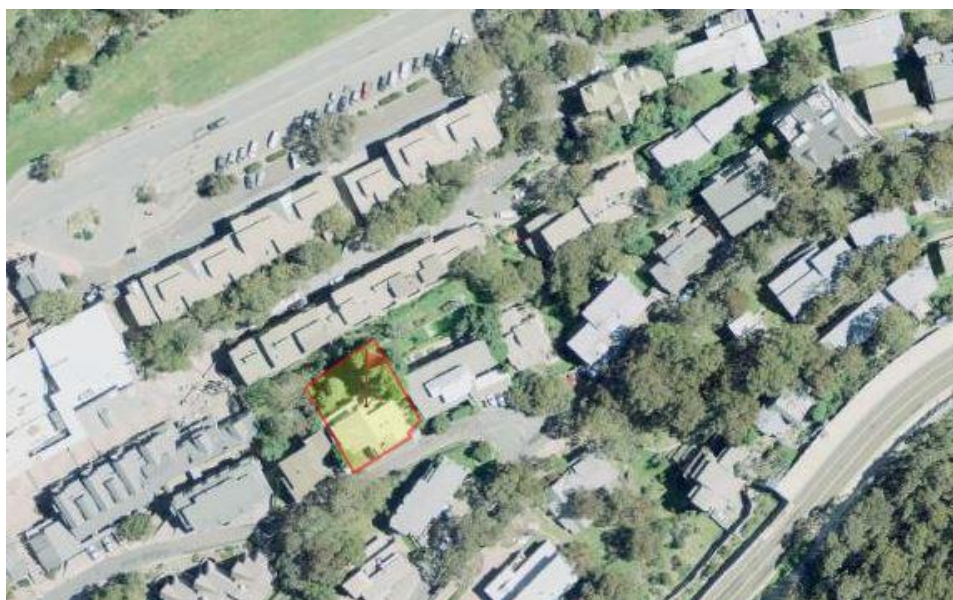
Photograph: 1 6 site and surrounding properties

The site falls from an approximate high of R.L. 1392.0 in the south-east corner to a low of approximately R.L. 1379.5 in the north-west corner. The site has a stepped front south boundary of 26.295m and side west boundary of 27.88m in length, as referenced from the provided survey plan.

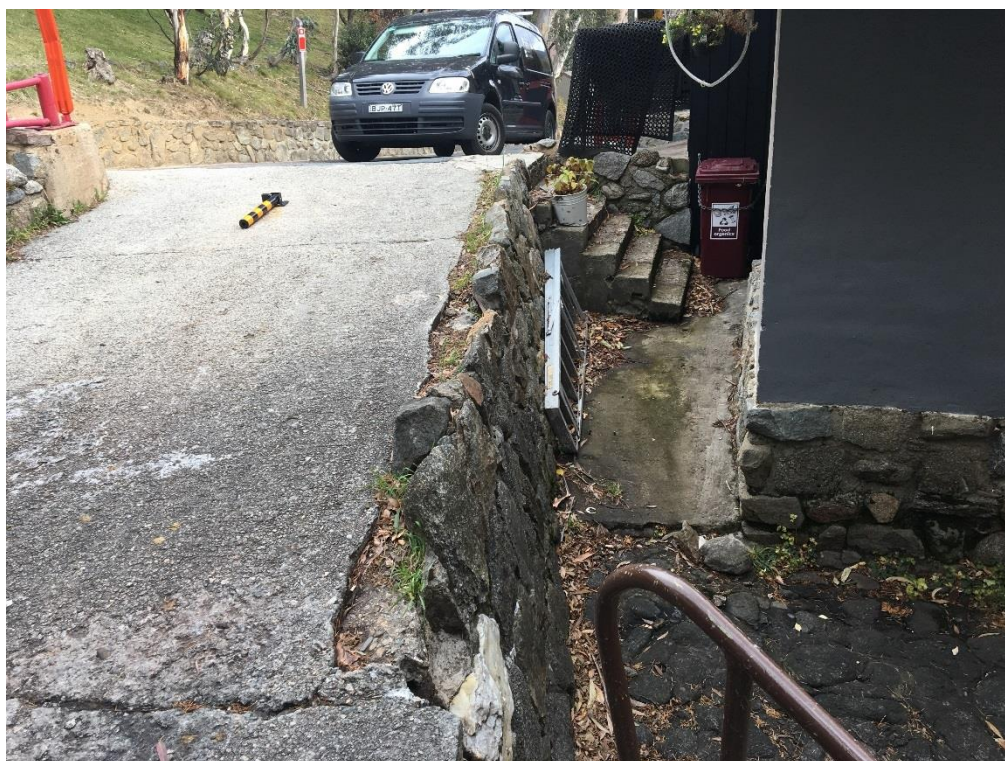
The neighbouring property upslope (No. 12 Banjo Driveway) is retained above the road pavement of Diggings Terrace by a low (<1.0m) rock retaining wall with moderate sloping lawn areas extending up to a two storey timber lodge building supported on its northern side above ground surface by a mortared rock footing wall. There were no indications on external walls of any foundation/footing movement adjacent to the site.

*Photograph: 2 – South-east corner of site showing neighbouring (No. 5) driveway and retention.*
