# Geotechnical Assessment for Deck Addition

## Aspen Creek Lodge, Thredbo, NSW

February 25th, 2022 Document: PE-2204-01 POINTE ENGINEERING PTY LTD

## Apartment 2, Aspen Creek, 8B Chimneys Way Thredbo, NSW

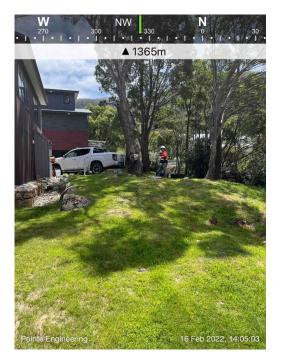
Figure 1 – BH22-01 Looking NW from extent of Site

A surface geotechnical hazard mapping visit was undertaken on Feb 16<sup>th</sup> 2022 by Pointe. During the visit, the Site was observed to have been subject to human disturbances. Levelling works were evidenced by a relatively flat backyard, 8m wide behind existing building as shown on Figure 1 below. Furthermore, at the North West portion of the site (at BH22-01 location), the existing ground is about 1m higher than the North East corner of site (at BH22-02 location). The backyard of the Site then

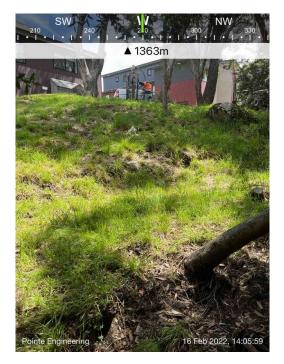
Figure 2 – Looking Up to Site, from unamed creek

slopes down North to the unnamed creek, at about 25 to 27 degrees from horizontal, referenced by Figure 2 below.

Evidence of surface instability was noted down the slope to creek in the form of topsoil sloughing and bent/buttressed tree trunk (see Figure 2 below).

The footing for the proposed deck should be set back at least 3m away from edge of slope to unnamed creek.

Surface water run-off should be intercepted and be directed away from any structure or open excavation. Swale drains might be used in the landscaping to avoid pooling of water and/or infiltration into slopes, particularly the slope down to unnamed creek.
