**Merritts Mountain House Restaurant –  
Sewer and Water Services  
Thredbo NSW**

**Geotechnical Assessment**

Our ref: 6713-1-G1 Rev 2  
7 April 2022

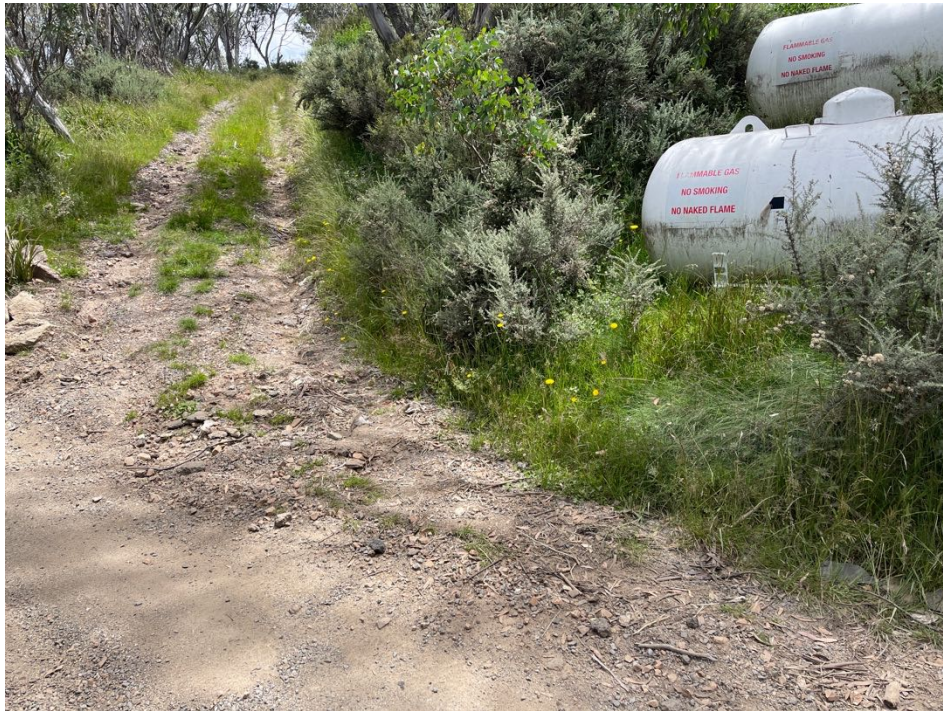
**Photo 1**

View of track down  
from Merritts  
Mountain House  
Restaurant past  
storage tanks

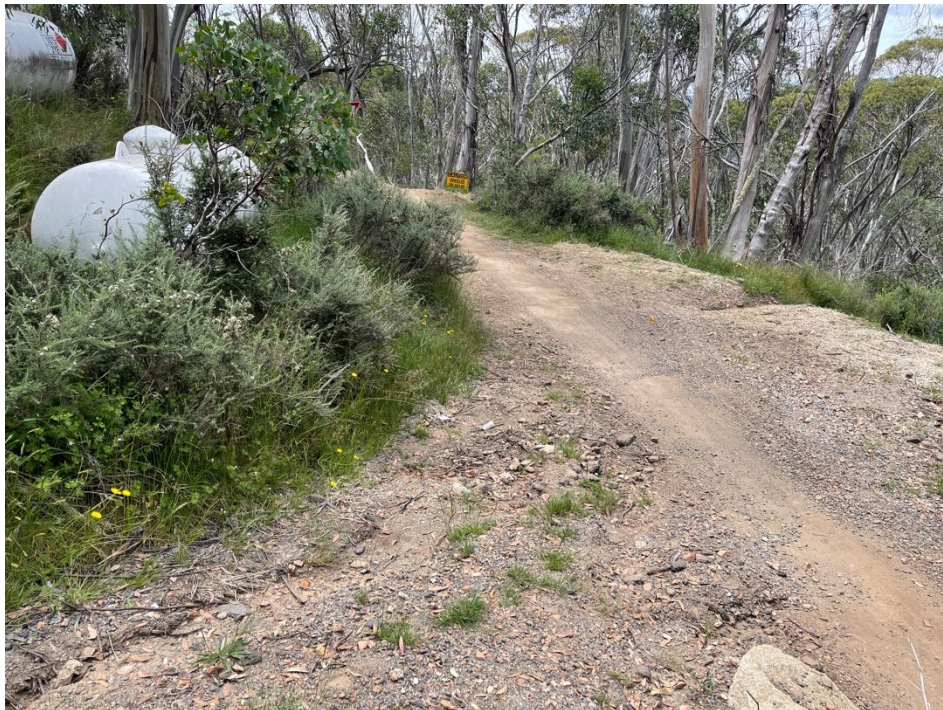
**Photo 2**

View of track  
adjacent to storage  
tanks (reverse view  
of Photo 1)

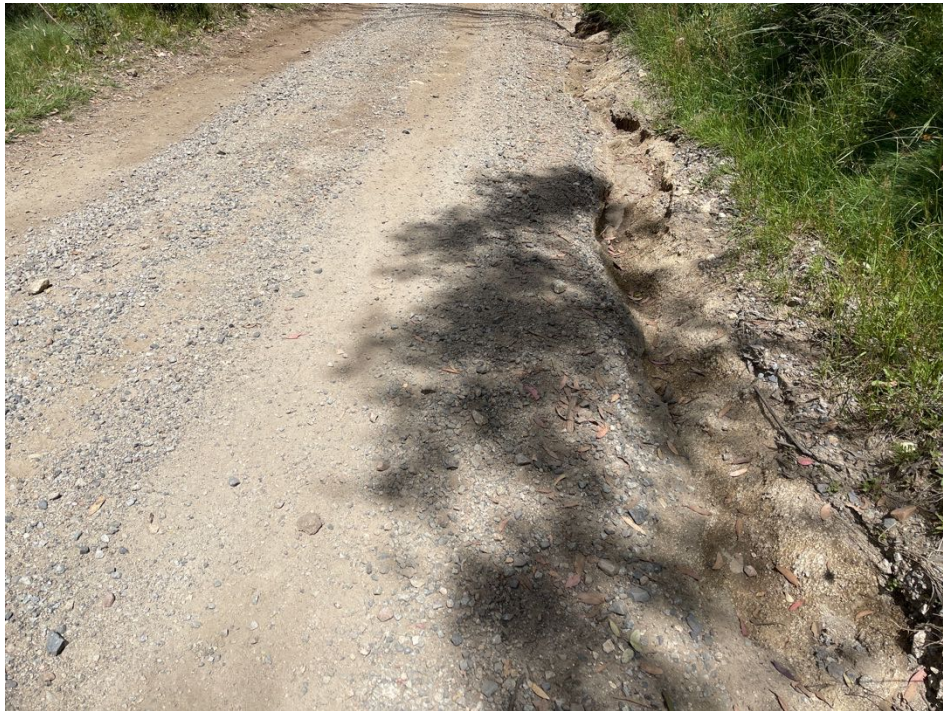
**Photo 3**

There was no obvious evidence of existing or potential landslides affecting the pipe alignment except for some road shoulder support works on the eastern (downhill) side of the vehicle track up to Merritts. It is noted that the potential failure mechanism for the track is assessed to be a shallow slump extending to just outside edge of the vehicle traffic path which is well away from the centre of the track where the services are to be located. After remedial works, the landslide risk is assessed to be **Low** with respect to property and **Acceptable** with respect to life.

Typical view of track erosion south of Merritts Mountain House Restaurant

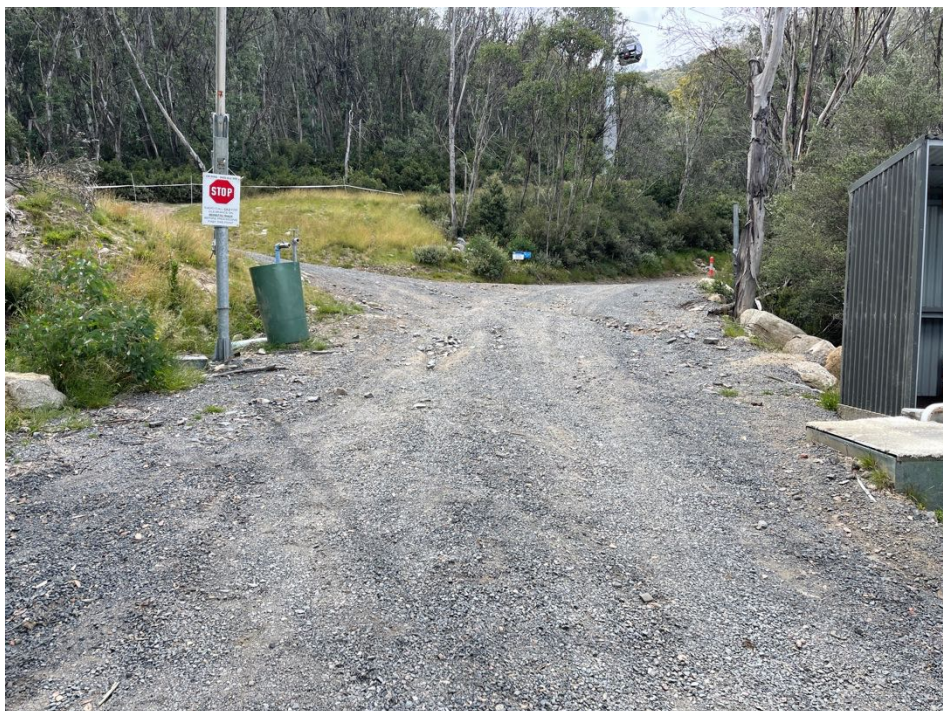
**Photo 4**

View of track near Mid Chair Lift

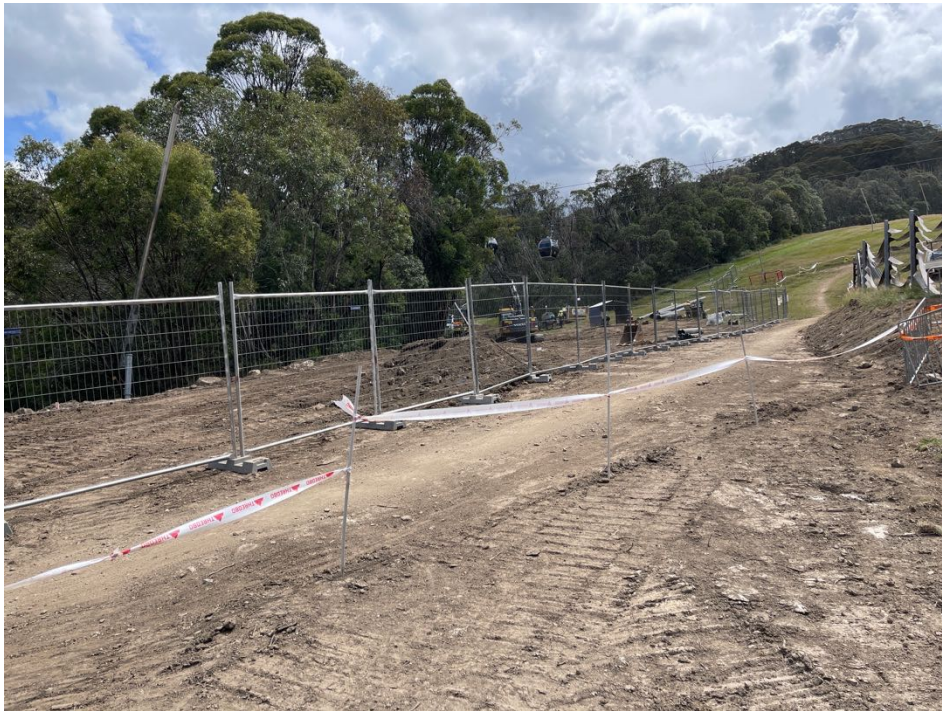
**Photo 5**

View of earthworks  
for nearby  
Sundowner  
Snowmaking  
Upgrade

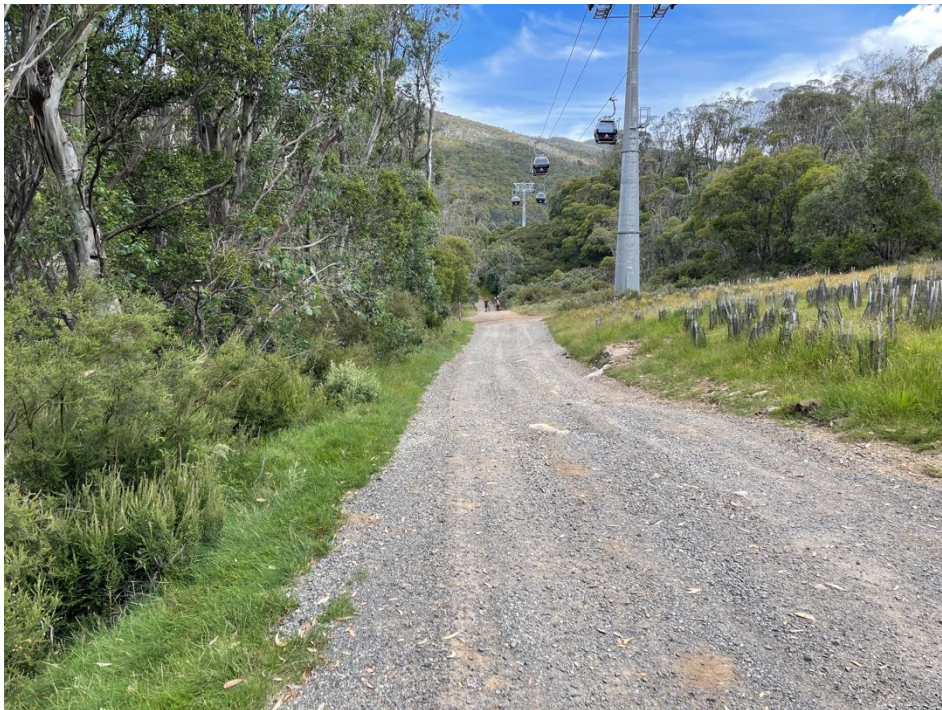
**Photo 6**

View of track  
heading towards UV  
Treatment building

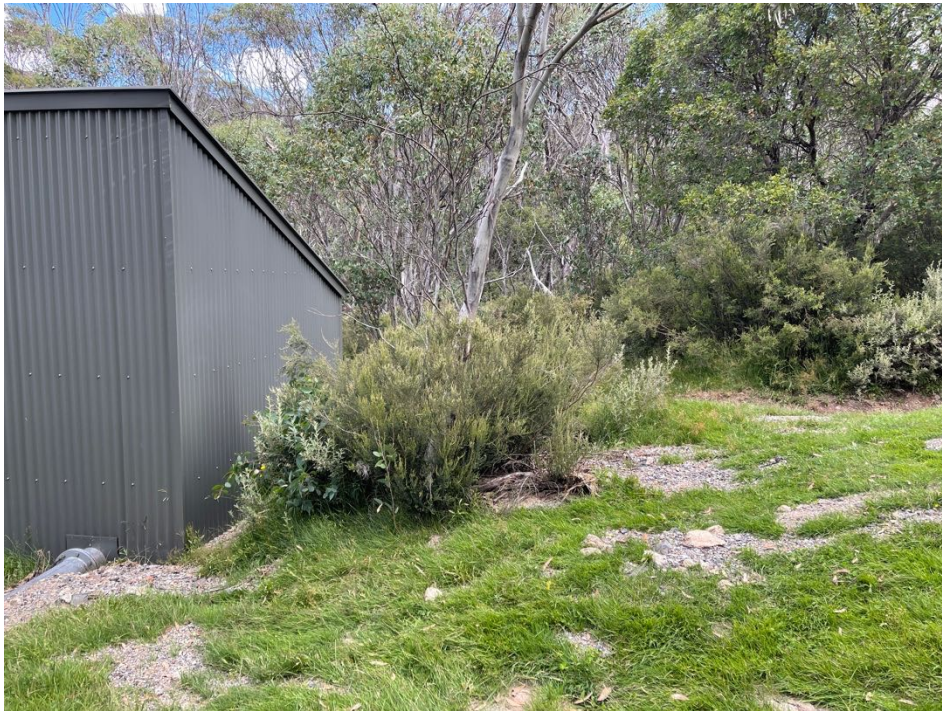
**Photo 7**

View of UV  
Treatment building,  
showing location of  
new pump extension

- Footings for the UV building should be formed on completely weathered or better granite, or dense or very dense sands, or very stiff or hard clays, and may be designed for a maximum allowable bearing pressure of 150 kPa. Further geotechnical advice should be sought if poorer foundation soils are exposed at footing excavation level.

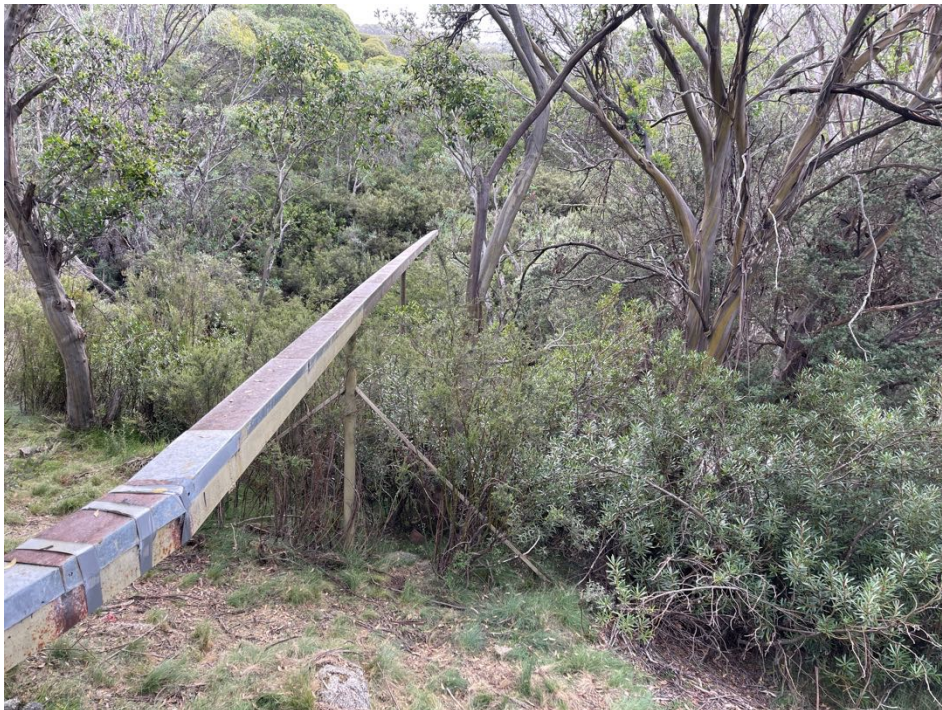
**Photo 8**

View of elevated  
sewer across creek
