### ASBESTOS REMOVAL SUMMARY (VERICO)

**SUBJECT: Carrington Hydraulic Engine House Internal Asbestos Removal Summary**

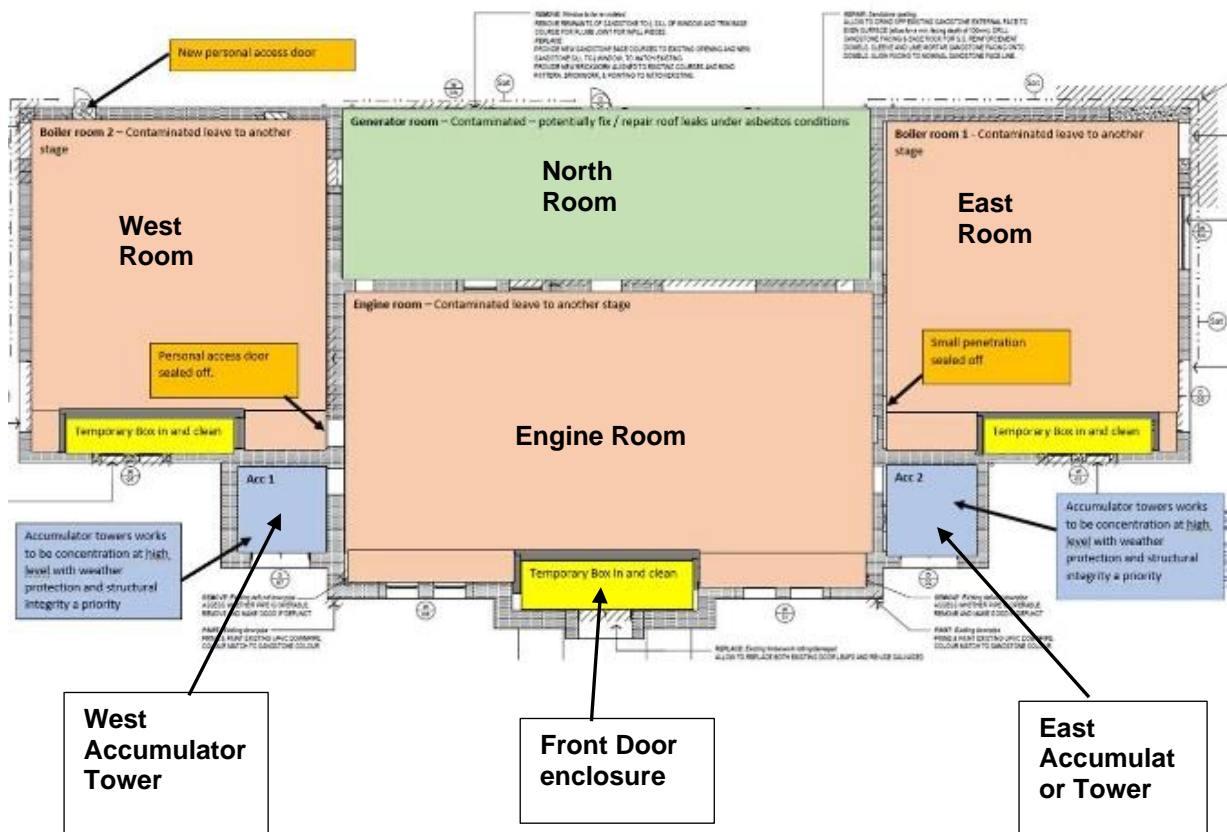
Figure 1 – CHEH Designated Removal Areas

A plan showing the designated removal areas is shown in Figure 1 below.
