## Appendix H

### OPTIONS ANALYSIS (EJE HERITAGE)

**RE: SHR:01987 Carrington Hydraulic Engine House – Engine Room Sub-Floor Asbestos Remediation Strategy - Options Analysis**

## **CARRINGTON HYDRAULIC ENGINE HOUSE – STAGE 3 – ENGINE ROOM ASBESTOS REMEDIATION**

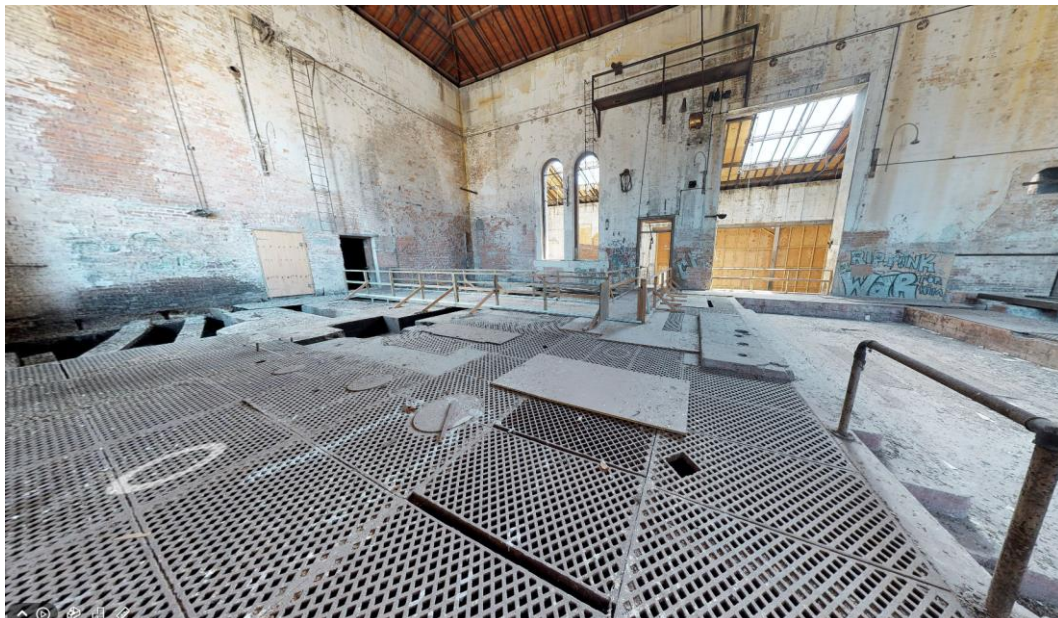
Figure 1. The floor of the Carrington Hydraulic Engine House main Engine Room is partially covered in original cast-iron floor grates suspended above a deep cavity on a steel column/beam structure. The grates are exceptionally heavy (not able to be lifted safely without hoisting equipment).

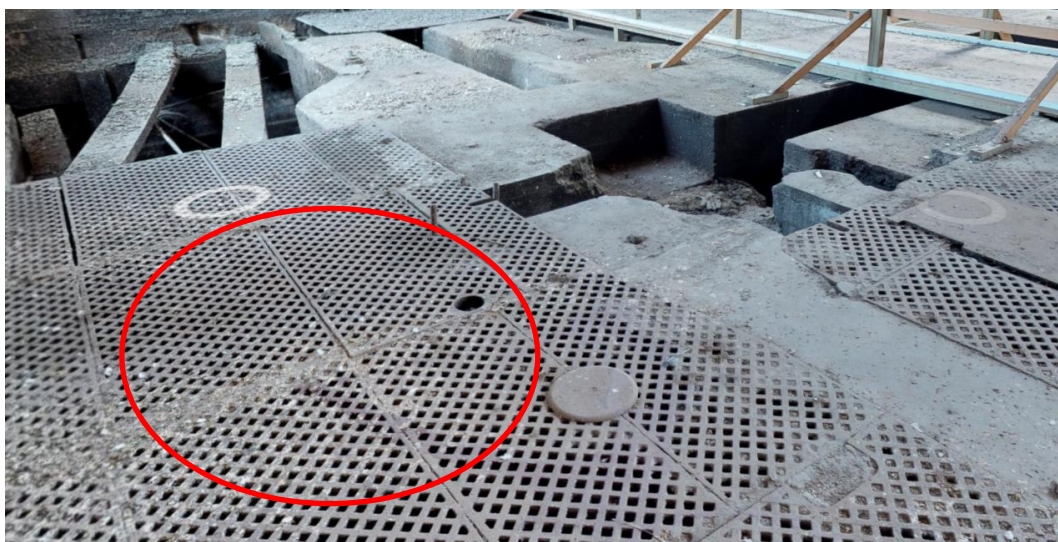
In summary, the nature of the hazard involves friable asbestos fibres stuck to/embedded within the original cast-iron floor grates of the engine room (Figure 1-2), and embedded asbestos material in the ground surface of the sub-floor cavity (Figure 3-5). The remaining surfaces of the Engine Room (and of the entire building) have been cleaned of asbestos by hazardous material specialists, and given clearance for occupation by the project's hygienist.

Figure 2. The cast iron floor grates present an asbestos hazard, with their porous surface containing remnant fibres despite previous cleaning in the room. Note also the large cavities present across parts of the floor. The hygienist has described that it would be implausible to fully clean the grates of asbestos in-situ, given the myriad openings and porous surface.

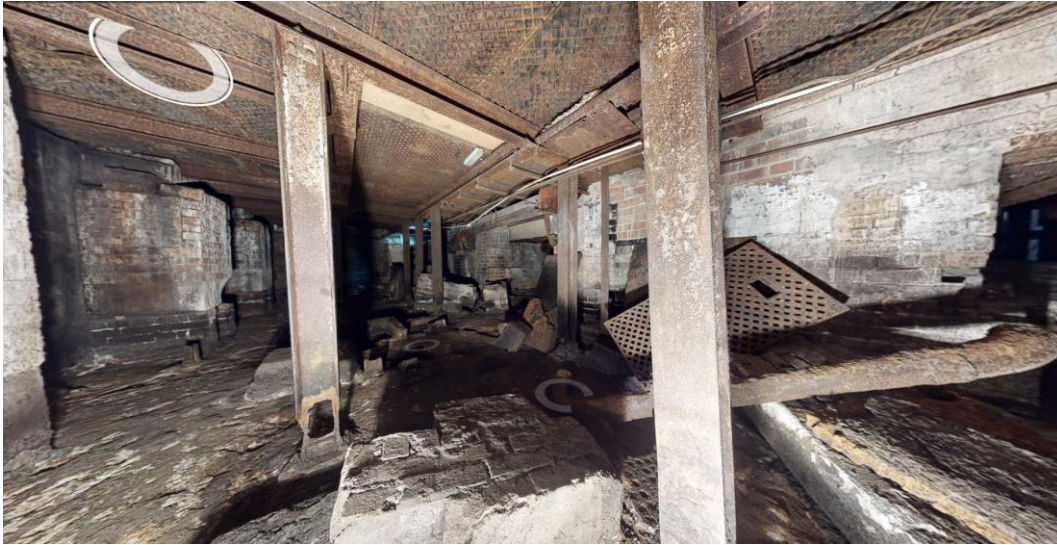
Figure 3. A very deep sub-floor cavity is present below the grates, which has been cleaned of asbestos as best as possible.

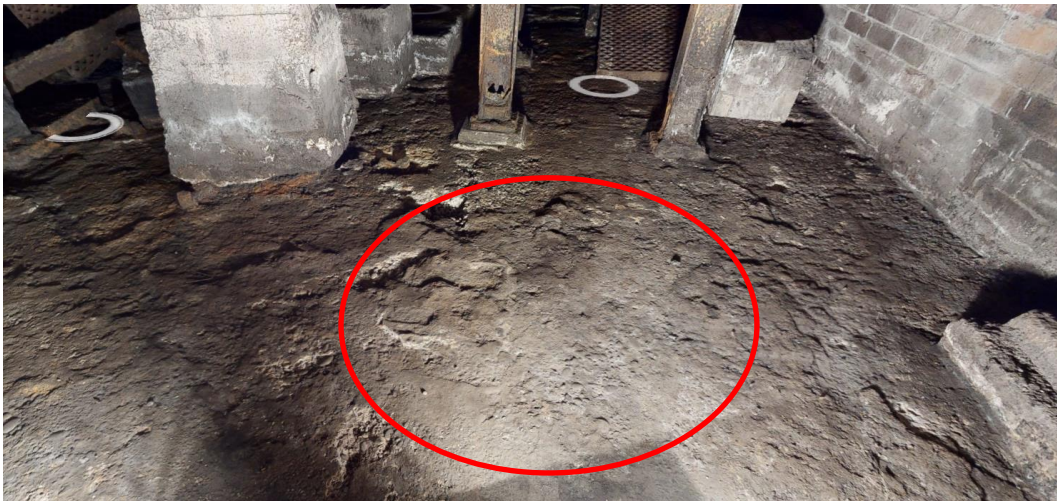
Figure 4. The solidified base surface however presents an asbestos hazard, with detectable asbestos physically embedded within the surface material.

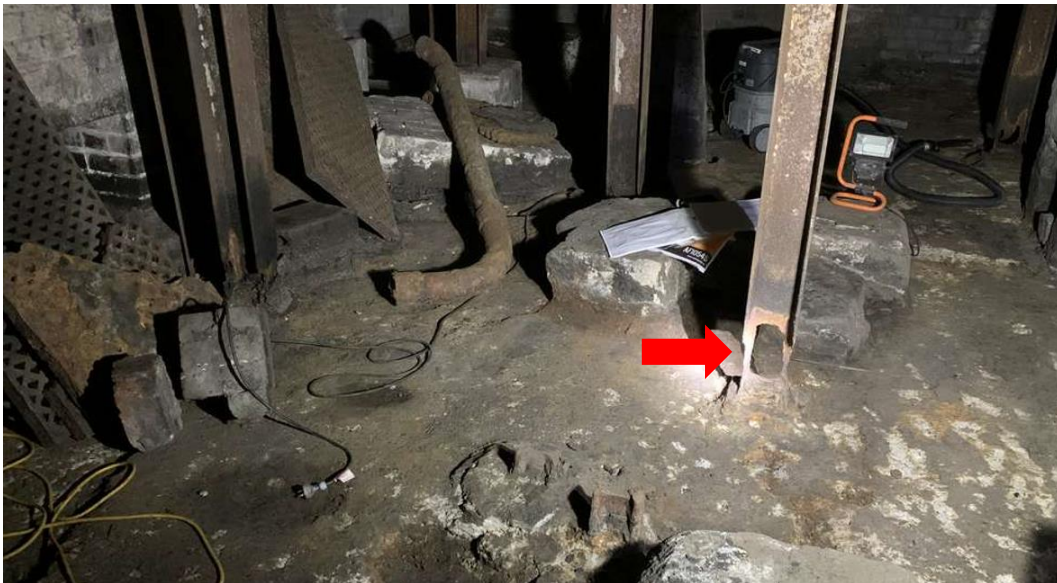
An additional hazard with the project is the poor structural integrity of the original steel floor framing in this room, with almost all columns supporting the cast-iron grates being corroded through more than 90% of their sectional area at their base (Figure 5). The main engine room floor section is as such non-trafficable in its current condition, and at extreme risk of collapse with any movement or interventions in the space.

Figure 5. Steel columns support the cast iron grates at the floor above, and all are suffering extreme corrosion particularly at their base, meaning that the grates are non-trafficable and at risk of collapse.
