# STRUCTURAL BUILDING REPORT

**PROJECT LOCATION**  
**310 Pine Brush Road Glen Martin**

**DRB PROJECT NUMBER**  
**211334**

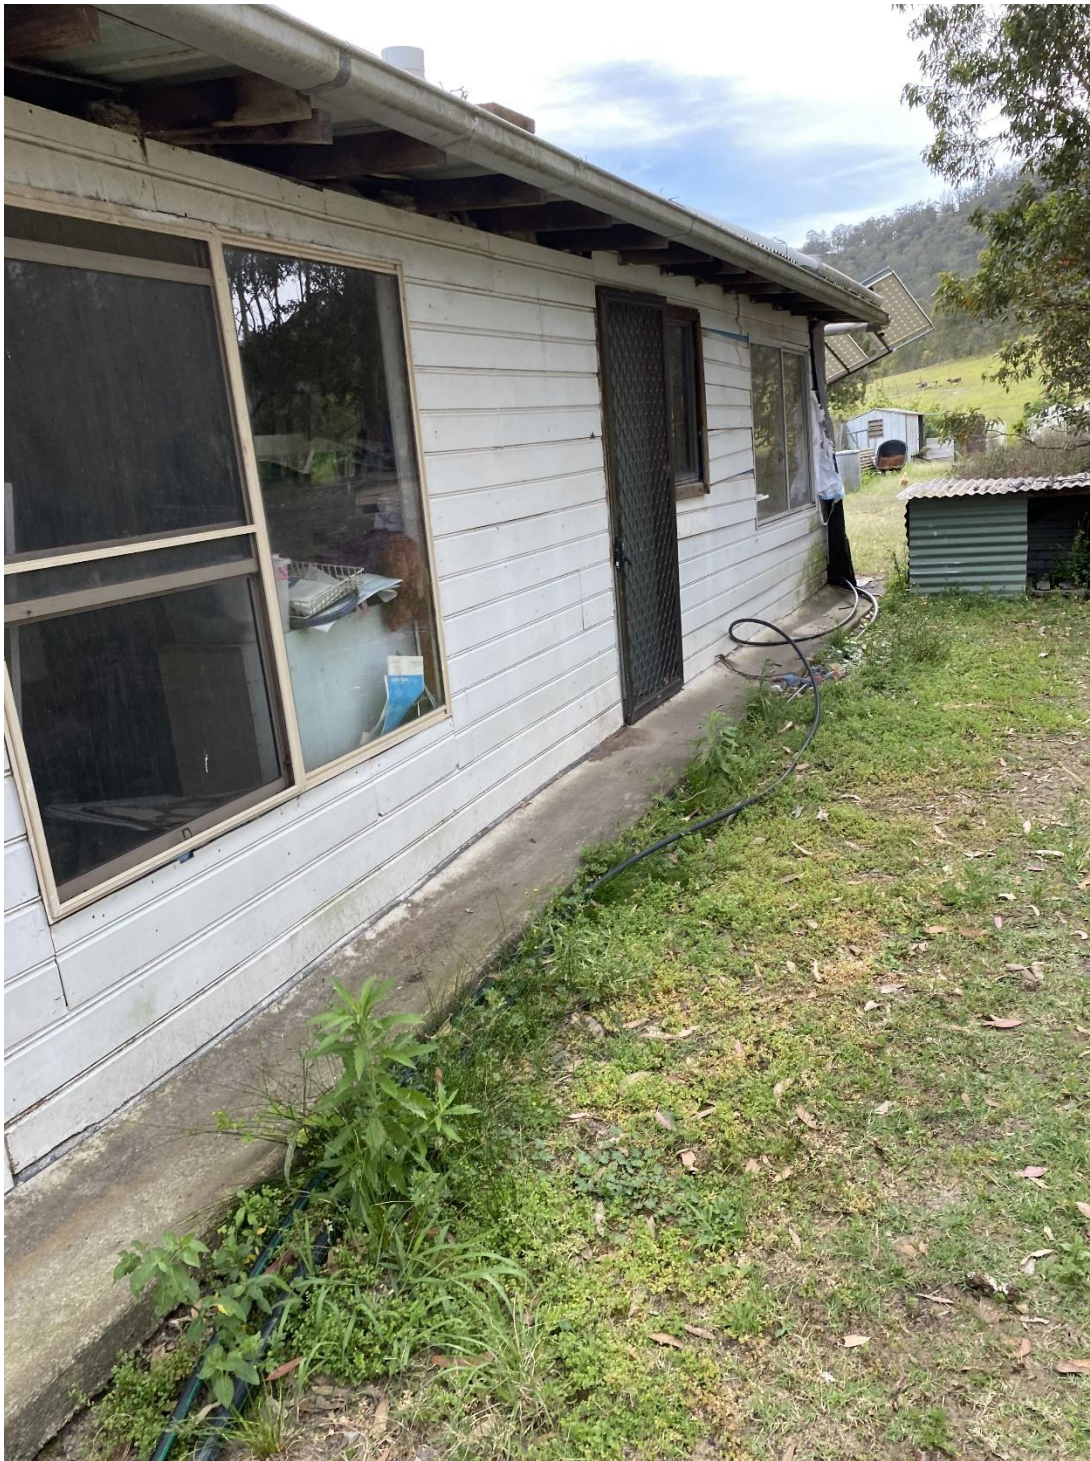
***Photograph 1 – South elevation of single storey dwelling.***

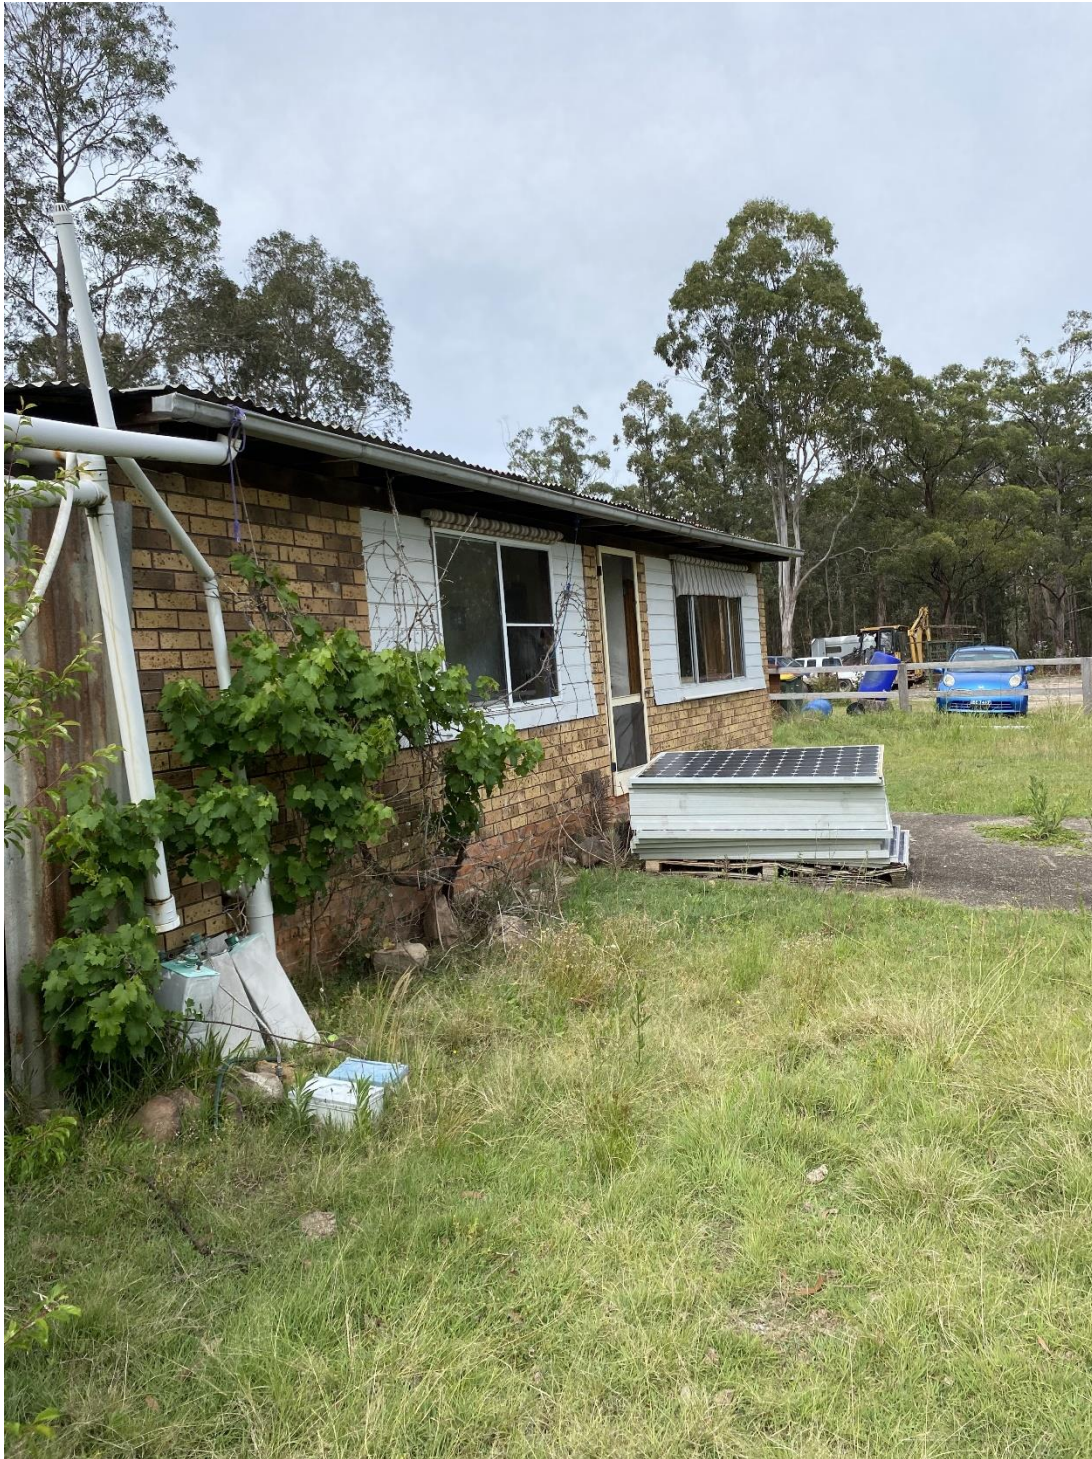
***Photograph 2 – North elevation of single storey dwelling.***

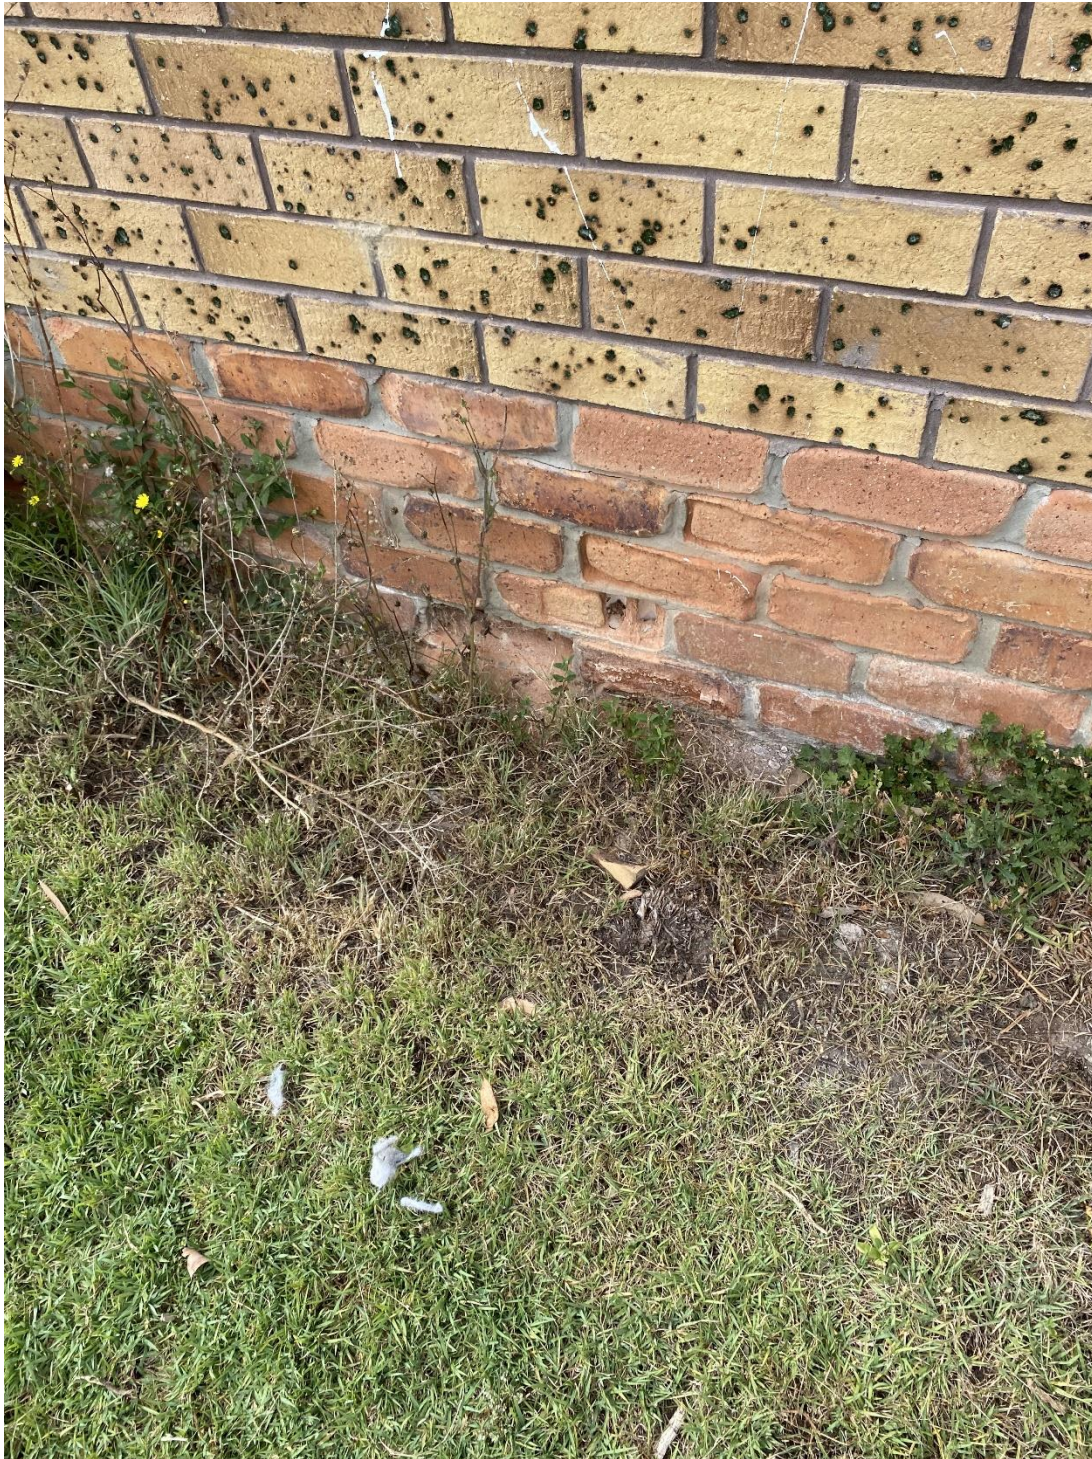
- Subfloor masonry on northern elevation
  - o The bricks in the subfloor masonry on the northern elevation have deteriorated and eroded. The affected bricks should be removed and replaced and the brickwork repointed as required.
  - o Damage to claddings has exposed timber framing to weather. Rectify cladding to restore weather protection to framing.

***Photograph 3 – Deterioration of subfloor masonry on single storey dwelling.***

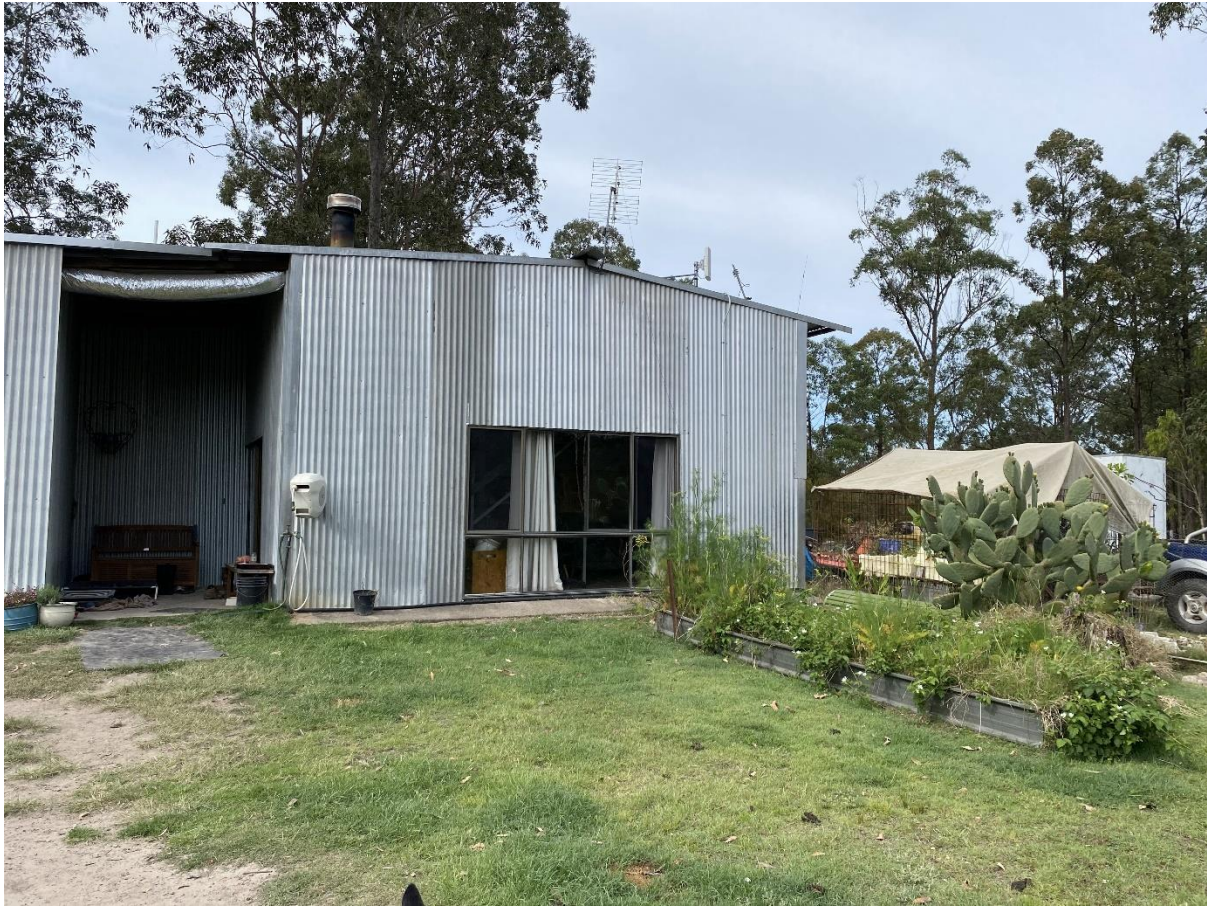
***Photograph 4 – North elevation west end of shed structure which is converted to habitable living space.***

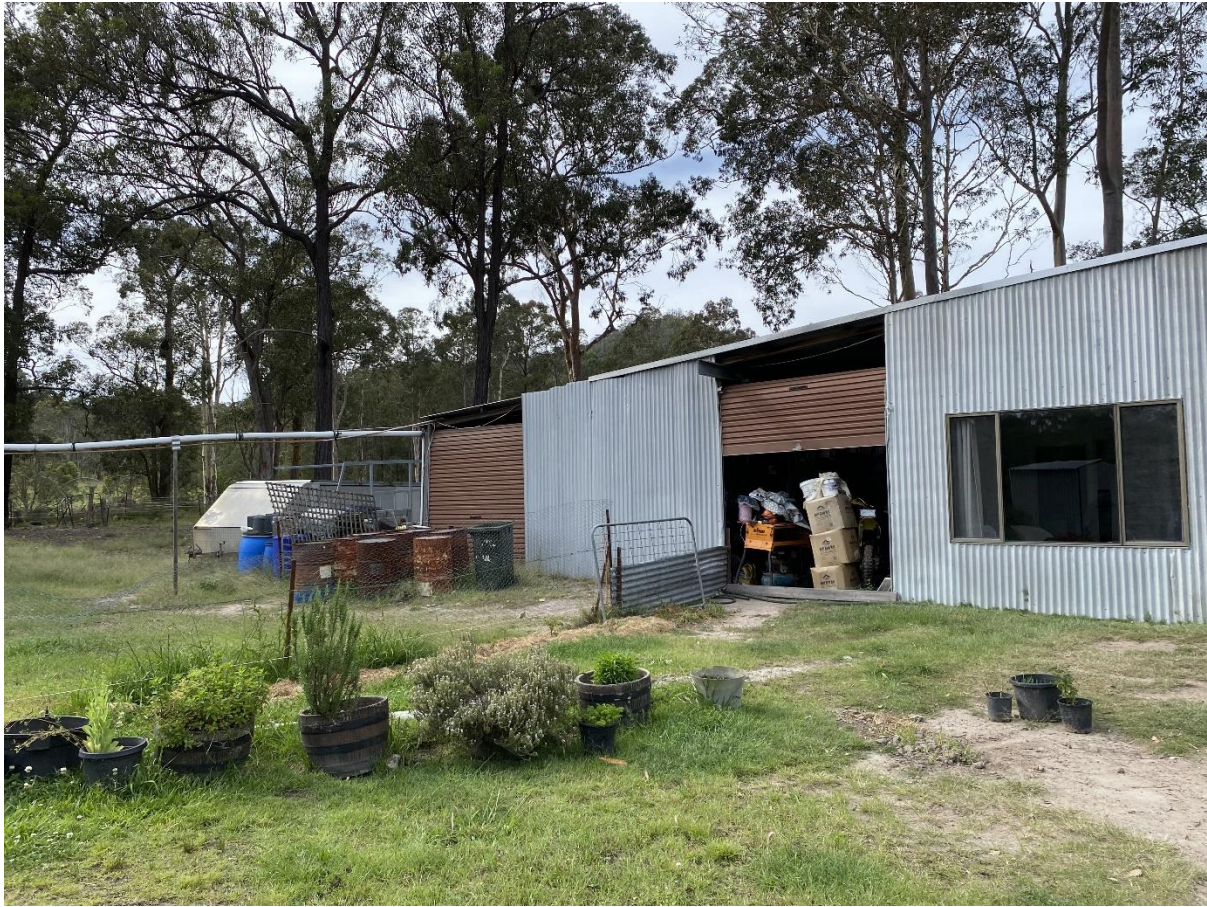
***Photograph 5 – North elevation, east end of shed structure used for storage.***

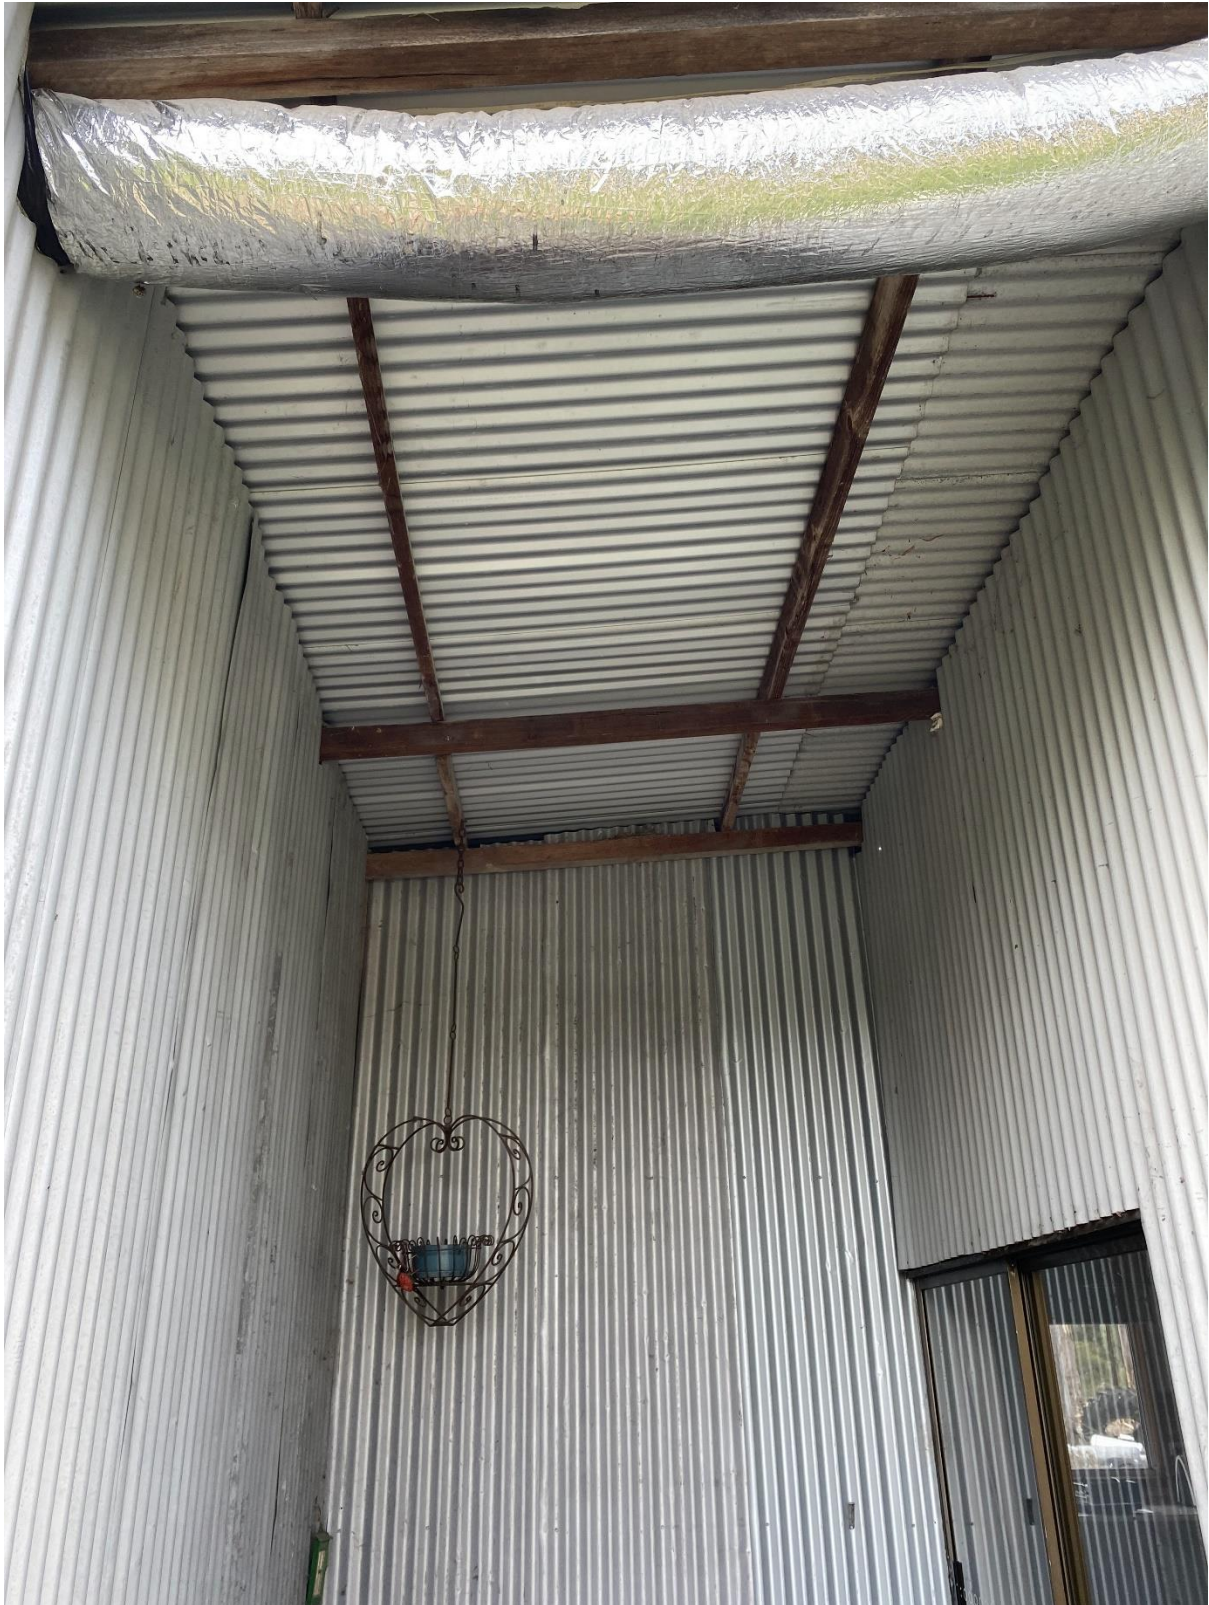
**Photograph 6 – Shed structure entry roof. Rafters spacing too large.**

- Framing
  - o The existing roof framing consists of hardwood rafters and battens supported on walls or hardwood/steel purlin beams.
    - Spacing between the existing hardwood rafters needs to be reduced to max 1200 centres. Add new 90x70 F27 KDHWB rafters to reduce spacing as required.

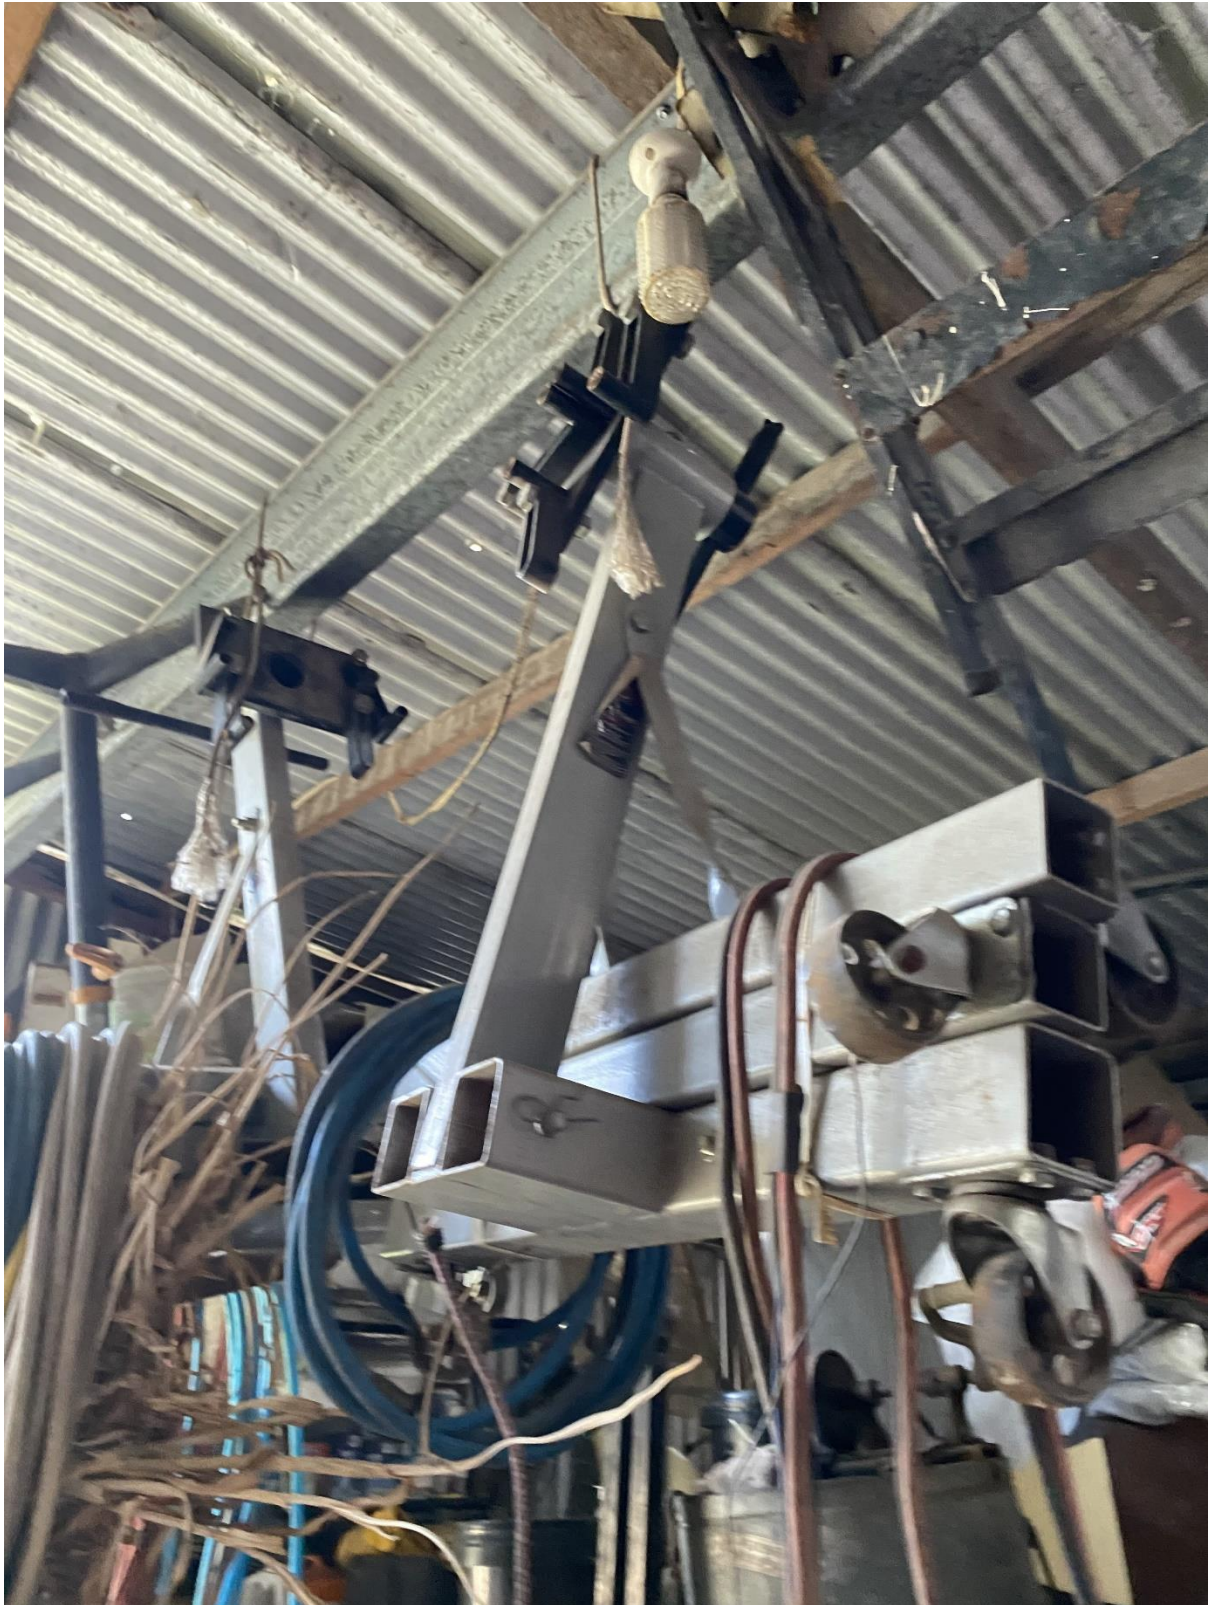
***Photograph 7 – C200 purlin beam requires two additional post supports to reduce span.***

- C200 purlin section roof beam spanning 8.8m requires two additional evenly spaced support posts to reduce span. Posts can be minimum 90x90 MGP10 with proprietary galvanised saddle bracket supported on pad footings to AS2870.

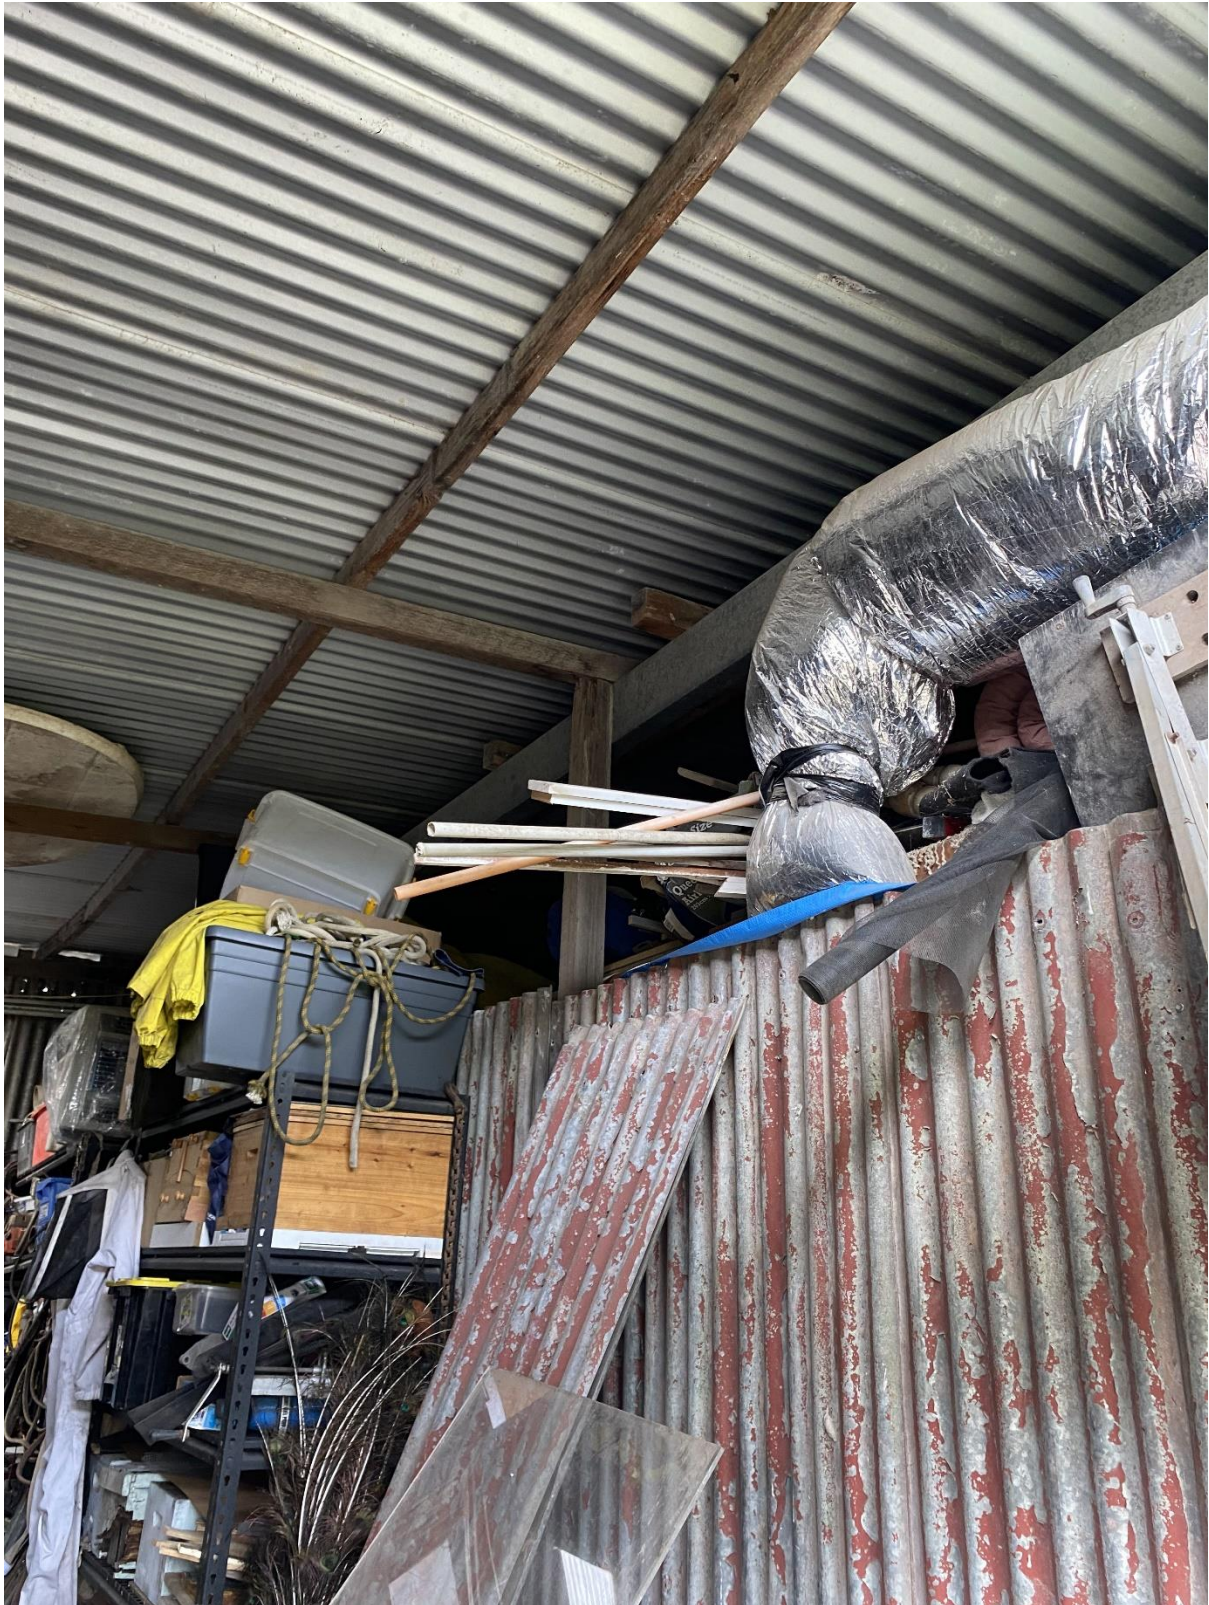
***Photograph 8 – Shed rafter spacing too large. Add rafters to reduce spacing.***

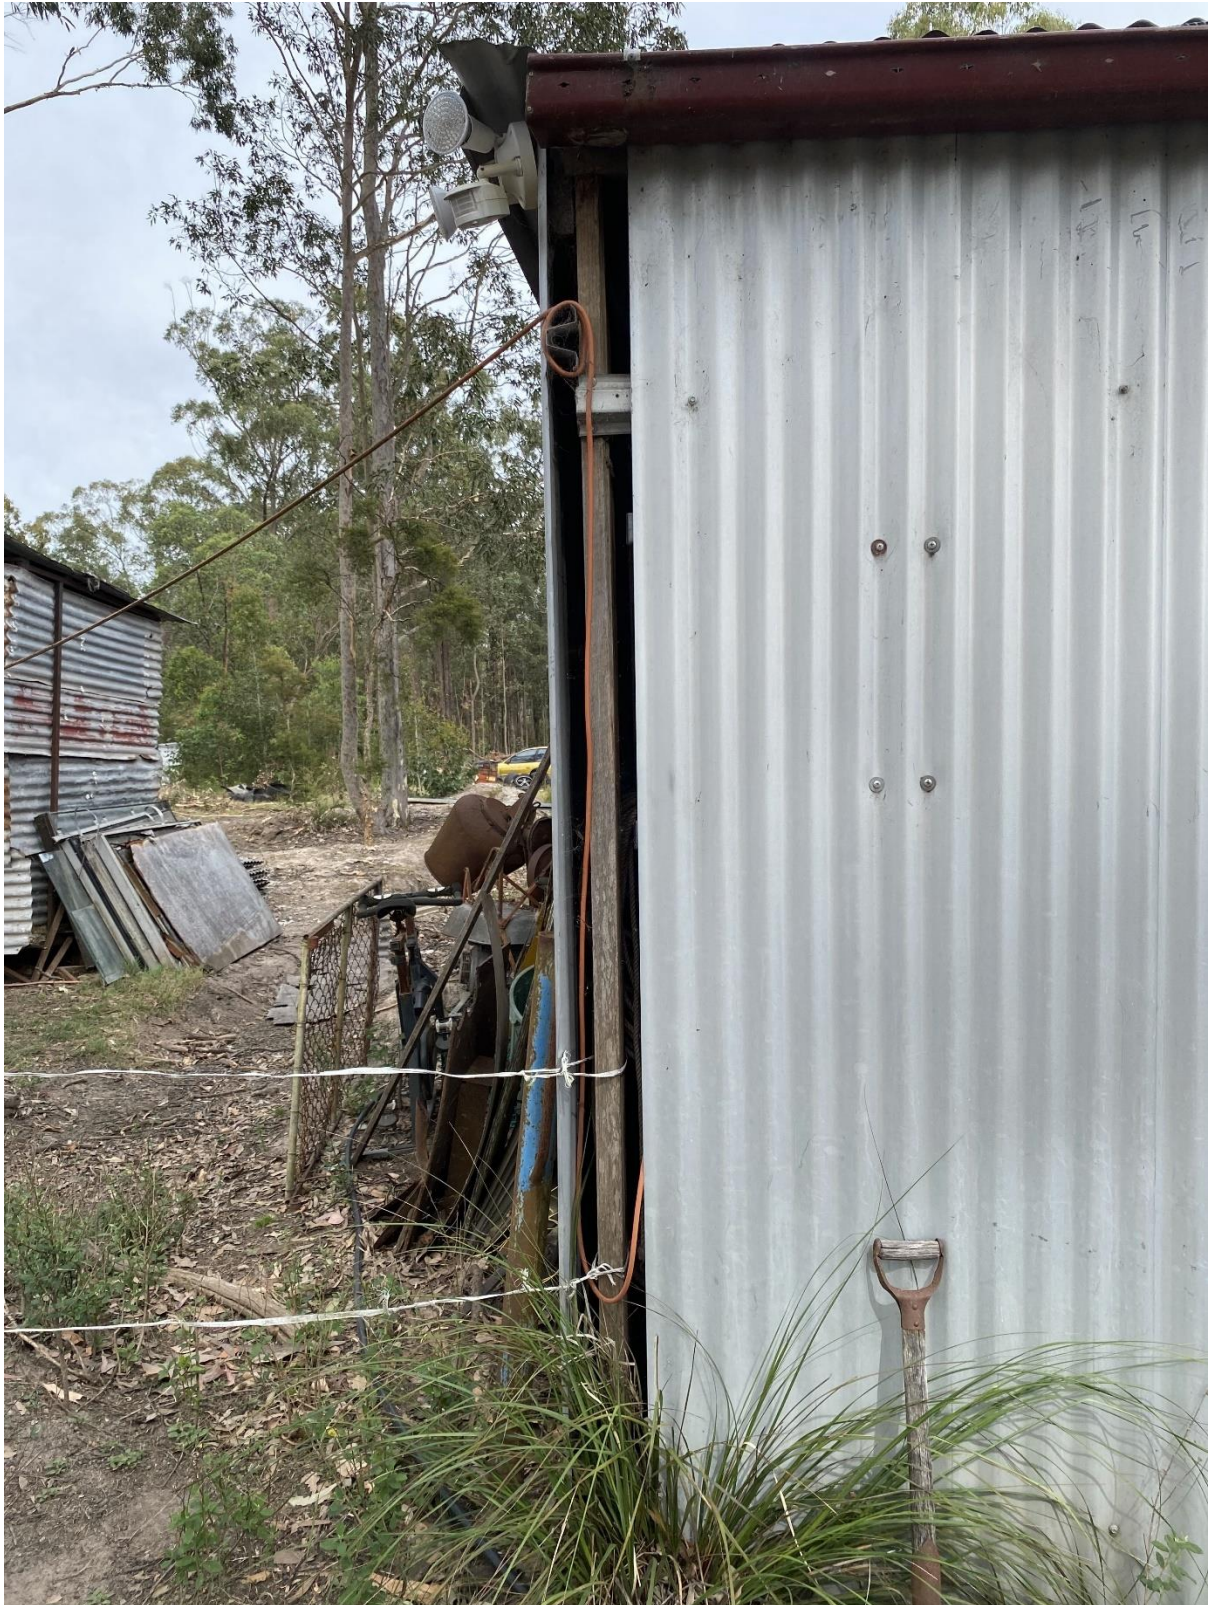
***Photograph 9 – Shed structure wall batten spacing too large and fixings missing.***

- Steel tophat wall batten spacing is too large for span between columns in eastern end of shed. Provide additional tophats in accordance with manufacturers specifications to achieve maximum spacing of 700mm.

- Fixings between tophats and sheeting missing. Install fixings in accordance with custom orb sheeting manufacturer specifications.
    - Wall and roof bracing missing. Provide steel strap bracing to AS1684 requirements.

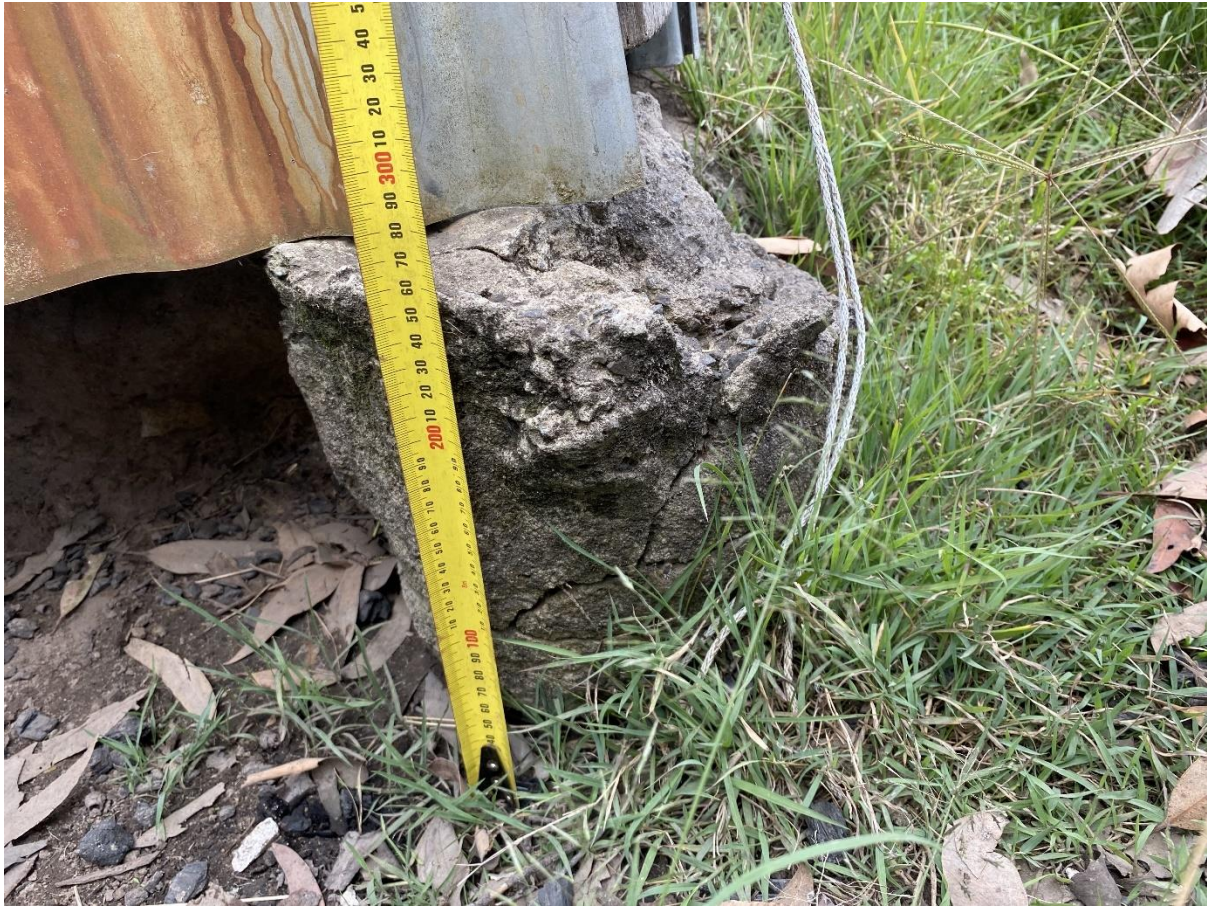
***Photograph 10 – Shed structure pad footing undermined and undersized.***

- Pad footings – Eastern end
  - o The pad footing at the north-eastern corner of the building has been undermined and is undersized. Add to existing footing or provide new footing to achieve minimum 500mm embedment into firm natural soil and minimum diameter of 400mm. Confirm size of other pad footings at eastern end of shed and upgrade as noted above if required.
