**Clearance Inspection Report
River Road Foreshore
Shoalhaven Heads**

Asbestos Clearance Certificate

Report Number: 20-10305-01-CL
Date of Report: 31/5/2019
Date of Inspection: 30/5/2019
Client: Opterra
Client Contact: Rylan Loemker
Client Address: 9 Spinks Rd, East Corrimal NSW 2518
Site Address: River Rd, Shoalhaven Heads NSW 2535

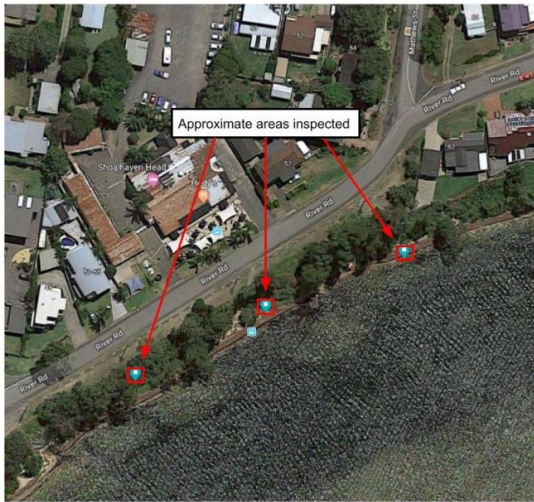
Photograph 1:

Site overlay indicating approximate areas inspected.

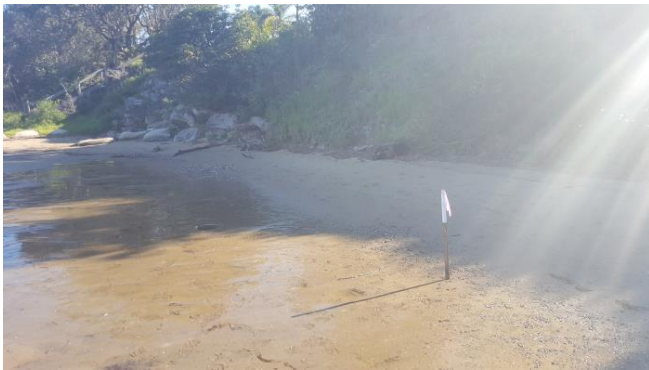
Photograph 2:

Representative image of the western marker site, at the time of inspection.

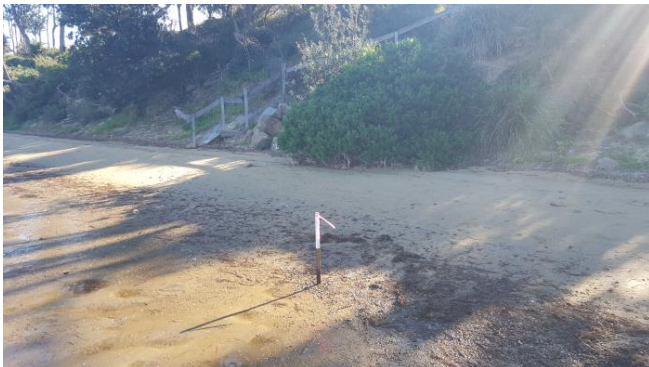
Photograph 3:

Representative image of the cenral marker site, at the time of inspection.

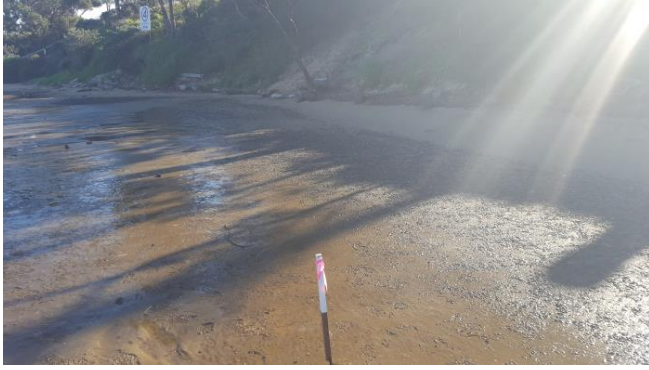
Photograph 4:

Representative image of the eastern marker site, at the time of inspection.
