# Coastal Management Advice: 68 - 86 River Road, Shoalhaven Heads

WRL TR 2021/24, February 2022

By M J Blacka

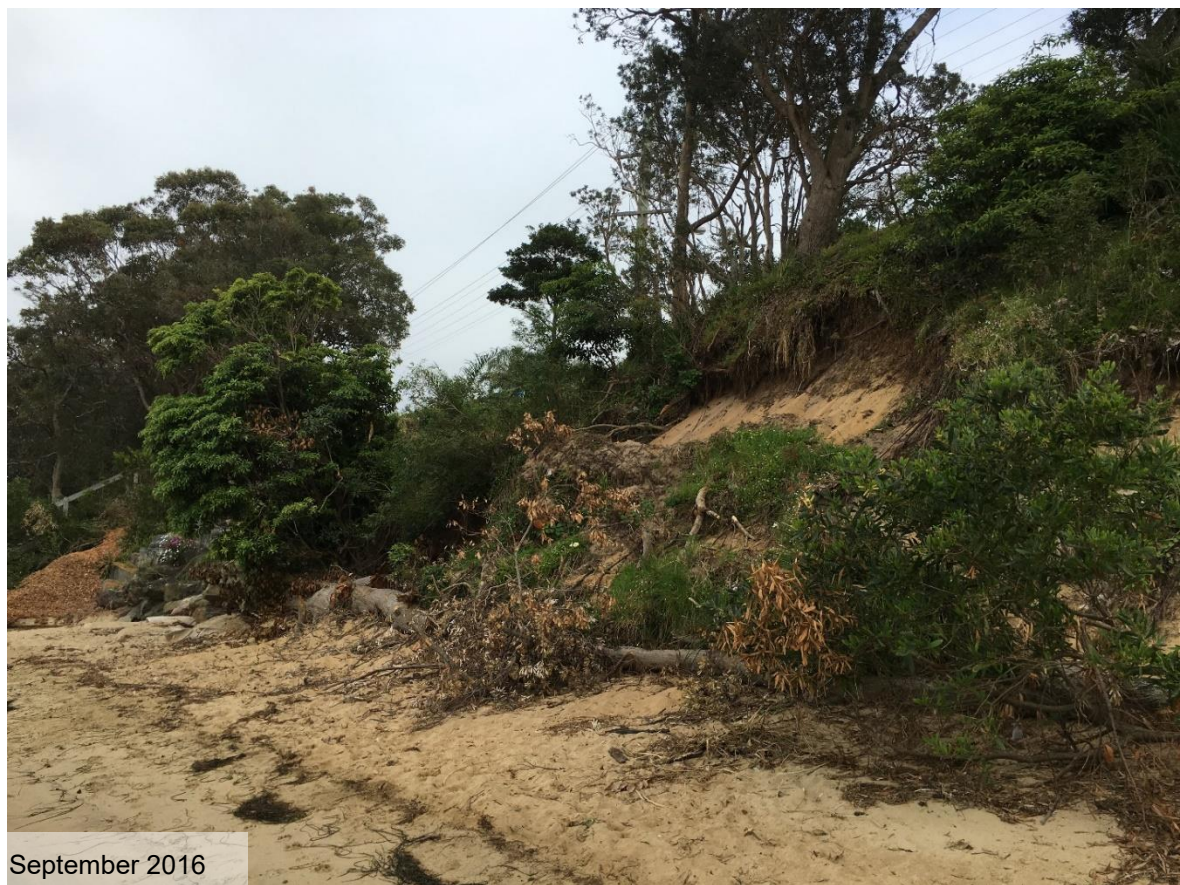
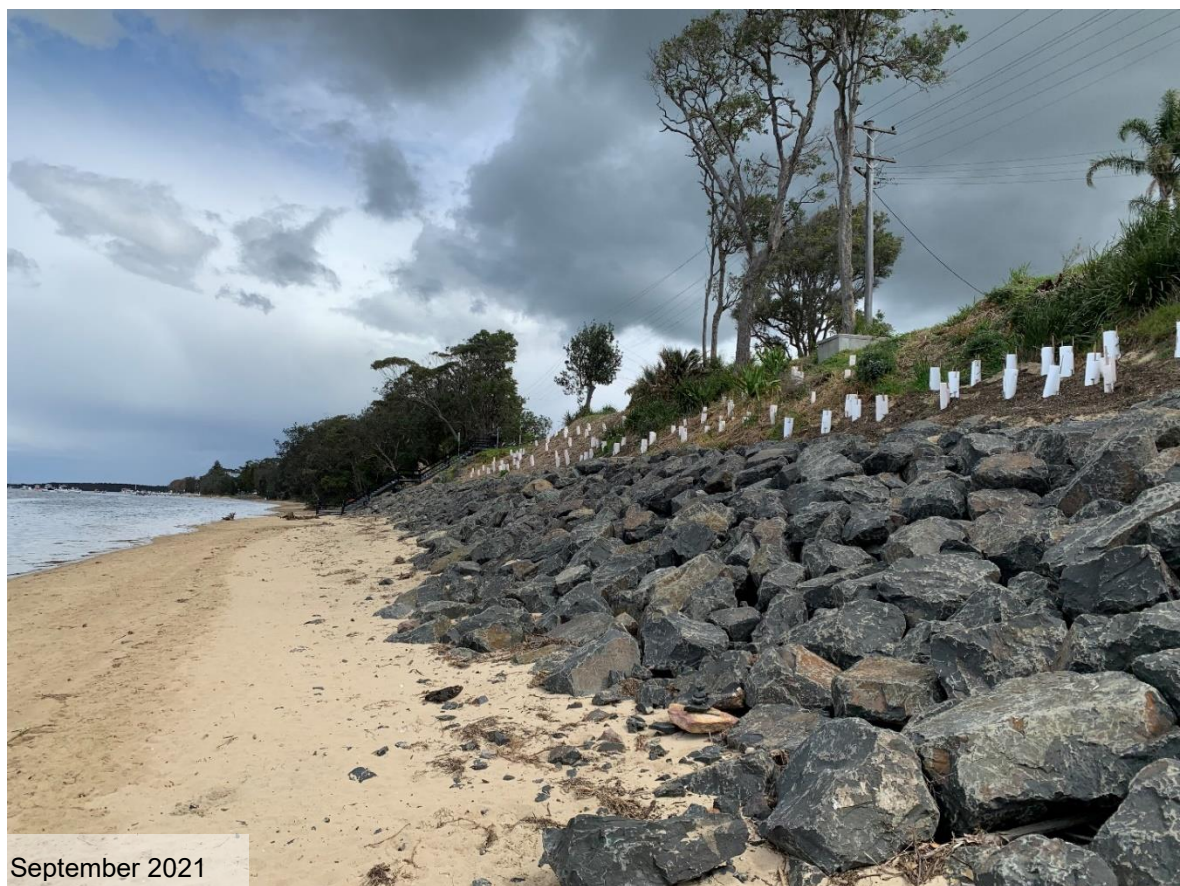
**Figure 3.2 Western end of rock revetment, at Ch 550 m looking west**

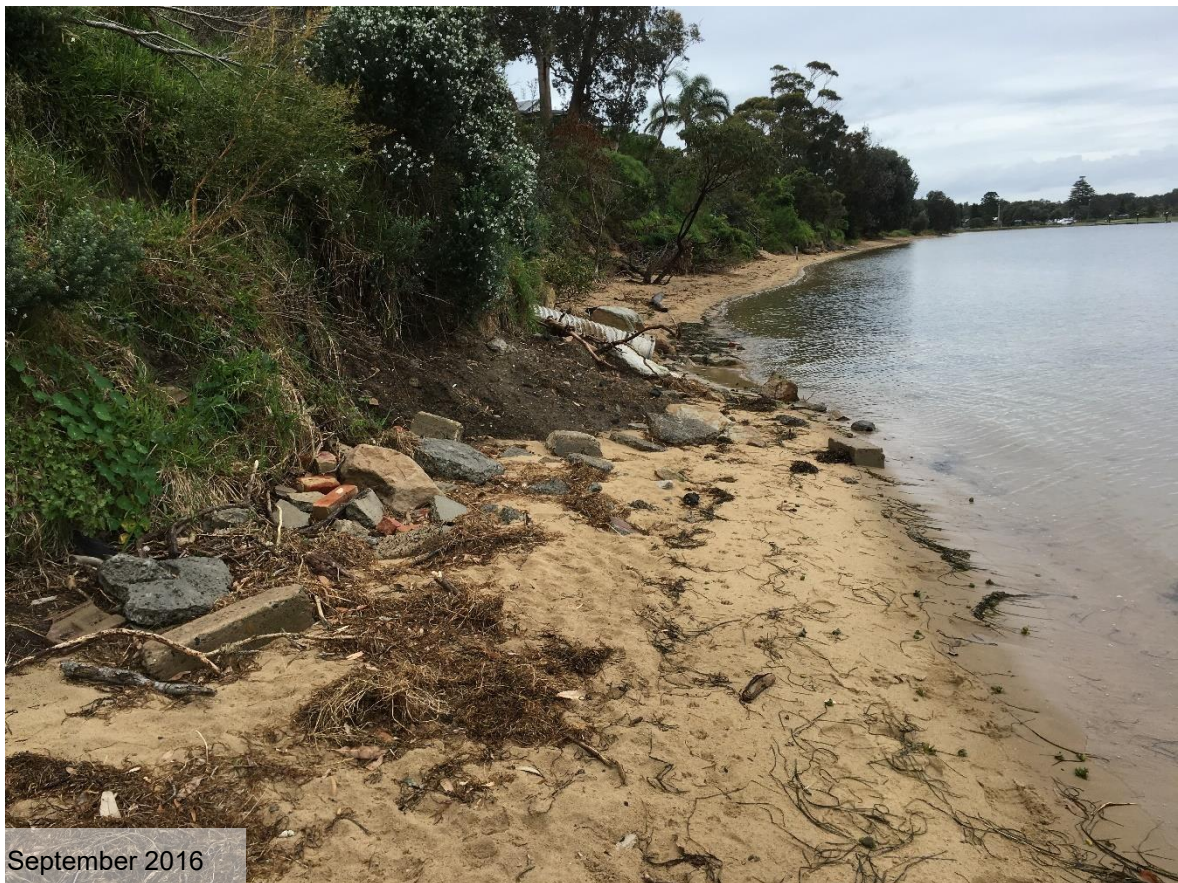
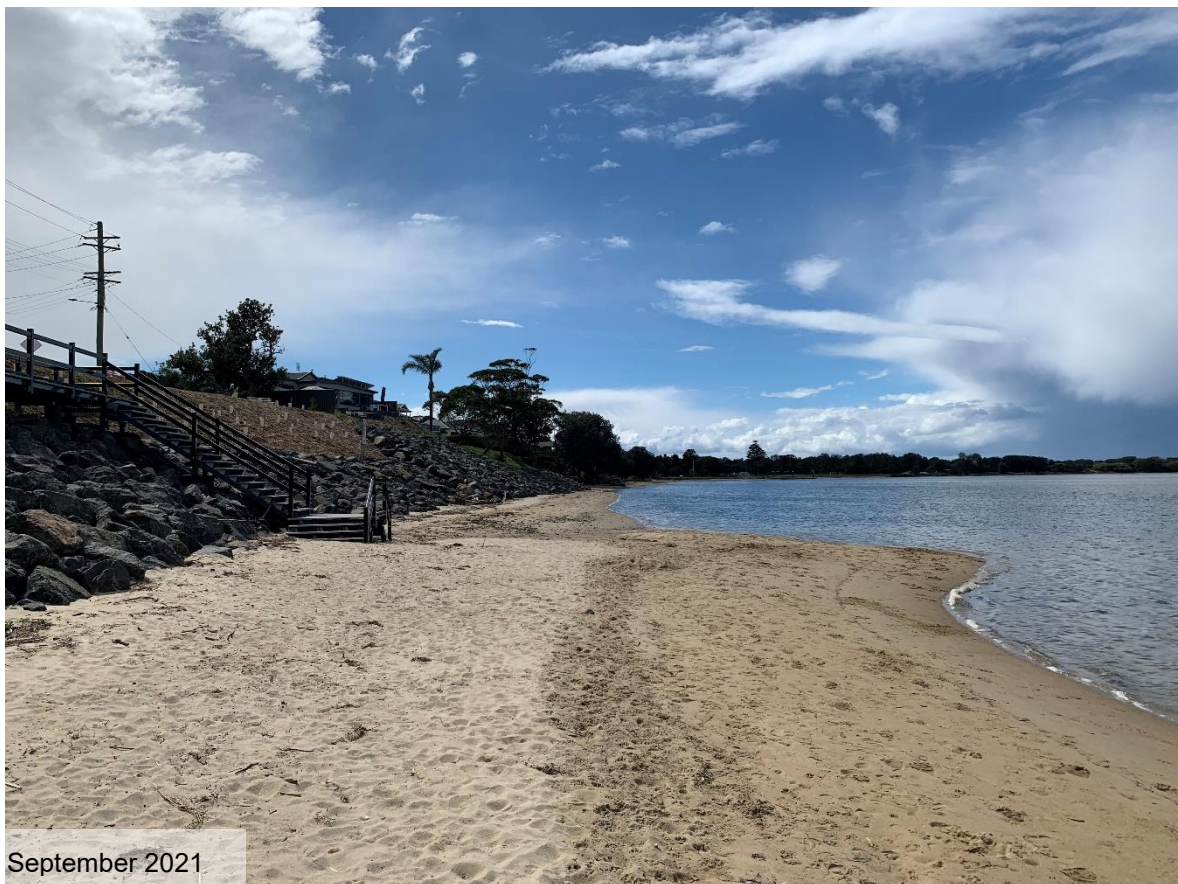
**Figure 3.3 Central section of rock revetment, at Ch 550 m looking east**

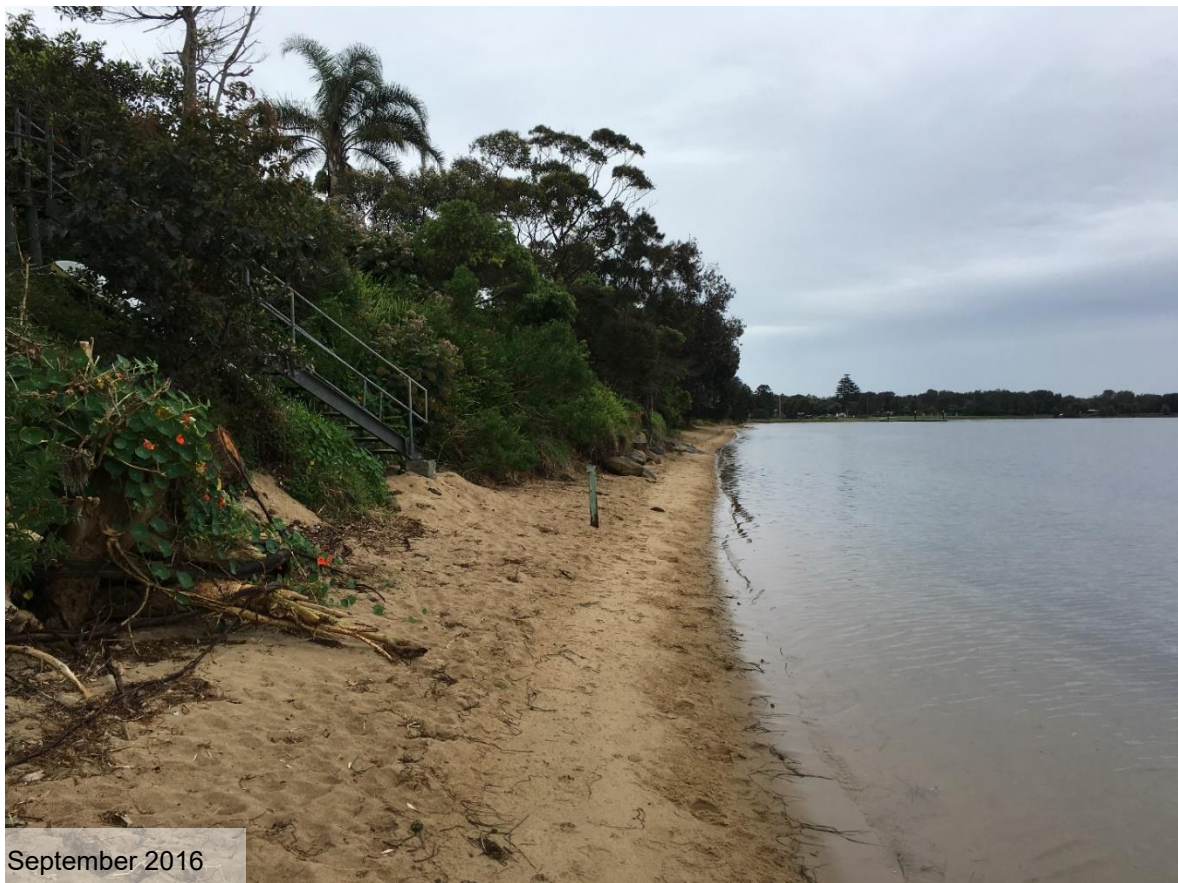
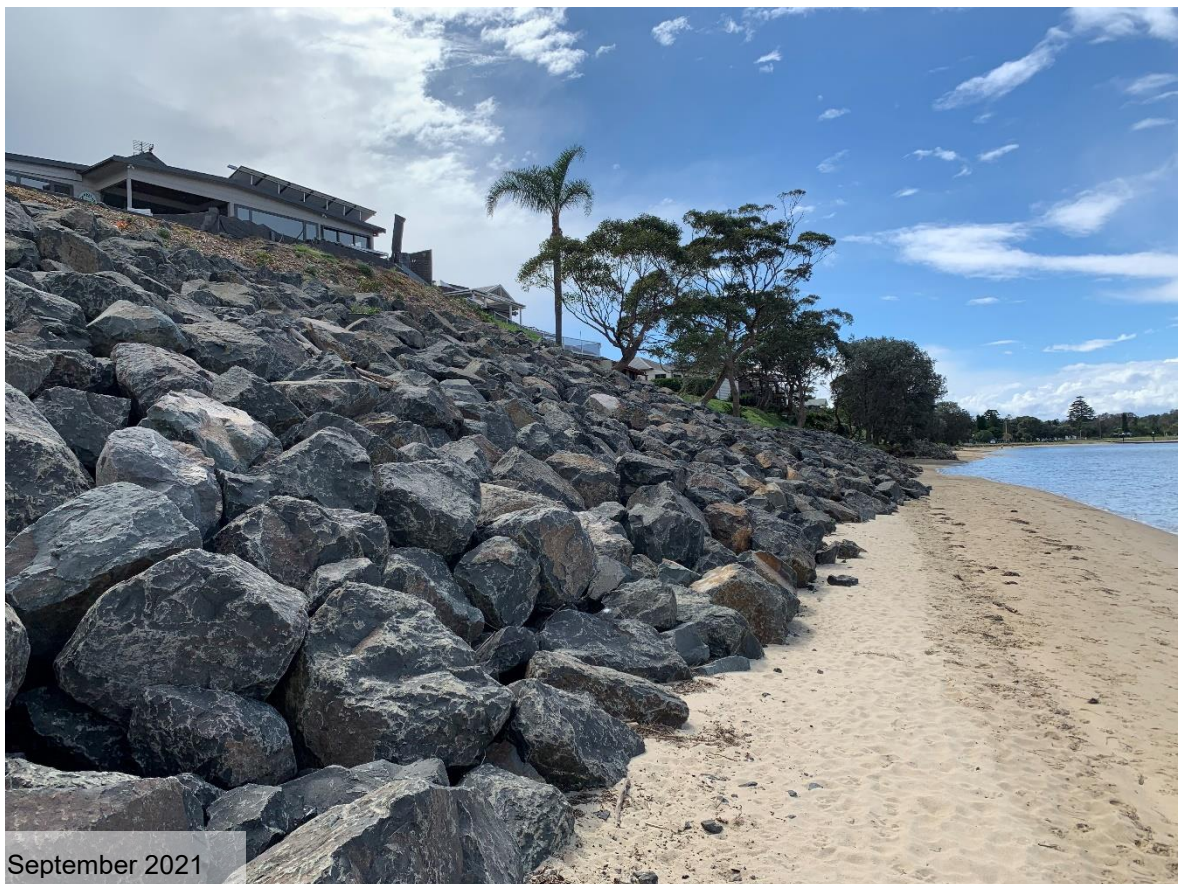
**Figure 3.4 Eastern section of rock revetment, at Ch 600 m looking east**

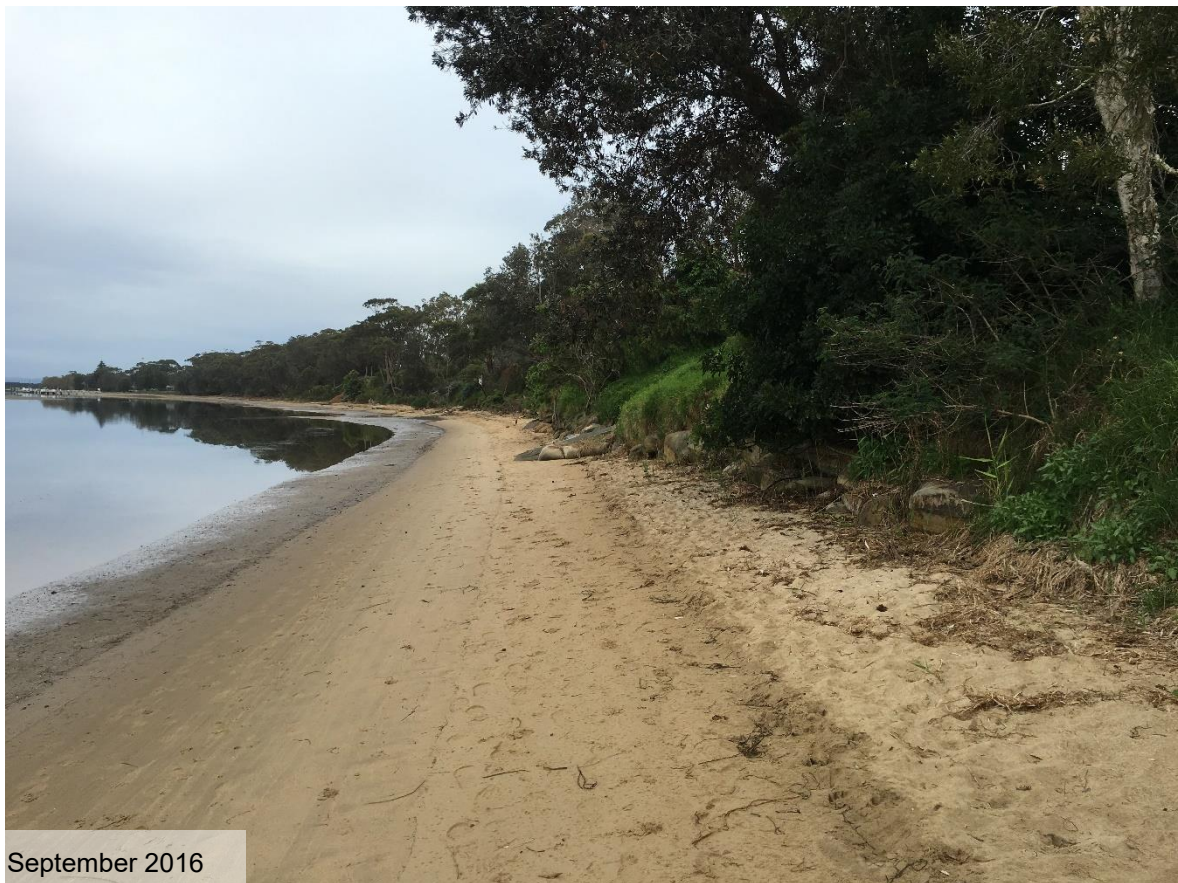
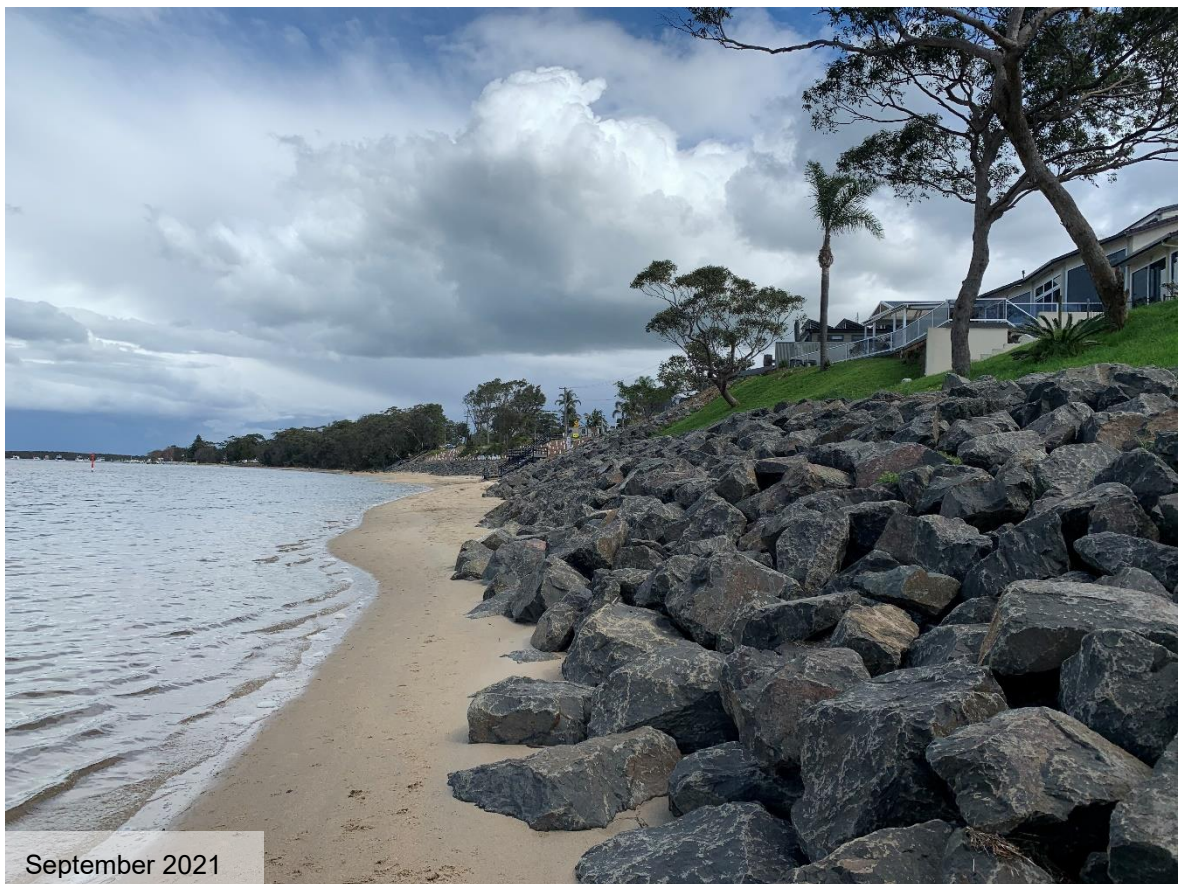
**Figure 3.5 Eastern end section of rock revetment, at Ch 700 m looking west**

With regards to the eastern end of the constructed revetment (east of the private concrete boat ramp at 64 River Road, ~Ch 690 m), a number of relevant observations were made during our inspection (see Figure 3.5 to Figure 3.7 for photos):

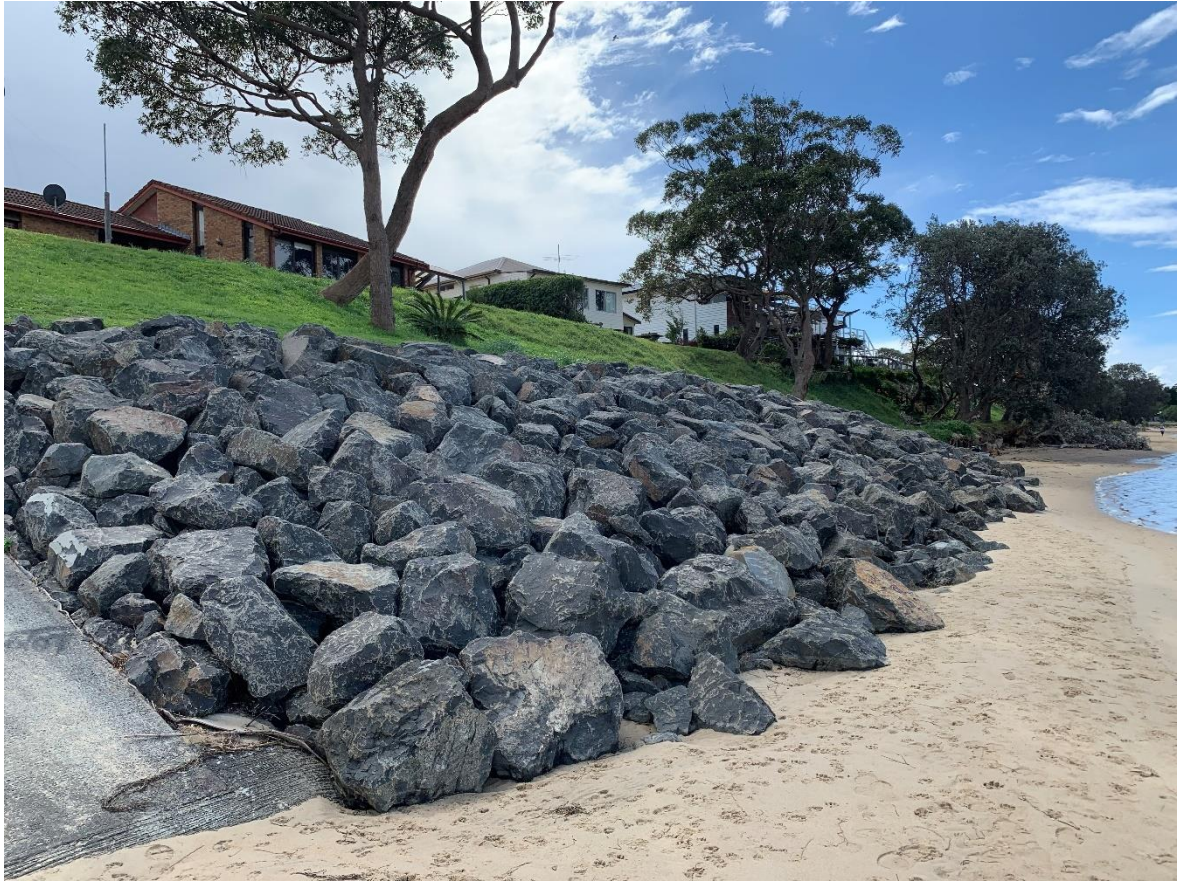
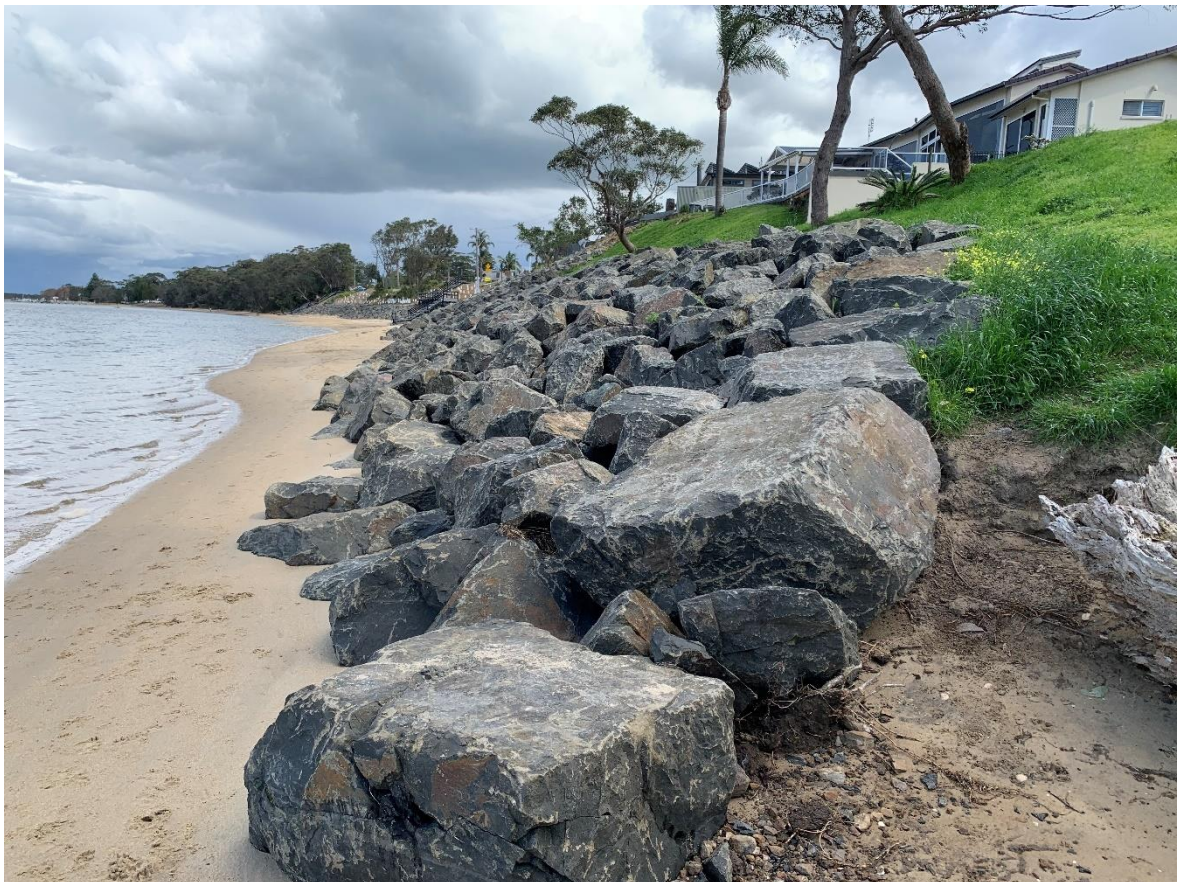
**Figure 3.6 Eastern end section of rock revetment (Ch 680 - 720 m)**

As shown in Figure 3.6, Figure 3.7 and discussed in Section 4.2, the area of beach immediately adjacent to the eastern end of the rock revetment (Ch 720 to 750 m) has experienced recent scouring, which is primarily the result of swash interacting with the revetment end in this area. The beach is also noted to be lower in this area and to have a lower sand volume compared with areas further west or east. Mapping (Figure 4.12) has shown that the top of the erosion scarp/bank in this area has not receded significantly since construction of the revetment, though it is difficult to tell from comparisons of photographs due to the extent of change with the revetment construction.

<b>Foreshore management zone</b>	<b>Recommended management approach<sup>1</sup></b>
Ch 680 - 720 m	<p><u>Now:</u></p> <p>Modify this section of rock revetment including:</p> <ul style="list-style-type: none"> <li>• Temporarily remove rock armour (primary and secondary) and geotextile underlayer</li> <li>• Re-align and profile lower section of earth bank to a slope of 1V:1.5H</li> <li>• Replace geotextile, secondary armour and a single layer of primary armour only, to a maximum crest height of 4 m AHD (adjacent to private boat ramp) and reducing to level of natural ground at the eastern end</li> <li>• Place excess/excavated soil onto current erosion scarp at eastern end of rock revetment, burying end of revetment within bank alignment if possible</li> </ul> <p>Nourish the intertidal area of beach to elevate it to a consistent longshore level (at least 1.1 m AHD) against revetment toe, per current level of beach areas further to the west.</p>

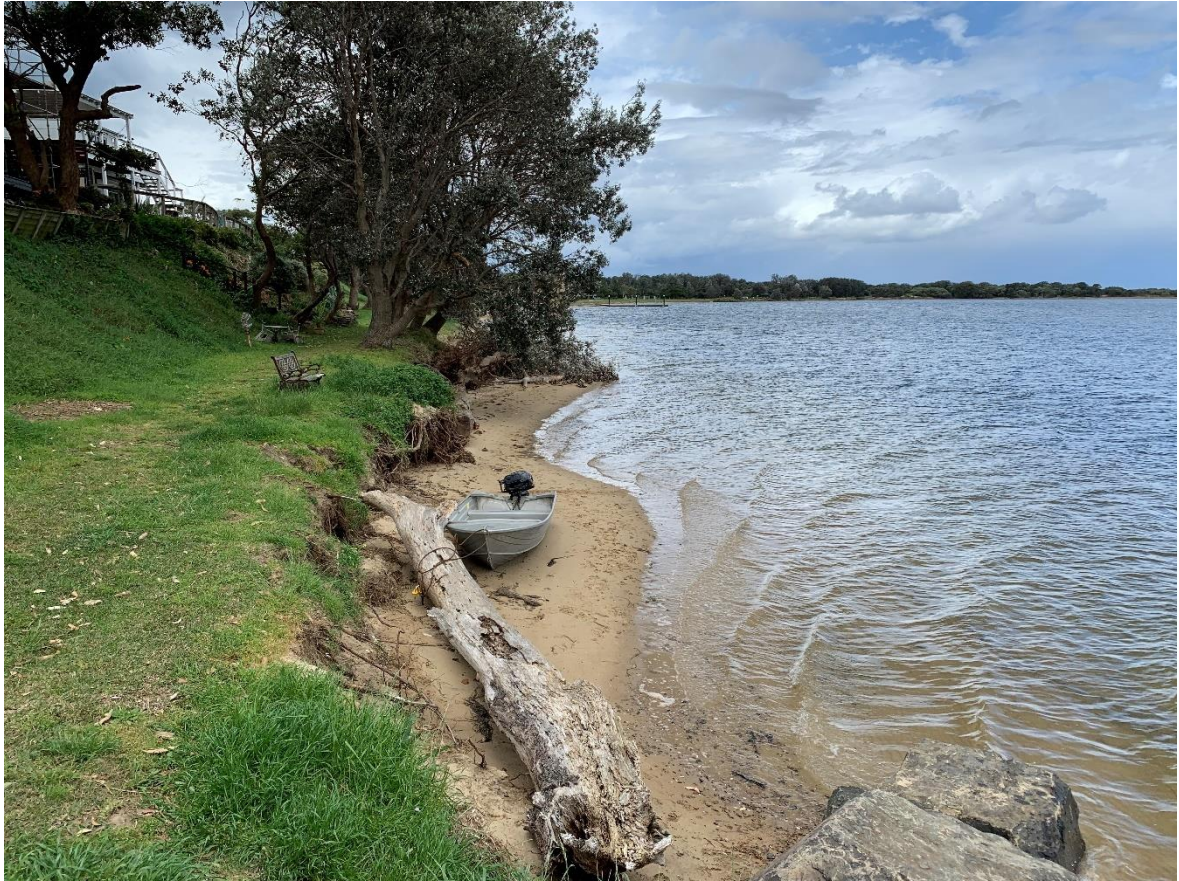
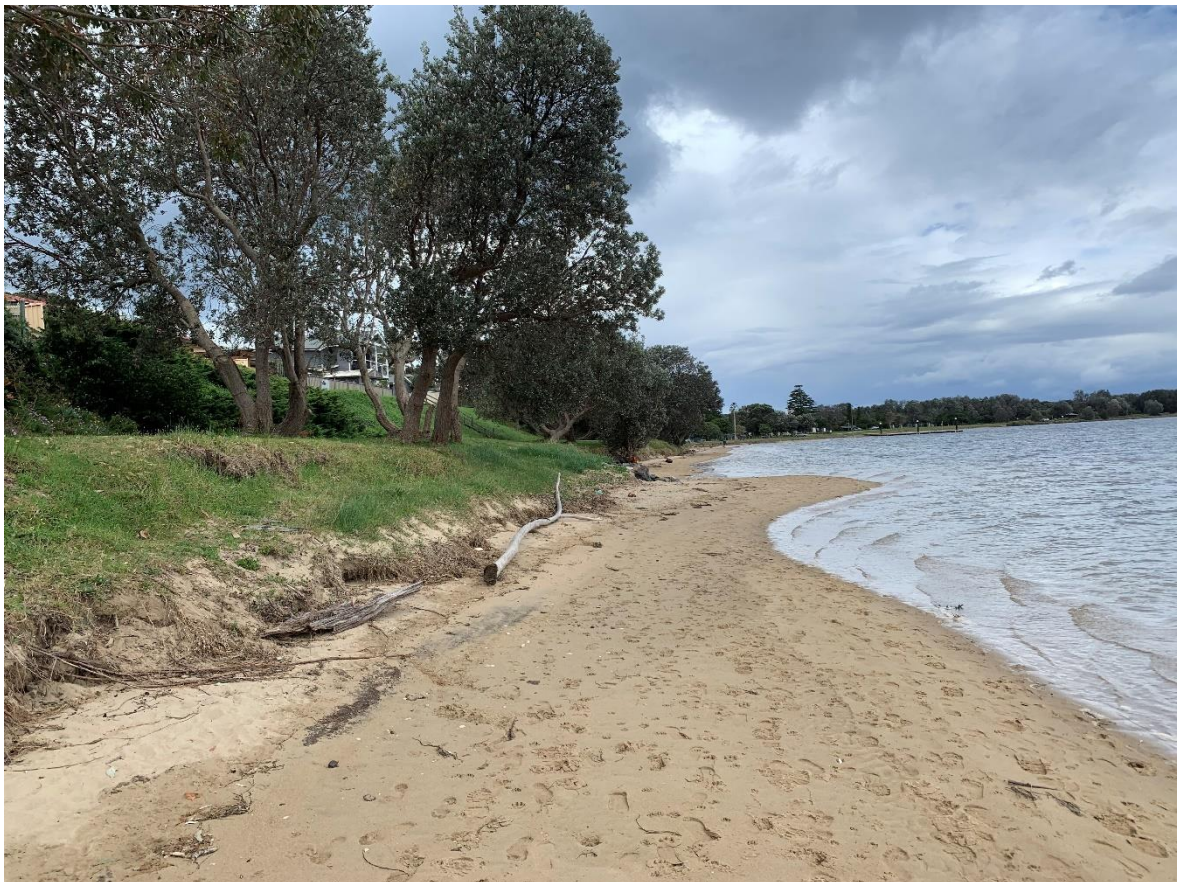
**Figure 3.7 Natural foreshore Ch 715 to 740 m (top) and Ch 750 to 800 m (bottom)**

Ch 720 - 800 m	<p><u>Now:</u> Nourish the intertidal section of beach in this localised area to achieve a more suitable beach volume, including re-building of the back-beach erosion scarp to a more stable slope. Stabilise the re-profiled bank surface and crest through revegetation and ground cover. Consider improved pedestrian access controls.</p> <p><u>Mid-Term Future:</u> Nourish beach more extensively if needed, or if recommended short-term nourishment volumes cannot be achieved.</p>
Ch 800 - 950 m	<p><u>Now:</u> Re-profile erosion scarp, stabilise surface, revegetate, consider improved access.</p> <p><u>Mid-Term Future:</u> Nourish beach more extensively if needed.</p>
All sections	<p>Monitor the beach through regular beach profile surveys or UAV surveys and collect photographs:</p> <ul style="list-style-type: none"> <li>• Quarterly (minimum 6-monthly)</li> <li>• After erosion events</li> </ul>

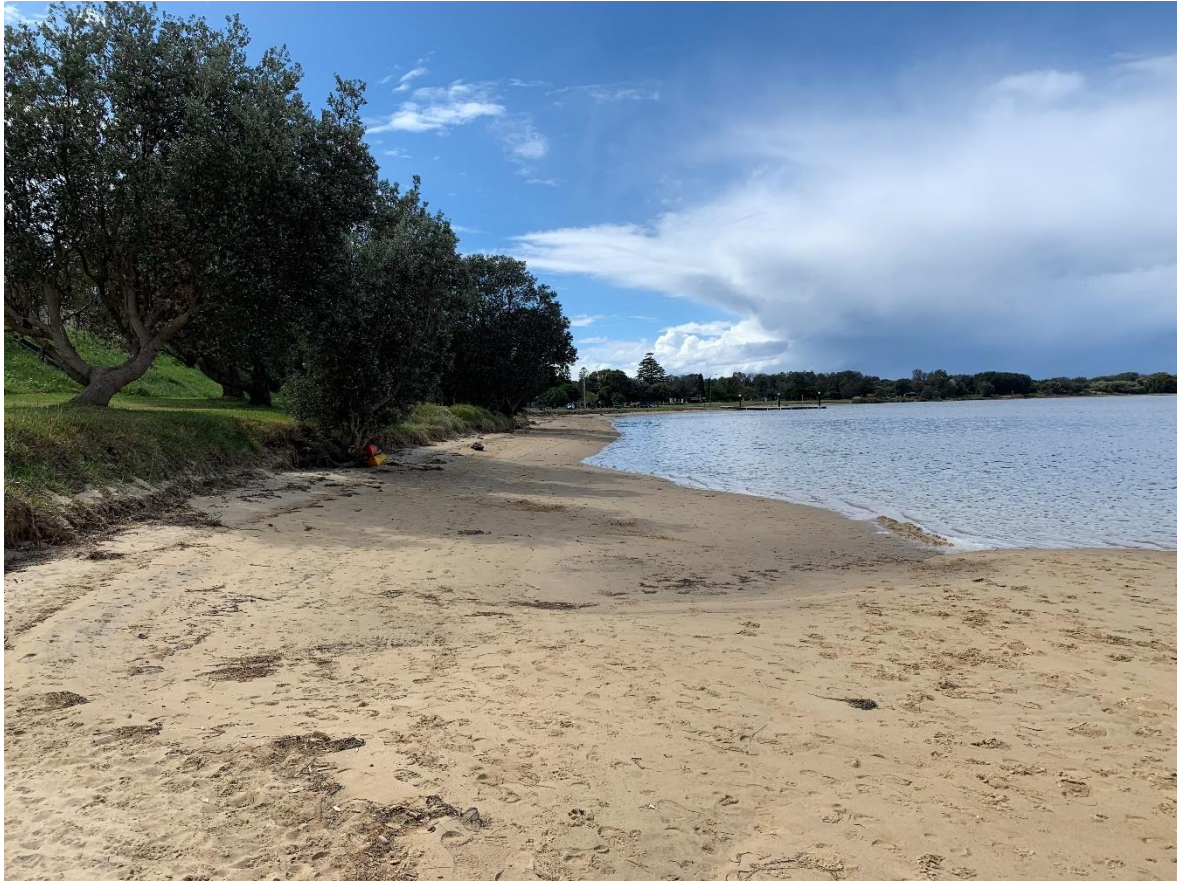
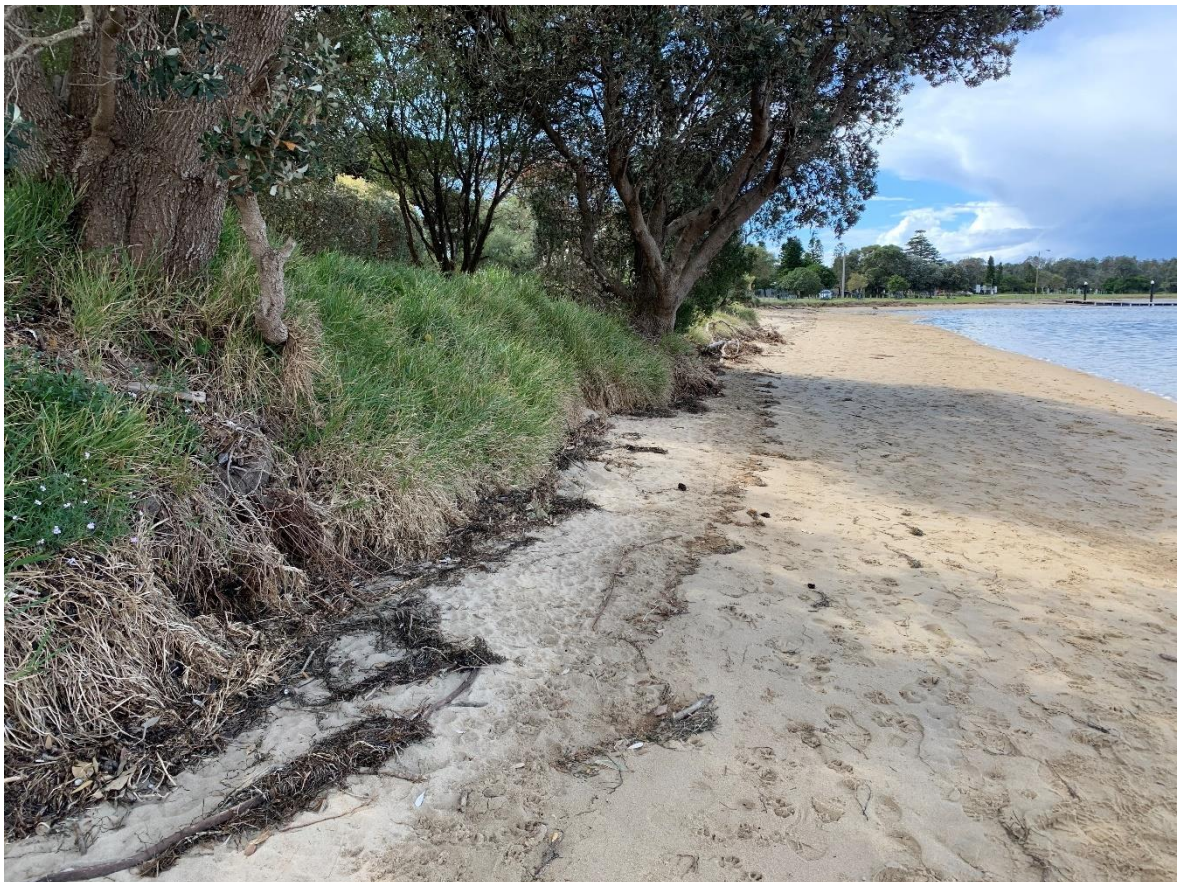
**Figure 3.8 Natural foreshore Ch 800 to 870 m (top) and Ch 840 to 930 m (bottom)**

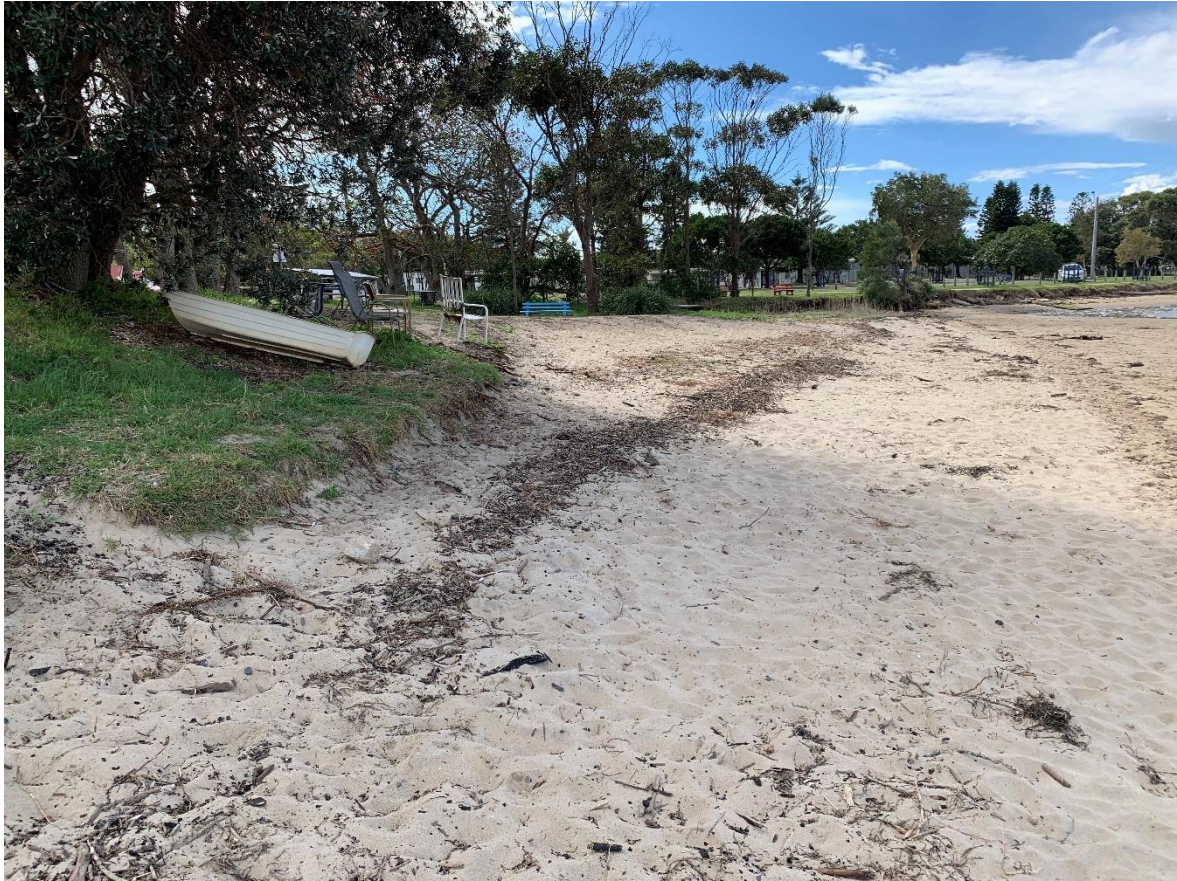
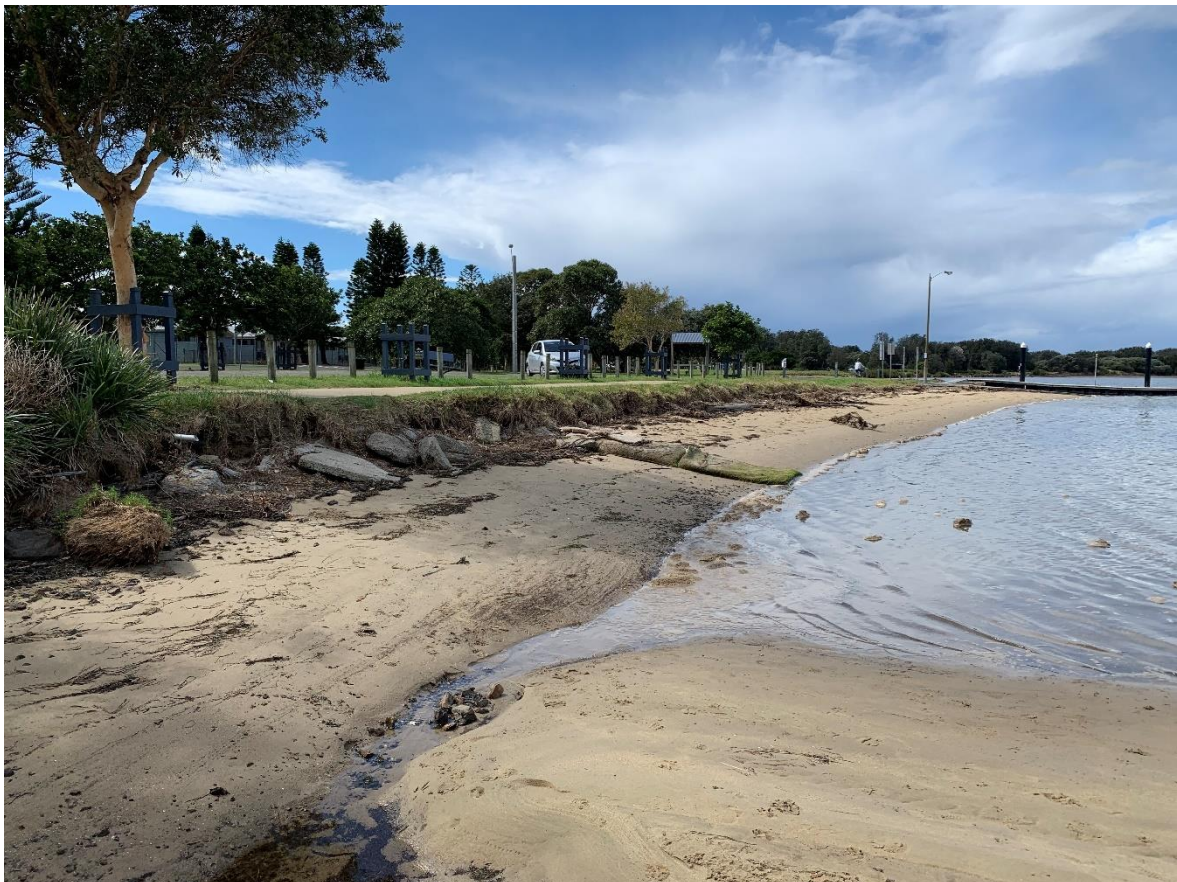
**Figure 3.9 Natural foreshore Ch 920 to 970 m (top) and Ch 980 to 1060 m (bottom)**

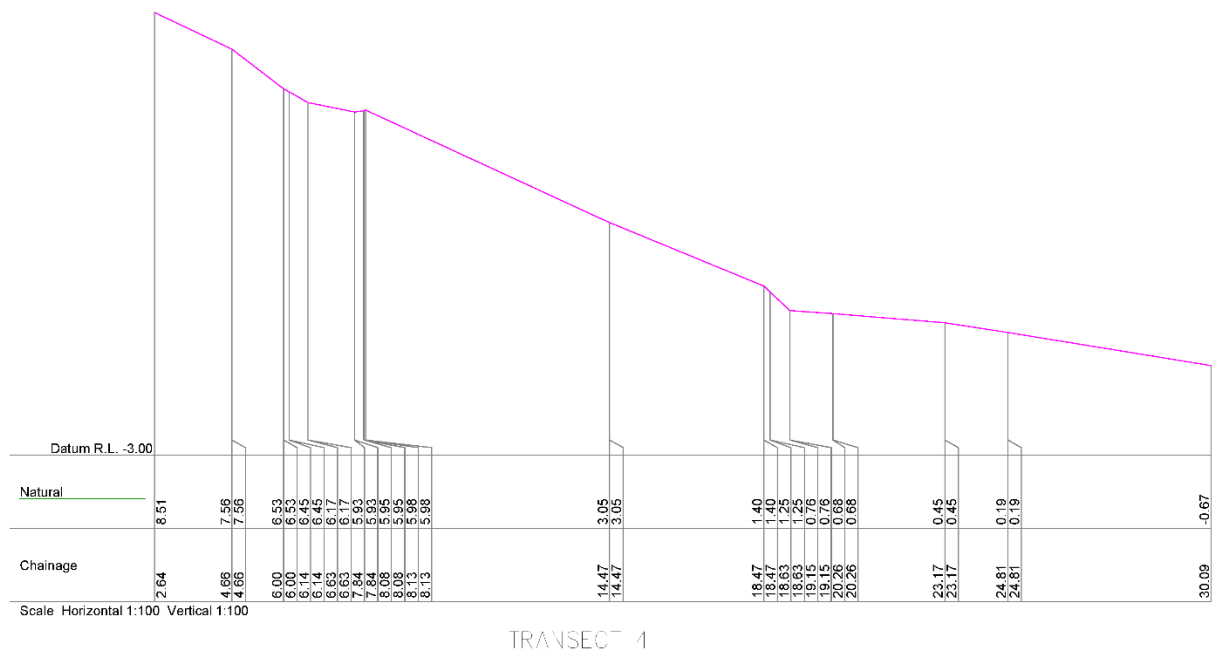
**Figure 3.14 Survey across revetment cross section completed by Council**  
**(Survey Transect 4, Ch 660 m)**

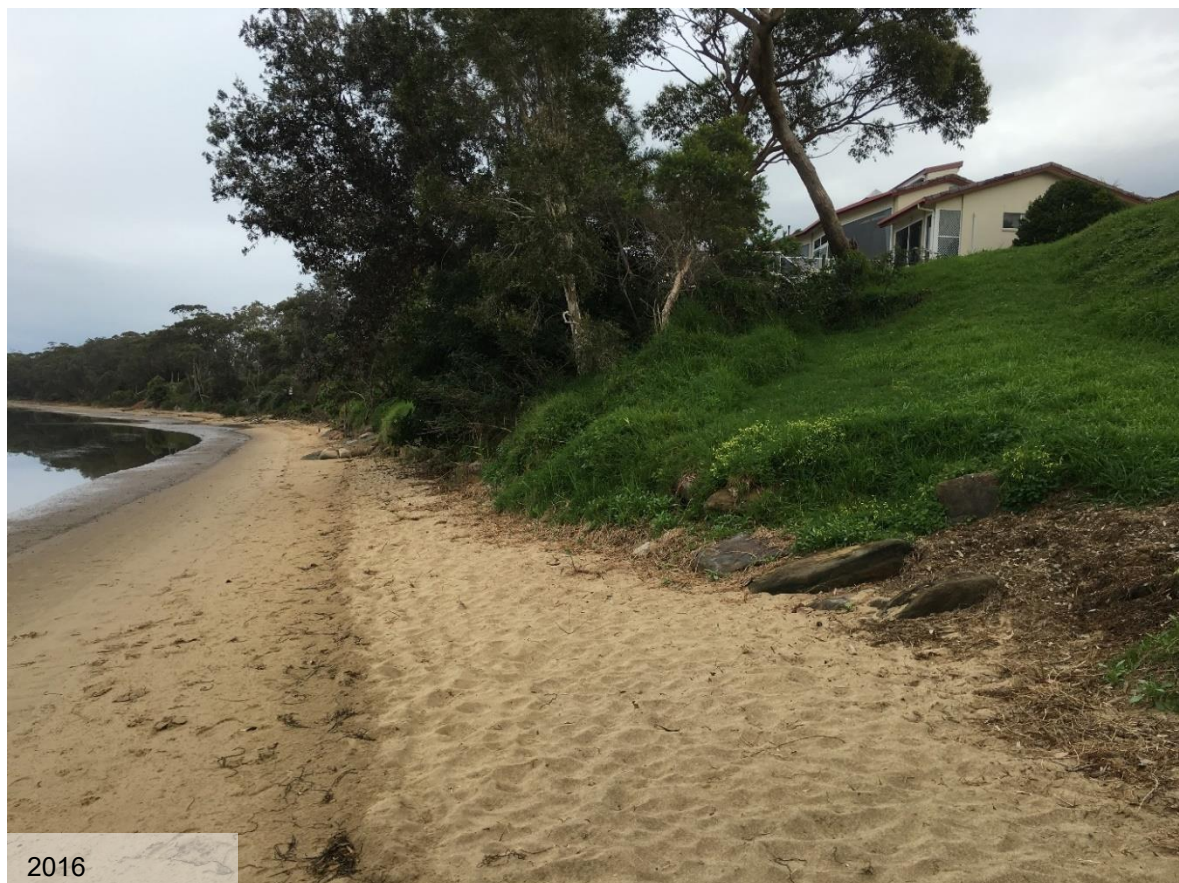
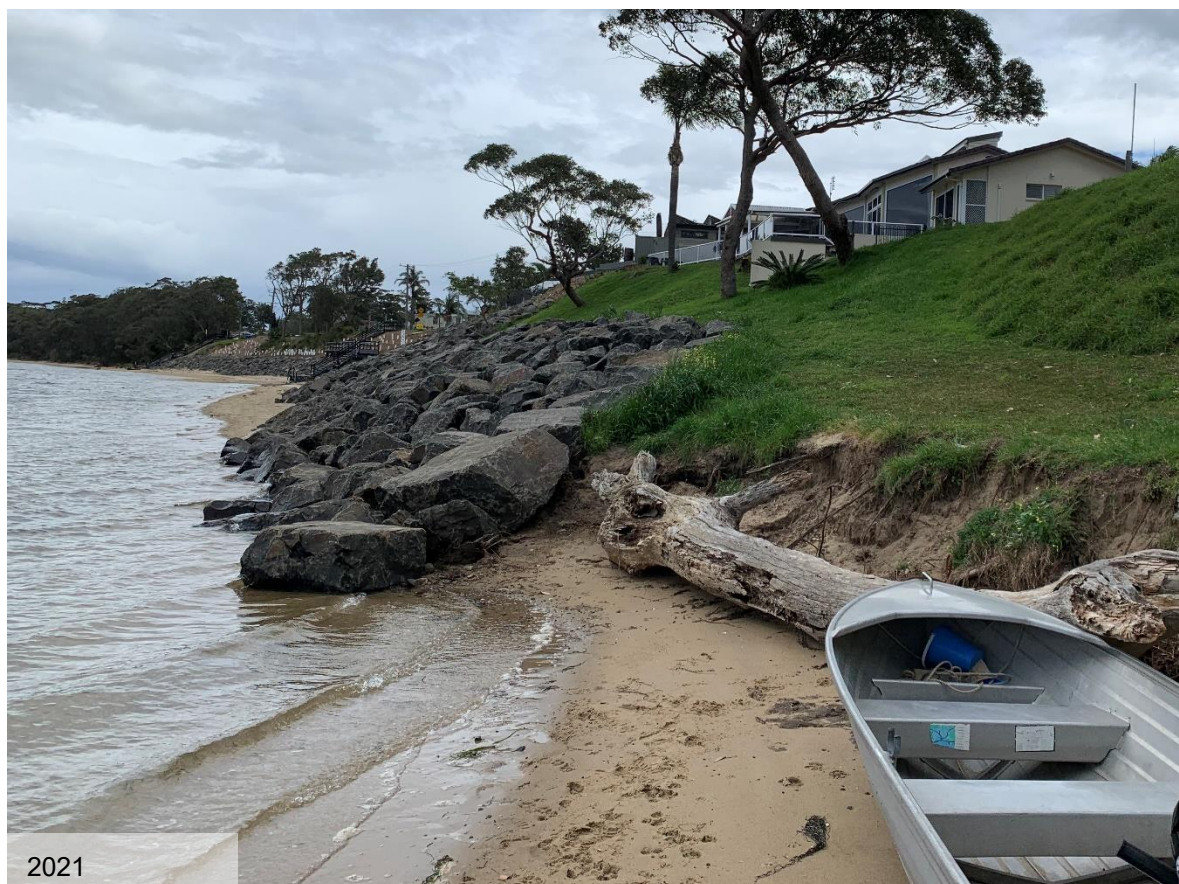
- the area immediately east of the revetment end (Ch 720 to 750 m) appears to have experienced some localised erosion (though this is difficult to quantify from the imagery)
- north of Ch 750 m, the bank defining the back of the beach has not visibly retreated since 2016, with the 2016 erosion scarp still visible at most locations
- between Ch 750 m and Ch 810 m, the level of the beach immediately at the toe of the bank appears to have lowered/eroded slightly (of the order of 100 to 200 mm), evident as slight undercutting of the bank at some localised sections.

**Figure 4.1 Foreshore taken at Ch 730 m, looking at Ch 670 to 730 m**

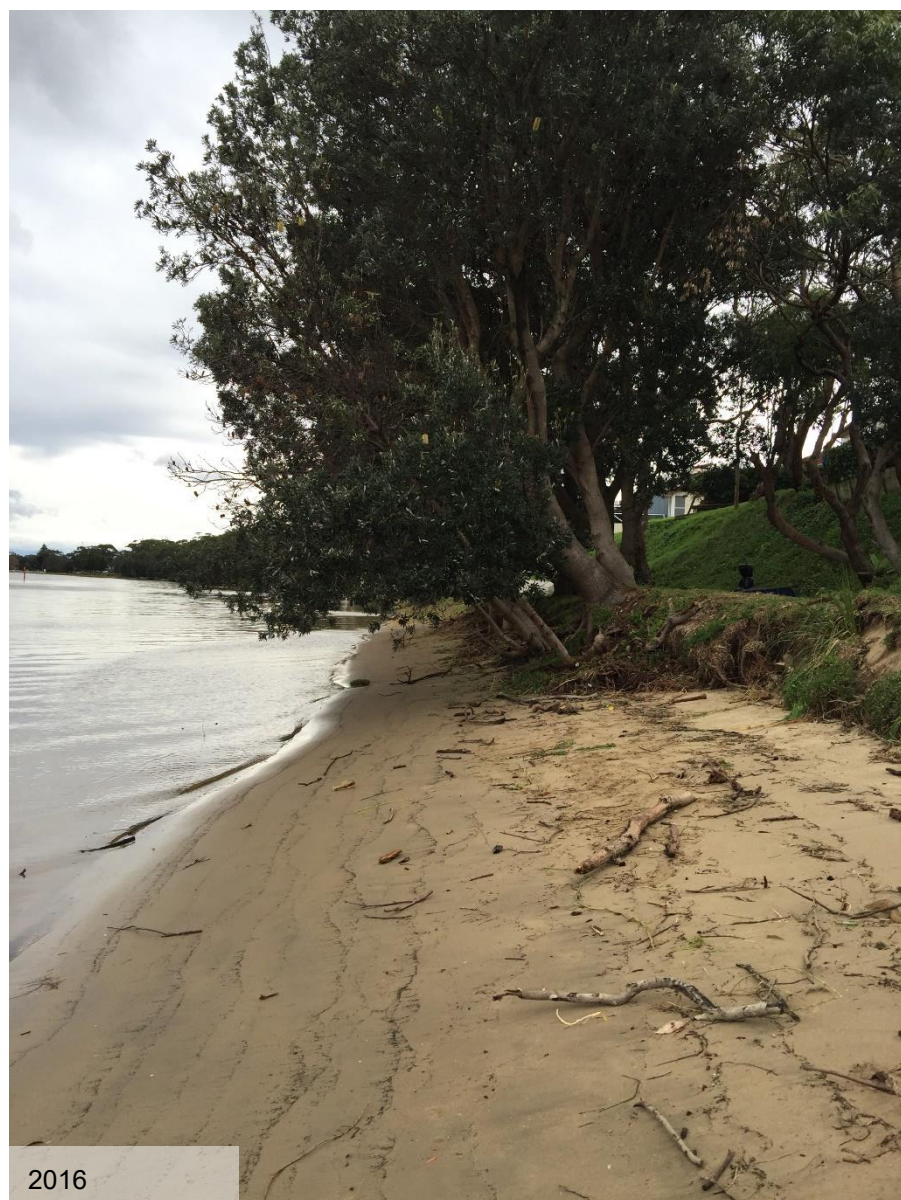
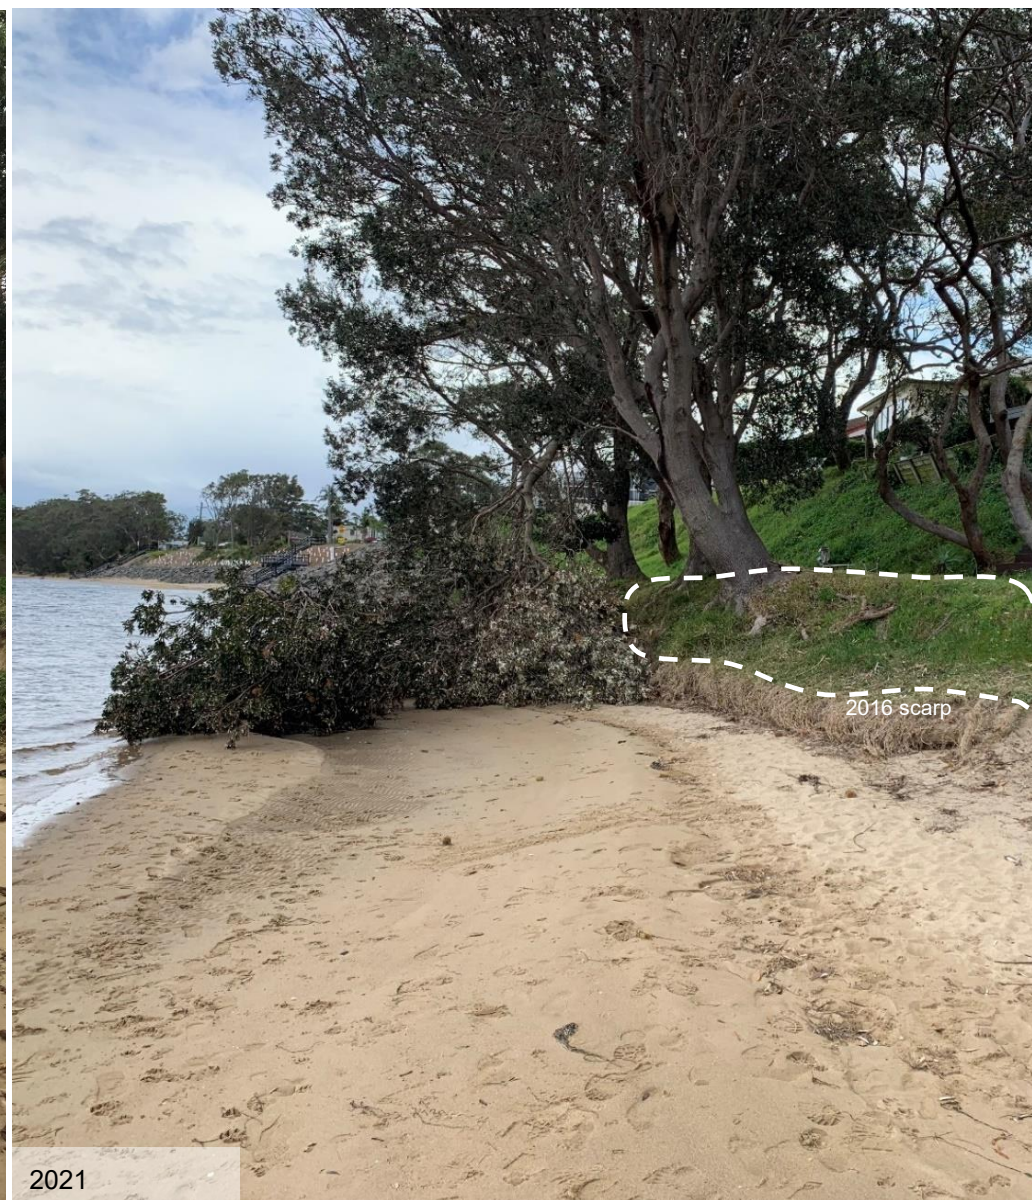
**Figure 4.2 Foreshore taken at Ch 770 m, looking at Ch 750 to 770 m**
