# Coastal Management Advice: 68 - 86 River Road, Shoalhaven Heads

WRL TR 2021/24, February 2022

By M J Blacka

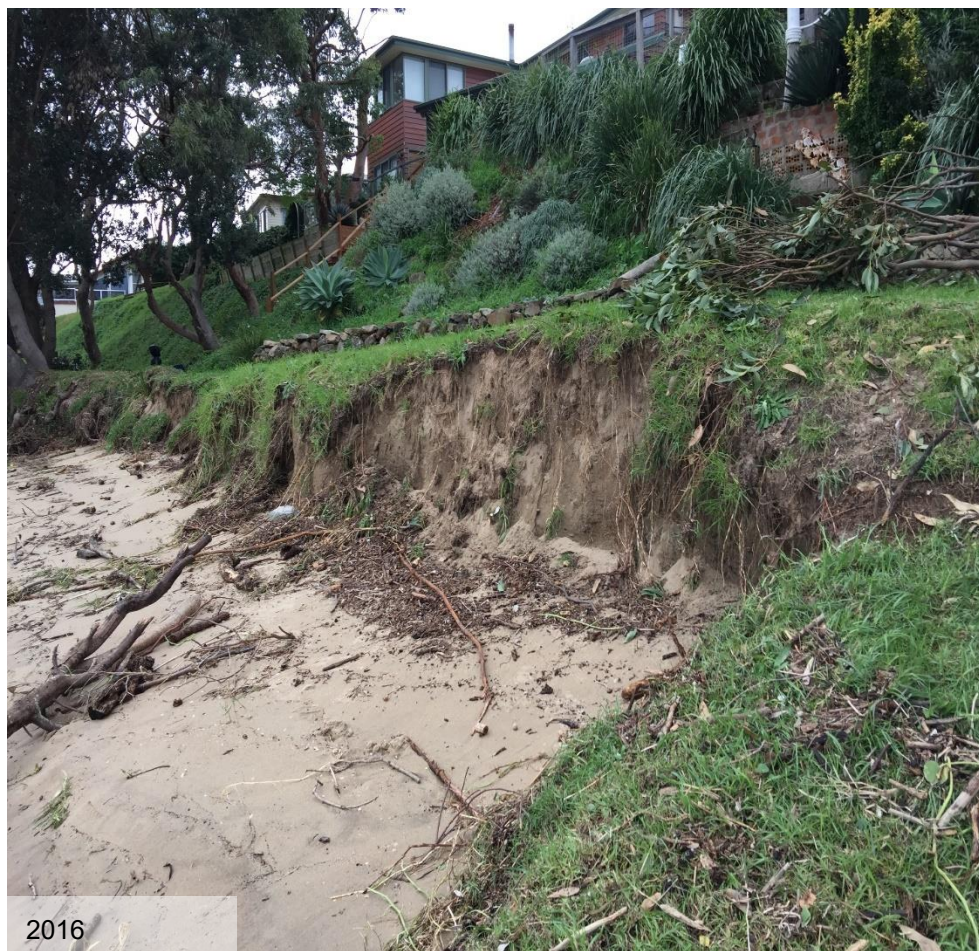
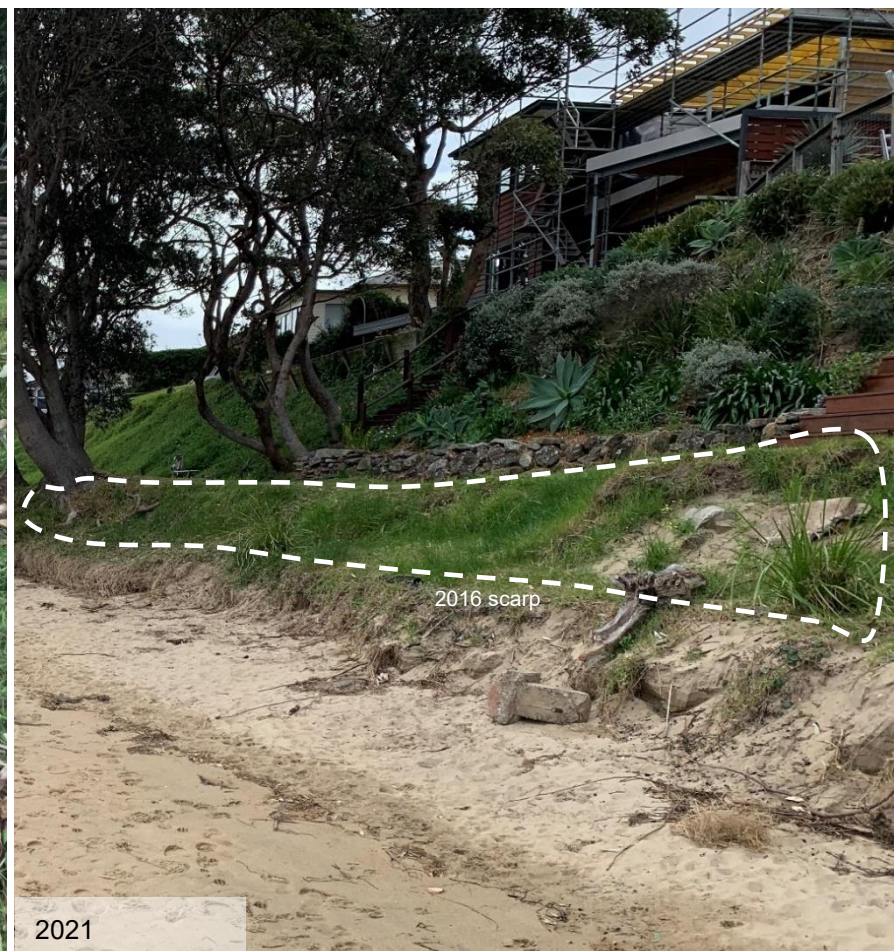
**Figure 4.3 Foreshore taken at Ch 780 m, looking at Ch 750 to 780 m**

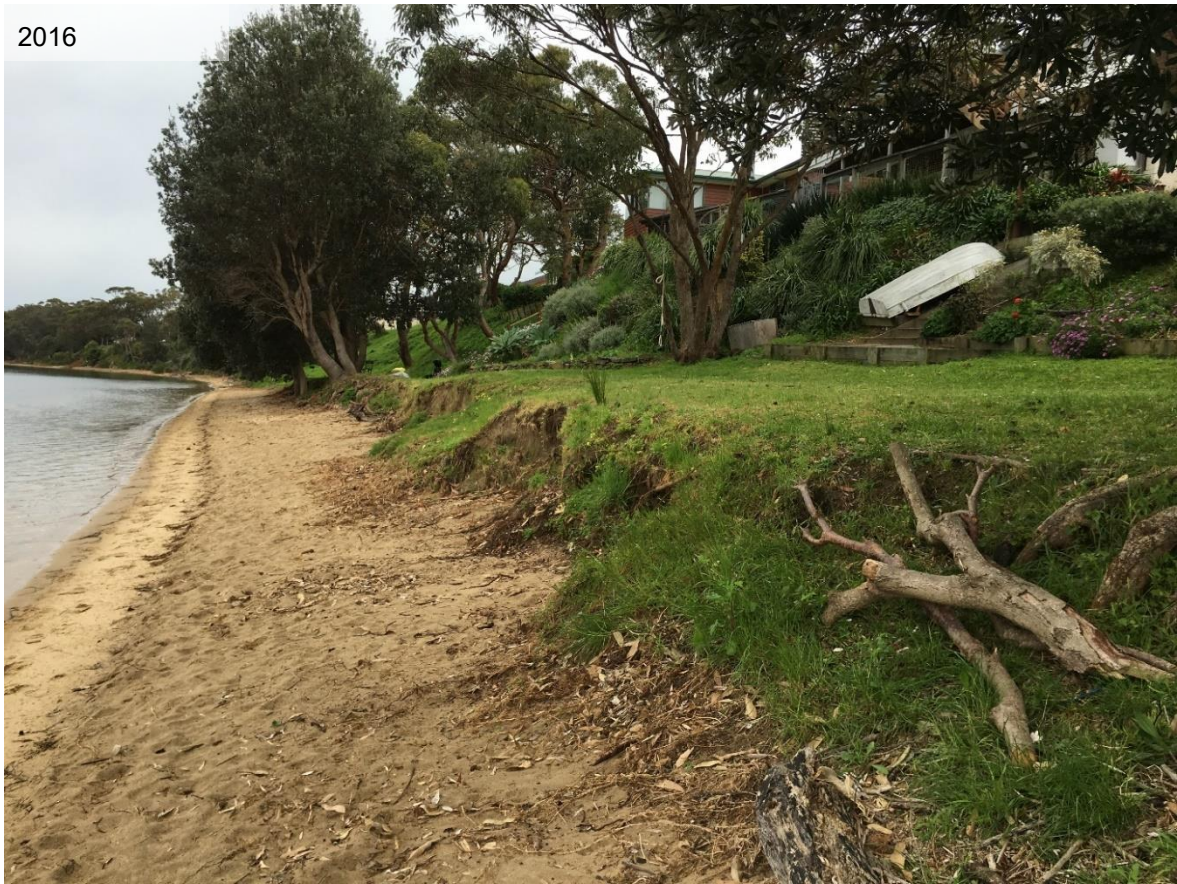
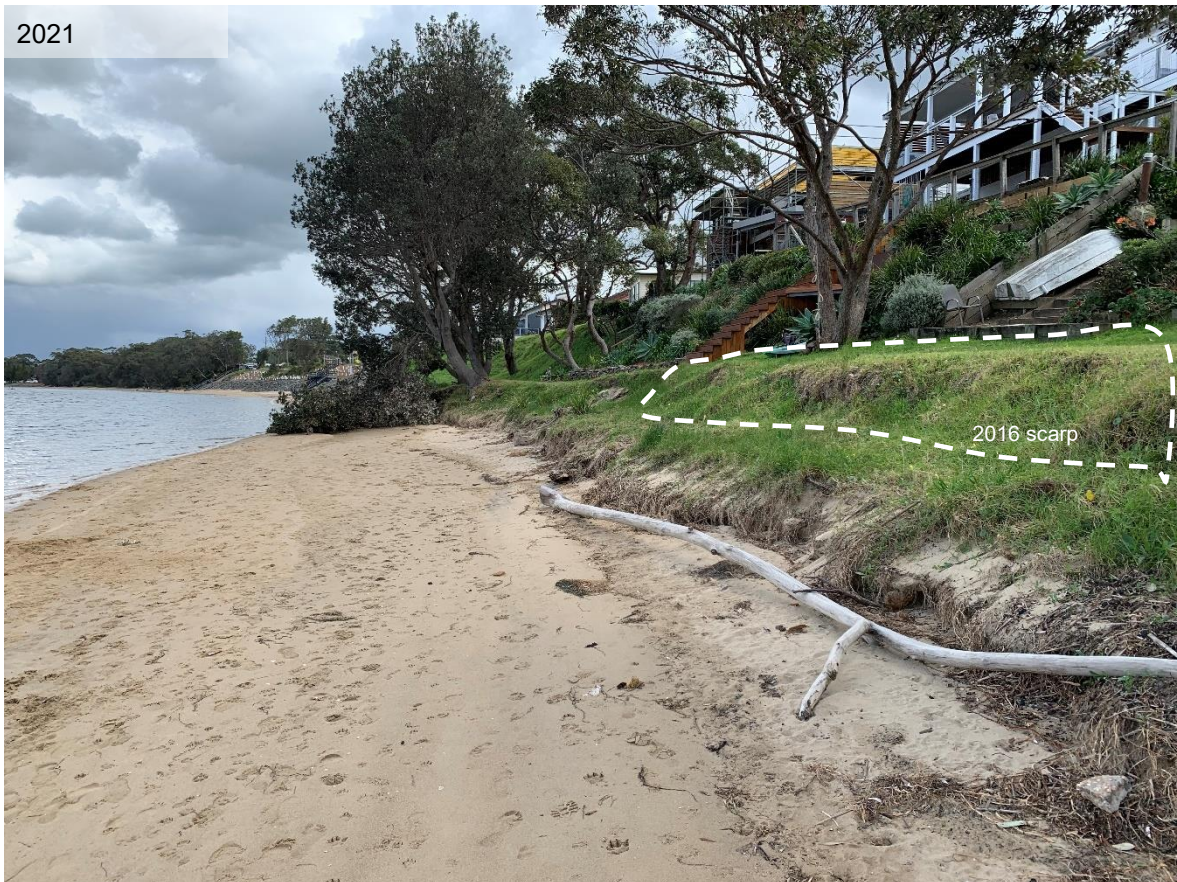
**Figure 4.4 Foreshore taken at Ch 790 m, looking at Ch 740 to 790 m**

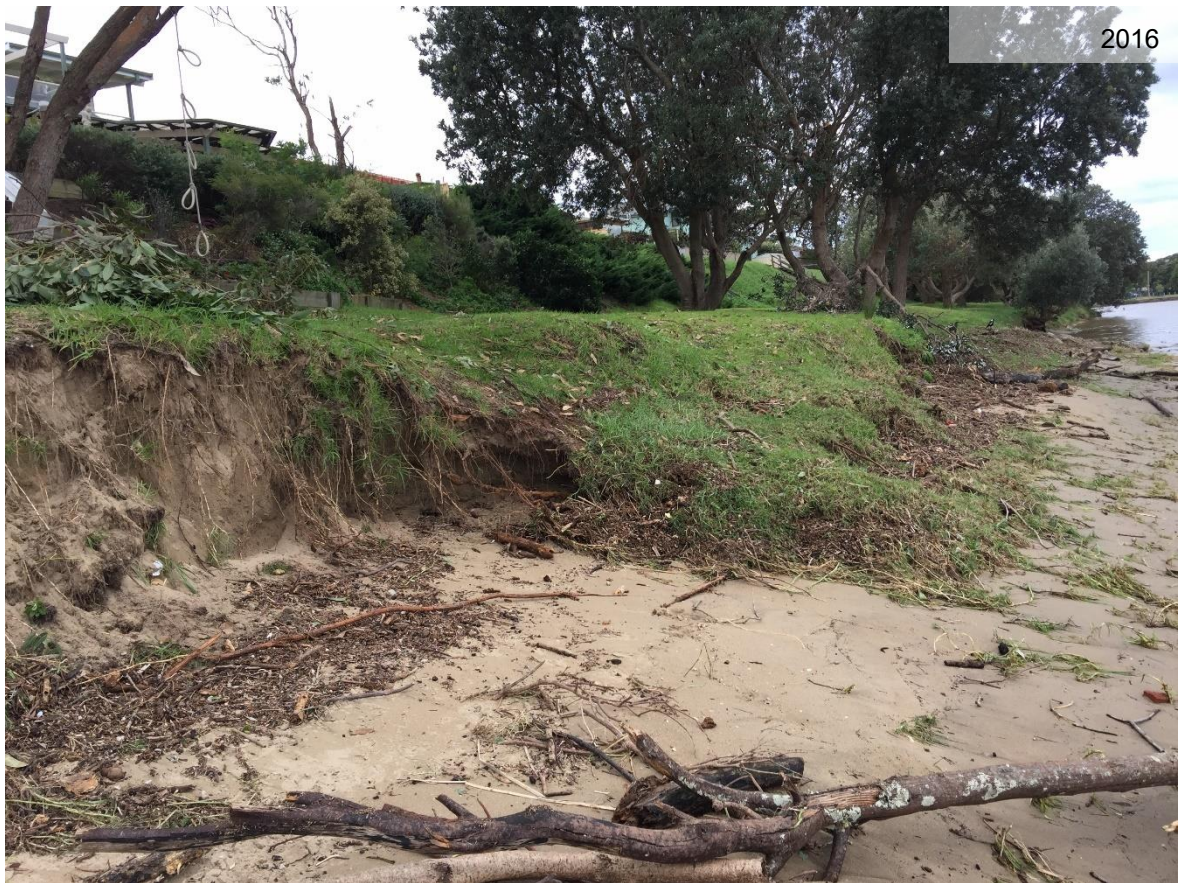
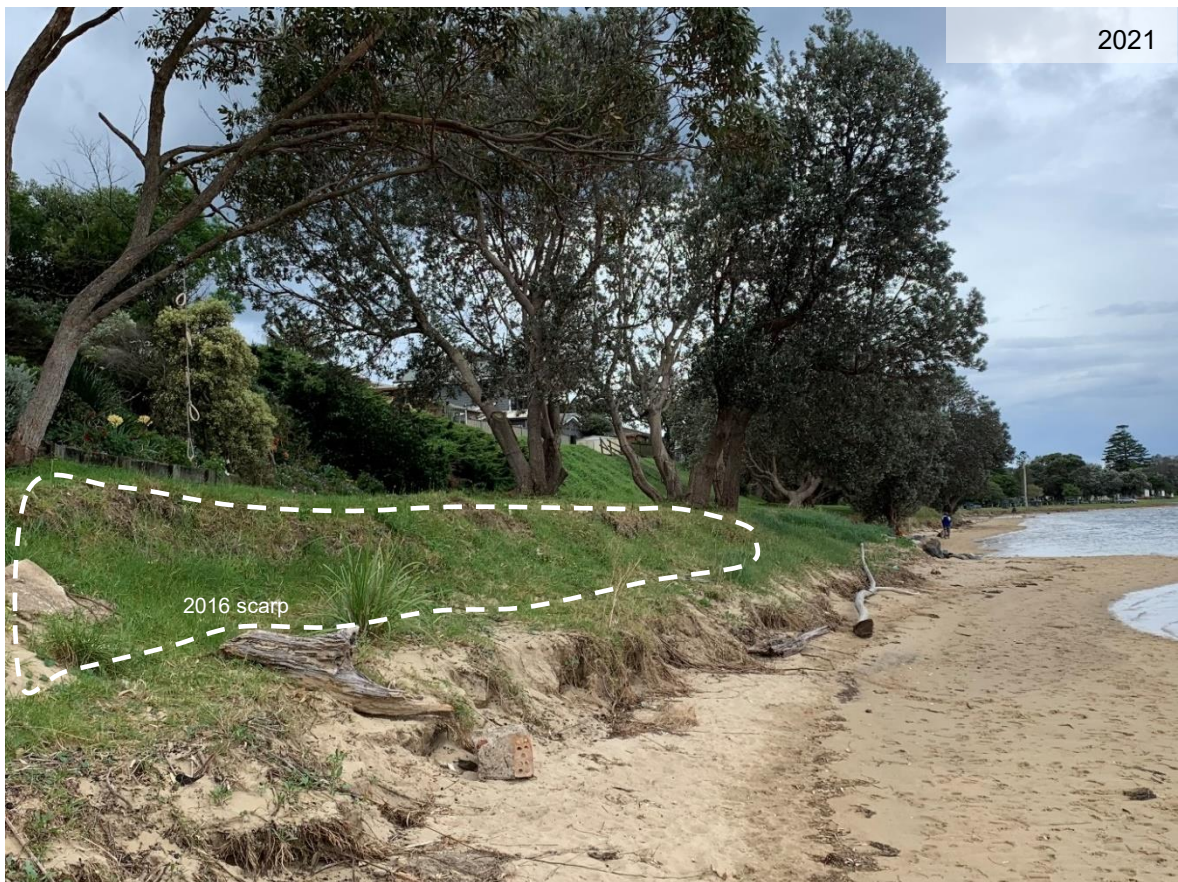
**Figure 4.5 Foreshore taken at Ch 760 m, looking at Ch 760 to 800 m**

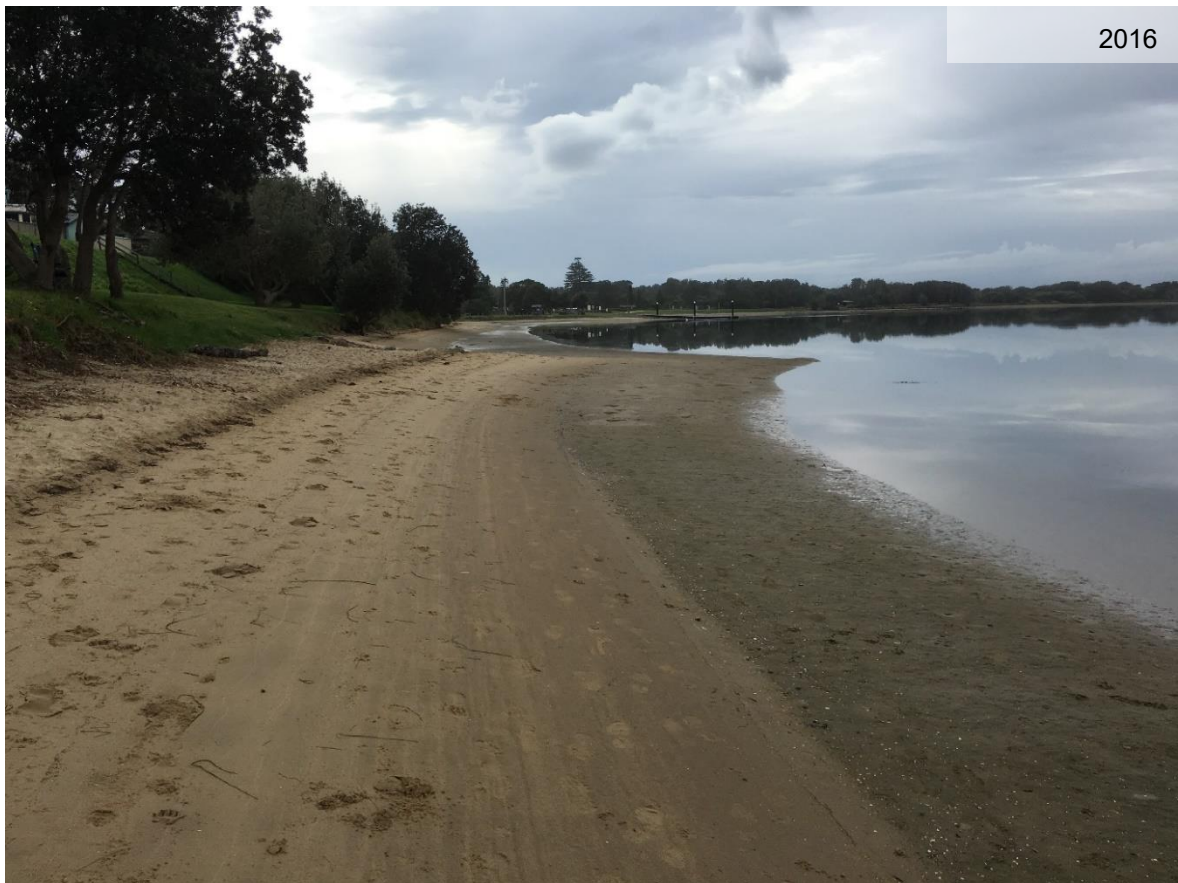
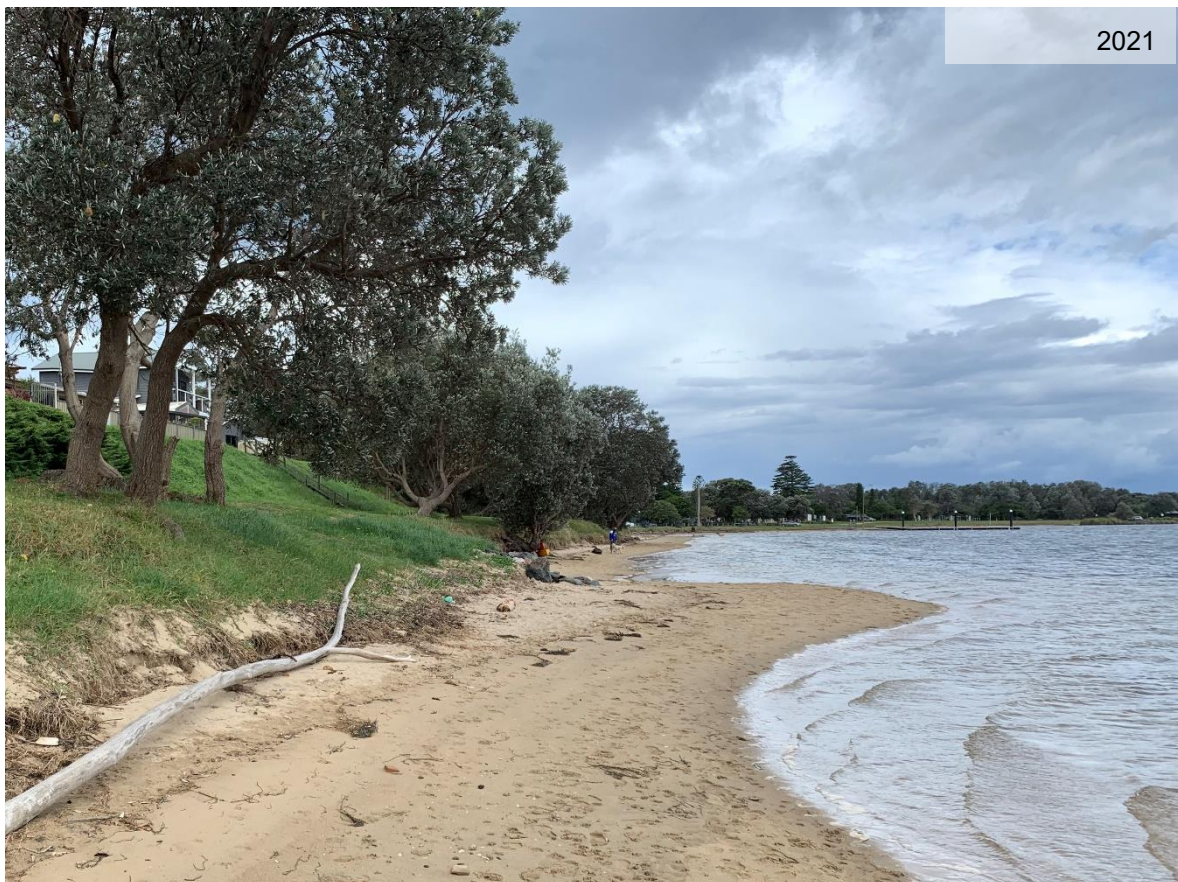
**Figure 4.6 Foreshore taken at Ch 775 m, looking at Ch 775 to 790 m**

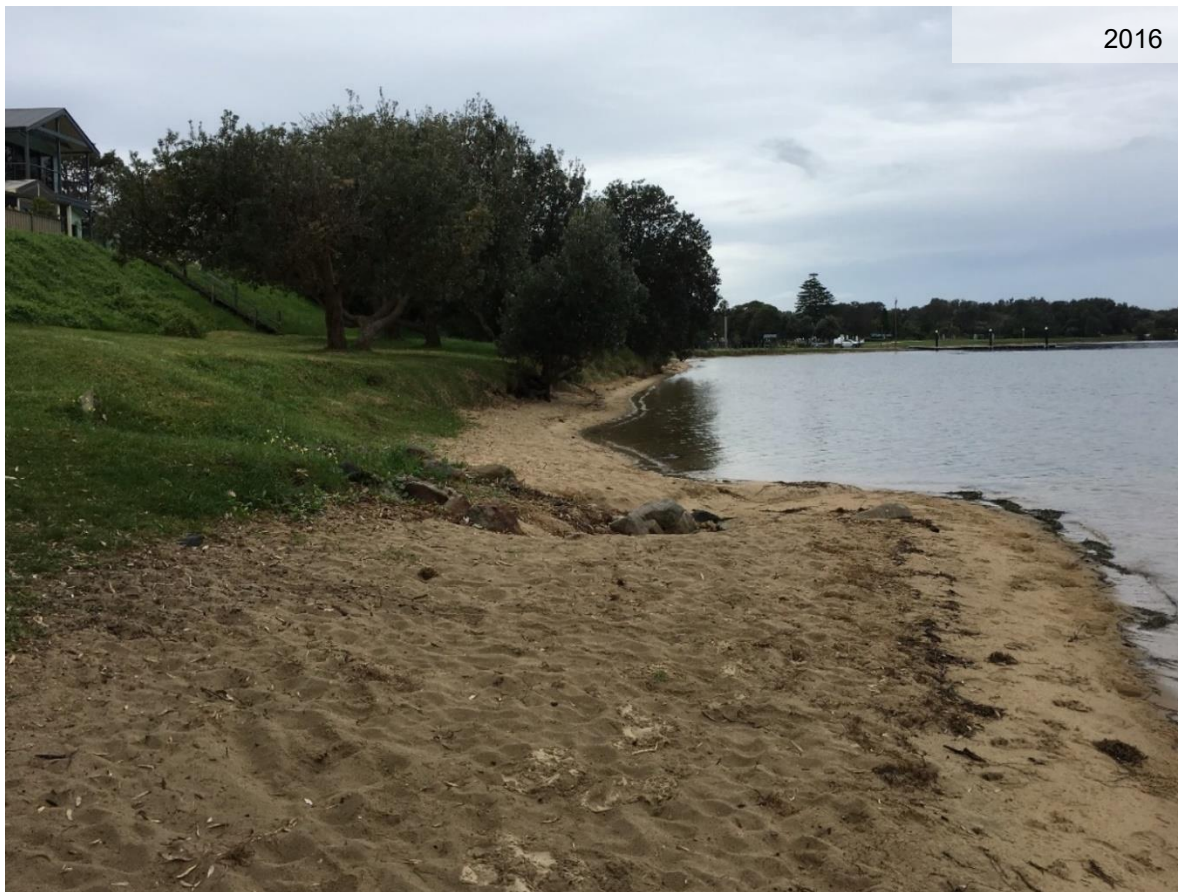
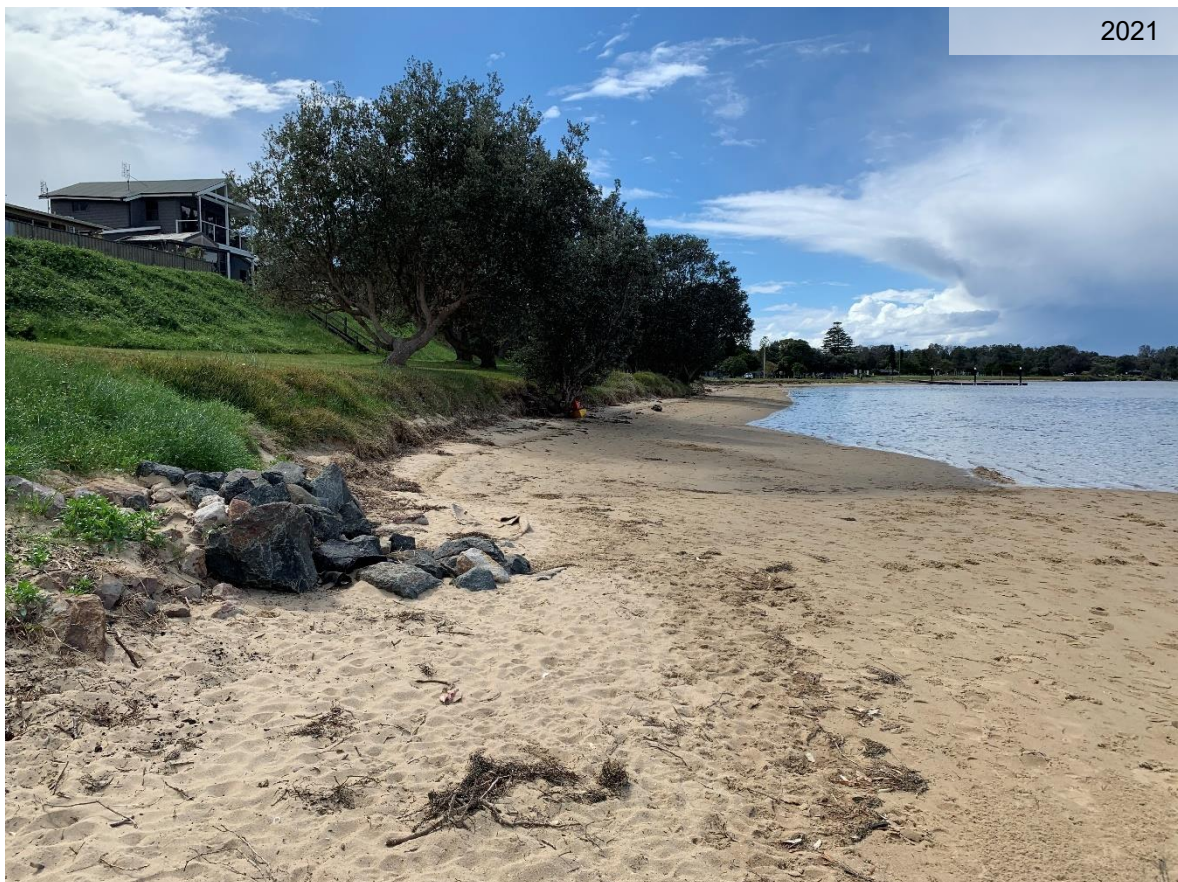
**Figure 4.7 Foreshore taken at Ch 790 m, looking at Ch 790 to 850 m**

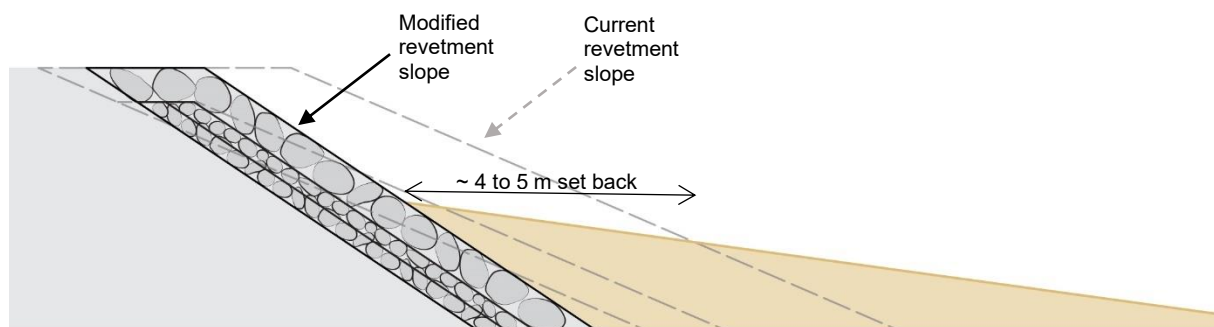
Figure 5.2 shows a schematic to illustrate the comparative difference between the current revetment construction in this area (as measured by Council's profile survey in October 2021), with the modified single layer design proposed by WRL. The modified structure will occupy approximately 4 to 5 m less beach width, and therefore have an alignment much closer to that recommended in Magryn's original design, as well as the alignment of the natural bank east of the revetment. This improved alignment will help to reduce scouring and end effects of the revetment on the adjacent stretch of beach, in particular with additional sand nourishment to raise the level of the beach against the revetment toe.

**Figure 5.2 Comparison of current revetment and modified design for Ch 680 to Ch 720 m**

To implement the proposed design would require removal of primary and secondary armour, removal of geotextile underlayer, and reshaping of the embankment behind the revetment to form the correct slope and alignment, followed by replacing of the geotextile and armouring. It is envisaged that this modification would happen sequentially (i.e. stripping and rebuilding ~10 m sections of the structure at a time). During this process it may be possible to retain and re-use the existing geotextile if it is not damaged, as the modified design has a reduced geotextile coverage area.
