Ref:21031-Struct-Certificate-B.doc

13-July-2022

**RE: No.134 MOOREFIELD ROAD, KINGSGROVE NSW
CONVERT OLD GARAGE TO A RUMPUS ROOM / GYM
STRUCTURAL ADEQUACY CERTIFICATE
FOR DEVELOPMENT APPLICATION**

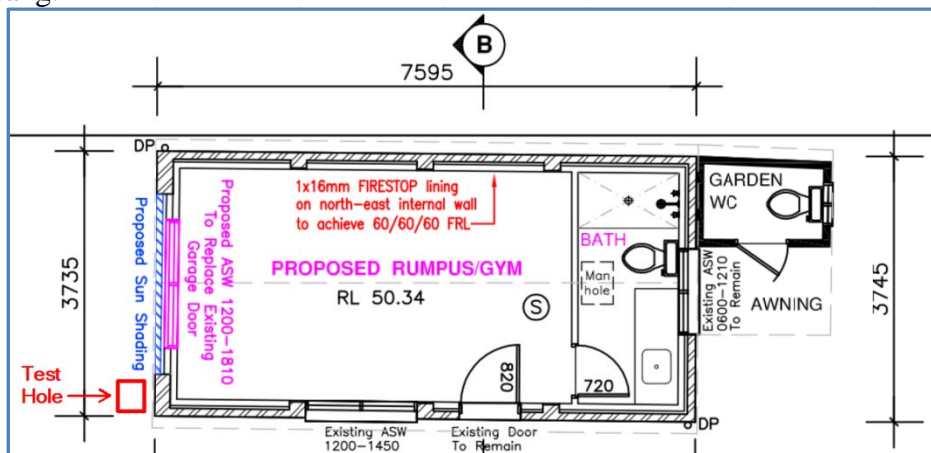
A test hole (location shown on Fig1.0) was excavated to expose the existing footing under the north-west wall. The brick footing is more than 400mm in depth and 300mm wide, and is in a good condition. Please see **Photo 1**.

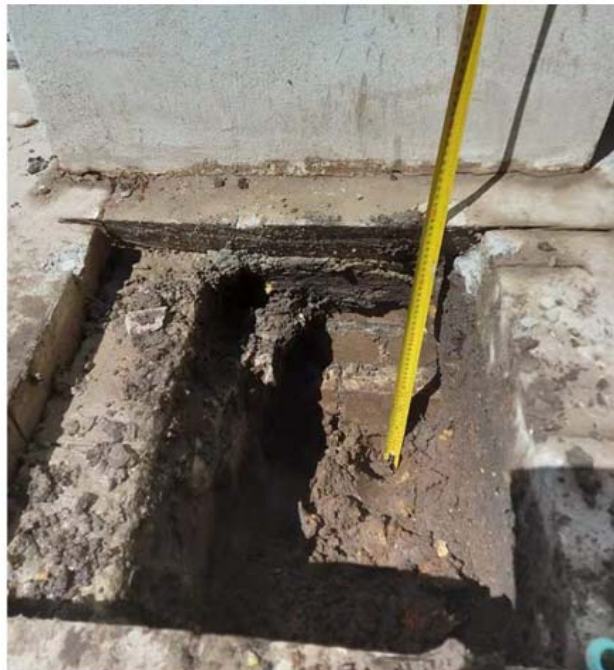
Photo 1.
Exposed original
brick footing in
good condition

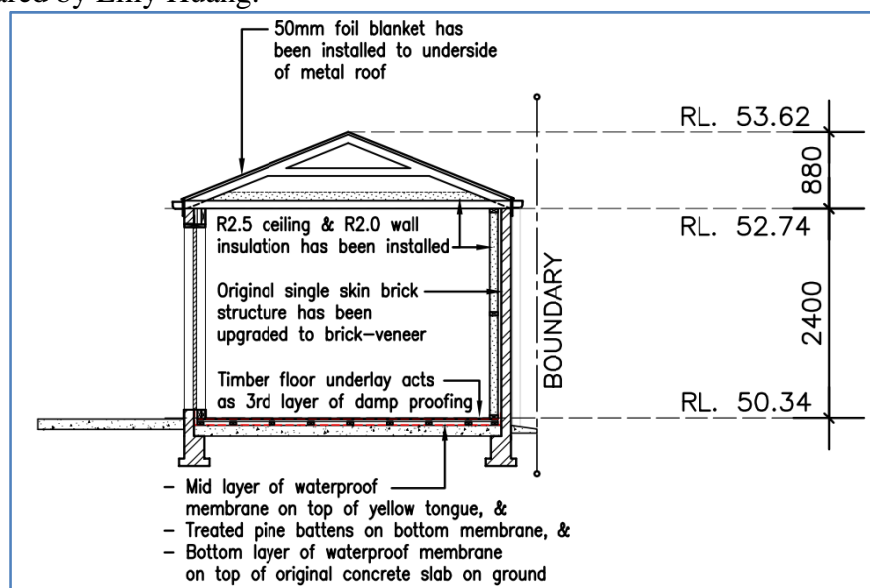
Fig 2.0

Based on our observation during site investigation, we confirm that the actual works of waterproof to slab/floor of the proposed Rumpus/gym are consistent with the details drawn on Section B-B (Fig.2.0) of the Architectural Plans dated 31/05/2022 prepared by Lilly Huang.

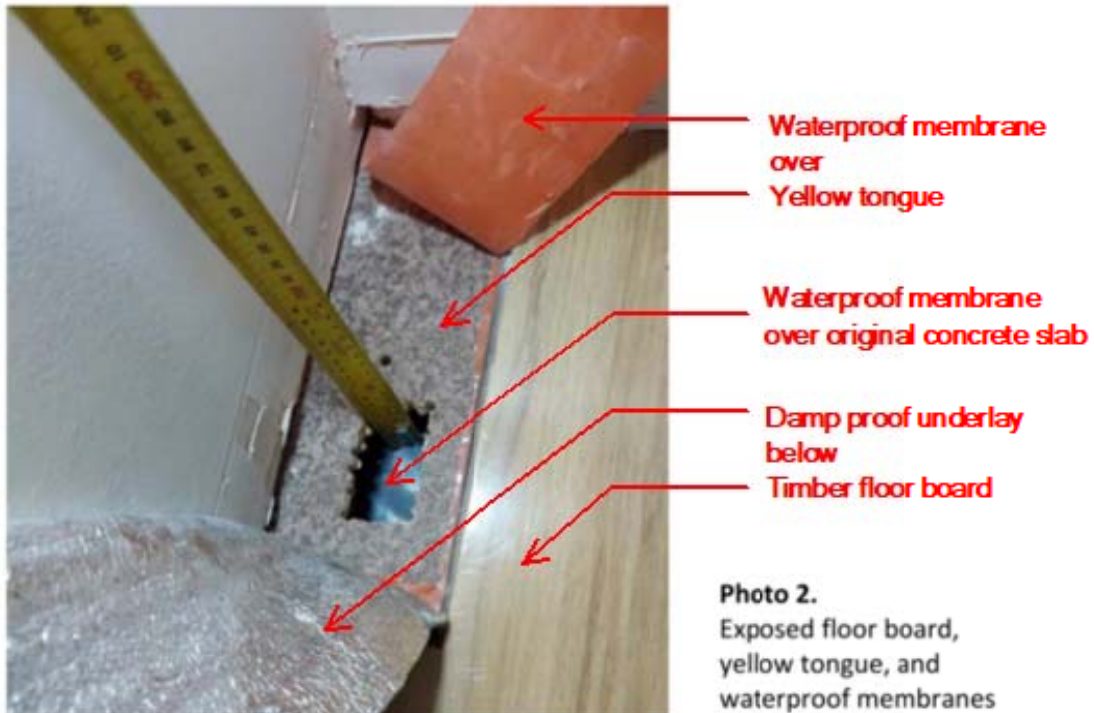
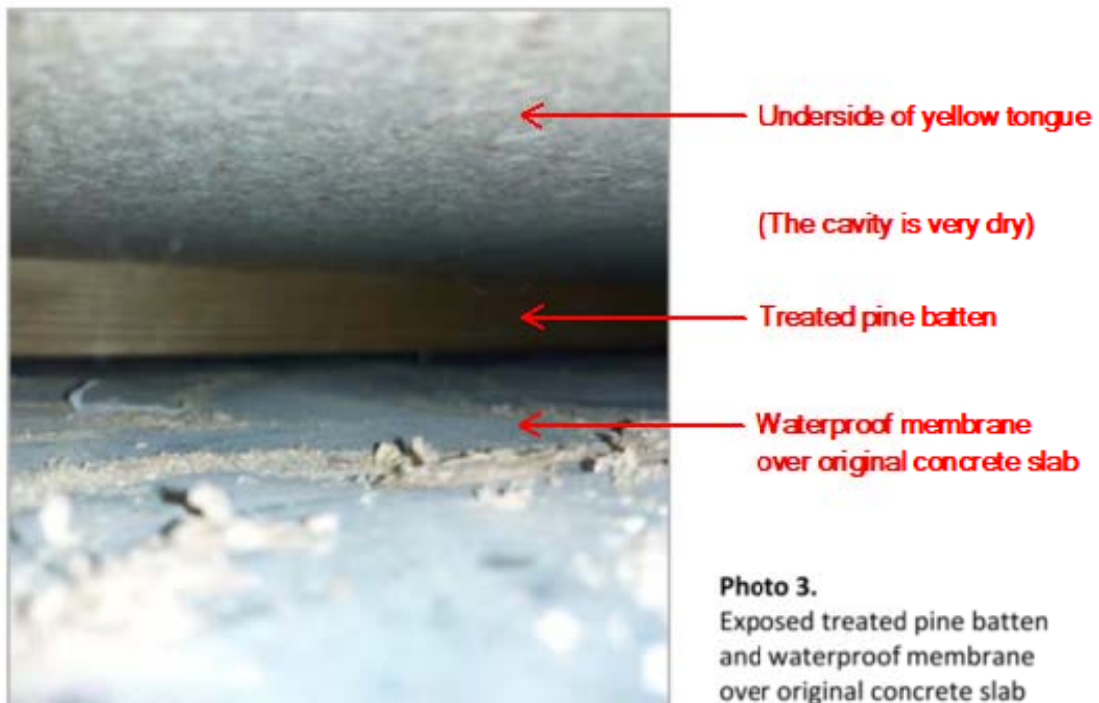
- First (bottom) layer of waterproof membrane (black) on top of original concrete slab on ground; and
- Treated pine battens on waterproof membrane; and
- Yellow tongue on battens (the cavity is very dry); and

- Second (mid) layer of waterproof membrane (orange) on top of yellow tongue; and
 - Third (top) layer of damp proofing (silver) is the timber floor underlay.
- Please see **Photo 2&3**.

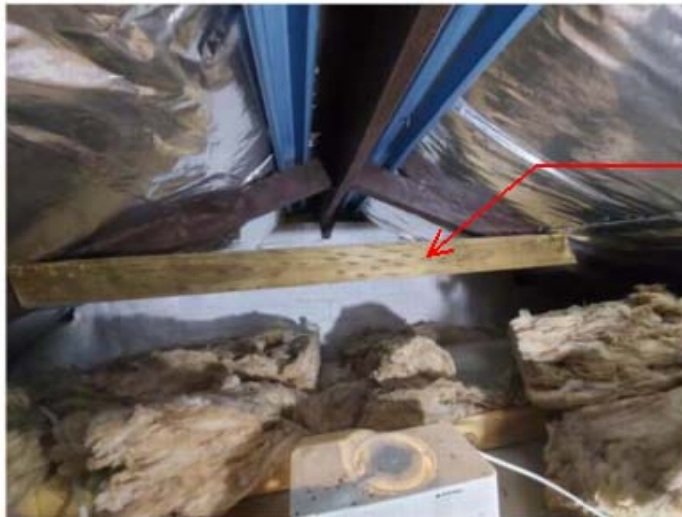
Added pine collar tie

Investigation of roof structure was done through the manhole which is located in the bathroom. Based on our observation at the time, we noticed that the original hardwood rafters, ridge board and ceiling joists remain unchanged whilst strut and collar ties have been added.

Photo 4.
Extra pine collar ties fixed
between original rafters

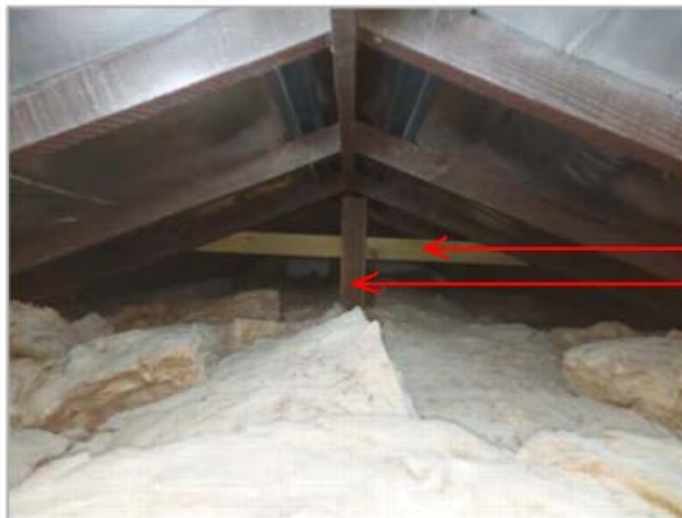
Added collar tie
& strut

Photo 5.
Extra strut under
original ridge board

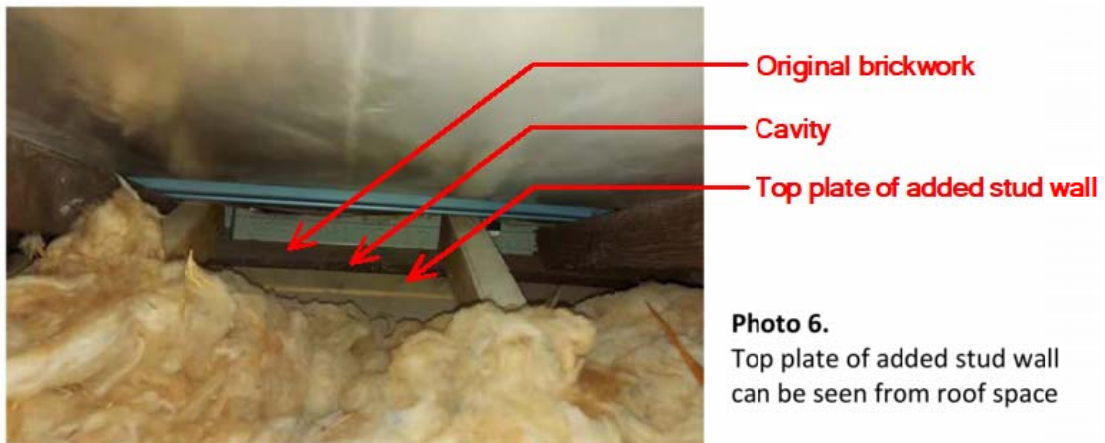
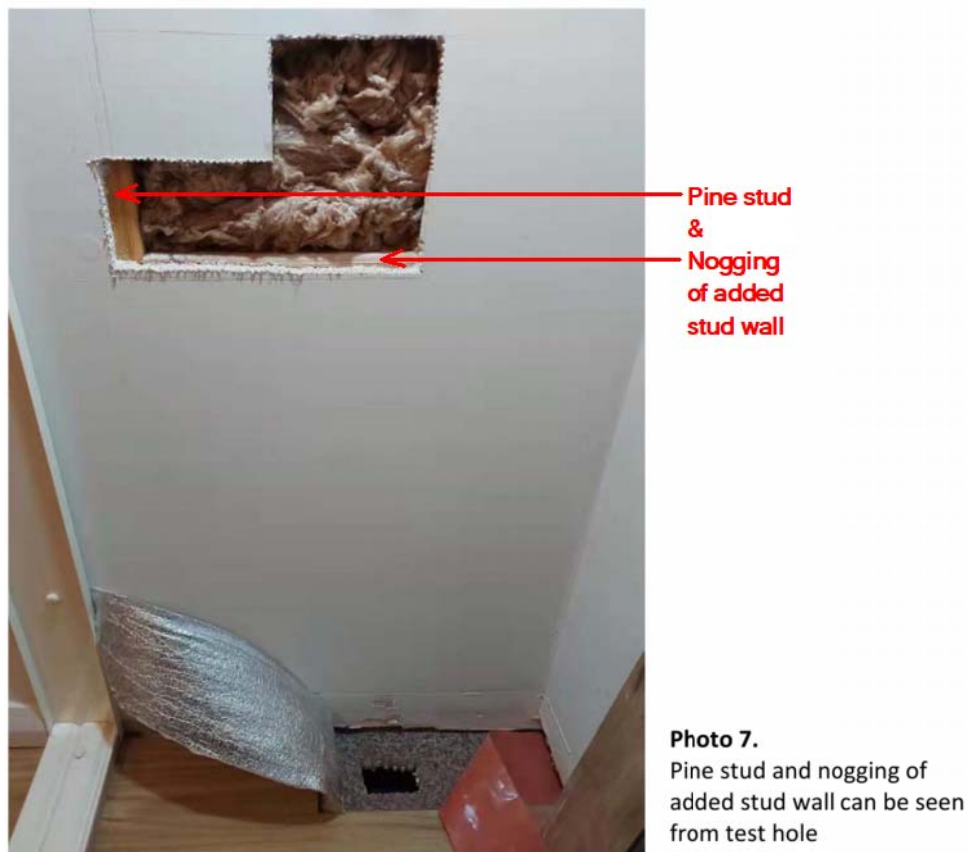
The original single skin brick structure has been converted to brick veneer. The top plate of the added wall framing can be seen from the roof space. Pine stud and nogging can be seen from the test hole. In our opinion the added timber wall framing is non-loaded bearing. Please see **Photo 6&7**.
