# **Proposed Alpine Coaster Thredbo NSW**

## **Geotechnical Investigation**

Our ref: 5920-G1 Rev 3  
11 August 2022

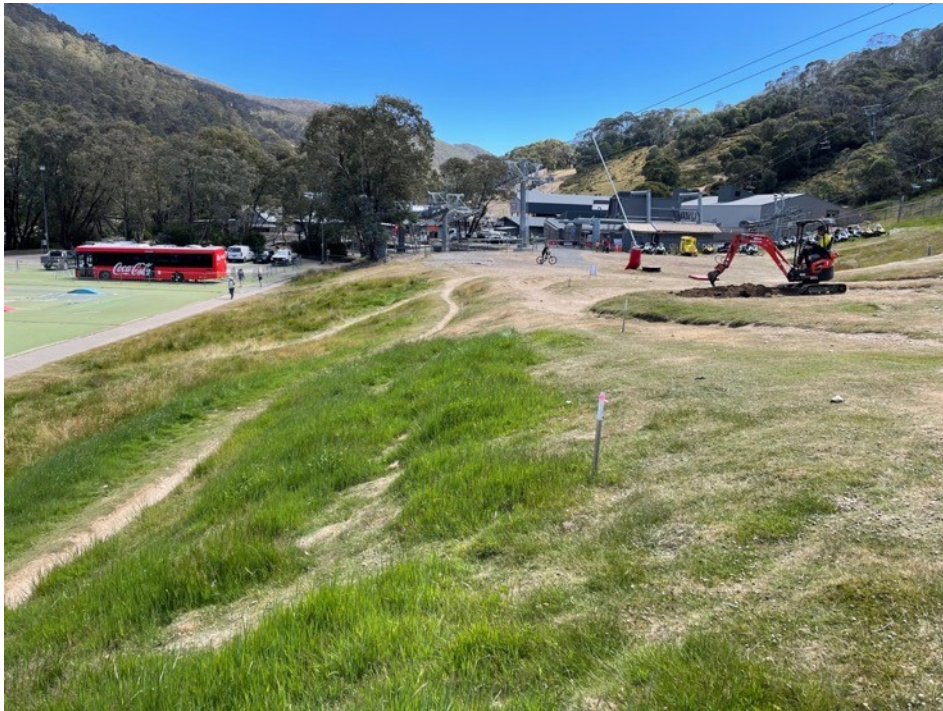
**Photo 1**  
North east of exit  
area, looking  
southwest towards  
circle construction

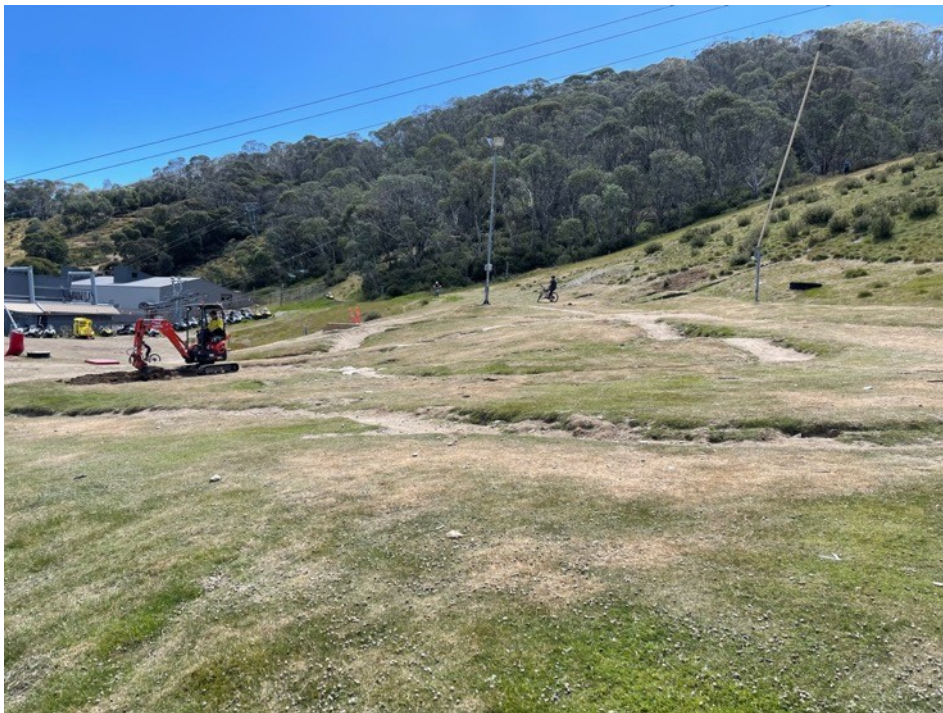
**Photo 2**  
From Photo 1  
location looking west

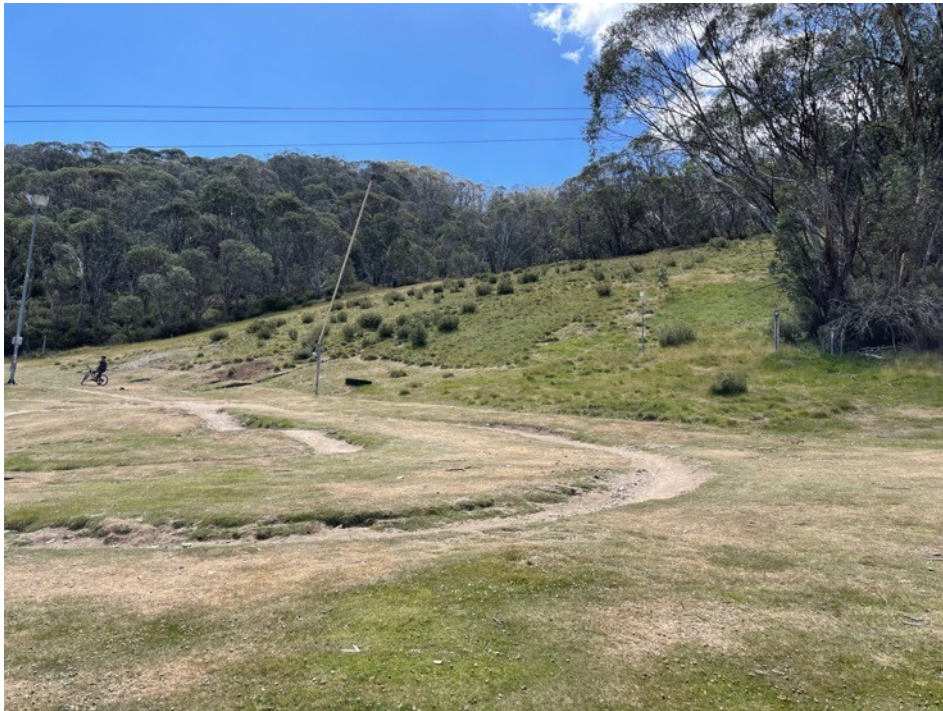
**Photo 3**  
From Photo 1  
location looking  
northwest

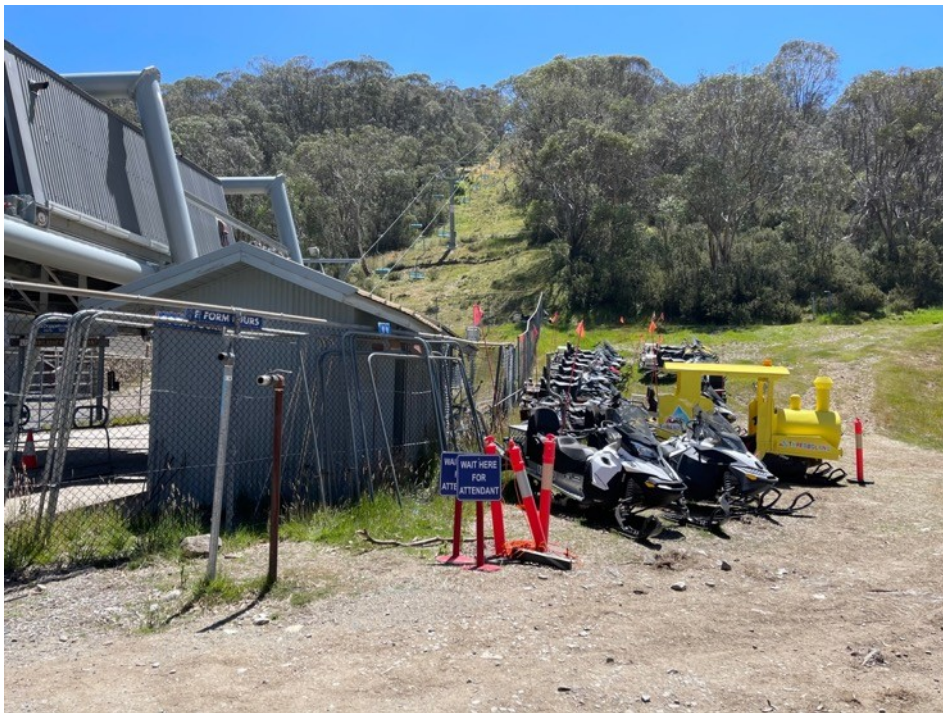
**Photo 4**  
View from tunnel  
location looking  
upslope to northwest

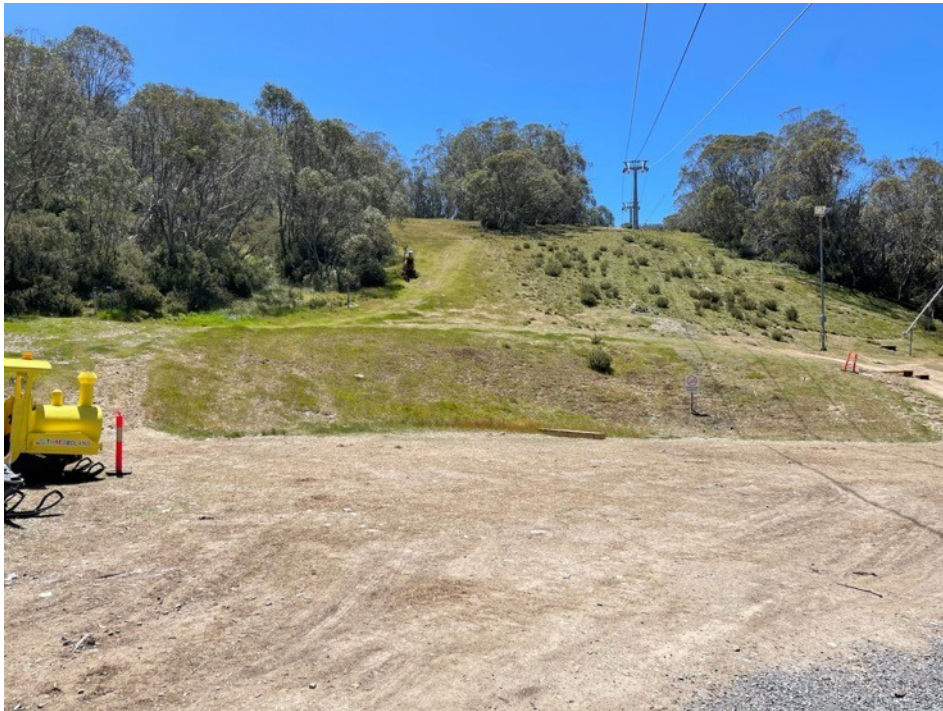
**Photo 5**  
View from Photo 4  
location looking north

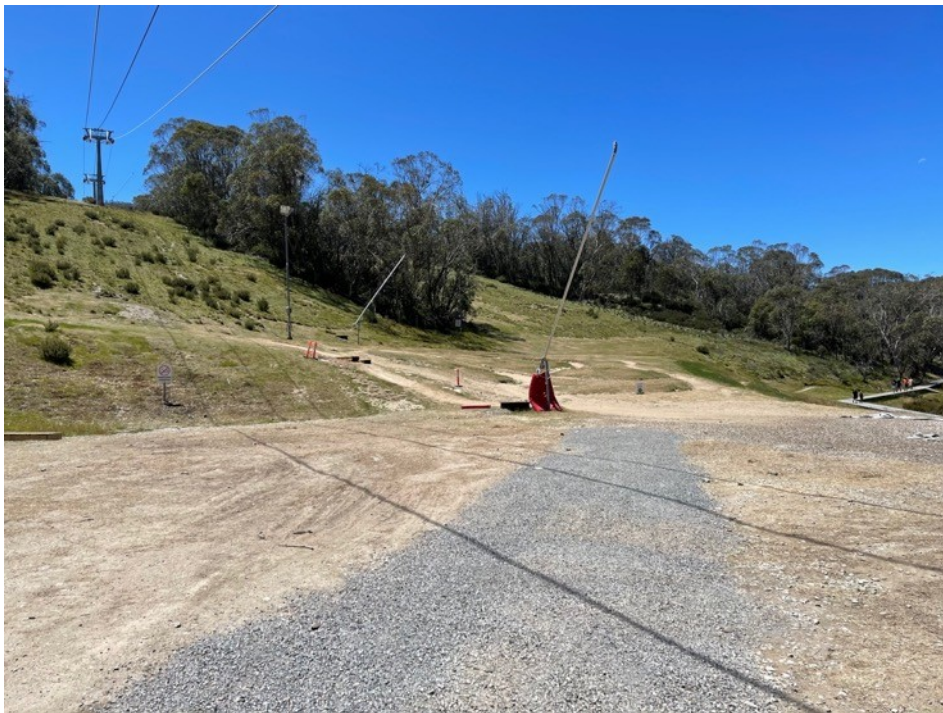
**Photo 6**  
View from Photo 4  
location looking  
northeast

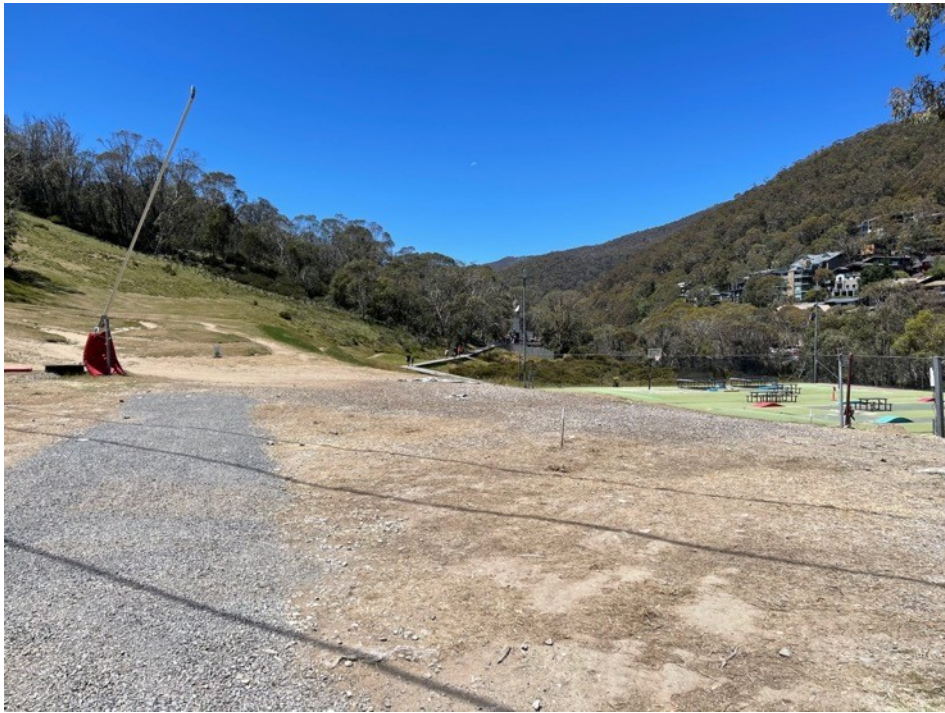
**Photo 7**  
View from Photo 4  
location looking east

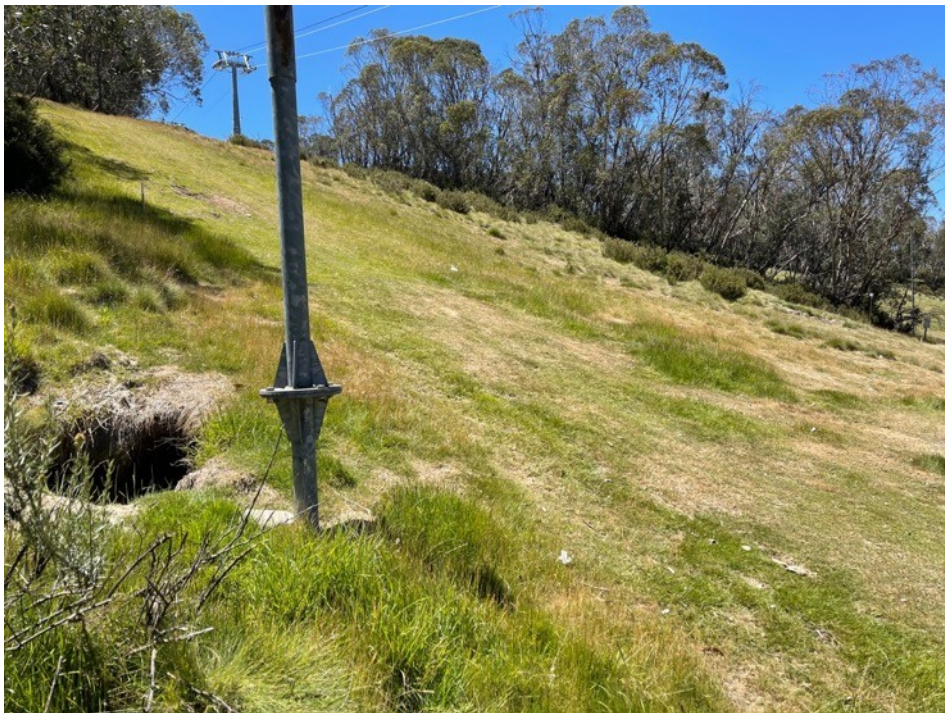
**Photo 8**  
View near TP13  
location looking north

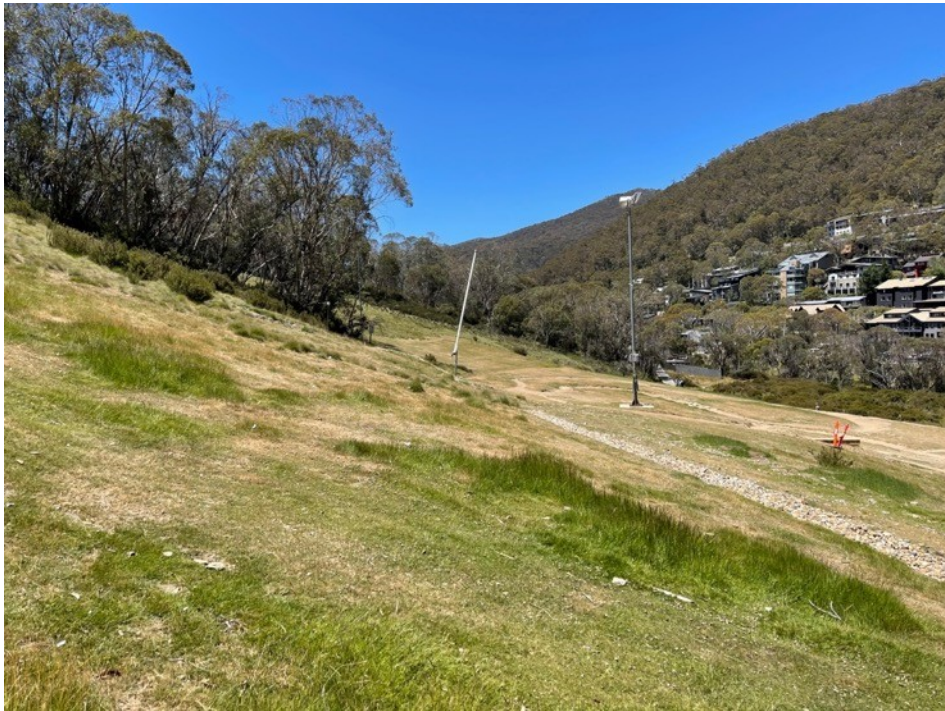
**Photo 9**  
View near TP13  
location looking east

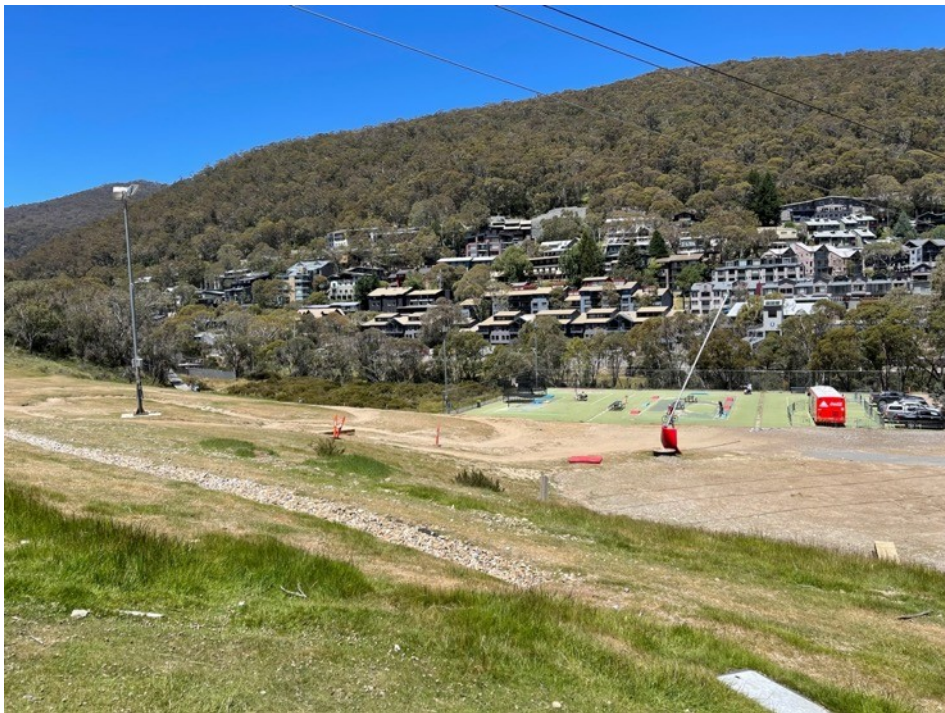
**Photo 10**  
View near TP13  
location looking  
southeast

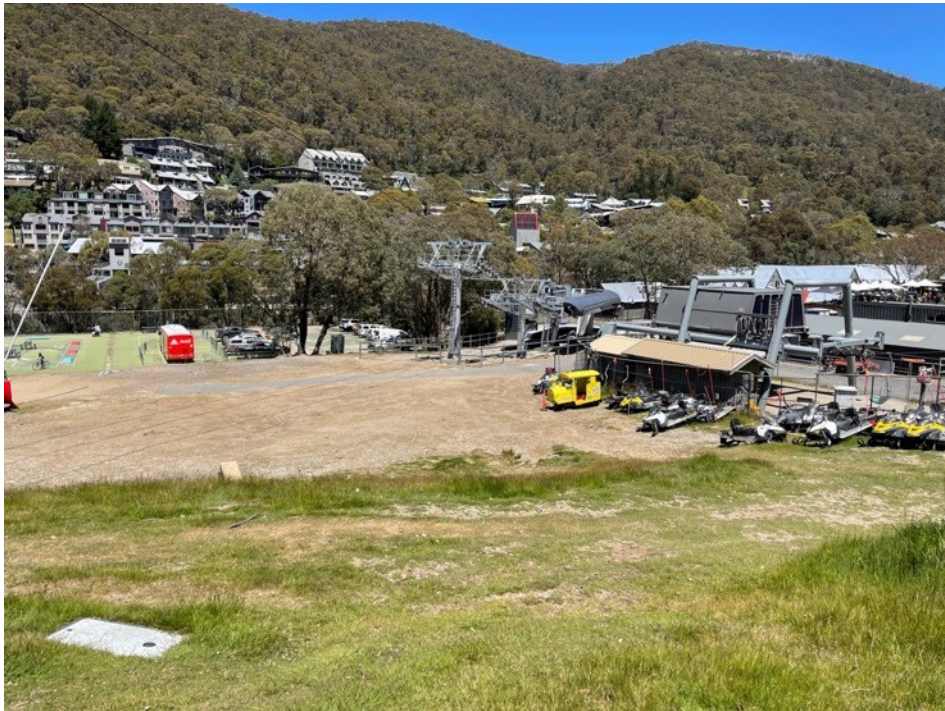
**Photo 11**  
View near TP13  
location looking  
south

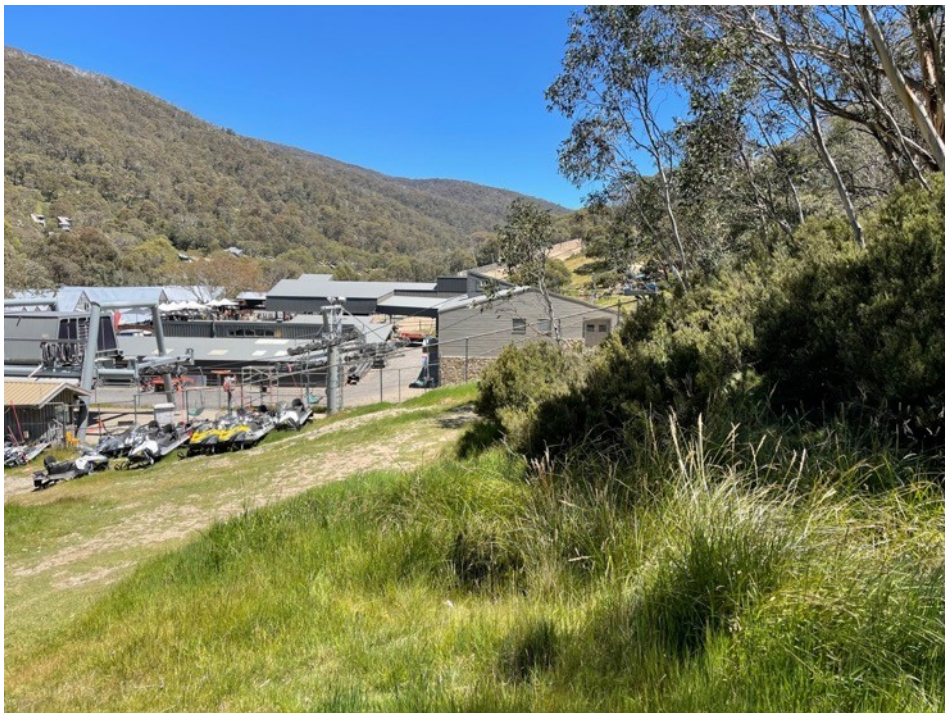
**Photo 12**  
View near TP13  
location looking  
southwest

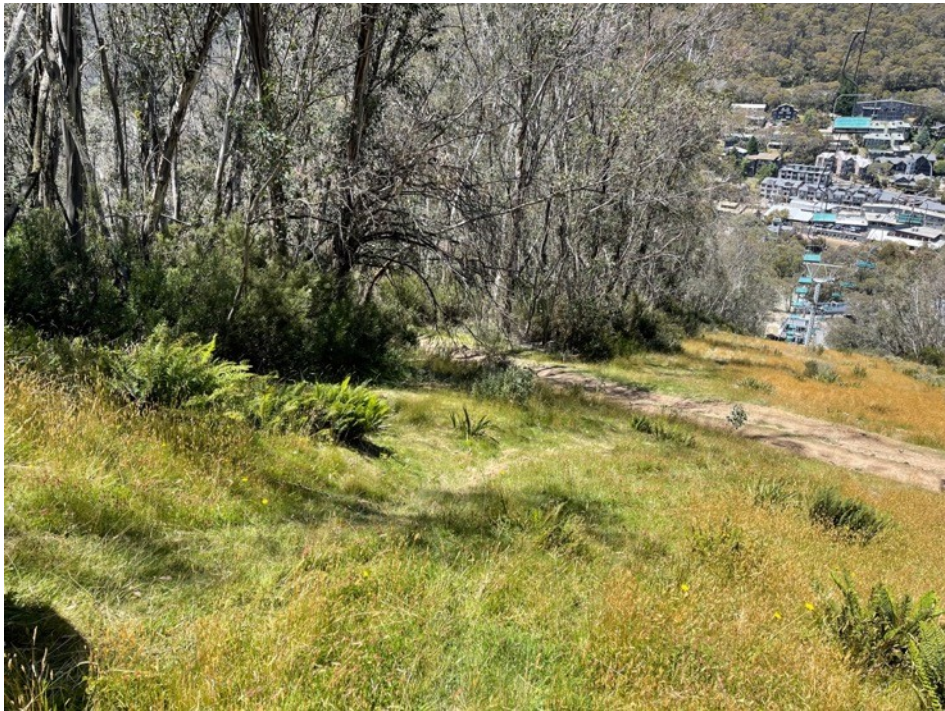
**Photo 13**  
View near TP22  
looking downslope  
(south east)

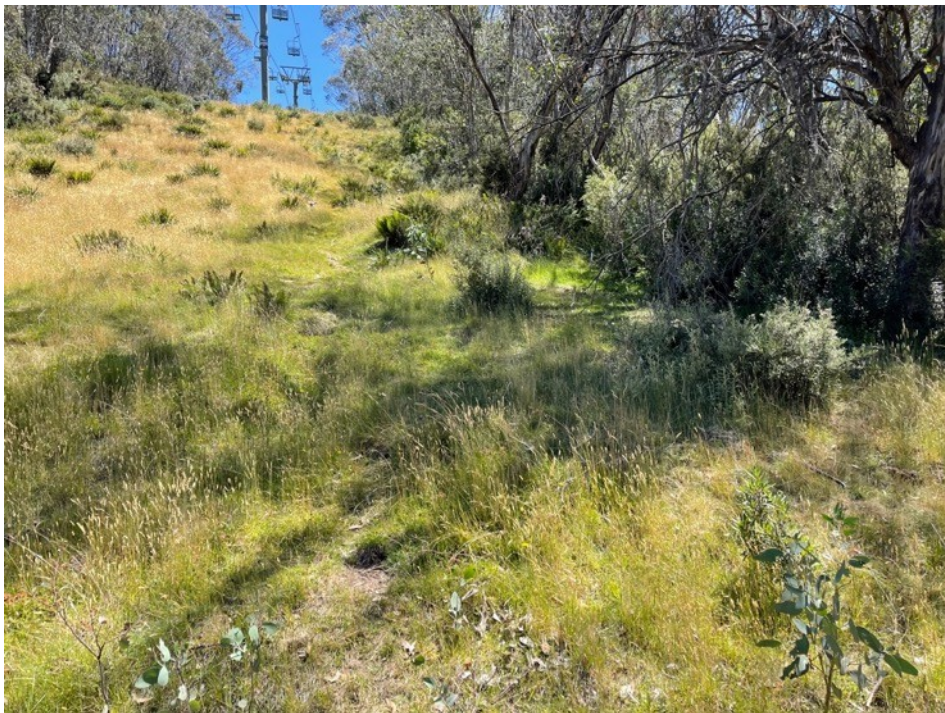
**Photo 14**  
View near TP22  
looking upslope  
(north west)

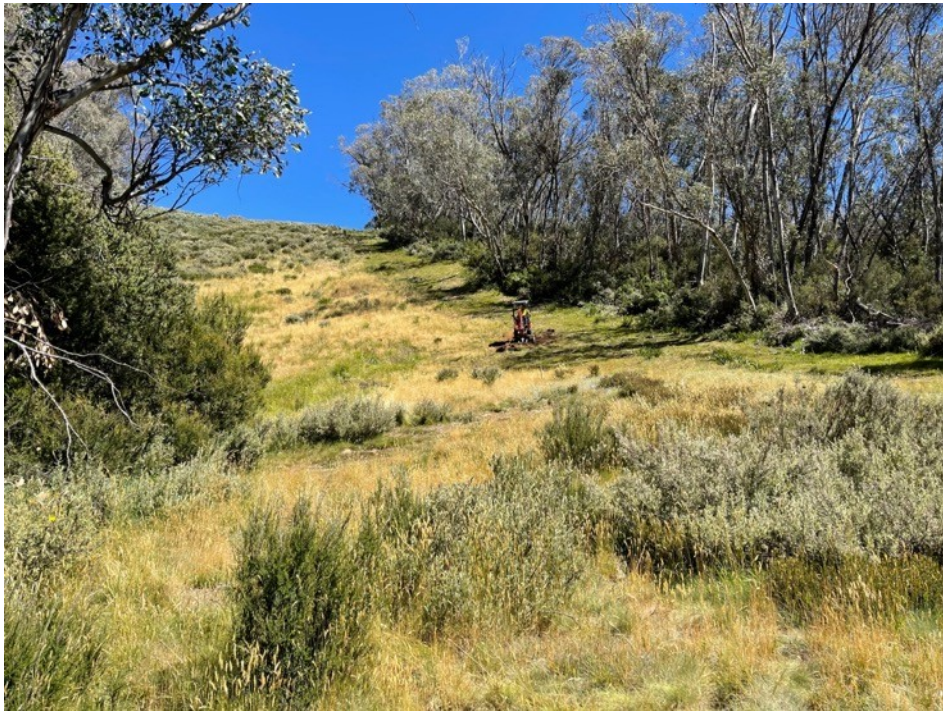
**Photo 15**  
View near TP07  
looking upslope  
(north west)

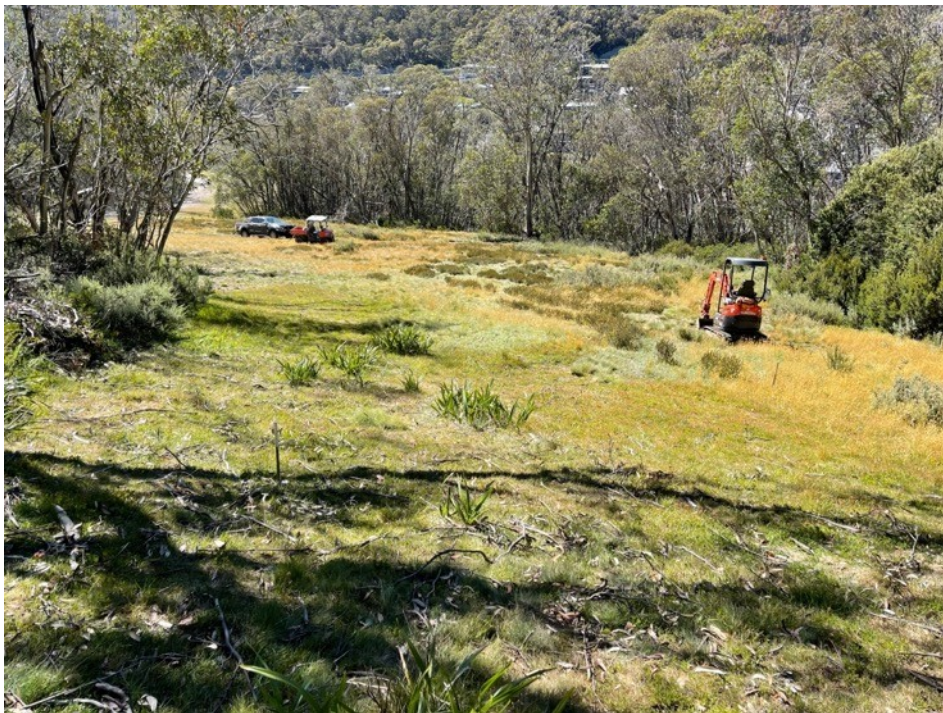
**Photo 16**  
View near TP06  
looking downslope  
towards TP05 (south  
east)

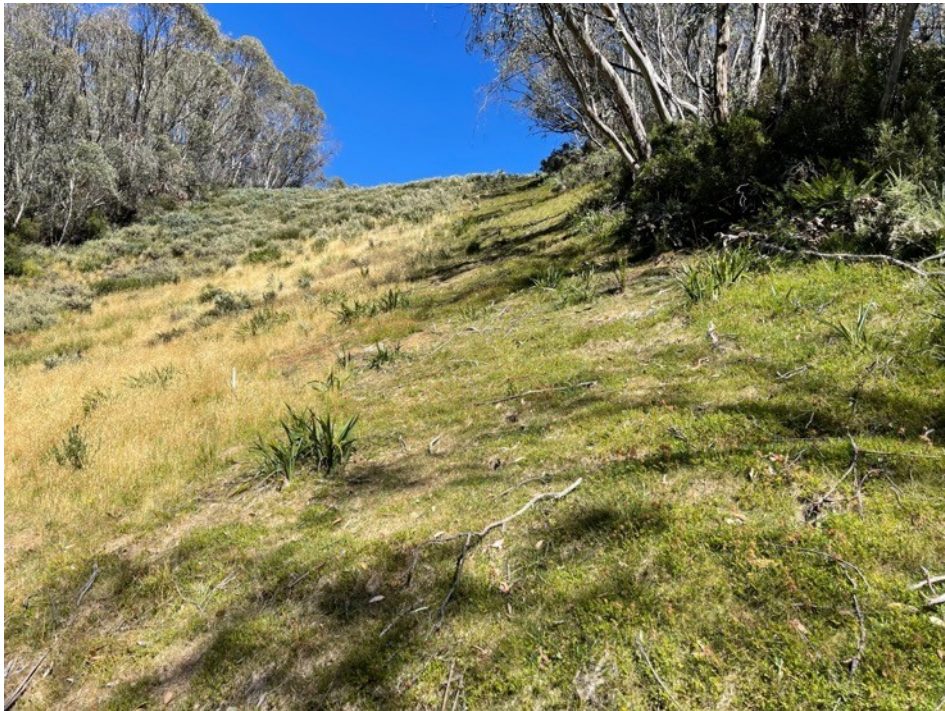
**Photo 17**  
View upslope of  
TP06 looking  
upslope (north west)

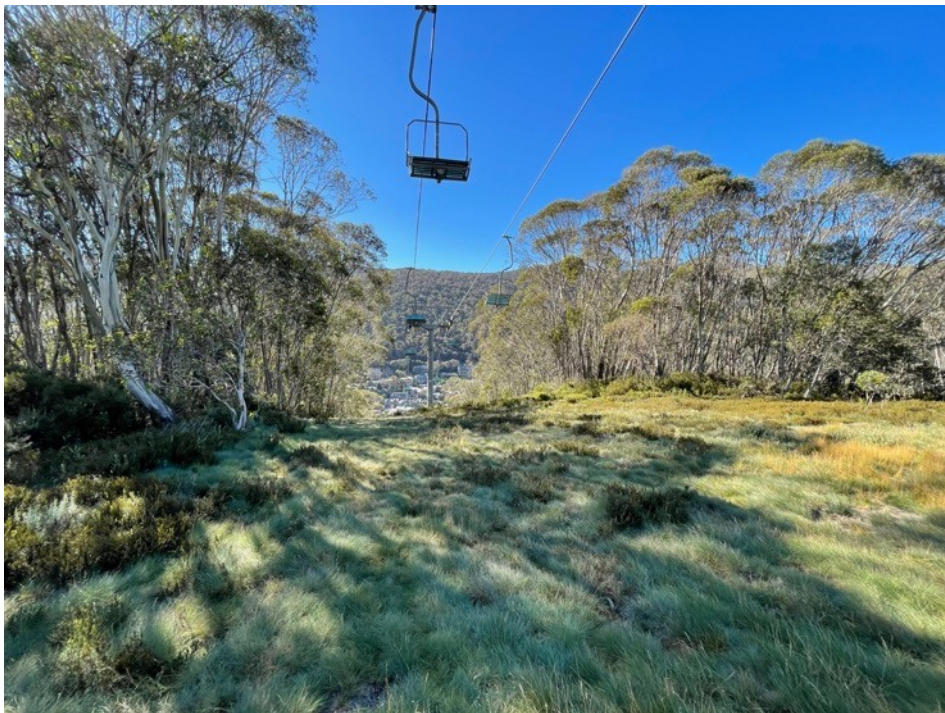
**Photo 18**  
View at top of  
coaster incline south  
west of TP01 looking  
downslope (south  
east)

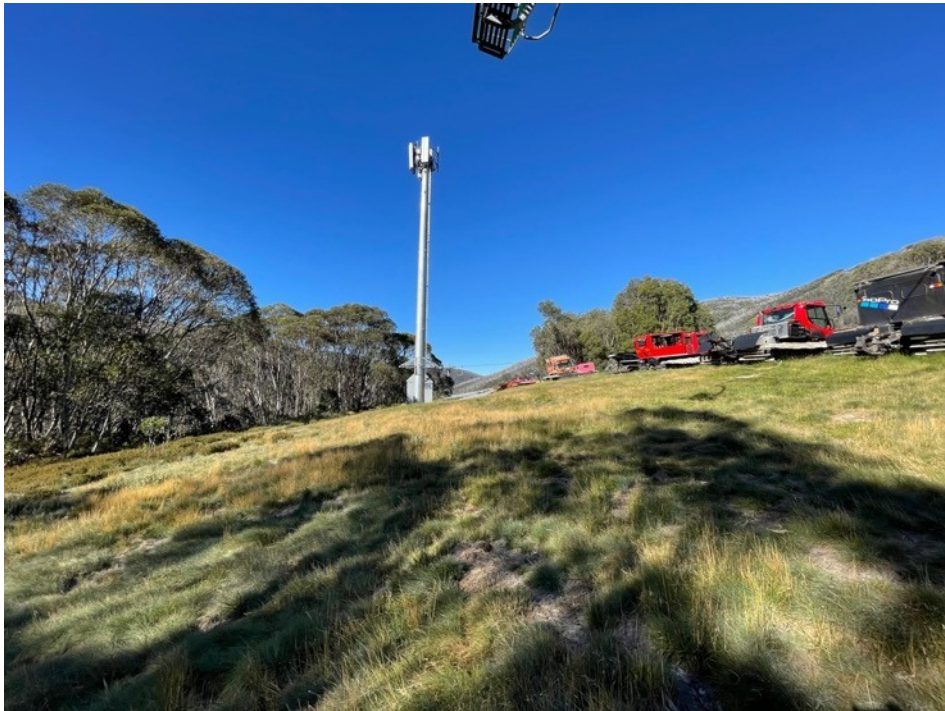
**Photo 19**

View north east of TP01 looking south west towards top of incline.

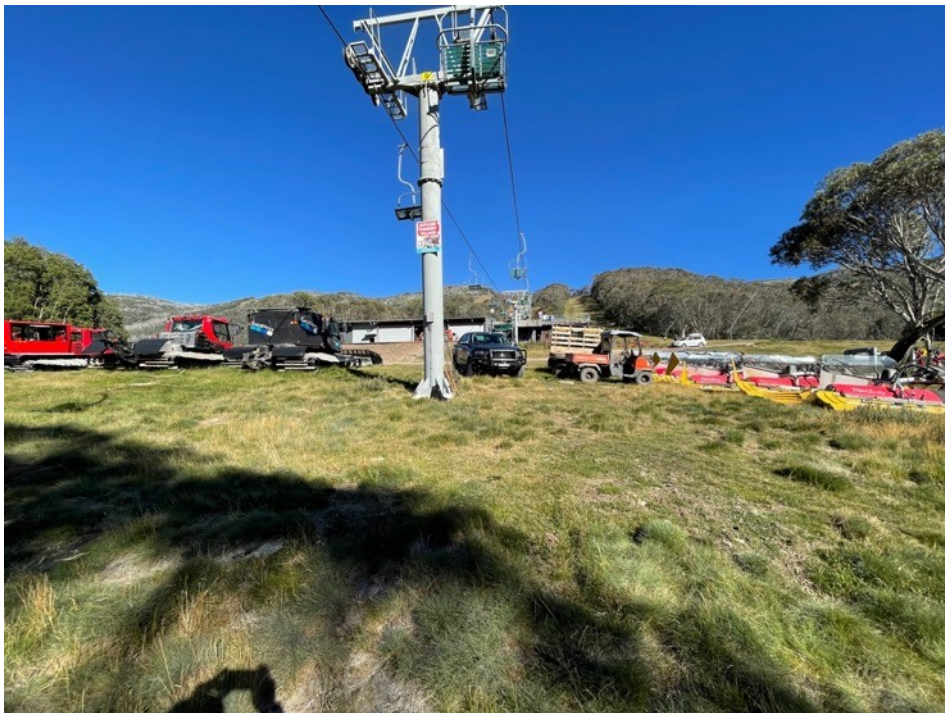
**Photo 20**

View near TP01 looking upslope (north west)
