2 Burley Road Padstow 2211

Predevelopment Tree Assessment Report

Date: 10/08/2022

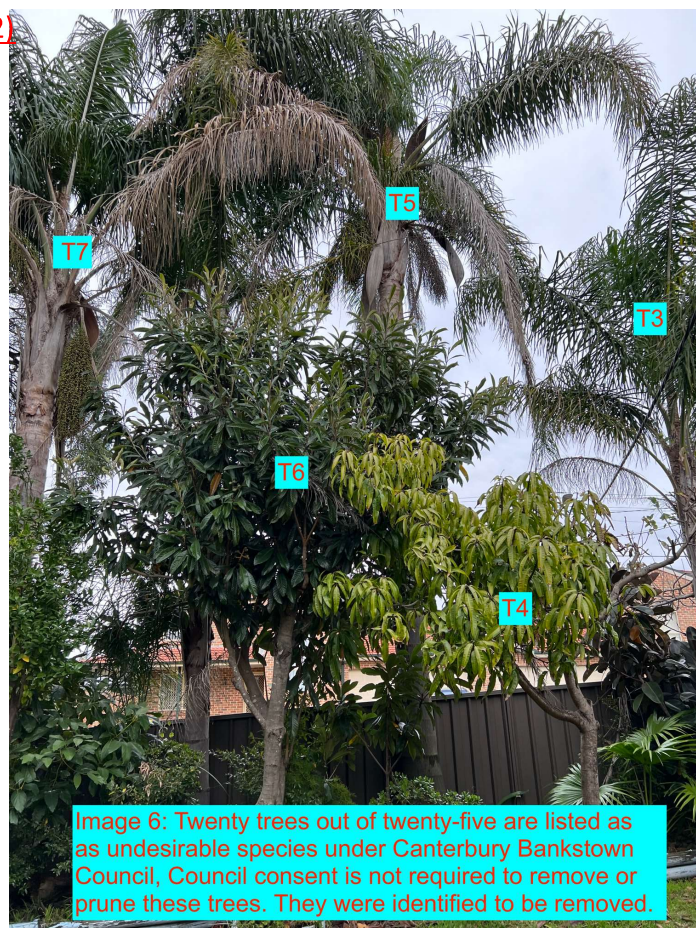
Tree no. 4

- Botanical Name: **Mangifera indica**
- Common Name: **Mango Tree**
- Location: **OS**
- DBH (cm): **13**
- DAB (m): **0.15**
- Canopy spreading: **(NS:2), (EW: 4)**
- Height (m): **2**
- Canopy density (%): **60**
- Type (N, R, E, P, S, Nox): **Native.**
- Age Class (Y/S/M/O): **Y**
- Crown class (D/C/I/S): **S**
- Crown condition (0-5): **3 Good**
- Root Zone: **Gr**
- Defect: **DW**
- Service/ Adjacent Structures: **F**
- Failure Potential: **1 Low**
- SULE: Safe Useful Life Expectancy rating:
Remove 4(a)
- TPZ (Tree Protection Zone) (R): **2m**
- SRZ (Structural Root Zone) (R): **1.5m**
- Risk: **Low**

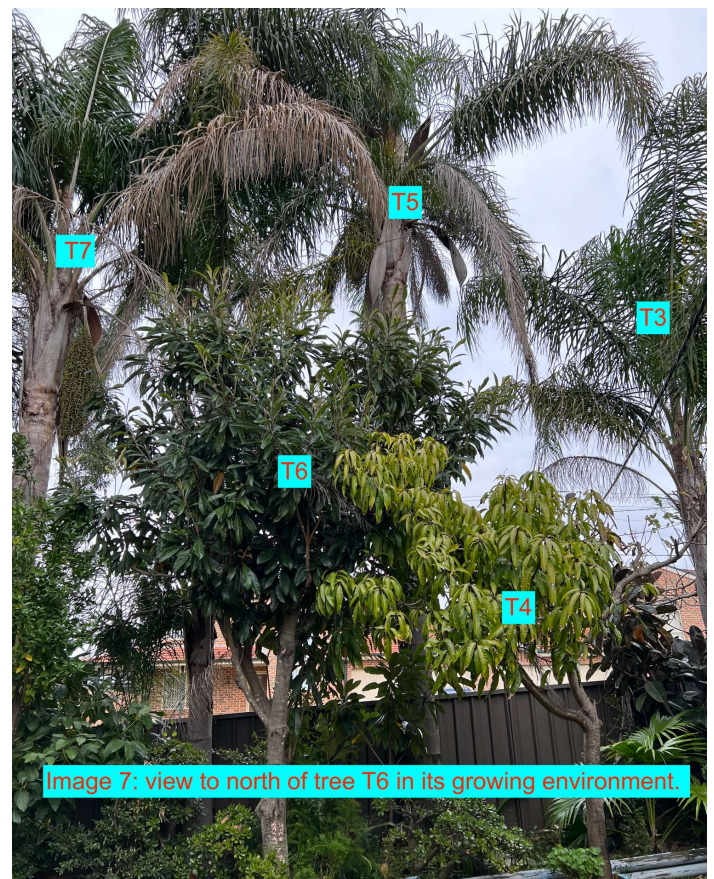
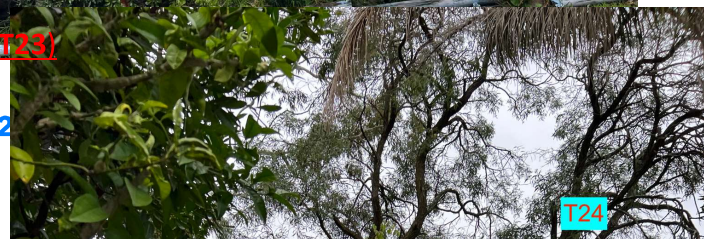
Groupe of Tree (T9, T10, T12, T14, T18, T19, & T23)

0.08 to 0.22		6 to 13		2 to 4		50 to 60		1 to 3		1 to 2		S		2		1.5 TO 1.6		Nil to 6%		Y to M											
Condition comments on tree as seen on the site: Several trees (Seven Citrus) are scattered within the site and they are proposed to be removed. Regardless of their location from the proposed development, these trees are listed as undesirable species under Canterbury Bankstown Council. In order to compensate for loss of amenity resulting from removal of these trees consideration should be taken to replacement planting according the council regulations. (Refer images: 7 & 8)

- Botanical Name: **Citrus limon.**
- Common Name: **Lemon Tree**
- Location: **OS**
- DBH (cm) **ranges: 6 to 13**
- DAB (m) **ranges: 0.08 to 0.22**
- Canopy spreading ranges: **(NS: 1-3), (EW:1-2)**
- Height (m) **ranges: 2m to 4**
- Canopy density (%) **ranges: 50% to 60**
- Type (N, R, E, P, S, Nox): **E.**
- Age Class (Y/S/M/O): **Y to M**
- Crown class (D/C/I/S): **S**
- Crown condition (0-5): **3 Good**
- Root Zone: **Gr**
- Defect: **DW**
- Service/ Adjacent Structures: **F**
- Failure Potential: **1 Low**
- SULE: Safe Useful Life Expectancy rating:
Remove 4 (a)
- TPZ (Tree Protection Zone) (R) **ranges: 2**
- SRZ (Structural Root Zone) (R): **ranges: 1.5 to 1.6m**
- **Risk: Low**

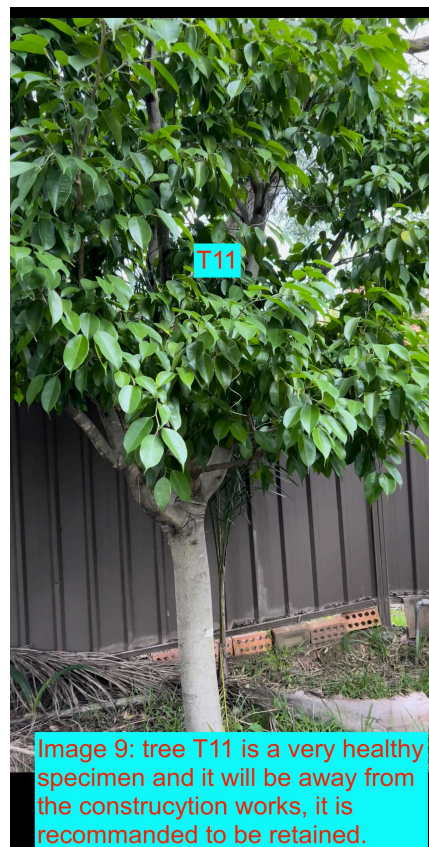
Tree no. 11

- Botanical Name: ***Ficus Benjamina***
- Common Name: **Weeping Benjamina**
- Location: **OS**
- DBH (cm): **16**
- DAB (m): **0.17**
- Canopy spreading: **(NS: 2), (EW: 2)**
- Height (m): **3**
- Canopy density (%): **80**
- Type (N, R, E, P, S, Nox): **Native.**
- Age Class (Y/S/M/O): **Y**
- Crown class (D/C/I/S): **S**
- Crown condition (0-5): **3 Good**
- Root Zone: **Gr**
- Defect: **DW**
- Service/ Adjacent Structures: **F**
- Failure Potential: **1 Low**
- SULE: Safe Useful Life Expectancy rating:
Medium 2(d)
- TPZ (Tree Protection Zone) (R): **2m**
- SRZ (Structural Root Zone) (R): **1.6m**
- **Risk: Low**

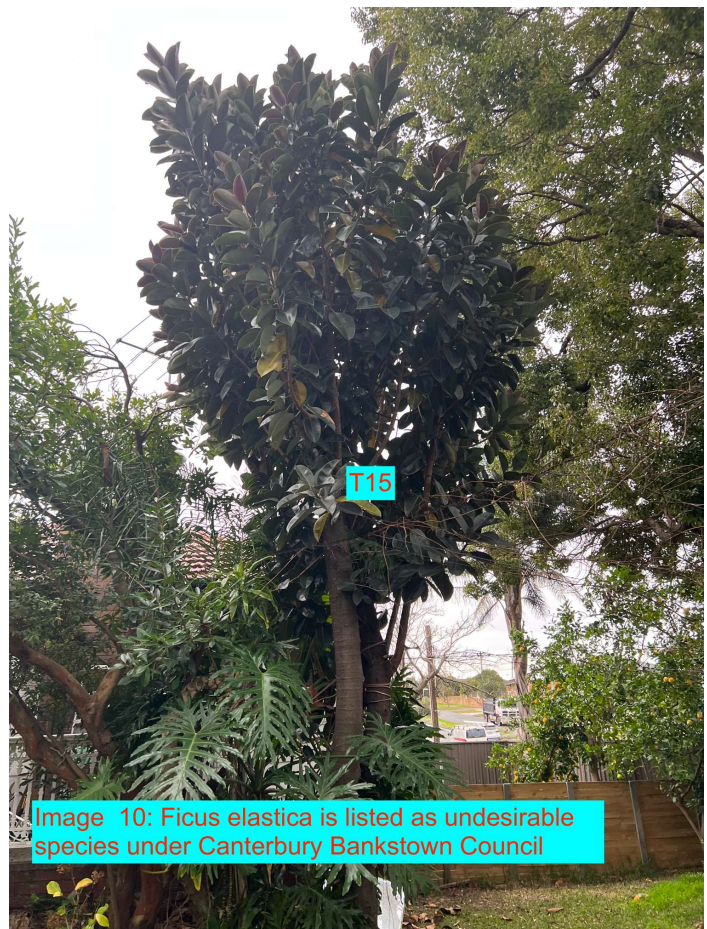
Tree no. 15

- Botanical Name: ***Ficus Elastica***
- Common Name: **Rubber Tree**
- DBH (cm): **41**
- DAB (m): **0.47**
- Canopy spreading: **(NS: 6), (EW: 4)**
- Height (m): **7**
- Canopy density (%): **80**
- Type (N, R, E, P, S, Nox): **Exotic.**
- Age Class (Y/S/M/O): **M**
- Crown class (D/C/I/S): **C**
- Crown condition (0-5): **3 Good**
- Root Zone: **Gr**
- Defect: **DW, L**
- Service/ Adjacent Structures: **H**
- Failure Potential: **1 Low**
- SULE: Safe Useful Life Expectancy rating:
Remove 4(a)
- TPZ (Tree Protection Zone) (R): **4.9m**
- SRZ (Structural Root Zone) (R): **2.4m**
- Risk: **Low**

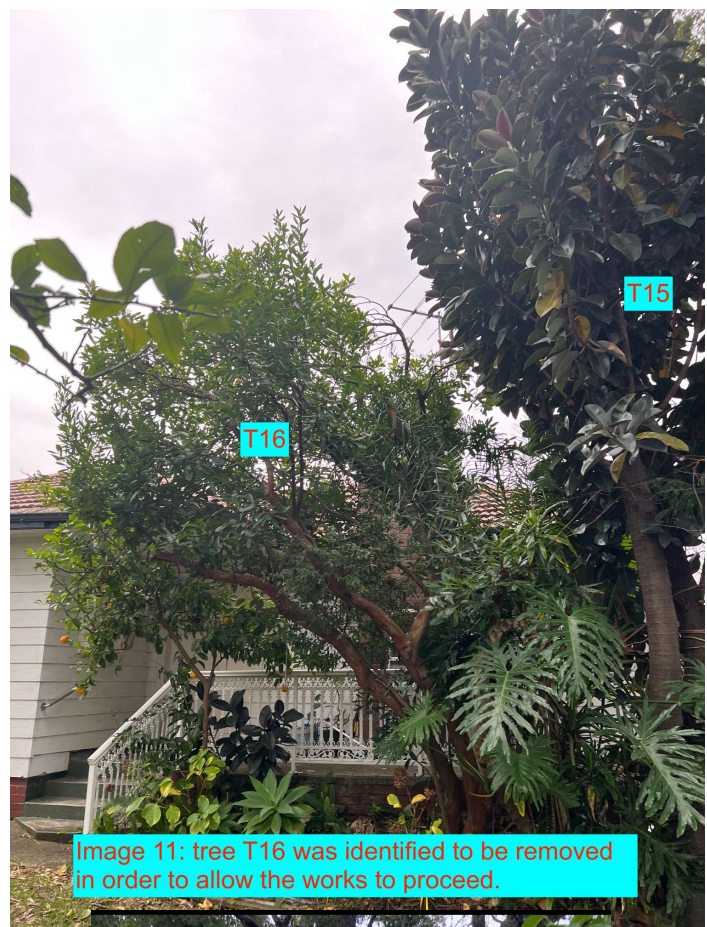
Tree no. 16

- Botanical Name: ***Gordonia axillaris***
- Common Name: **Fried Egg Plant**
- Location: **OS**
- DBH (cm): **26**
- DAB (m): **0.47**
- Canopy spreading: **(NS: 4), (EW: 2)**
- Height (m): **5**
- Canopy density (%): **60**
- Type (N, R, E, P, S, Nox): **Native.**
- Age Class (Y/S/M/O): **M**
- Crown class (D/C/I/S): **S**
- Crown condition (0-5): **3 Good**
- Root Zone: **Gr**
- Defect: **DW**
- Service/ Adjacent Structures: **H**
- Failure Potential: **1 Low**
- SULE: Safe Useful Life Expectancy rating:
Medium 2(d)
- TPZ (Tree Protection Zone) (R): **3.1m**
- SRZ (Structural Root Zone) (R): **2.4m**
- Risk: **Low**

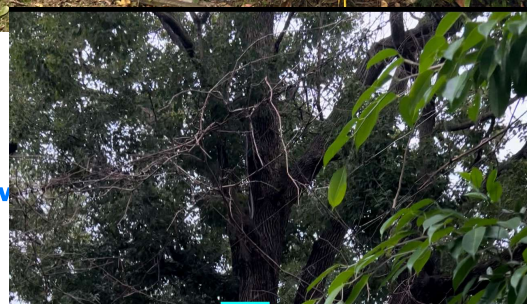
Tree no. 17

- Botanical Name: **Cinnamomum camphora**
- Common Name: **Camphor Laurel**
- DBH (cm): **110**
- DAB (m): **1.33**
- Canopy spreading: **(NS: 10), (EW: 15)**
- Height (m): **14**
- Canopy density (%): **85**
- Type (N, R, E, P, S, Nox): **Exotic.**
- Age Class (Y/S/M/O): **M**
- Crown class (D/C/I/S): **D**
- Crown condition (0-5): **3 Good**
- Root Zone: **Gr**
- Defect: **DW**
- Service/ Adjacent Structures: **F, PL**
- Failure Potential: **1 Low**
- SULE: Safe Useful Life Expectancy rating:
Remove 4(a)
- TPZ (Tree Protection Zone) (R): **13.2m**
- SRZ (Structural Root Zone) (R): **3.7m**
- **Risk: Low**

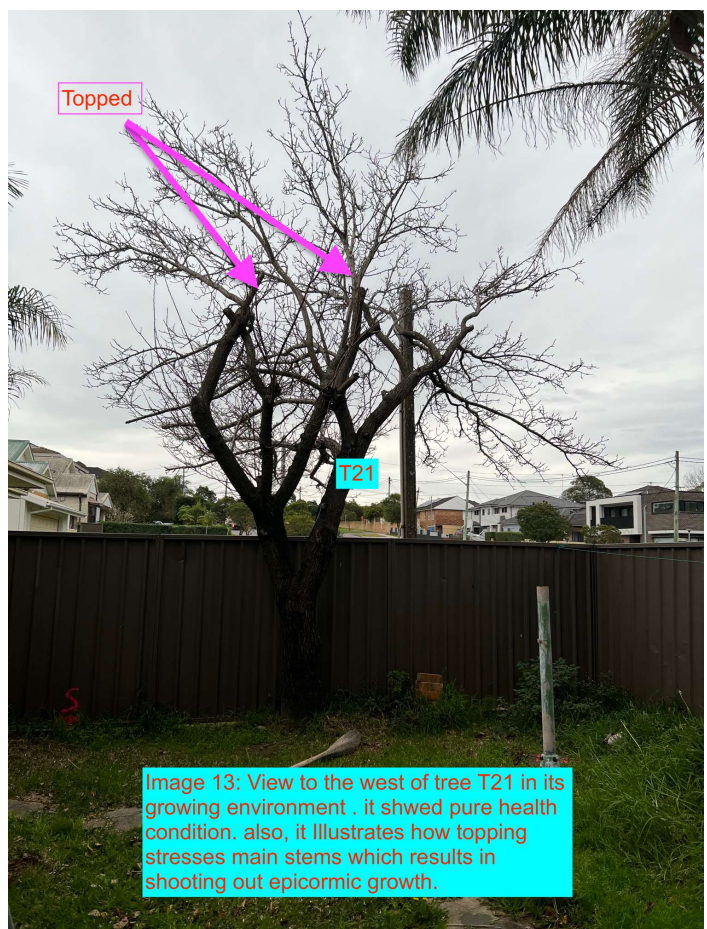
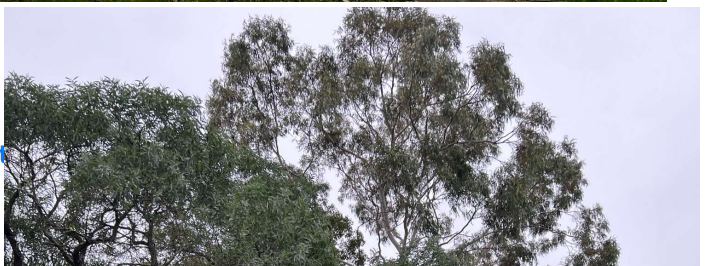
Tree no. 21

- Botanical Name: ***Prunus sp.***
- Common Name: **Prunus**
- DBH (cm): **38**
- DAB (m): **0.48**
- Canopy spreading: **(NS: 6), (EW: 4)**
- Height (m): **5**
- Canopy density (%): **75**
- Type (N, R, E, P, S, Nox): **Exotic.**
- Age Class (Y/S/M/O): **M**
- Crown class (D/C/I/S): **C**
- Crown condition (0-5): **3 Good**
- Root Zone: **Gr**
- Defect: **DW, EP**
- Service/ Adjacent Structures: **F**
- Failure Potential: **1 Low**
- SULE: Safe Useful Life Expectancy rating:
Remove 4(a)
- TPZ (Tree Protection Zone) (R): **4.5m**
- SRZ (Structural Root Zone) (R): **2.4m**
- **Risk: Low**

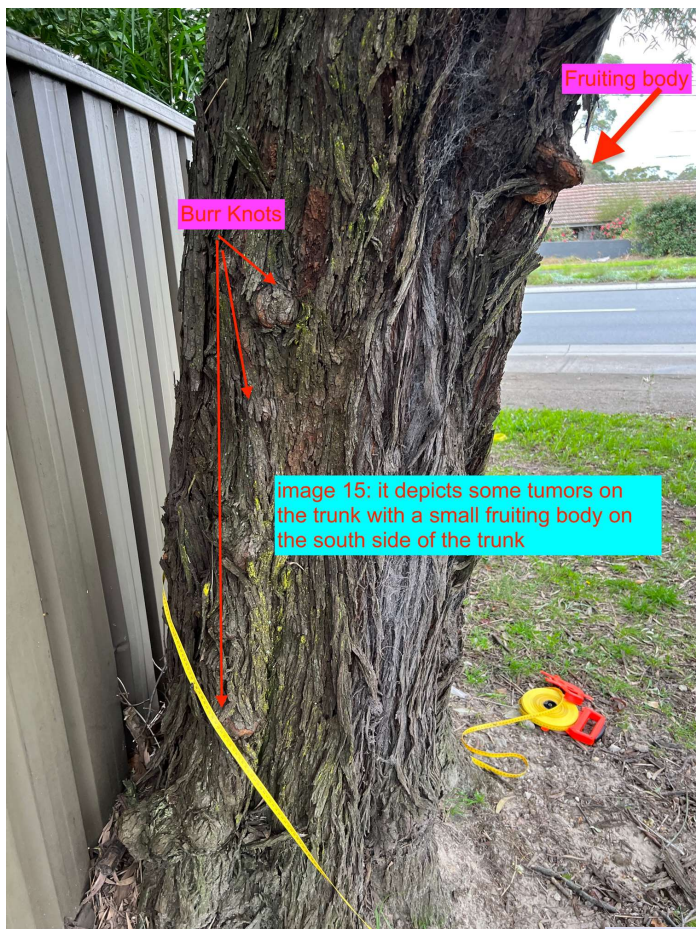
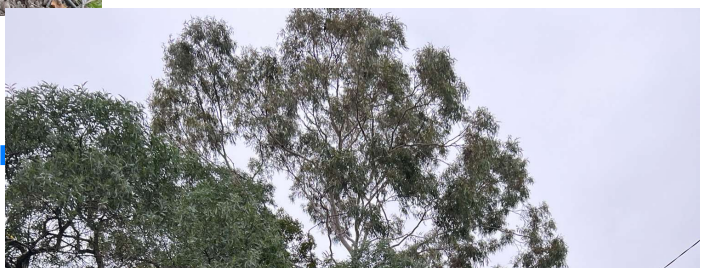
Tree no. 24

- Botanical Name: ***Acacia longifolia***
- Common Name: **Acacia**
- Location: **NS**
- DBH (cm): **63**
- DAB (m): **0.70**
- Canopy spreading: **(NS: 8), (EW: 12)**
- Height (m): **10**
- Canopy density (%): **80**
- Type (N, R, E, P, S, Nox): **Native.**
- Age Class (Y/S/M/O): **M**
- Crown class (D/C/I/S): **S**
- Crown condition (0-5): **3 Good**
- Root Zone: **Gr**
- Defect: **DW, canker**
- Service/ Adjacent Structures: **F, PL**
- Failure Potential: **1 Low**
- SULE: Safe Useful Life Expectancy rating:
Medium 2(d)
- TPZ (Tree Protection Zone) (R): **7.5m**
- SRZ (Structural Root Zone) (R): **2.8m**
- Risk: **Low**
