DILAPIDATION REPORT

Council Assets surrounding
Lot 27, 17 Mae Crescent,
Panania

Fairmont Homes

Prepared By: Sidarth Rajkumar
Date: June 2022
Ref: 220453-001-DR
Revision: A

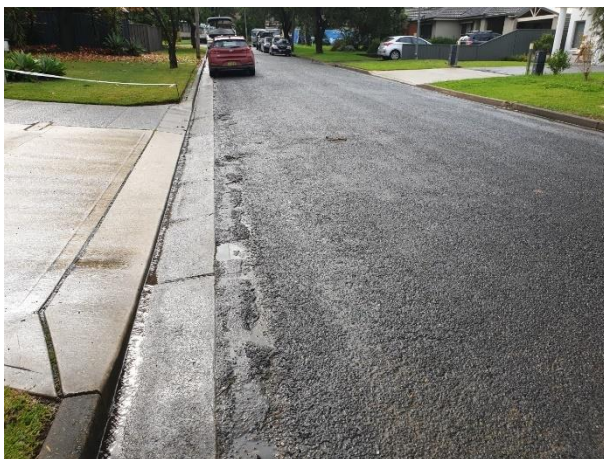
Photo 2.1-5
Existing condition of kerb and gutter and road surface (facing north)

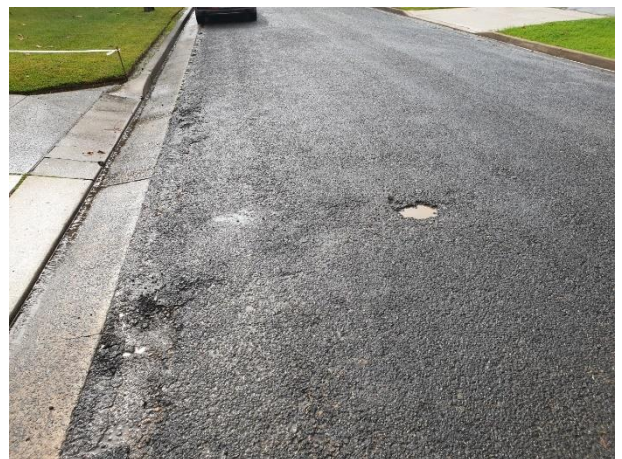
Photo 2.1-6
Existing condition of kerb and gutter and road surface (facing north)

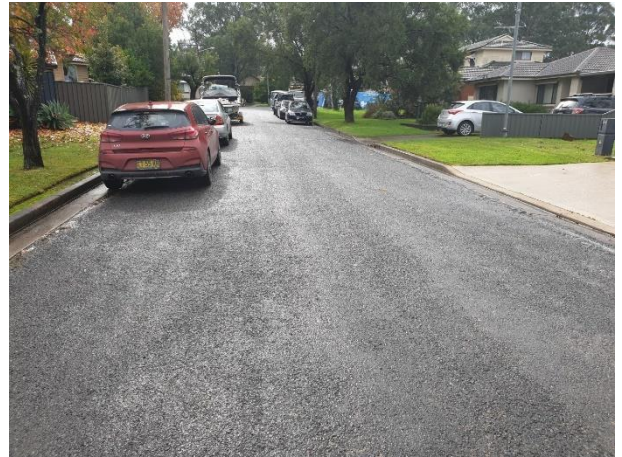
Photo 2.1-8
Existing condition of kerb and gutter and road surface (facing north)

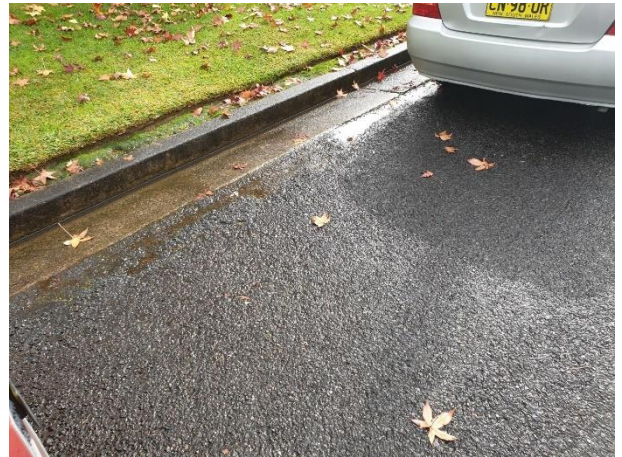
Photo 2.1-10
Existing condition of kerb and gutter (facing north-west)

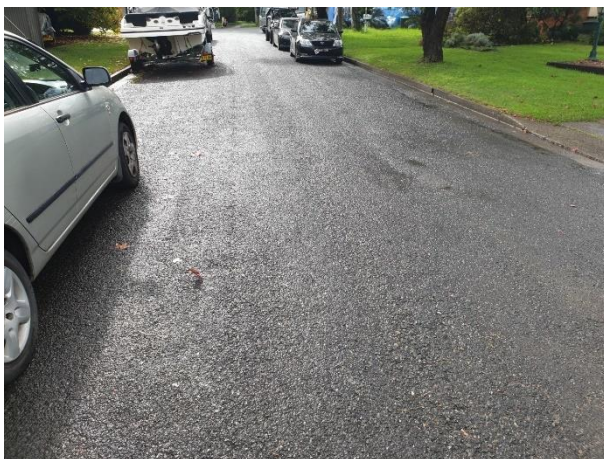
Photo 2.1-11
Existing condition of road surface (facing north)

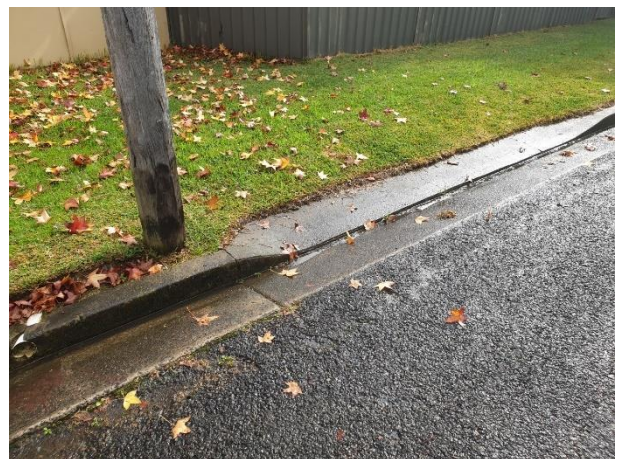
Photo 2.1-12
Existing condition of layback and kerb & gutter (facing north-west)

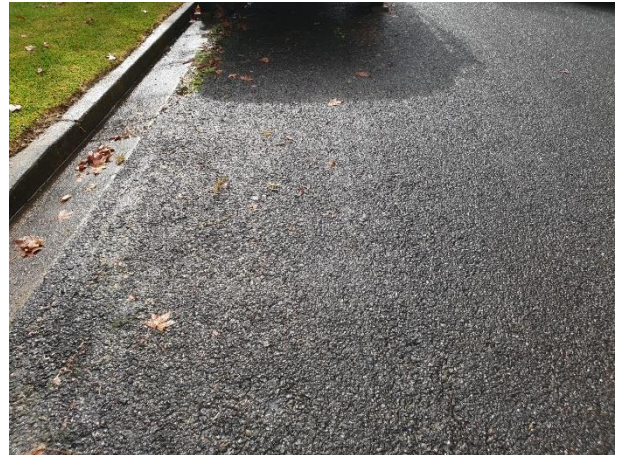
Photo 2.1-14
Existing condition of the road (facing north)

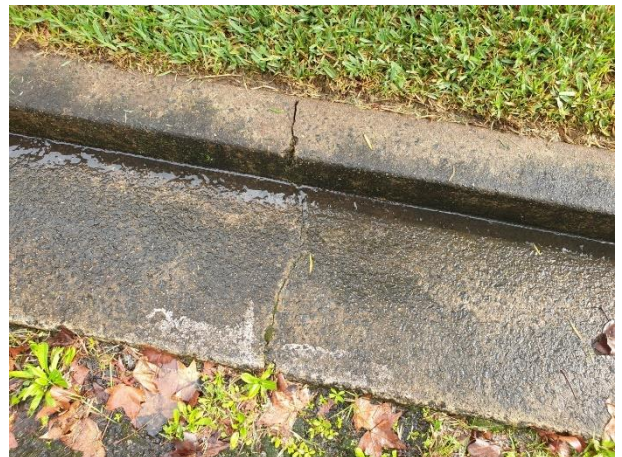
Photo 2.1-16
Cracking observed in kerb and gutter (facing west)

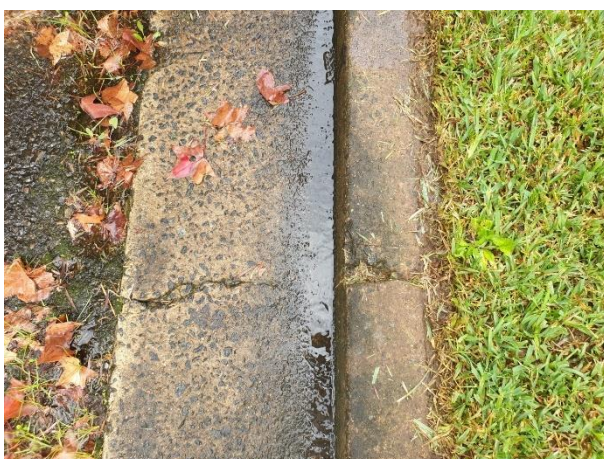
Photo 2.1-17
Cracking observed in kerb and gutter (facing south)

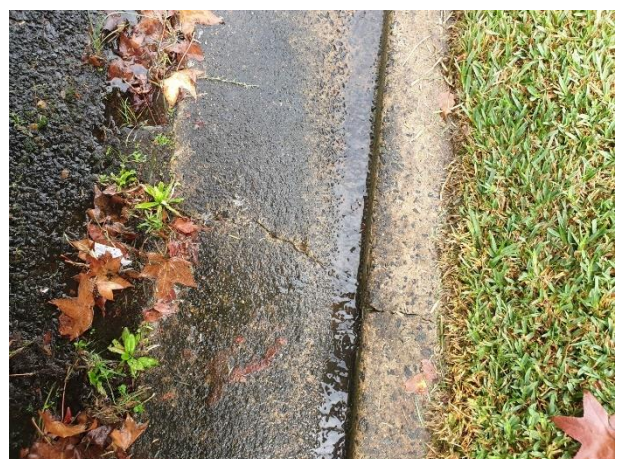
Photo 2.1-18
Cracking observed in kerb and gutter (facing south)

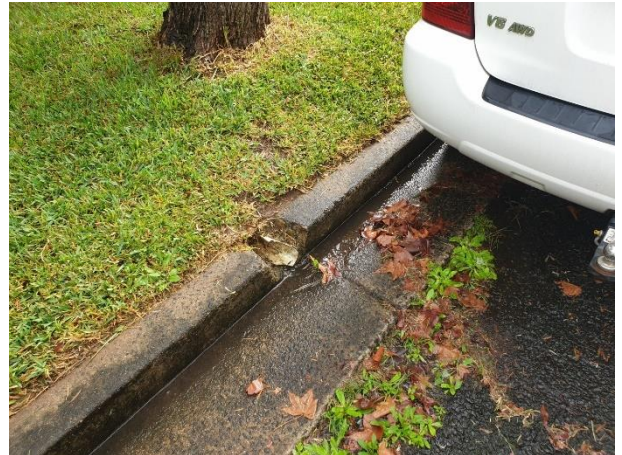
Photo 2.1-20
Damaged kerb & gutter observed adjacent No. 17 (facing north)

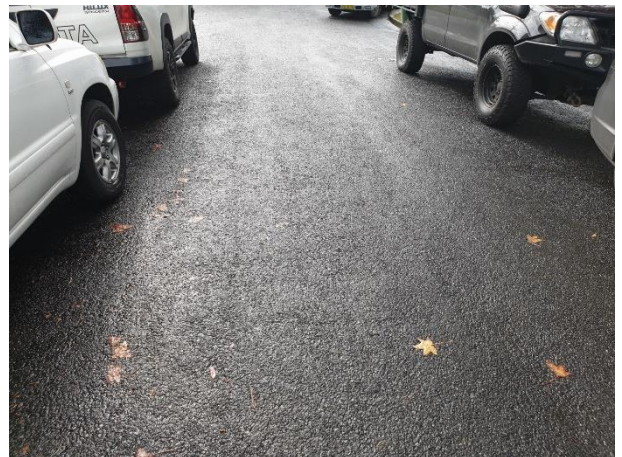
Photo 2.1-22
Existing condition of road surface adjacent No. 17 (facing north)

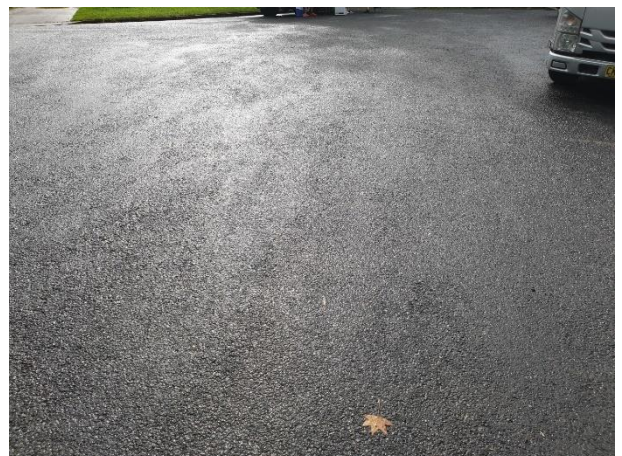
Photo 2.1-24
Existing condition of road surface adjacent No. 17 (facing north)

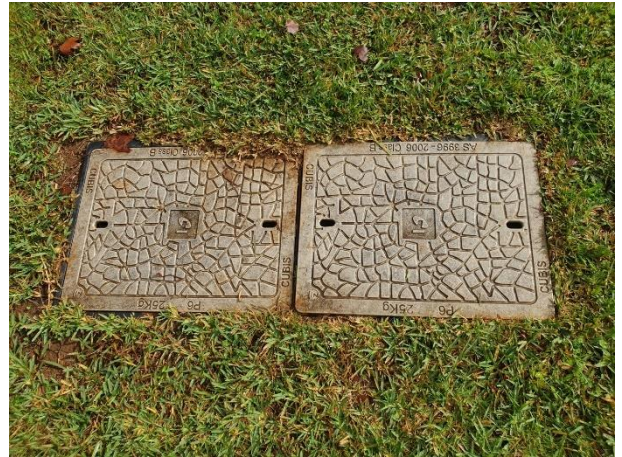
Photo 2.1-26
Existing condition of communications pit adjacent No. 17

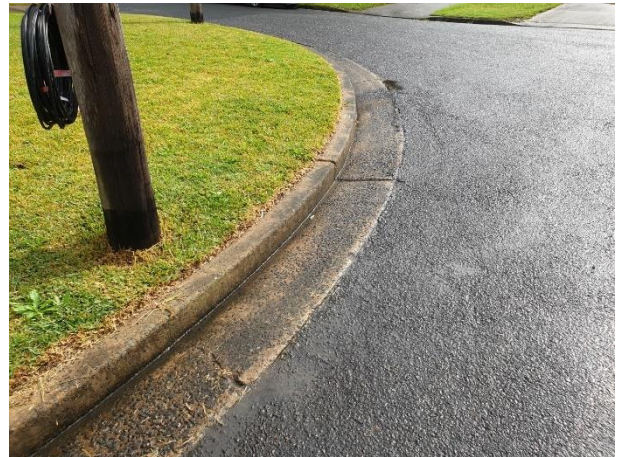
Photo 2.1-28
Existing condition of kerb & gutter adjacent No. 17 (facing north)

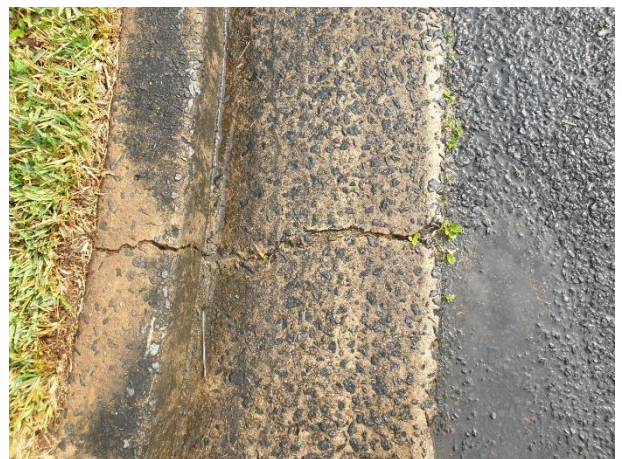
Photo 2.1-30
Cracking observed in kerb & gutter adjacent No. 17

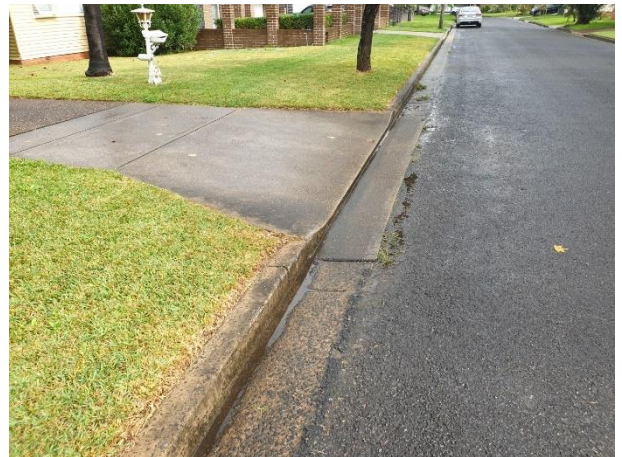
Photo 2.1-32
Existing condition of driveway to No. 17 (facing west)

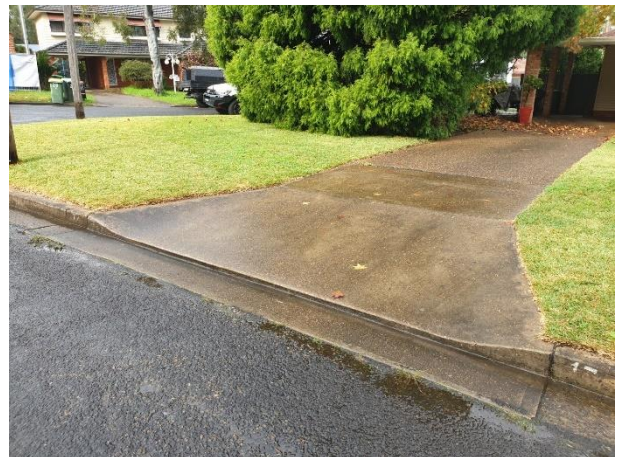
Photo 2.1-34
Existing condition of driveway, kerb and gutter and road surface adjacent No. 17 (facing south)

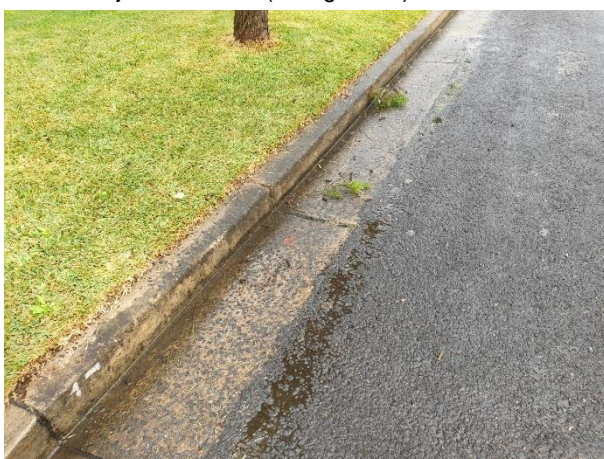
Photo 2.1-35
Existing condition of the kerb & gutter adjacent No. 17

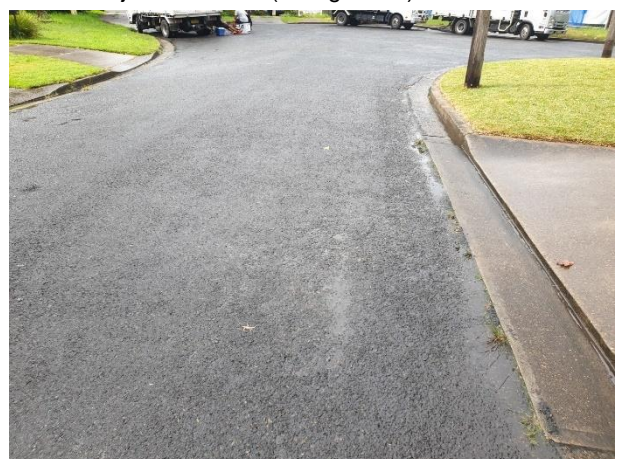
Photo 2.1-36
Existing condition of road surface adjacent No. 17 (facing east)

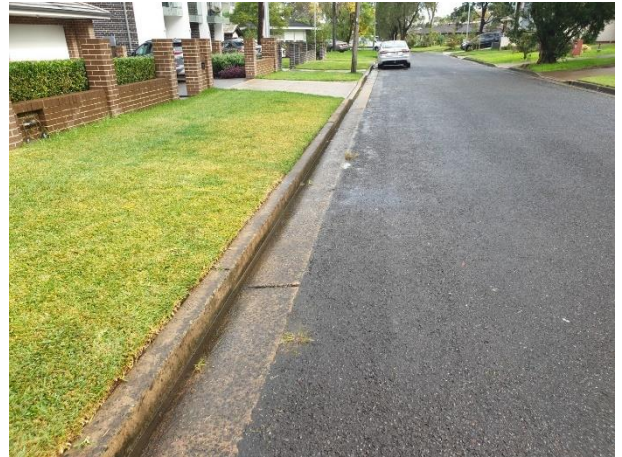
Photo 2.1-38

Existing condition of verge, kerb & gutter and road surface adjacent No. 15 (facing west)

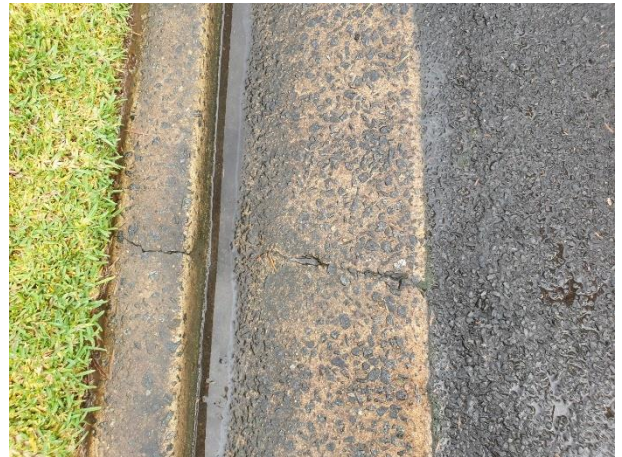
Photo 2.1-40

Cracking observed in kerb & gutter adjacent No. 17

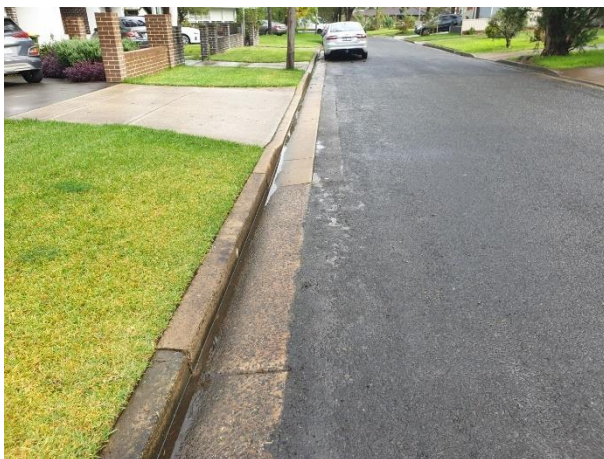
Photo 2.1-41

Existing condition of verge, kerb & gutter and road surface adjacent No. 15 (facing west)

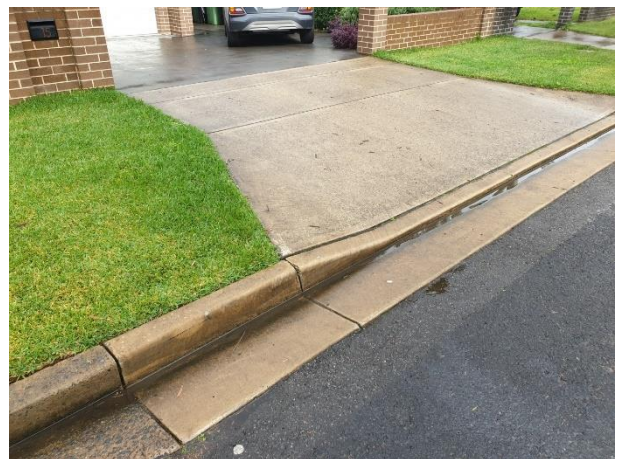
Photo 2.1-42

Existing condition of driveway to No. 15 (facing south)

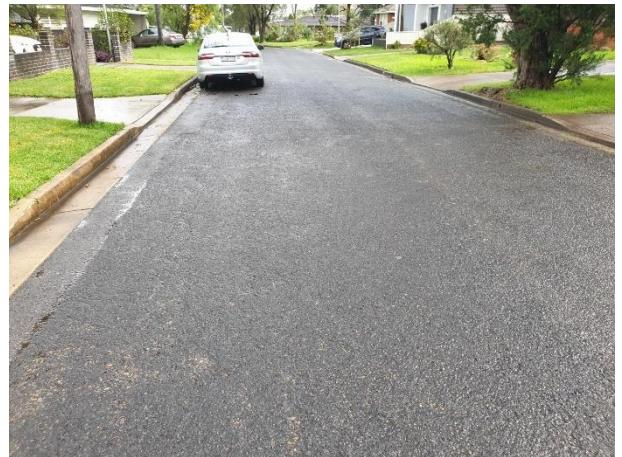
Photo 2.1-44
Existing condition of road surface adjacent No. 15 (facing west)

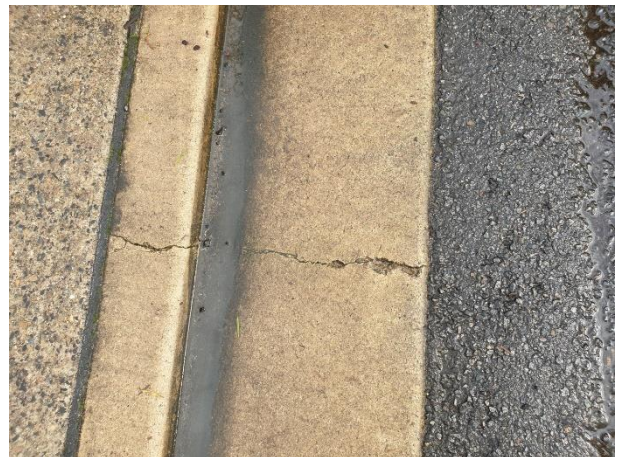
Photo 2.1-46
Cracking observed in layback to No. 15

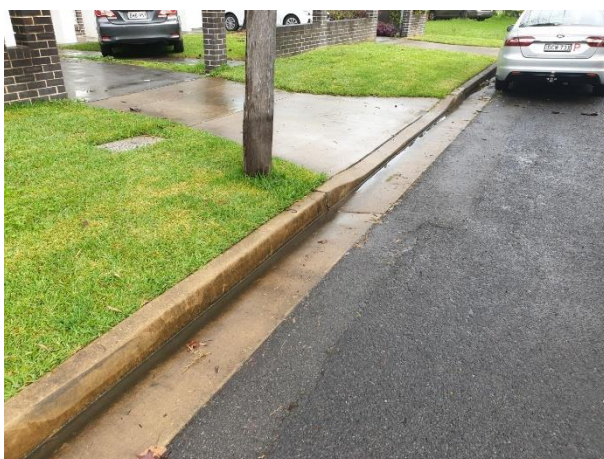
Photo 2.1-47
Existing condition of road surface adjacent No. 13 (facing west)

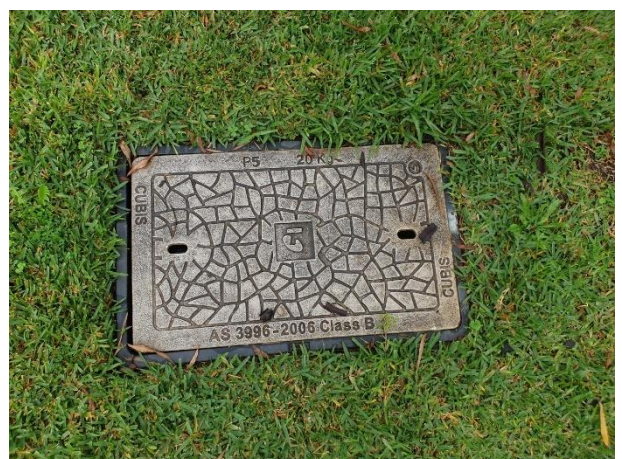
Photo 2.1-48
Existing condition of communications pit adjacent No. 13

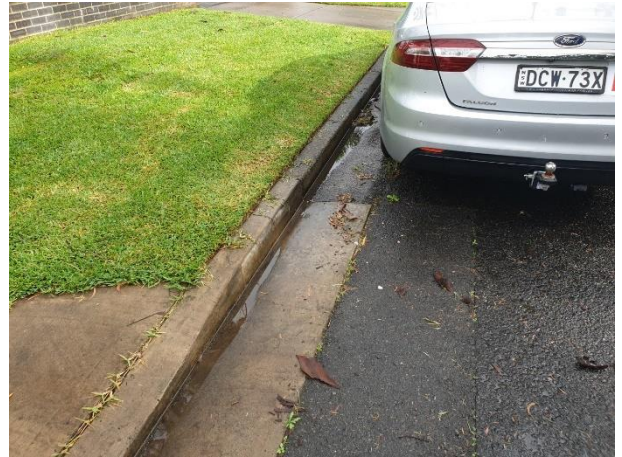
Photo 2.1-50
Existing condition of kerb & gutter adjacent No. 13A (facing west)

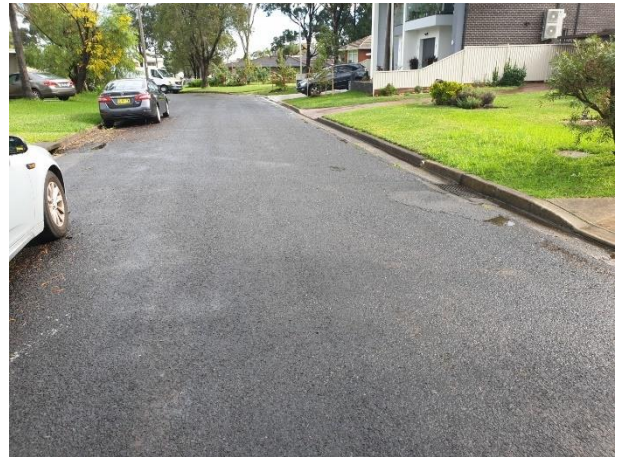
Photo 2.1-52
Existing condition of road surface (facing west)

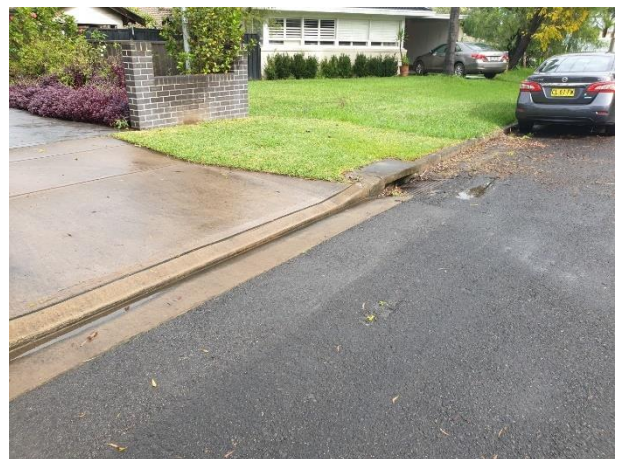
Photo 2.1-54
Existing condition of layback and road surface adjacent to No. 13

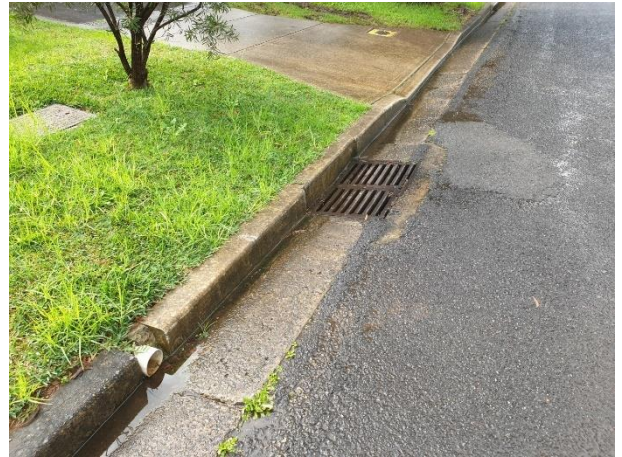
Photo 2.1-56
Existing condition of verge, kerb & gutter and road surface (facing east)

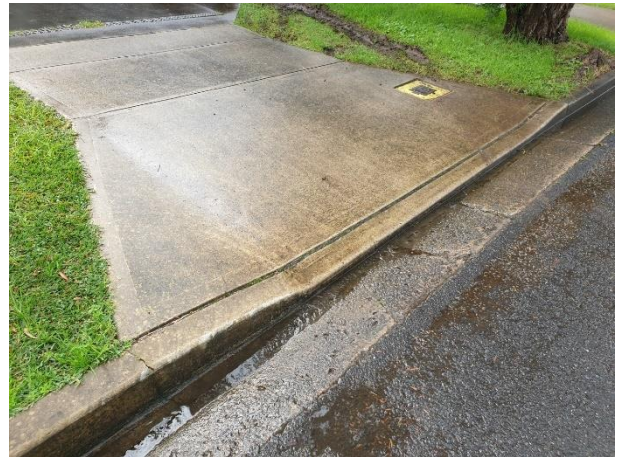
Photo 2.1-58
Existing condition of driveway to No. 16 (facing north)

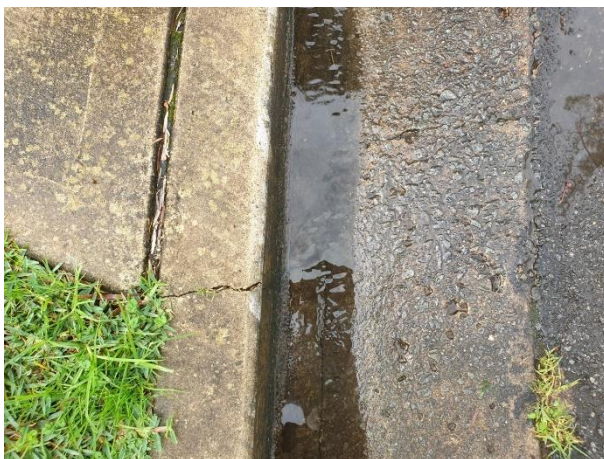
Photo 2.1-59
Cracking observed in layback to No. 16

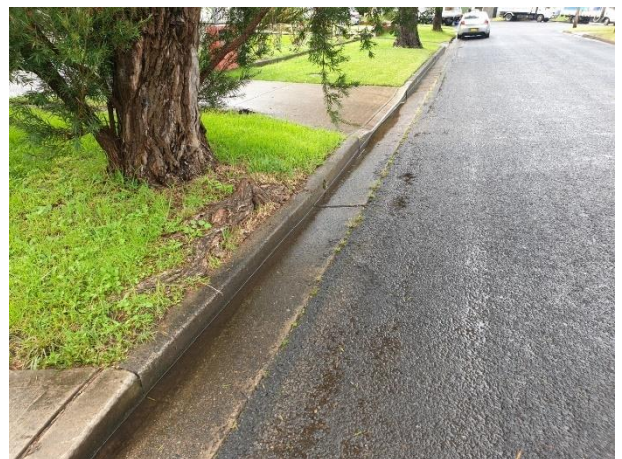
Photo 2.1-60
Existing condition of verge, kerb & gutter and road surface adjacent No. 16 (facing east)

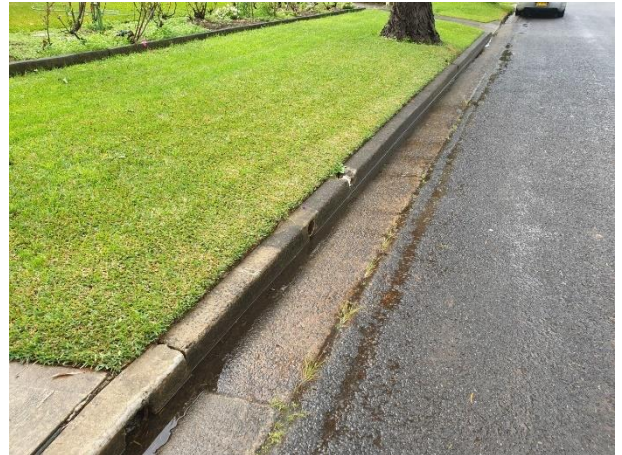
Photo 2.1-62

Existing condition of verge, kerb & gutter and road surface adjacent No. 16A (facing east)

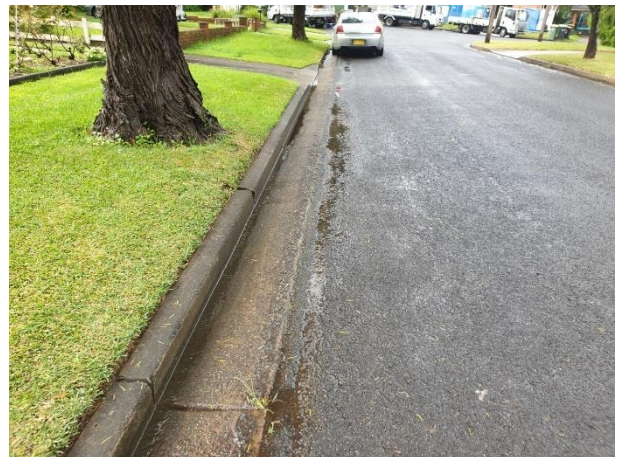
Photo 2.1-64

Existing condition of verge, kerb & gutter and road surface adjacent No. 16A (facing east)

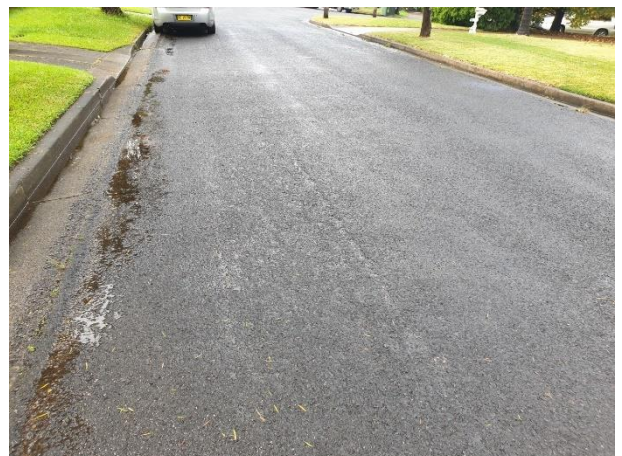
Photo 2.1-66

Existing condition of verge, kerb & gutter and road surface adjacent No. 16A (facing east)

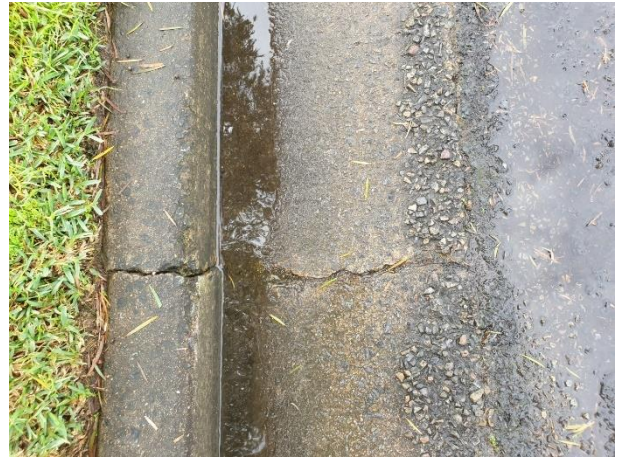
Photo 2.1-68

Cracking observed in kerb & gutter adjacent No. 16A

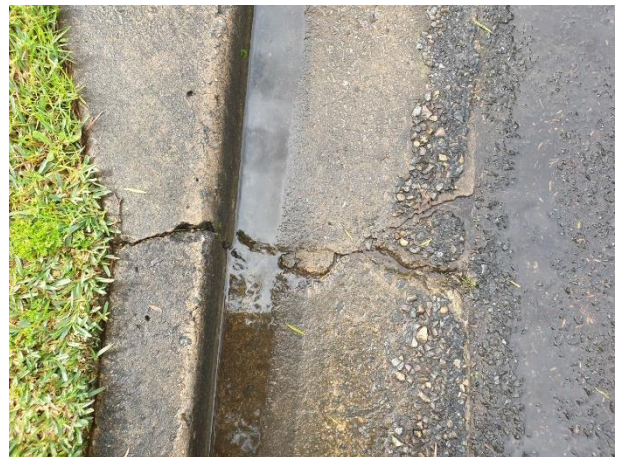
Photo 2.1-70

Cracking observed in kerb & gutter adjacent No. 18

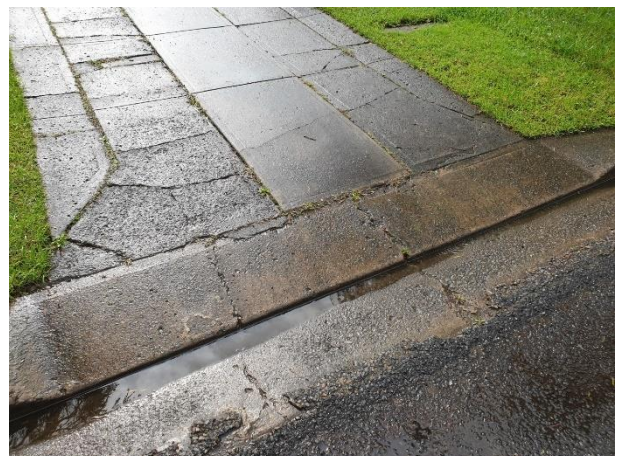
Photo 2.1-72

Existing condition of driveway and layback to No.18 (facing north)

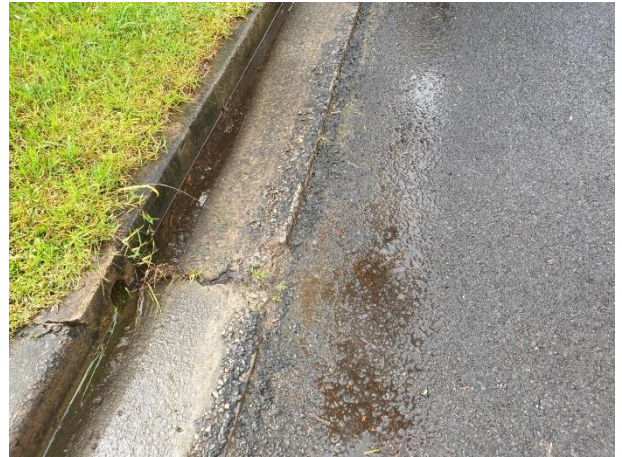
Photo 2.1-74
Existing condition of the kerb & gutter adjacent No. 18

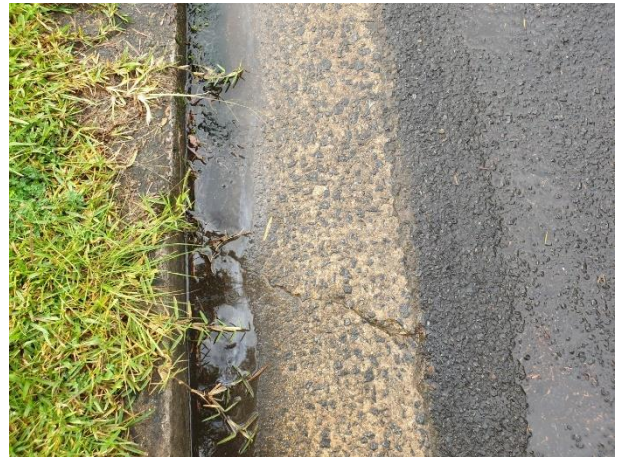
Photo 2.1-76
Cracking observed in kerb & gutter adjacent No. 20

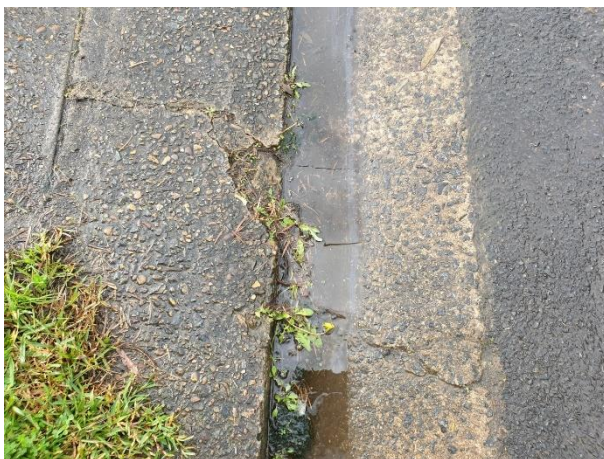
Photo 2.1-77
Chipping observed in layback to No. 20

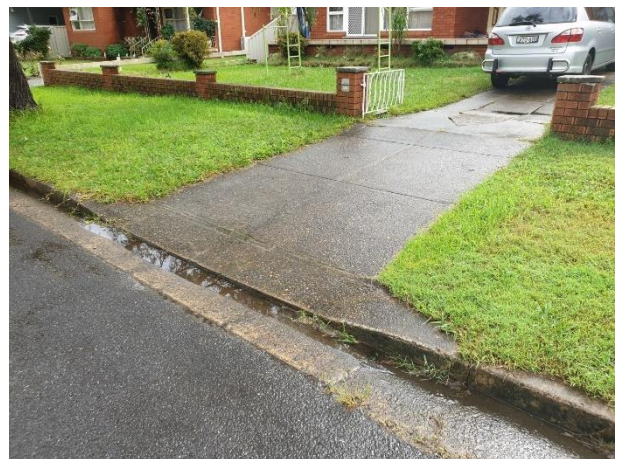
Photo 2.1-78
Existing condition of driveway to No. 20 (facing north)

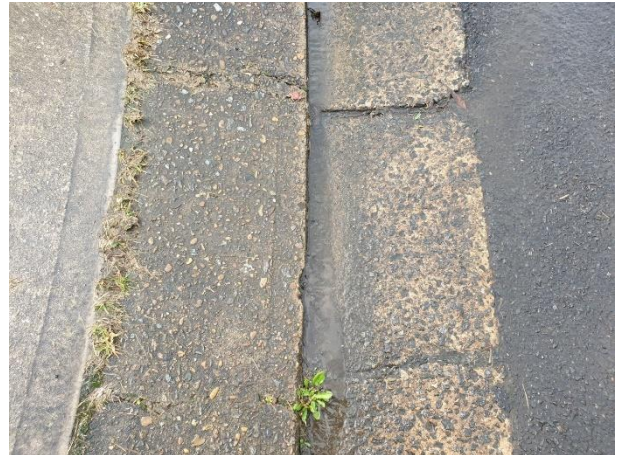
Photo 2.1-80
Cracking observed in layback to No. 22

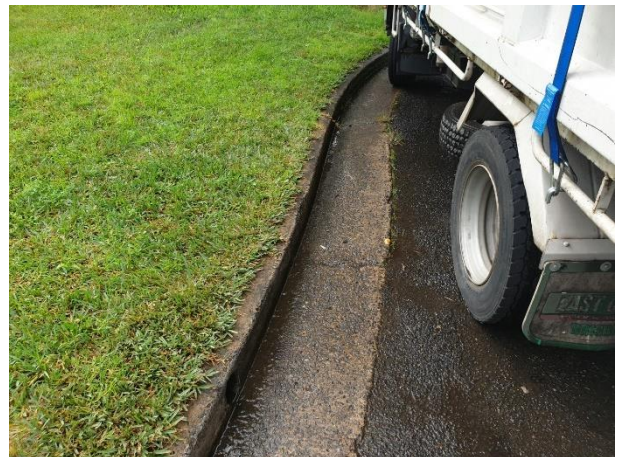
Photo 2.1-82
Existing condition of kerb & gutter adjacent No. 22 (facing north-east)

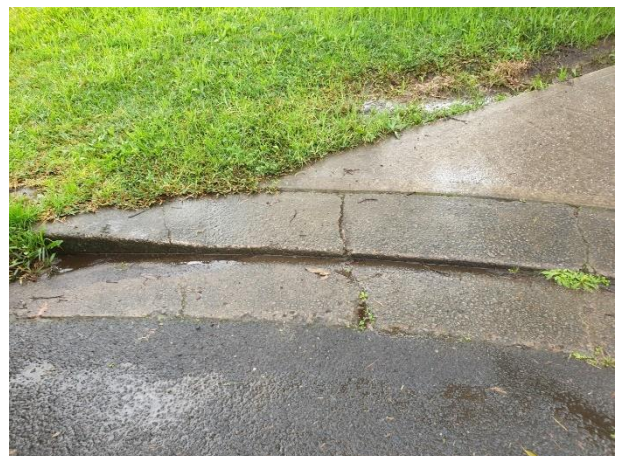
Photo 2.1-84
Cracking observed in layback to No. 24 (facing north)

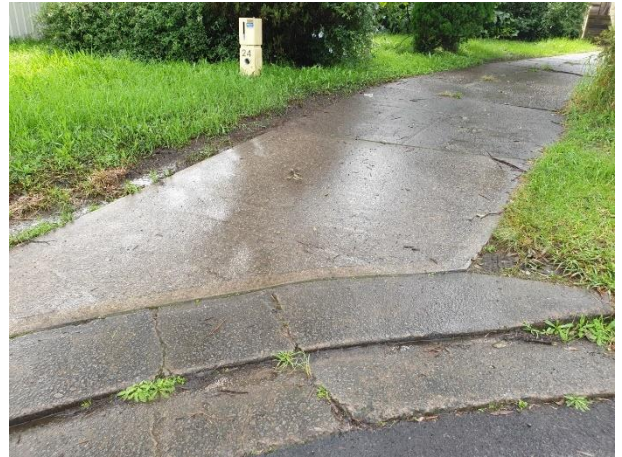
Photo 2.1-86
Cracking observed in layback to No. 24 (facing north)

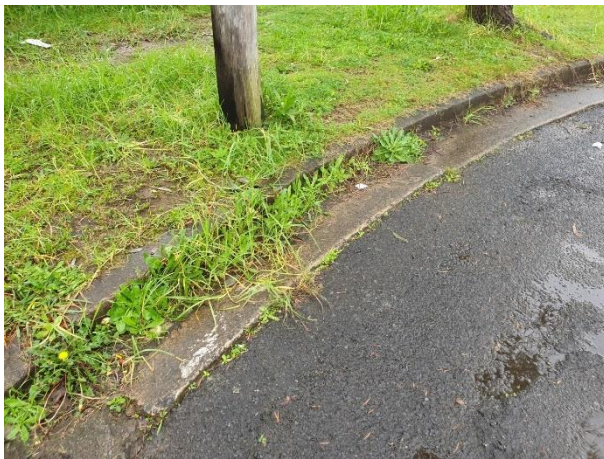
Photo 2.1-87
Existing condition of kerb & gutter adjacent No. 24 (facing north)

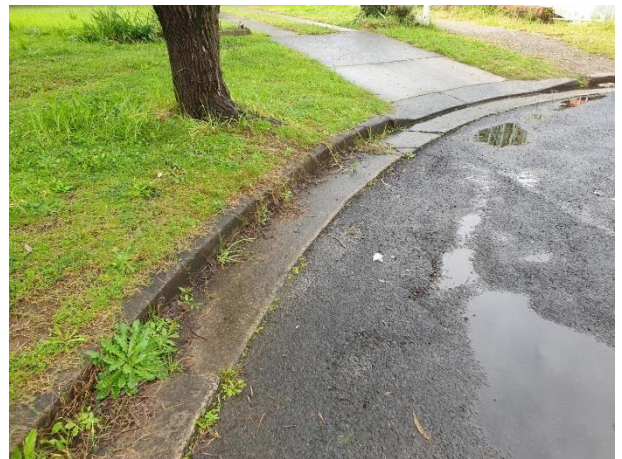
Photo 2.1-88
Existing condition of kerb and gutter and road surface adjacent to No. 24 (facing east)

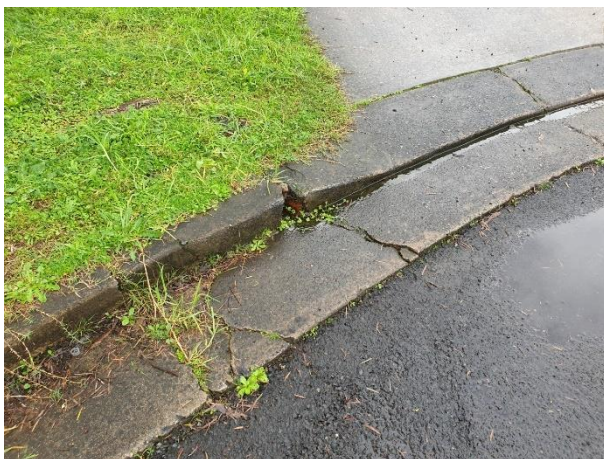
Photo 2.1-89
Cracking observed in layback to No. 26 (facing east)

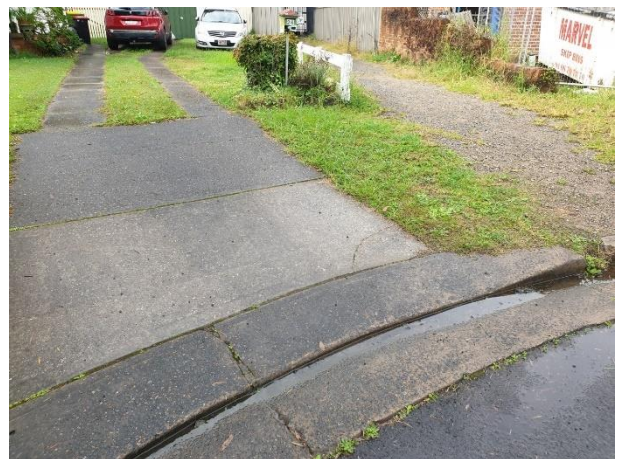
Photo 2.1-90
Cracking observed in layback to No. 26 (facing east)

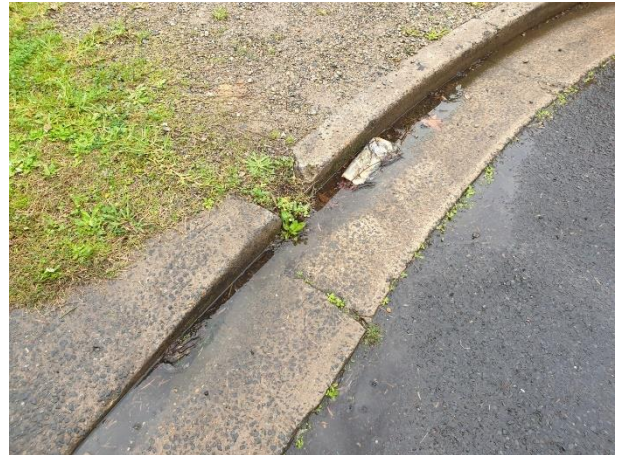
Photo 2.1-92
Chipping of kerb and gutter observed adjacent No. 26 (facing east)

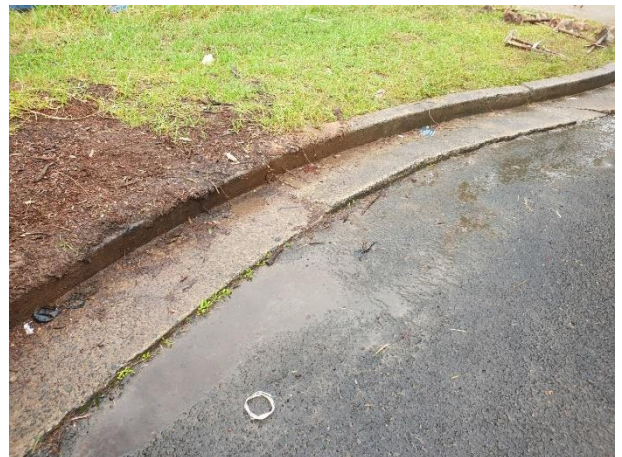
Photo 2.1-94
Existing condition of verge, kerb and gutter and road surface adjacent No. 28

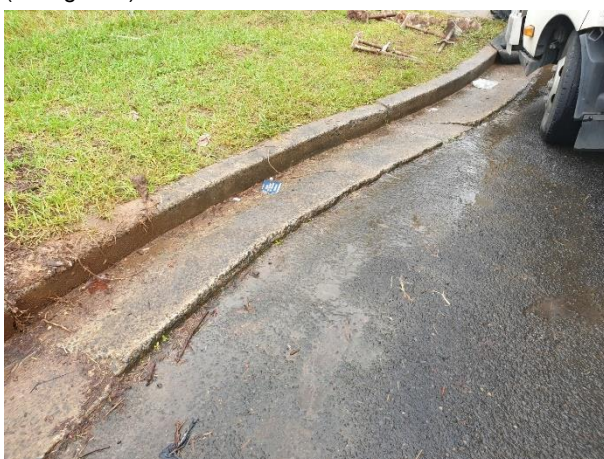
Photo 2.1-95
Existing condition of kerb and gutter and road surface adjacent No. 28 (construction works occurring at No. 28)

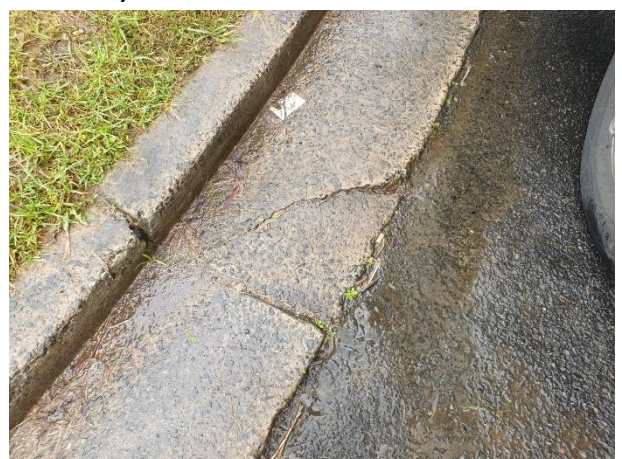
Photo 2.1-96
Cracking observed in kerb and gutter adjacent No. 28 (facing south)

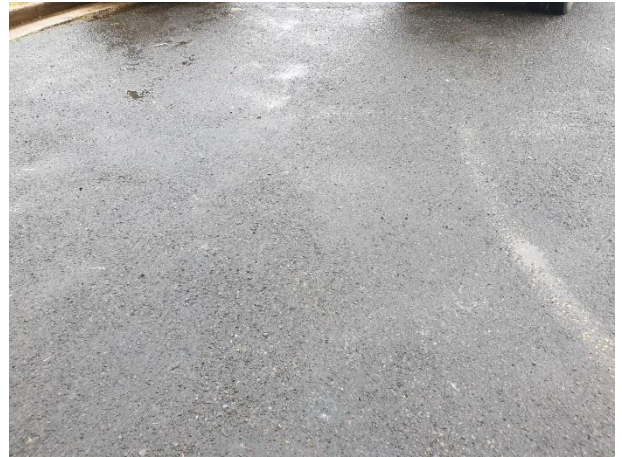
Photo 2.1-98
Existing condition of road surface adjacent No. 28 (facing north)

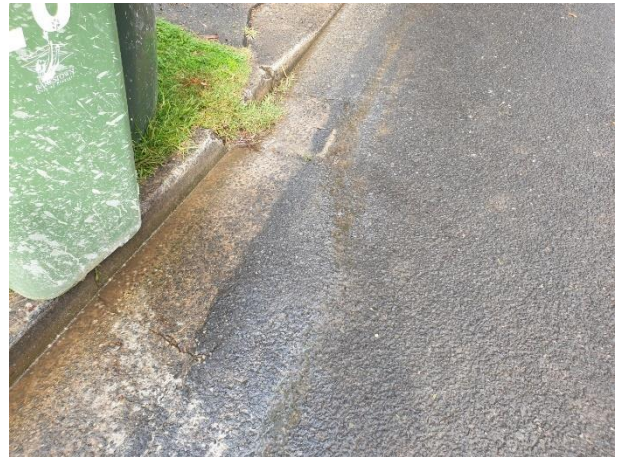
Photo 2.1-100
Existing condition of kerb and gutter adjacent No. 28 (facing south)

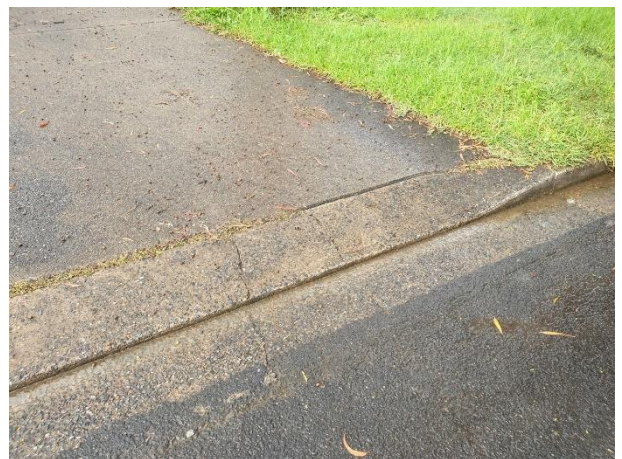
Photo 2.1-102
Cracking observed in layback to No. 30 (facing east)

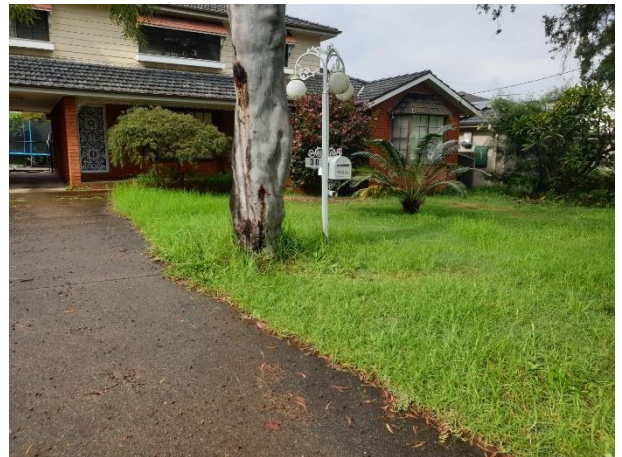
Photo 2.1-104

Existing condition of driveway to No. 30 (facing east)

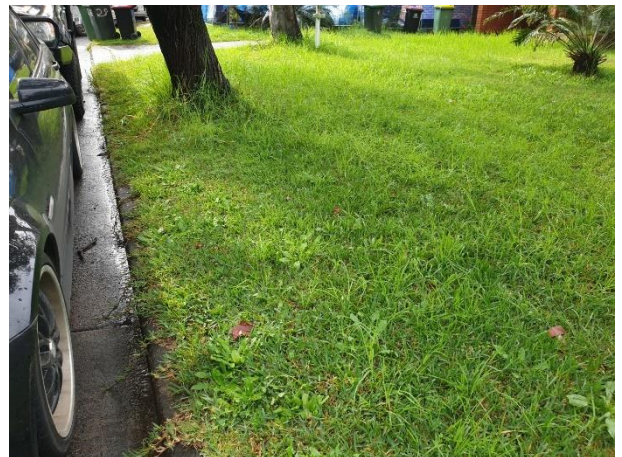
Photo 2.1-106

Existing condition of verge adjacent No. 30 (facing north)

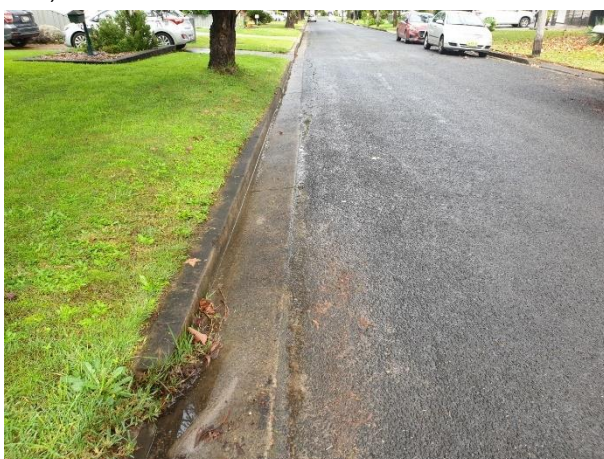
Photo 2.1-107

Existing condition of verge, kerb & gutter and road surface adjacent No. 30 (facing south)

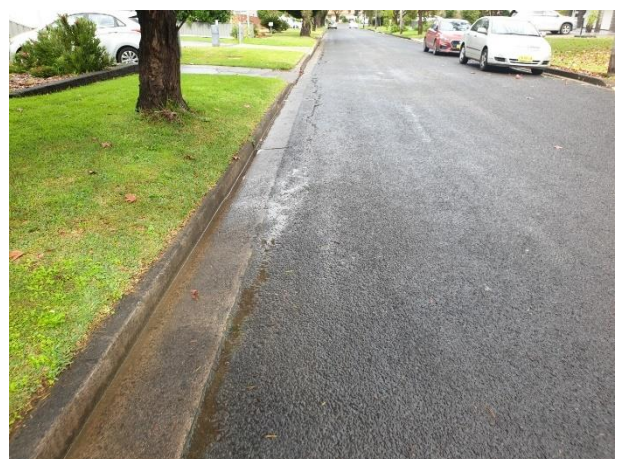
Photo 2.1-108

Existing condition of verge, kerb & gutter and road surface adjacent No. 30 (facing south)

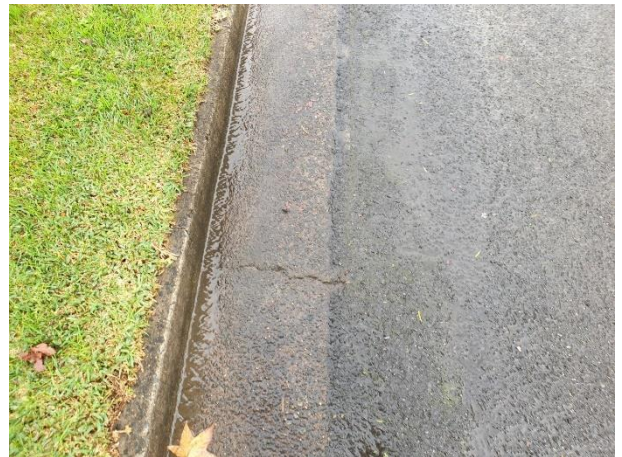
Photo 2.1-110
Cracking observed in kerb & gutter adjacent No. 32

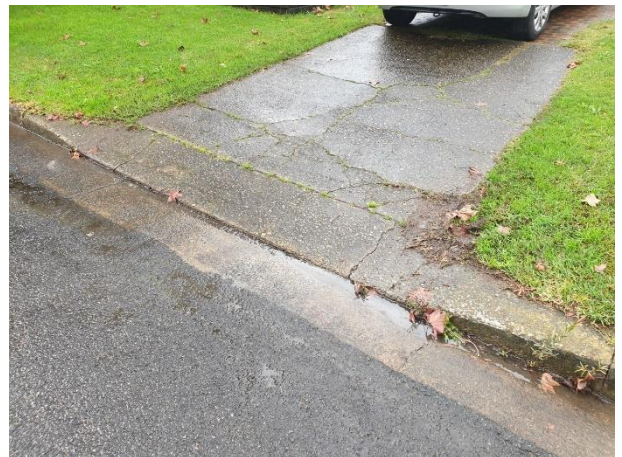
Photo 2.1-112
Existing condition of driveway and kerb and gutter adjacent No. 32 (facing east)

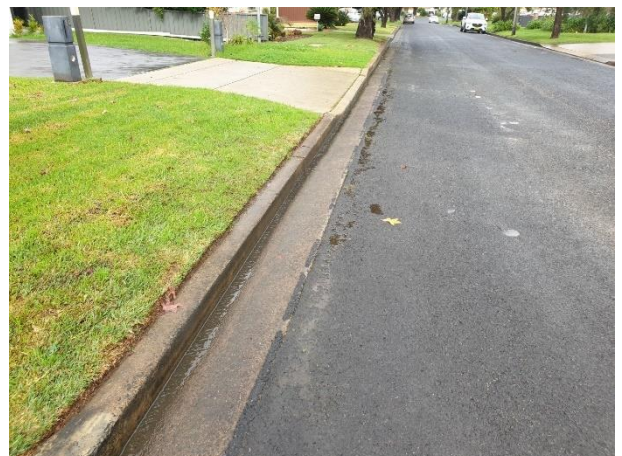
Photo 2.1-114
Existing condition of kerb and gutter and road surface adjacent No. 32 (facing south)

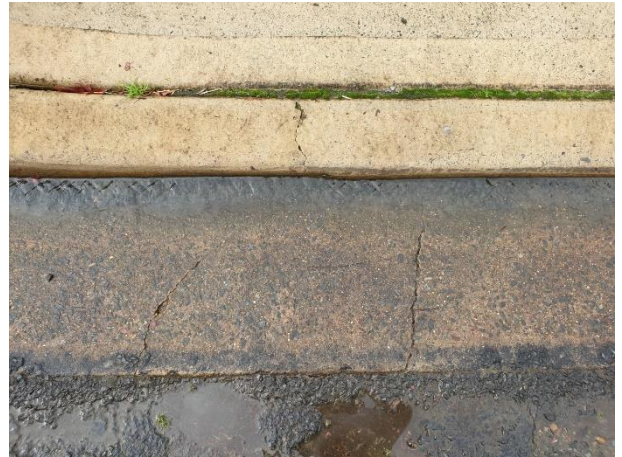
Photo 2.1-116

Cracking observed in layback to No. 34

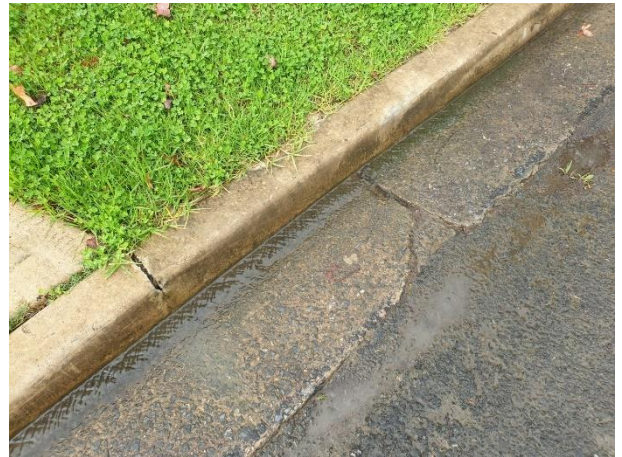
Photo 2.1-118

Cracking observed in kerb & gutter adjacent No. 34 (facing south east)
