## **Preliminary Site Investigation**

427 Burwood Road

Belmore NSW 2192

E21260-1

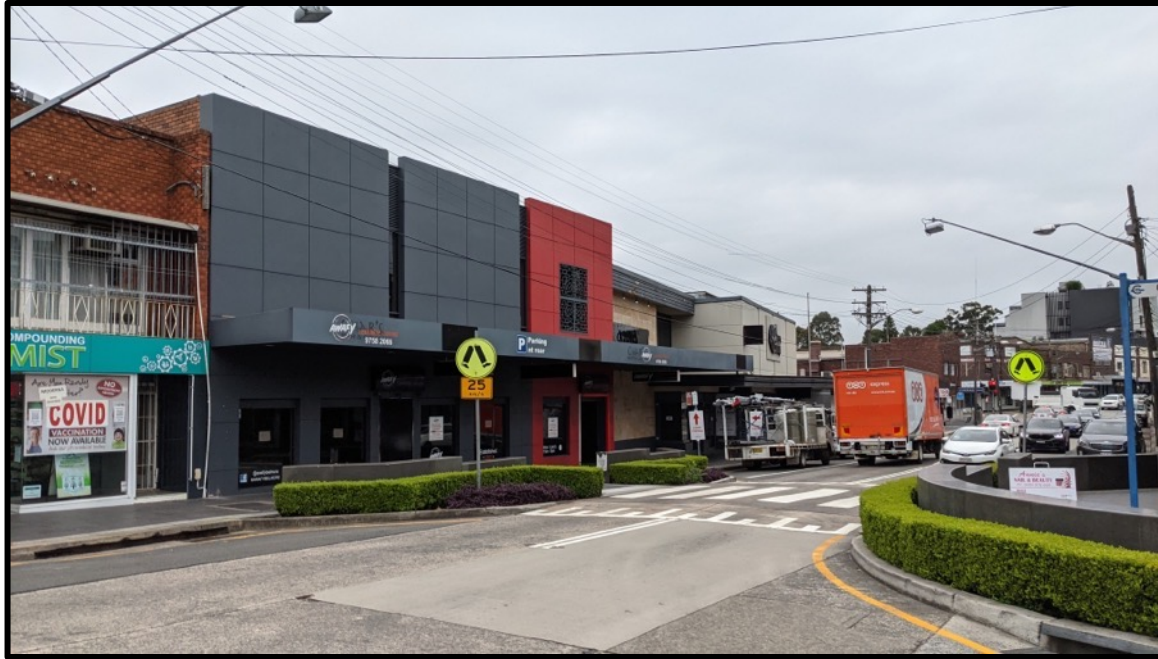
Figure 10. View of site from Burwood Road, the site contained a two storey brick and concrete commercial building with an awning.

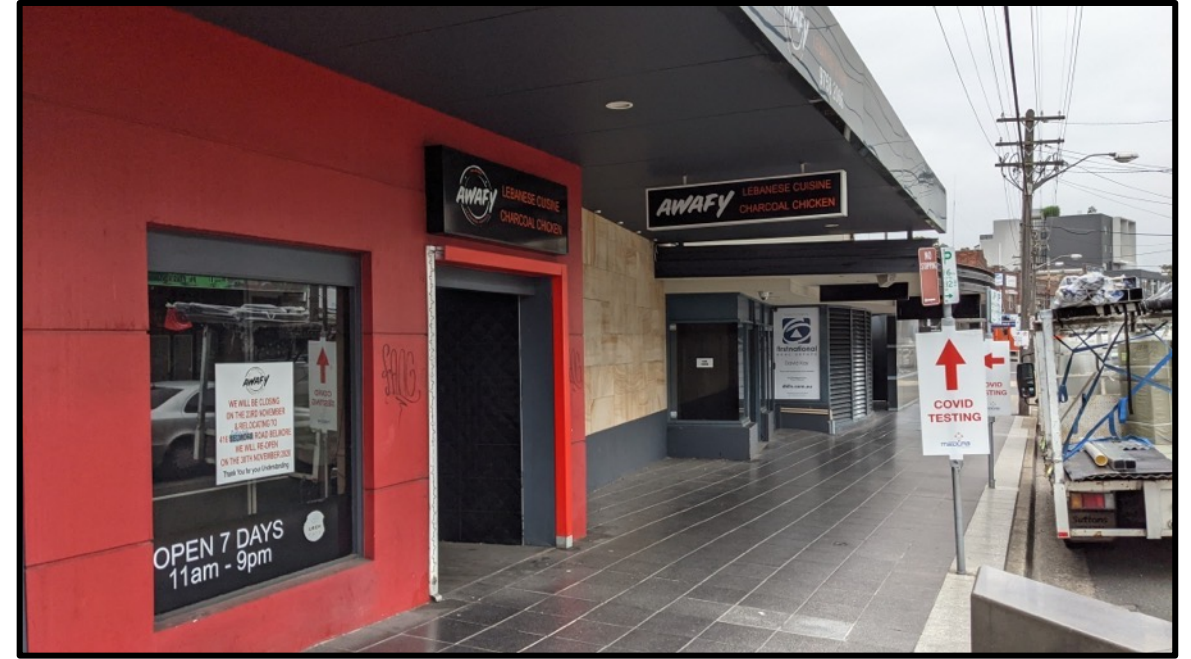
Figure 11. The entrance to the site was tiled and sealed.

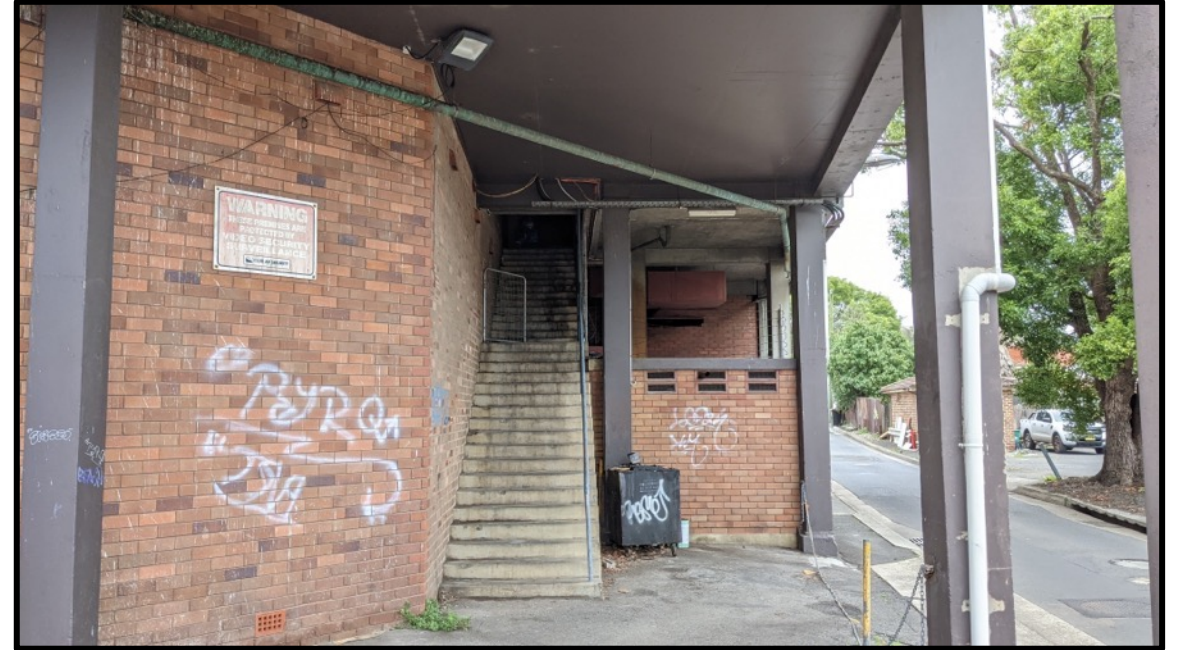
Figure 15. Rear of the site. The site building was bricked in this area, supported by concrete pylons and had a concrete staircase. Graffiti was present across much of the first storey external walls.

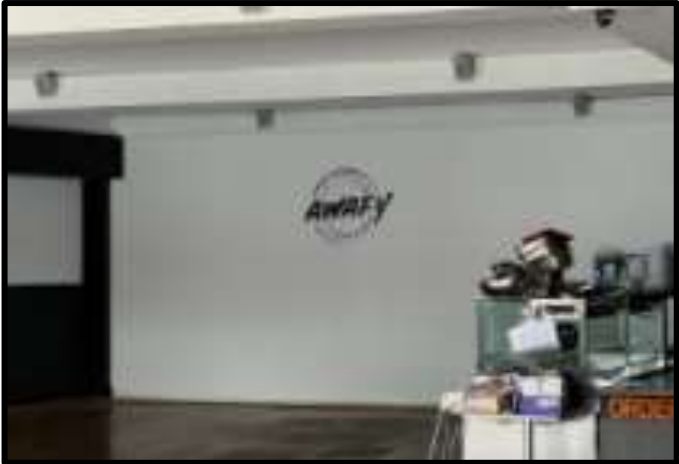
Occurrence	Friability	Status	Occurrence Details	Comments and Risk Assessment	Image
<b>ASBESTOS</b>					
Wall material present within the rear end of the store.	Non-Friable	Negative	First Recorded: 17.02.21 Reinspection Due: 17.02.26 Labelled: No Removed: Yes Sample Tested: Yes  <b>Name: Sample 2</b>  <b>No Asbestos Detected</b>  <b>Lead: &lt;0.001 mg/kg</b>	<b>Low Risk</b>  There was minimal risk in obtaining the sample. It is recommended that appropriate PPE should be worn by field technician to minimise risk of injury.

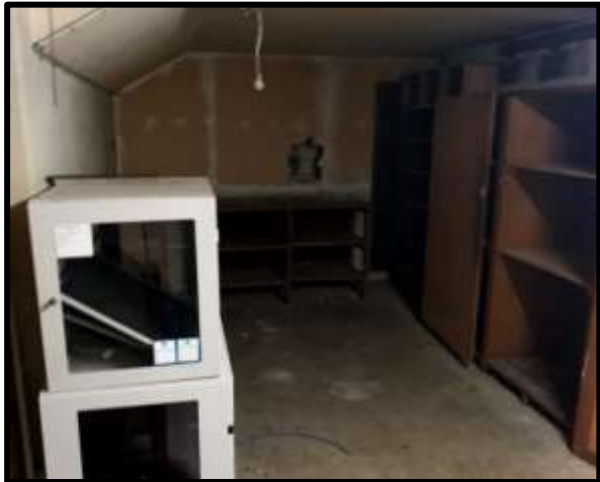
Material from a room located between the un – named storefront and AWAFY.	Non-Friable	Negative	<p>First Recorded: 17.02.21 Reinspection Due: 17.02.26 Labelled: No Removed: Yes Sample Tested: Yes</p> <p><b>Name: Sample 4</b></p> <p><b>No Asbestos Detected</b></p> <p><b>Lead: &lt;0.001 mg/kg</b></p>	<p><b>Low Risk</b></p> <p>There was minimal risk in obtaining the sample. It is recommended that appropriate PPE should be worn by field technician to minimise risk of injury.</p>

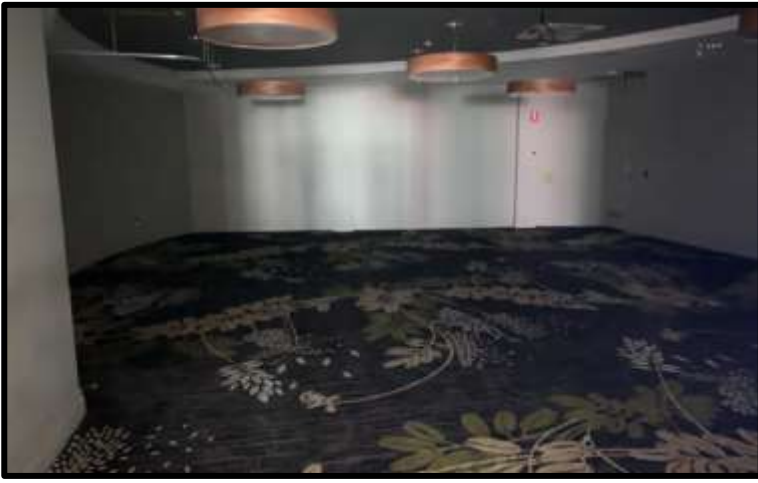
Wall material from the main hallway of the un – named storefront.	Non-Friable	Negative	<p>First Recorded: 17.02.21 Reinspection Due: 17.02.26 Labelled: No Removed: Yes Sample Tested: Yes</p> <p><b>Name: Sample 5</b></p> <p><b>No Asbestos Detected</b></p>	<p><b>Low Risk</b></p> <p>There was minimal risk in obtaining the sample. It is recommended that appropriate PPE should be worn by field technician to minimise risk of injury.</p>

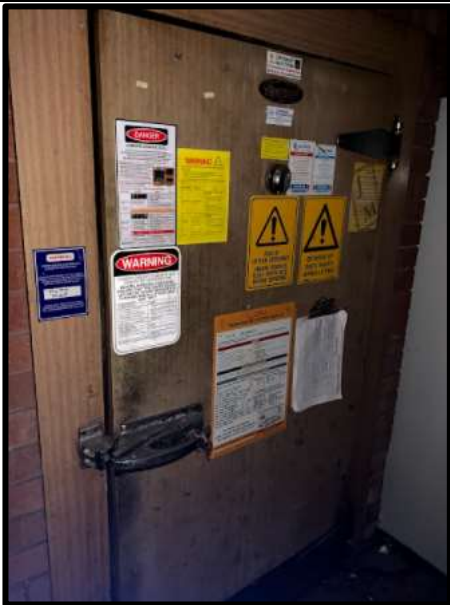
Electrical room within the ground floor	Non - Friable	Positive	First Recorded: 17.02.21 Reinspection Due: 17.02.26 Labelled: No Removed: No Sample Tested: No	<p><b>Low Risk</b></p> <p>No sample was taken due no access to the area.</p> <p>It is recommended that appropriate PPE should be worn by field technician to minimise risk of injury if/when sample if being collected.</p>

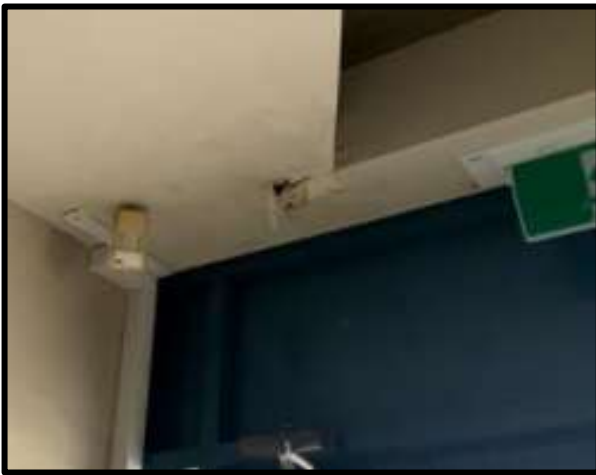
<b>LEAD PAINT</b>					
Lead paint from the entrance of the un – named store front.	NA	Negative	First Recorded: 17.02.21 Reinspection Due: 17.02.26 Labelled: Yes Removed: Yes Sample Tested: Yes  <b>Name: Sample 1</b>  <b>Lead Paint: &lt;0.001 mg/kg</b>	<p><b>Low Risk</b></p> <p>There was minimal risk in obtaining the sample.</p> <p>However, it is recommended that appropriate PPE should be worn by field technician to minimise risk of injury.</p>

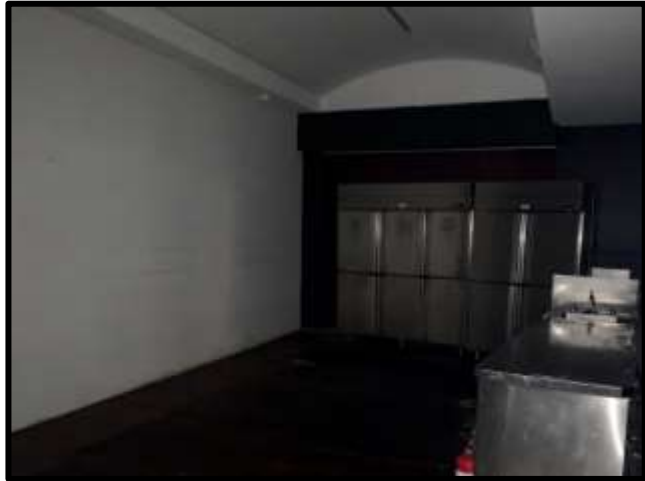
Paint material from the rear end room of AWAFY.	NA	Negative	<p>First Recorded: 17.02.21 Reinspection Due: 17.02.26 Labelled: No Removed: No Sample Tested: No</p> <p><b>Name: Sample 3</b></p> <p><b>Lead Paint: &lt;0.001 mg/kg</b></p>	<p><b>Low Risk</b></p> <p>There was minimal risk in obtaining the sample.</p> <p>However, it is recommended that appropriate PPE should be worn by field technician to minimise risk of injury.</p>

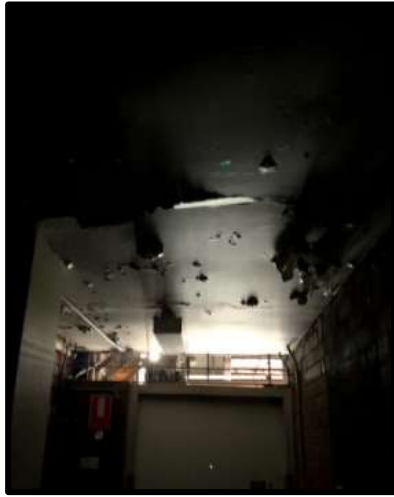
Paint material from the ceiling of one of the room.	Yes	Positive	<p>First Recorded: 17.02.21 Reinspection Due: 17.02.26 Labelled: Yes Removed: Yes Sample Tested: Yes</p> <p><b>Name: Sample 6</b></p> <p><b>Lead Paint: 0.12 mg/kg</b></p>	<p><b>Low Risk</b></p> <p>There was minimal risk in obtaining the sample.</p> <p>It is recommended that appropriate PPE should be worn by field technician to minimise risk of injury.</p>

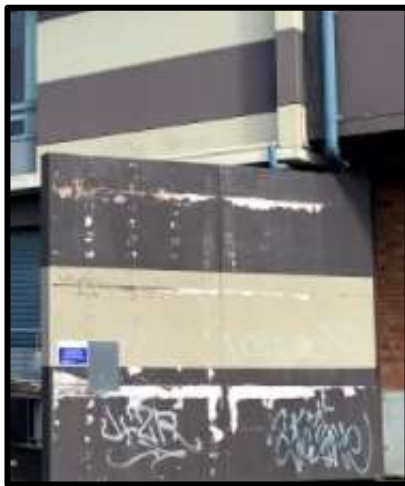
Paint located outside the building.	NA	N/A	First Recorded: 17.02.21 Reinspection Due: 17.02.26 Labelled: No Removed: No Sample Tested: No	<b>Low Risk</b>  No sample was taken.  It is recommended that appropriate PPE should be worn by field technician to minimise risk of injury.

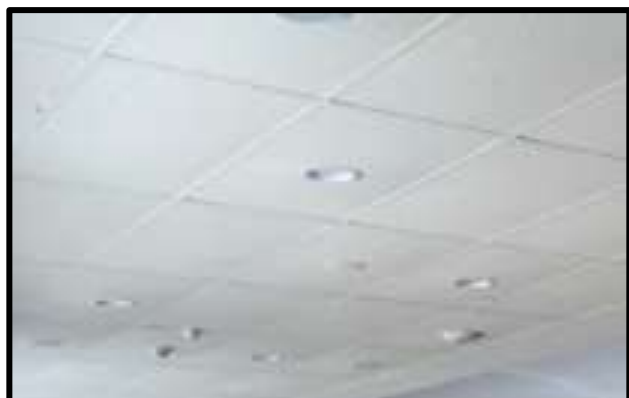
<b>PCB</b>					
Down lights within Store	N/A	Assumed Negative	First Recorded: 17.02.21 Reinspection Due: 17.02.26 Labelled: No Removed: No Sample Tested: No	<b>Low Risk</b>  No sample was taken due to the light being in viable condition.  It is recommended that appropriate PPE should be worn by field technician to minimise risk of injury.

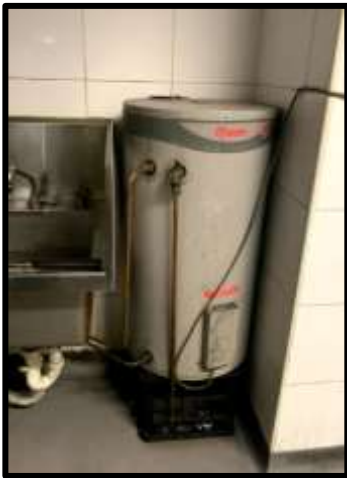
SMF					
Water heater within the kitchen area.	N/A	Assumed positive	First Recorded: 17.02.21 Reinspection Due: 17.02.26 Labelled: No Removed: No Sample Tested: No	<b>Low Risk</b>  No sample was taken due to the items being in viable conditions.  It is recommended that appropriate PPE should be worn by field technician to minimise risk of injury.

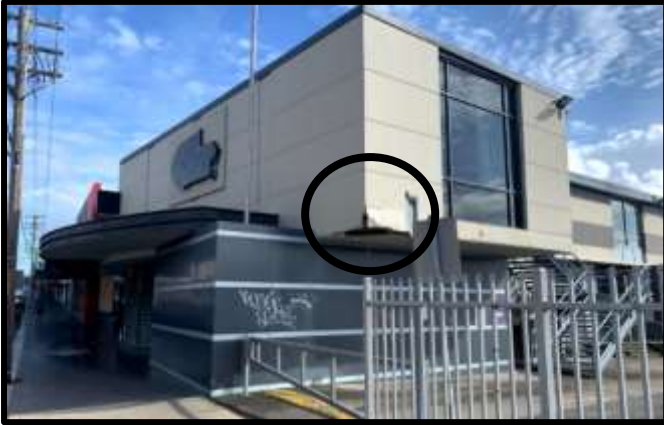
Image 1: Depicts the front view of the site. The site is a two-level structural dwelling used for commercial purposes. There is a vent coming out of the structure. In addition, there is an area which is eroding (seen from circle).
