Hazardous Materials Survey

7A Racecourse Road, West Gosford NSW

Report No. A1292_HMS_140524

Date: 17 May 2024

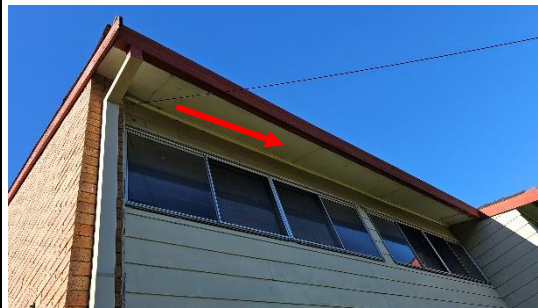
Asbestos Health Risk / Action Rating	Hazard Management Recommendations			Remediation Action (where applicable)			
Minimal Risk R4	The material is in good condition. In its current state this material does not pose an immediate health risk to Site users unless disturbed.			Remove by Class B Licensed Asbestos Removalist prior to renovation or demolition works			
Location - Description		Hazardous Material	Condition	Quantity	Sample ID	Labelled / Signage	Photo(s)
Residence – Exterior– cladding – all aspects – asbestos cement sheet		Chrysotile (non-friable)	Fair Weathered, some minor damage	~ 155 m ²	24-My0039206	No

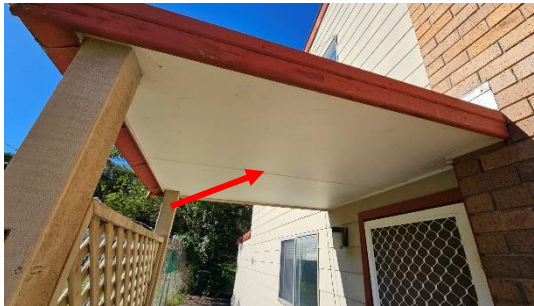
Asbestos Health Risk / Action Rating	Hazard Management Recommendations			Remediation Action (where applicable)			
Minimal Risk R4	The material is in good condition. In its current state this material does not pose an immediate health risk to Site users unless disturbed.			Remove by Class B Licensed Asbestos Removalist prior to renovation or demolition works commencing			
Location - Description		Hazardous Material	Condition	Quantity	Sample ID	Labelled / Signage	Photo(s)
Residence - Exterior – entry ceiling (above entrance door) – western aspect – ceiling lining – asbestos cement sheet		Chrysotile Asbestos (non-friable)	Good No damage	~0.25 m ²	Same as 11222.07/AS14	No

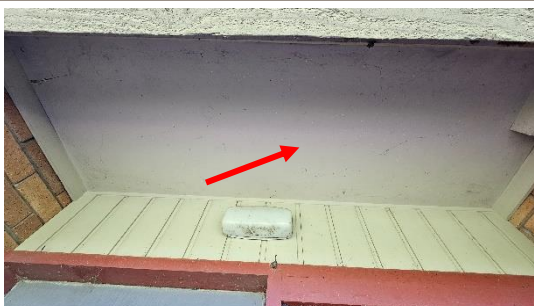
Asbestos Health Risk / Action Rating	Hazard Management Recommendations			Remediation Action (where applicable)			
Minimal Risk R4	The material is in good condition. In its current state this material does not pose an immediate health risk to Site users unless disturbed.			Remove by Class B Licensed Asbestos Removalist prior to renovation or demolition works commencing			
Location - Description		Hazardous Material	Condition	Quantity	Sample ID	Labelled / Signage	Photo(s)
Residence - Exterior – ceiling (above rear entrance door) – eastern aspect – ceiling lining – asbestos cement sheet		Chrysotile Asbestos (non-friable)	Good No damage	~2 m ²	Same as 11222.07/AS14	No

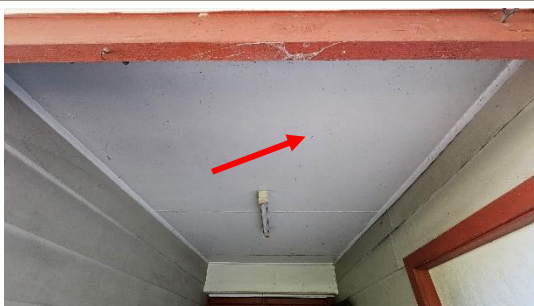
Asbestos Health Risk / Action Rating	Hazard Management Recommendations			Remediation Action (where applicable)			
Minimal Risk R4	The material is in good condition. In its current state this material does not pose an immediate health risk to Site users unless disturbed.			Remove by Class B Licensed Asbestos Removalist prior to renovation or demolition works commencing

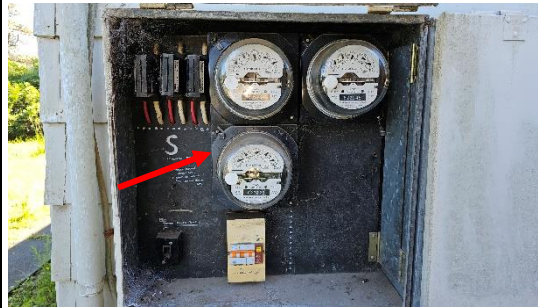
Asbestos Health Risk / Action Rating	Hazard Management Recommendations			Remediation Action (where applicable)			
N/A	The material is in good condition. This material does not pose a health risk to Site users. Labelled incorrectly as containing asbestos.			Remove asbestos warning label

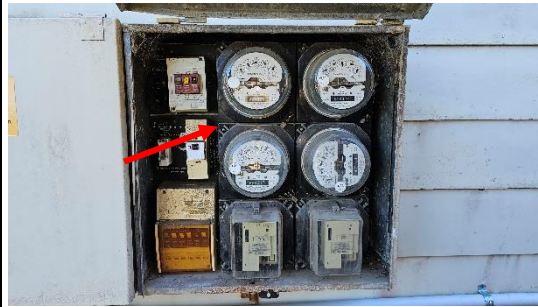
Asbestos Health Risk / Action Rating	Hazard Management Recommendations			Remediation Action (where applicable)			
N/A	The material is in good condition. This material does not pose a health risk to Site users. Labelled incorrectly as containing asbestos.			Remove asbestos warning label

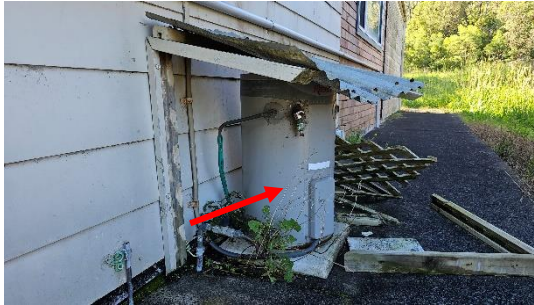
Asbestos Health Risk / Action Rating	Hazard Management Recommendations			Remediation Action (where applicable)			
N/A	The material is in good condition. In its current state this material does not pose an immediate health risk to Site users unless disturbed.			Remove prior to renovation or demolition works commencing			
Location - Description		Hazardous Material	Condition	Quantity	Sample ID	Labelled / Signage	Photo(s)
Residence - Exterior – all aspects – cream paint		Paint (Lead Free <0.1%)	Fair Flaking and heavily worn on southern aspect	-	Pb1	N/A

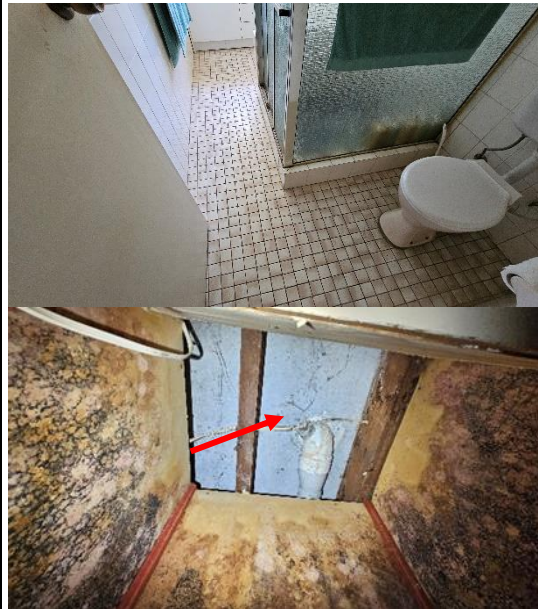
Asbestos Health Risk / Action Rating	Hazard Management Recommendations			Remediation Action (where applicable)			
Low Risk R3	The material is in fair condition. In its current state this material does not pose an immediate health risk to Site users unless disturbed.			Remove by Class B Licensed Asbestos Removalist prior to renovation or demolition works

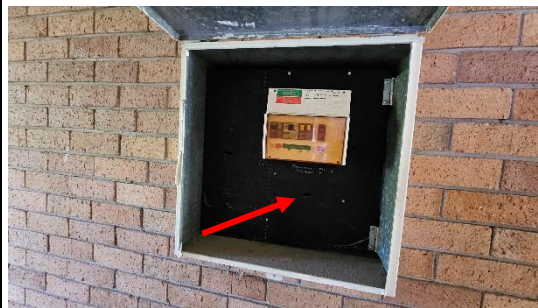
Asbestos Health Risk / Action Rating	Hazard Management Recommendations			Remediation Action (where applicable)			
Low Risk R3	The material is in fair condition. In its current state this material does not pose an immediate health risk to Site users unless disturbed.			Remove by Class B Licensed Asbestos Removalist prior to renovation or demolition works

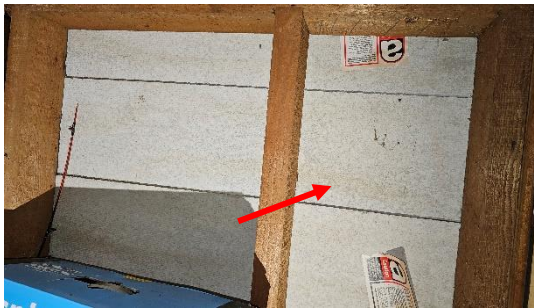
Asbestos Health Risk / Action Rating	Hazard Management Recommendations			Remediation Action (where applicable)			
Low Risk R3	The material is in fair condition. In its current state this material does not pose an immediate health risk to Site users unless disturbed.			Remove by Class B Licensed Asbestos Removalist prior to renovation or demolition works			
Location - Description		Hazardous Material	Condition	Quantity	Sample ID	Labelled / Signage	Photo(s)
Residence – Interior – first floor – bathroom – wall linings – fibre cement sheet		No asbestos detected	Good No damage	-	Same as 11222.07/AS12	N/A

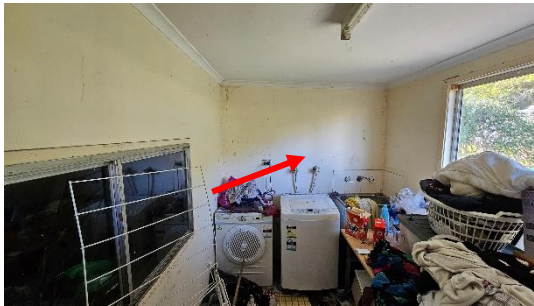
Asbestos Health Risk / Action Rating	Hazard Management Recommendations			Remediation Action (where applicable)			
N/A	The material is in good condition. This material does not pose a health risk to Site users.			-

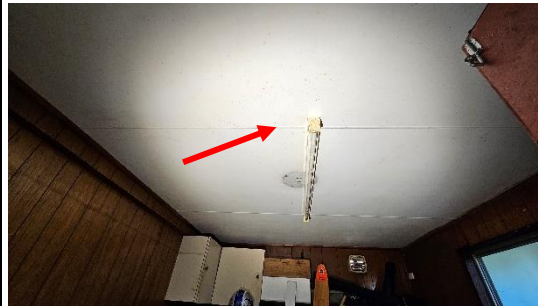
Asbestos Health Risk / Action Rating	Hazard Management Recommendations			Remediation Action (where applicable)			
N/A	The material is in good condition. This material does not pose a health risk to Site users.			-			
Location - Description		Hazardous Material	Condition	Quantity	Sample ID	Labelled / Signage	Photo(s)
Laundry – Interior – ground floor –eastern laundry – wall linings – fibre cement sheet		No asbestos detected	Good No damage	-	11222.07/AS11	N/A

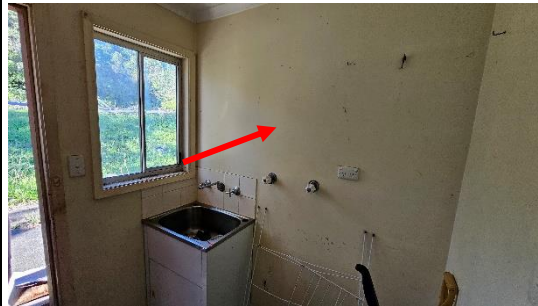
Asbestos Health Risk / Action Rating	Hazard Management Recommendations			Remediation Action (where applicable)			
N/A	The material is in good condition. This material does not pose a health risk to Site users.			-

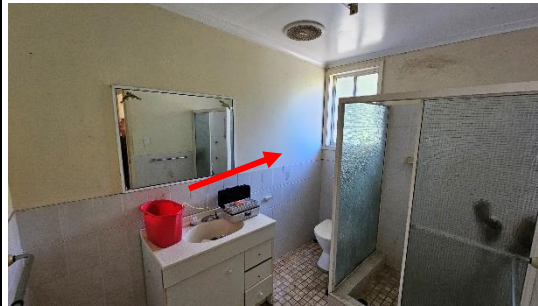
Asbestos Health Risk / Action Rating	Hazard Management Recommendations			Remediation Action (where applicable)			
N/A	The material is in good condition. This material does not pose a health risk to Site users.			-

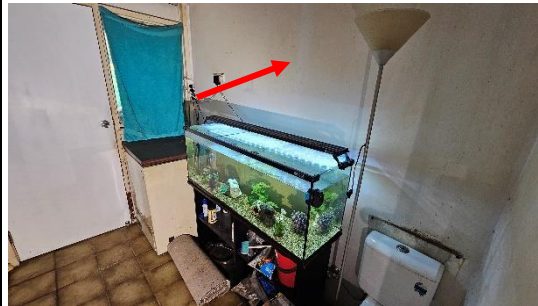
Asbestos Health Risk / Action Rating	Hazard Management Recommendations			Remediation Action (where applicable)			
N/A	The material is in good condition. This material does not pose a health risk to Site users.			-			
Location - Description		Hazardous Material	Condition	Quantity	Sample ID	Labelled / Signage	Photo(s)
Residence - Interior – ground floor – hot water system – metal encased synthetic mineral fibre insulation		Synthetic Mineral Fibre	Good No damage	-	-	No

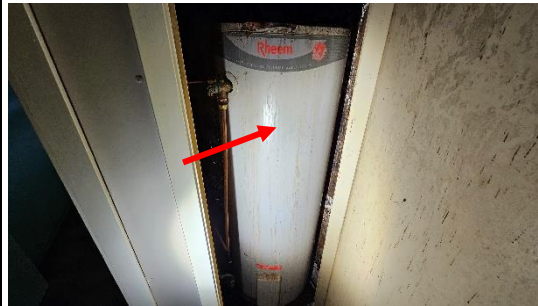
Asbestos Health Risk / Action Rating	Hazard Management Recommendations			Remediation Action (where applicable)			
N/A	The material is in good condition. In its current state this material does not pose an immediate health risk to Site users unless disturbed.			Remove prior to renovation or demolition works commencing

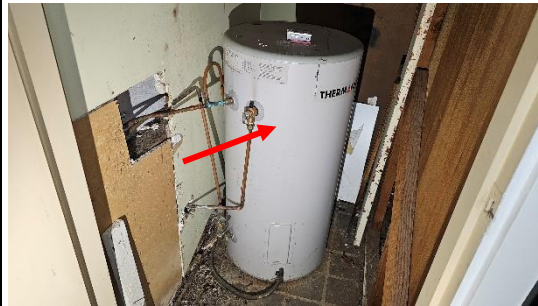
Asbestos Health Risk / Action Rating	Hazard Management Recommendations			Remediation Action (where applicable)			
N/A	The material is in good condition. In its current state this material does not pose an immediate health risk to Site users unless disturbed.			Remove prior to renovation or demolition works commencing

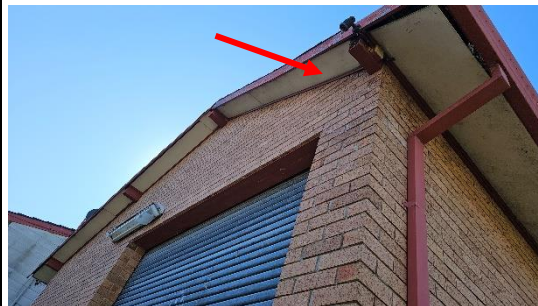
Asbestos Health Risk / Action Rating	Hazard Management Recommendations			Remediation Action (where applicable)			
Low Risk R3	The material is in fair condition. In its current state this material does not pose an immediate health risk to Site users unless disturbed.			Remove by Class B Licensed Asbestos Removalist prior to renovation or demolition works			
Location - Description		Hazardous Material	Condition	Quantity	Sample ID	Labelled / Signage	Photo(s)
Garage – Exterior – tile verge – eastern and western aspects – asbestos cement sheet		Chrysotile (non-friable)	Fair Weathered	~ 14 lineal metres	11222.07/AS15	No

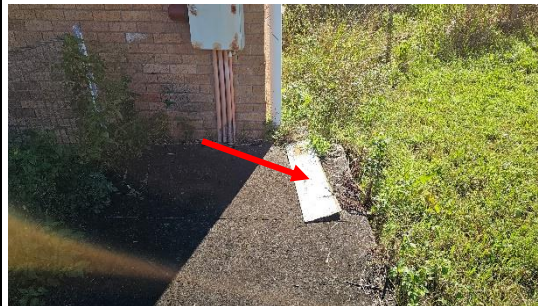
Asbestos Health Risk / Action Rating	Hazard Management Recommendations			Remediation Action (where applicable)			
Moderate Risk R2	The material is in fair condition. In its current state this material does pose an immediate health risk to Site users if disturbed.			Remove by Class B Licensed Asbestos Removalist before further disturbance

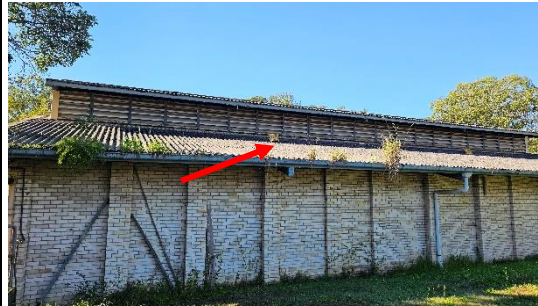
Asbestos Health Risk / Action Rating	Hazard Management Recommendations			Remediation Action (where applicable)			
Moderate Risk R2	The material is in poor condition. In its current state this material does pose an immediate health risk to Site users if disturbed.			Remove by Class B Licensed Asbestos Removalist before further disturbance

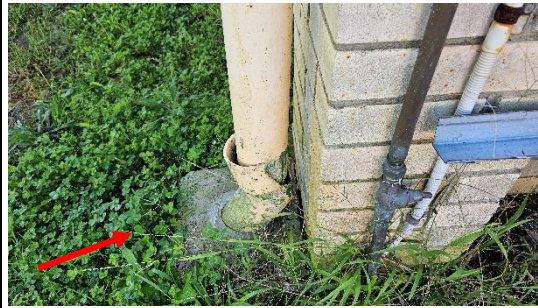
Asbestos Health Risk / Action Rating	Hazard Management Recommendations			Remediation Action (where applicable)			
High Risk R1	The material is in friable condition. In its current state this material does pose an immediate health risk to Site users.			Remove by Class A Licensed Asbestos Removalist as soon as practicable

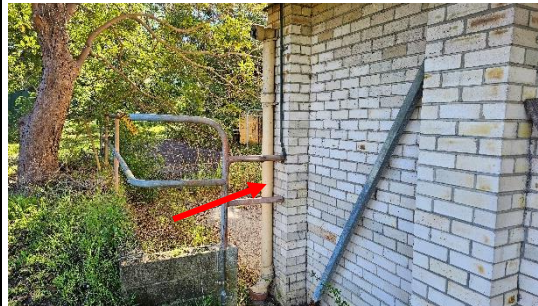
Asbestos Health Risk / Action Rating	Hazard Management Recommendations			Remediation Action (where applicable)			
Moderate Risk R2	The material is in poor condition. In its current state this material does pose an immediate health risk to Site users if disturbed.			Remove by Class B Licensed Asbestos Removalist before further disturbance			
Location - Description		Hazardous Material	Condition	Quantity	Sample ID	Labelled / Signage	Photo(s)
Stables – Exterior – ground surface – northwestern aspect – loose asbestos fibre in soil		Chrysotile & Amosite Asbestos (non-friable)	Poor Exposed	~16 m²	11222.07/AS09	No

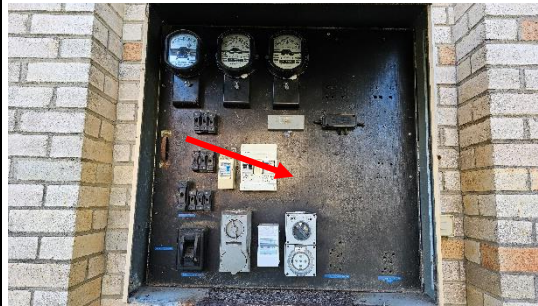
Asbestos Health Risk / Action Rating	Hazard Management Recommendations			Remediation Action (where applicable)			
Low Risk R3	The material is in fair condition. In its current state this material does not pose an immediate health risk to Site users unless disturbed.			Remove by Class B Licensed Asbestos Removalist prior to renovation or demolition works

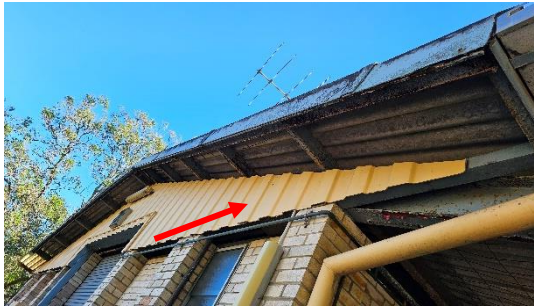
Asbestos Health Risk / Action Rating	Hazard Management Recommendations			Remediation Action (where applicable)			
N/A	The paint is in good condition with no flaking or weathering.			Material should be handled with care and paint encapsulated or removed according to guidelines

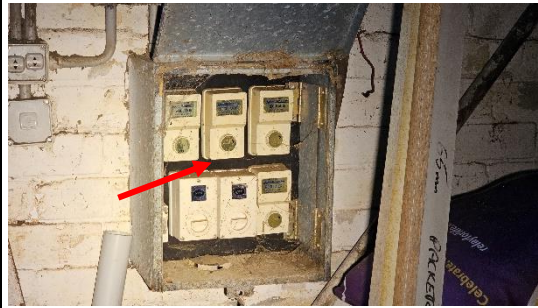
Asbestos Health Risk / Action Rating	Hazard Management Recommendations			Remediation Action (where applicable)			
Low Risk R3	The material is in fair condition. In its current state this material does not pose an immediate health risk to Site users unless disturbed.			Remove by Class B Licensed Asbestos Removalist prior to renovation or demolition works

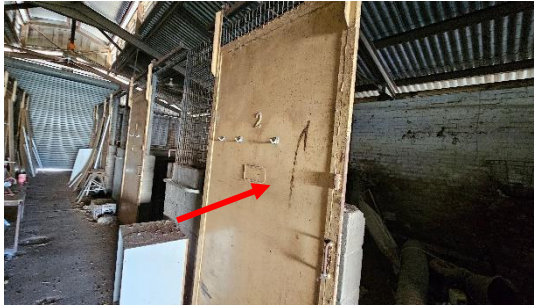
Asbestos Health Risk / Action Rating	Hazard Management Recommendations			Remediation Action (where applicable)			
N/A	The paint is in good condition with minor flaking and weathering.			Material should be handled with care and paint encapsulated or removed according to guidelines			
Location - Description		Hazardous Material	Condition	Quantity	Sample ID	Labelled / Signage	Photo(s)
Stables - Interior – Washroom – hot water system – metal encased synthetic mineral fibre insulation		Synthetic Mineral Fibre	Good No damage	-	-	No

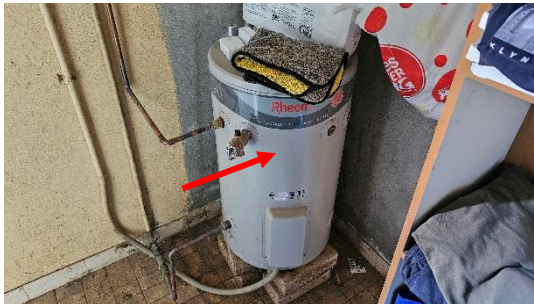
Asbestos Health Risk / Action Rating	Hazard Management Recommendations			Remediation Action (where applicable)			
N/A	The material is in good condition. In its current state this material does not pose an immediate health risk to Site users unless disturbed.			Remove prior to renovation or demolition works commencing

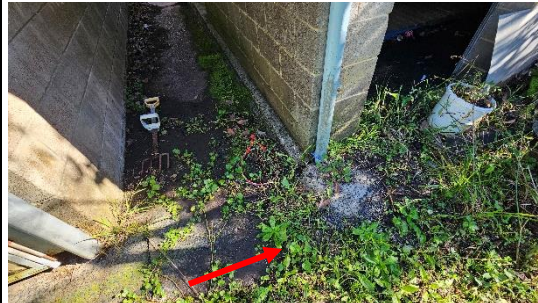
Asbestos Health Risk / Action Rating	Hazard Management Recommendations			Remediation Action (where applicable)			
High Risk R1	The material is in friable condition. In its current state this material does pose an immediate health risk to Site users.			Remove by Class A Licensed Asbestos Removalist as soon as practicable

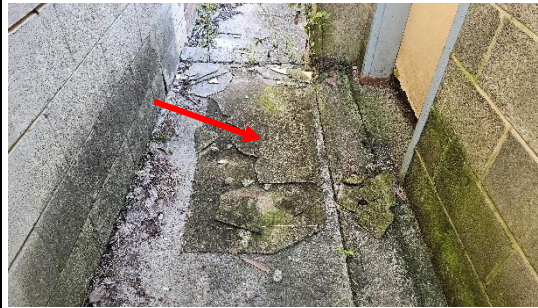
Asbestos Health Risk / Action Rating	Hazard Management Recommendations			Remediation Action (where applicable)			
Moderate Risk R2	The material is in poor condition. In its current state this material does pose an immediate health risk to Site users if disturbed.			Remove by Class B Licensed Asbestos Removalist before further disturbance

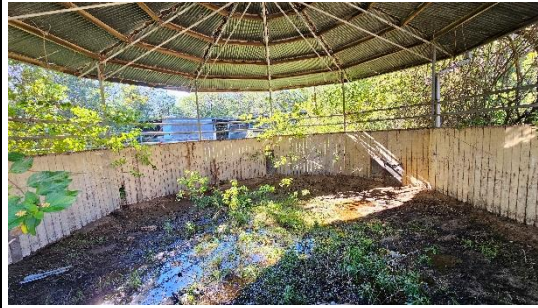
Asbestos Health Risk / Action Rating	Hazard Management Recommendations			Remediation Action (where applicable)			
N/A	The paint is in poor condition with flaking or weathering.			Material should be handled with care and paint encapsulated or removed according to guidelines

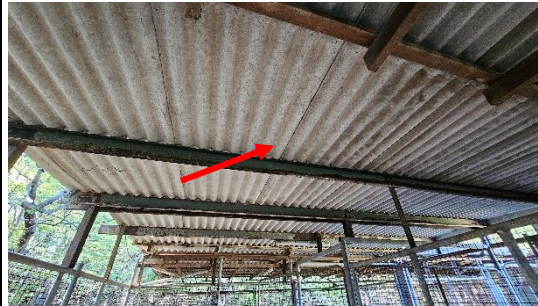
Asbestos Health Risk / Action Rating	Hazard Management Recommendations			Remediation Action (where applicable)			
Moderate Risk R2	The material is in poor condition. In its current state this material does pose an immediate health risk to Site users if disturbed.			Remove by Class B Licensed Asbestos Removalist before further disturbance

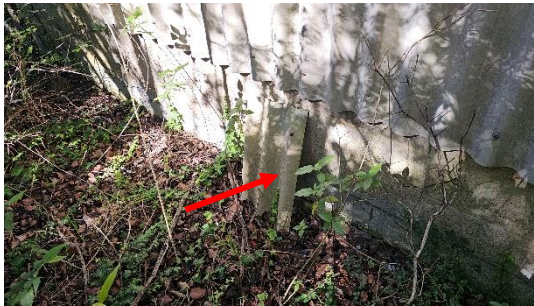
Asbestos Health Risk / Action Rating	Hazard Management Recommendations			Remediation Action (where applicable)			
Moderate Risk R2	The material is in poor condition. In its current state this material does pose an immediate health risk to Site users if disturbed.			Remove by Class B Licensed Asbestos Removalist before further disturbance

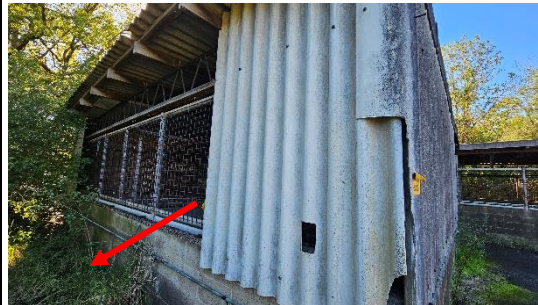
Asbestos Health Risk / Action Rating	Hazard Management Recommendations			Remediation Action (where applicable)			
High Risk R1	The material is in friable condition. In its current state this material does pose an immediate health risk to Site users.			Remove by Class A Licensed Asbestos Removalist as soon as practicable
