Our ref: 7087-G1 26 February 2023

## Ski Patrol Hut, Top of Quad Express Chairlift, Perisher, Centre Valley Geotechnical Assessment

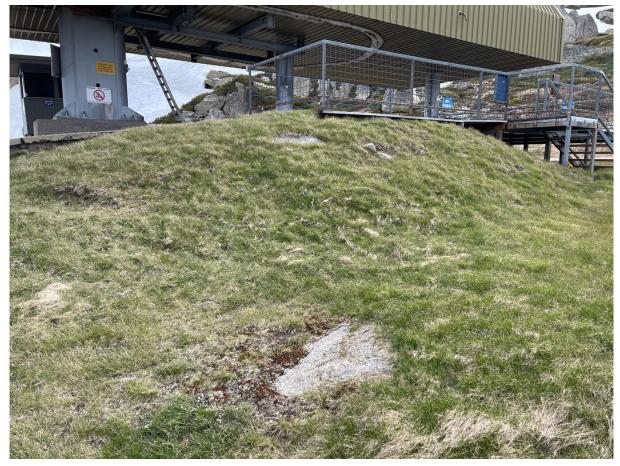
The ground next to the offload ramp where the Ski Hut is to be located has been filled up to about 1.5m depth, as shown in Photos 1 and 2. The fill has been battered at about 2H:1V and has been covered with grass.

**Photo 1**View of proposed Ski Patrol Hut looking across slope to southwest.

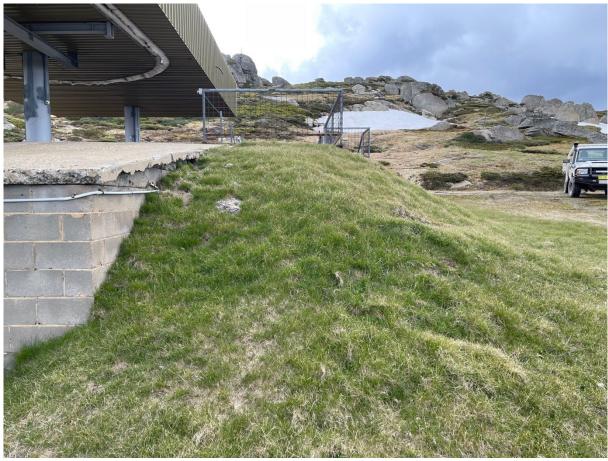
**Photo 2**View of proposed Ski Patrol Hut looking upslope to west-north-west.

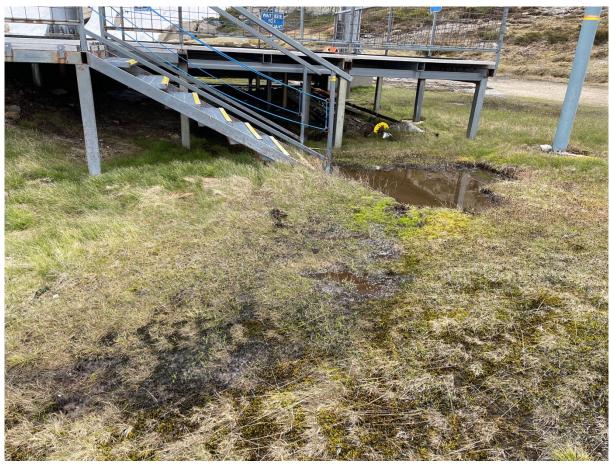
Photo 3

The uphill side of the filled area had ponded water from uphill surface runoff, which drains around the eastern edge of the fill as shown in Photo 3. The water has locally saturated and softened the ground.

Vie of stairs at rear of proposed Ski Hut, looking across slope to southwest. Note ponded surface water at rear, wet / softened ground along drainage flow path downslope.

It is also recommended that surface drainage be improved to prevent water from ponding on the uphill side of the unload and Ski Hut area.
