# Structural Condition Assessment

Norbrick Dr. and Old Windsor Rd. Pedestrian Bridge - Sign Structures

Prepared for: Mulpha Norwest Pty Ltd

Ref No: 2311081

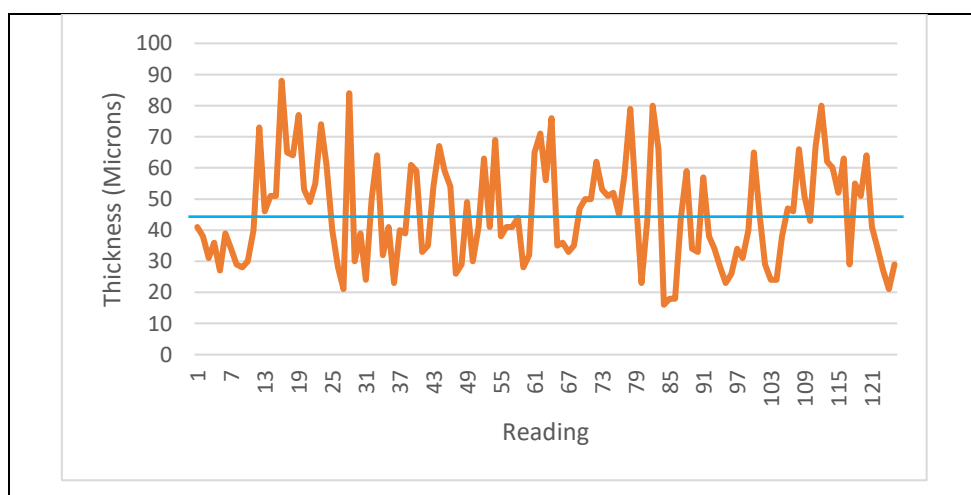
**Figure 7- Paint thickness readings (Sign 1 and Sign 2)**

- The total thickness of the coating (blue coat and the top white coat) over the structural members was measured using PosiTector FND5 thickness gauge. The protective coating has a thickness ranging from 16 microns to 88 microns, with an average of 45.5 microns based on 125 readings (Figure 7).

Localised slight to severe corrosion was observed on the top and bottom members of the sign structural frames. The average coating thickness was measured as 45.5 microns. As per AS/NZS 2312.1 (i.e. guide to the protection of structural steel against atmospheric corrosion by the use of protective coating- Part 1: paint coatings), the sign structures fall under atmospheric corrosivity category C2 to C3 (Low to medium). Based on Table 6.3 of AS2312.1, various protective coating systems can be applied to achieve a 15-25 year' service life (e.g. high build epoxy system, polyurethane system). Most of the protective coating systems mentioned in the Table 6.3 of AS2312.1 have total nominal dry film thickness larger than 150 microns. There is no information regarding the specification of the existing coating system in the documents provided to CCSR. Therefore, the thickness of the existing paint with average of 45 micron is considered inadequate unless the members have duplex protective coating system, galvanised and paint.

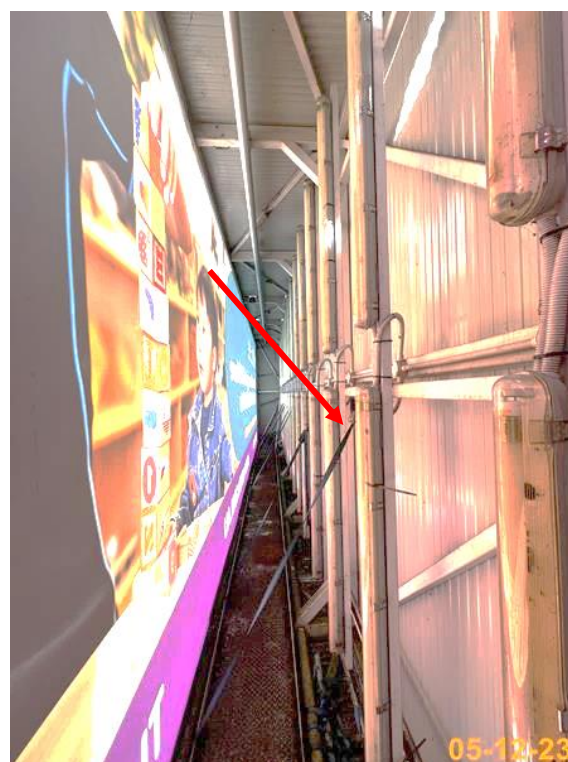
- Both sign boxes have two tensioning bars (CHS 60x3.6) welded between the bottom chords (indicated by the yellow arrows above). (Refer to **Figure 1** and **Photograph 78**)
- The sign banner was tensioned with ratchet straps attached to its edge at one end and tied around the non-structural horizontal Light Rod supports at the other end. (Refer to **Photographs 78-79-80-81-83-84**)
- Due to the way the straps were installed, the straps rub against the edge of the walkway checker plate. (Refer to **Photographs 81-85**)
- Surface corrosion was observed on several rachets. Broken and faulty rachets and torn straps were found on the floor of the sign boxes. (Refer to **Photograph 79**)

- We strongly recommend that only the existing tensioning bars be used for securing and tensioning the banners. If this is not possible, it is crucial to have a structural engineer assess the structural adequacy of the light rod supports and any other element that straps will be in contact with (walkway plate, etc.)

- The current strap installation method is incorrect and poses a high risk of tearing due to friction against the sharp edge of the walkway checker plate. It is also a trip hazard for the maintenance team. We recommend that only the existing tensioning bars be used for securing the banners.
- Any ratchets showing even slight surface corrosion shall be replaced with new stainless steel or galvanized ratchets.
- Broken and faulty rachets and straps shall be removed from the interior space of the sign boxes.

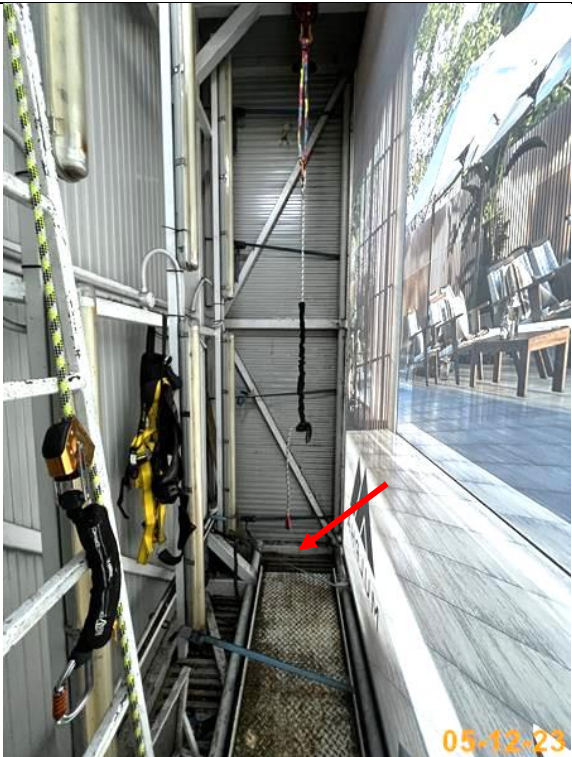
<p><b>Photograph 1</b>  <u>Sign 1 – Defect 6.1</u>  - Corrosion of structural members</p>

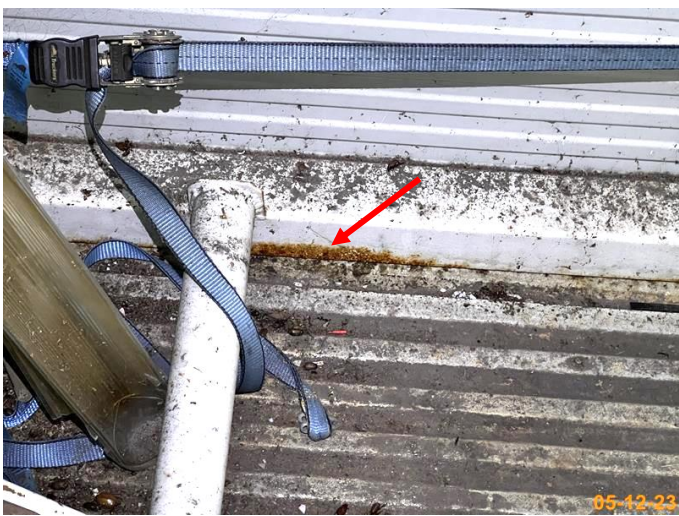
- Minor to moderate corrosion was observed on the bottom members of the sign frame. (Refer to **Photographs 2-4-5-7-19-54-56**)
- Moderate localised paint flaking was noted on the bottom members of the sign frame in the areas where the corrugated metal sheet lining of the sign comes into contact with the bottom members of the frame. (Refer to **Photographs 19-54-56**)
- Waterponding was noted at the east end of Sign 1 and the west end of Sign 2. Moderate-severe corrosion was observed on the bottom member of the frame where water was ponds. (Refer to **Photographs 20-25-55-56**)

<p><b>Photograph 2</b>  <u>Sign 1 – Defect 6.1</u>  - Paint degradation and corrosion of structural members  - Closed up view of <b>Photograph 1</b>.</p>

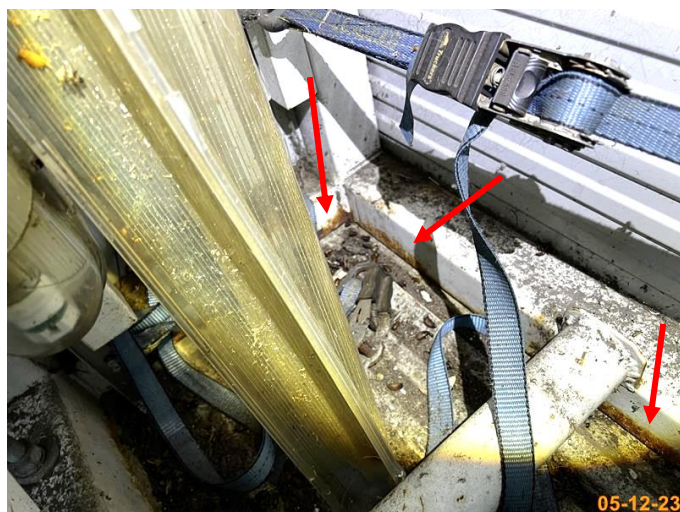
**Photograph 3**

- Paint degradation and surface corrosion of structural members
- Closed up view of **Photograph 1**.

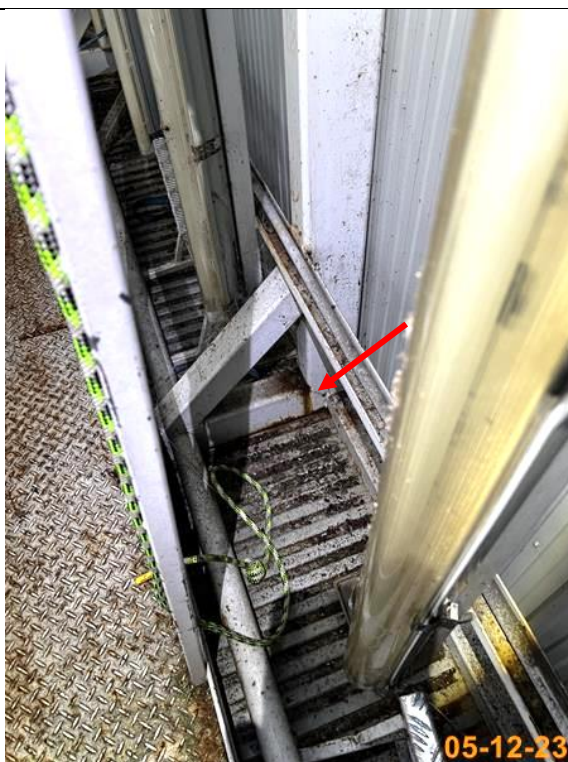
**Photograph 6**

- Paint degradation and surface corrosion of structural members

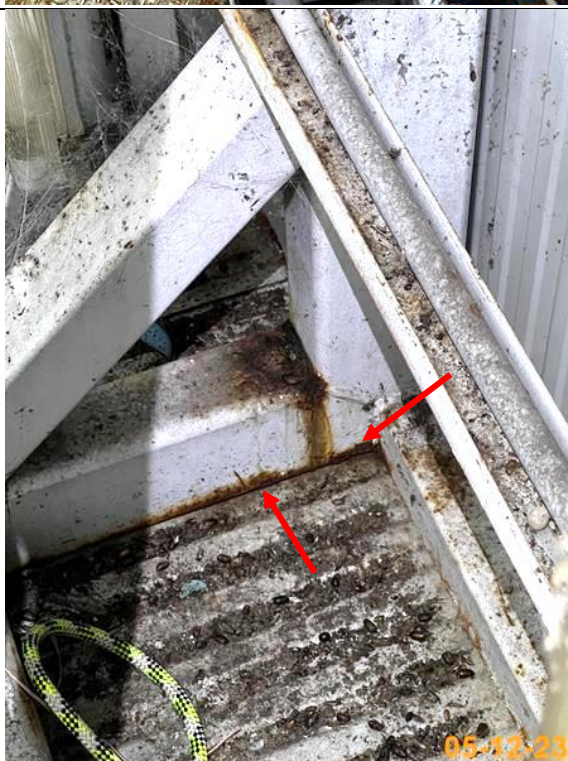
**Photograph 7**

- Closed up view of **Photograph 6**.

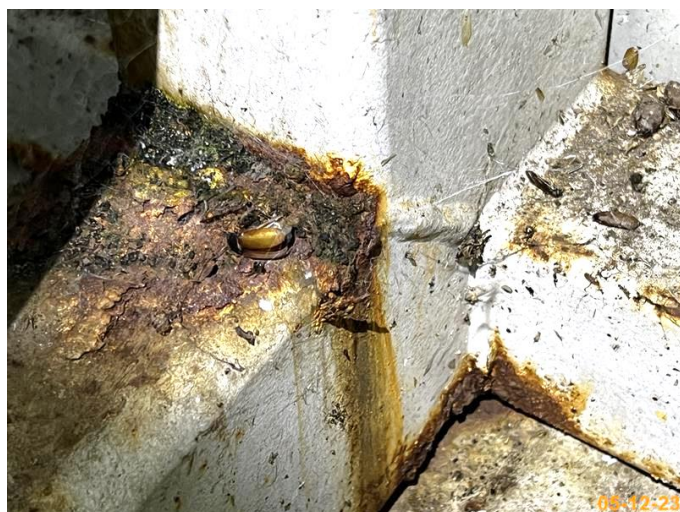
**Photograph 8**

- Paint degradation and surface corrosion of structural members
- Closed up view of **Photograph 7**.

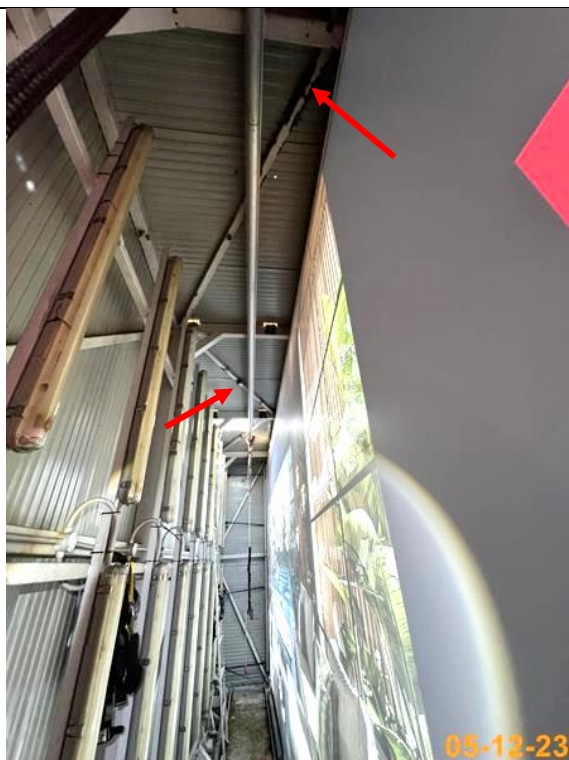
**Photograph 9**

<b>Location(s):</b> Sign 1 and Sign 2	
<b>Inspection Date:</b> 05 December 2023	<b>Testing:</b> DFT test
<b>Observations:</b>  <u>General</u> - It seems that the structural frame of the sign is coated with two layers of protection. The initial layer is blue, serving as the original protective coating, while the upper layer is white. It is highly probable that this white layer was applied retrospectively. (Refer to <b>Photographs 19-31</b> )  <u>Frame Top Chord</u> - Moderate to severe corrosion of frame top chord was observed around bolts T1 and T2. (Refer to <b>Photographs 9-10-12-13-26-32-33-42-46</b> )

- Paint degradation and localised corrosion of structural members

Regarding the corrosion and paint flaking of the top members near bolts T1 and T2, we recommend the following remedial works be undertaken:

- Remove the corrosion product to achieve Sa 2½ cleanliness.
- Engineer to assess the section loss of the affected structural members
- Member with more than 10% section loss shall be replaced or structurally strengthened as per the Engineer's specification. The new member(s) or strengthened areas shall be coated with a proprietary corrosion protective coating system in accordance to AS2312.1.
- For areas with less than 10% section loss, the surfaces shall be prepared and fully cleaned, and the affected area be painted as per AS2312.1 standard and the Manufacturer's current technical data sheets.

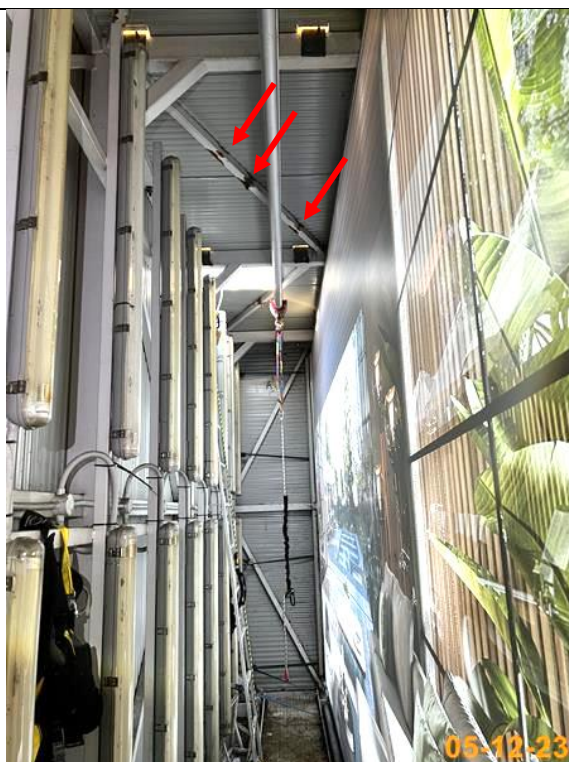
**Photograph 12**

- Localised corrosion of structural members

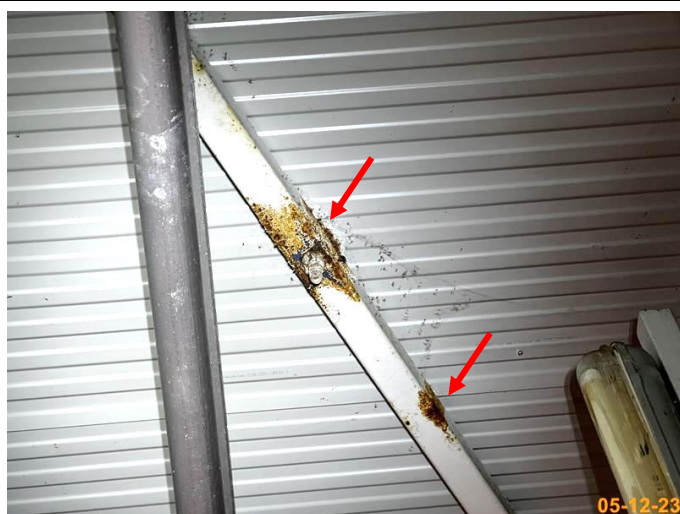
**Photograph 13**

- Localised corrosion of structural members
- Closed up view of **Photograph 12.**

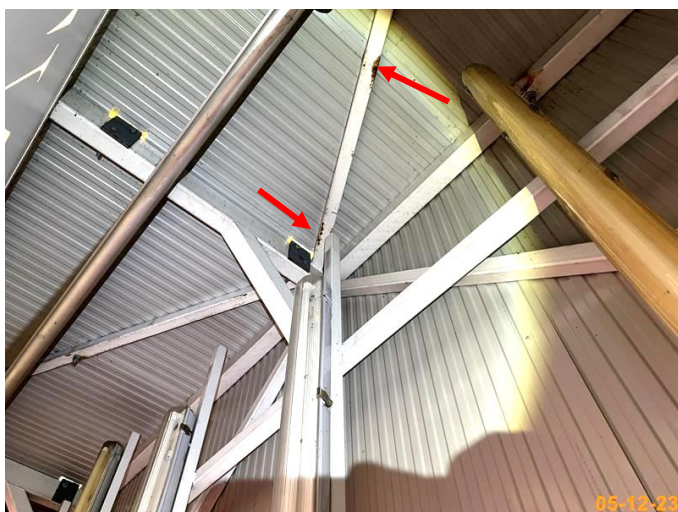
**Photograph 14**

- Localised corrosion of structural members

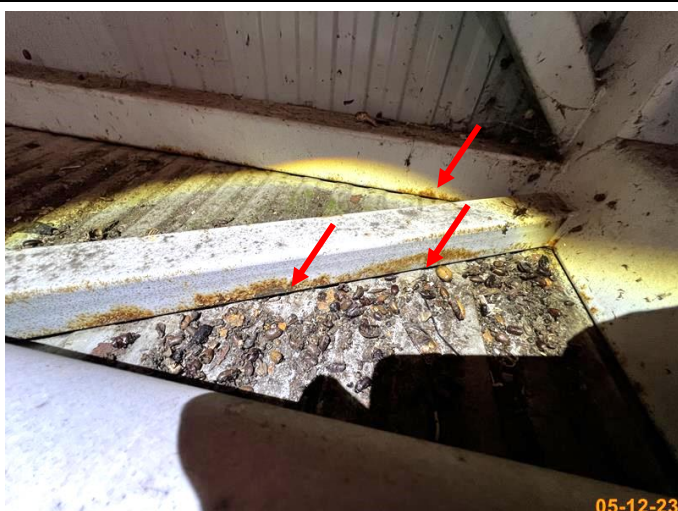
**Photograph 16**

- Rust staining

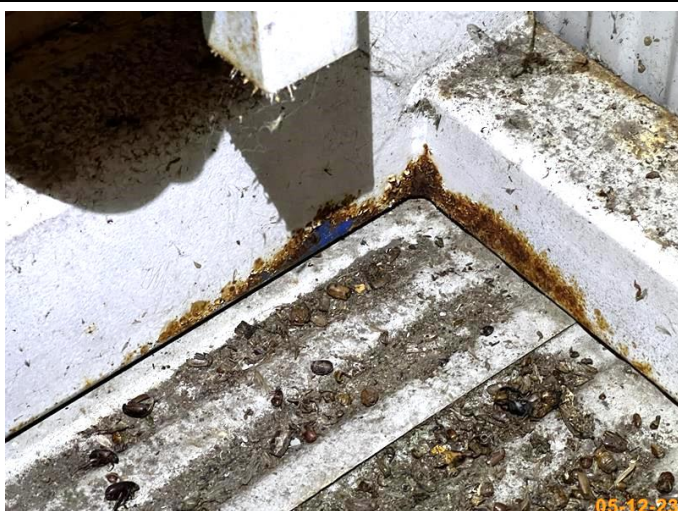
**Photograph 19**

Close up view of **Photograph 18**.

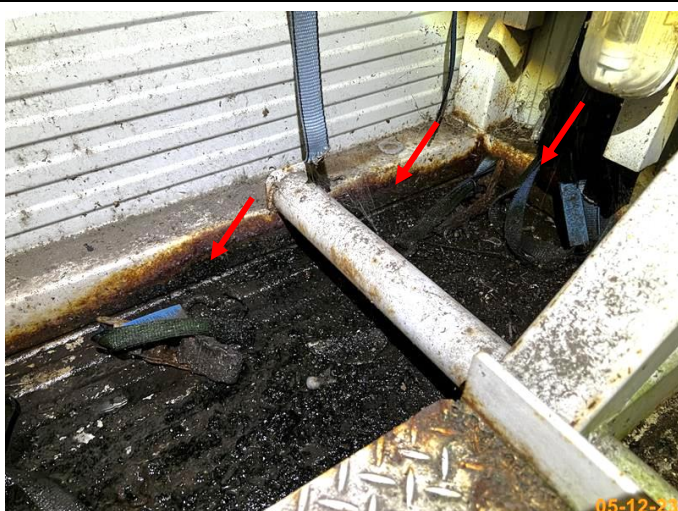
**Photograph 22**

As above.

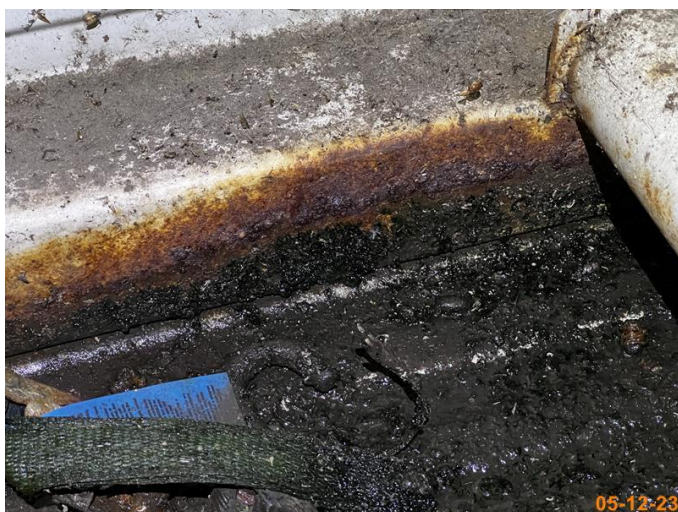
**Photograph 23**  
Sign 1 – Defect 6.1  
 Close-up view of **Photograph 22**.

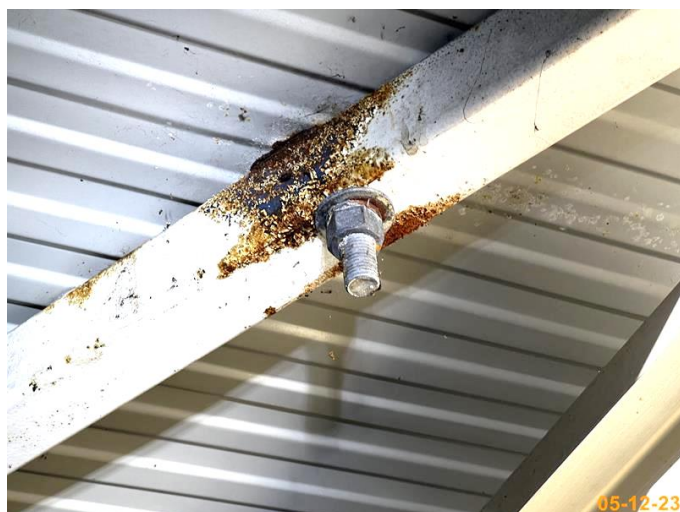
**Photograph 26**

- Localised corrosion of structural members

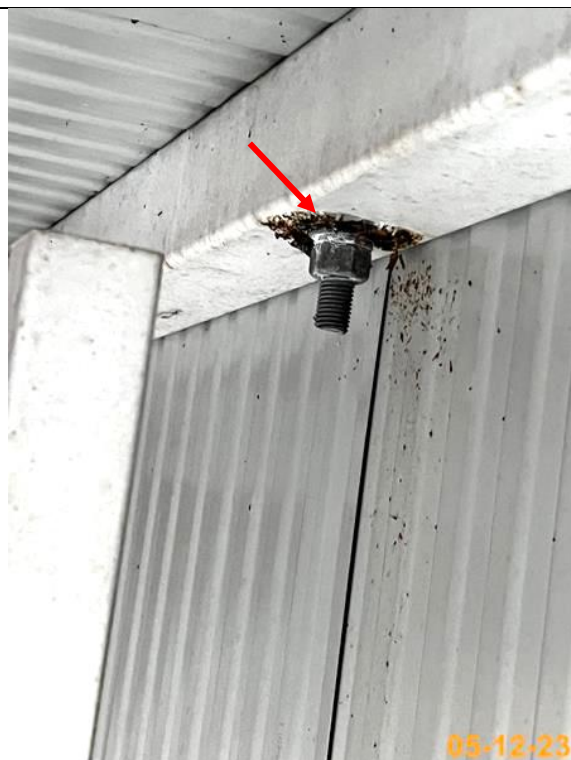
**Photograph 27**

- Localised corrosion of structural members

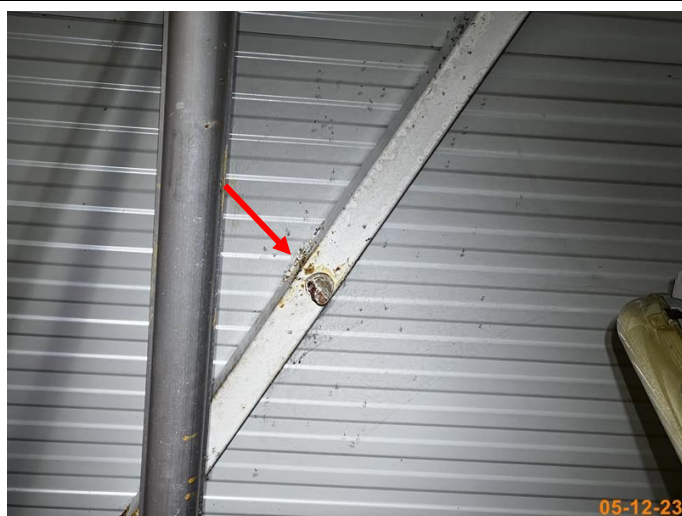
**Photograph 28**

- Minor localised corrosion of structural members

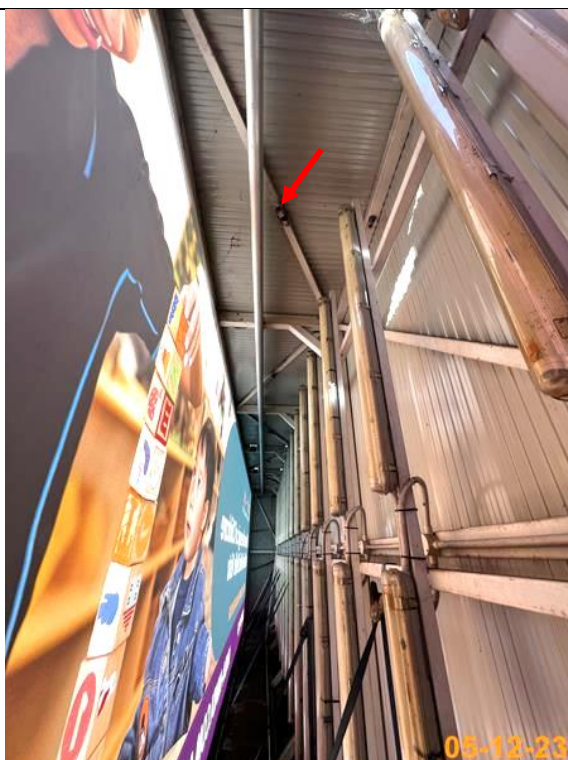
**Photograph 32**

- Localised corrosion of structural members

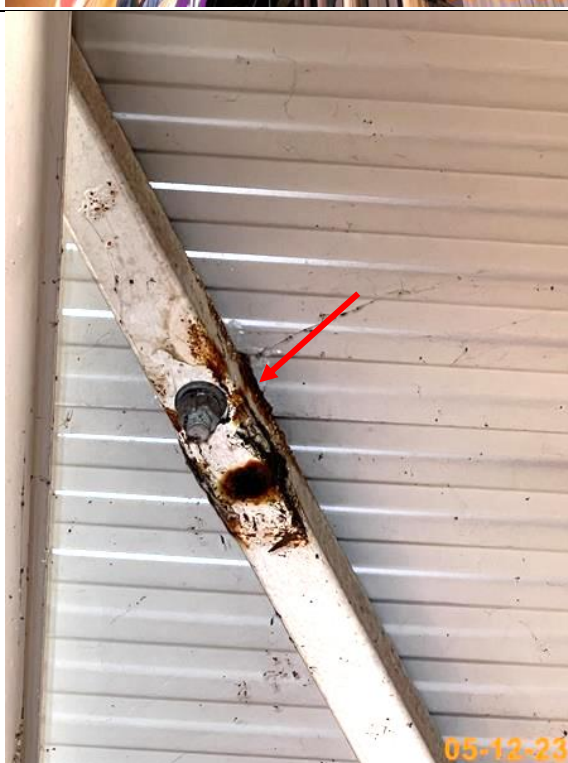
**Photograph 33**

- Localised corrosion of structural members  
- Closed up view of **Photograph 32.**

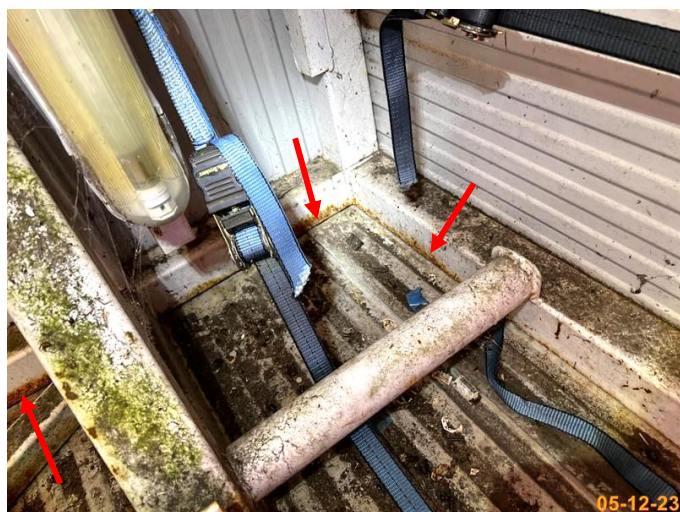
**Photograph 34**

- Localised surface corrosion of structural members

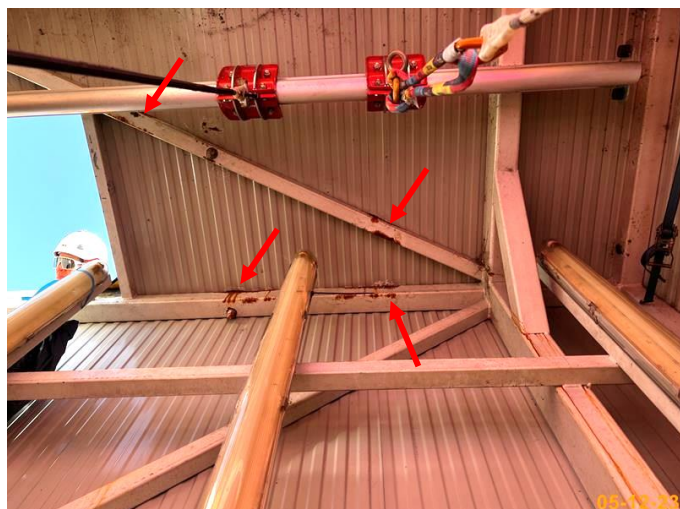
**Photograph 35**

- Localised corrosion of structural members

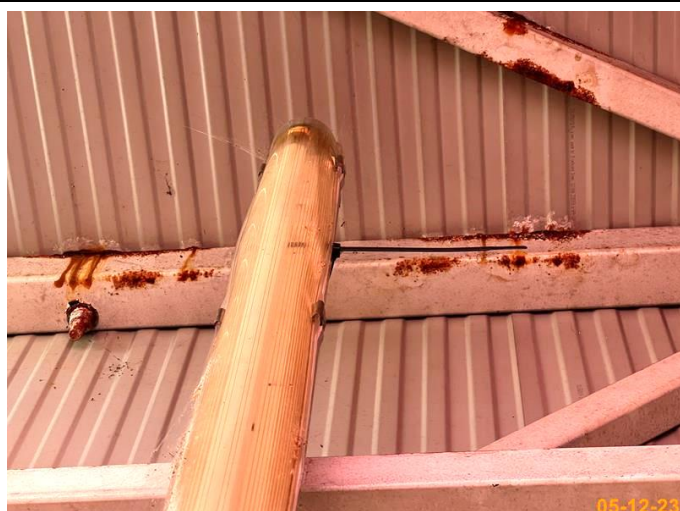
**Photograph 36**

- It appears the original T2 bolt holes were mistakenly placed, and new bolts were installed adjacent to their location. The original holes remain open. Moderate to severe corrosion was observed around both the new and original T2 bolts. (Refer to **Photographs 42-46-47-49-50**)
- Moderate-Severe localised paint flaking (the top coat) and brown rust stains were observed on the top chords and diagonal stiffeners. (Refer to **Photographs 26-36-57-58**)
- Moderate to severe localized corrosion was observed where the corrugated metal sheet lining of the sign comes into contact with the top members of the sign frame. (Refer to **Photographs 36-58**)

- Localised corrosion of structural members and cladding panels  
- Closed up view of **Photograph 35**.

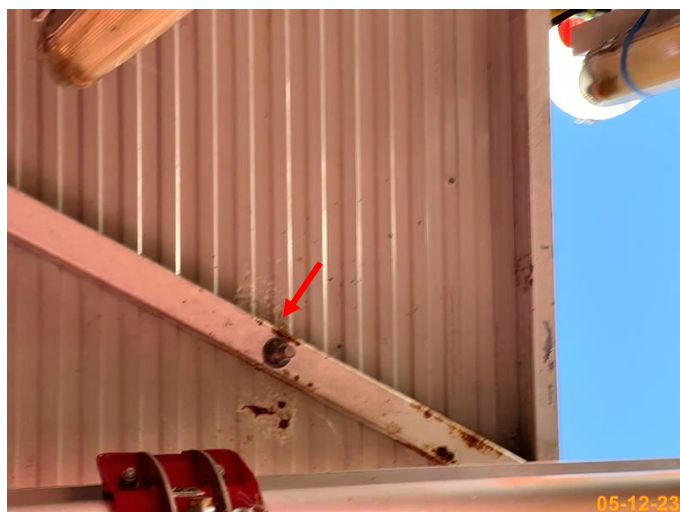
**Photograph 37**

- Localised corrosion of structural members

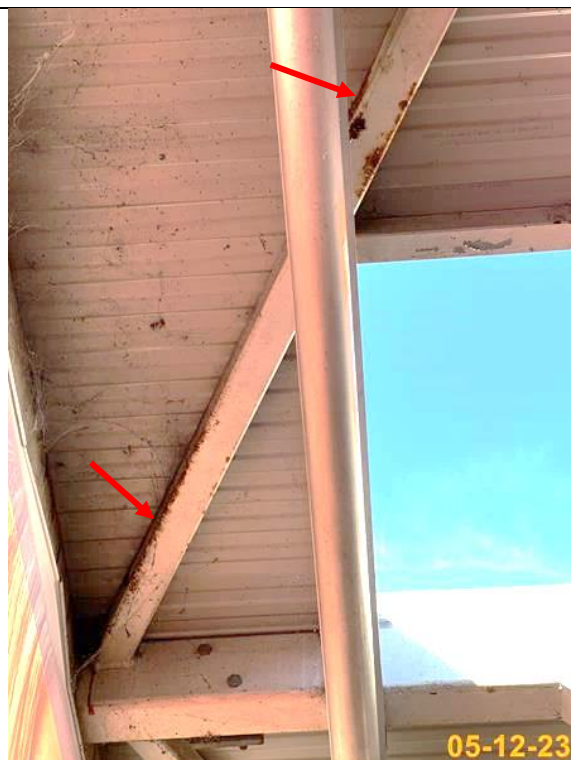
**Photograph 38**

- Localised corrosion of structural members

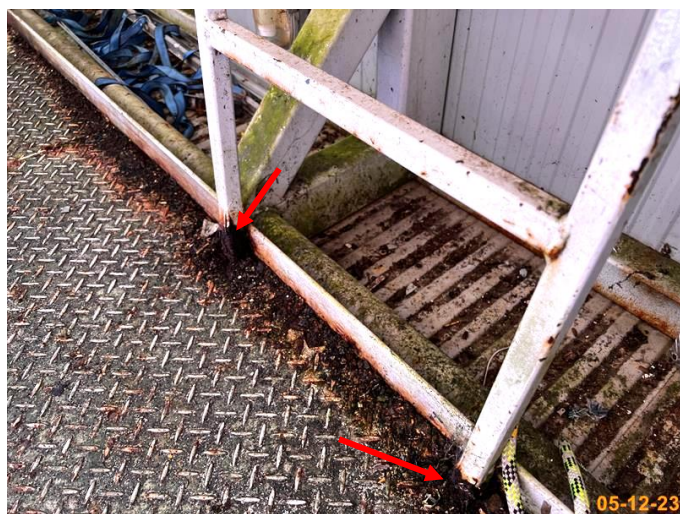
**Photograph 39**

- Corrosion of steel ladder (weld zone)

Access Ladders: corrosion needs to be removed from the corroded sections of the access ladders. For corrosion more than 10% (section loss more than 10%), we recommend the whole ladder be replaced with a new ladder, suitably coated as per with AS2312.1 standards. The welding zones (where ladder is welded to the sign frame) shall be coated with corrosion protective coating as per the Standard.

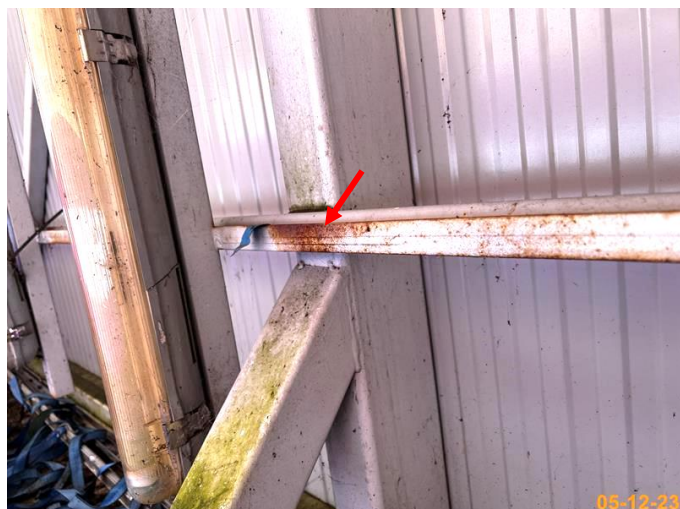
**Photograph 40**

- Paint discolouration and minor surface corrosion

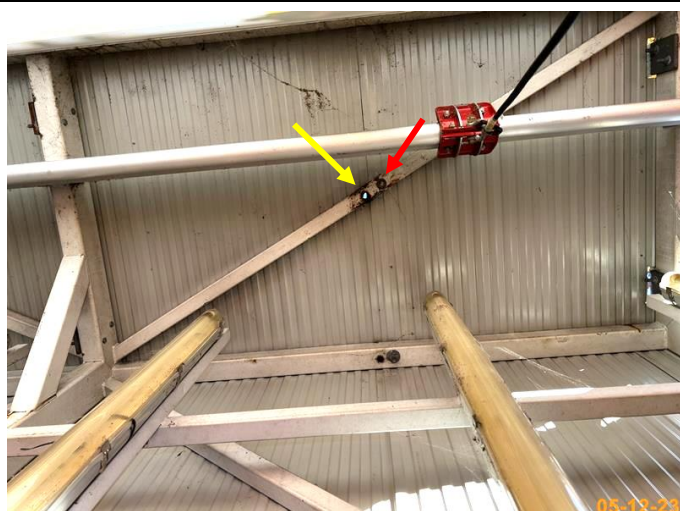
**Photograph 41**

- Localised corrosion of structural members
- An open bolt hole in the diagonal stiffener

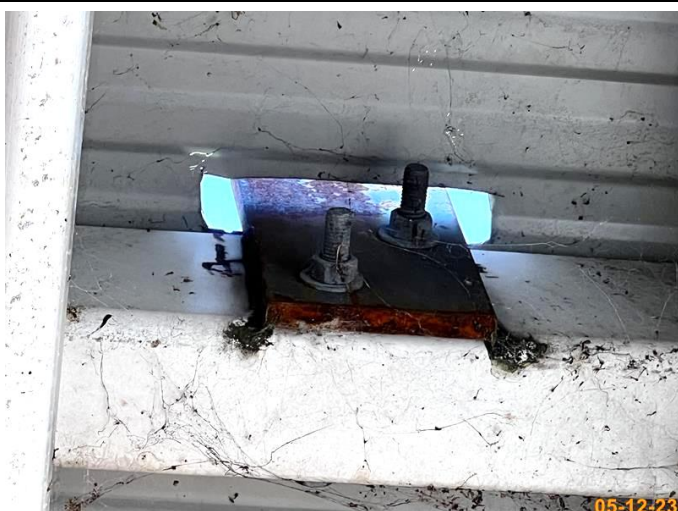
**Photograph 44**

- Corrosion of sign box anchor points.

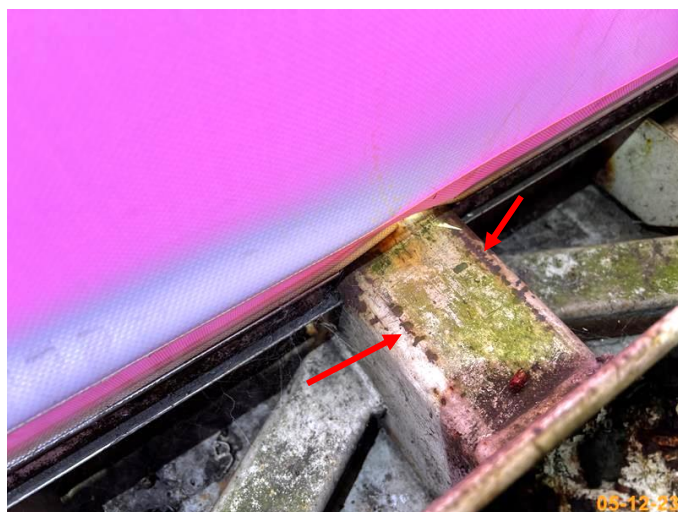
**Photograph 45**

- Abrasion of coating layer due to the movement of the banner and friction between the banner clamp and the bottom chord of the structure.

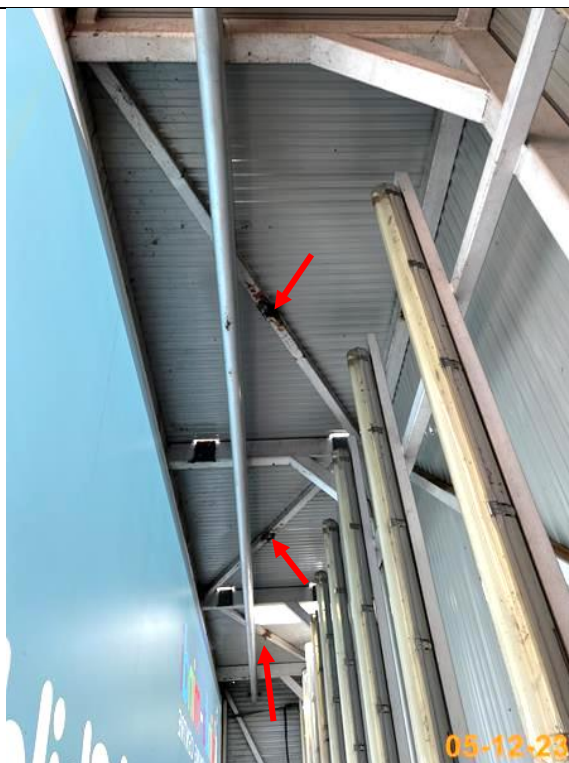
**Photograph 46**

- Localised corrosion of structural members of the sign structure

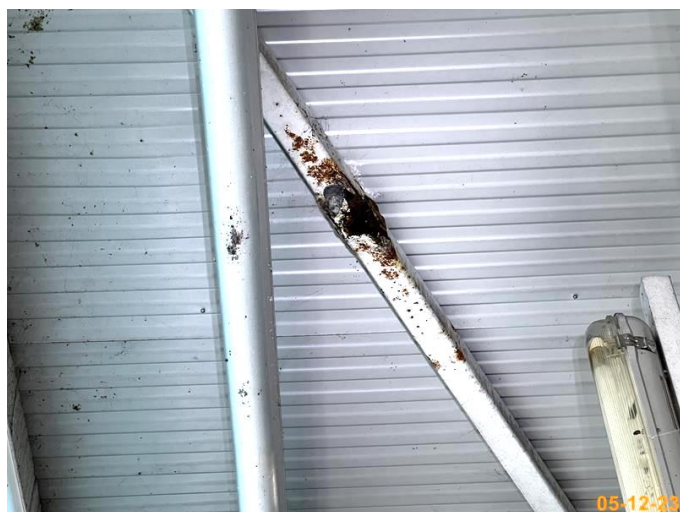
**Photograph 47**

- Closed up view of **Photograph 46**.

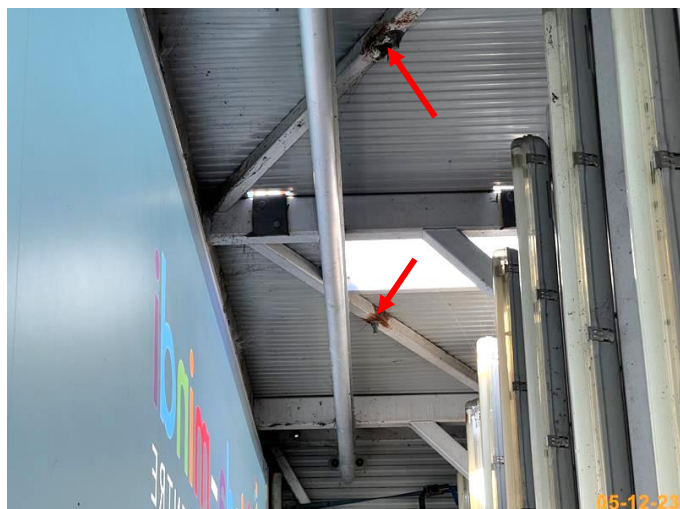
**Photograph 48**

- Closed up view of **Photograph 46**.

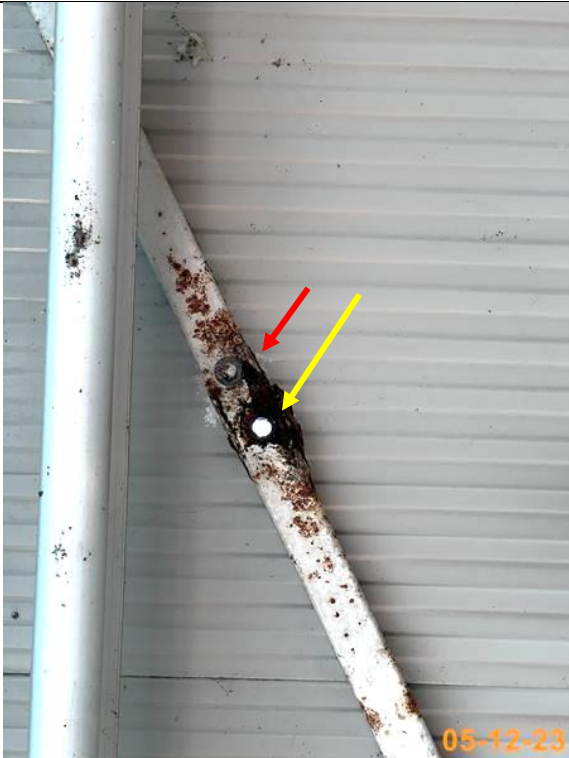
<p><b>Photograph 49</b> <u>Sign 2 – Defect 6.1</u></p> <ul style="list-style-type: none"> <li>- Localised corrosion of structural members</li> <li>- An open bolt hole in the diagonal stiffener</li> <li>- Closed up view of <b>Photograph 48</b>.</li> </ul>

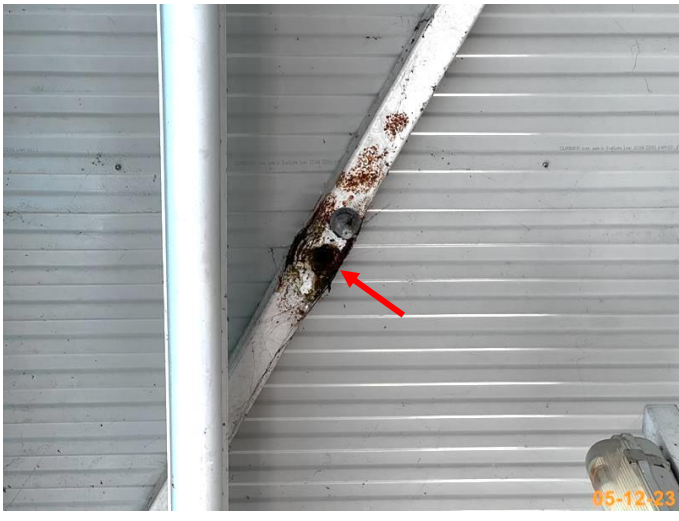
<p><b>Photograph 50</b> <u>Sign 2 – Defect 6.1</u></p> <ul style="list-style-type: none"> <li>- Closed up view of <b>Photograph 48</b>.</li> </ul>

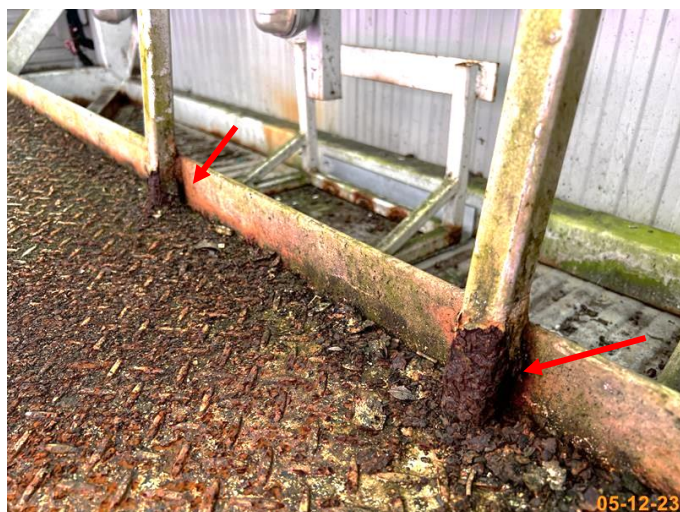
**Photograph 51**

- The steel ladders were severely corroded where they connect to the bottom chord of the frame (both signs). (Refer to **Photograph 51**)

- Corrosion of ladder (weld zone)

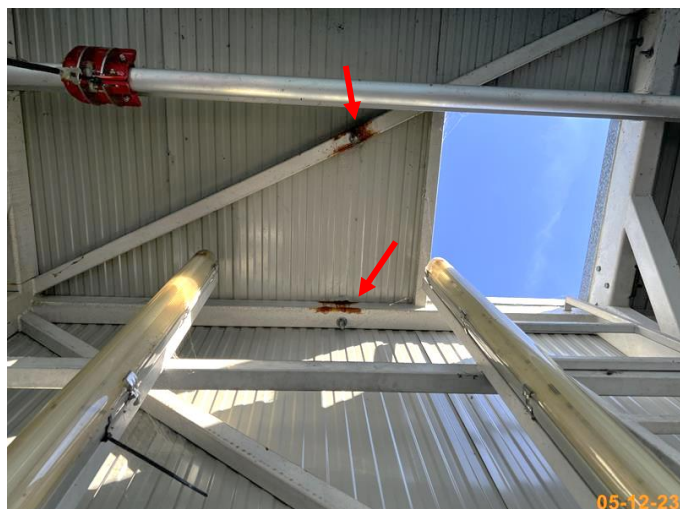
**Photograph 52**

- Localised corrosion of structural members

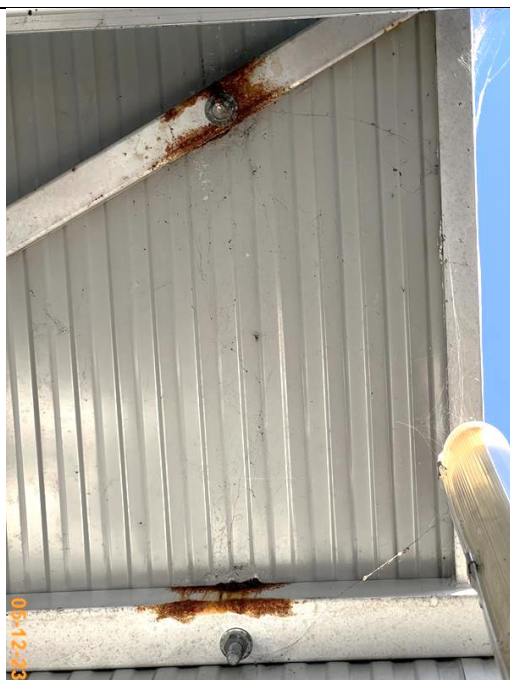
**Photograph 53**

- Closed up view of **Photograph 52**.

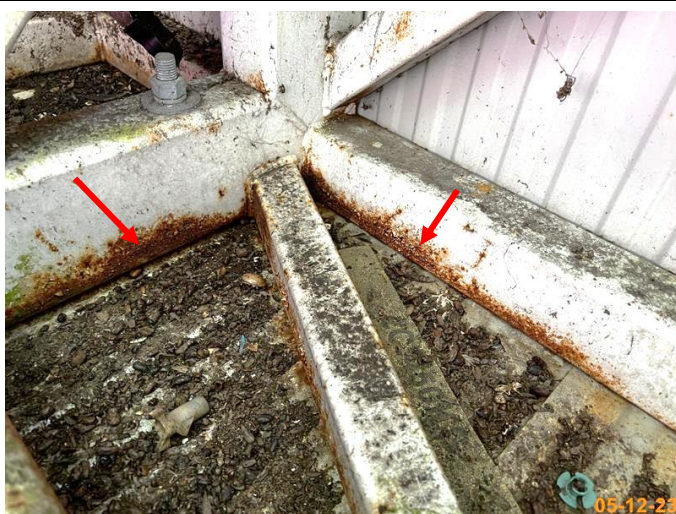
**Photograph 54**

- Surface corrosion of bottom chords and members of the sign structure

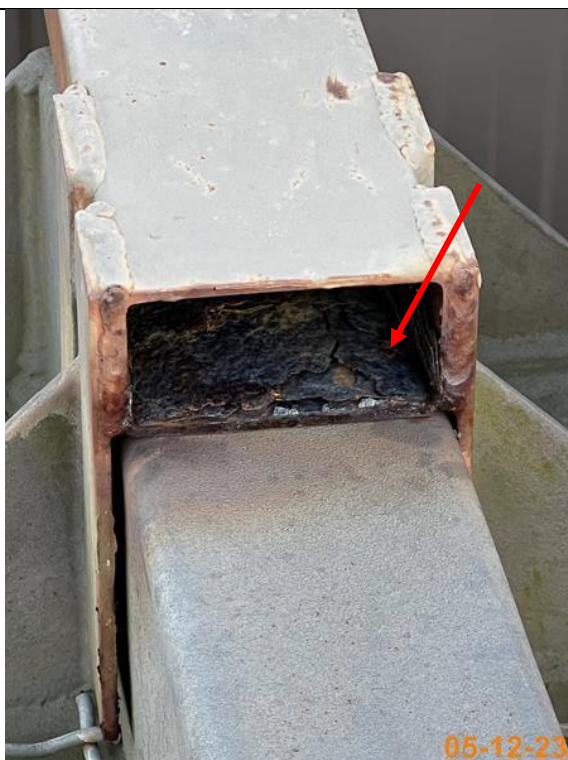
**Photograph 63**

CCSR was engaged to assess the condition of the sign structures internally. As part of our duty of care, we wish to inform the owner that during our inspection, we observed moderate to severe corrosion on the inside faces of the 'BEAM 2' hollow sections outside the sign boxes for both Sign 1 and Sign 2 (refer to **Photographs 62-71**).

- Closed up view of **Photograph 62**.

1. Inspection: All BEAM 2s need to be inspected to determine the extent of the corrosion. This may involve additional visual inspection, as well as non-destructive testing techniques.
2. Replacement: Any beams with moderate to severe corrosion on the inside face should be replaced with new beams suitably coated for corrosion protection. This coating could include hot-dip galvanization (HDG) and/or a high-quality corrosion-protective paint system.
3. Cap Plates: Cap plates with ventilation holes shall be installed at the ends of the new beams and the existing beams to minimise rainwater entering the hollow sections. This will help to prevent further corrosion from occurring inside the beams.

The above-mentioned remedial works require special equipment and teams. Conducting cutting, grinding, painting, and welding inside the confined space of the sign structure is complicated and considered very high-risk work. Considering the age of the structure, paint condition, locations of corrosion, and inadequate coating thickness, the owner of the signs may consider disassembling the sign structures (detaching the sign box from 'BEAM 1' and 'BEAM 2'), carefully lowering it, and transporting it to a controlled factory environment. Then, in the factory, all cladding panels can be removed, providing access for a thorough assessment of the hidden surfaces of the top and bottom structural members. In the factory environment, the entire sign structure can be prepared and painted using suitable quality assurance measures. In addition, severely corroded members with more than 10% section loss can be safely replaced or strengthened in the factory in accordance to the engineer's specifications.

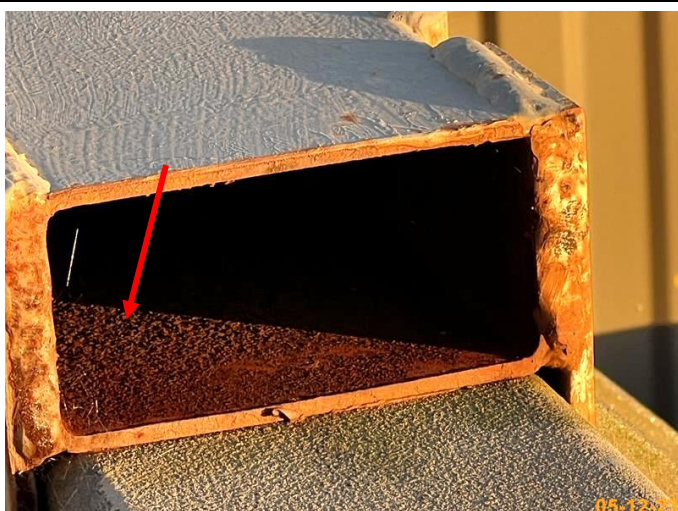
**Photograph 67**

- Closed up view of **Photograph 65**.

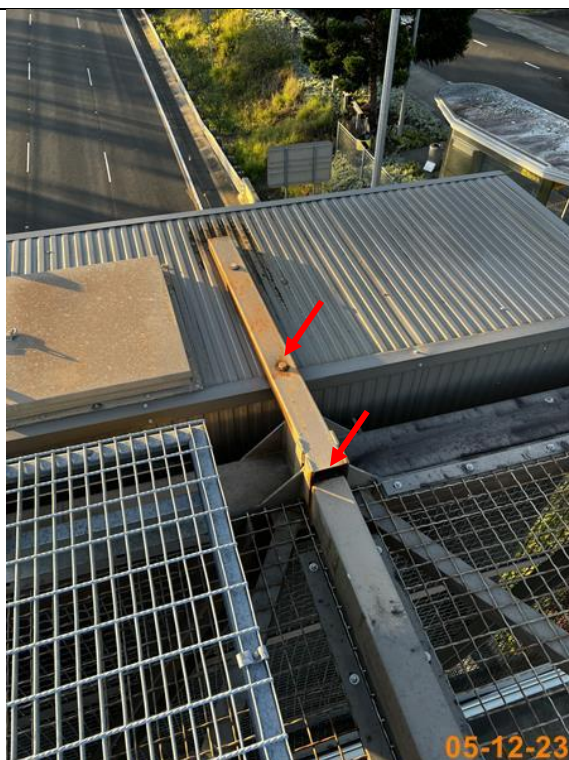
**Photograph 70**

- Severe corrosion of BEAM 2 (inner faces)
- Surface corrosion of BEAM 2 (outer faces)

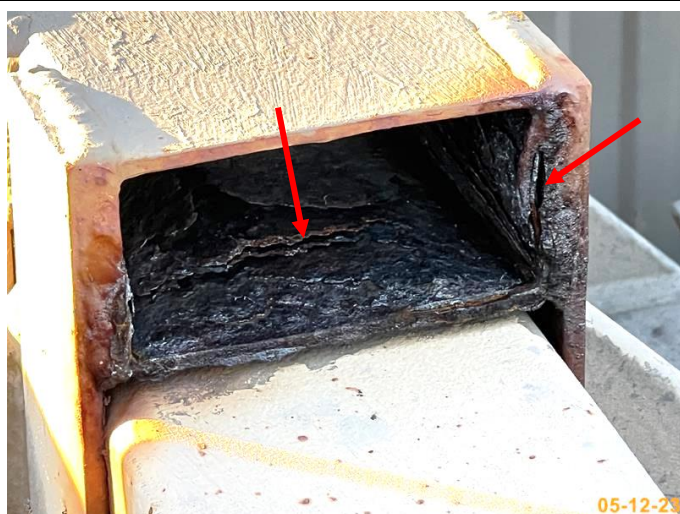
**Photograph 71**

- Closed up view of **Photograph 70**.

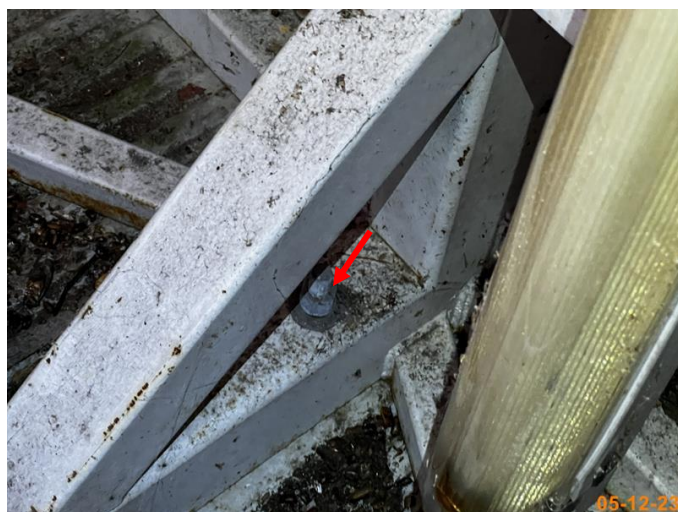
**Photograph 72**

- The top and bottom chords of the frame were connected to BEAMS 1 and 2 using bolts, nuts, and washers. (Refer to **Figures 1 and 3 - Photographs 72**)
- All readily accessible bolts from the walkway within the sign boxes were hand-tested for looseness. One loose nut was identified (in Sign 2) and hand-tightened by our engineer as a safety precaution. (Refer to **Photograph 76**)
- There was no lock nut installed on Bolts B1, B2, T1 and T2. (Refer to **Photographs 72-73-74-75**)
- Split lock washers were installed on some of the Bolts. (Refer to **Photograph 73**)
- Some bolts lacked both lock nuts and split lock washers. (Refer to **Photograph 74-75-76-77**)
- Surface corrosion (rust stains) was observed on a number of Bolts T1 and T2 (on the bolt head, washer and nuts). (Refer to **Photograph 66-70-77**)

According to the original structural drawings for the sign structure, locking nuts should have been installed on all Bolts B1, B2, T1, and T2. However, during inspection, no locking nuts were found, but split lock washers were present on some bolts. Split washers and locking nuts are both types of fasteners used to prevent bolts and nuts from loosening due to vibration or movement. However, they have distinct differences in design and application. Splitting washers are more suitable for non-critical connections with minimal vibration, while lock nuts are generally used for critical connections experiencing high stress and extreme vibration.

Based on the level of vibration the sign structure experiences on the bridge and since these bolts are the main structural bolts that connect the sign boxes to the supporting beams, we recommend that locking nuts be installed on all bolts as per the original structural drawings.

Corroded bolts, nuts and washer to be replaced like-for-like.

All bolts shall be hand-tested and loose nuts to be tightened using a standard wrench to a 'snug-tight' condition as per the approved structural drawings.

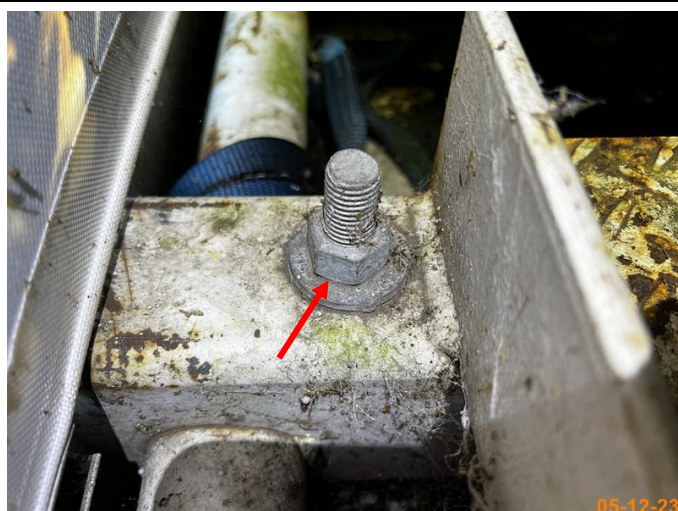
**Photograph 74**

- No locking nut
- No split washer

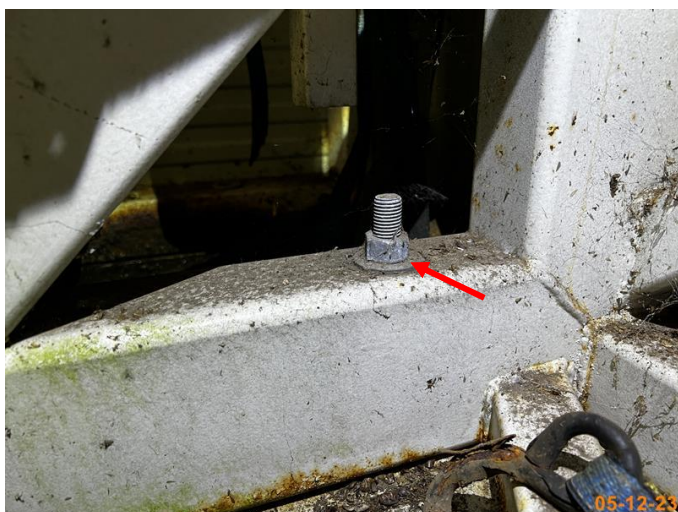
**Photograph 75**  
Sign 1 – Defect 6.2  
- No locking nut  
- No split washer

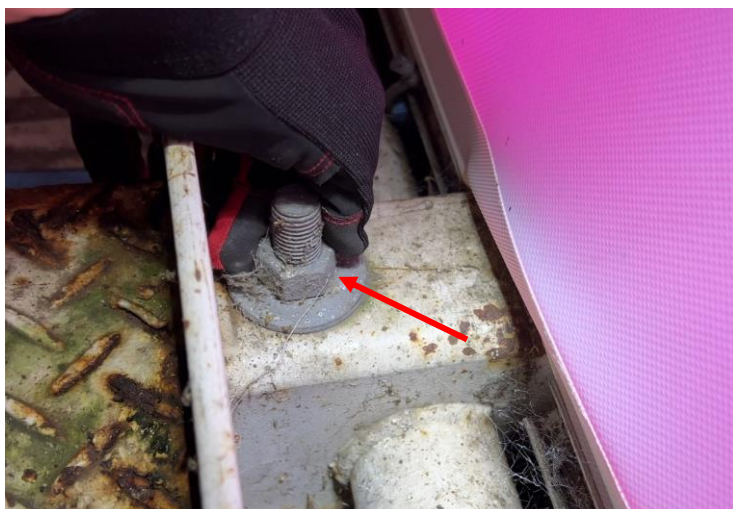
**Photograph 76**  
Sign 2 – Defect 6.2  
- Loose nut  
- No locking nut  
- No split washer

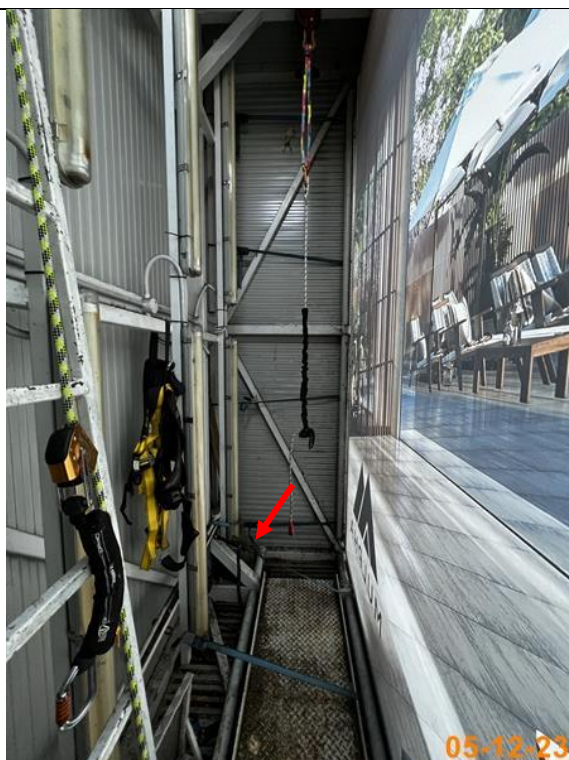
**Photograph 78**

- Rusted ratchet
- Strap in contact to the edge of walkway checker plate
