# Structural Condition Assessment

Norbrick Dr. and Old Windsor Rd. Pedestrian Bridge - Sign Structures

Prepared for: Mulpha Norwest Pty Ltd

Ref No: 2311081

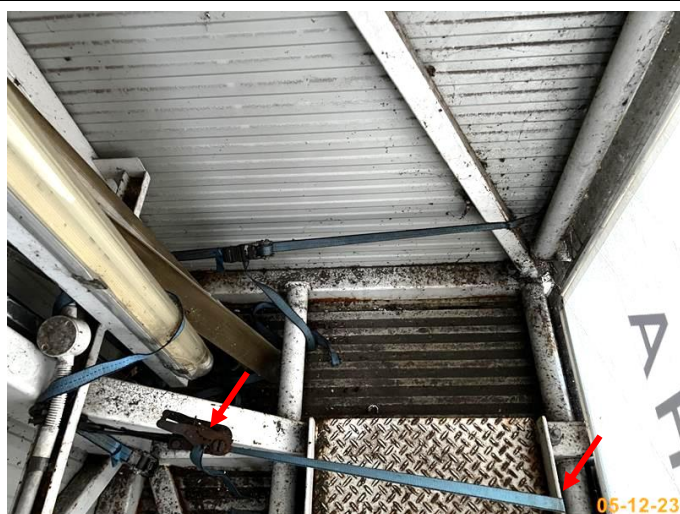
**Photograph 79**

- Both sign boxes have two tensioning bars (CHS 60x3.6) welded between the bottom chords (indicated by the yellow arrows above). (Refer to **Figure 1** and **Photograph 78**)
- The sign banner was tensioned with ratchet straps attached to its edge at one end and tied around the non-structural horizontal Light Rod supports at the other end. (Refer to **Photographs 78-79-80-81-83-84**)
- Due to the way the straps were installed, the straps rub against the edge of the walkway checker plate. (Refer to **Photographs 81-85**)
- Surface corrosion was observed on several rachets. Broken and faulty rachets and torn straps were found on the floor of the sign boxes. (Refer to **Photograph 79**)

- Closed up view of **Photograph 78**.

- The current strap installation method is incorrect and poses a high risk of tearing due to friction against the sharp edge of the walkway checker plate. It is also a trip hazard for the maintenance team. We recommend that only the existing tensioning bars be used for securing the banners.
- Any ratchets showing even slight surface corrosion shall be replaced with new stainless steel or galvanized ratchets.
- Broken and faulty rachets and straps shall be removed from the interior space of the sign boxes.

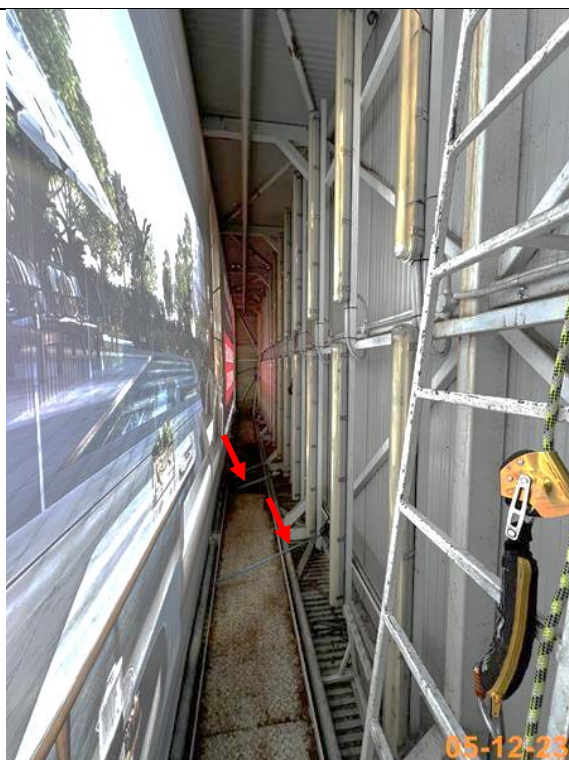
**Photograph 80**

- Ratchet strap for tensioning the banner

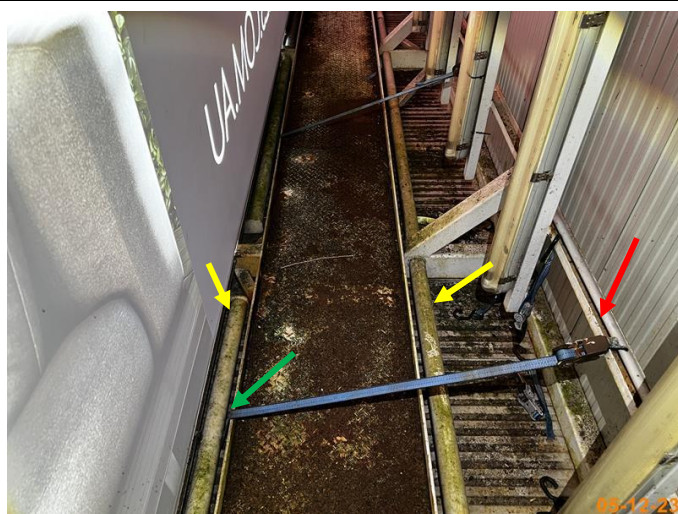
**Photograph 81**

- The sign banner was tensioned with ratchet straps attached to its edge at one end and tied around the non-structural horizontal Light Rod supports at the other end.
- Due to the way the straps were installed, the straps rub against the edge of the walkway checker plate
- Tensioning bars (yellow arrows)

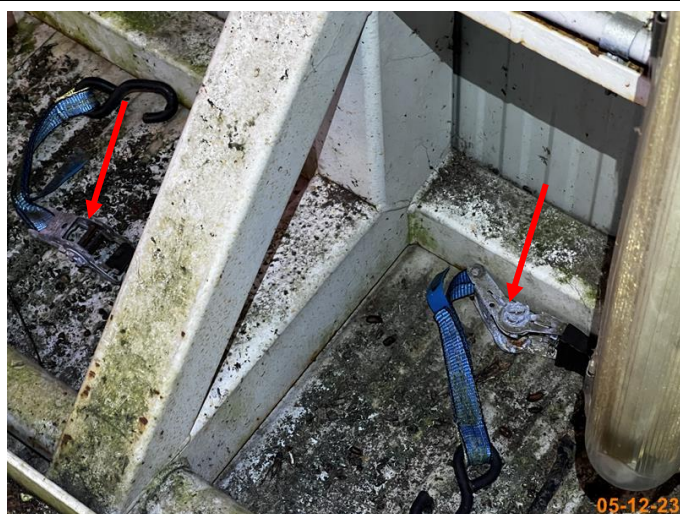
**Photograph 82**

- Broken ratchets on the floor

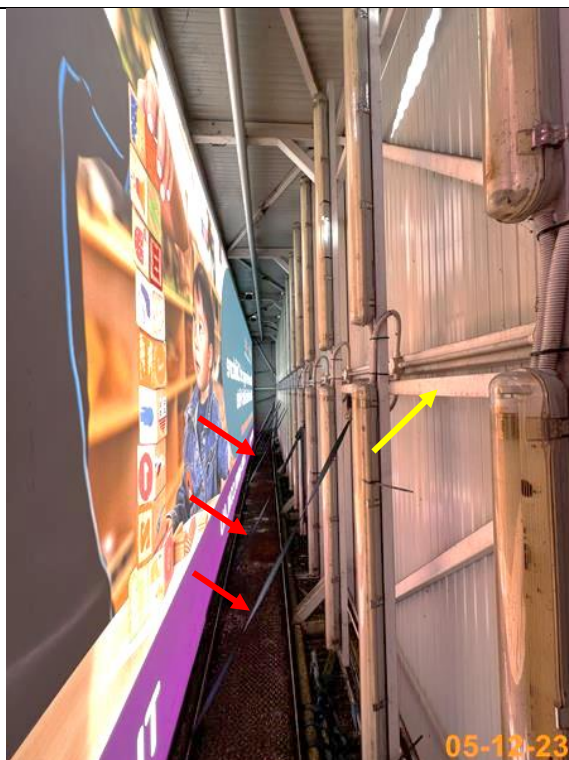
**Photograph 83**

- The sign banner was tensioned with ratchet straps attached to its edge at one end and tied around the non-structural horizontal Light Rod supports at the other end (yellow arrow).
- Due to the way the straps were installed, the straps rub against the edge of the walkway checker plate

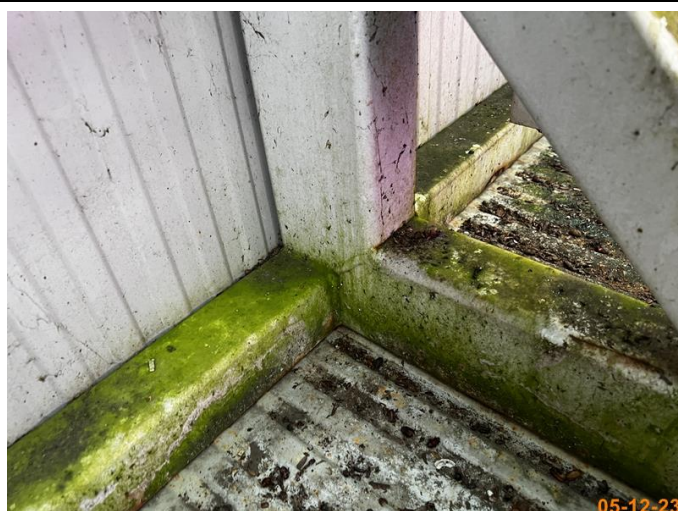
**Photograph 86**

- Mould growth was observed on the frame structure of Sign 2. (Refer to **Photographs 86-88**)

- a) Mould can trap moisture against the painted surface, creating a perfect environment for corrosion. Over time, this can compromise the integrity of the steel and lead to structural weaknesses.
- b) Mould can penetrate and feed on organic components within the paint. This can cause the paint to degrade, leading to discolouration, peeling, and flaking.

The sign boxes were not equipped with mechanical ventilation. Penetration of moisture and water vapours from the gaps and unsealed joints around the banner and other parts of the signs, coupled with inadequate ventilation are the two main factors contributing to the identified mould growth. We recommend that all gaps and joints be suitably sealed to minimise the infiltration of moisture and water to the interior of the sign boxes. In addition, we recommend that a mechanical ventilation system (with intake and exhaust fans) be designed and installed to reduce the humidity and prevent moisture buildup in the sign boxes.

- Mould growth on structural members

A mould cleaner specialist shall be engaged and the areas with mould shall be cleaned and treated as per their instruction. Ensure that the chemicals used in the cleaning process do not degrade the performance and durability of the existing coating system.

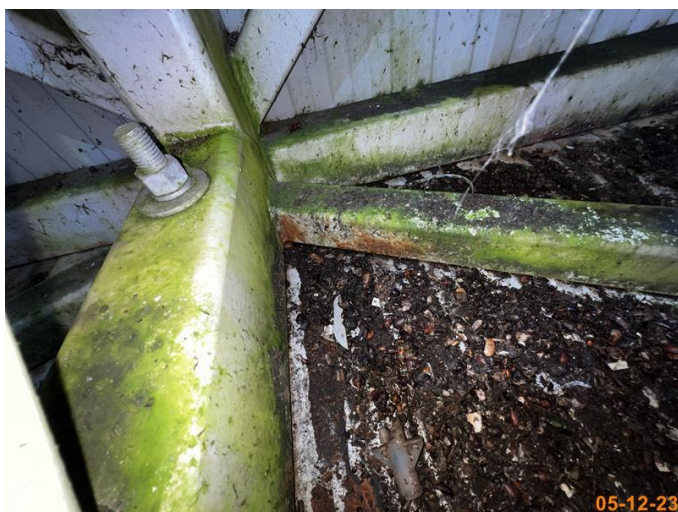
**Photograph 87**  
Sign 2 – Defect 6.4  
As above.
