# Level 2 Inspection Report

## Old Windsor Road Pedestrian Bridge

**Mulpha Norwest Pty Ltd**

Ref: 241212\_R001

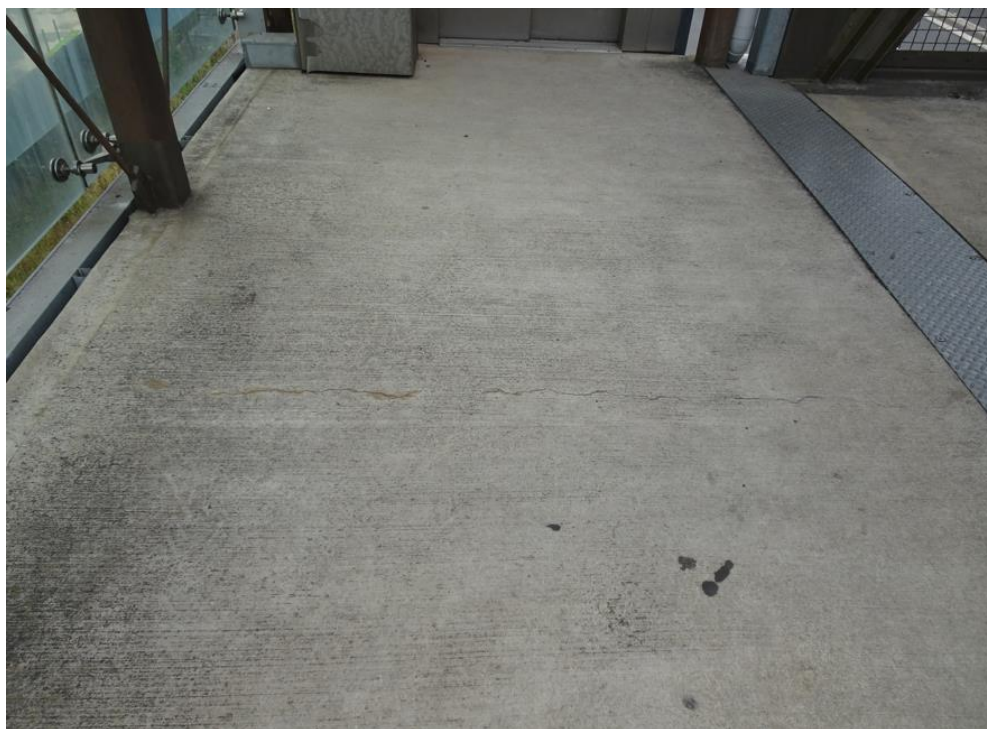
Photo 1 – Concrete deck slab with wide crack at eastern end.

Element Code	Environment	MMS		Inspector's Comments on Required Actions and Locations on Structure	Estimated Quantity	Units	Date for Completion	Photo No.
		Act No.	Activity Description					
CDSL	M	730.15 769.09	Monitor Bridge Element M769 Repair Concrete cracks – Deck Slab (CDSL)	Monitor crack extent (length and width) at E/end of main span. Monitor transverse cracks to top of main span at E & W/ends. Some crack repair may be required for Bondek slab where structural concrete cracks are at W/end.	3	m <sup>2</sup>	May 2026	1,2,32,35
PPIR	M	712.00	M700 Paint Repairs, Minor	Repair protective coating where surface rust is apparent to base at E/end staircase column.	1	m <sup>2</sup>	May 2026	6,7,15,38
MSWS	M	480.04	M480 Clean Scuppers	Clear-out blocked scuppers and ensure working drainage systems at E & W/ends.	2	item	May 2026	3,4,5
SBGI	M	712.00	M700 Paint Repairs, Minor	Repair protective coating where surface rust is apparent to base at E/end staircase.	2	m <sup>2</sup>	May 2026	13,14

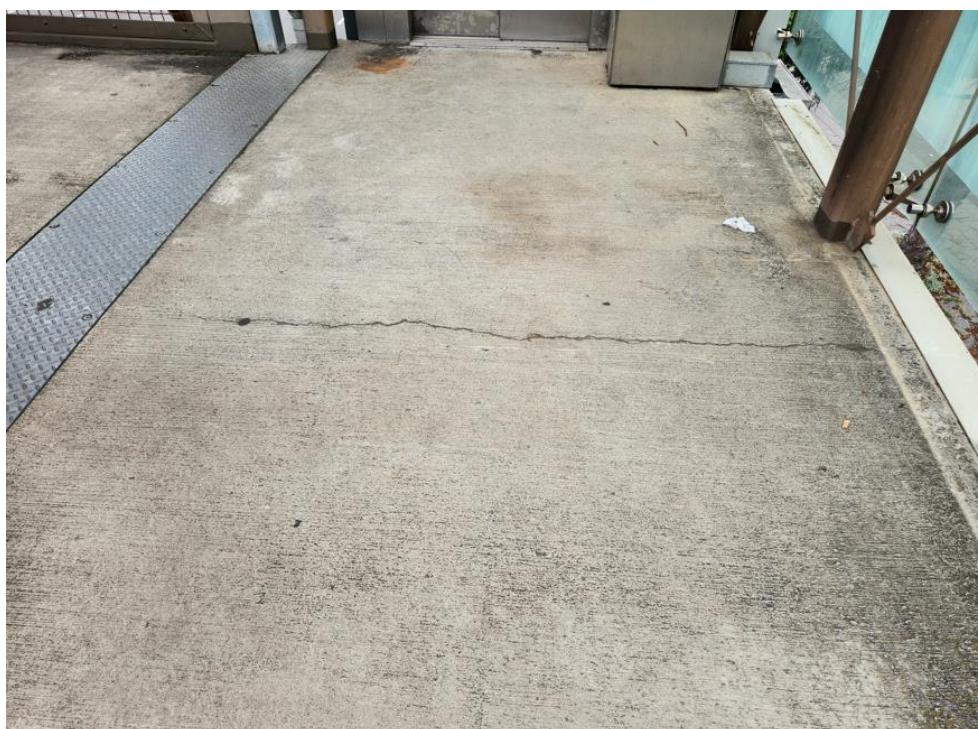
Photo 2 – Concrete deck Slab with wide crack at western end.

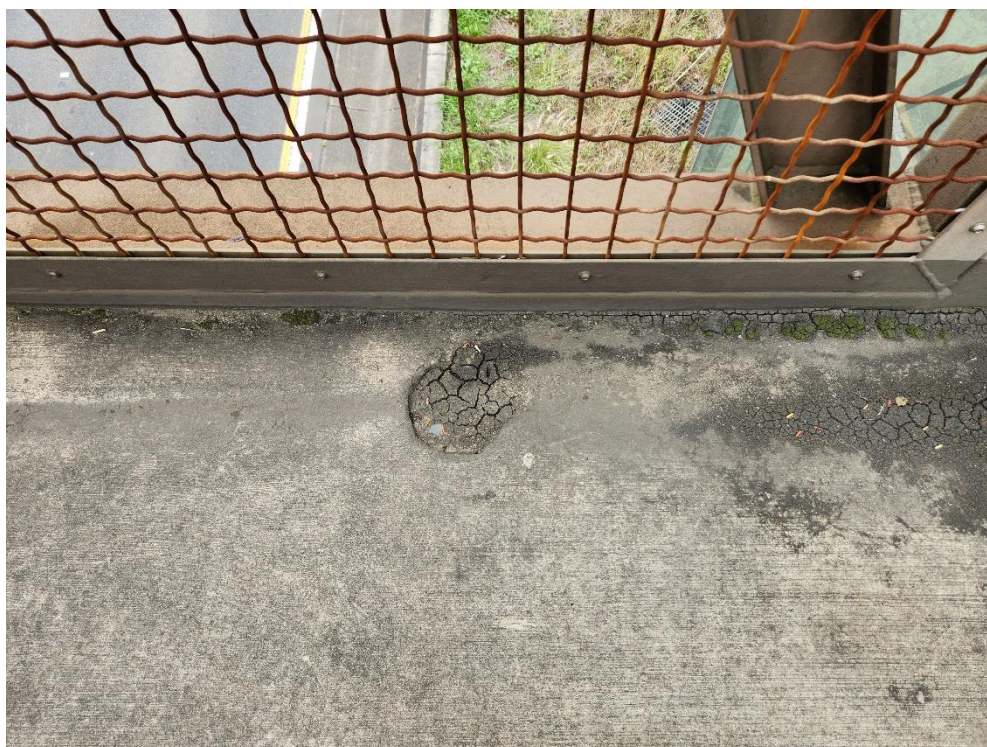
Photo 3 – Fully blocked scuppers at western end.

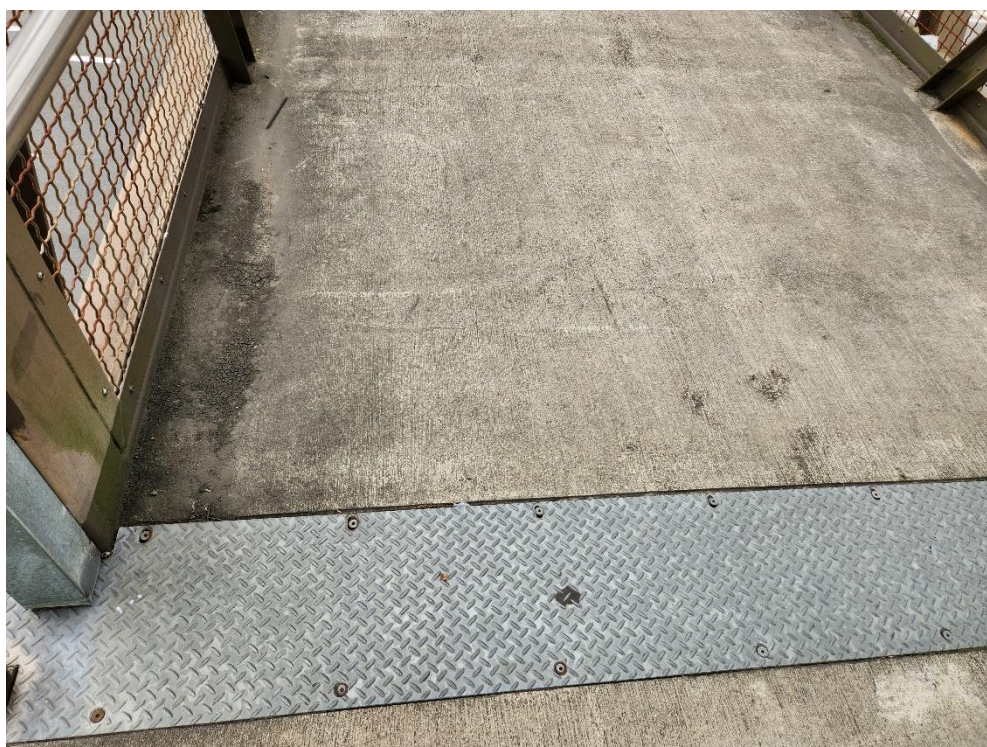
Photo 4 – Fully blocked scuppers at western end.

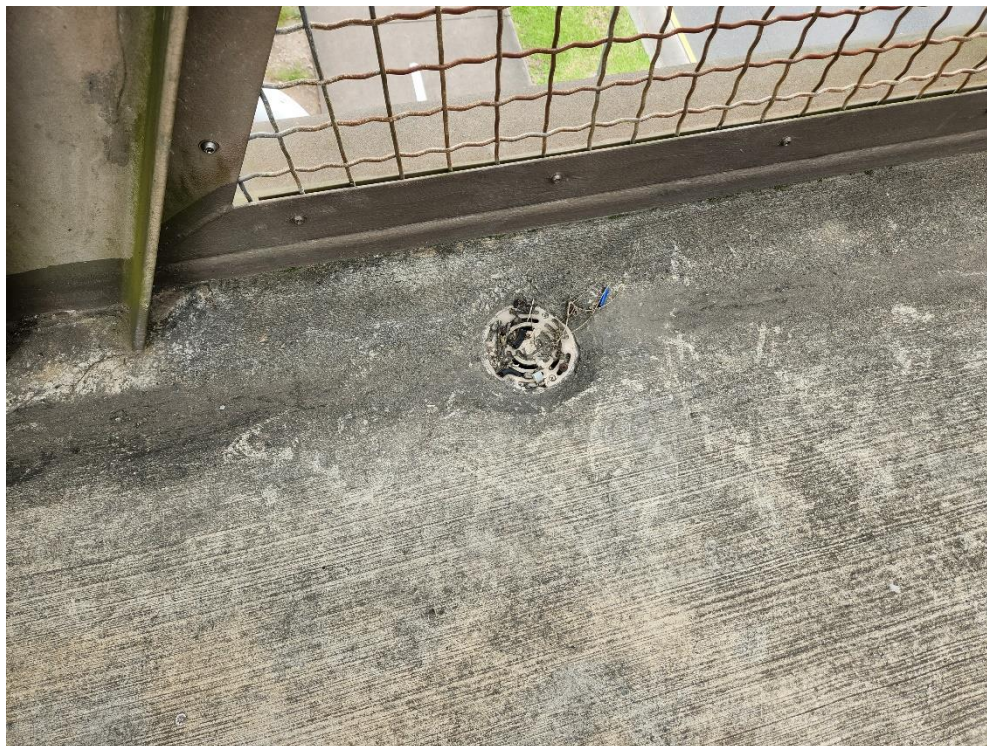
Photo 5 – Semi blocked scuppers at eastern end.

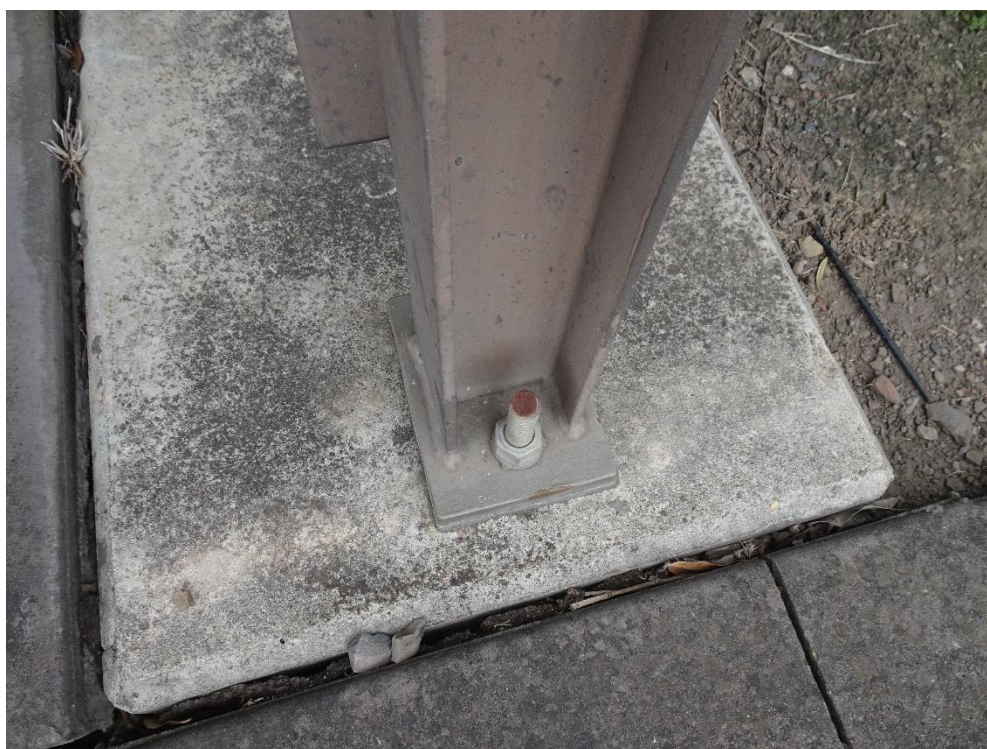
Photo 6 – Eastern end staircase – localised protective coating failure in steel elements.

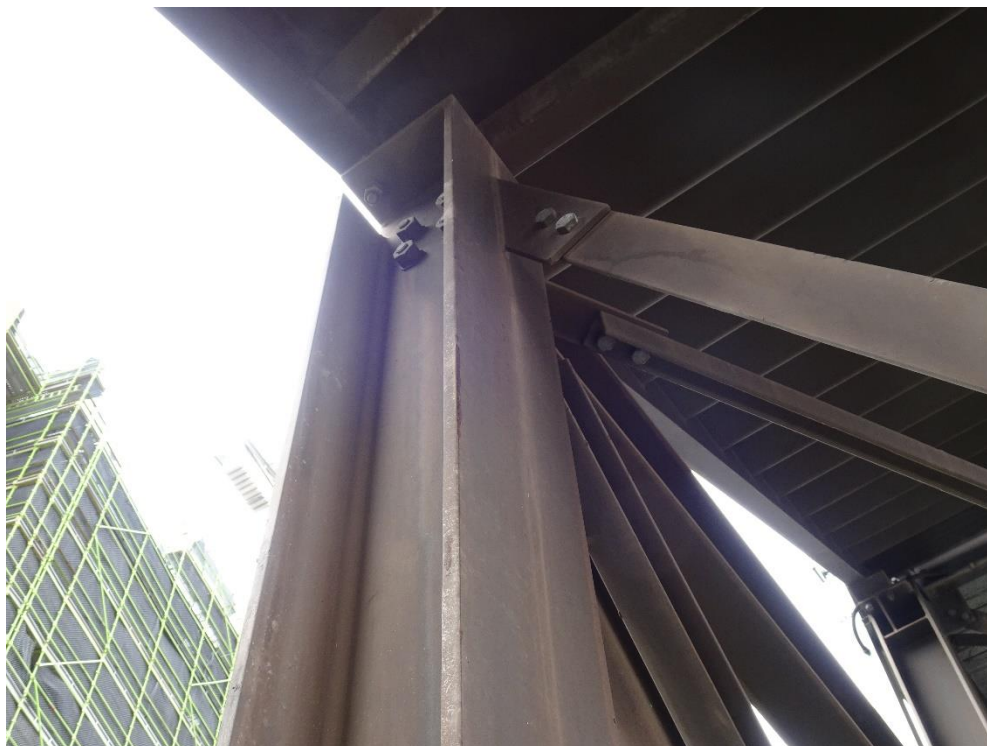
Photo 7 – Eastern end staircase – localised protective coating failure in steel columns.

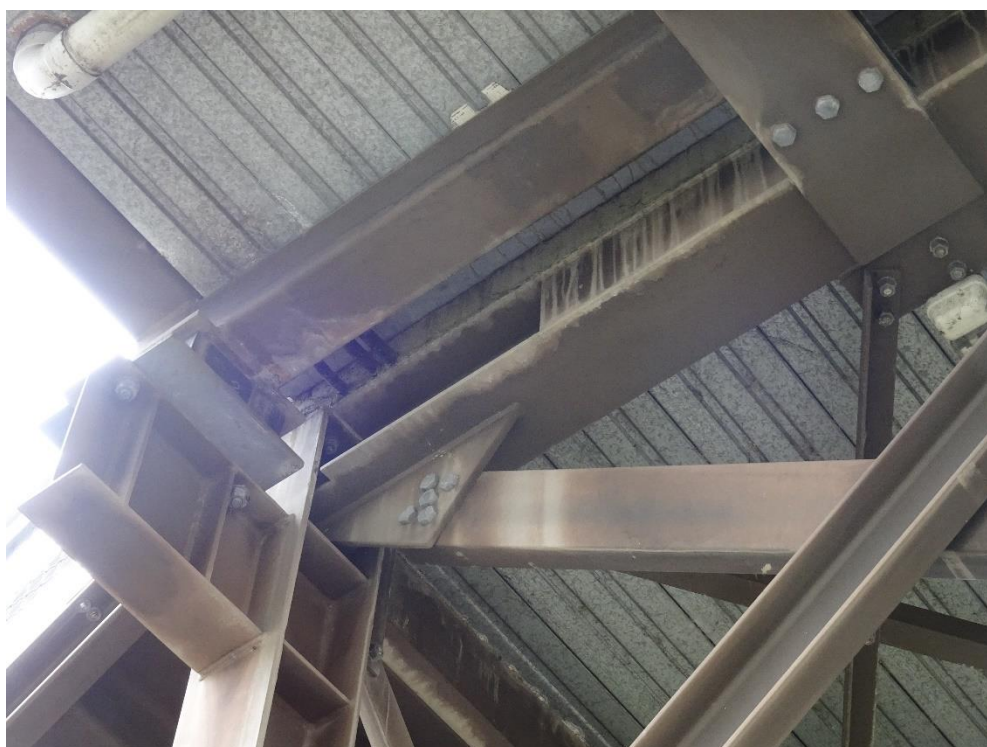
Photo 8 – Eastern end transverse beam – localised protective coating failure in steel elements.

PTCG	M	712.00	M700 Paint Repairs, Minor	Repair protective coating where rust is apparent to cross girder at E & W/ends.	3	m <sup>2</sup>	May 2026	8,9,10,16,17
PTDG	M	712.00	M700 Paint Repairs, Minor	Repair protective coating where rust is apparent to cross girder at E & W/ends.	1	m <sup>2</sup>	May 2026	22
PCBT	M	712.00	M700 Paint Repairs, Minor	Repair protective coating where corrosion is apparent to cable bracing or protective coating is cracked at E & W/end.	1	m <sup>2</sup>	May 2026	11,12,21

PTCG	M	712.00	M700 Paint Repairs, Minor	Repair protective coating where efflorescence is apparent to cross girders at W & E/end.	2	m <sup>2</sup>	May 2026	8,17
SCBT	M	712.00	M700 Paint Repairs, Minor	Repair protective coating where red rust is apparent to eye hook bolt at maintenance access.	1	m <sup>2</sup>	May 2026	29,30
SCOD	M	766.00	M762 Rehabilitate and/or Preserve Deck	Rehabilitate Bondek aluminium sheet where rust is apparent at E/end & N/W side.	1	m <sup>2</sup>	May 2026	18,23,24
MATT	M	790.00	M788 Other Specific Maintenance	Repair detached glass frame at eastern end of bridge.	1	Each	May 2026	31

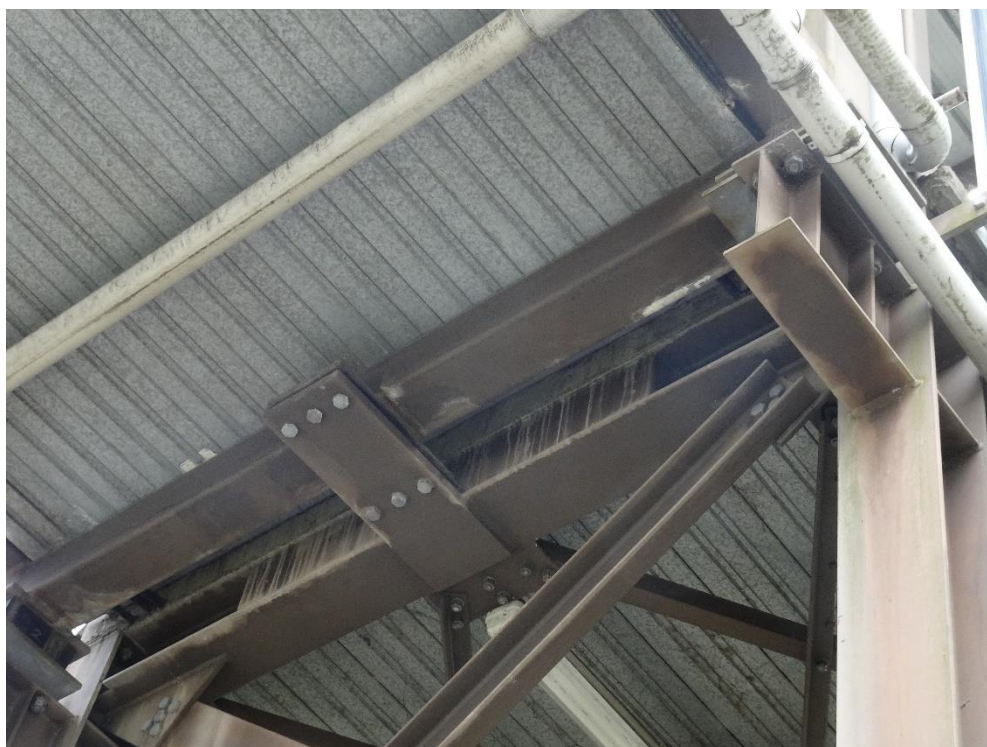
Photo 9 – Eastern end transverse beam – localised protective coating failure in steel elements.

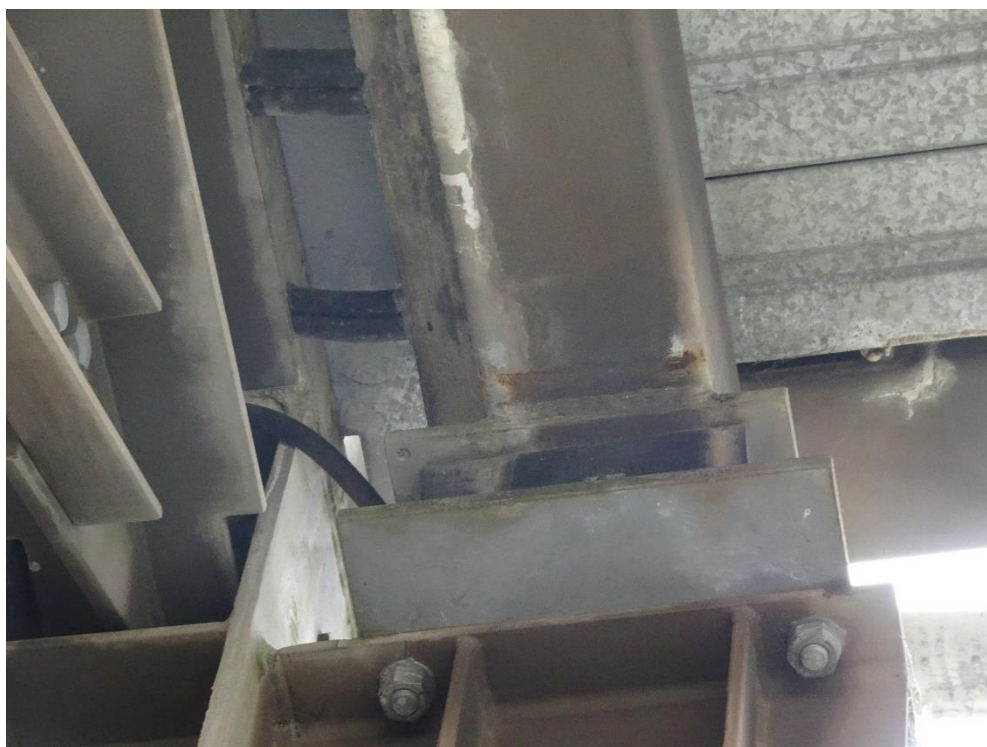
Photo 10 – Eastern end transverse beam – localised protective coating failure in steel elements.

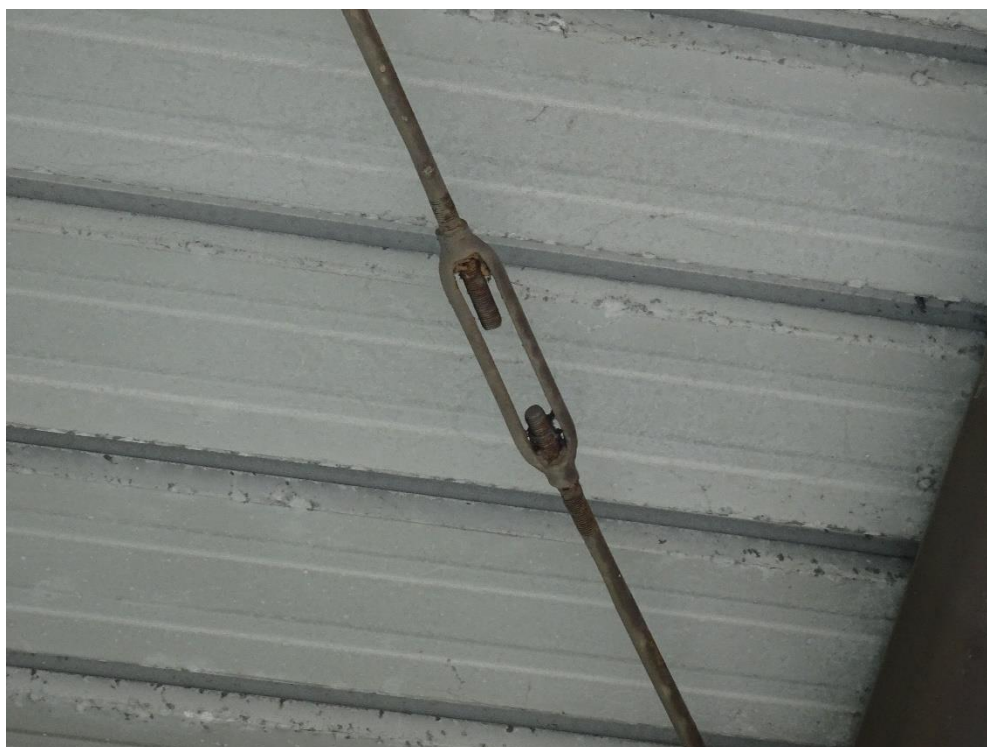
Photo 11 – Eastern end bracing – localised protective coating failure in steel elements.

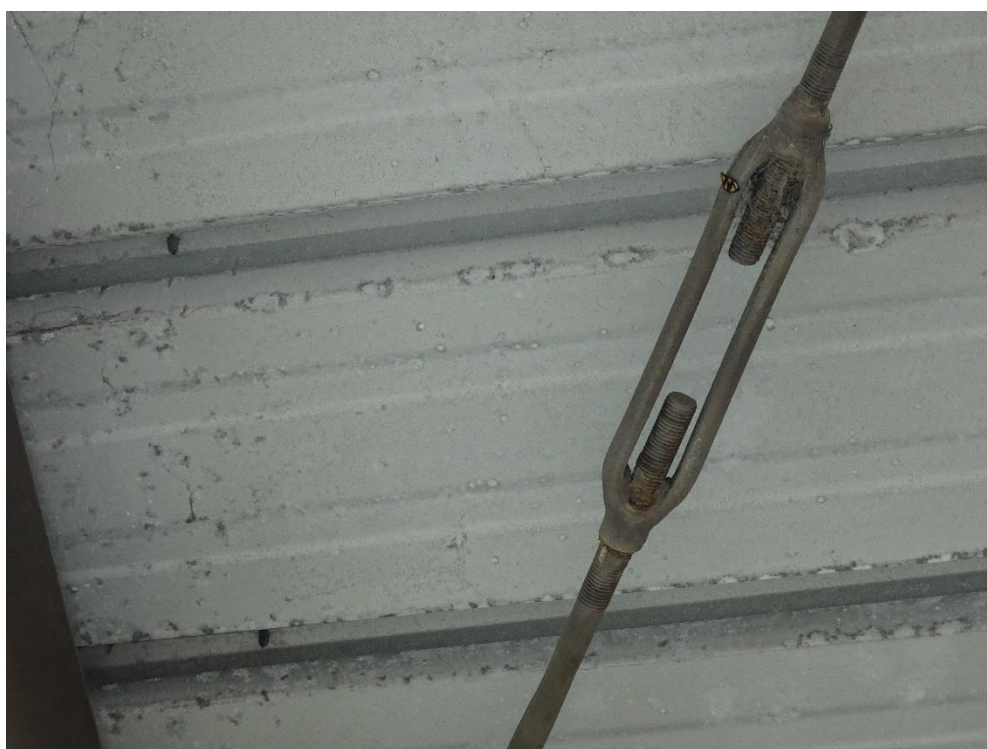
Photo 12 – Eastern end bracing – localised protective coating failure in steel elements.

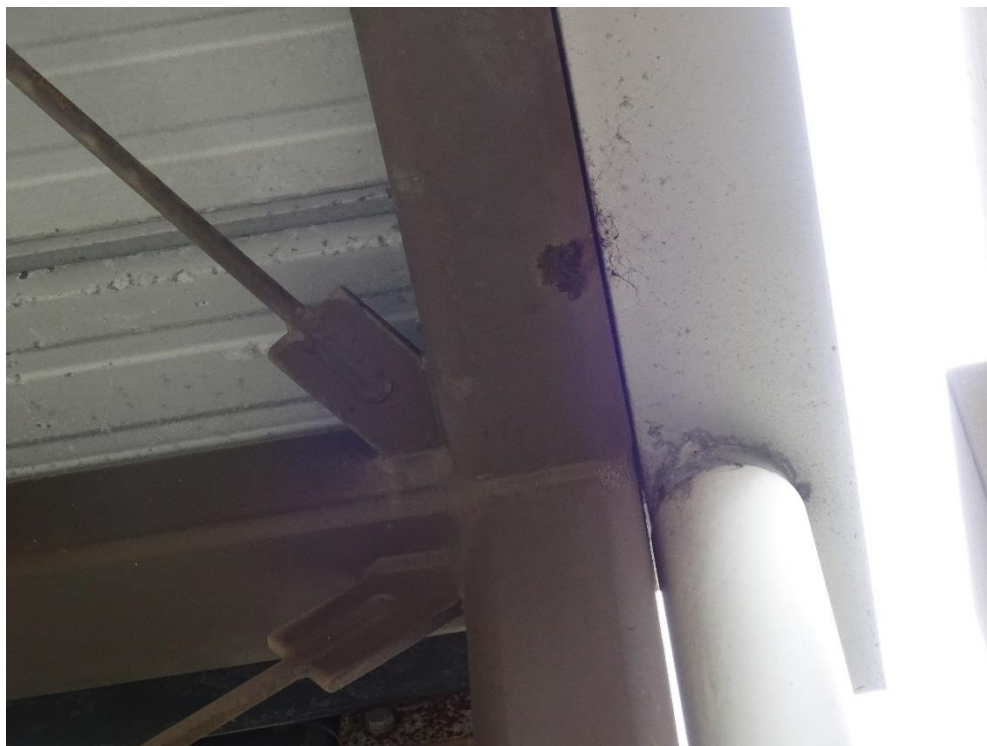
Photo 13 – Eastern end roof beam – localised protective coating failure in steel elements.

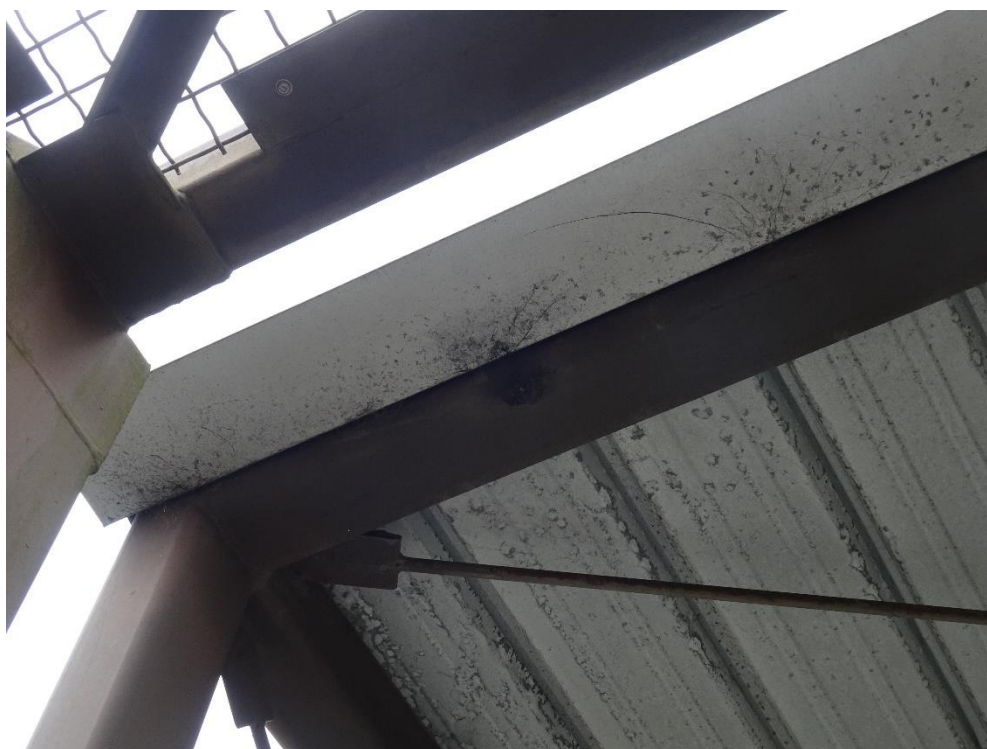
Photo 14 – Eastern end roof beam – localised protective coating failure in steel elements.

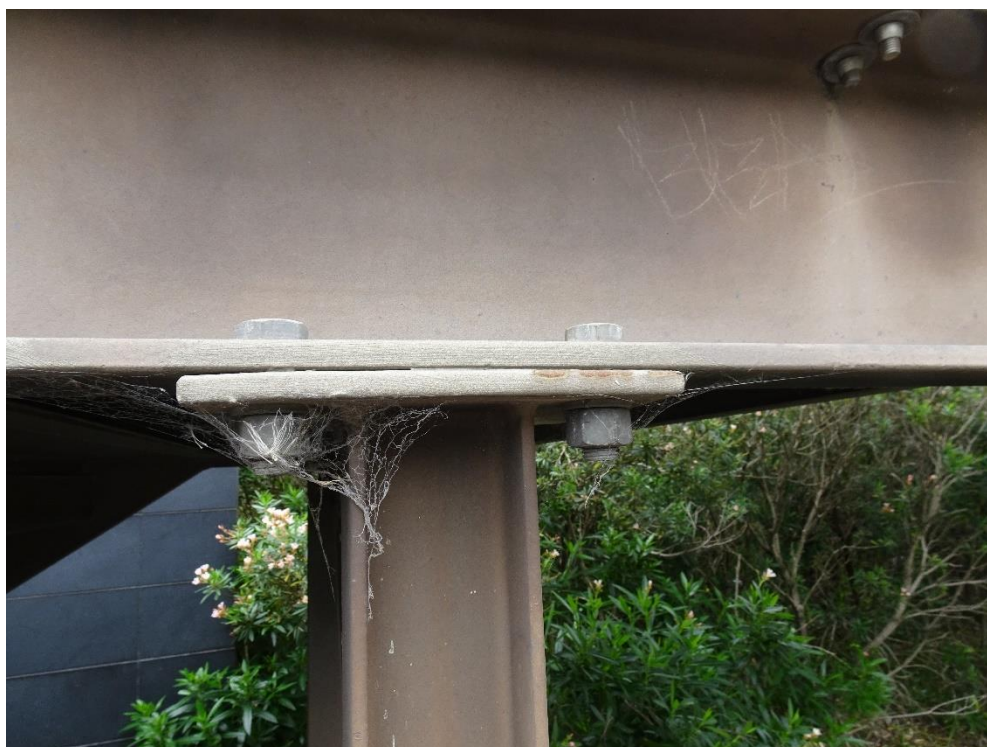
Photo 15 – Eastern end staircase – localised protective coating failure in steel elements.

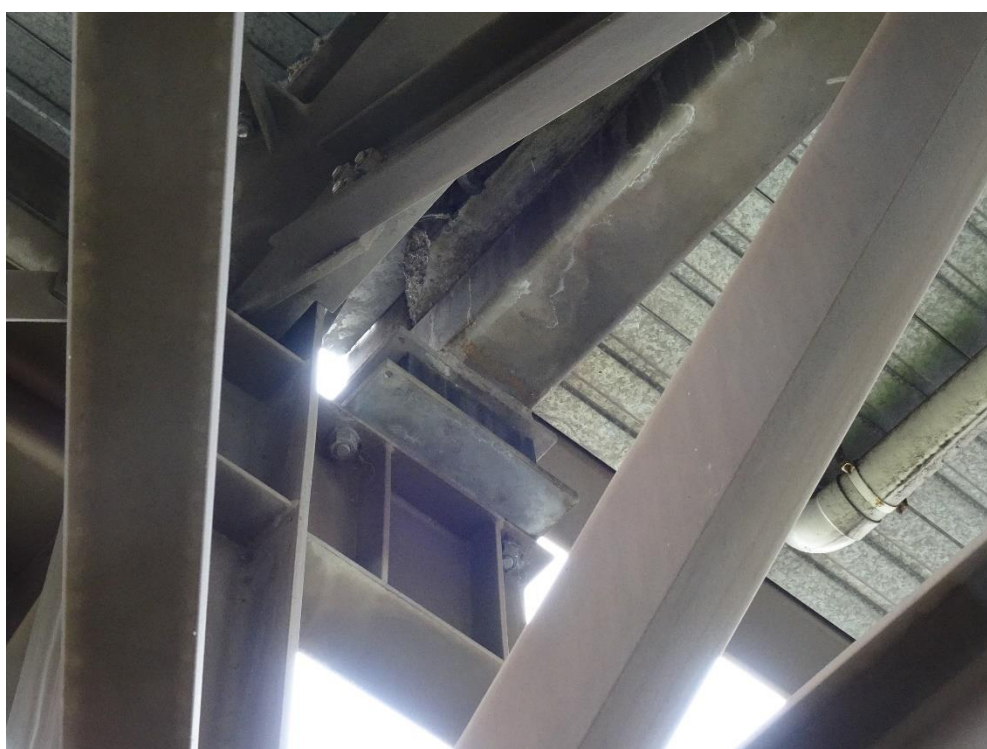
Photo 16 – Western end transverse beam – localised protective coating failure in steel elements.

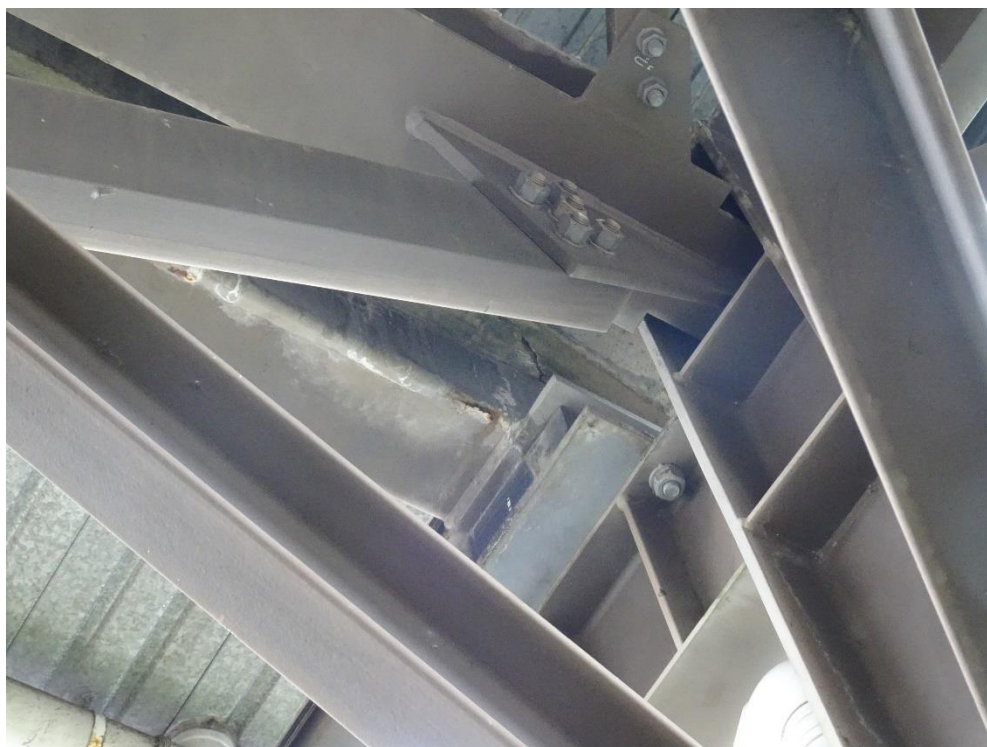
Photo 17 – Western end transverse beam – localised protective coating failure in steel elements.

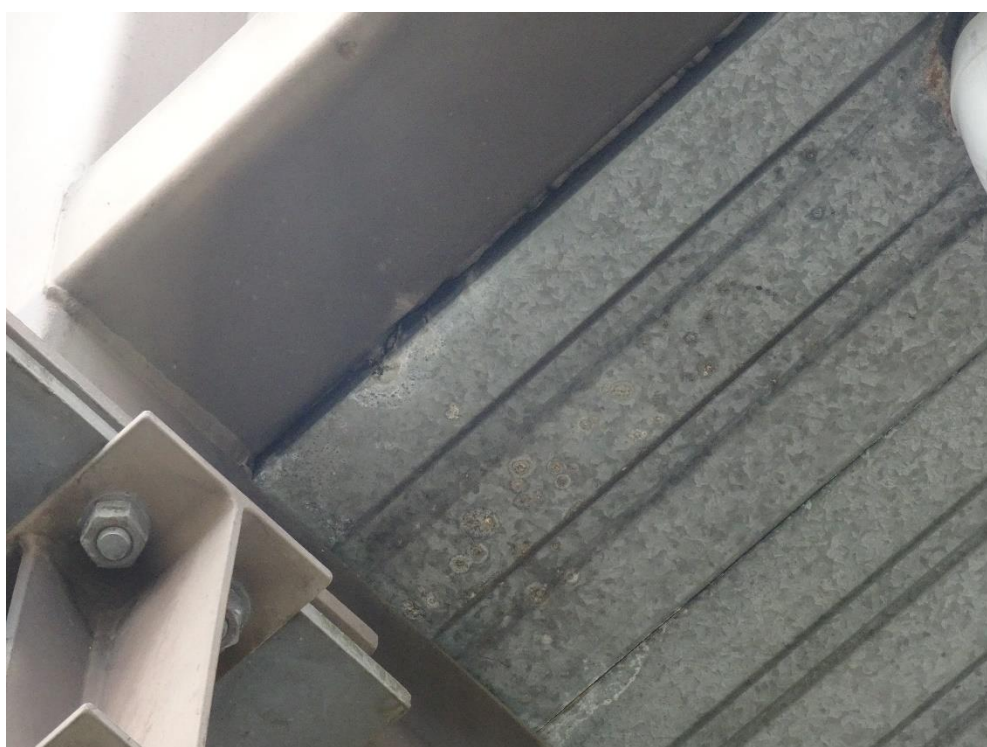
Photo 18 – Eastern end Bondek – localised rust in steel elements.

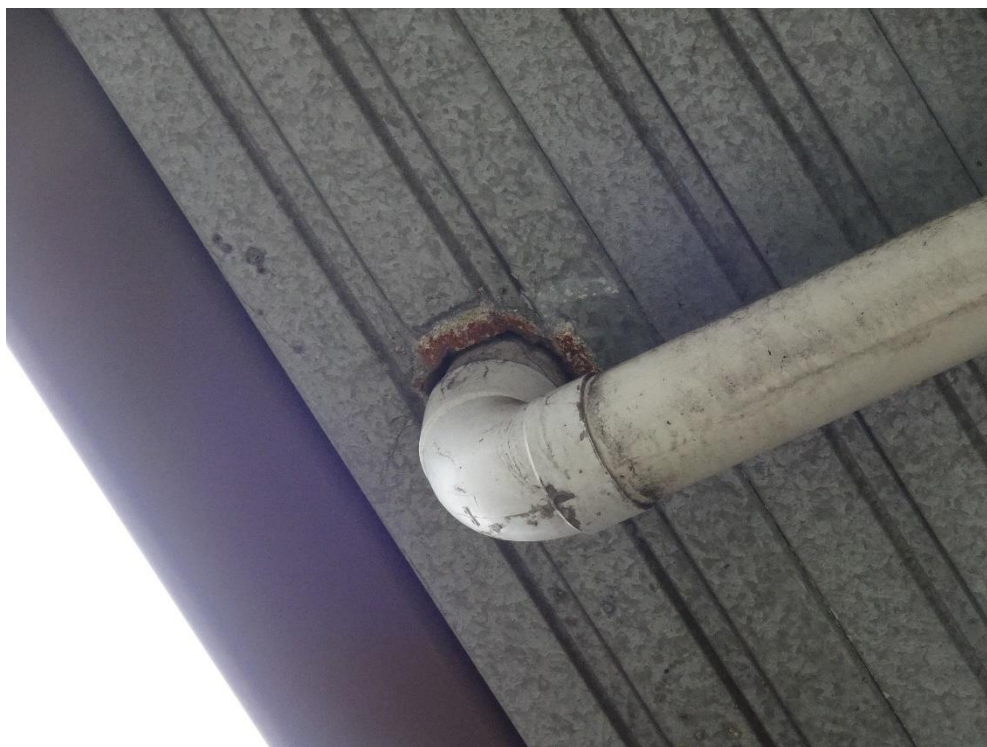
Photo 19 – Eastern end Bondek at pipe location – localised rust in steel elements.

PCOD	M	766.00	M762 Rehabilitate and/or Preserve Deck	Rehabilitate protective coating where surface rust is apparent to Bondek aluminium sheet at pipe penetrations at E and W/ends. Sealant to be provided around pipe penetrations.	1	m <sup>2</sup>	May 2026	19
PDBR	M	712.00	M700 Paint Repairs, Minor	Repair protective coating where surface rust and cracking is apparent to diagonal bracing at E/end.	1	m <sup>2</sup>	May 2026	20,33,34
PPIR	M	712.00	M700 Paint Repairs, Minor	Repair protective coating where red rust is apparent to steel piers at W & E/end.	2	m <sup>2</sup>	May 2026	25
SPIR	M	781.00	M778 Steel Structural Elements, Other Specific Maintenance	Tighten loose nut at W/end staircase steel pier. Repair protective coating where handrails and connections are rusted.	1	Each	May 2026	26
PTBC	M	712.00	M700 Paint Repairs, Minor	Repair protective coating where red rust is apparent to truss bottom chord at W/end.	4	m <sup>2</sup>	May 2026	27,28

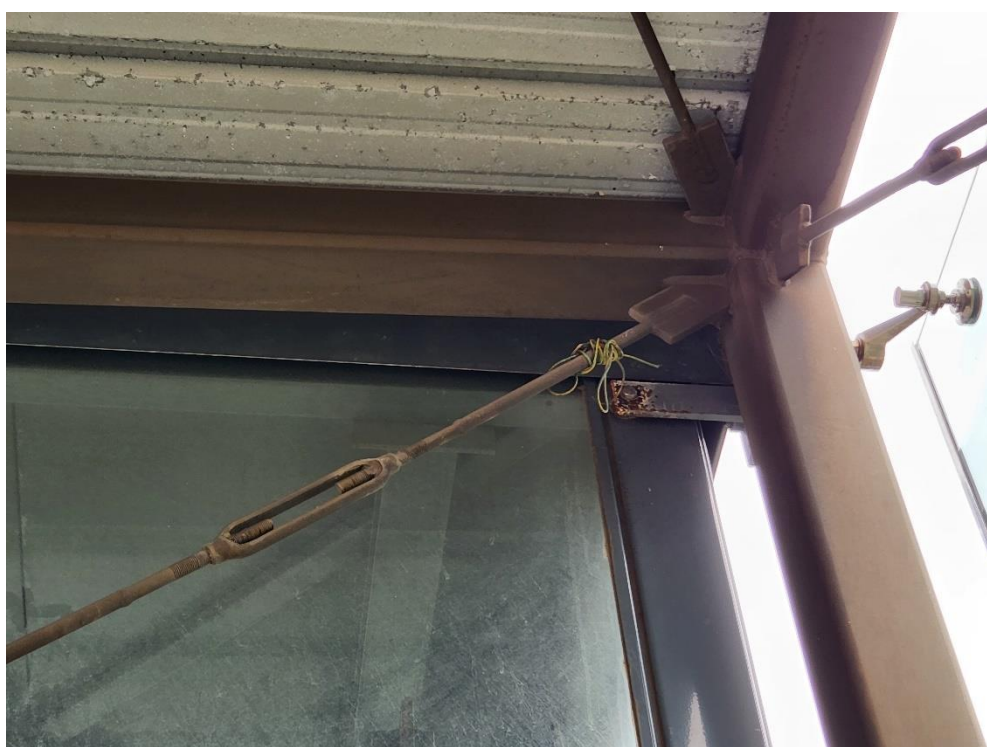
Photo 20 – Western end bracing – Rust on protective coating of steel bracket

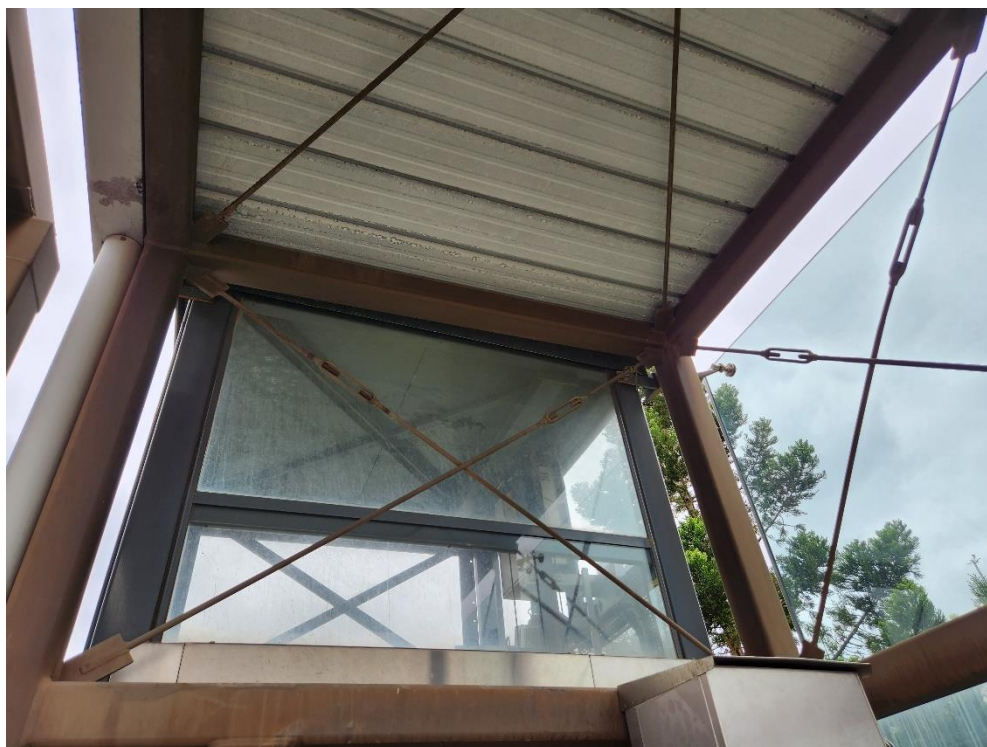
Photo 21 – Western end bracing – localised protective coating failure in steel elements.

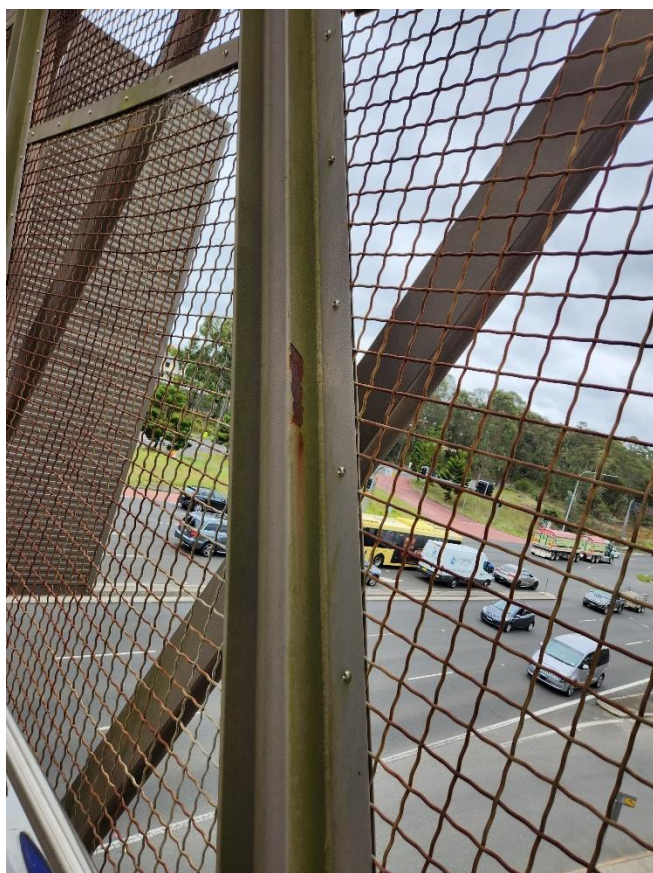
Photo 22 – Eastern end diagonal – localised protective coating failure in steel element.

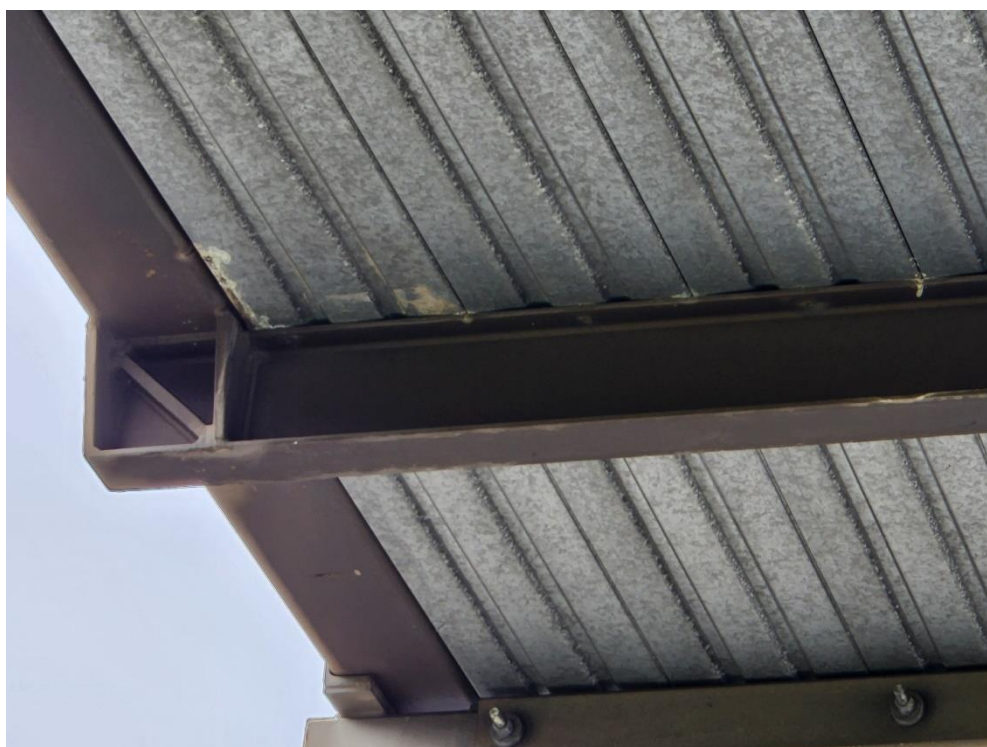
Photo 23 – Western end Bondek – localised rust in steel element.

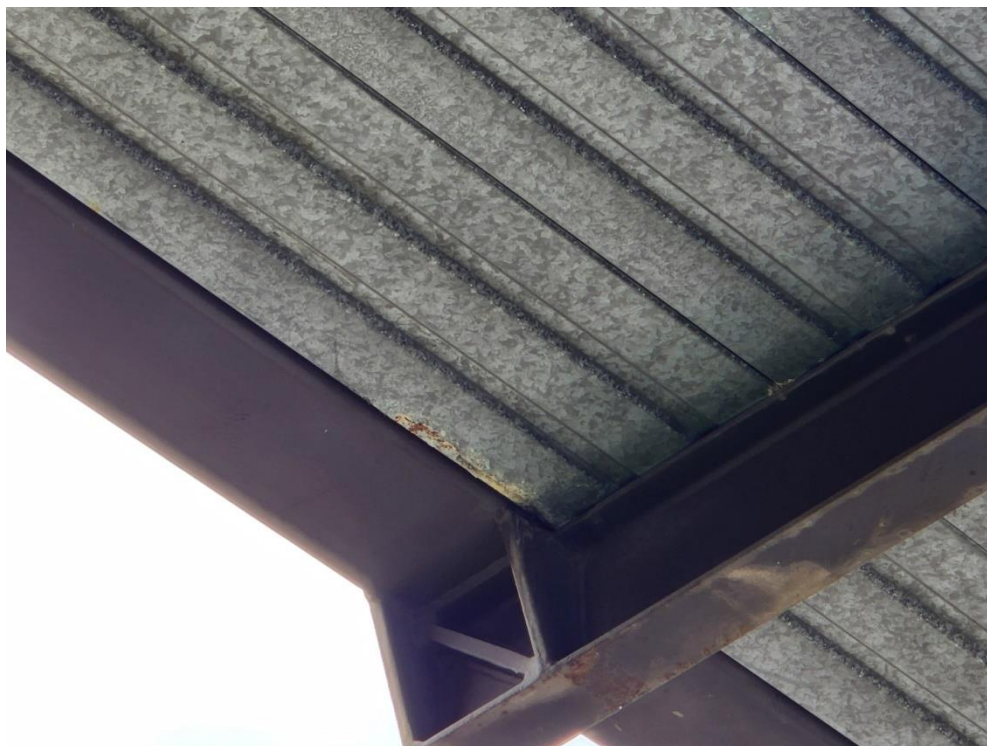
Photo 24 – Western end Bondek – localised rust in steel element.

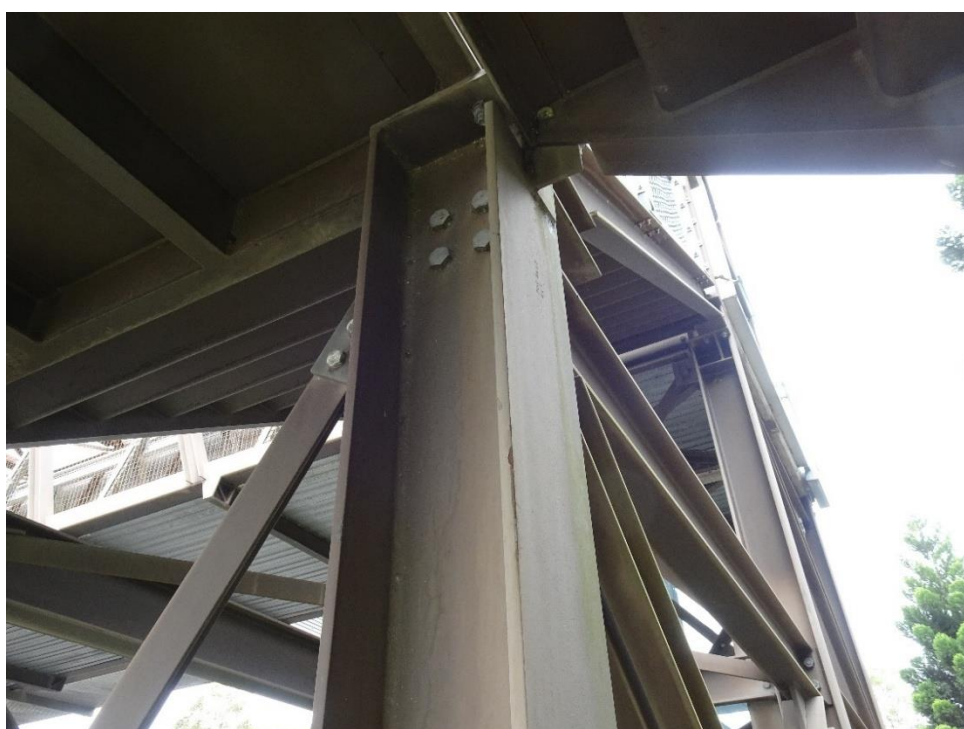
Photo 25 – Steel pier – localised protective coating failure in steel elements.

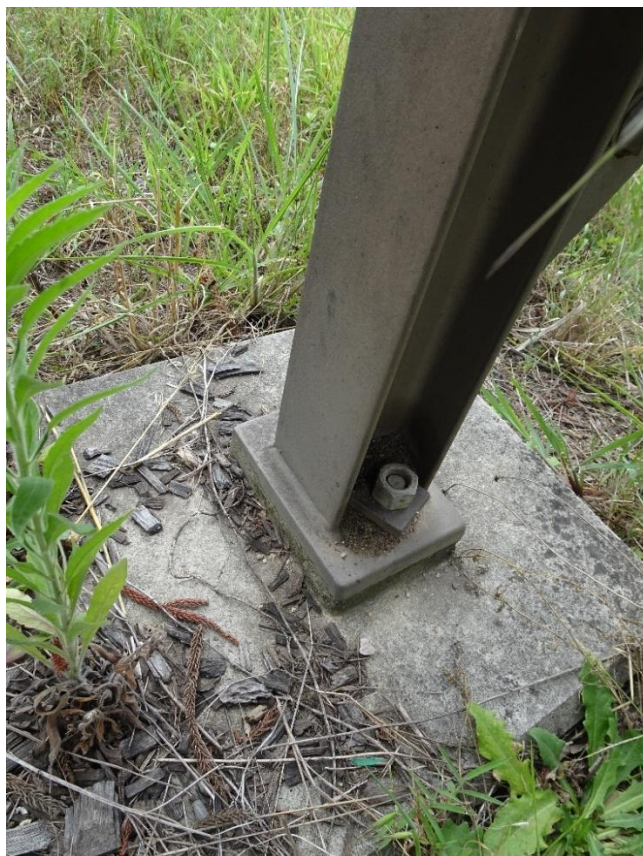
Photo 26 – Western staircase steel pier – tighten loose nut.

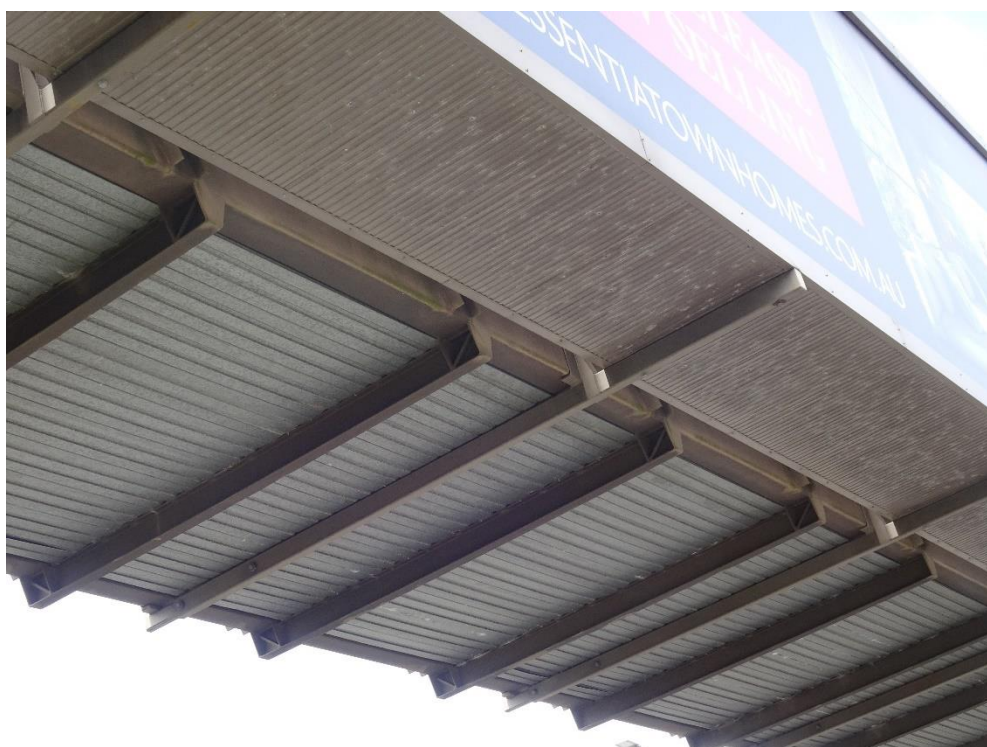
Photo 27 – Bridge bottom chords - localised protective coating failure in steel elements.

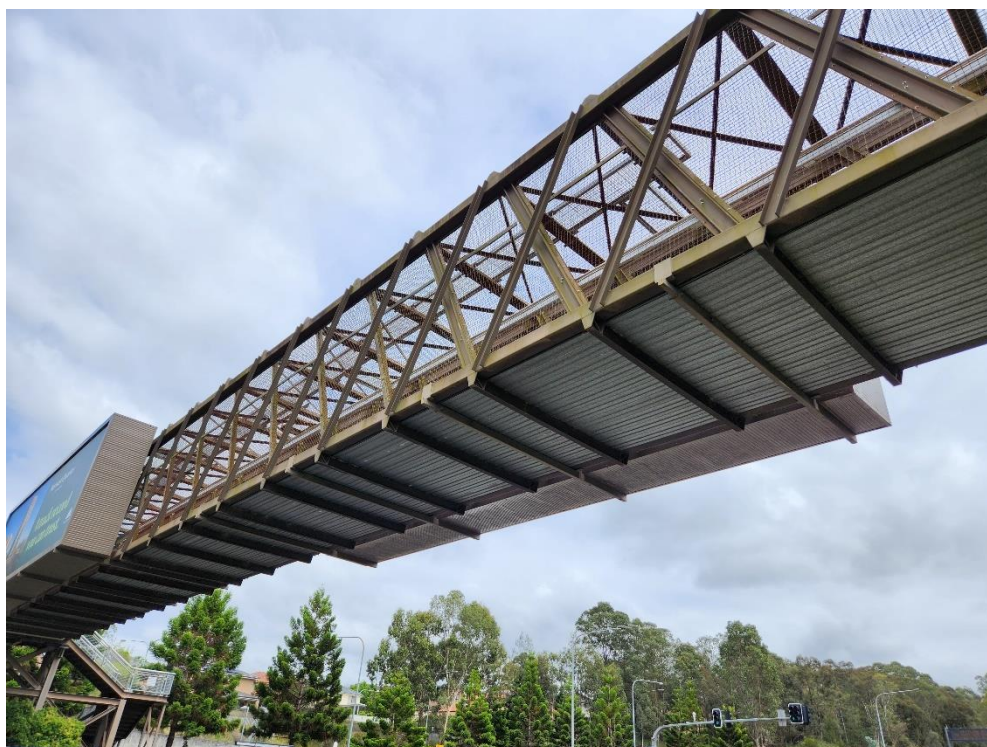
Photo 28 – Bridge bottom chords - localised protective coating failure in steel elements.

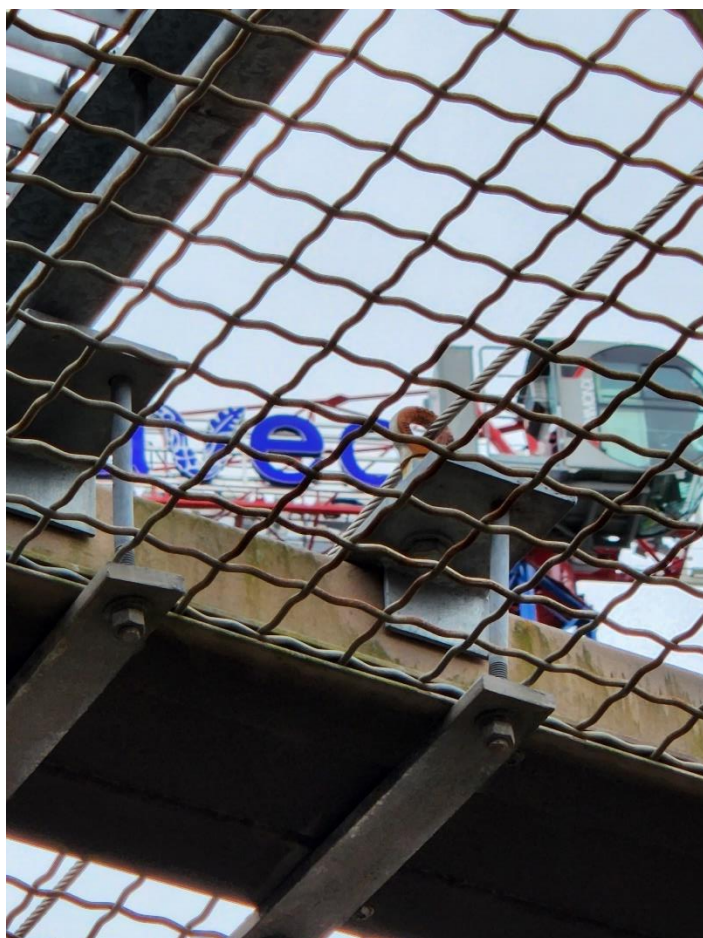
Photo 29 – Maintenance access – rust on hook bolt.

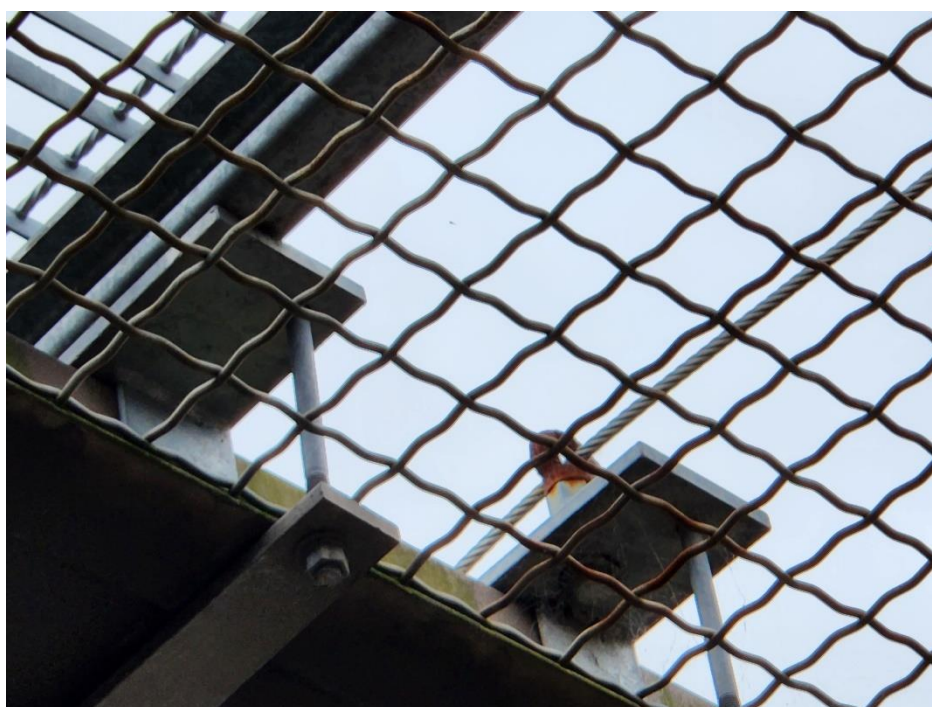
Photo 30 – Maintenance access – rust on hook bolt.
