# Level 2 Inspection Report

## Old Windsor Road Pedestrian Bridge

**Mulpha Norwest Pty Ltd**

Ref: 241212\_R001

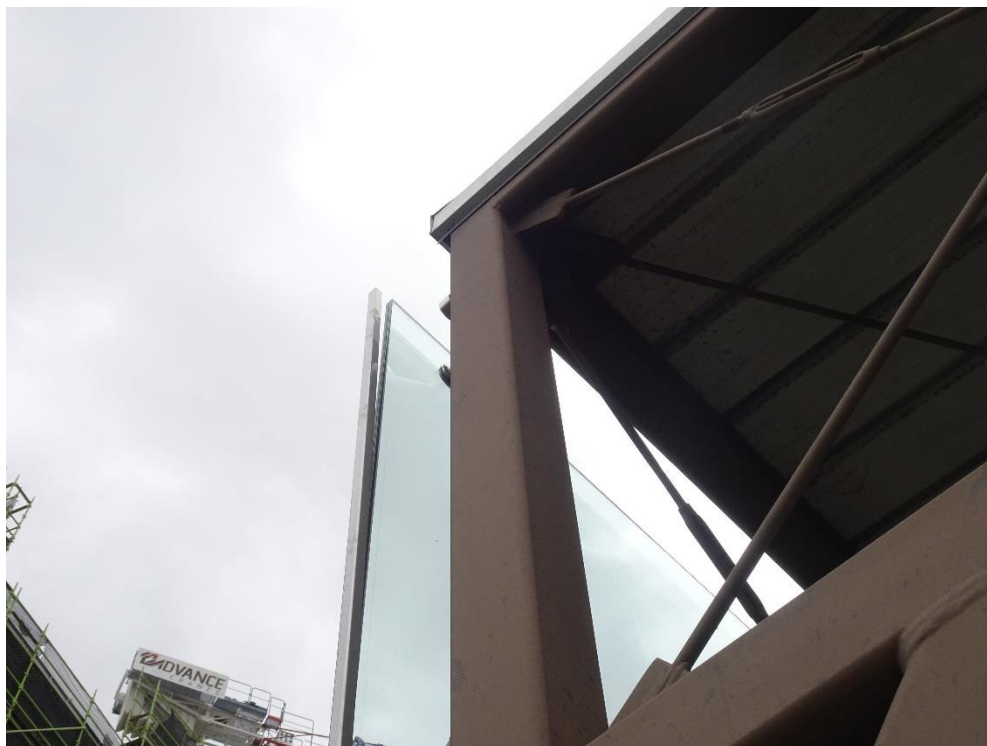
Photo 31 – Eastern end - glass framing detached.

PTCG	M	712.00	M700 Paint Repairs, Minor	Repair protective coating where efflorescence is apparent to cross girders at W & E/end.	2	m <sup>2</sup>	May 2026	8,17
SCBT	M	712.00	M700 Paint Repairs, Minor	Repair protective coating where red rust is apparent to eye hook bolt at maintenance access.	1	m <sup>2</sup>	May 2026	29,30
SCOD	M	766.00	M762 Rehabilitate and/or Preserve Deck	Rehabilitate Bondek aluminium sheet where rust is apparent at E/end & N/W side.	1	m <sup>2</sup>	May 2026	18,23,24
MATT	M	790.00	M788 Other Specific Maintenance	Repair detached glass frame at eastern end of bridge.	1	Each	May 2026	31

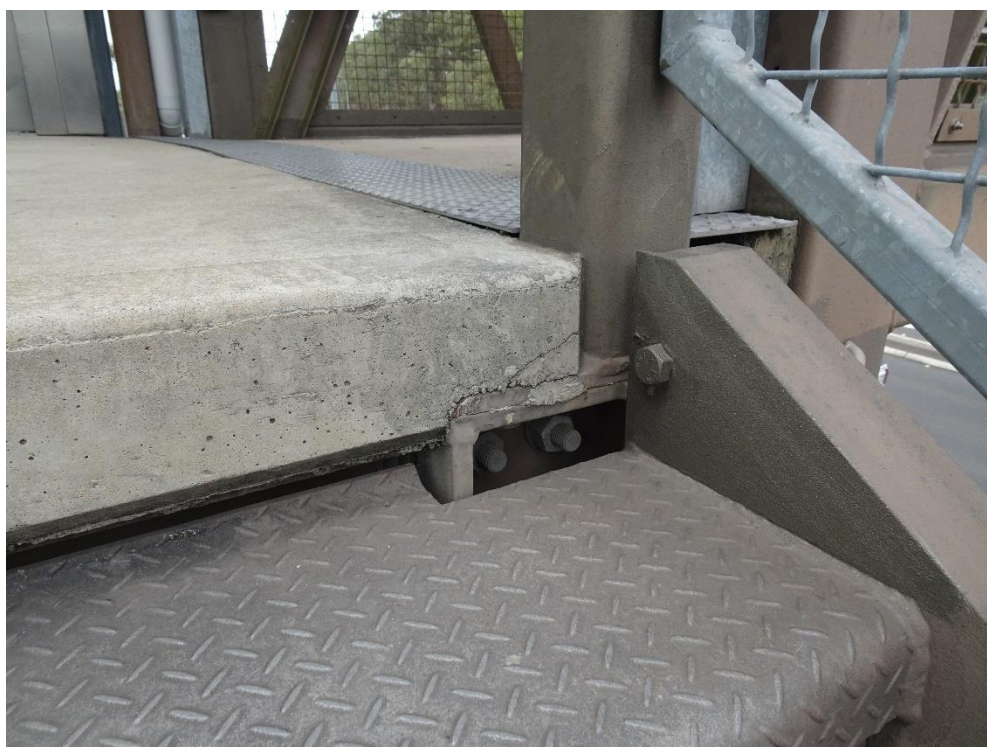
Photo 32 – Eastern end – slab cracking.

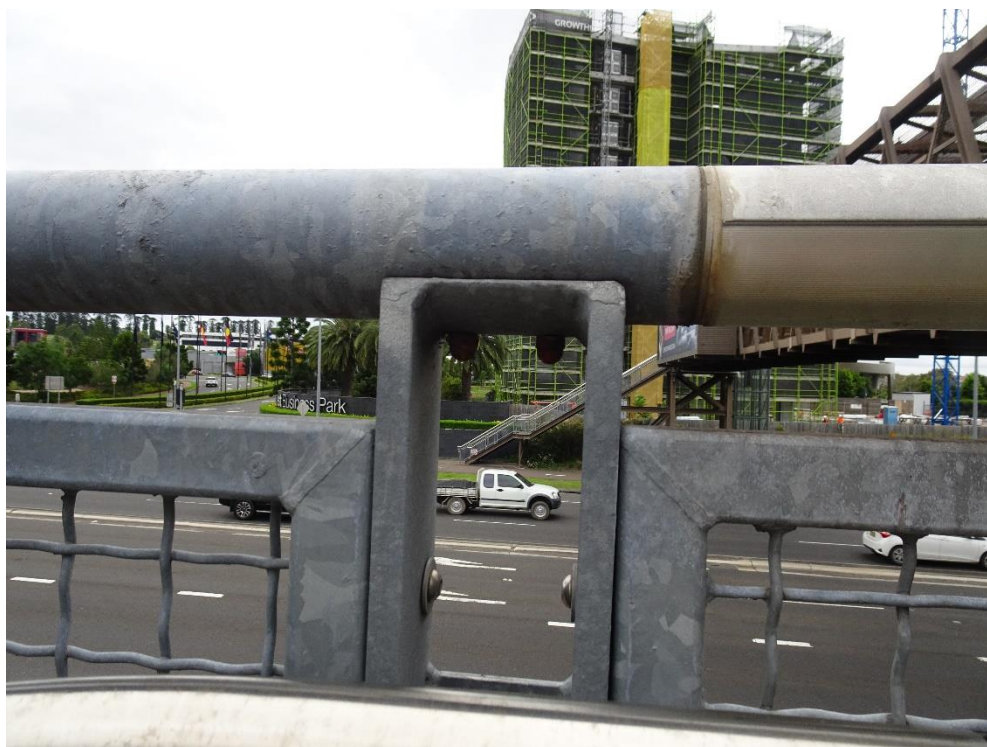
Photo 33 – Handrail and bolt connection rusting.

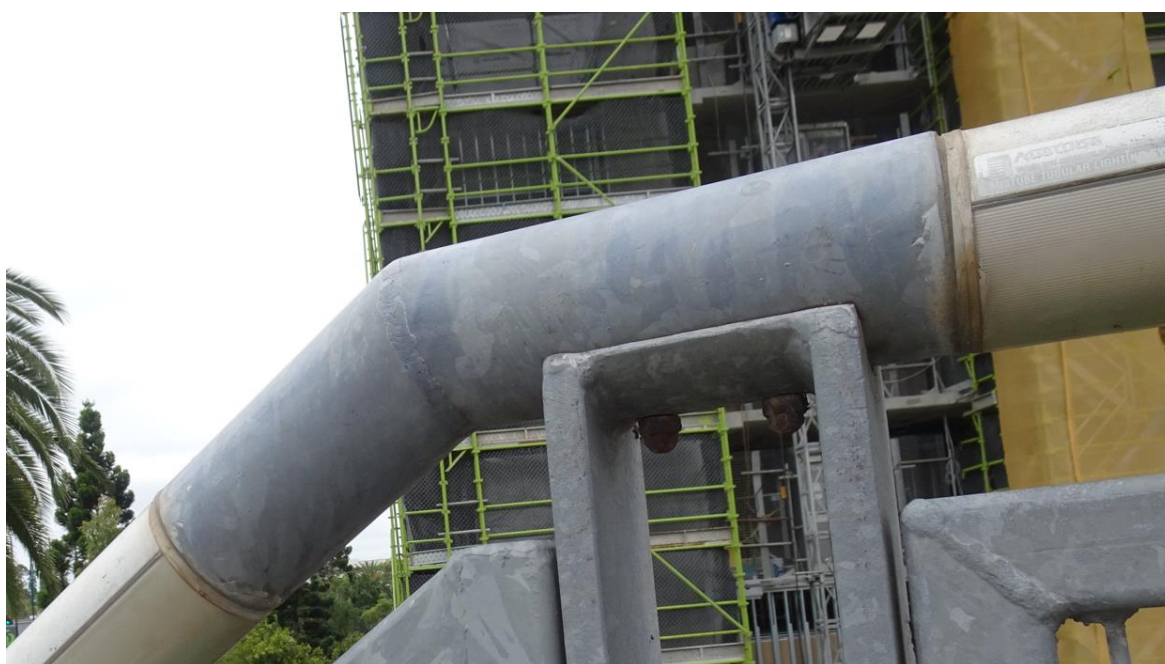
Photo 34 – Handrail and bolt connection rusting.

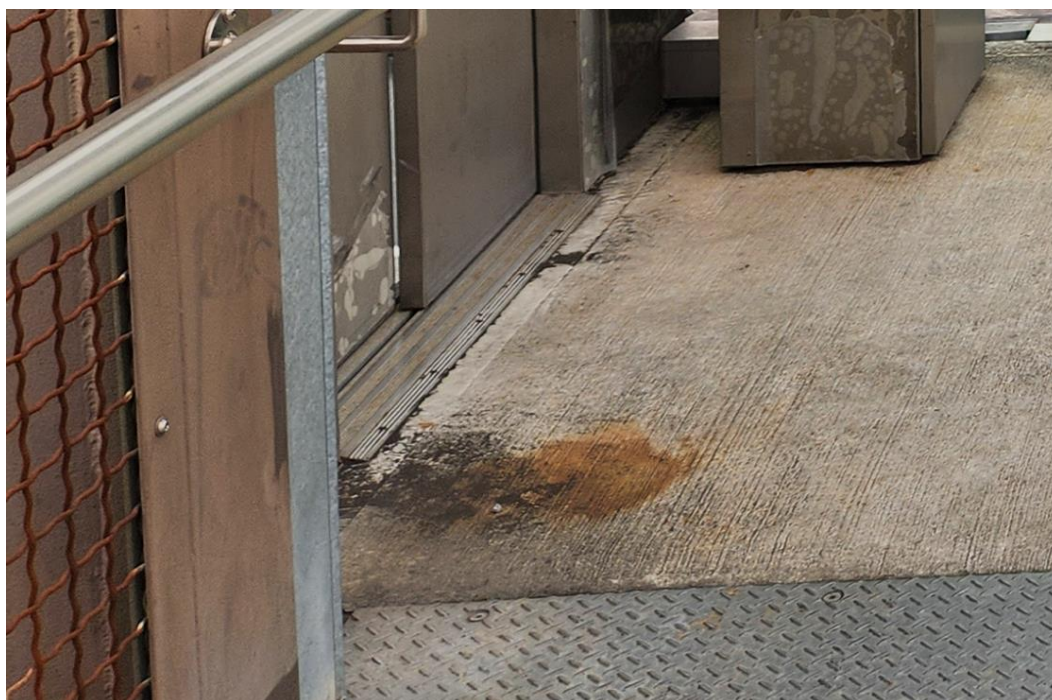
Photo 35 –Western End – Abutment – rust on Bondek slab.

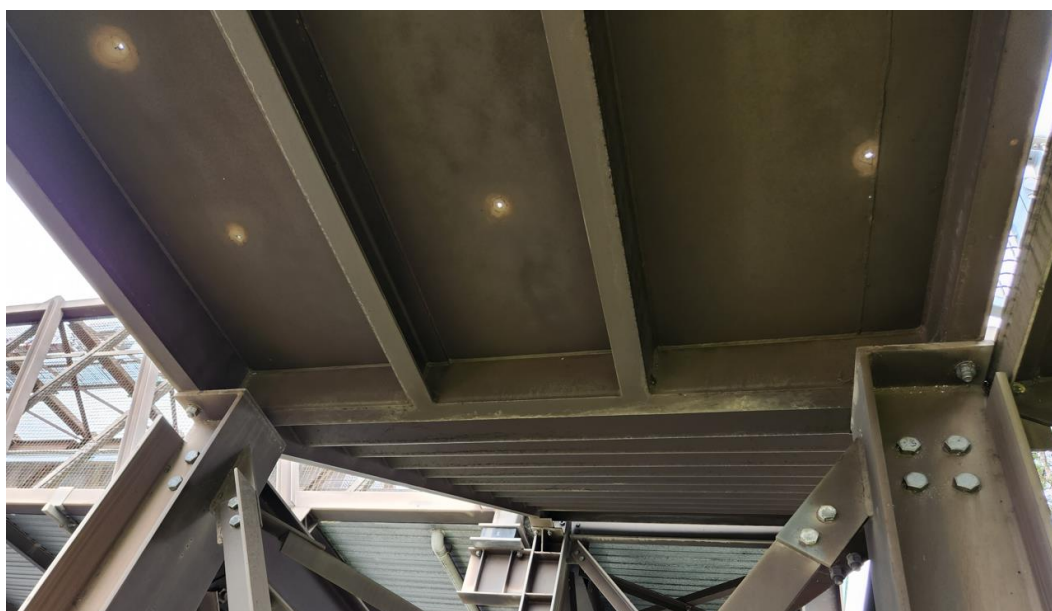
Photo 36 – Western End – Staircase – efflorescence around drilled holes in steel sheeting.

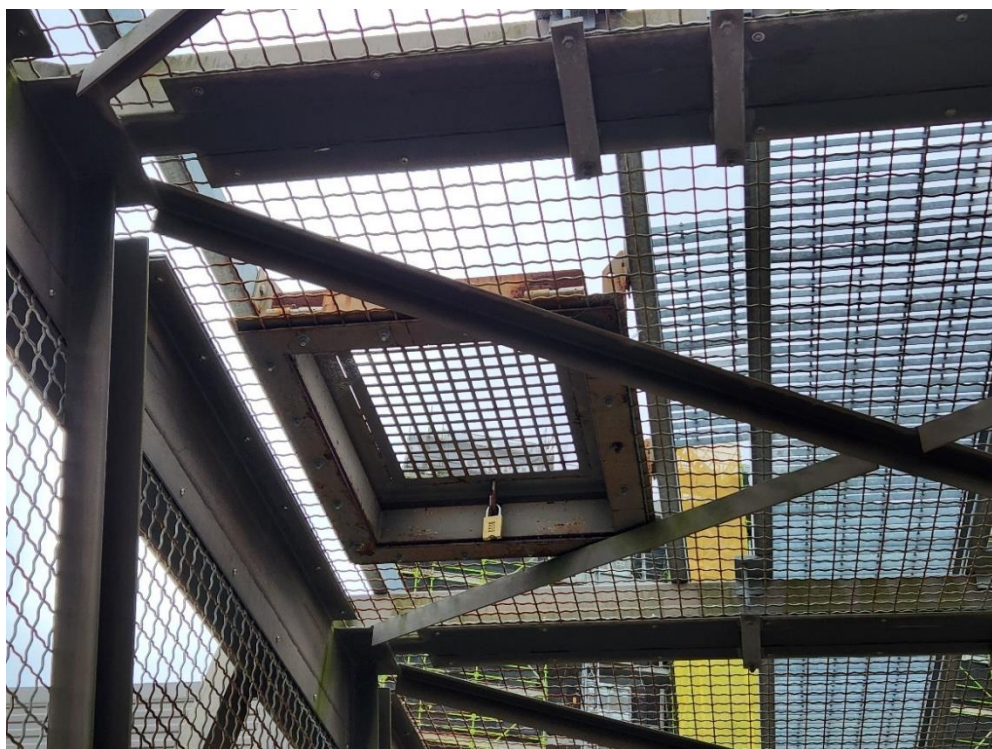
Photo 37– Maintenance access – rust to protective coating of steel element.

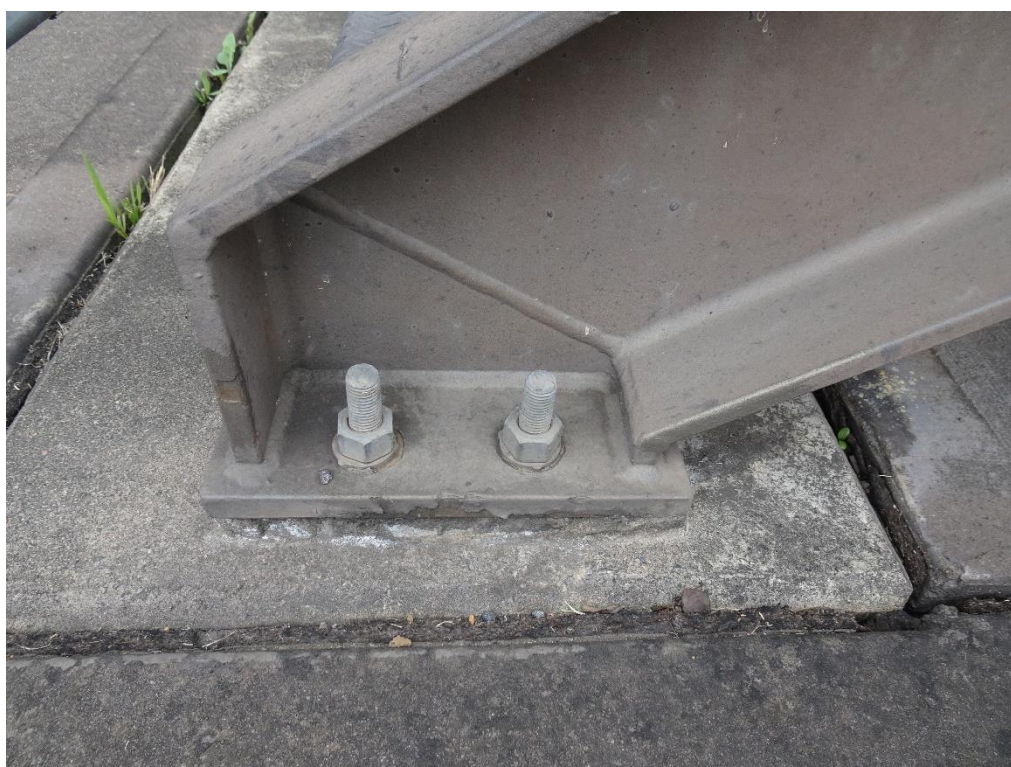
Photo 38 – Eastern End – Staircase –failure of protective coating of steel element and base plate.

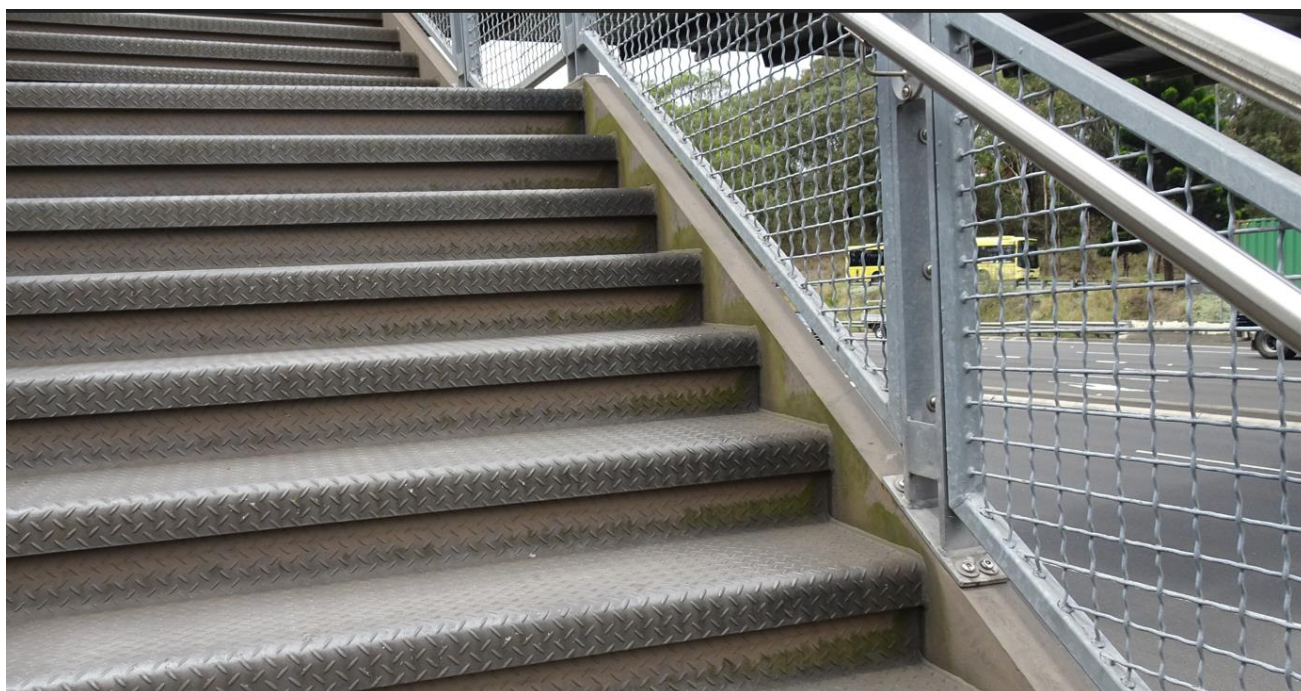
Photo 39 – Western End – Staircase – general moss on steel sheeting.

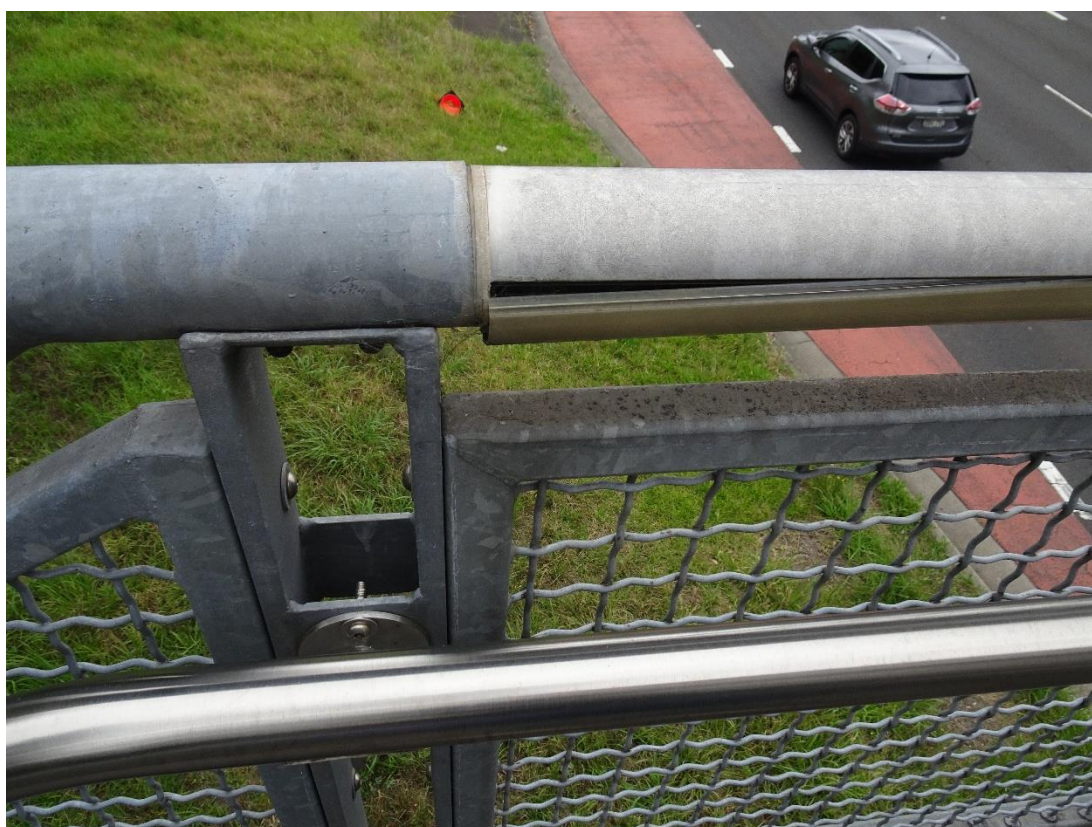
Photo 40 – Eastern End – Separation of railings.
