SITE AUDIT REPORT

Remediation Action Plan, Kogarah
War Memorial Pool, Carss Park NSW

Prepared for: Georges River Council

Project Number: E040

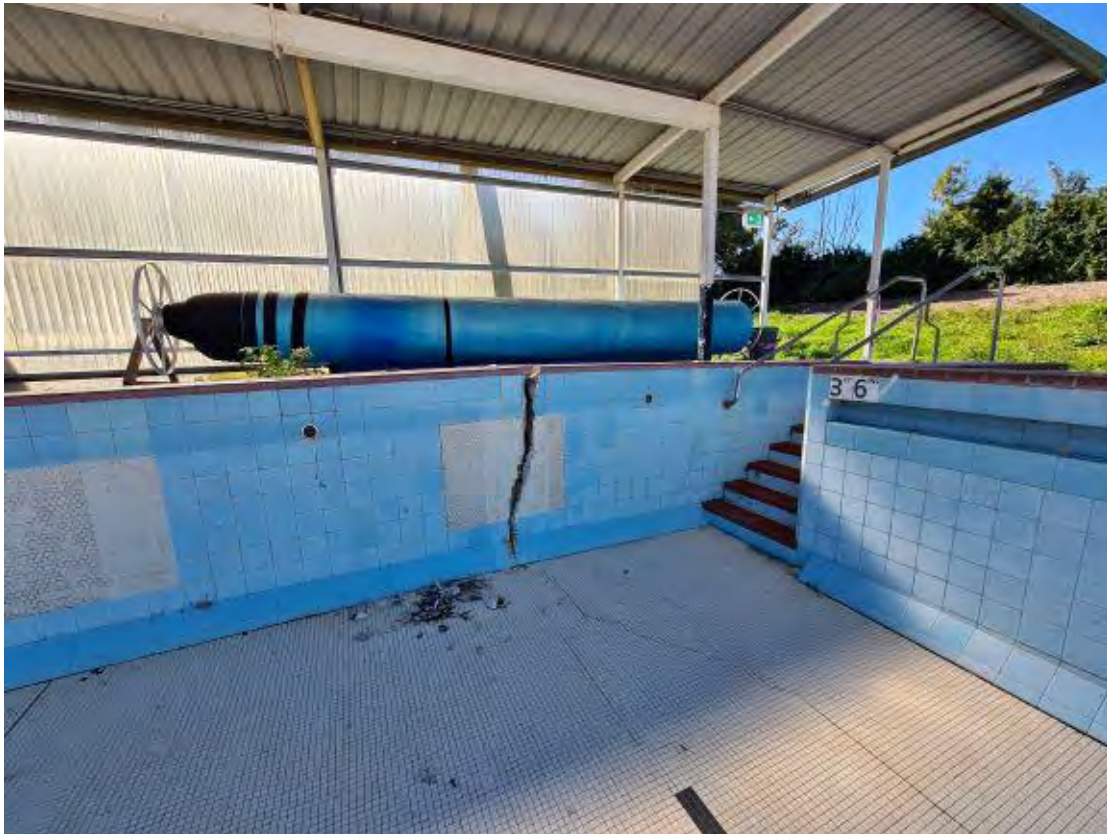
- The site was occupied by a swimming pool (drained) with associated single-storey buildings (closed and fenced). The swimming pool was observed to have significant cracking in the walls;

Photo 1: Looking north showing a large crack in the pool wall

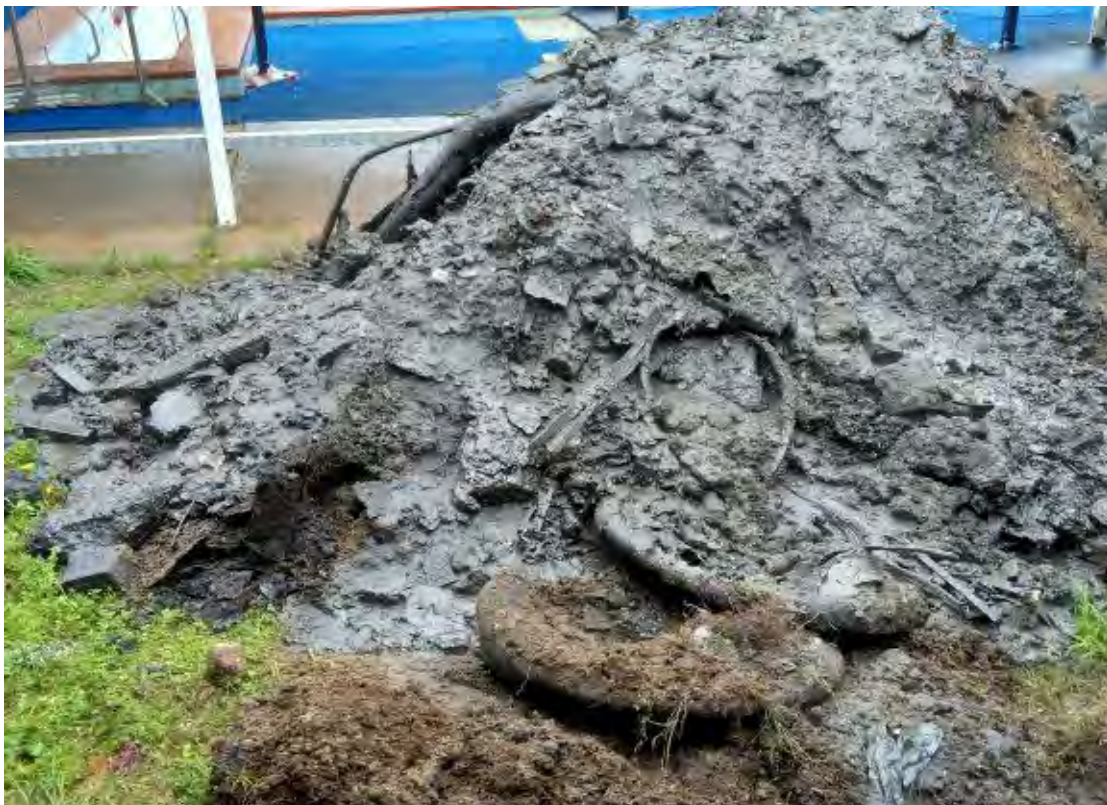
Staining, hydrocarbon odours and sulfurous odours were observed within some boreholes generally below the groundwater table. The PID results were generally low, with a maximum result of 13 ppm recorded in sample TP121/2.9-3.0.

Photo 2: TP121 looking east showing fill material from beneath water table

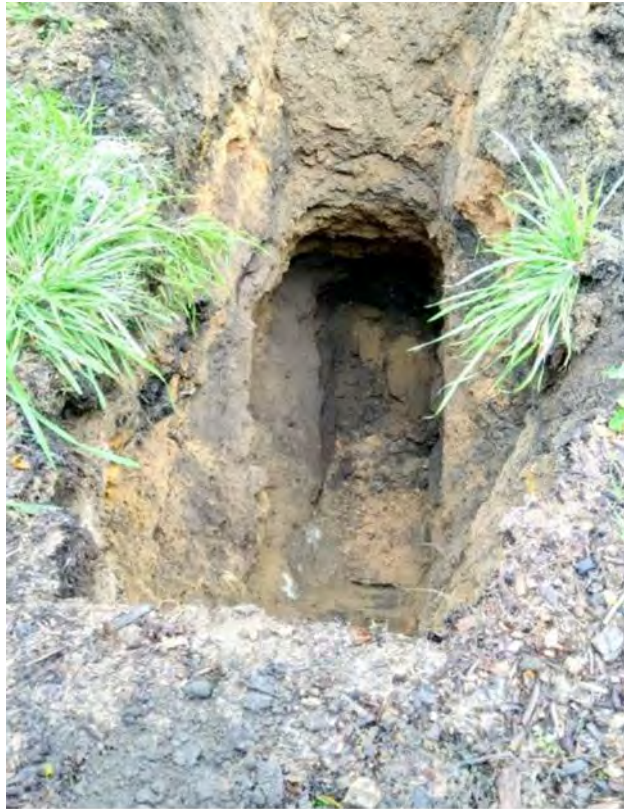
Photo 3: TP126 looking west showing the soil profile

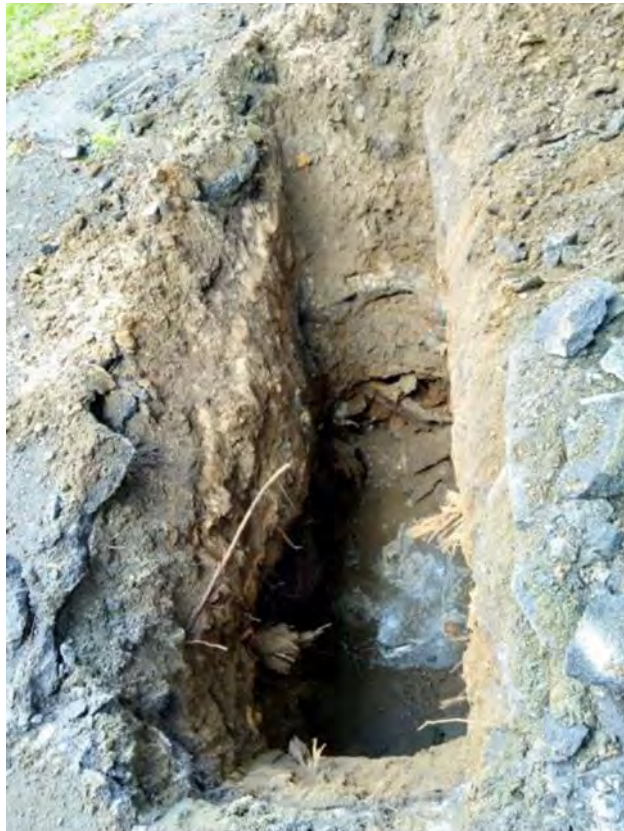
Photo 4: P128 looking east showing soil profile and groundwater at base of test pit

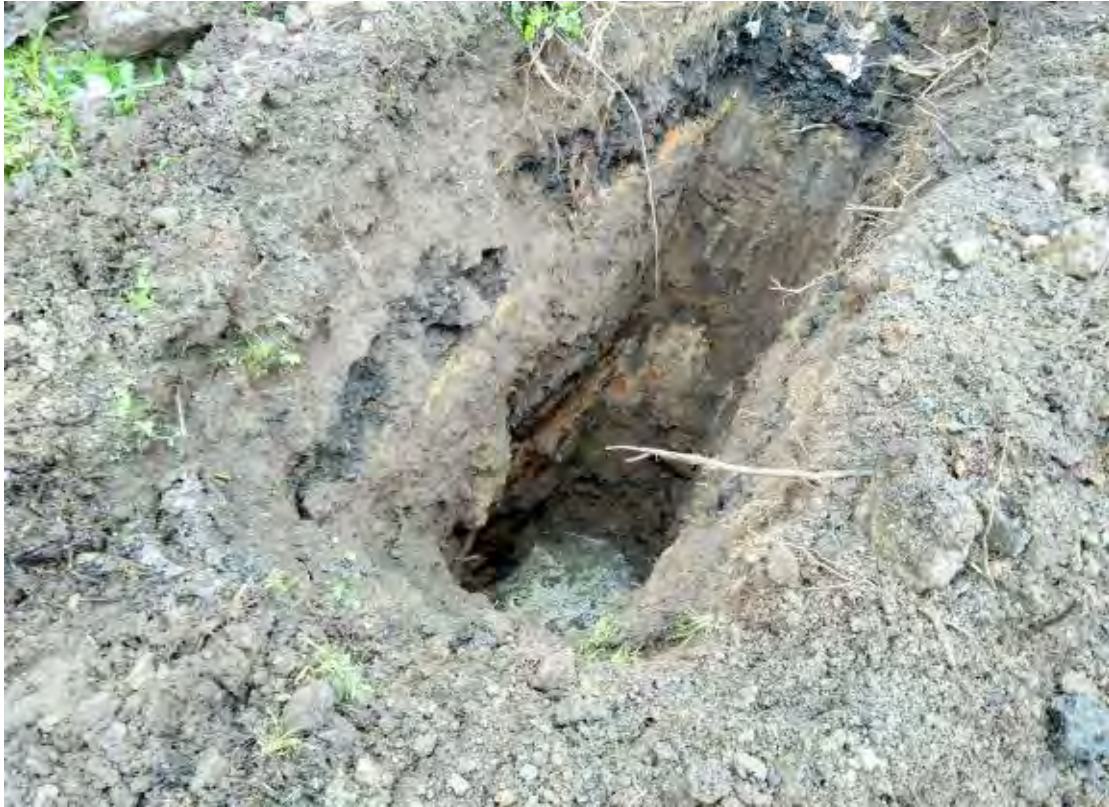
Photo 5: TP124 looking east showing soil profile with groundwater seepage at base of excavation
