# Arboricultural Development Assessment Report

Kogarah War Memorial Pool  
Carss Park NSW 2221  
September 2020  
*Final*  
(Updated 22<sup>nd</sup> Feb 2021)

Prepared for: Georges River Council

Prepared by: Paul Vezgoff  
Consulting Arborist  
ISA, AA  
Arboriculture Australia  
Registered Consultant

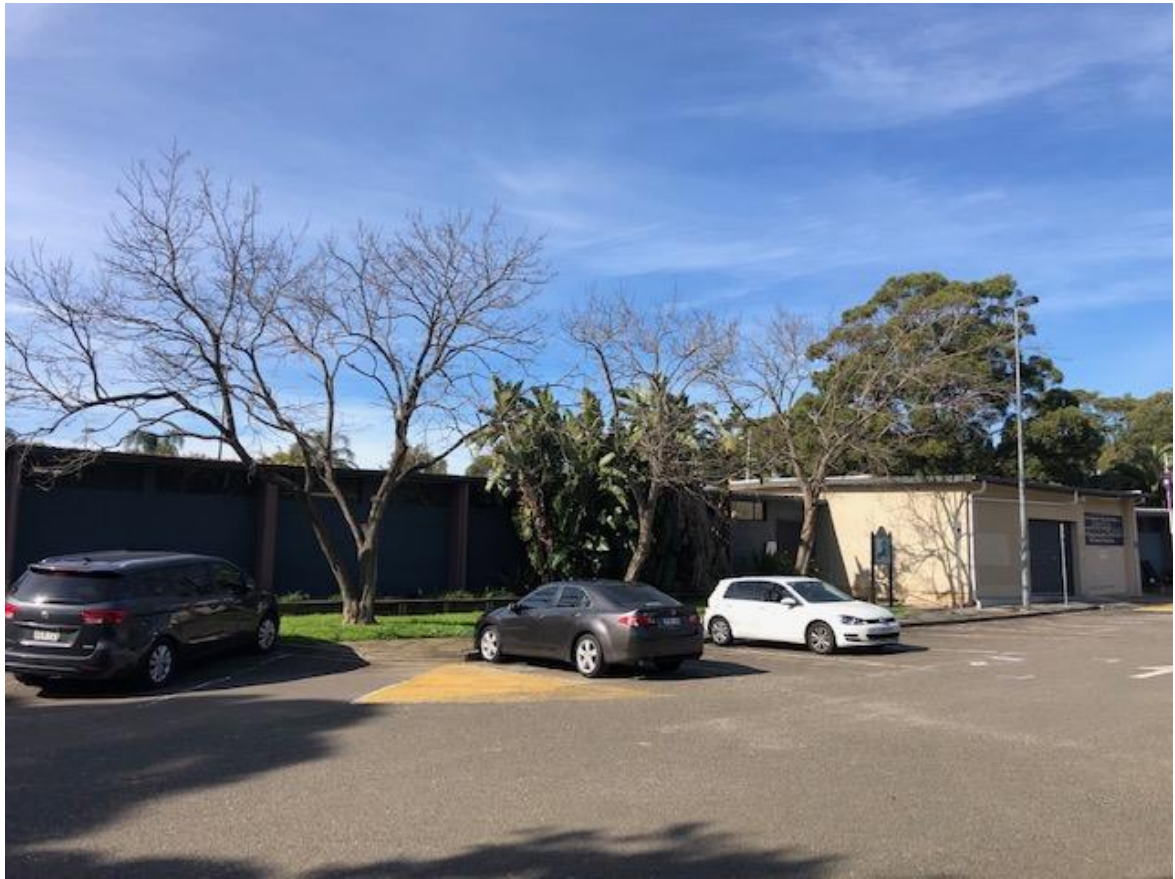
**Plate 1:** Image showing Trees 14-16 (*Robinia sp.*). P. Vezgoff

| Tree | Species | Height (m) | Spread (m) | DBH (m) | Live canopy % | Defects | SULE | Condition | Age | Comments | TPZ (m) | SRZ (m) | Native | Exotic |
|---|---|---|---|---|---|---|---|---|---|---|---|---|---|---|
| 14 | Black locust (Robinia pseudoacacia 'Frisia') | 8 | 4.8 | 0.34 | 90 | No visual defects | 2c removed for more suitable planting | Good | Mature | | 4.1 | 2.3 | | |
| 15 | Black locust (Robinia pseudoacacia 'Frisia') | 7 | 4 | 0.3 | 90 | No visual defects | 2c removed for more suitable planting | Good | Mature | | 3.6 | 2.2 | | |
| 16 | Black locust (Robinia pseudoacacia 'Frisia') | 8 | 4.8 | 0.34 | 90 | No visual defects | 2c removed for more suitable planting | Good | Mature | | 4.1 | 2.3 | | |

Based on the demolition works and soil remediation required, Trees required to be removed are numbered as 14-16, 33-65, 74-93, 97. The majority of these trees are exotic specimens.

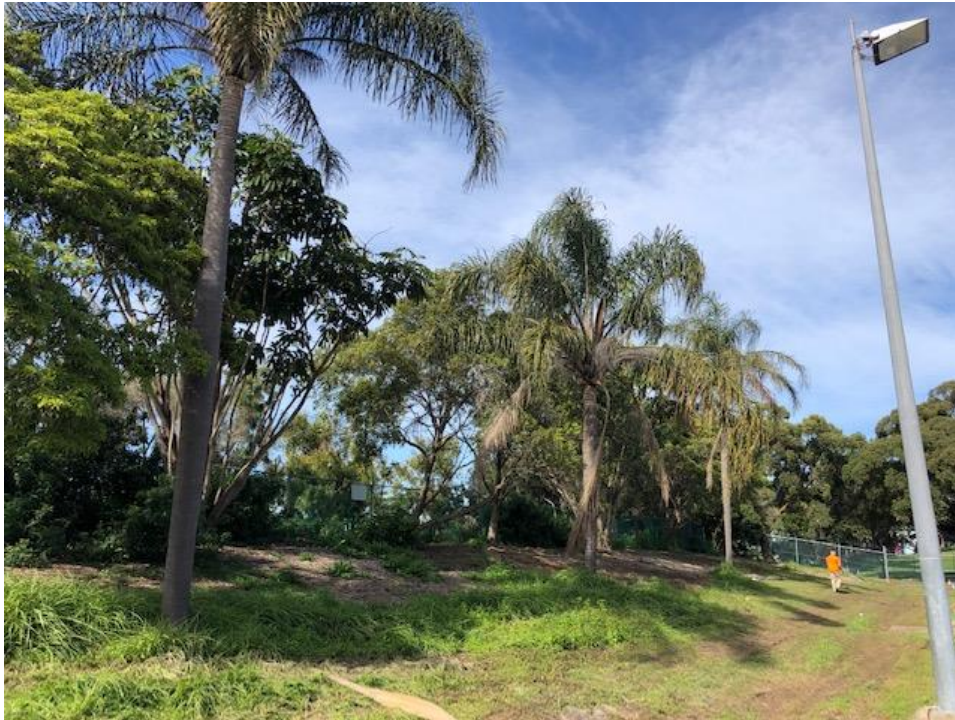
- 3.7 Other trees within the Pool area, that are mostly exotic specimens, consist of Kentia Palm (*Howea fosteriana*), *Dyopsis decaryi*, Hill's weeping fig (*Ficus microcarpa* var. *Hillii*), Native daphne (*Pittosporum undulatum*), Umbrella tree (*Shefflera actinophylla*), Cocos palm (*Syagrus romanzoffiana*), Jacaranda (*Jacaranda mimosifolia*) and a row of several Mexican fan palms (*Washingtonia robusta*).

**Plate 4:** Image showing some of the many exotic specimens surrounding the pool garden area. P. Vezgoff

In general, the site trees were mostly assessed as being in good health and condition with long ratings being 1a and 2a but the exotic specimens for the purpose of this project would be considered to have a 2c rating that being; *2c removed for more suitable planting.*

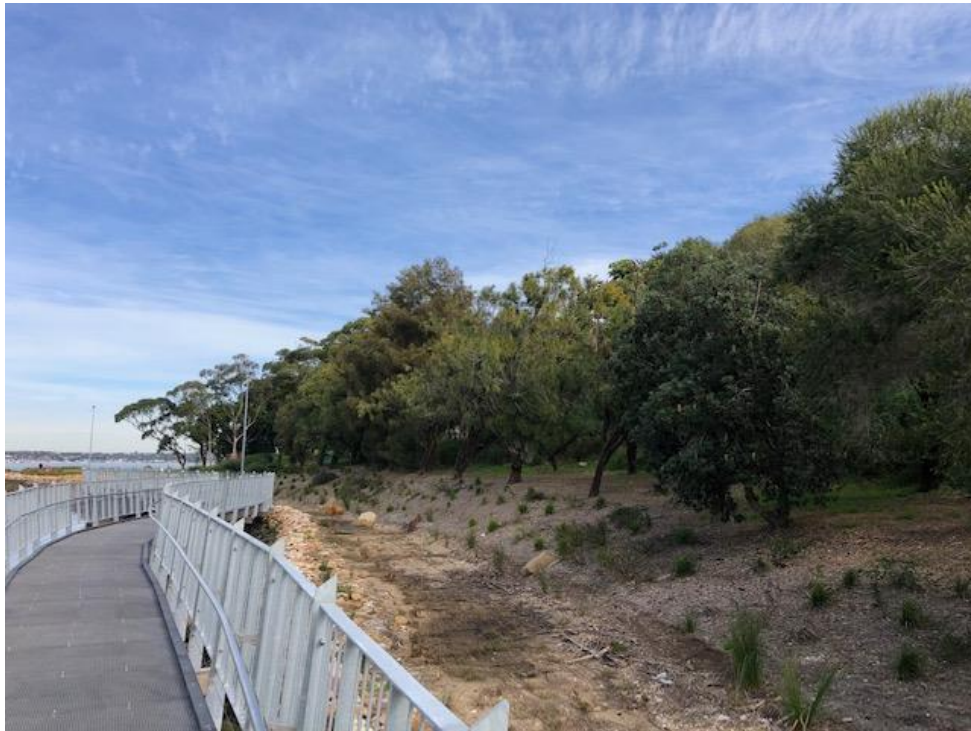
- 3.8 Along the foreshore area is a row of what is mostly Forest Oak (*Allocasurina torulosa*) with some individual semi mature *Eucalyptus* specimens. Many of these specimens are of a stunted nature and are not very tall (Plate 5). The dense vegetation along the northern boundary of the pool and the park appear to be shrubs that have long since died due to being overrun by vigorous *Bougainvillea* plants.

**Plate 5:** Image showing the trees along the foreshore area. P. Vezgoff
