Snowmaking and Services Corridor Snowgums to Kareela, Thredbo NSW

Geotechnical Assessment

Our ref: 7228-G1 Rev 1 9 August 2023

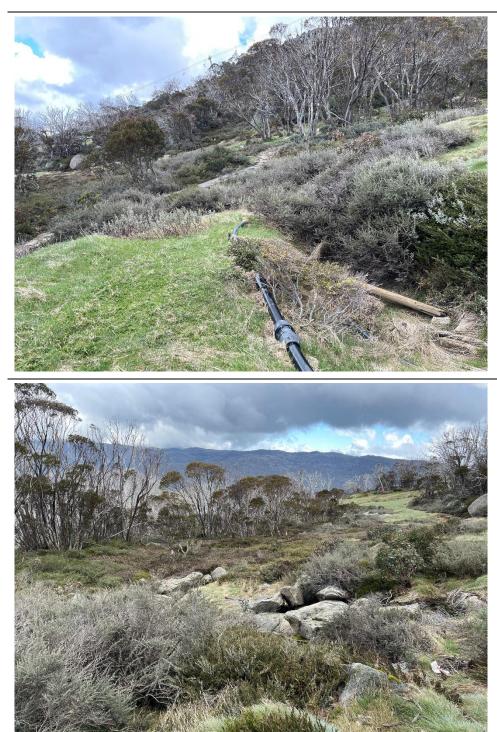
Photo 1 View of slope south-west of Black

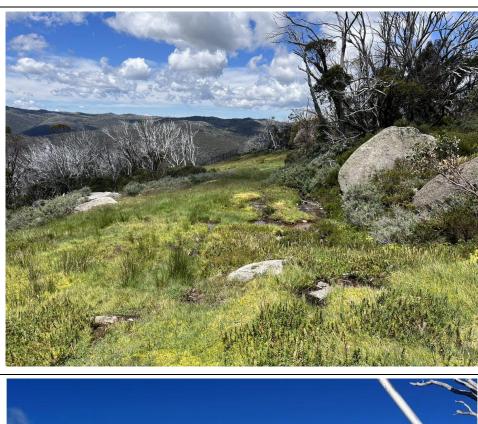
Photo 3

Wet area above Kareela Hutte. Source: Kosciuszko Thredbo Pty Ltd.

Temporary surface water diversions will be required where cutting the sections of trenching through the drainage lines. Where groundwater is encountered within trench excavations, temporary diversion downslope will be required until the affected section of trench can be completed.

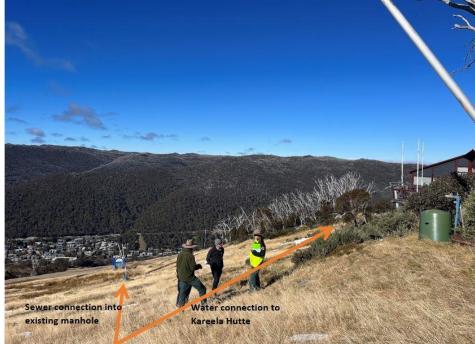
Photo 4

View of service trench entry to Kareela Hutte. Source: Kosciuszko Thredbo Pty Ltd

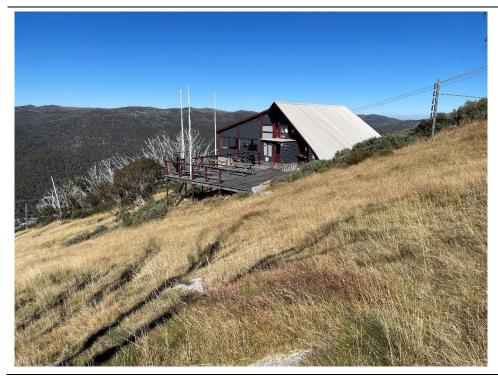
Photo 5

View of northern side of Kareela Hutte where service trench will approach.
