Geotechnical Investigation Report

**Proposed Golf Course Subdivision
2/4 Crackenback Drive, Thredbo NSW**

3 August 2023

14871-GR-1-1-Rev B

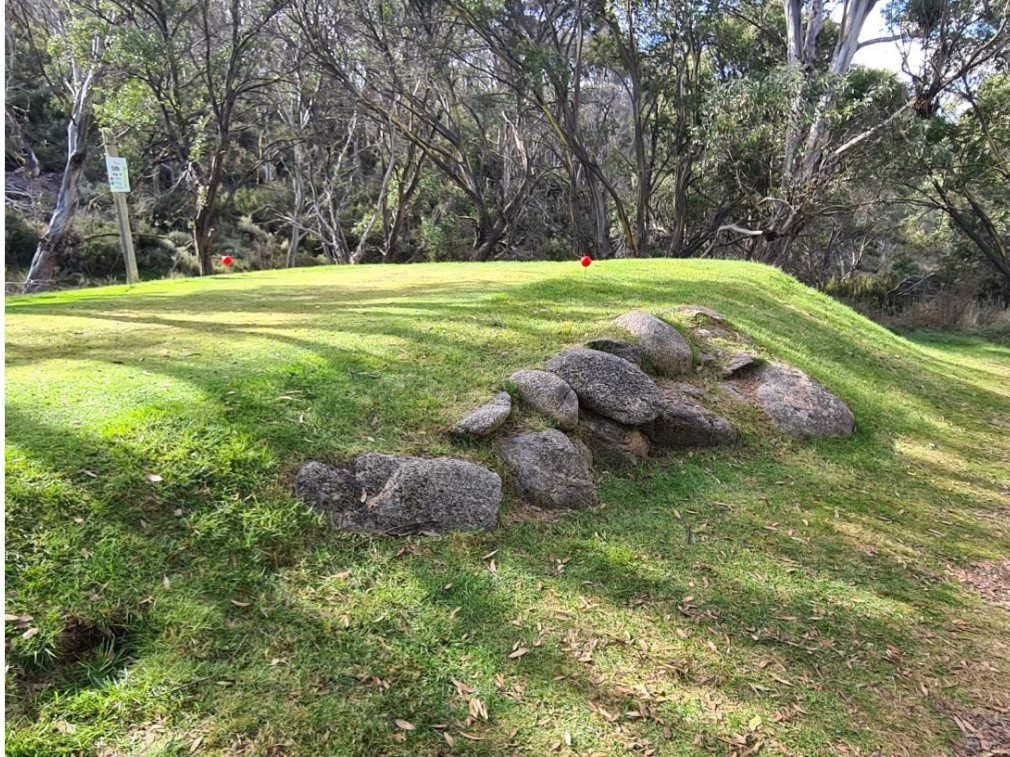
Photo 1 – Granodiorite Boulders Observed at the Northwest Section of the Site

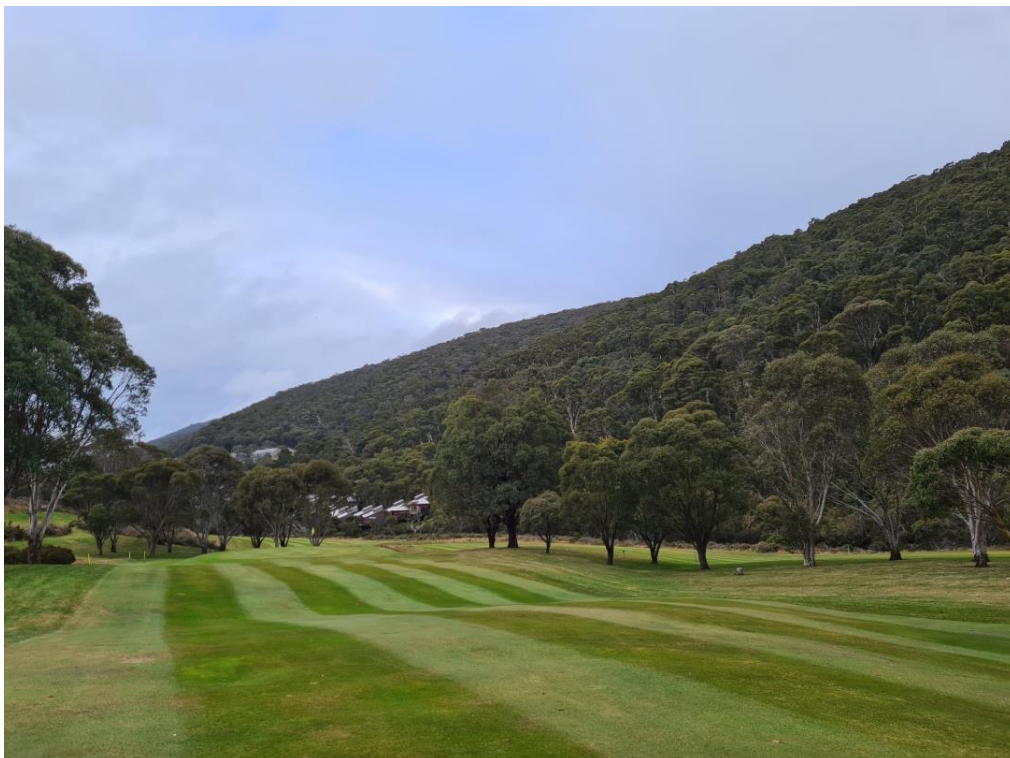
Photo 2 – General Site Conditions Looking Northeast

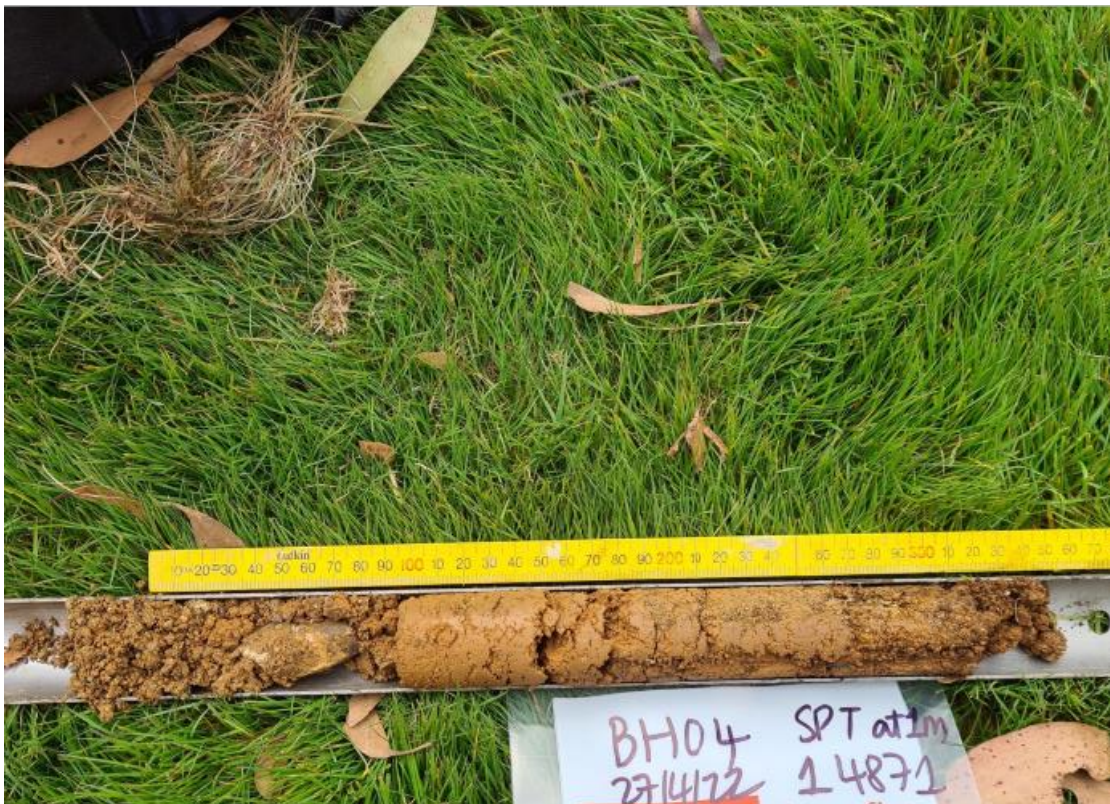
Photo 4 - SPT Split Spoon Samples at BH04, 1m (N=10)
