# Geotechnical Investigation Report

**Proposed Golf Course Subdivision  
2/4 Crackenback Drive, Thredbo NSW**

**20 November 2025**

**14871-GR-1-1-Rev E**

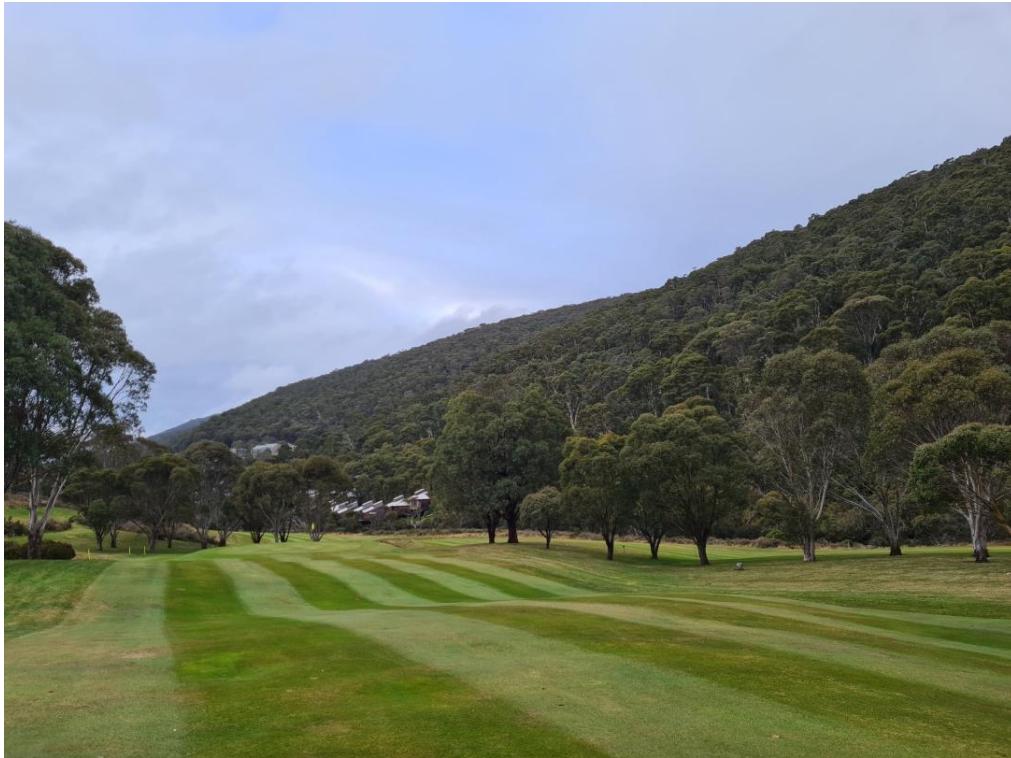
**Photo 1 - General Site Conditions Looking Northeast with Mountain Ranges in View**

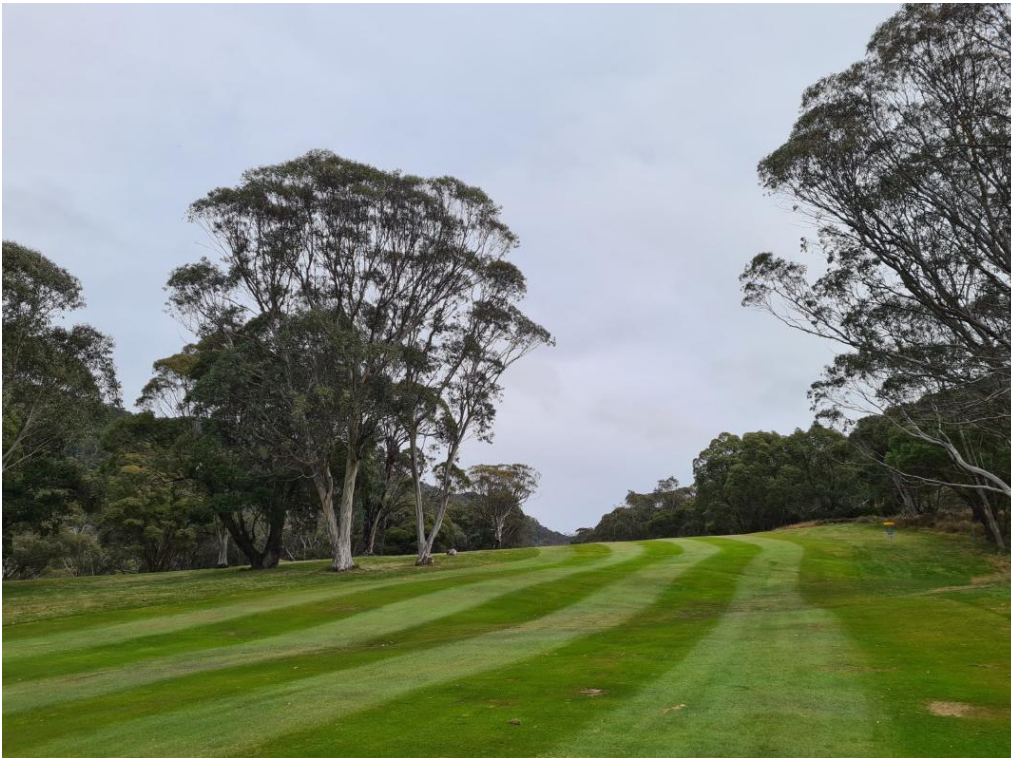
**Photo 2 - General Site Conditions, Looking Southwest  
Showing Gentle Gradient Toward the Southeast**

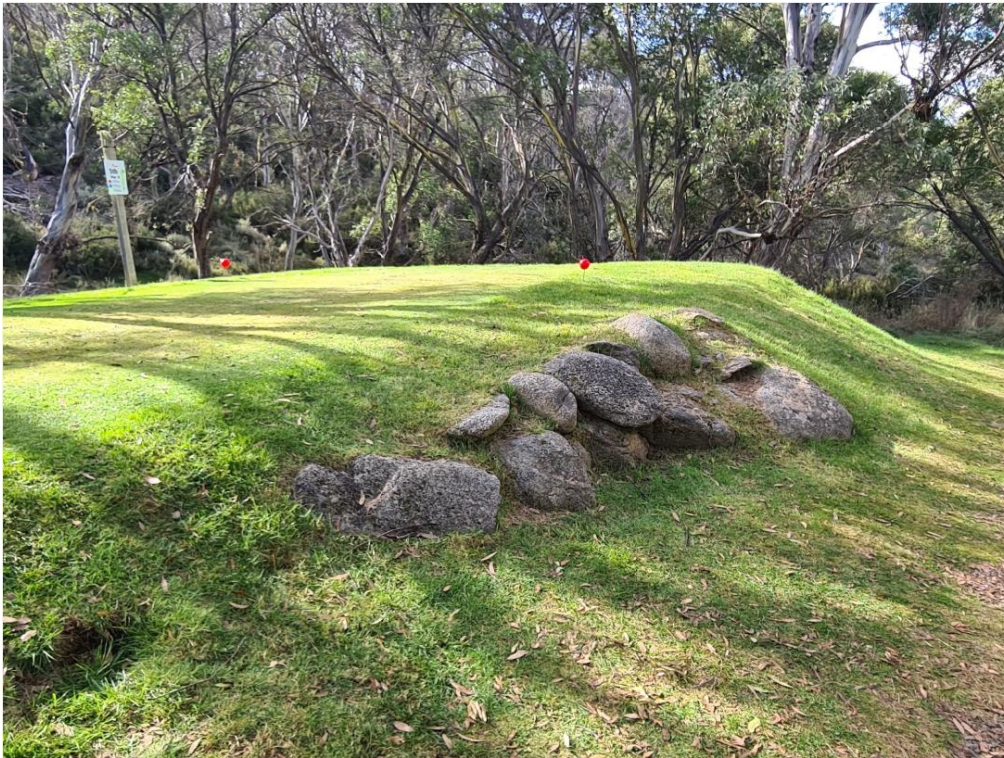
Figure 2 below shows the site location with its surroundings. During the site walkover as part of the investigation, granodiorite boulders were observed across the site, particularly at the northwest section.

**Photo 3 – Granodiorite Boulders (Assumed Backfilled) Observed at the Northwest Section of the Site**

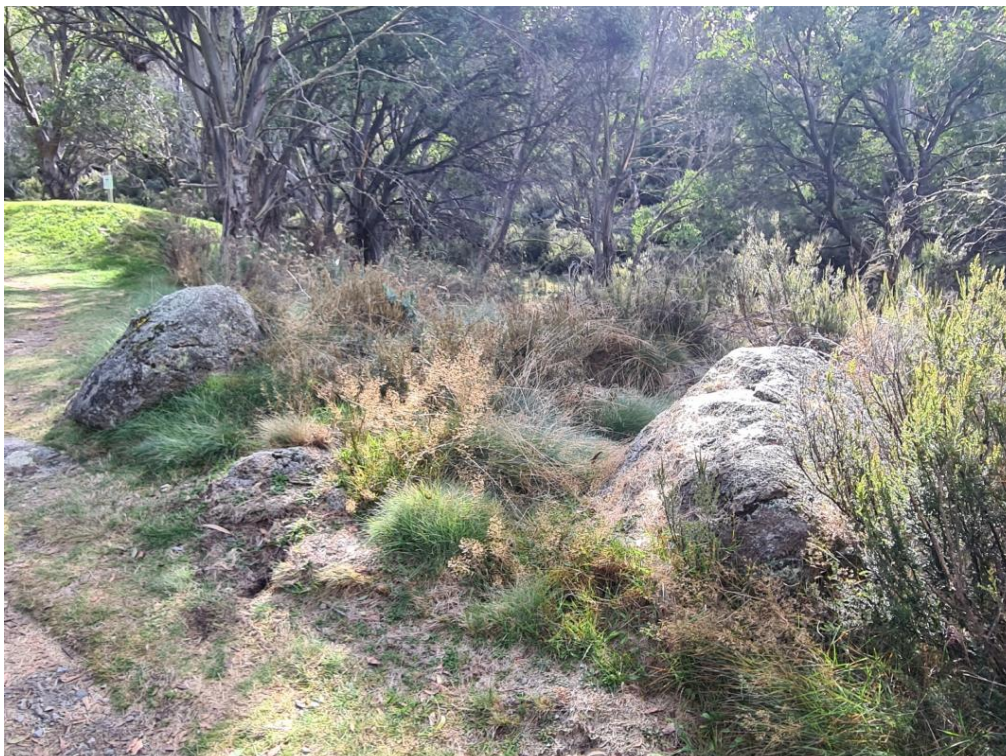
**Photo 4 - Natural Granodiorite Boulders within the Site Vicinity**

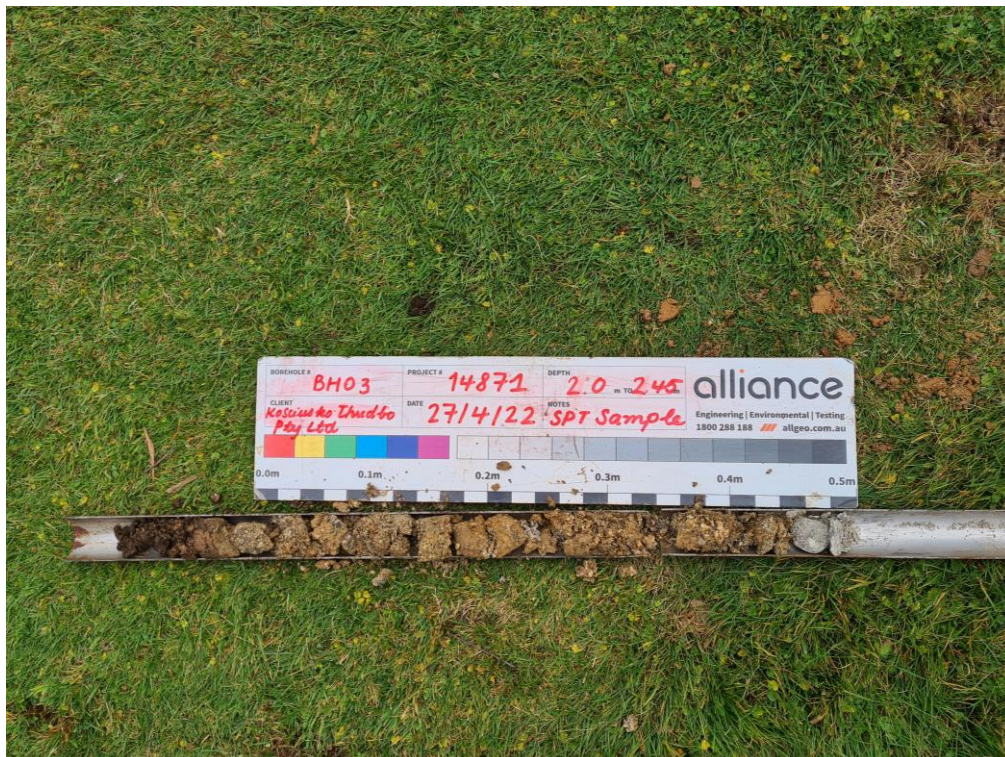
Photo 6 - SPT Split Spoon Samples at BH0, 2m-2.45m (N=32)
