The Dog on the Tucker Box Redevelopment Tree Inventory

August 2023
Ref. 23/452.

Trees on The Dog on the Tucker Box Site, Five Mile, via Gundagai.

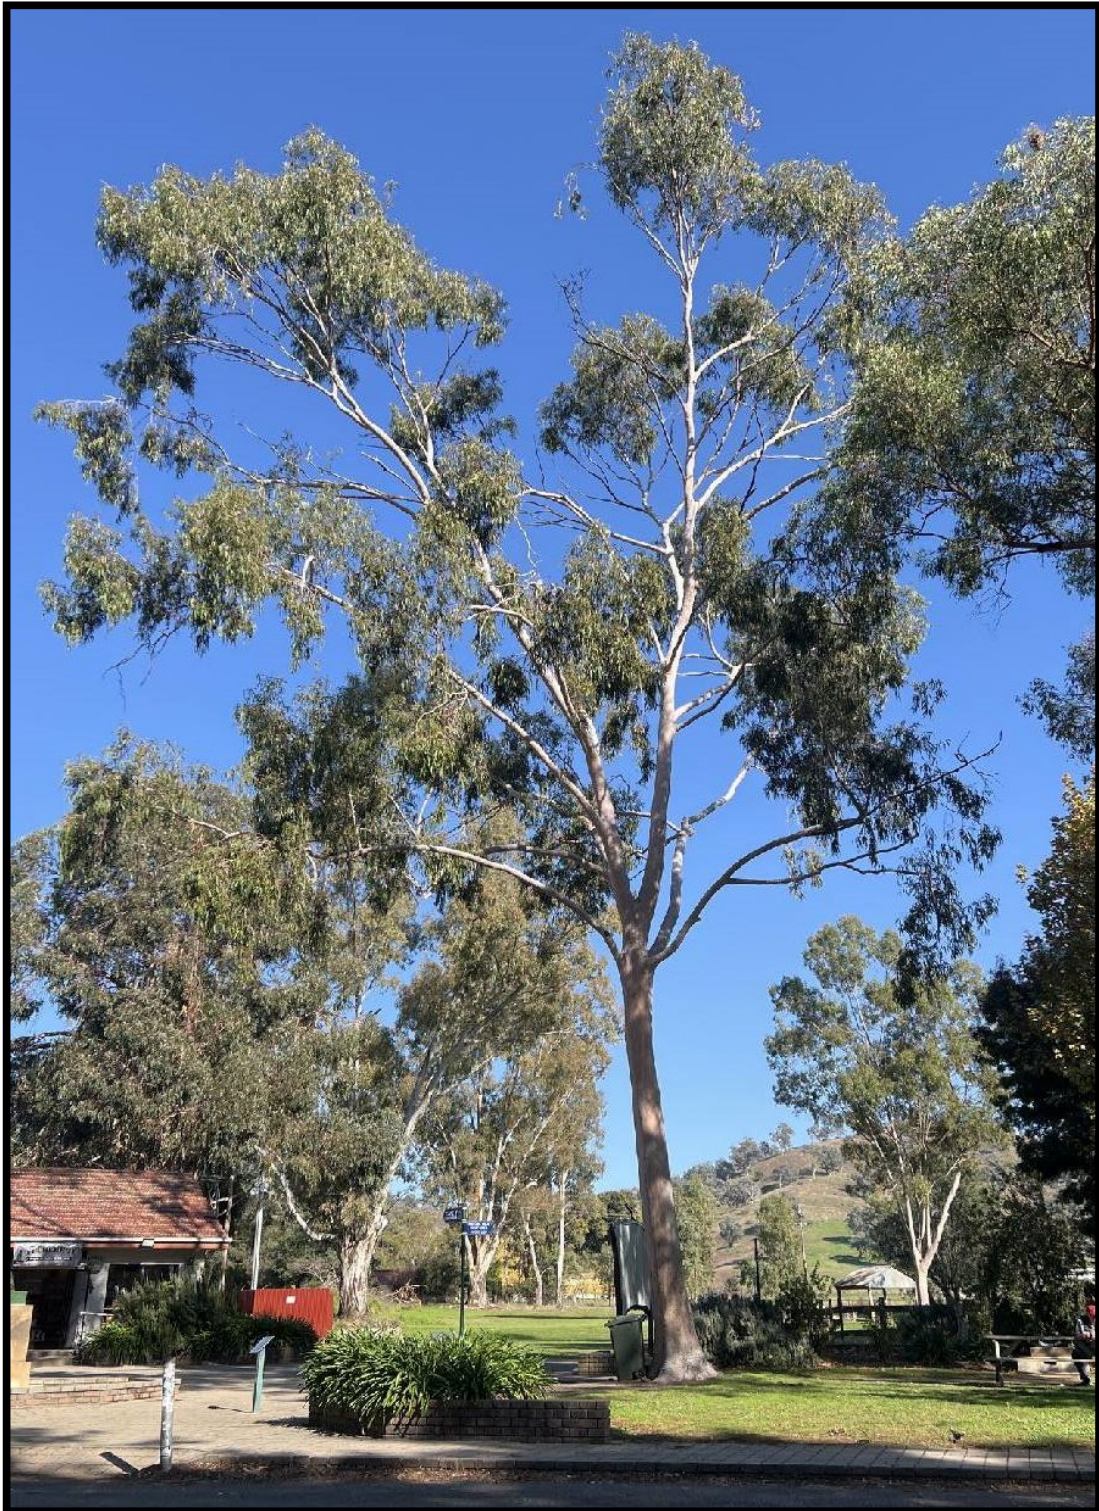
Exhibit 5 – Tree No. 11.

Tree No. 11, a Lemon-scented Gum (*Corymbia citriodora*), is the only tree within the footprint of the proposed development that is proposed to be retained, within a future courtyard of the proposed development (see Appendix D). This tree is illustrated in Exhibit 5. The tree is currently characterised by a high (& sparse) crown with perimeter (small diameter) deadwood and prior limb failures (to 150mm diameter). The tree's crown density is probably attributable to its current surrounds of hard pavement and lawn areas (which would be subject to compaction from heavy pedestrian foot traffic). Proposals for the amended landscape surrounds of this tree involve lawn areas, mulched garden beds and paved footpaths traversing the courtyard space. It is imperative that this tree be given full and adequate protection during any future construction works (in accordance with AS4970-2009; *Protection of trees on development sites*).

All existing trees that are retained on the development site should be given full and adequate protection during construction works (in accordance with AS4970-2009; *Protection of trees on development sites*) and all necessary work undertaken on them should be carried out in accordance with AS4373-2007; *Pruning of amenity trees*.

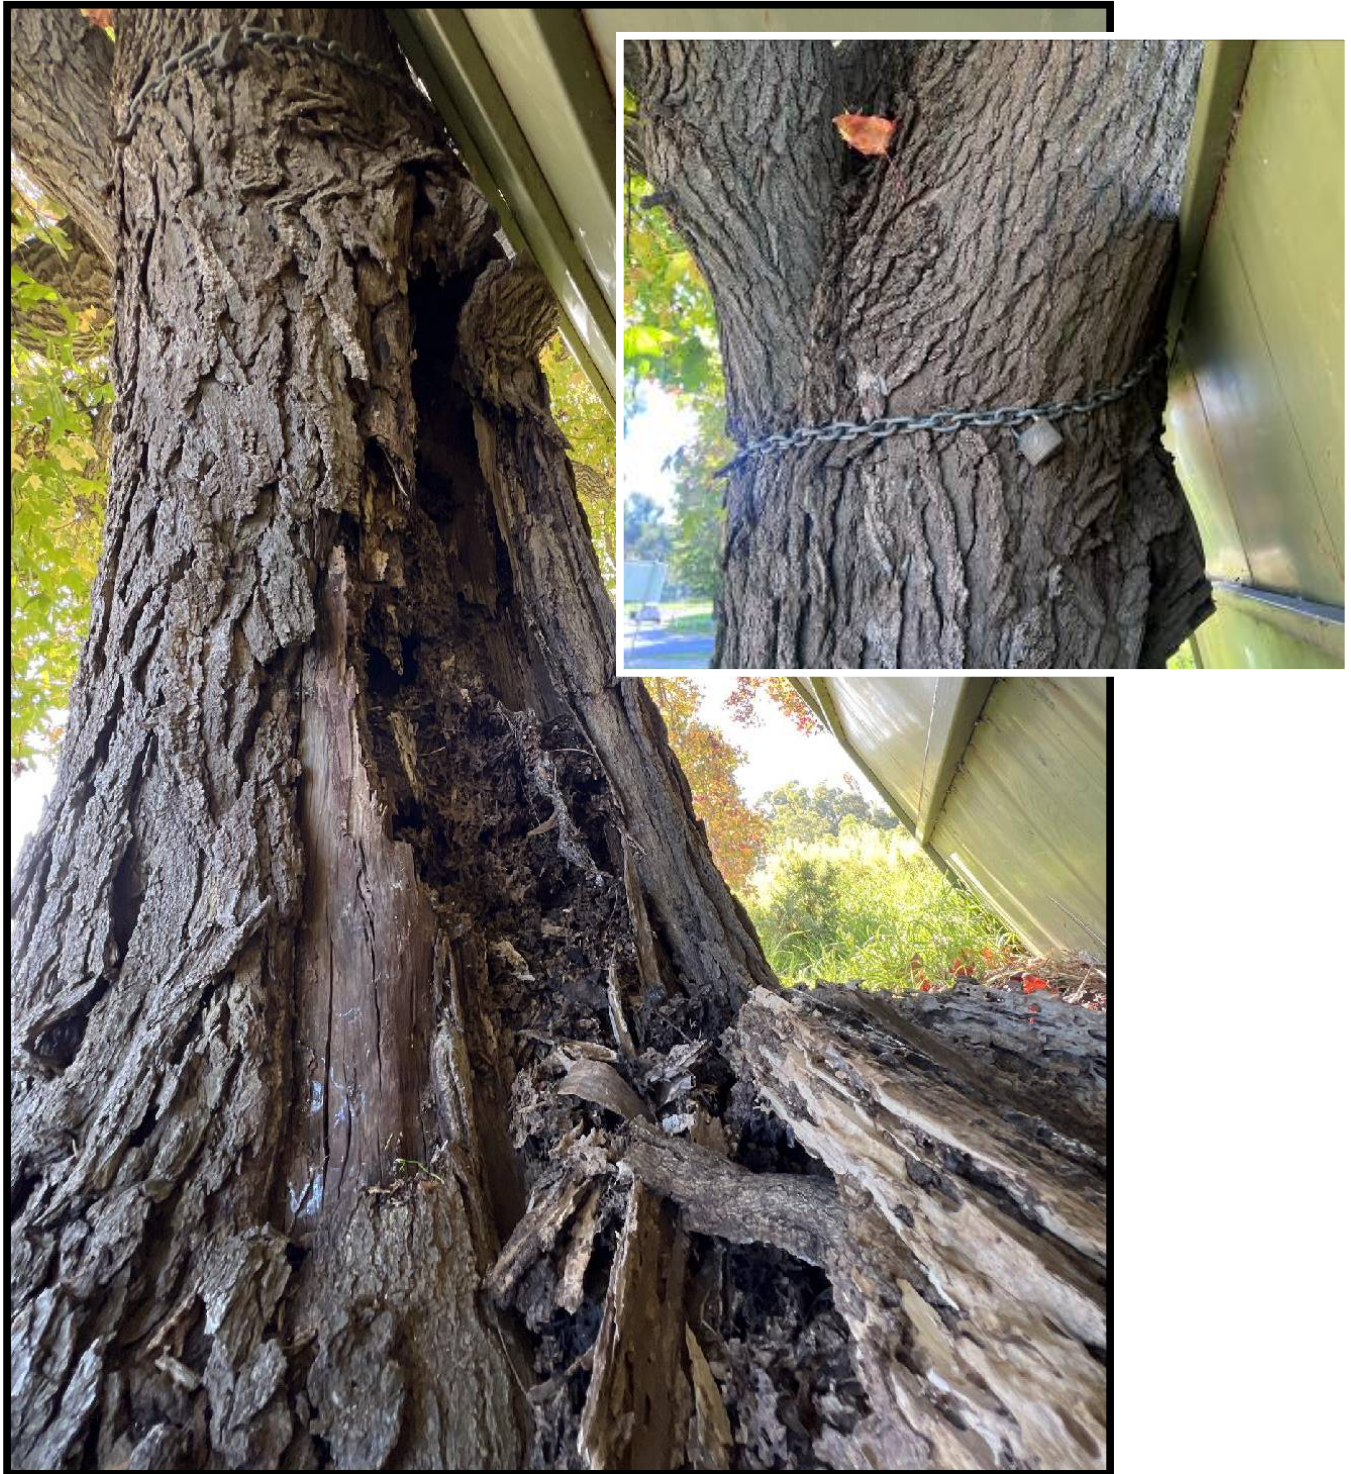
Tree No. 20, a Liquidamber (*Liquidambar styraciflua*), was identified during the recording and assessment work as being unsuitable for retention, irrespective of site planning considerations. It is large tree with basal stem wound (1.5m long and 400-500mm across) & decay on the south-east side of the tree's stem. The wounding and decay probably originates from the removal of a lower lateral branch to affix signage to the tree (see Exhibit 6). The tree's long term stability is compromised by this structural fault and a future stem failure is a realistic possibility.

Exhibit 6– The wounding and decay on the stem of Tree No. 20.

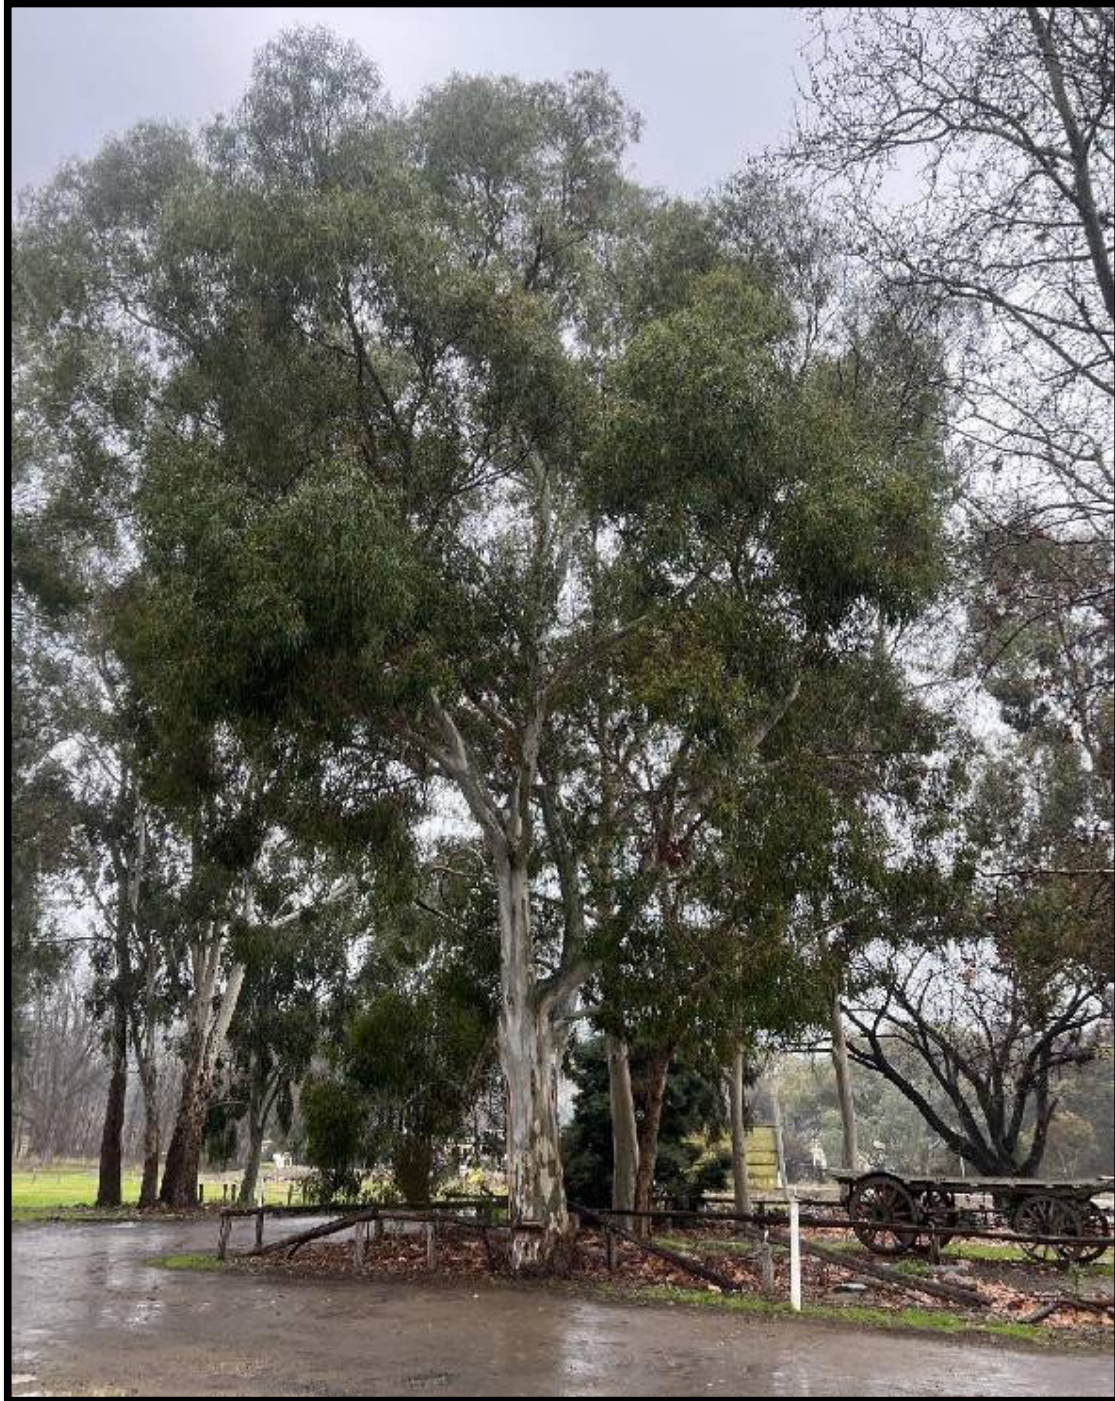
Tree No. 4

Tree Nos. 4, 7 and 8, all Brittle Gums (*Eucalyptus mannifera*), are also proposed to be retained. Tree 4 is well removed from any proposed construction works. Tree Nos. 7 and 8 could be potentially impacted by the construction of parking facilities on the eastern edge of their requisite tree protection zones (TPZs – see Section 5.2.1 and Appendix D). The proposed parking areas detailed on the Development Drawings may encroach on those Tree's TPZs, but the works would be limited to sealing of car park surfacing, the encroachment is expected to be "minor" (less than 10% of the TPZ) and the area lost to encroachment can be compensated for by extension of the remaining TPZ area which will not be impacted by any proposed development. Alteration of surface levels in this area will be subject to future detailed engineering design, and should be minimised in the vicinity of the those trees if they are to be successfully retained. Additionally an edging detail that involves fixing by point "pinning", rather than excavation for a "flush concrete edge", should be investigated for the proposed car park areas that encroach on the TPZ's of Tree Nos. 7 and 8.

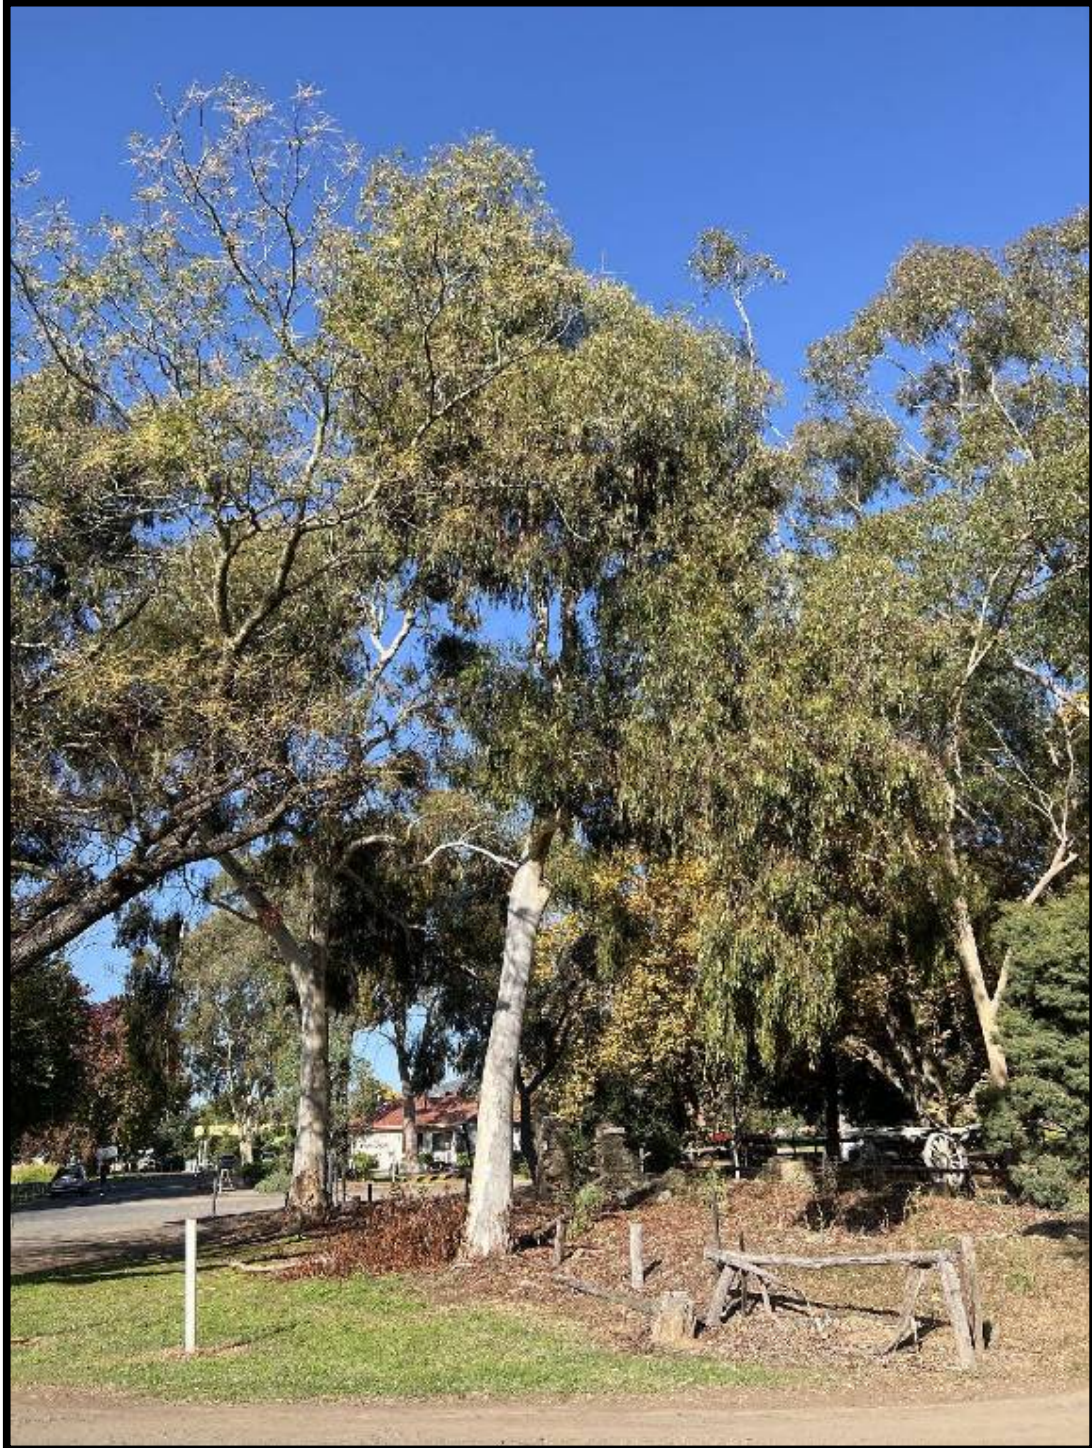
4.1.5 – Tree No. 8

8	<i>Eucalyptus mannifera</i>	Brittle Gum	18	50	Fair	Similar to Tree 7, also Cockie damage high on stem
9	<i>Melia azederach</i>	White Cedar	12	100	Fair	Large tree, has previously had major laterals shortened (for vehicle clearance) especially N & E of crown; deadwood high in crown & perimeter dieback; current season defoliation by sawfly larvae
10	<i>Eucalyptus sideroxylon</i>	Mugga Ironbark	15	40	Fair	High crown with SW leaders (over lawn / picnic tables) shortened; basal water shoots (E & N) from root pruning(?); extensive mistletoe infestation of crown
11	<i>Corymbia citriodora</i>	Lemon-scented Gum	18	50	Fair	High (& sparse) crown with perimeter (small diameter) deadwood and prior limb failures to 150mm; crown density probably attributable to surrounding ground compaction / pavement.
12	<i>Platanus X hispanica</i>	Plane Tree	15	70	Good	Deadwood, to about 100mm diameter, throughout crown.

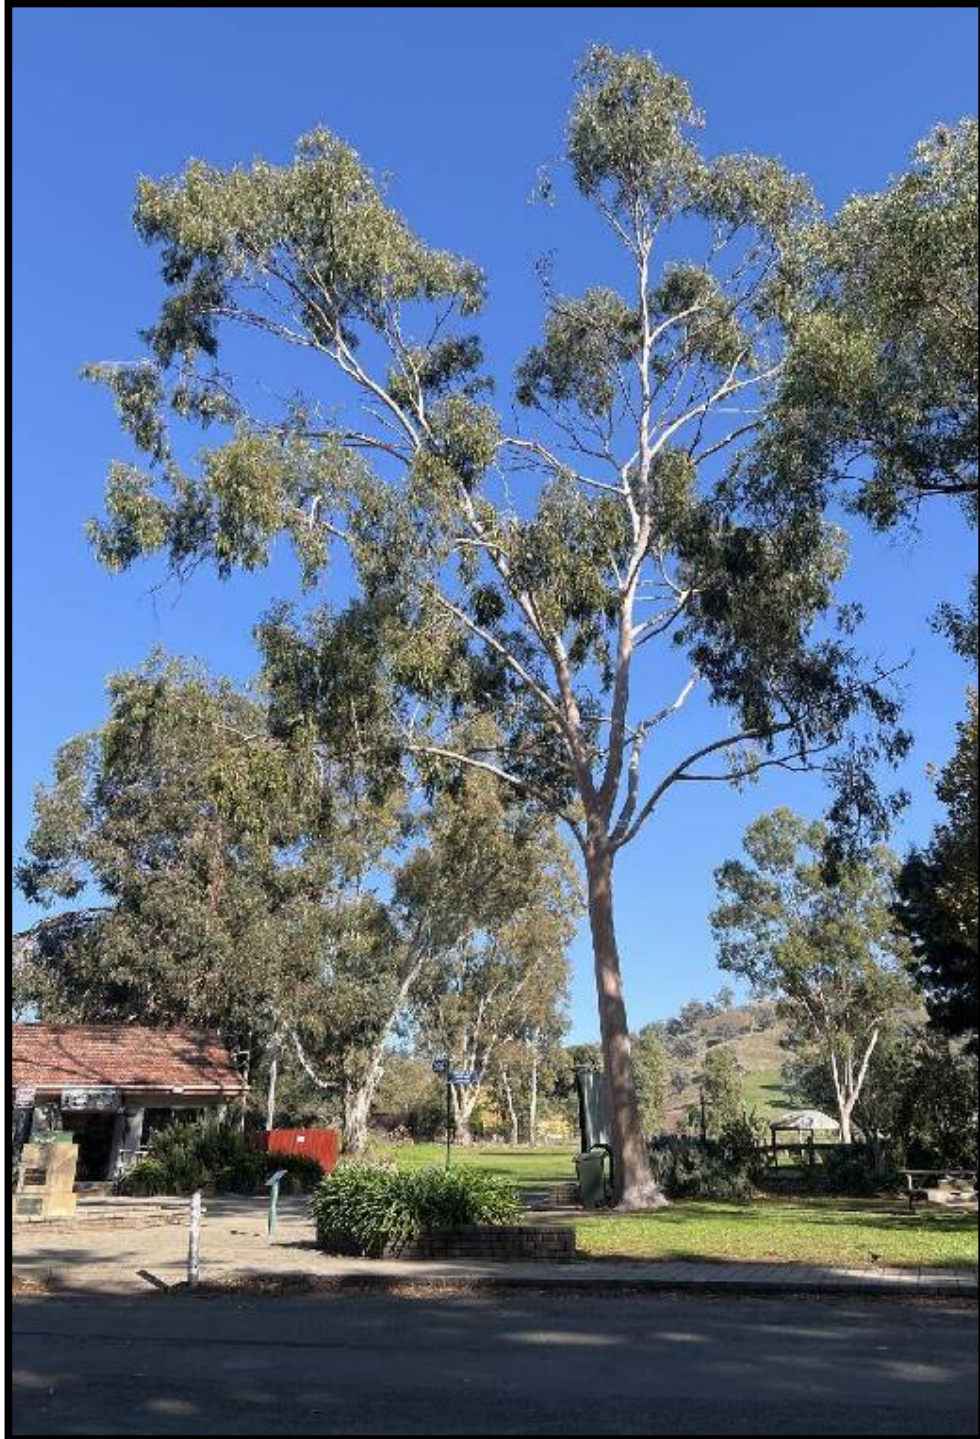
Tree No. 11

The resultant SRZ for Tree 11, discussed in Section 4, would be approximately 3 metres.
