ARBORICULTURAL IMPACT ASSESSMENT

63 Ramsay Road,
Picnic Point
NSW

**REPORT COMISSIONED BY MAK URBAN GROUP
REPORT PREPARED BY NICK MAYNARD**

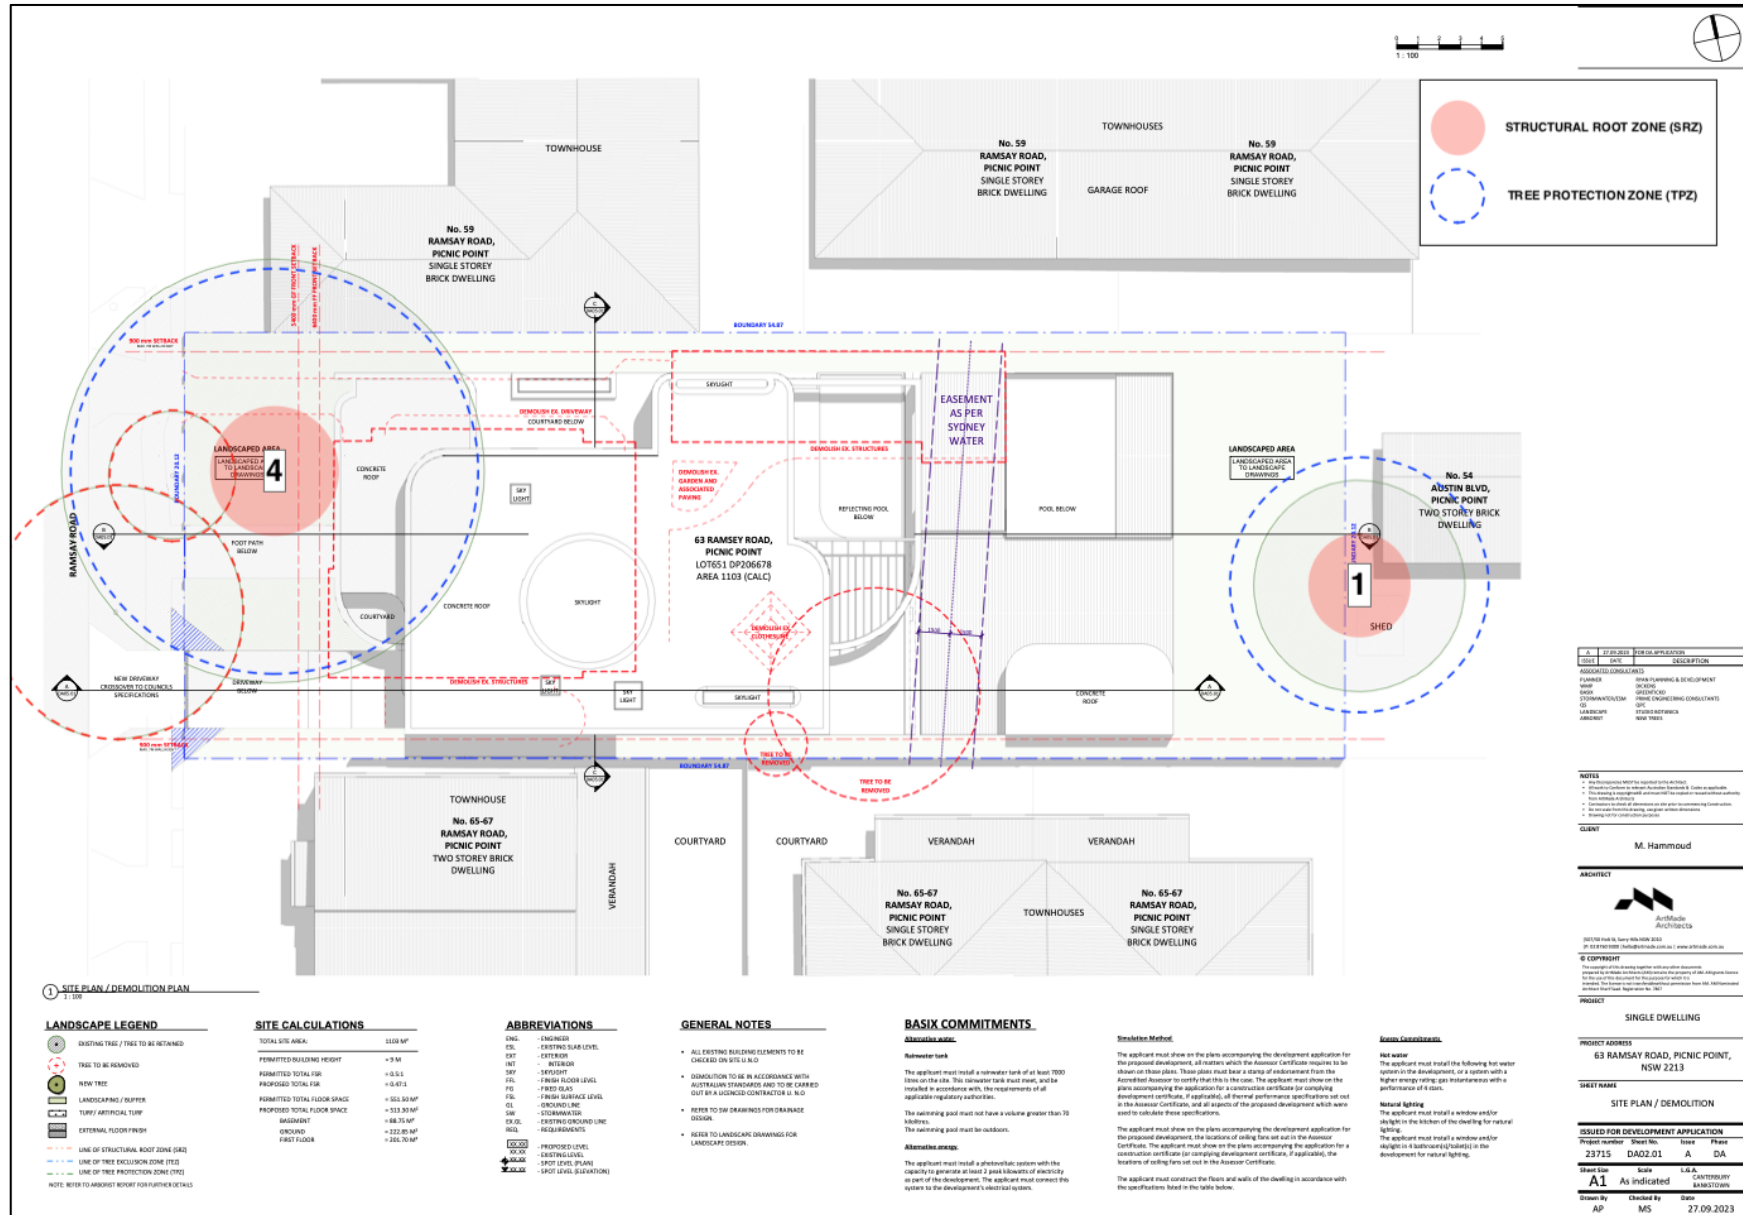
PLAN 3: Site Plan - Calculated SRZ & Tpz for retained trees (Plan supplied by client September 2023).

Tree 1 is not expected to experience encroachments into its calculated TPZ from proposed demolition, excavation or construction works. Refer to Appendix 13 and Appendix 14 for further details.

Tree 4 can expect TPZ encroachments during 'existing dwelling' demolition and 'existing driveway' demolition. The demolition of the 'existing driveway' will actually decrease the covered TPZ surface area and be somewhat beneficial for tree health and vitality.

Prior to demolition fence protection is to be installed around Tree 4 using AS:4970-2009 guidelines. The demolition of the 'existing driveway' and existing 'concrete dwelling foundations' should be performed under 'Project Arborist' supervision. Refer to Appendix 13 and Appendix 14 for protection details.

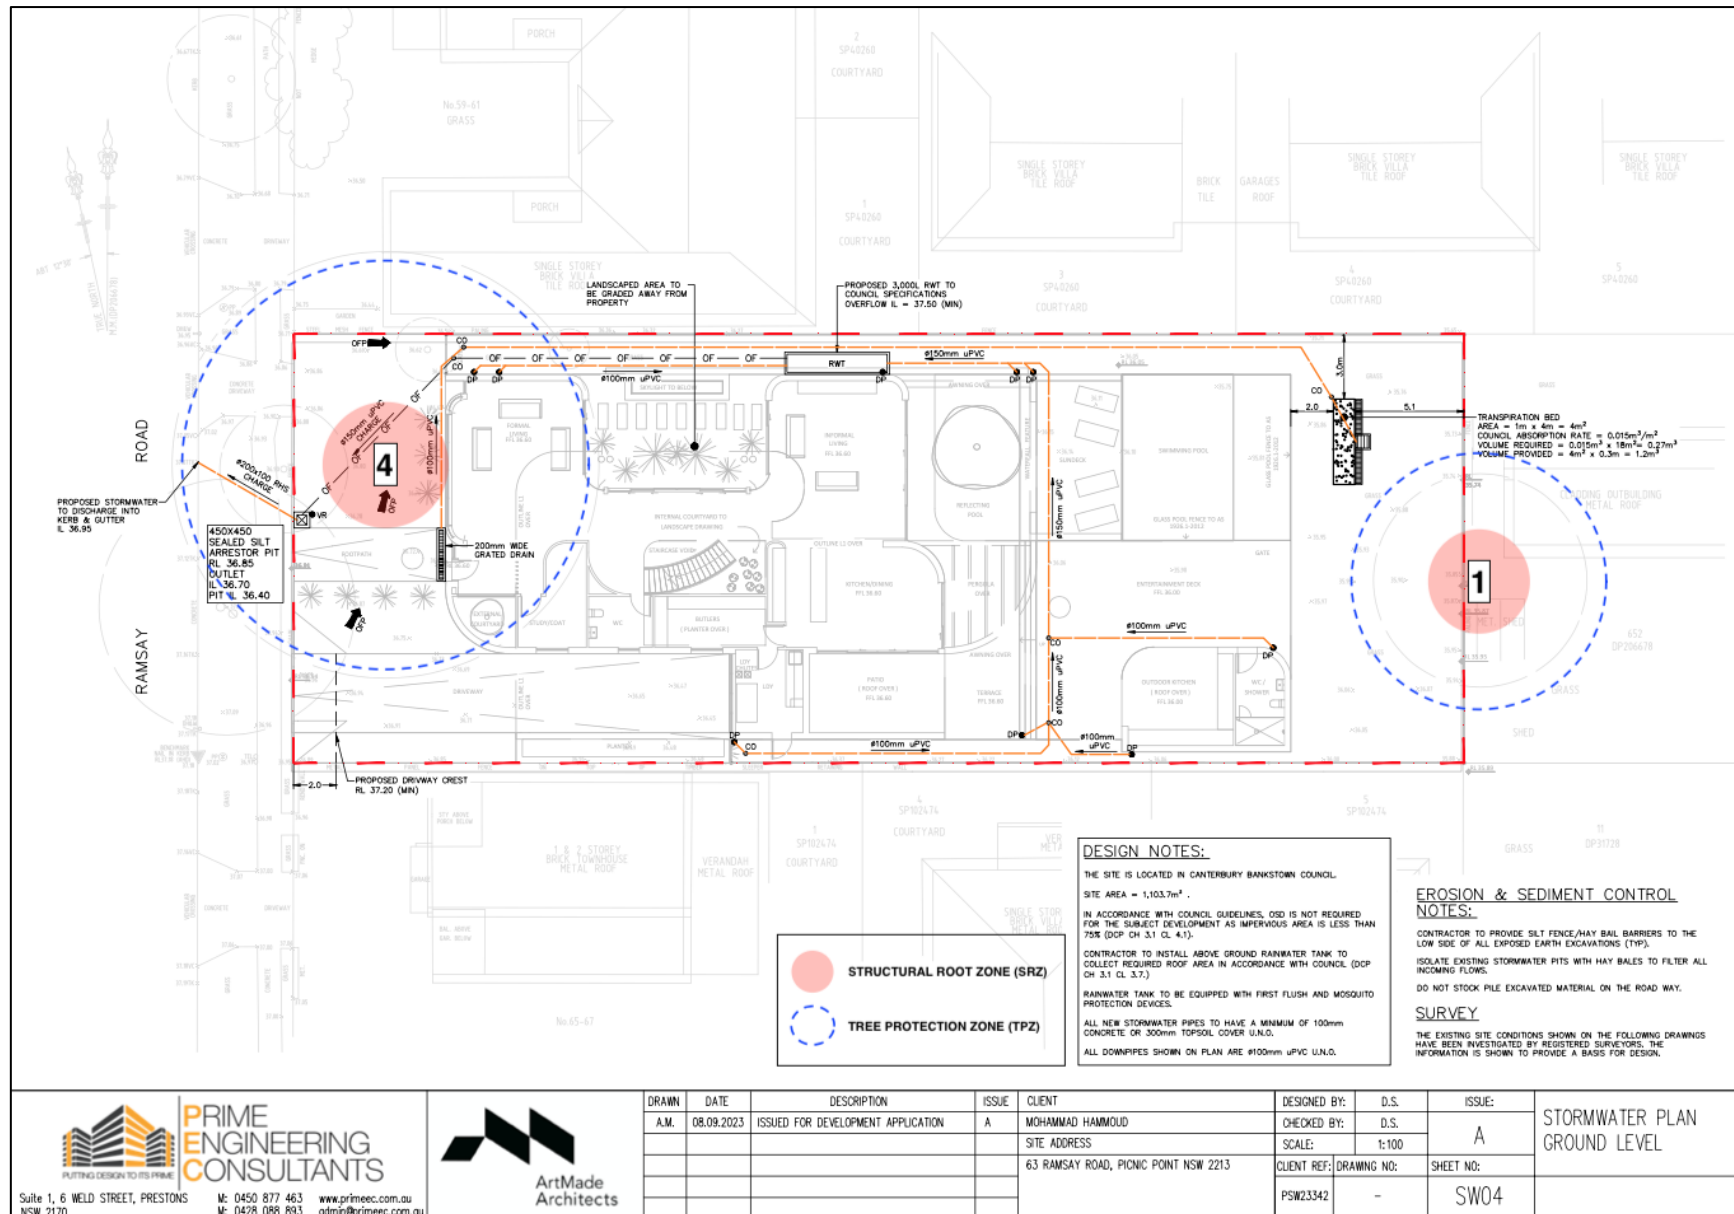
PLAN 4: Stormwater Plan - Calculated SRZ and TPZ for retained trees (Plan supplied by client September 2023).

Under the proposed 'stormwater design' Tree 4's calculated SRZ and calculated TPZ would experience major encroachments during proposed 'stormwater pipe' and associated 'stormwater infrastructure' construction. Refer to Appendix 14 for specific details.

To conform with AS:4970-2009 guidelines the proposed 'stormwater pipe' and associated 'stormwater infrastructure' within the SRZ and TPZ of Tree 4 will either require relocation or major root exploration to ensure significant structural and transport roots are not severed or damaged during hydraulic infrastructure construction. Refer to Appendix 15 for further details.

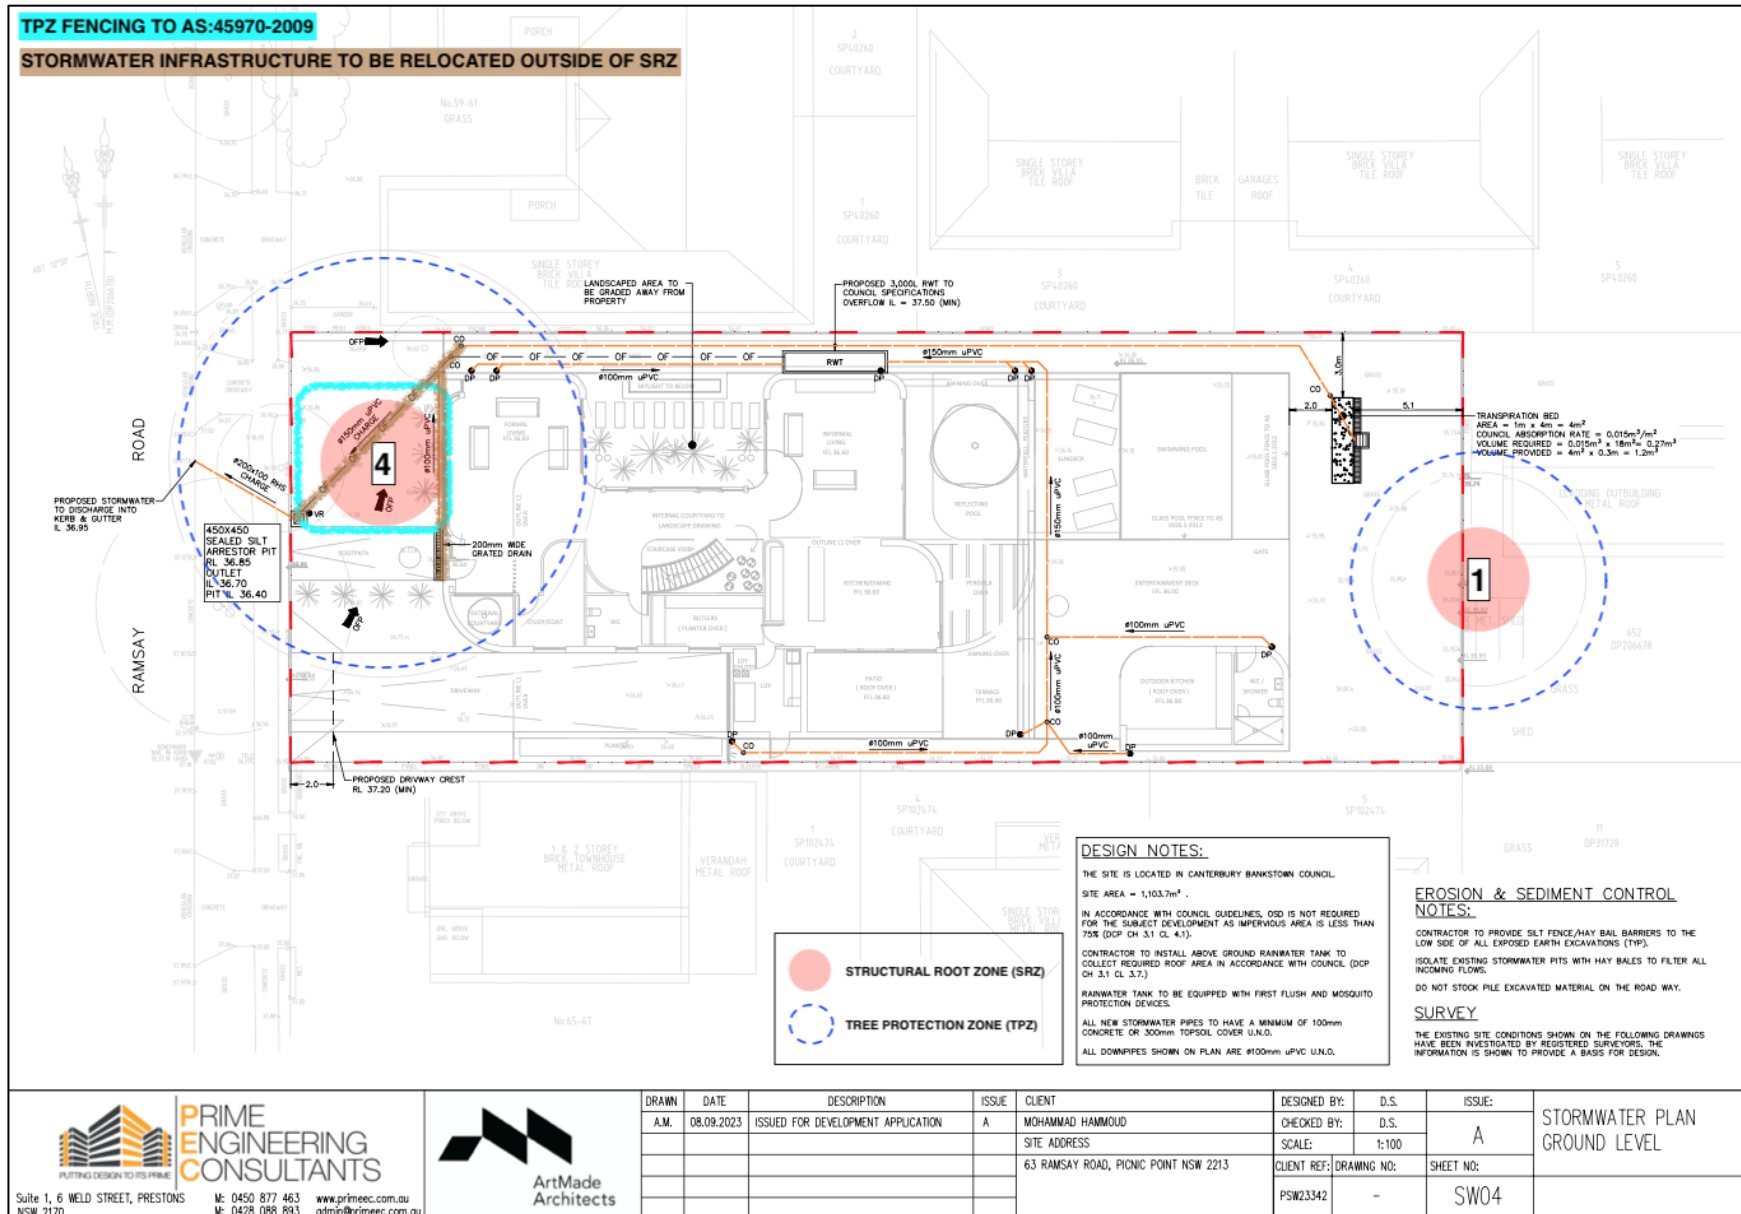
PLAN 4: Stormwater Plan - Tree protection detail for retained trees (Plan supplied by client September 2023).

- Tree 4 is a site tree that is expected to experience minor TPZ encroachments through existing dwelling foundation demolition and existing driveway demolition. These encroachments for the new dwelling have been calculated as less than a 10% increase to coverage of Tree 4's calculated TPZ and are considered acceptable using AS:4970-2009 as a guide for reference. Tree 4 is also expected to experience major SRZ and TPZ encroachments through the proposed hydraulic infrastructure construction works. Tree 4 will require major protection considerations including the relocation of stormwater pipes. Refer to Appendix 15 for further details. Tree 4 will require physical protection in the form of TPZ fencing in accordance with AS:4970-2009. Refer to Appendix 10 and Appendix 15 for further details.

- Tree 4 will require major protection considerations. It is recommended that physical protection in the form of TPZ fencing in accordance with AS:4970-2009 be installed around Tree 4 prior to the commencement of any demolition activities. Installed physical protection must remain in place for the duration of the site's development. Refer to Appendix 15 for further details.

- It is recommended that a 'Project Arborist' supervise 'existing driveway demolition' and 'existing dwelling concrete slab demolition' within Tree 4's calculated TPZ.

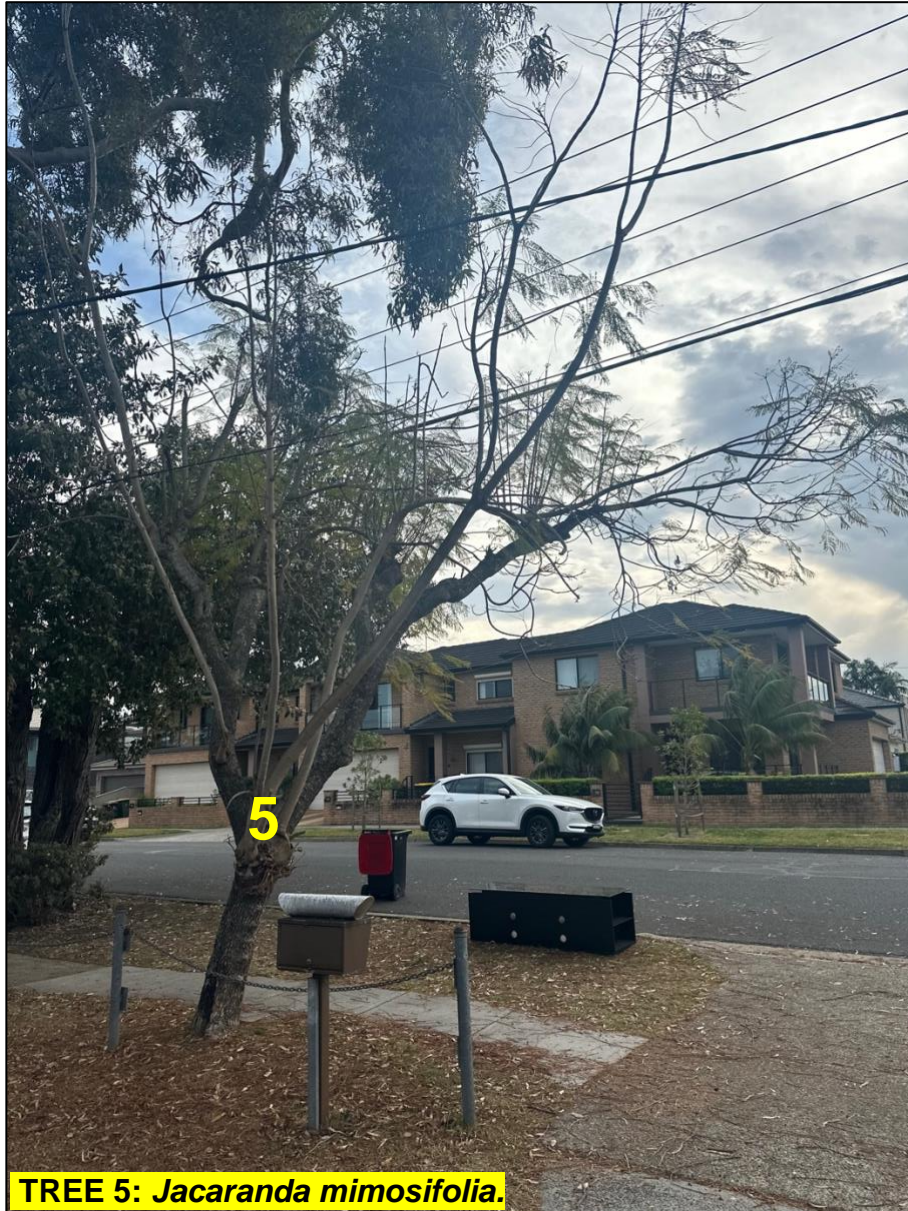
TREE 5: *Jacaranda mimosifolia*.

Tree 5 is basically a 2-meter stump with epicormic growth for a canopy.

Tree 5 has been proposed for removal to facilitate the proposed 'landscaping design'.

Tree 5 will require consent from Local Council before it can be removed. Tree 5 is to be assessed for removal by council as part of the sites DA.

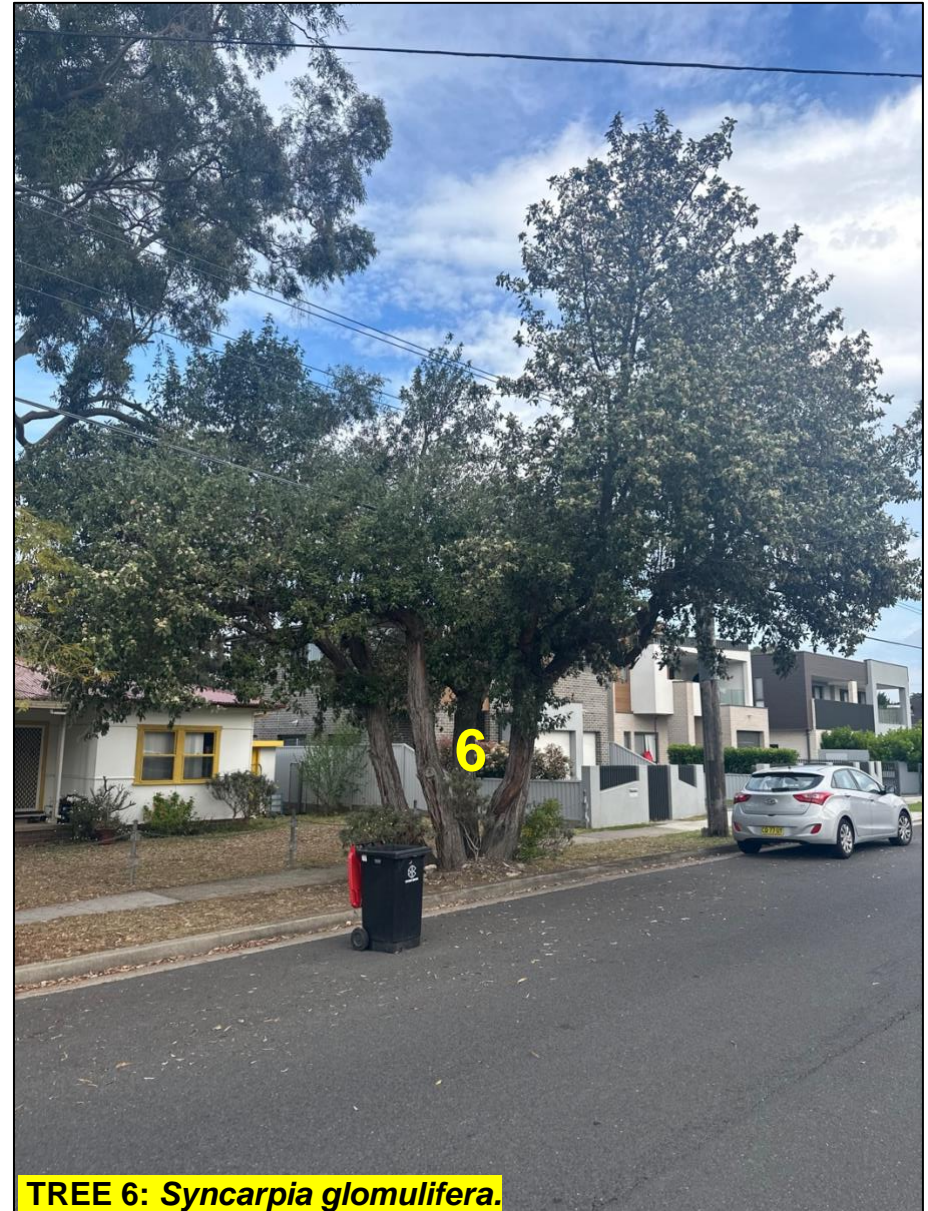
TREE 6: *Syncarpia glomulifera*.

Tree 6 is a council street tree growing underneath the power lines at the front of the subject site.

Tree 6 has been proposed for removal to facilitate the proposed 'driveway crossover'.

Tree 6 will require consent from Local Council before it can be removed. Tree 6 is to be assessed for removal by council as part of the sites DA.
