# STRUCTURAL REPORT

## Structural Feasibility & Recommendations

Administration Building - Hennessy College, Young

Catholic Education Archdiocese of Canberra & Goulburn (CECG)

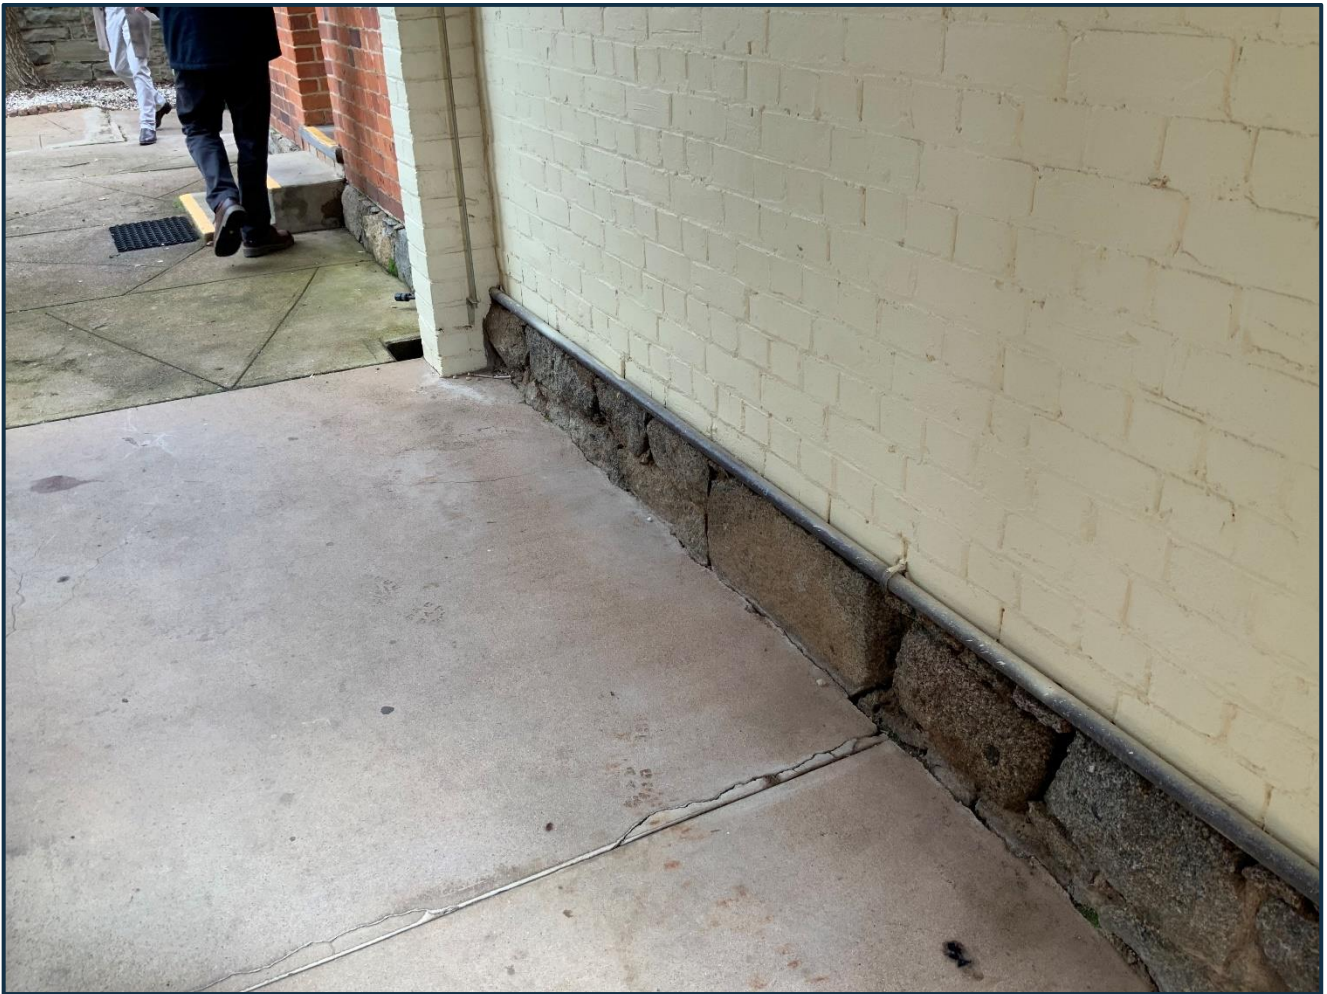
As access to the ground floor sub-space was not possible during the inspection, the existing foundations below the external brick walls could only be visually inspected at limited locations around the external perimeter. The existing foundations consist of large rectangular granite blocks and appear to be in good condition as showing in Figure 1.

FIGURE 3 - SITE PHOTO OF THE EXISTING EXTERNAL PERIMETER BUILDING FOUNDATIONS

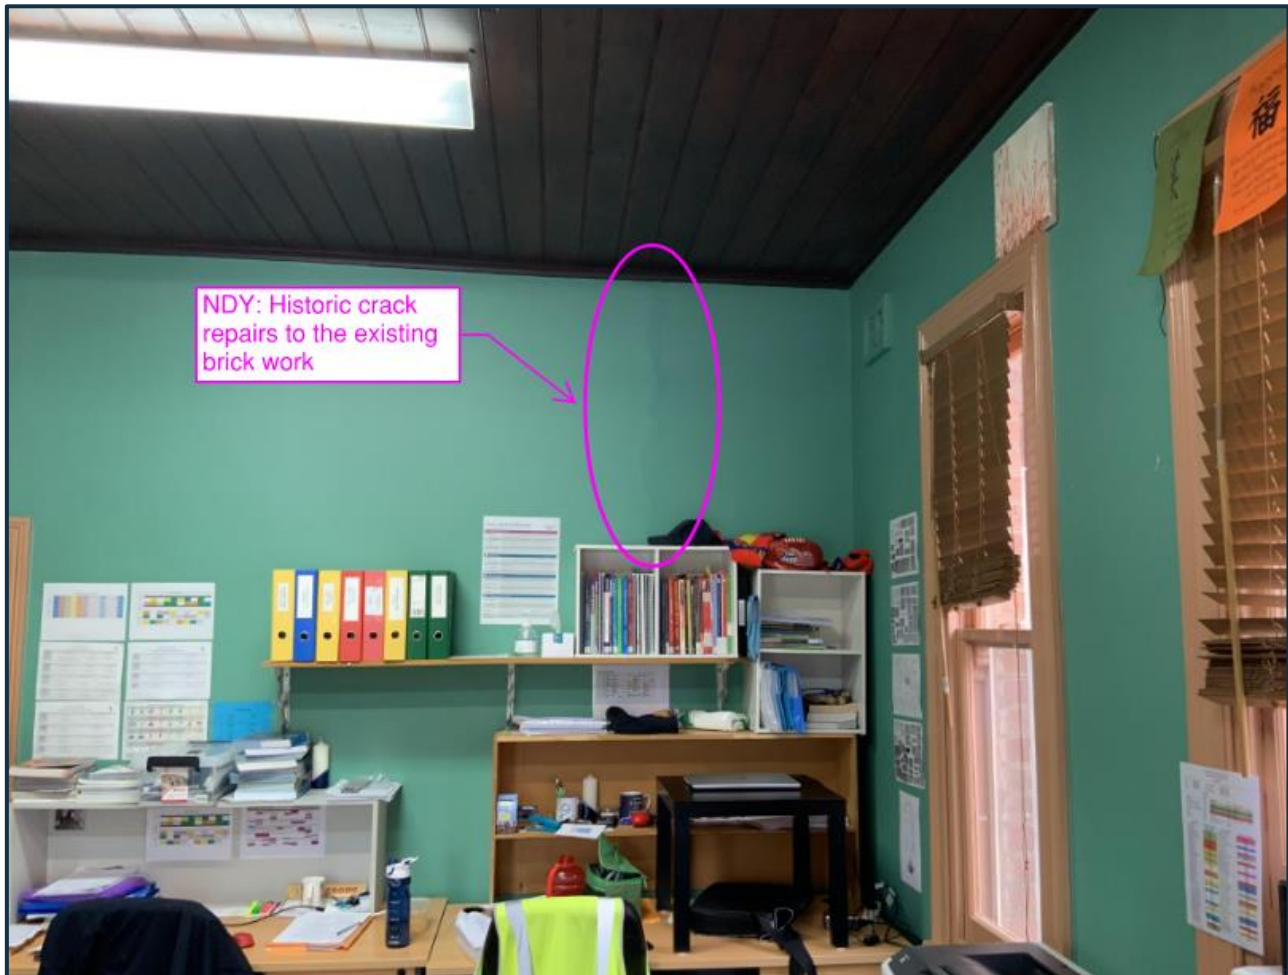
The historic crack patterns that were observed in the brick walls during the inspection are generally as expected for structures like the administration building.

FIGURE 4 - HISTORIC REPAIRS OF CRACKING IN THE EXISTING BRICK WALLS

- Required maintenance to existing brick work such as repointing of mortar joints and crack repairs can be undertaken with the proposed refurbishment.

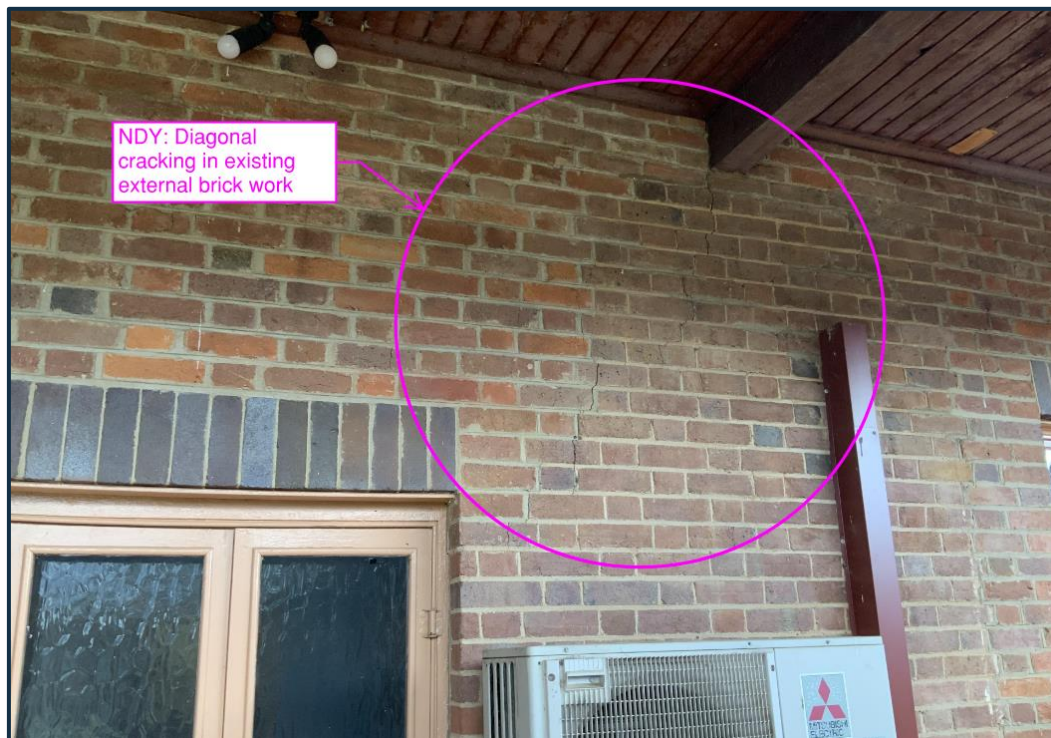
FIGURE 5 - VISIBLE DIAGONAL CRACKING IN AN EXTERNAL PERIMETER BRICK WALL

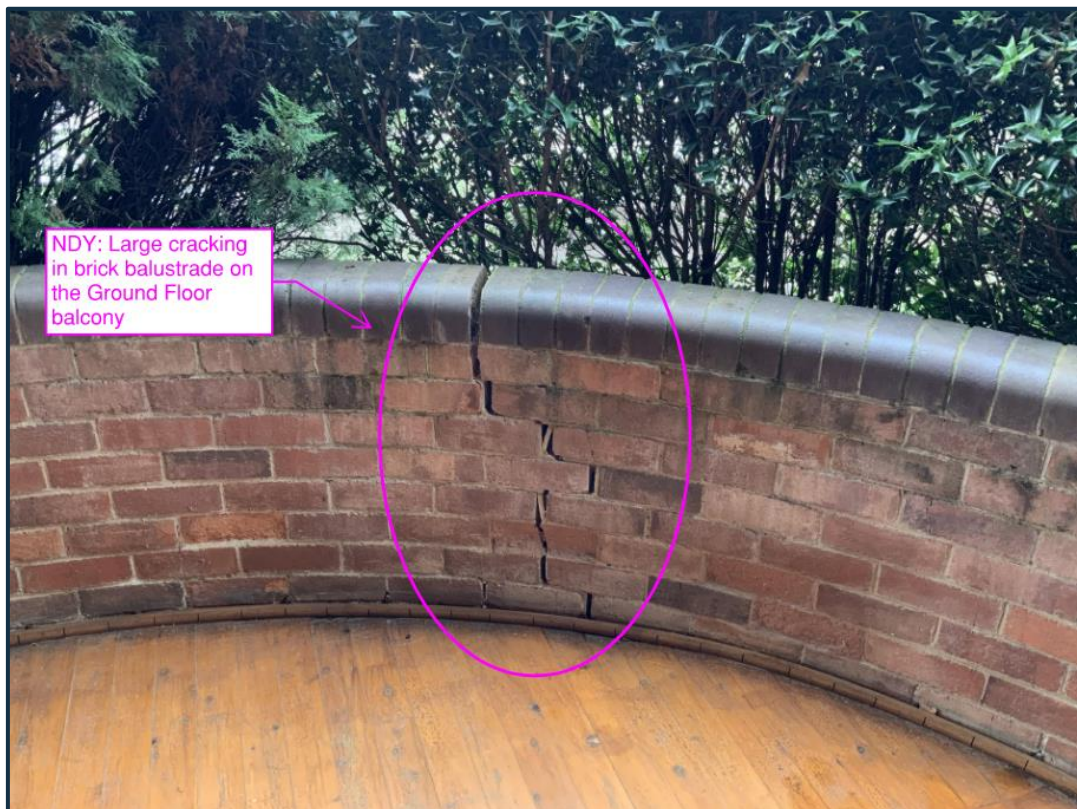
During the site inspection, signs of localised movement and cracking was observed in some of the existing brick balustrades located on the balcony perimeters as shown in Figure 6. These cracks were the most significant damage that was visually observed during the inspection.

FIGURE 6 - LARGE VERTICAL CRACKING IN THE EXISTING GROUND FLOOR BRICK BALUSTRADE

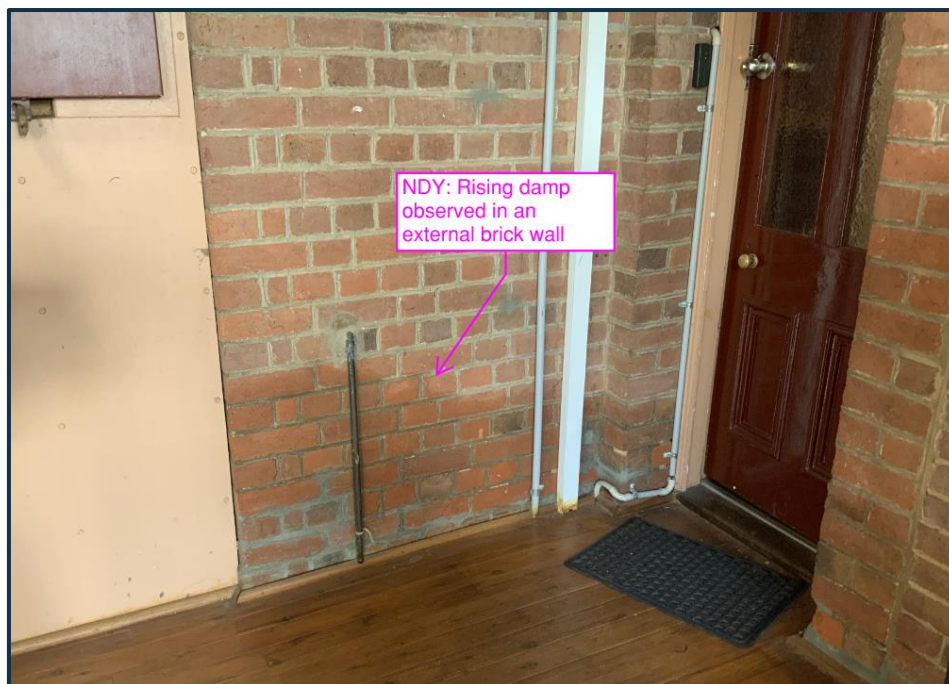
Evidence of rising damp was observed in an external perimeter wall as shown in Figure 7.

FIGURE 7 - RISING DAMP OBSERVED IN AN EXTERNAL BRICK WALL

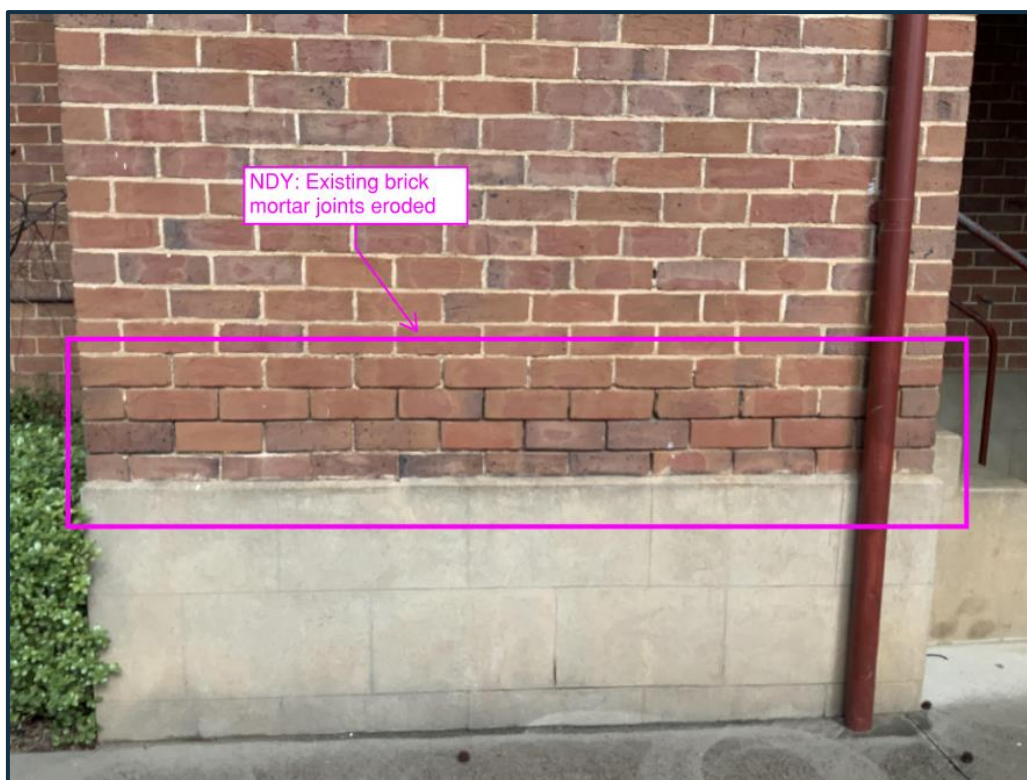
Some external brick walls showed signs of deterioration and erosion of existing mortar joints as shown in Figure 8, however the condition of the brick mortar joints that could be visually inspected throughout the building is generally considered good.

FIGURE 8 - LOCALLY ERODED BRICK MORTAR JOINTS IN AN EXTERNAL BRICK WALL

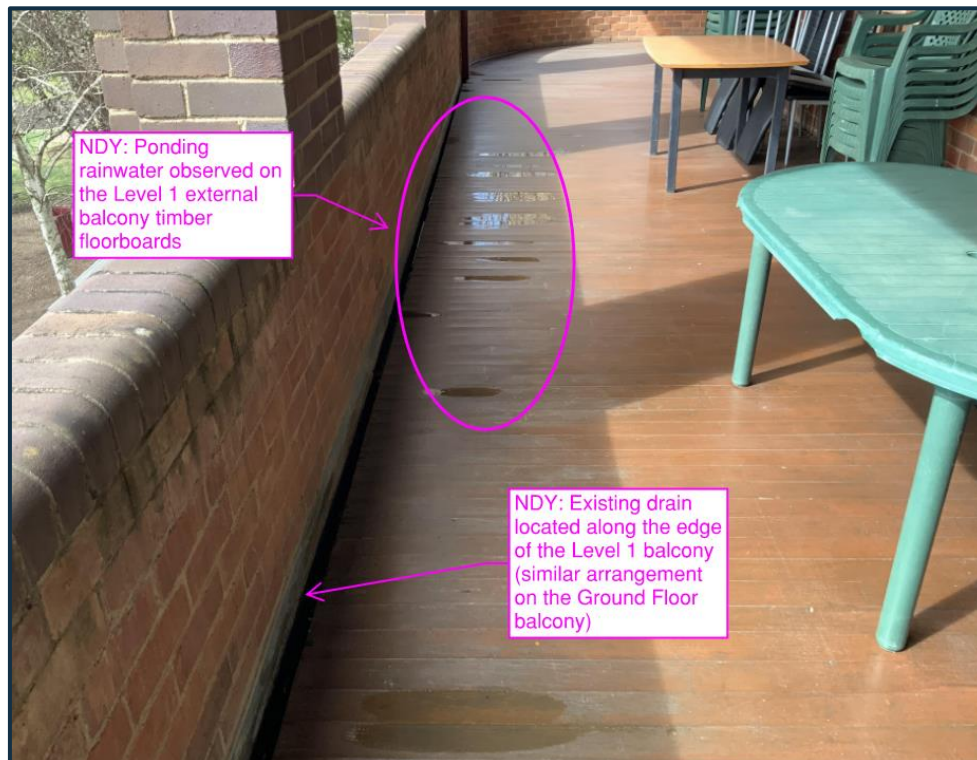
The external timber floorboards on the Ground Floor and Level 1 balcony areas have been damaged due to long-term exposure to weather and rain. Rainwater during the inspection was observed to pond and drain across the top surface of the timber floorboards towards the strip drain as shown in Figure 9.

FIGURE 9 - SITE PHOTO OF THE LEVEL 1 EXTERNAL BALCONY WITH PONDING RAINWATER OBSERVED

Extensive swelling and cupping in the timber floorboards was noted on both floors with signs of rot and heavy staining observed in several locations on the soffit of the Level 1 balcony.

- Repairs to the existing external timber floorboards can be completed as part of the refurbishment works. New methods and products can be considered as a solution to the existing water proofing issues and moisture damage observed at the existing balcony zones during the inspection.

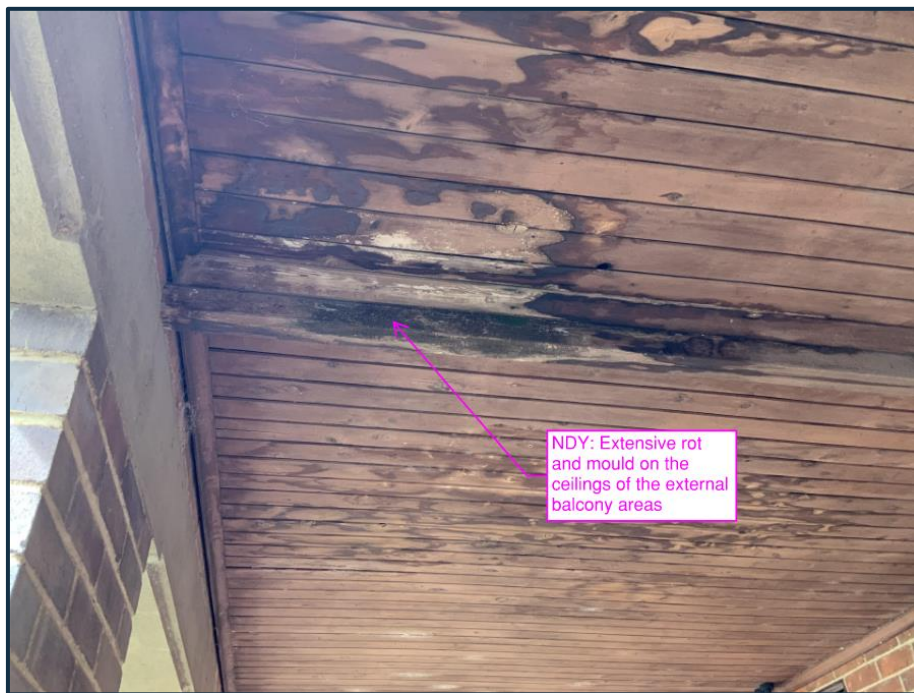
As the external floorboards have been exposed to long-term moisture, it is possible and likely that extensive water damage has occurred to the concealed structural timber members in these areas. Figure 10 shows a site photo of extensive mould and rot damage that was observed on the ceiling of the external balcony.

FIGURE 10 - EVIDENCE OF ROT AND MOULD ON BOTH BALCONY CEILINGS

- During the site inspection, the condition of the timber floorboards and ceilings in the external balcony areas suggest it is very likely that the existing structural timber and brick work in these zones will require repair or complete replacement. It is recommended that an allowance is made for the structural works related to these areas.
- The large cracking observed in the brick balustrades on the Ground Floor and level 1 indicates movement in the foundations and elements directly supporting these balustrades has occurred. Provision for repair and strengthening works should be considered as part of the refurbishment.

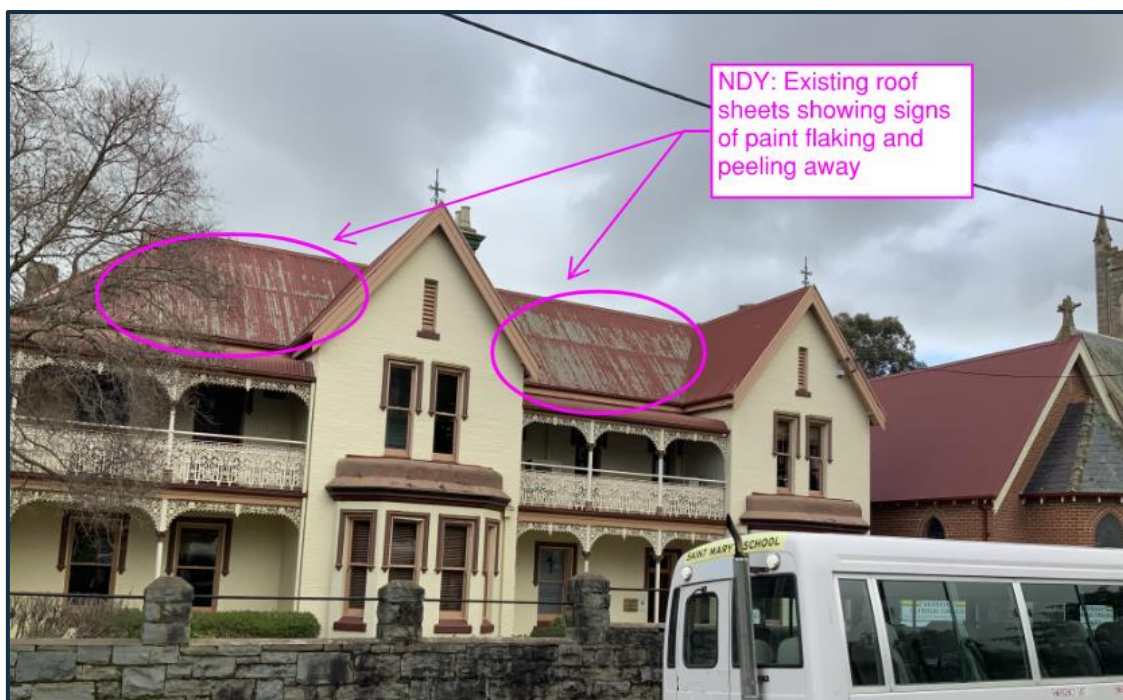
The steel sheet roof could only be visually inspected from a distance (standing on Ripon Street, at the front of the building) and is considered to be in fair to poor condition. The large portion of the roof sheets appear to have paint flaking and peeling away as shown in Figure 11. The roof at the rear of the building could not be visually inspected, however staining and water damage on the underside of the Level 1 balcony ceiling was noted. An existing brick parapet has been constructed around the building perimeter at roof level. It is possible that a box gutter or similar drainage system has been installed around the parapet. Staining and mould around the perimeter of the Level 1 balcony ceiling may indicate previous overflow or leakage into the roof space and water damage to the timber roof structure is therefore likely.

FIGURE 11 - SITE PHOTO OF THE CONDITION OF THE EXISTING ROOF SHEETS

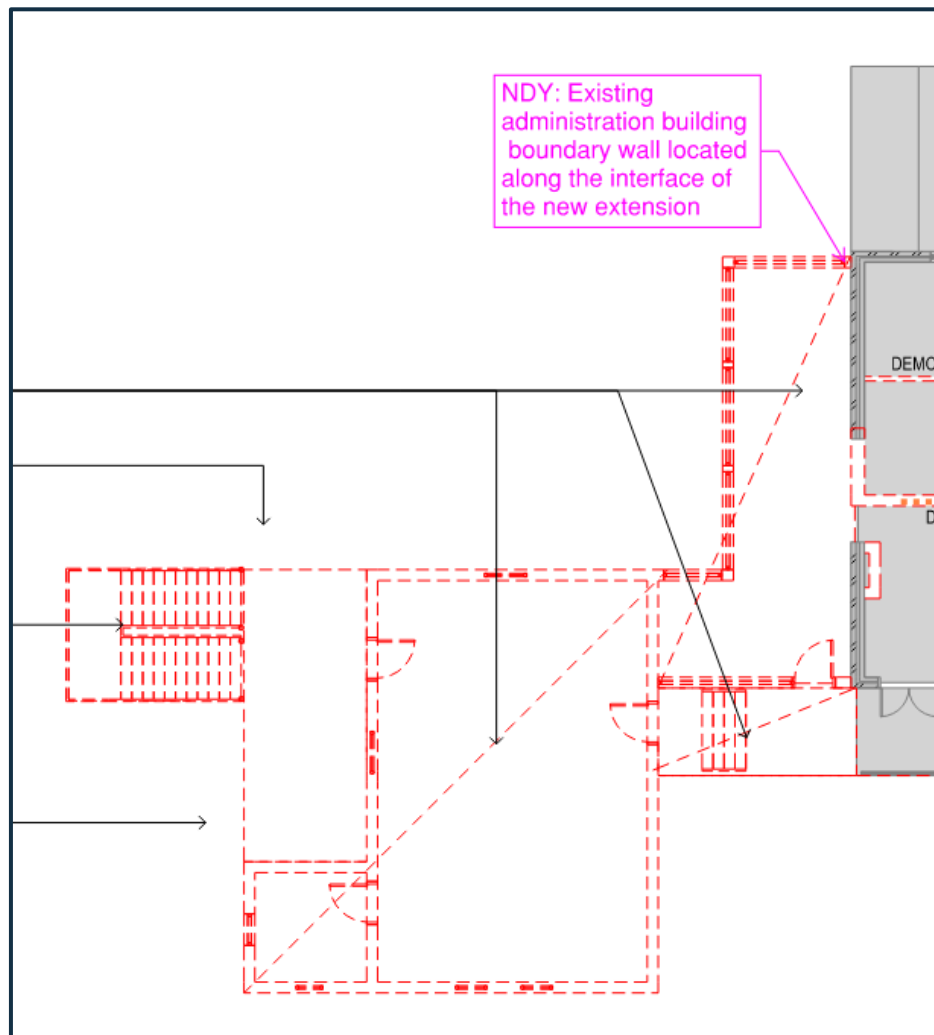
- The demolition of the existing building where the proposed new extension is to be located is shown in Figure 22. The proposed arrangement will expose the existing foundations below the boundary brick wall of the administration building. The extension will require new foundations and footings to be constructed which will potentially undermine the existing footings. An allowance for underpinning of existing footings and foundations should be made in the new works.

FIGURE 22 - EXISTING BOUNDARY BRICK WALL TO BE RETAINED

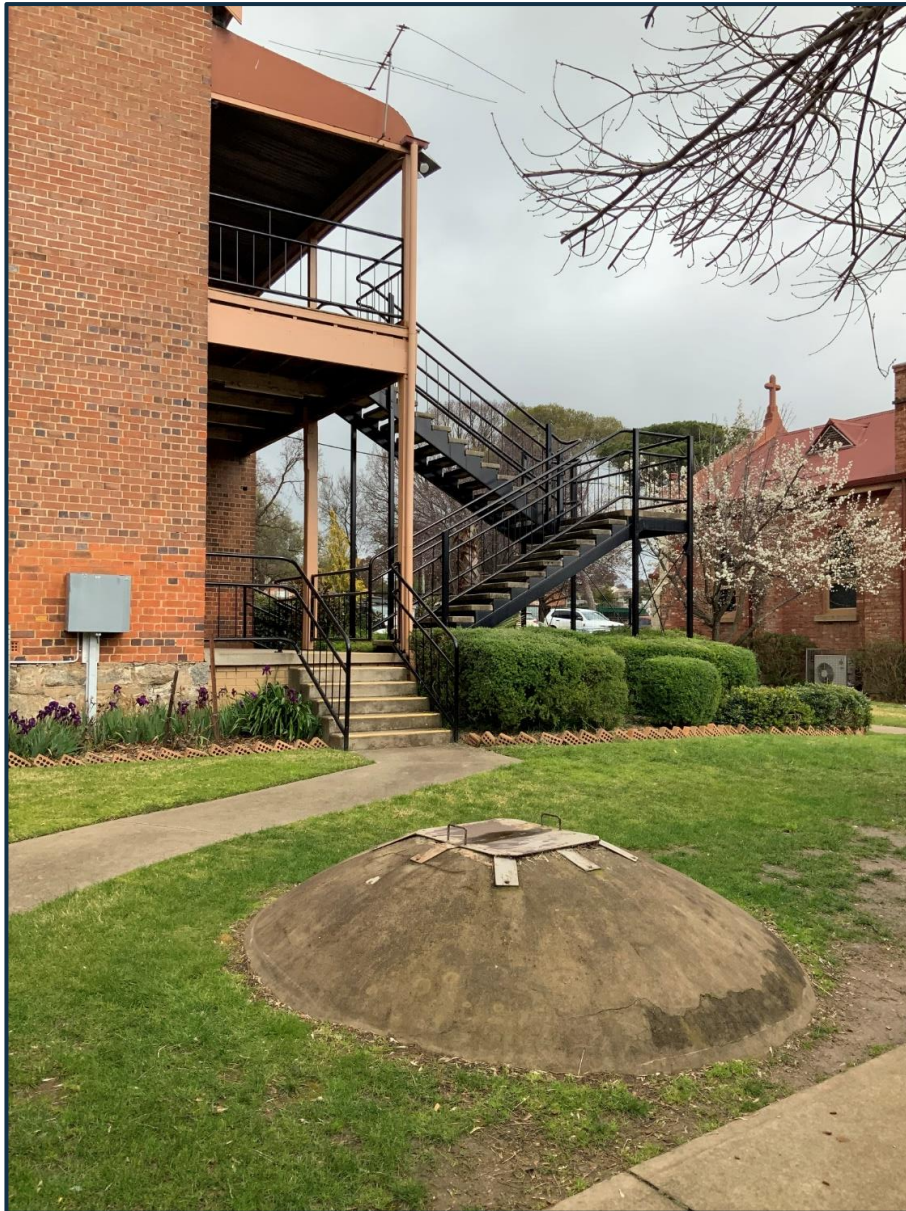
- During the site visit, an existing concrete dome located at the rear of the building was visually inspected as shown in Figure 23. The dome appears to be sealed for a significant period and the original purpose of this structure is not known. Considering the age of the administration building, it might be possible that an underground well or water storage space has been constructed below the visible dome lid. It is recommended that a detailed investigation of this element is completed, including internal inspections.
- The existing concrete dome will need to be demolished to accommodate the new extension. The geotechnical investigation should specifically address the soil adjacent to the dome.
- An allowance to infill an inground void should be considered as part of the project scope.

FIGURE 23 - CONCRETE DOME AT THE NATURAL GROUND LEVEL (REAR OF BUILDING)
