COMPLIANCE REPORT

7 Ripon Street, YOUNG NSW

25th April 2022

Hennessy Catholic College

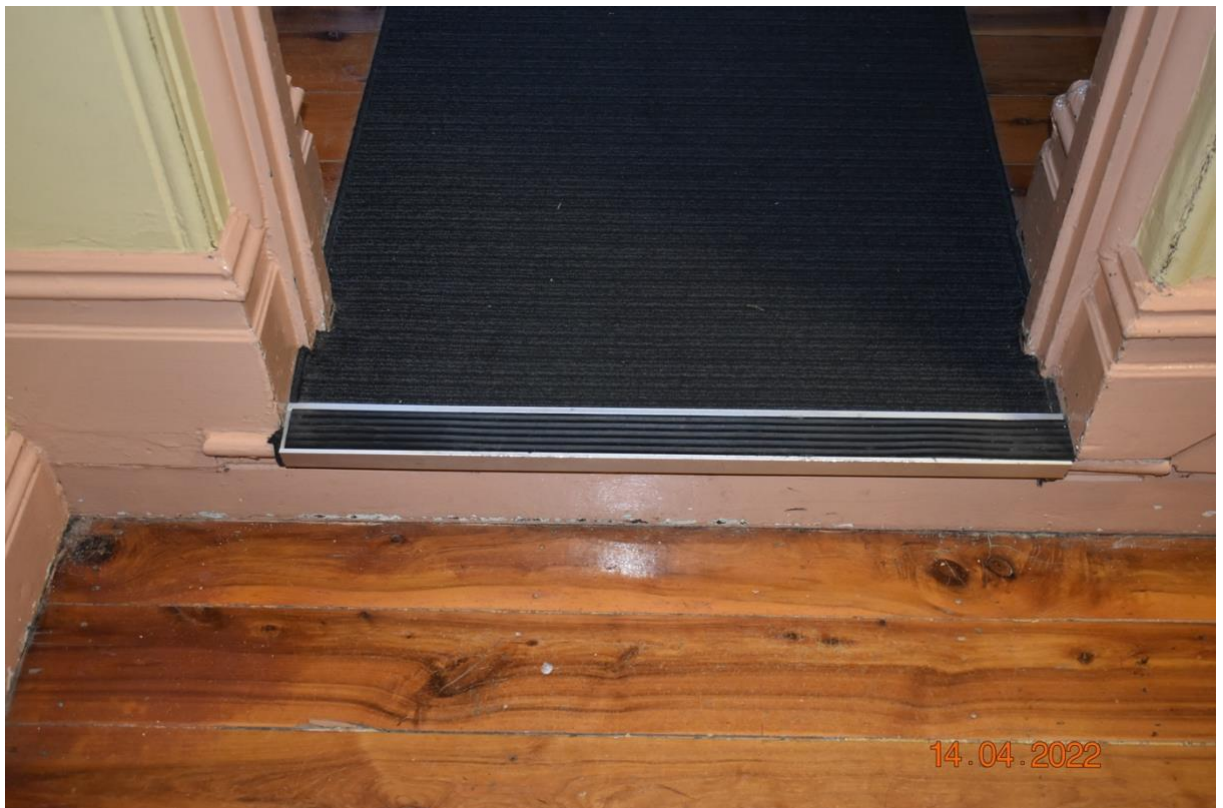
Pic.2. Step in CAPT
