**SEASONED TREE
CONSULTING**

**ARBORICULTURAL IMPACT
ASSESSMENT REPORT**

Prepared for
Gary Carli c/o DMPS

Site address
**8 Dawn Fraser Avenue,
Sydney Olympic Park**

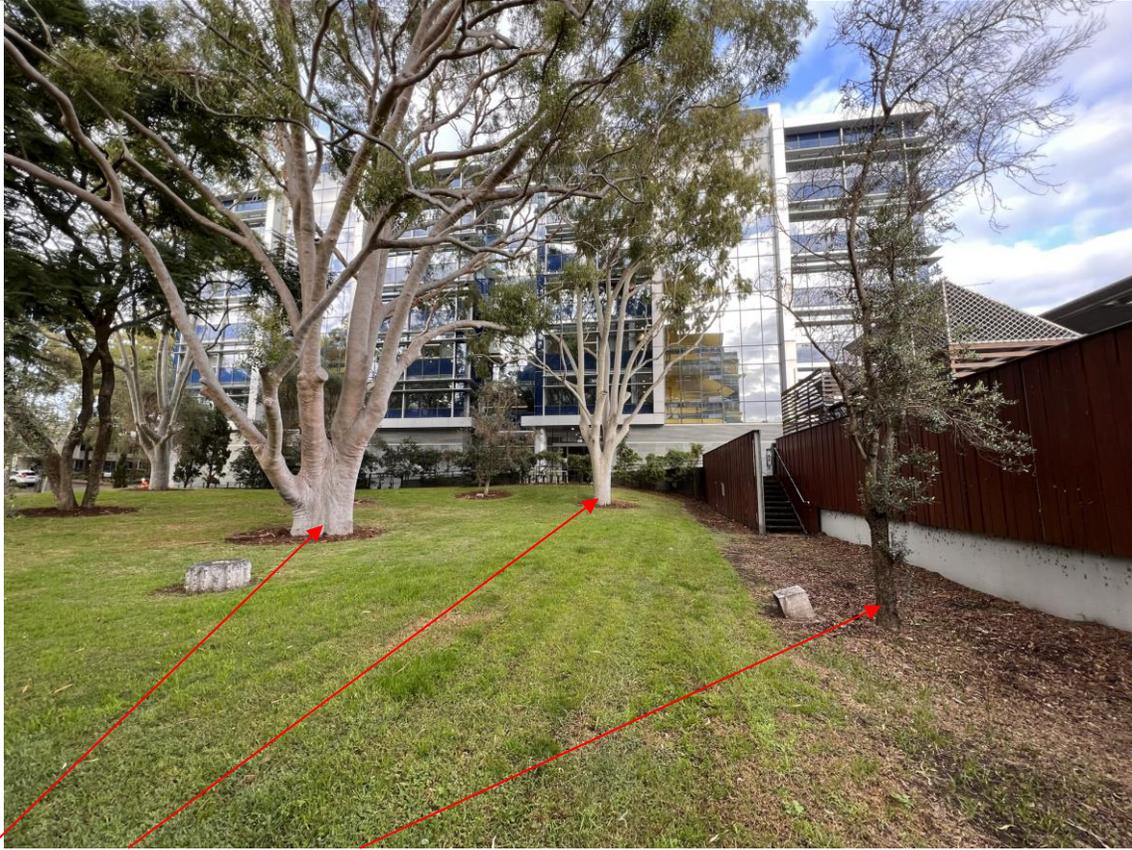
Image c: T5, T6, T1

5	<i>Corymbia citriodora</i> , Lemon scented Gum	AA	15	3.6	706.9	Minor	<p>The subject tree is large and possesses a very high retention value. The tree has been heavily pruned on the north side of the canopy and has a large amount of clearance from the building. No pruning of the canopy will be required.</p> <p>The tree has a calculated encroachment of up to 67.4sqm (= 9.5%). Existing building coverage brings new encroachment down to approximately 36.7sqm (=5.1%), deemed to be a minor encroachment.</p> <p>Concern about root pruning was noted due to the tree's high retention value and that the tree is located within the adjoining property. Root mapping was therefore recommended and this was undertaken on 11th August 2023.</p> <p>Root Mapping is described in detail within Section 7 (Page 12) and shows that no roots were found. The soil profile is highly disturbed and compacted.</p> <p>It is recommended that Project Arborist supervision for the deep excavation for the ground floor services room be undertaken.</p> <p>The note is made that if any access through Stockroute park is required for construction purposes, ground protection must be installed if transiting past any park tree. Further advice would be provided on this by the nominated Project Arborist within a final Tree Protection Plan.</p>	Retain and protect.

Tree ID	Species	Retention value	TPZ radius (m)	SRZ Radius (m)	TPZ Area (sqM)	TPZ encroachment	Discussion/ Conclusion	Recommendation
6	<i>Corymbia citriodora</i> , Lemon scented Gum	A1	10.08	3.1	319.2	Minor	<p>The subject tree is large and possesses a very high retention value. The tree has been heavily pruned on the north side of the canopy and has a large amount of clearance from the building. No pruning of the canopy will be required.</p> <p>The tree has a calculated encroachment of up to 76.2sqm (= 23%) into the TPZ. Existing building coverage brings new encroachment down to approximately 7.6sqm (=2.4%), deemed to be a minor encroachment.</p> <p>This amount of encroachment is deemed acceptable under the AS4970 (Protection of Trees on Development sites) and the tree will be able to be retained in a viable condition.</p>	Retain and protect.
7	Row of <i>Jacaranda mimosifolia</i> , Jacarandas	A1	3	1.8	28.3	Nil	<p>A row of street trees located along Dawn Fraser Avenue.</p> <p>The trees will not be subject to encroachment as the existing awning along the first floor level is to be retained as is.</p> <p>Trunk protection will be required to be installed to reduce the risk of damage whilst building materials are being unloaded on Dawn Fraser Avenue.</p>	Retain and protect.

- 10.2 It is recommended that trees **T3, T4, T5, T6, T7 and T8 (total of 6 trees which includes 2 groups of trees) all be retained and protected**.
- 10.3 To retain **T5 and T6** in a viable condition, the excavation works within the TPZ must be strictly supervised and if any roots are encountered, all root pruning works must be managed and documented by an experienced Project Arborist. Only roots under 40mm in diameter are to be pruned by the Project Arborist. If roots over 40mm in diameter are encountered, then contact should be made with the Sydney Olympic Park Authority Arborist to discuss.

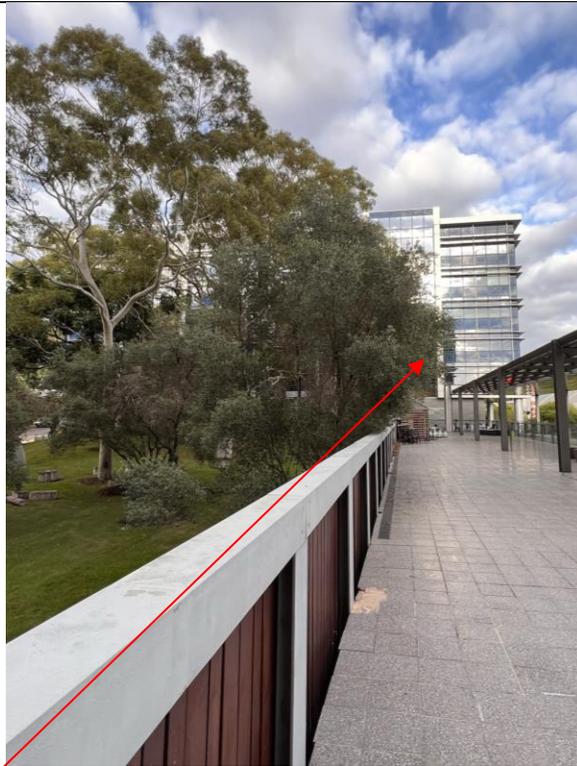
Tree ID	Species	Retention value	TPZ radius (m)	SRZ Radius (m)	TPZ Area (sqM)	TPZ encroachment	Discussion/ Conclusion	Recommendation
4	<i>Olea europaea</i> , European Olive	A2	3.6	2.0	40.7	Nil	<p>The subject tree is in good overall condition with no calculated encroachment.</p> <p>It is possible that the regular canopy pruning of this tree (that has been carried out in past years by the Hellenic Association members) will be undertaken by the Hellenic Association members. The style of pruning that has been used in the past is lopping and topping, which, whilst not an accepted arboricultural practice, does not affect Olive trees due to their tolerance to this practice. Minor pruning may be required on the north side of the tree to provide some clearance to the building. I have included marked up photos on page 24. This minor pruning appears to be less than 10% of the canopy and would not impact the health or condition of the tree at all.</p>	Retain and protect.

Image d: T4- minimal overhanging foliage

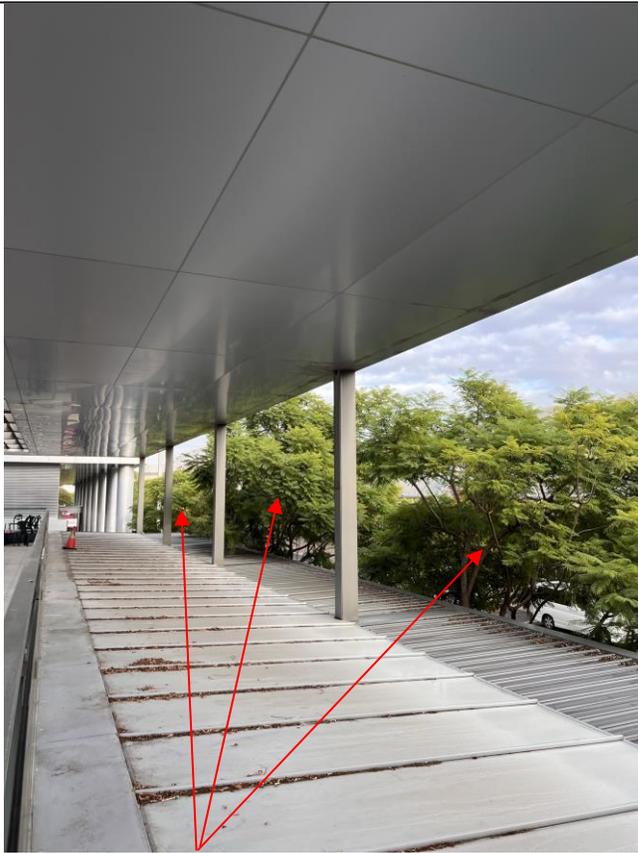
Image e:

T7 (Multiple Jacarandas)

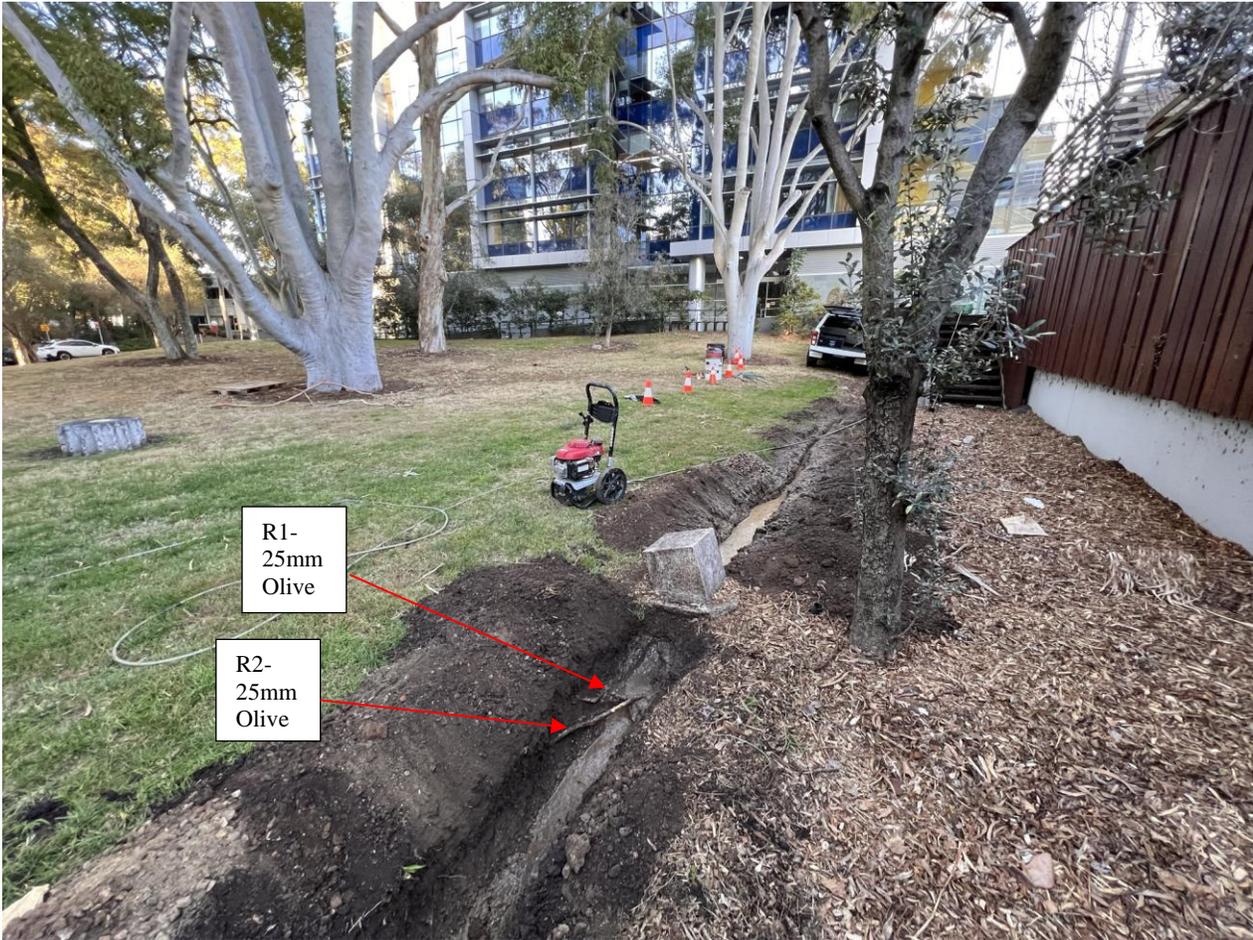
Root Number	Root diameter (mm)	Root distance below ground level (mm)	Setback distance from the western end of trench (m)	Notes
R1	25	200	7.8	Olive root found.
R2	25	200	7.8	Olive root found.

Image k: Root investigation trench

- 8.1 The trench excavation of close to 13m in total length unearthed a total of 2 roots of small diameter that are from T1. As this tree is recommended to be removed these 2 roots will be removed as well.
- 8.2 There may be roots from T5 and T6 deeper in the soil profile than root investigation was able to be undertaken to. Arboricultural supervision of the excavation works will be required. If root pruning is required, it must be undertaken by a minimum AQF Level 4 Arborist in conjunction with the site excavation activities.

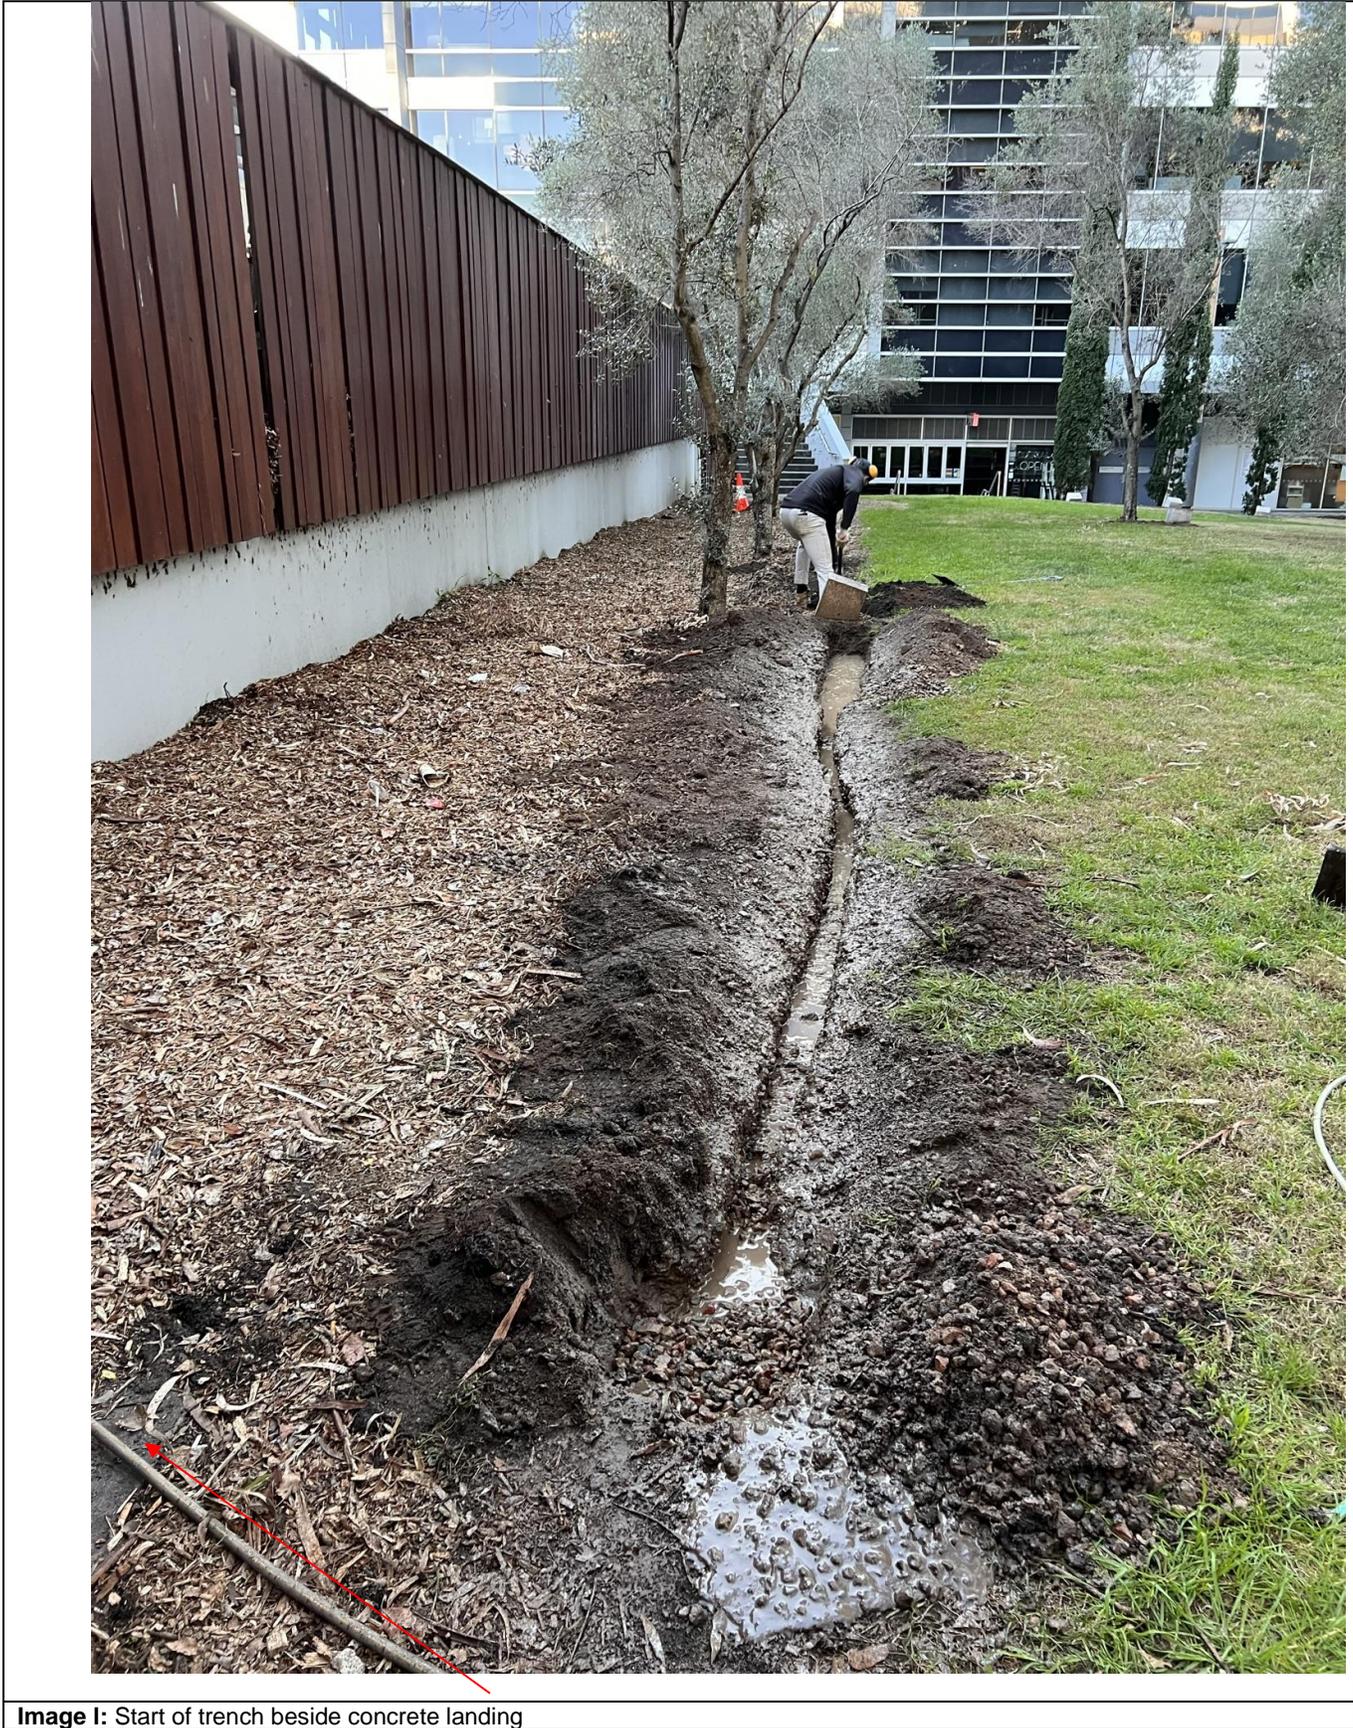
Image I: Start of trench beside concrete landing

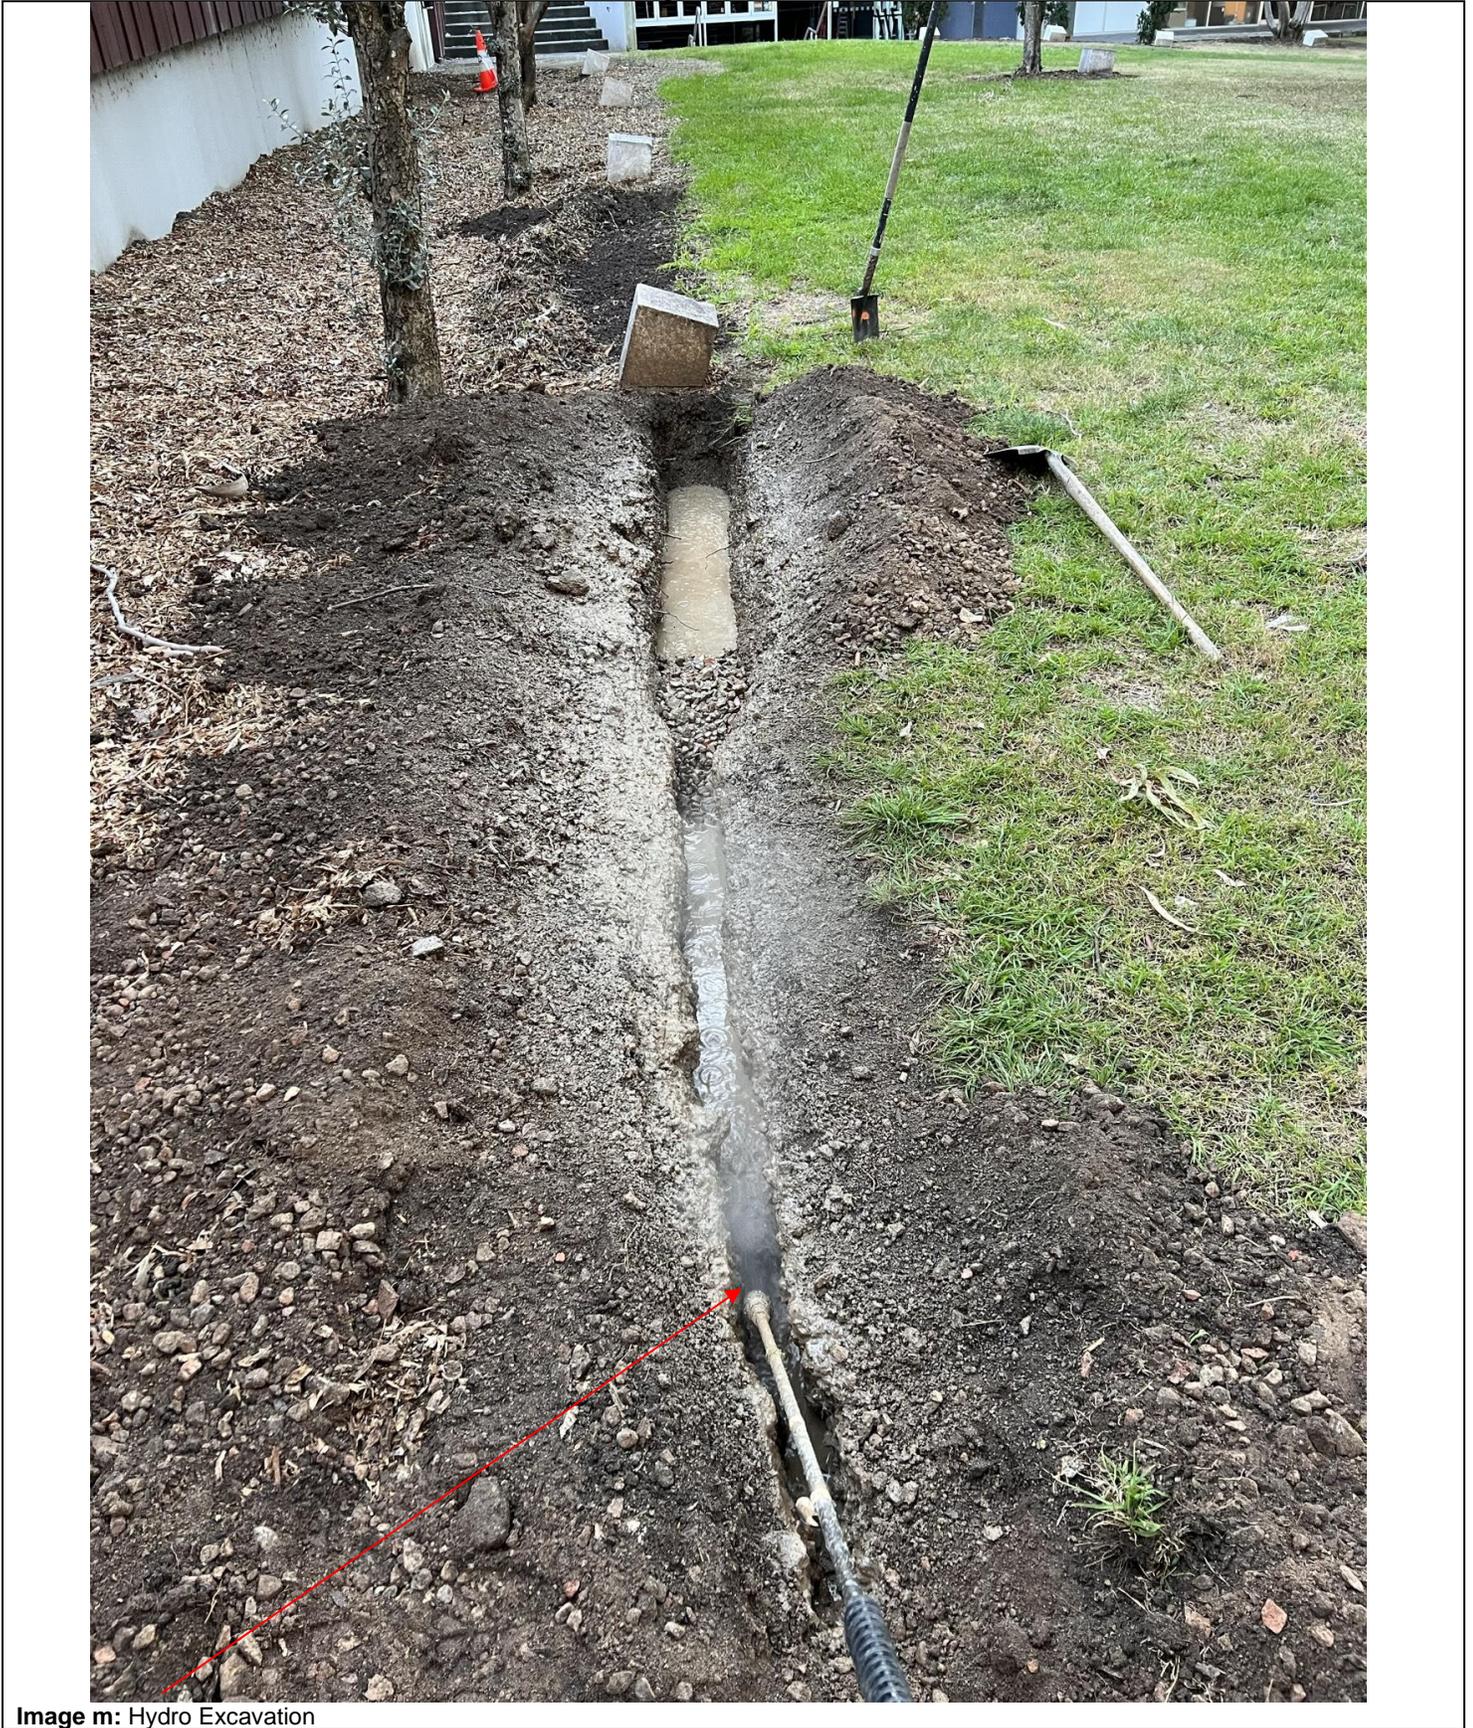
Image m: Hydro Excavation

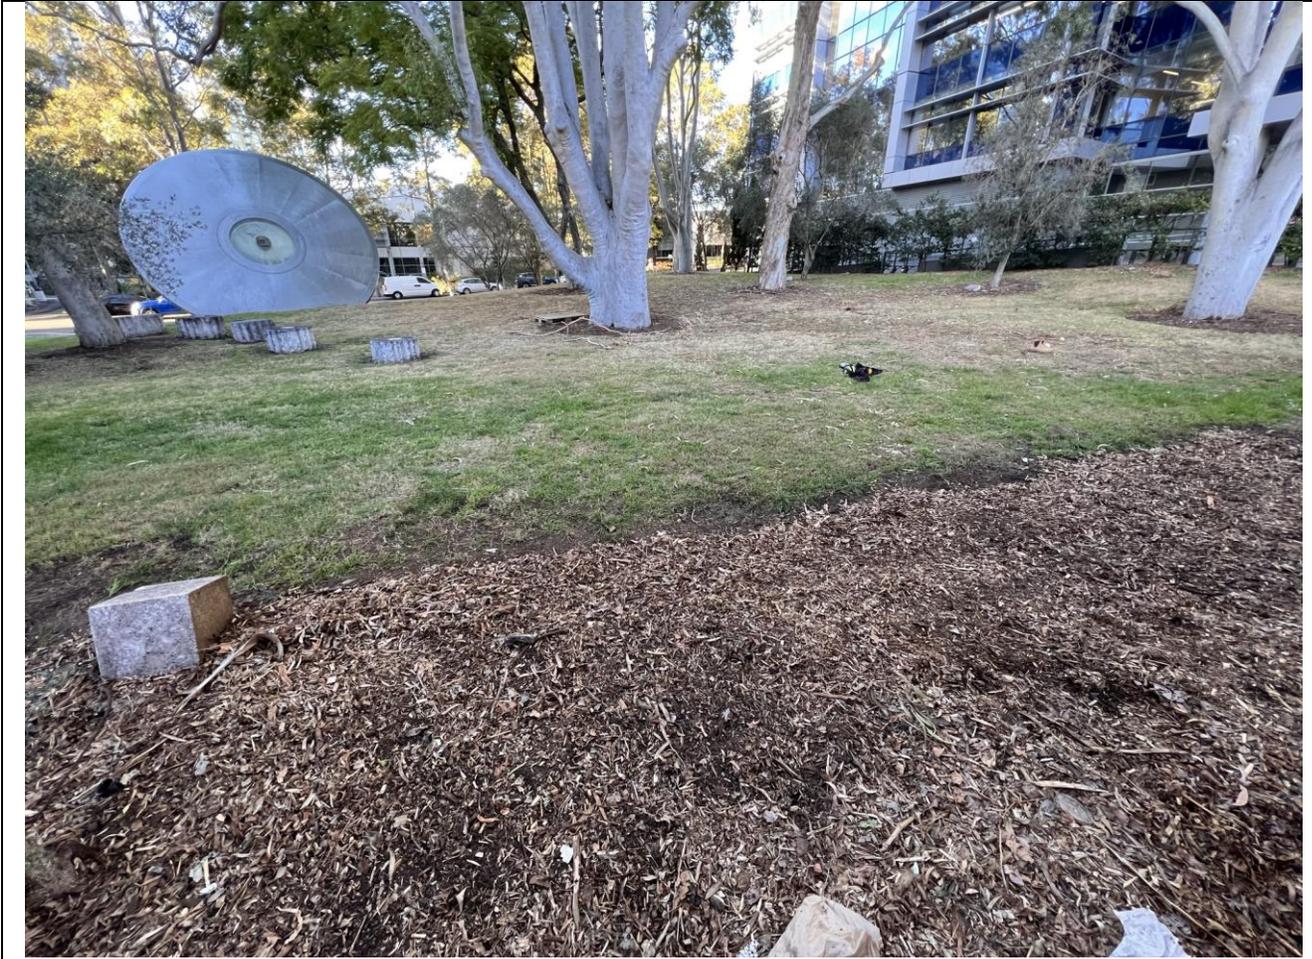
Image m: Soil reinstated plus mulch spread once investigation was complete
