Service protection report

Joseph plumbing

Property Address: 8 Hillview Avenue, Bankstown, NSW 2200

Client: (Nemco Design)

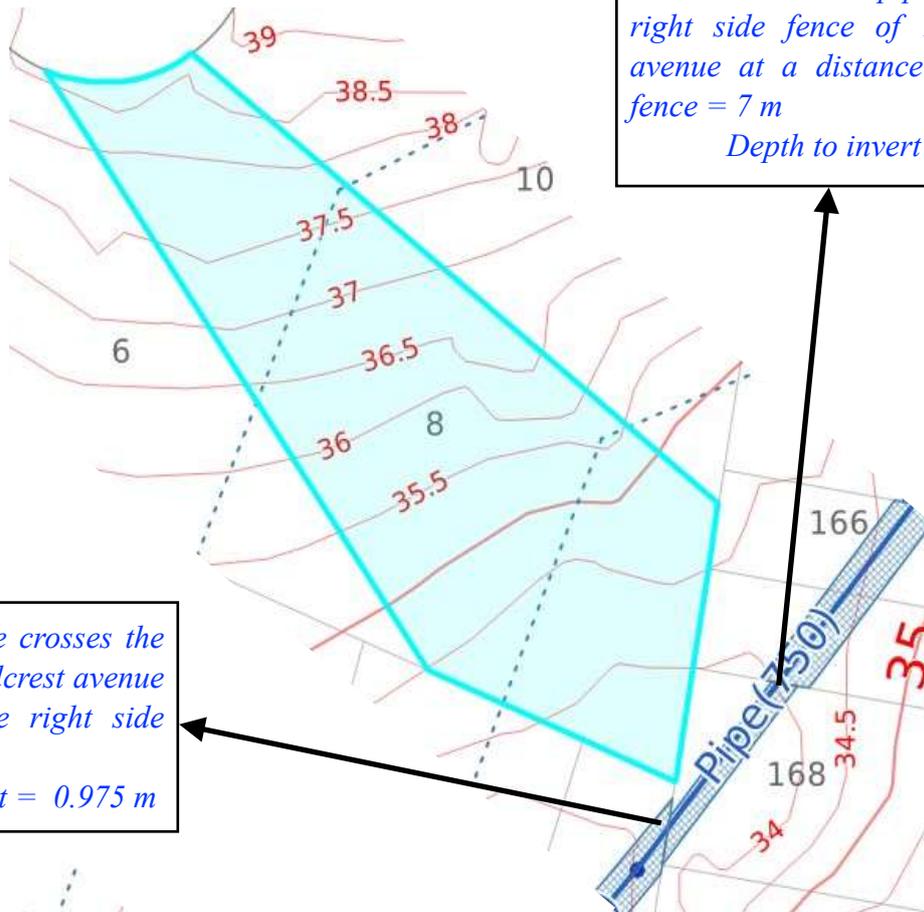
*The Storm water pipe crosses the right side fence of 168 Hillcrest avenue at a distance to the back fence = 7 m
Depth to invert = 0.875 m*

*The Storm water pipe crosses the back fence of 168 Hillcrest avenue at a distance to the right side fence = 13.65 m
Depth to invert = 0.975 m*

Pipe size: 750 mm

Pipe type: R.C.

Strata: Clay, Soil
