ADVERTISING SIGNAGE STRUCTURE

Cowpasture Road, Bossley Park – Inbound & Outbound

Structural Condition Report

21 AUGUST 2023

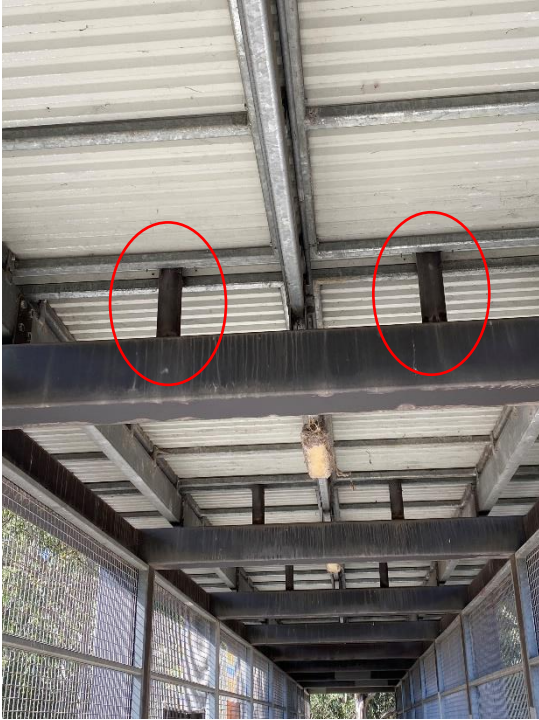
Photo 1 – Signage structure legs welded to bridge superstructure (circled).

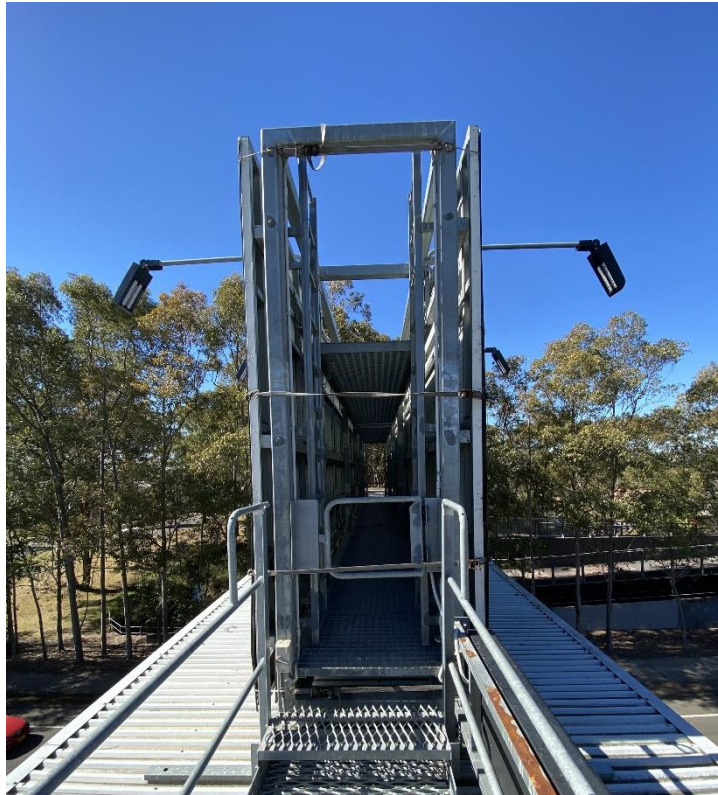
Both catwalks exceed minimum width requirements and are equipped with compliant handrails and kick rails (where required). A permanent fixed ladder located at each end of the catwalk, provides access between the gantry levels. The ends of the upper catwalk are only fitted with safety chains, which does not necessarily provide adequate fall protection.

Photo 2 – General end view of signage structure

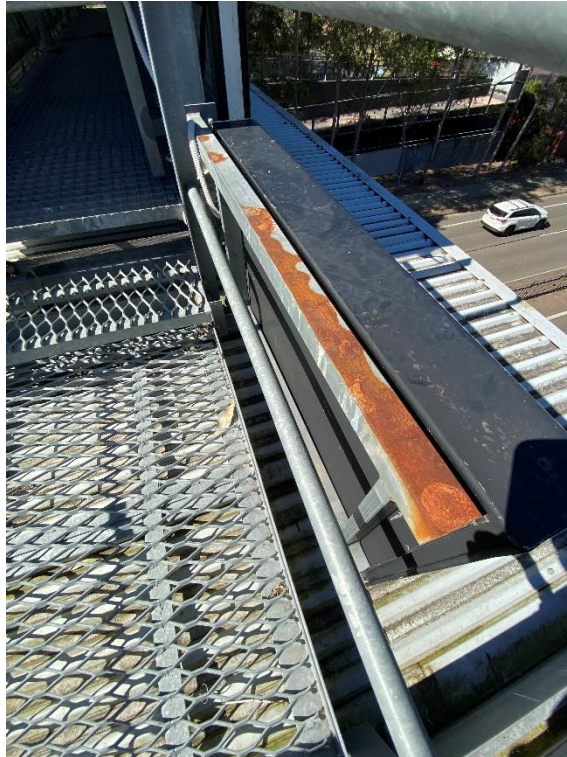
- Minor surface corrosion to logo box support framing (both sides).

Photo 10 – Minor surface logo box support framing (west).

We would recommend that the surface corrosion be wire brush cleaned and treated with a proprietary cold galvanising paint at the next scheduled maintenance programme, to avoid further corrosion developing and potentially more costly remediation. This may involve the complete replacement of nuts and bolts.

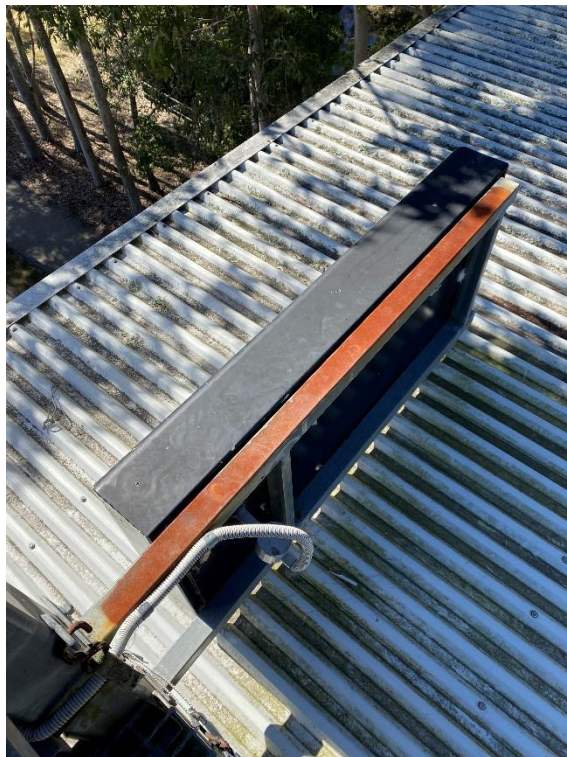
Photo 11 – Minor surface logo box support framing (east).

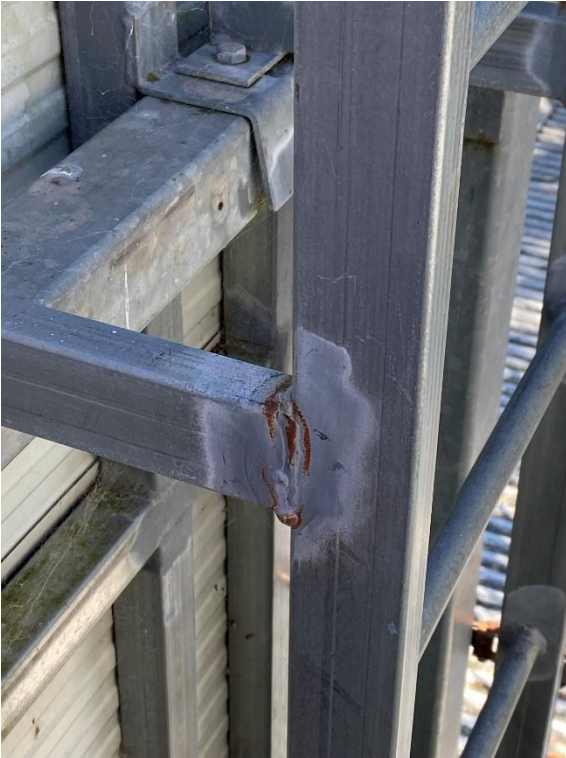
- Minor surface corrosion to vertical ladder support framing.

Photo 12 – Minor surface corrosion to vertical ladder support framing.

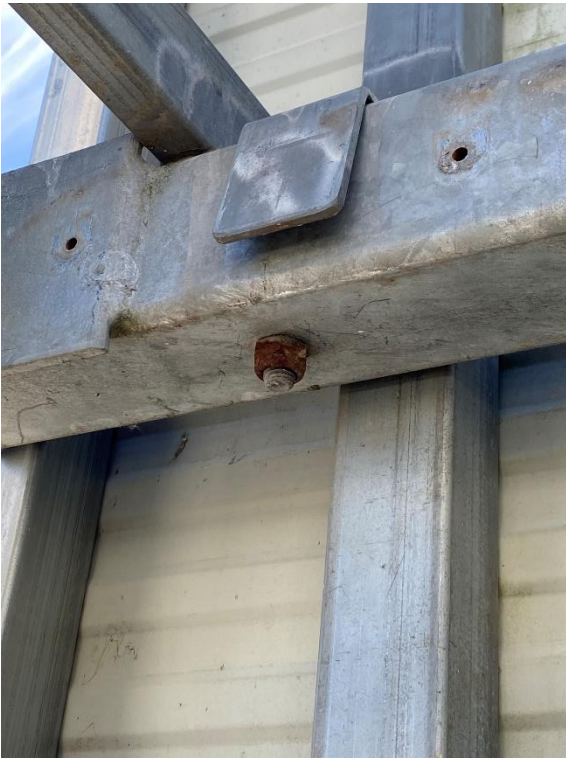
- Corroding nut to vertical ladder support framing.

Photo 13 – Corroding nut to vertical ladder support framing.

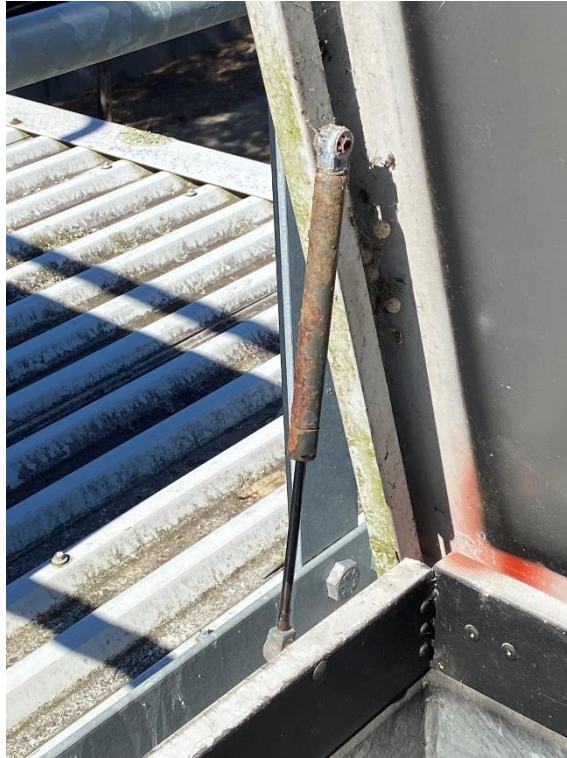
- Deteriorating hatch strut.

Photo 14 – Deteriorating hatch strut.

The deteriorating hatch struts be replaced.

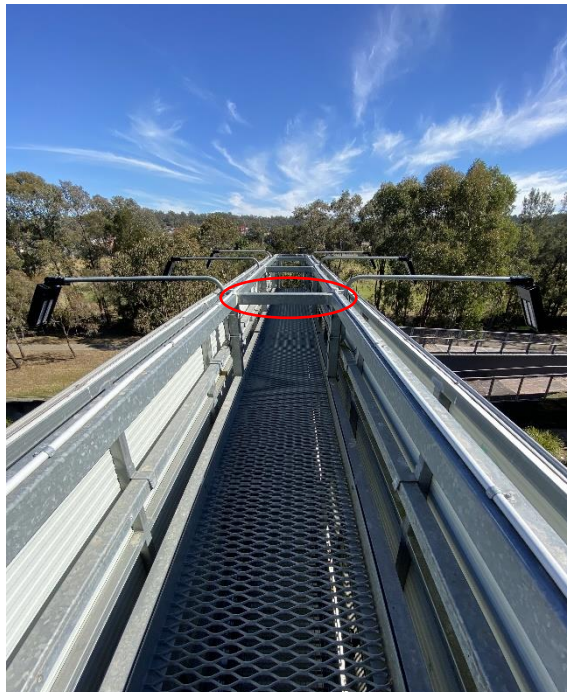
- Trip hazards to top catwalk.

Photo 15 – Trip hazards to top catwalk (circled).

Elimination of the trip hazards would necessitate total redesign and fabrication of the signage structure – a significantly costly exercise. In lieu of replacing the structure, measures such as ‘tiger tape’ on the trip hazard and warning signs should be instated.
