Proposed Demolition of Sonnblick Lodge

Kosciuszko
Thredbo Pty Ltd

10 Bobuck Lane,
Thredbo, NSW

Proposed Demolition of Sonnblick Lodge **10 Bobuck Lane, Thredbo, NSW** *Geotechnical Investigation & Landslide Risk Assessment*

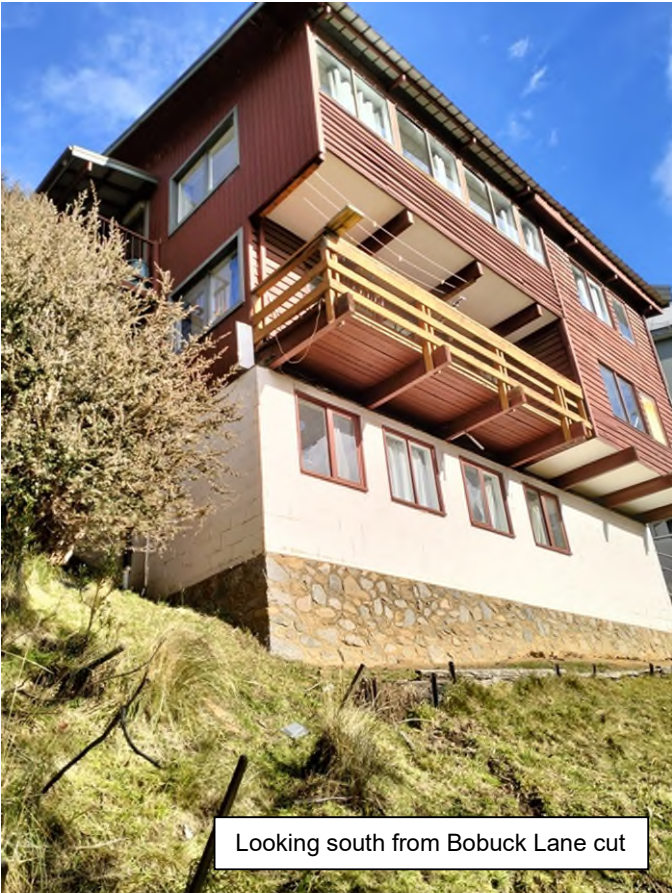
<p data-bbox="678 981 896 1029">Sonnblick Lodge</p> <p data-bbox="159 1276 589 1324">Looking north from Bobuck Lane cut</p>

<p data-bbox="1525 1292 1944 1340">Looking south from Bobuck Lane cut</p>

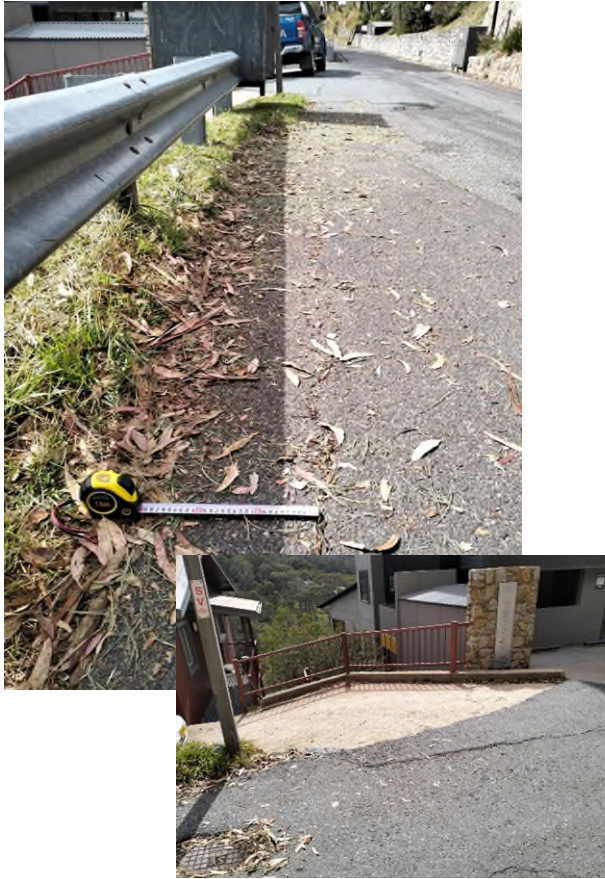
Aspect & Location	Observations	
	2023	2024
Bobuck Lane	<p>Multiple tension cracks – Pavement of lower Bobuck Lane</p> <p>The cracks are to 10mm wide and running to 6m long. One tension crack in front of the driveway to 2.5m long.</p>

<p>Three tension cracks on the lower (outer) lane adjacent to the Sonnblick Lodge. The cracks are 10mm to 30mm wide and 1-3m long. The tension crack in front of the driveway remained ~2.5m long.</p>

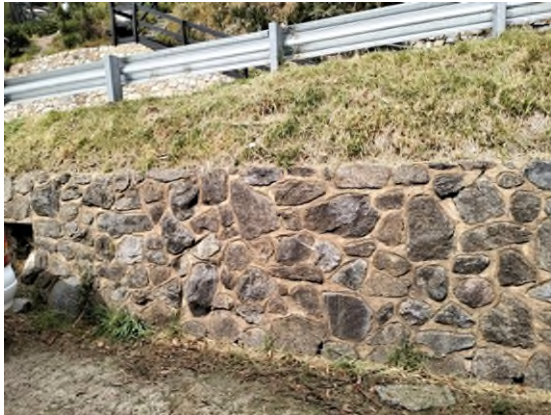
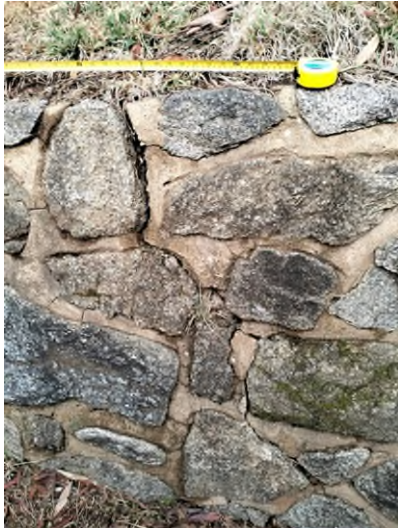
Aspect & Location	Observations	
	2023	2024
Cracking in the Retaining Walls – RW 4 (Driveway Retaining Wall) Beneath Bobuck Lane	<p>Generally, good condition cracks through mortar to 20mm, some detached stones: no bulging or tilting.</p>

<p>The cracks run through mortar to 20mm, some detached stones: no bulging or tilting.</p>
<p>RW3 (Beneath/ supporting driveway) Most to wet soils, soil erosion/</p>	<p>The weep holes existed at the base of the retaining wall. However, the soils (fill) below RW3 were moist to wet, in loose density.</p>

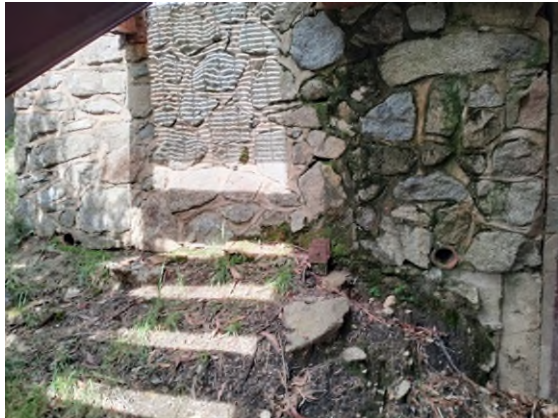
<p>The weep holes were wet soils below RW3 that were moist to wet. Some water was dripping from the roof. There is no surface drainage catching water from the roof.</p> <p>DCP 2 & 3 were done at the toe of the RW3 retaining wall.</p>

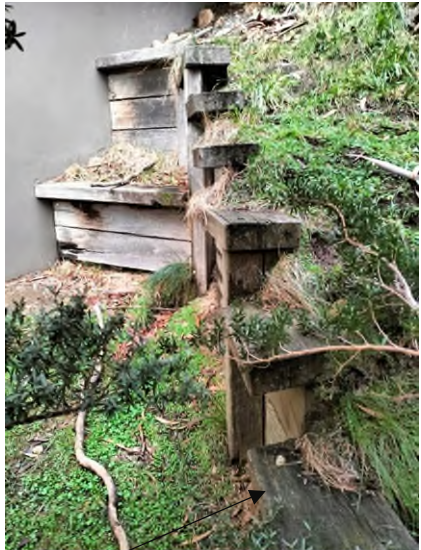
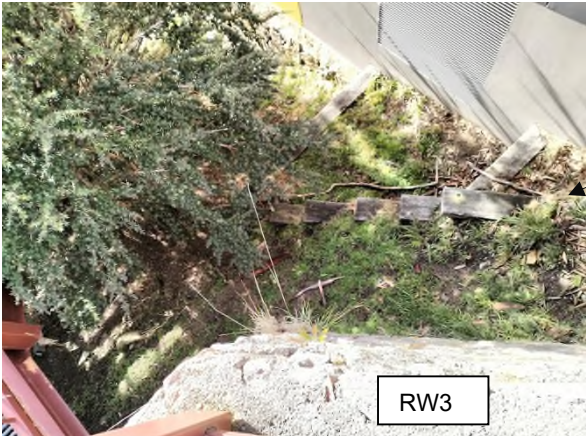
<div>RW3</div><div>View on timber retaining walls from above</div></div>

Aspect & Location	Observations	
	2023	2024
Batters on the western side of the block (boundary with Lot 801)	No photographs are available.	<p>The access stairs to level 1 are located on the western side of the block. Loose, moist, and wet soils (fill) were observed on the batters beneath the stairs. The subsurface drain inlet adjacent to the lodge was partially blocked with leaves and debris. Timber retaining walls on the block boundary were in good condition with only minor tilting.</p> <div>

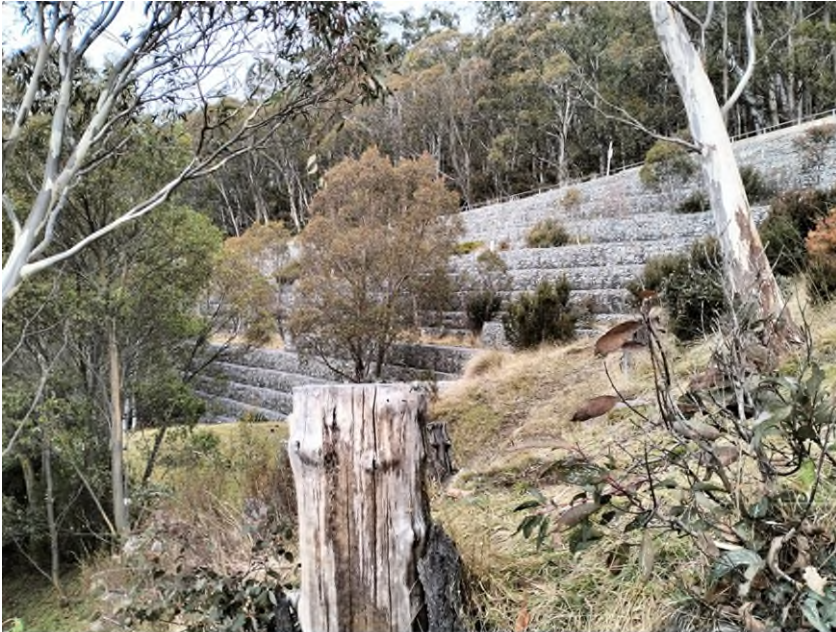
Aspect & Location	Observations	
	2023	2024
Alpine Way Cut	<p>The Alpine Way has been reconstructed, including gabion retaining walls with subsurface horizontal drainage above and below the road.</p>

<p>Reconstructed Alpine Way embankment at location of 1997 Landslide</p>

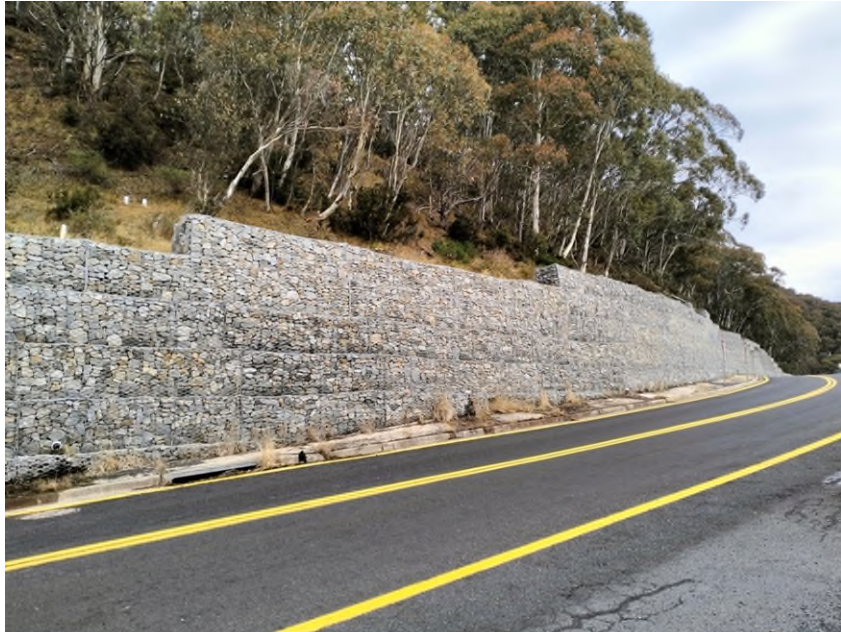
<p>Reconstructed Alpine Way cut (~70m upslope Lot 802)</p>

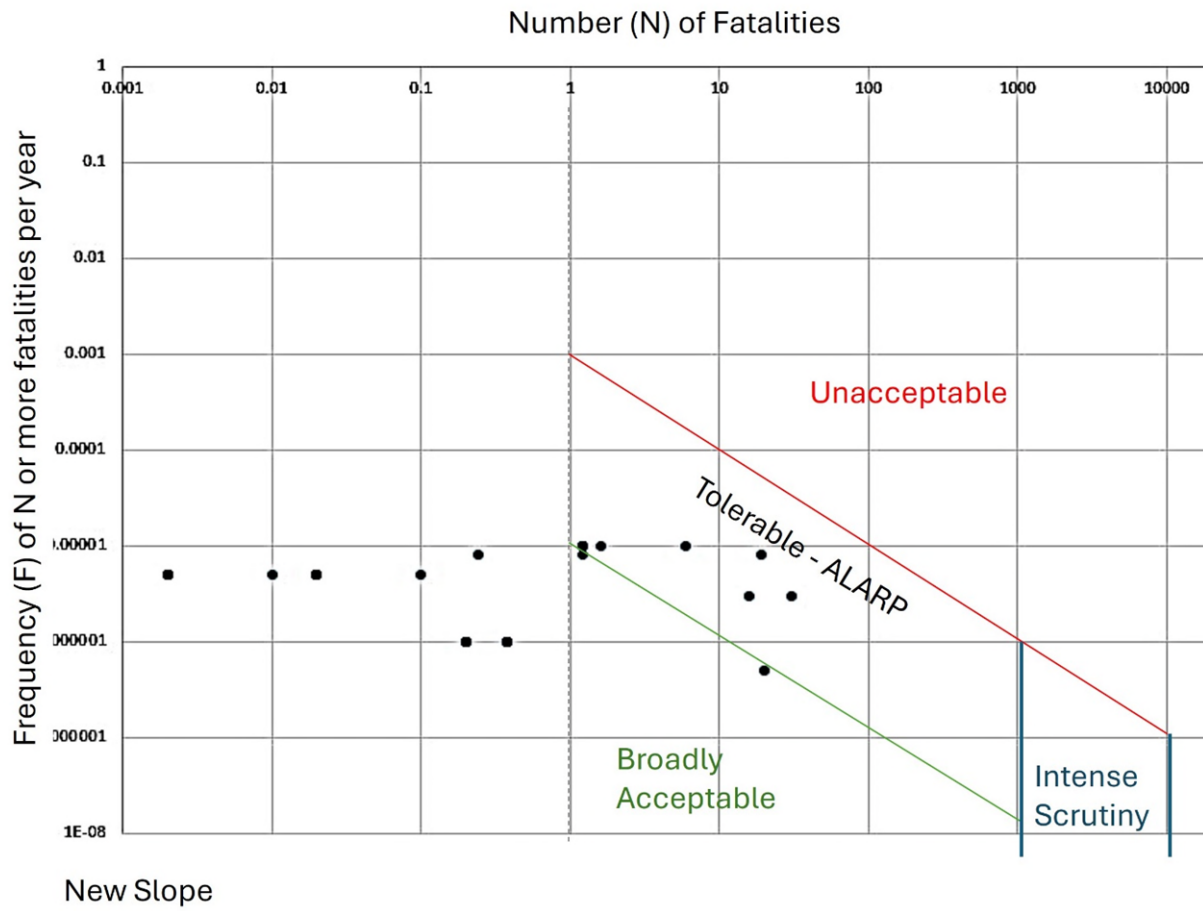
Plate 6: Societal Risk Assessment Plot (N-F) for Lot 802 and the vicinity – New Slope

As shown on Plate 6, the proposed new slope (in case if properly engineered) will decrease the societal risks to 'Tolerable' (ALARP) and 'Broadly Acceptable' areas.
