# **Hazardous Chemicals Assessment**

**Blakebrook Public School**

3 August 2023

Project Ref: 754-SYDGE319200-1

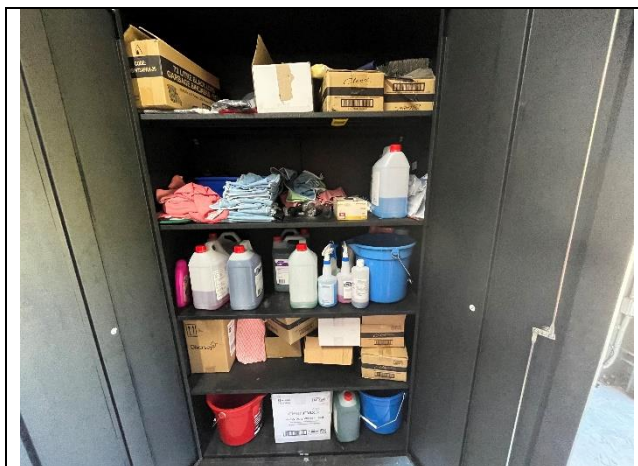
**Photo 01.** Chemicals stored within Building H, Maintenance Shed.

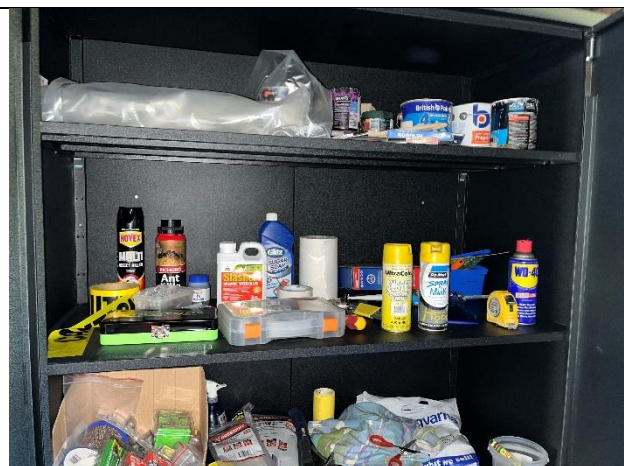
**Photo 02.** Class 2.1 Flammable Gases and Class 3 Flammable Liquids stored together in the Building D Mower Shed.

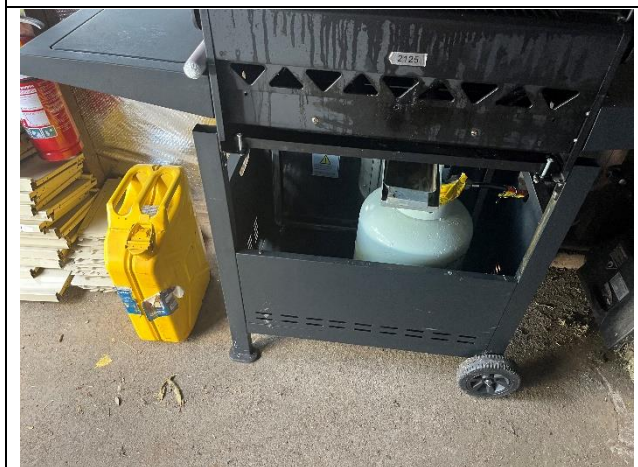
**Photo 03.** Class 2.1 Flammable Gases and Class 3 Flammable Liquids stored together in the Building D Mower Shed.

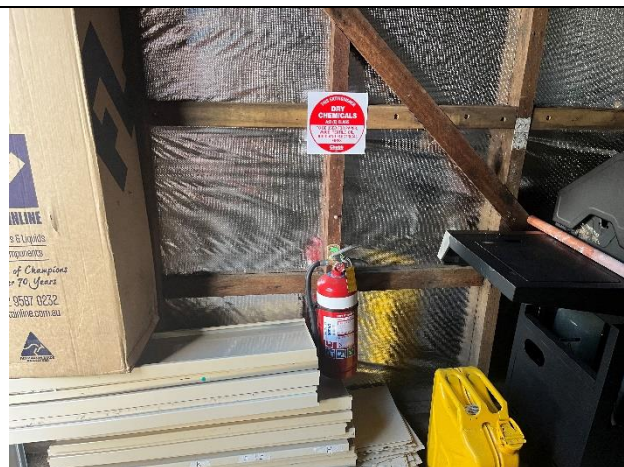
**Photo 04.** Fire Extinguisher adjacent chemical storage in the Building D Mower shed.

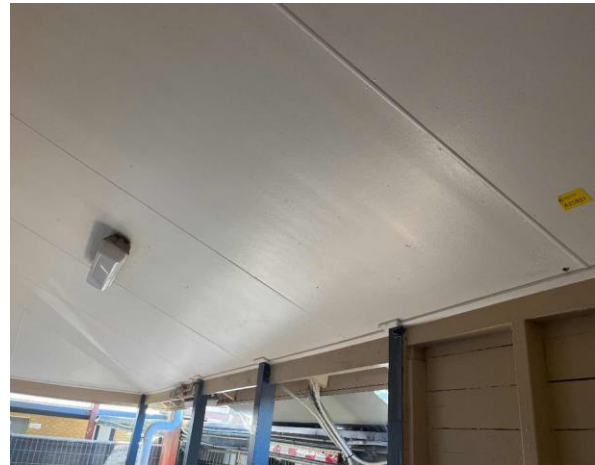
Line ID 4: External, Building E, Eastern Verandah, Ceiling, Fibre Cement Sheet - Chrysotile Asbestos Detected

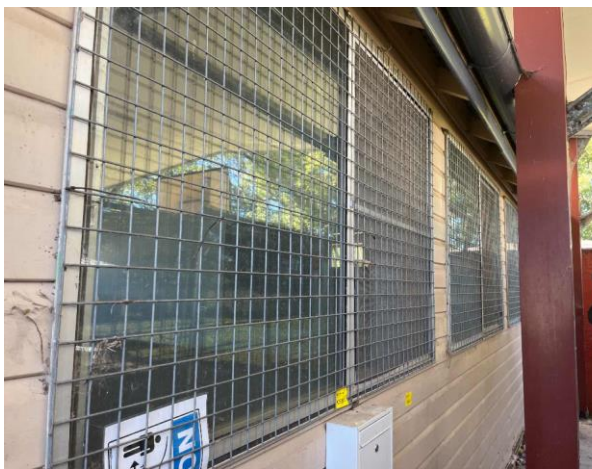
Line ID 5: External, Building E, Northern Side, Aluminium Framed Windows, Mastic - Chrysotile Asbestos Detected

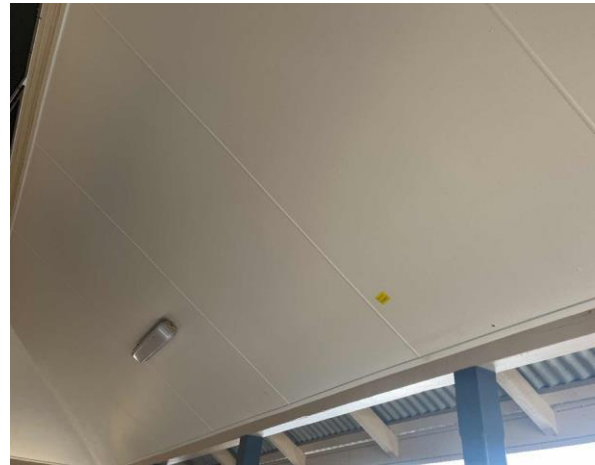
Line ID 8: External, Building F, East and West Verandah, Ceiling, Fibre Cement Sheet - Chrysotile Asbestos Detected

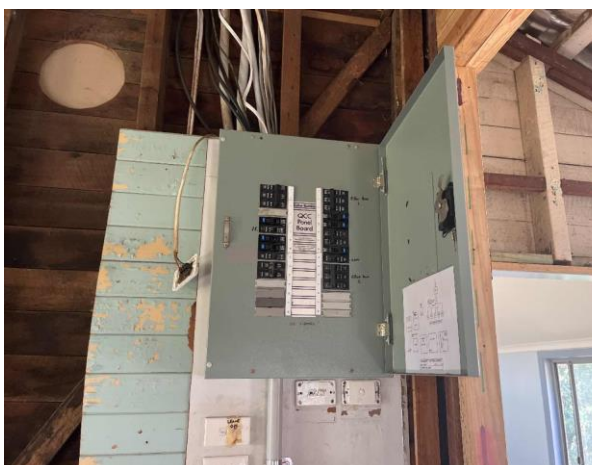
Line ID 18: Internal, Building A, Throughout, Switchboard, HRC Fuses - Suspected Asbestos

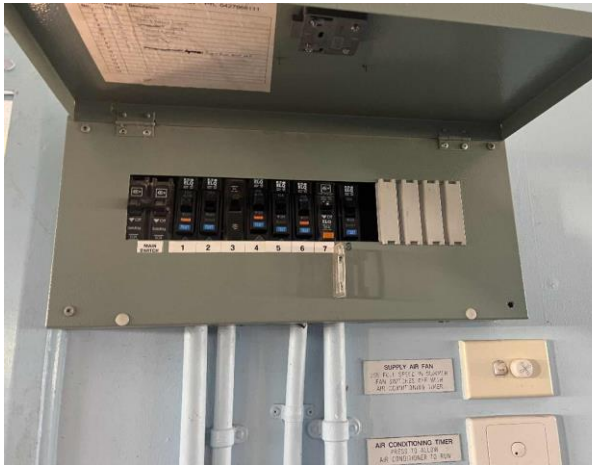
Line ID 22: Internal, Building E, Adjacent Entrance, Switchboard, HRC Fuses - Suspected Asbestos

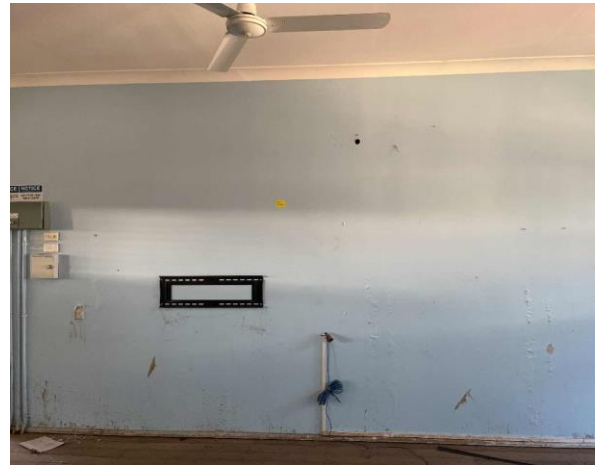
Line ID 23: Internal, Building E, Throughout, Walls, Fibre Cement Sheet - Chrysotile Asbestos Detected

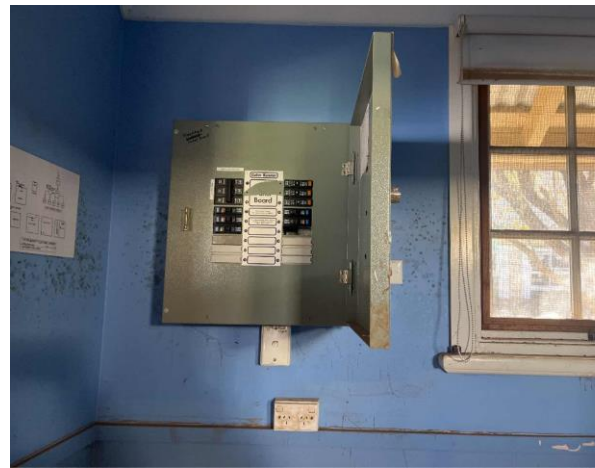
Line ID 25: Internal, Building F, North West Room, Switchboard, HRC Fuses - Suspected Asbestos

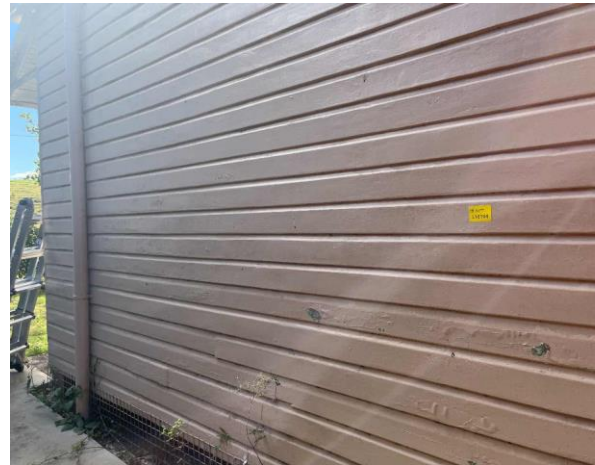
Line ID 32: External, Building A, Throughout, Walls, Beige Paint - Lead Detected (0.13% w/w)

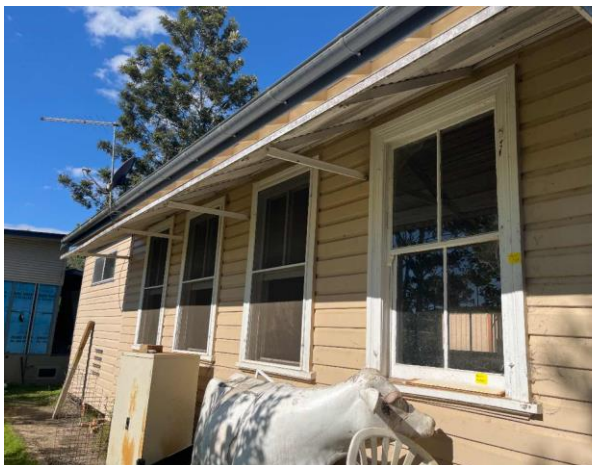
Line ID 33: External, Building A, Throughout, Window and Door Frames, White Paint - Lead Detected (2.8% w/w)

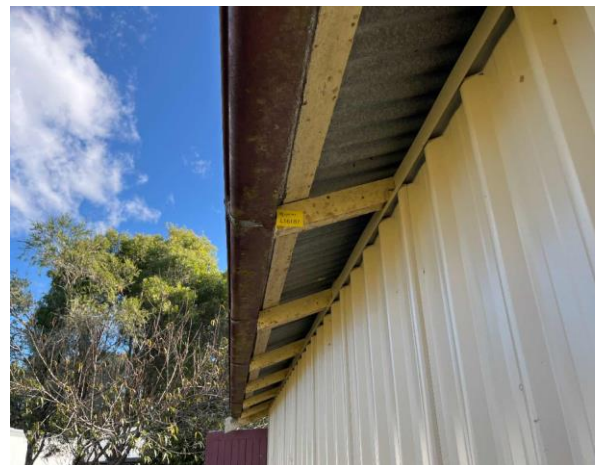
Line ID 34: External, Building D, Throughout, Window Frame and Wooden Frame Work, Beige Paint - Lead Detected (0.15% w/w)

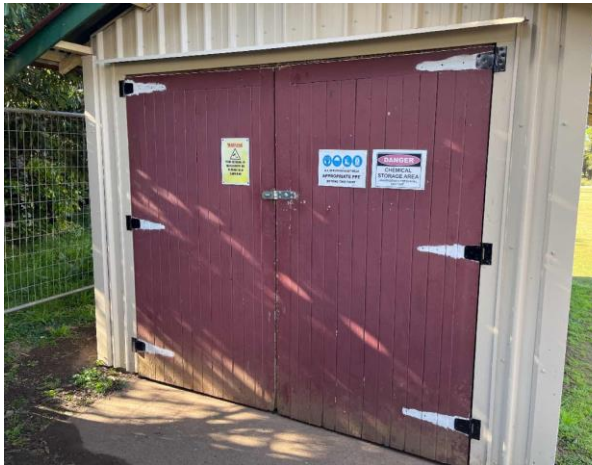
Line ID 35: External, Building D, Western Wall, Double Doors, Red (Dark) Paint - Lead Detected (0.054% w/w)

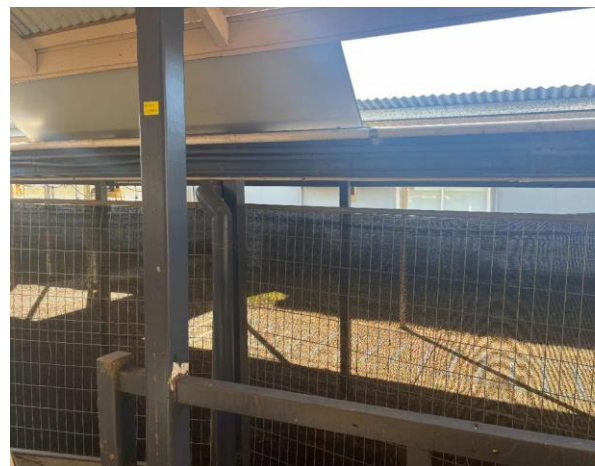
Line ID 40: External, Building F, Throughout, Handrails, Posts and Doors, Blue (Dark) Paint - Lead Detected (0.11% w/w)

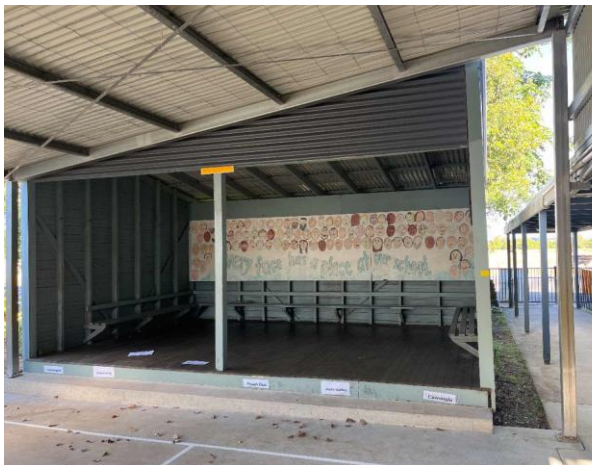
Line ID 43: External, Building G, Throughout, Walls, Green Paint - Lead Detected (0.21% w/w)

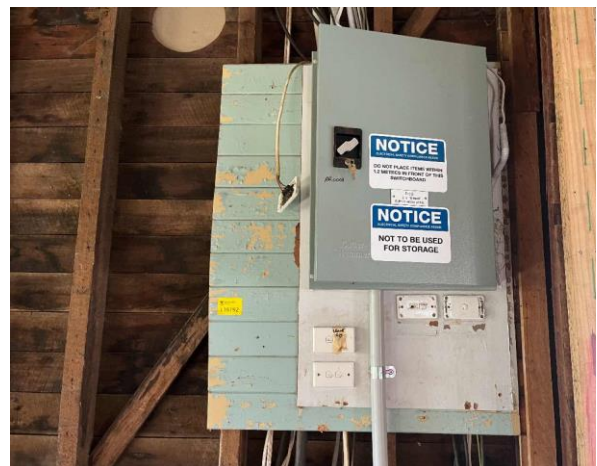
Line ID 46: Internal, Building A, Throughout, Panel Behind Switchboard, Light Blue Paint - Lead Detected (6.4% w/w)

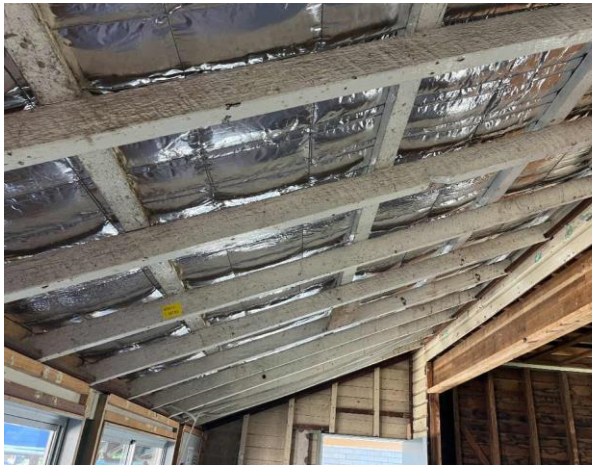
Line ID 47: Internal, Building A, Throughout, To Rafters, White Paint - Lead Detected (0.80% w/w)

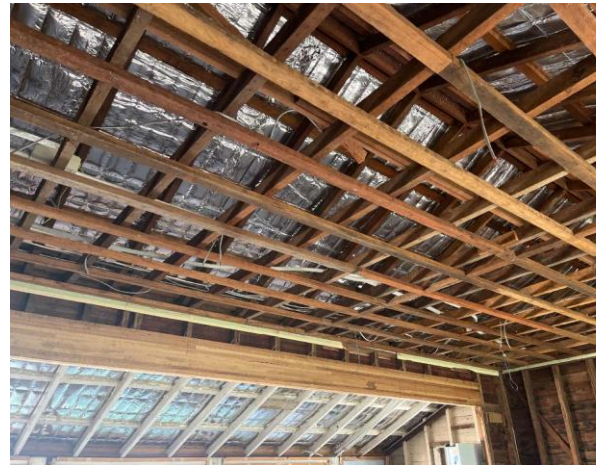
Line ID 61: Internal, Building A, Throughout, Ceiling, Sarking Insulation - Suspected SMF

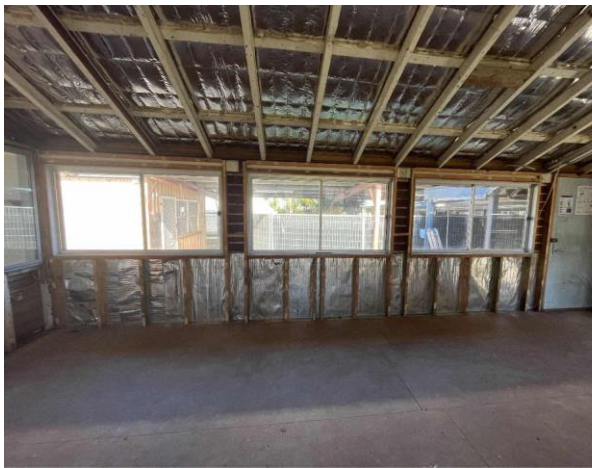
Line ID 62: Internal, Building A, Throughout, Walls, Sarking Insulation - Suspected SMF

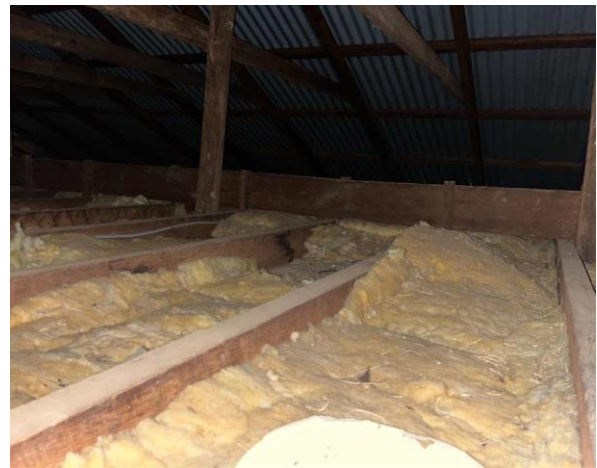
Line ID 63: Internal, Building E, Throughout, Ceiling Void, Insulation Batts - Suspected SMF

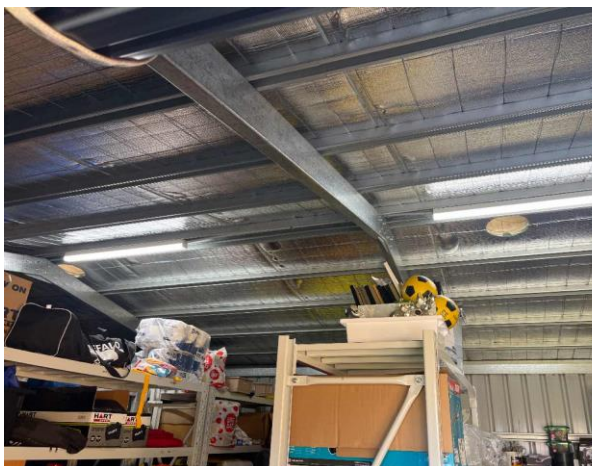
Line ID 64: Internal, Building H, Throughout, Ceiling, Sarking Insulation - Suspected SMF

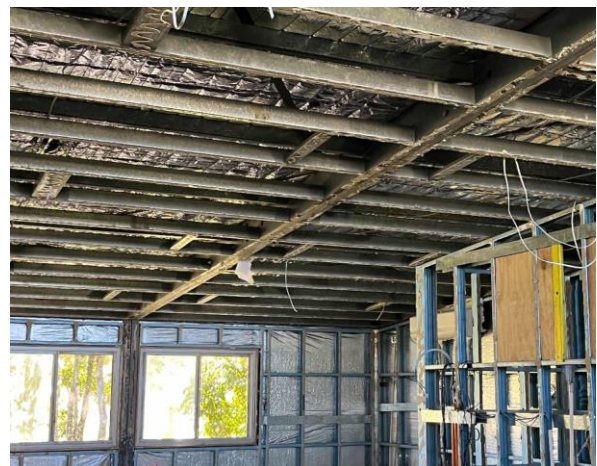
Line ID 65: Internal, Building I, Throughout, Debris to Ceiling, Insulation Batts - Suspected SMF

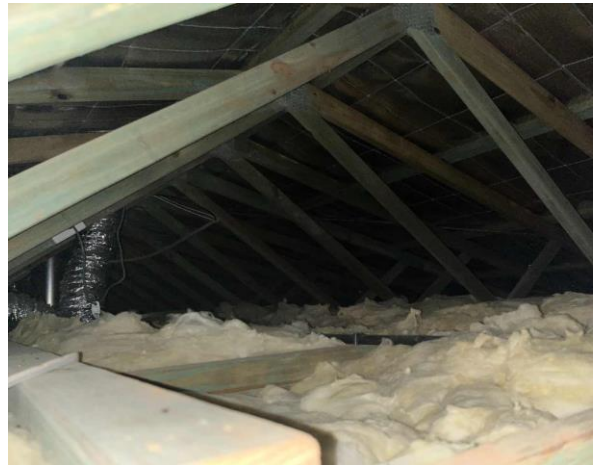
Line ID 67: Internal, Building J, Throughout, Ceiling Void, Insulation Batts - Suspected SMF

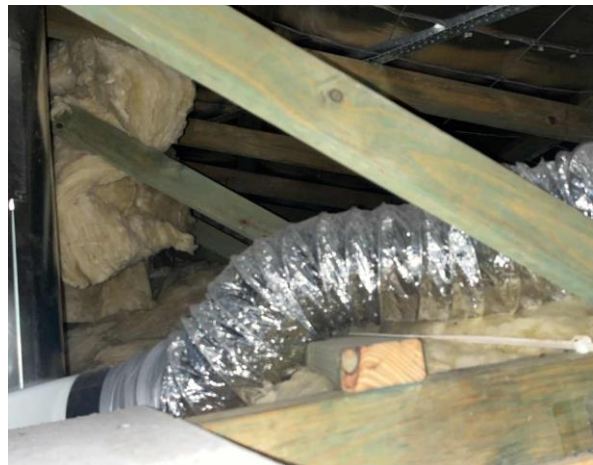
Line ID 69: Internal, Building J, Throughout, Flexible Ductwork, Internal Insulation - Suspected SMF

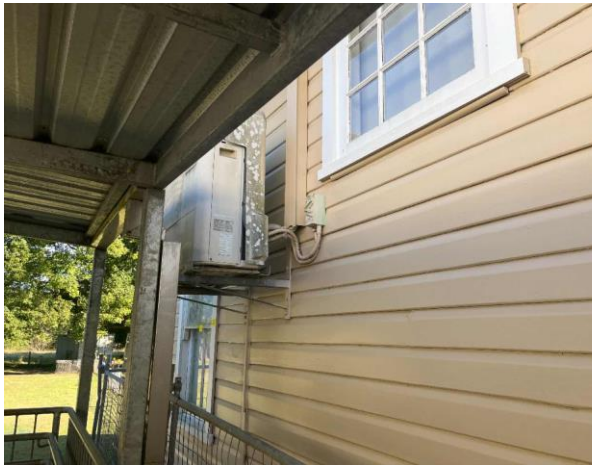
Line ID 72: External, Building F, South Side, Fujitsu Air Conditioning unit, R22 Hydrochlorofluorocarbon (HCFC) - ODS Refrigerant
