45-47 Denman Ave, KootingalPreliminary Site Investigation July 2023

Title	45-47 Denman Ave, Kootingal Preliminary Site Investigation
Authored on behalf of Broadcrest Consulting Pty Ltd by:	ENVIOLE STATE OF THE PARTY OF T
Signed:	
Dated:	27.07.2023

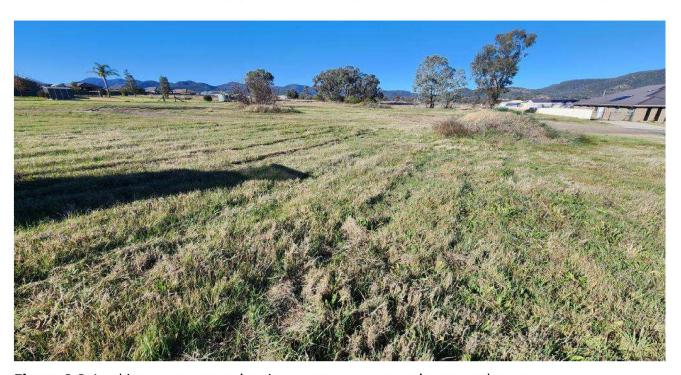
At the time of inspection, the site was unoccupied and vegetated with pasture grass and scattered trees (Figure 2.2). The site was positioned within a mostly residential setting on the eastern side of Denman Road. Visual inspection failed to identify any obvious indicators of site contamination. However, several small stockpiles of soil and demolition waste were identified (Figure 2.3 – 2.5) which may contain contaminants of concern (refer to Section 2.8). The stockpiles were heavily grown over with grass so detailed inspection was not possible.

Figure 2-2: Looking west across the site – pasture grass and scattered trees

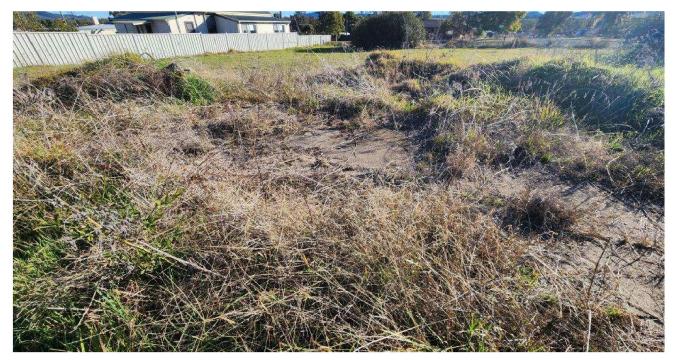
Figure 2-3: Foundations and stockpiled demolition waste from a former residence on site

At the time of inspection, the site was unoccupied. However, several small stockpiles of soil and demolition waste were identified which may contain contaminants of concern. Each location is described within Table 2.1 below and annotated on Figure 3.1. It is noted that the stockpiles were heavily grown over with grass so detailed inspection was not possible. Additional lengths and large fragments of concrete were also identified elsewhere on site which will require removal prior to any future subdivision.

At the time of inspection, the site was unoccupied and vegetated with pasture grass and scattered trees (Figure 2.2). The site was positioned within a mostly residential setting on the eastern side of Denman Road. Visual inspection failed to identify any obvious indicators of site contamination. However, several small stockpiles of soil and demolition waste were identified (Figure 2.3 – 2.5) which may contain contaminants of concern.

- 1. Stockpiles identified on the site (Locations of concern #1 #6) are removed by suitably licensed waste management contractors. All stockpiled materials are to be pre-classified in accordance with the NSW EPA Waste Classification Guidelines by a suitably qualified person **prior to** excavation or removal from site. If potentially hazardous materials are encountered:

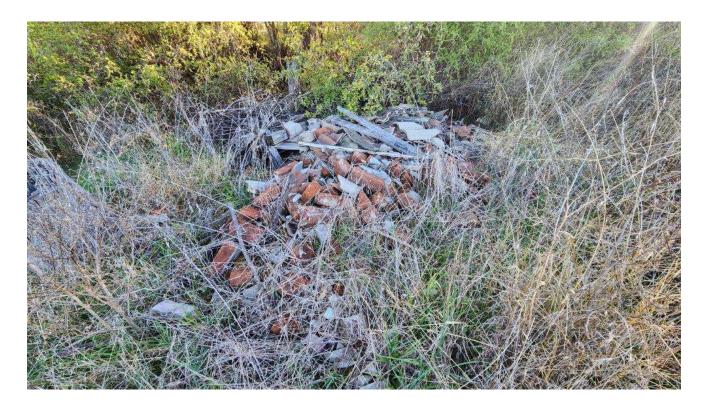
Figure 2-4: One of several small stockpiles of concrete, brick and building rubble on site

- 2. Other stockpiles of concrete on the site be removed.
- 3. The location of former sheds on the site (Location of Concern #7 shaded yellow on Figure 3.1) be investigated for respective contaminants of concern by way of a Detailed Site Investigation (DSI). This must be undertaken by a suitably qualified and experienced land contamination consultant. Should significant contamination be identified, an appropriate Remediation Action Plan be prepared for the site.

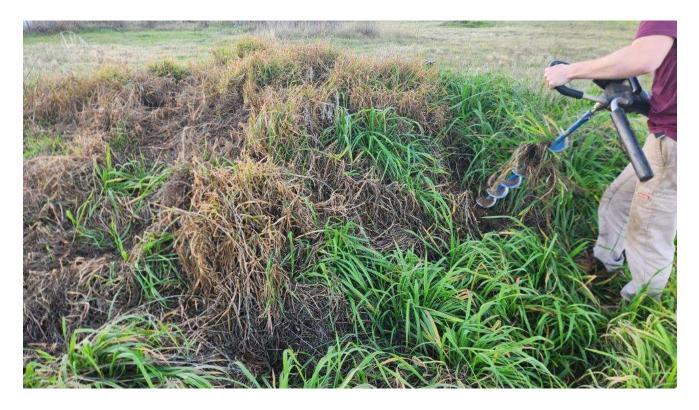
Figure 2-5: One of several small stockpiles of soil

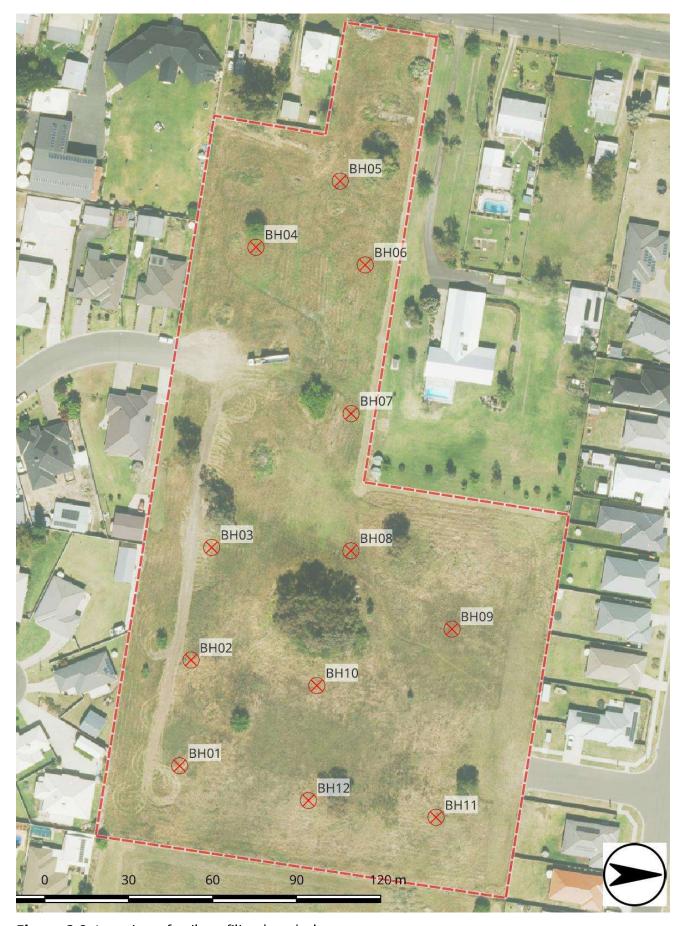
The site occupies a gently-sloping, south-facing side-slope of approximately 3% gradient. There were no indicators of mass cutting and filling, retaining or terra-forming on the site. Twelve (12) bore holes were drilled across the site using a 50mm push-tube sampler supplemented with dynamic cone penetrometer testing (Figure 2.9). Soil profiles were highly consistent comprising:

There were no signs of filling within any of the twelve drilled boreholes. Soil logs are provided within Appendix D. Additional information pertaining to subterranean conditions can be found within accompanying Geotechnical Investigation by Broadcrest Consulting (July, 2023).

Figure 2-9: Location of soil profiling boreholes

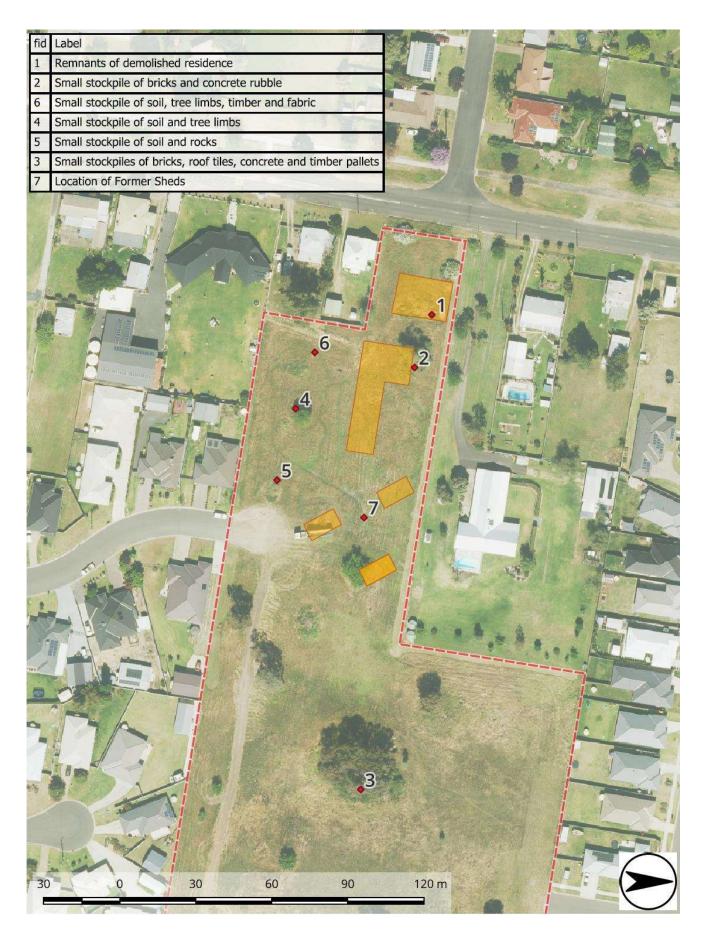
Heavy Metals, Hydrocarbons (TRH / PAH), BTEXN, OCOP and Asbestos have been identified as potential contaminants of concern within selected locations on this site. Based on current land usage (vacant allotment) exposure risk to on-site personnel is considered **Very Low**. However, exposure risk to on-site personnel during the construction phase of the development and potential occupants of future residential allotments is considered **Moderate**. An exposure risk via dermal contact and/or inhalation is considered possible without appropriate remediation or preventative measures.

Figure 3-1: Locations of areas of concern across the site – red dots represent stockpiles whilst yellow shaded areas represent location of former residence and sheds
