# Arlberg Ski Lodge - Proposed Extension

## Geotechnical Investigation Report

Arlberg Ski Club Limited

11 April 2024

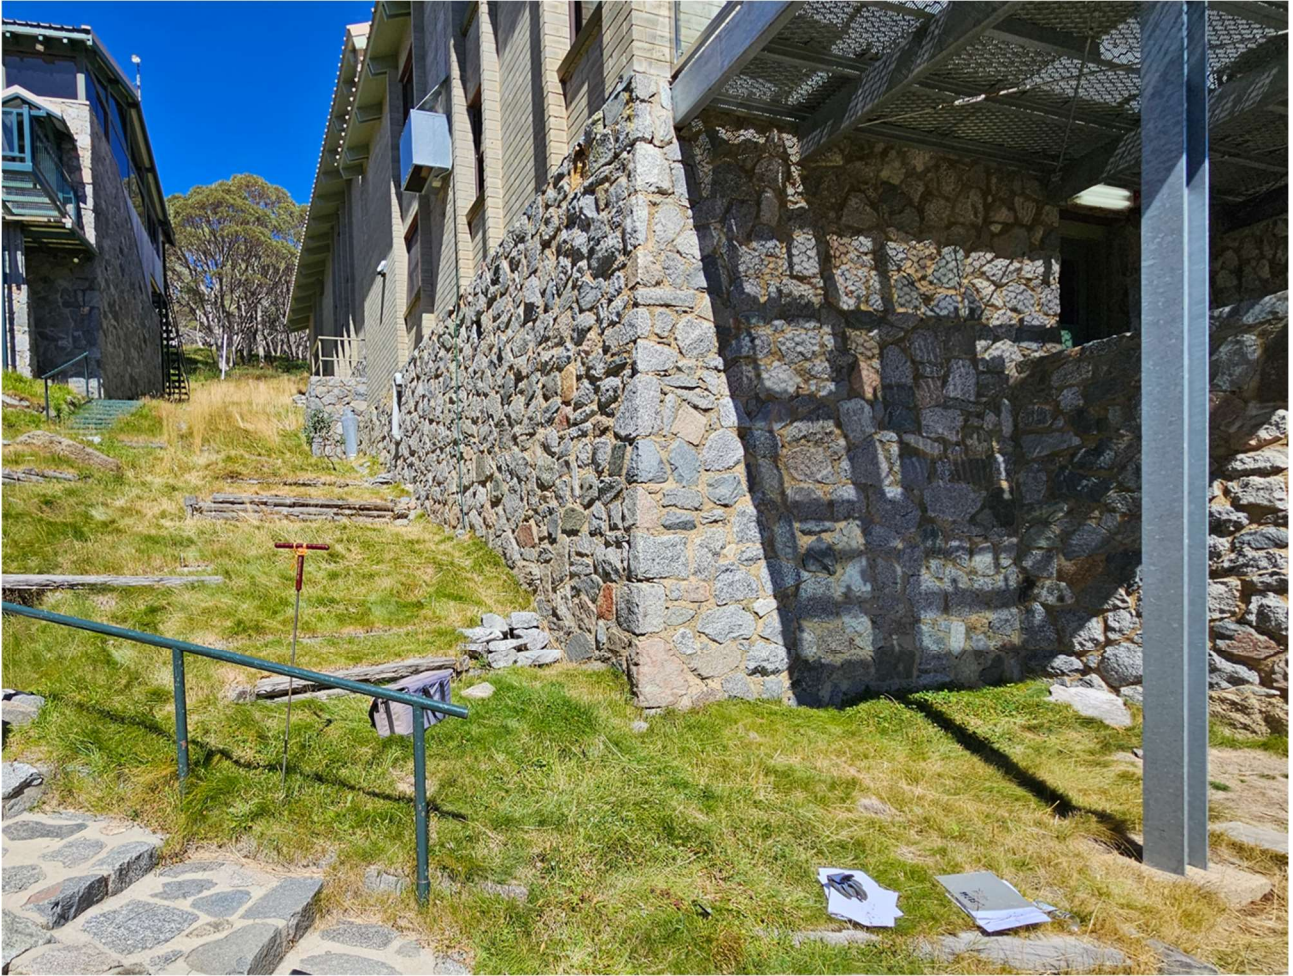
*Plate 5 – View of the north-eastern corner of the existing structure. Note the approximately 18° slope. The proposed extension area which is the subject of this report, is at the right of the photograph.*

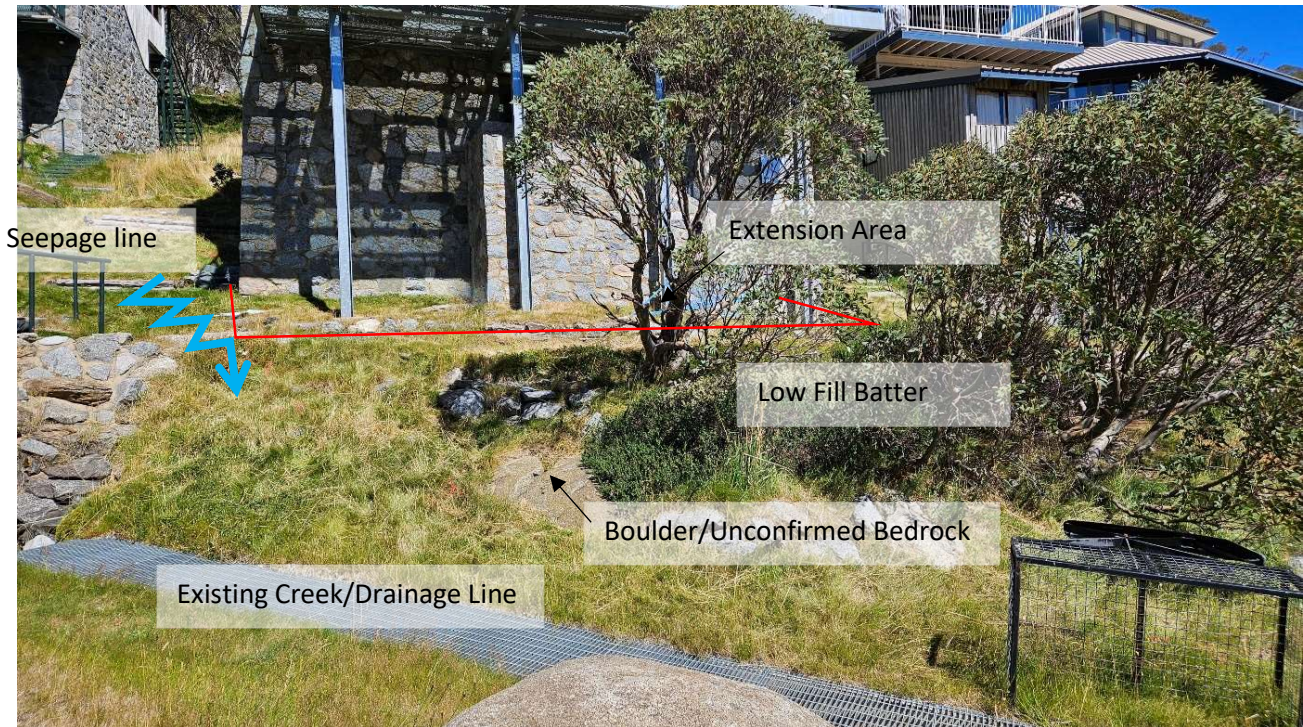
*Plate 6 – View of the frontage of the existing structure. Note the drainage line from left to right; location of seepage (blue arrow) and the approximate level of the proposed extension (red). Note the fill batter below the extension zone. Note surficial cobbles and boulders, and potential large boulder or bedrock outcrop at the red arrow.*

Groundwater was not encountered at HA01 or HA02. However, seepage was encountered at the eastern side of the extension area, near HA02. This seepage may be natural or associated with anthropogenic changes to drainage on the site (e.g. trenching of services along the eastern side of the existing building, to the building frontage).

Notwithstanding the foundation system selected, the existing seepage point on the eastern side of the extension area should be provided with slotted subsoil drainage to channelise/capture the flow and to avoid weakening of the future foundations from infiltration.

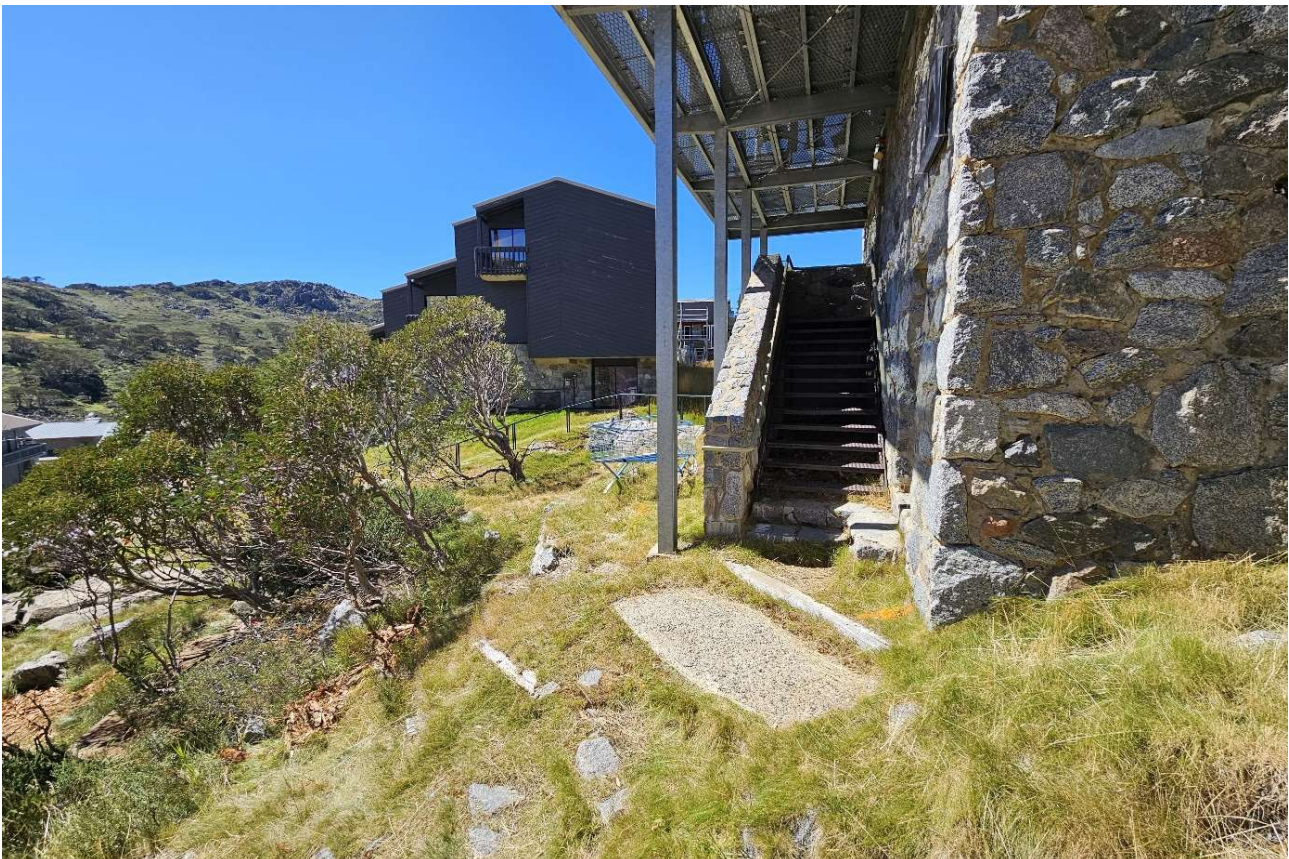
*Plate 7 – View east of the extension area. Note the fill area at and below the proposed extension area. The existing posts, deck and stairs are to be demolished.*

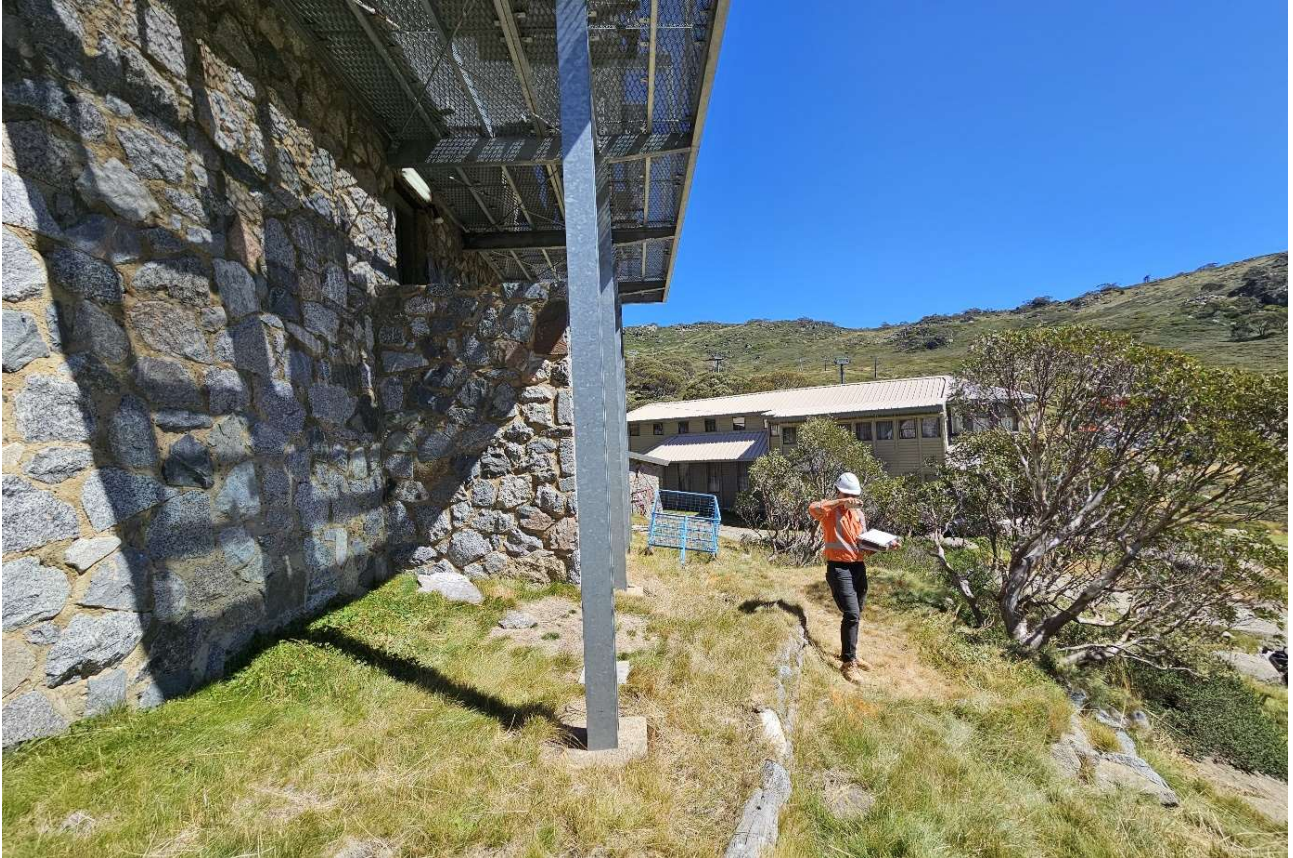
*Plate 8 – View west of the extension area. Note the fill area at and below the proposed extension area. The existing posts, deck and stairs are to be demolished. The level of the new extension is approximately at the lower level where the engineer is standing.*

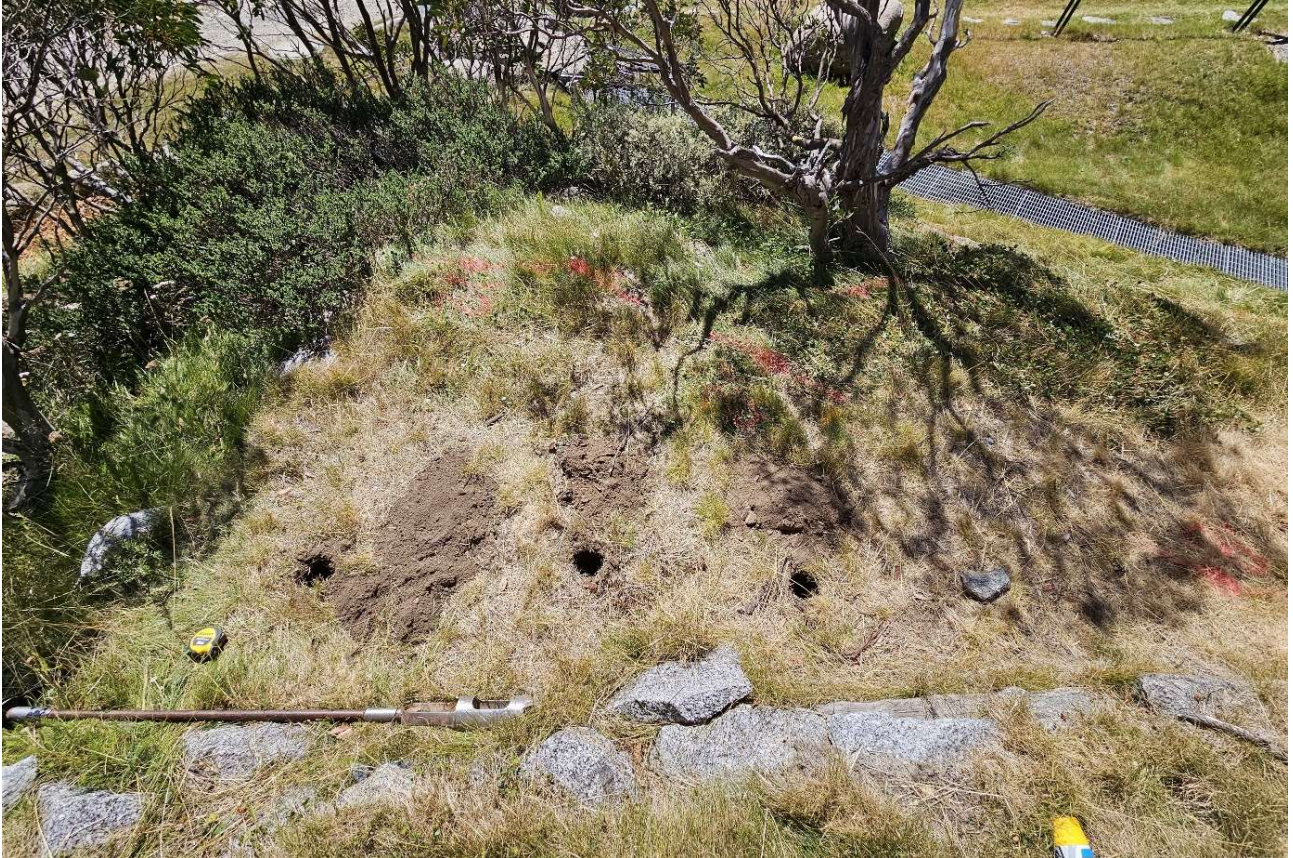
*Plate 9 – HA01 location (three attempts, each refused at shallow depth on cobbles in the fill). Note underground services running from right to left (pink ground marks), likely comprising of kitchen liquid waste to the grease trap at the left of the photograph. A sewer line is inferred from the services location to run from right to left within the slope below this level.*

Based on the services location carried out during our investigation, underground power, kitchen liquid waste and a sewer were identified as passing through or nearby the extension footprint. These services will require protection (or relocation) from the new foundation or fill replacement works.

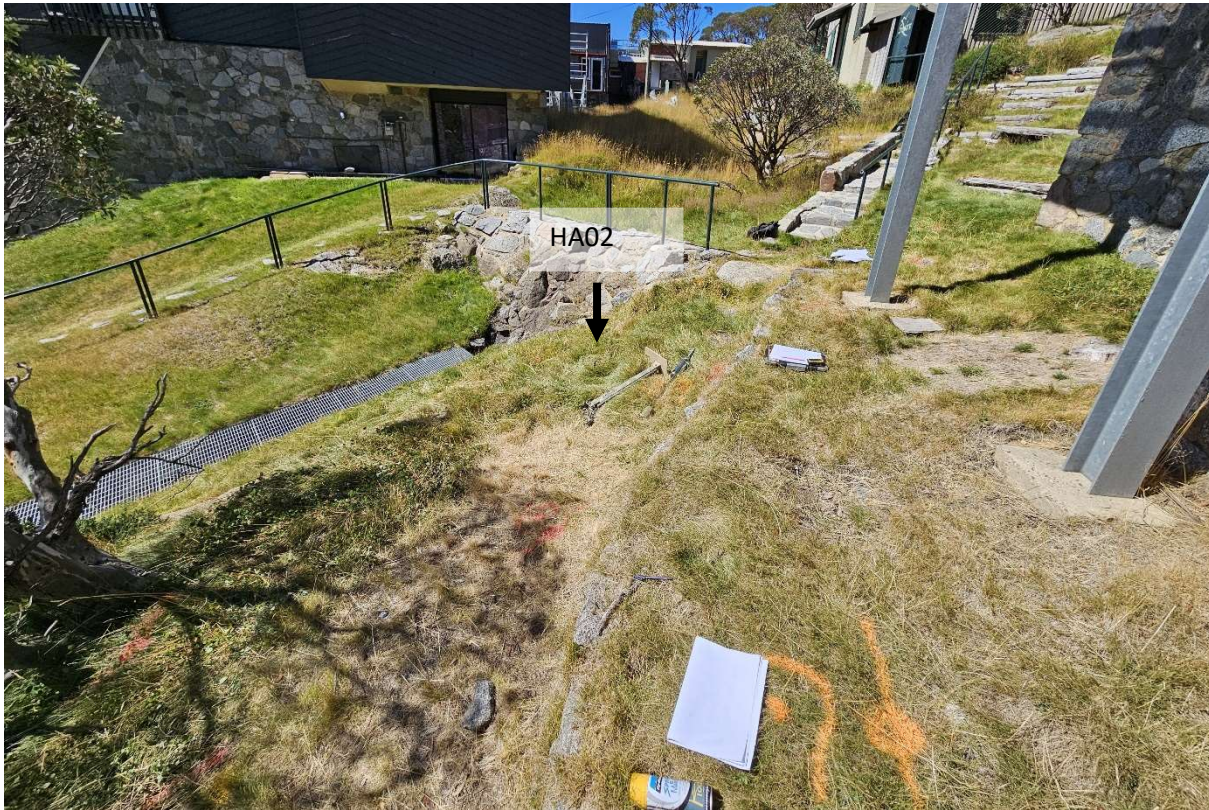
*Plate 10 – HA02 location shown. Note underground power at the right of the photograph (orange ground marks), and kitchen and sewer drainage lines at the left of the photograph.*

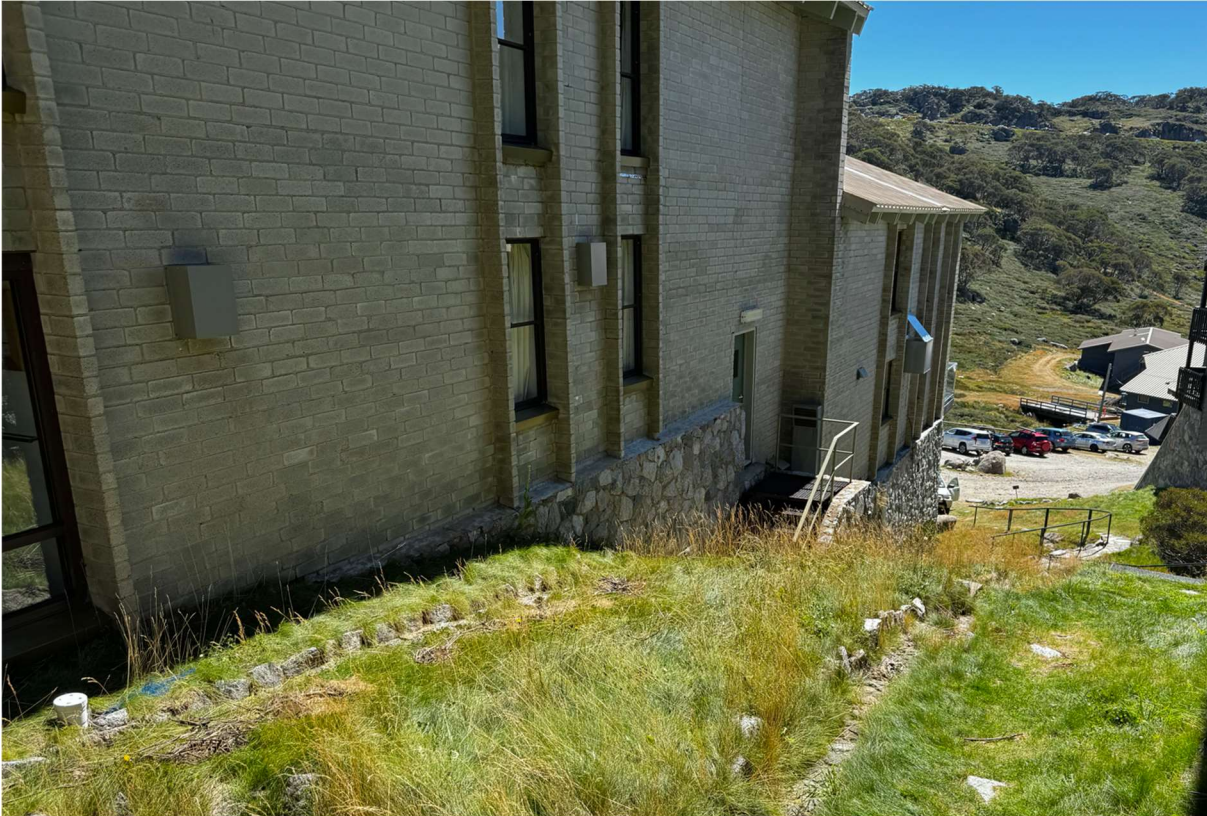
*Plate 11 – View downslope of the existing structure above the proposed extension area. Note drainage channels.*

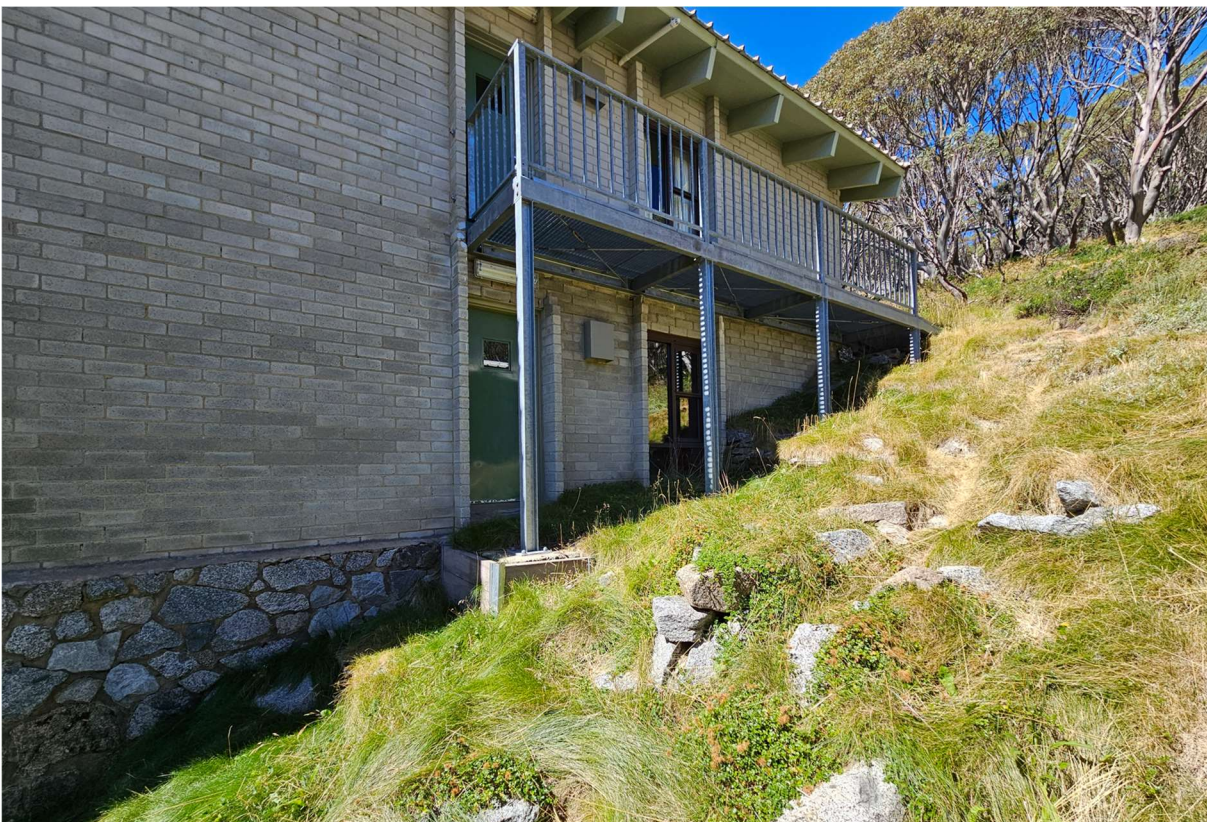
*Plate 12 – View upslope of the existing structure above the proposed extension area. Note drainage channels. Note irregular surface due to the presence of surficial cobbles and boulders. Note slope extending significant distance above the property.*

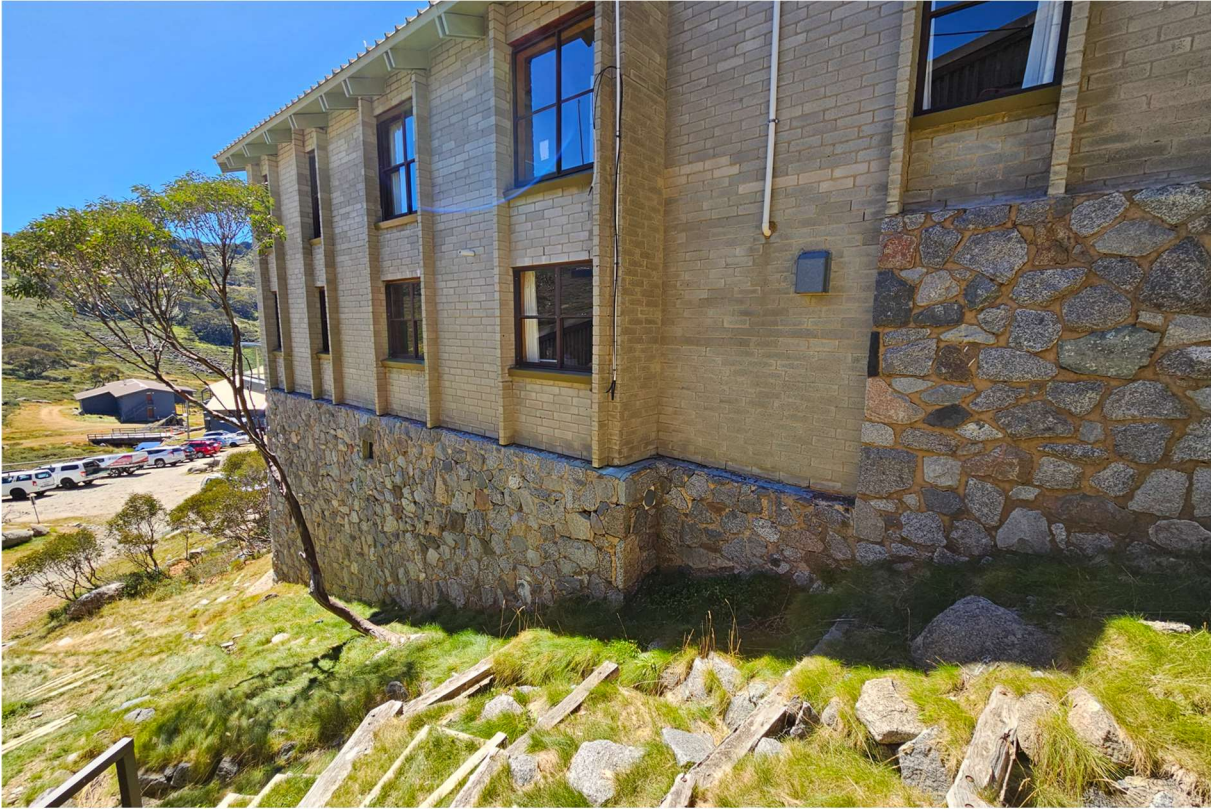
The stone façade of the existing structure typically exhibited some localised or loosening. A detailed review of existing structural performance was not conducted, however, no significant structural damage was observed.

*Plate 13 – View downhill of western façade. Minor cracking and dislodgement of stone pitching was evident, predominantly on the lower zone of the structure in this photograph. Note terraced steps.*

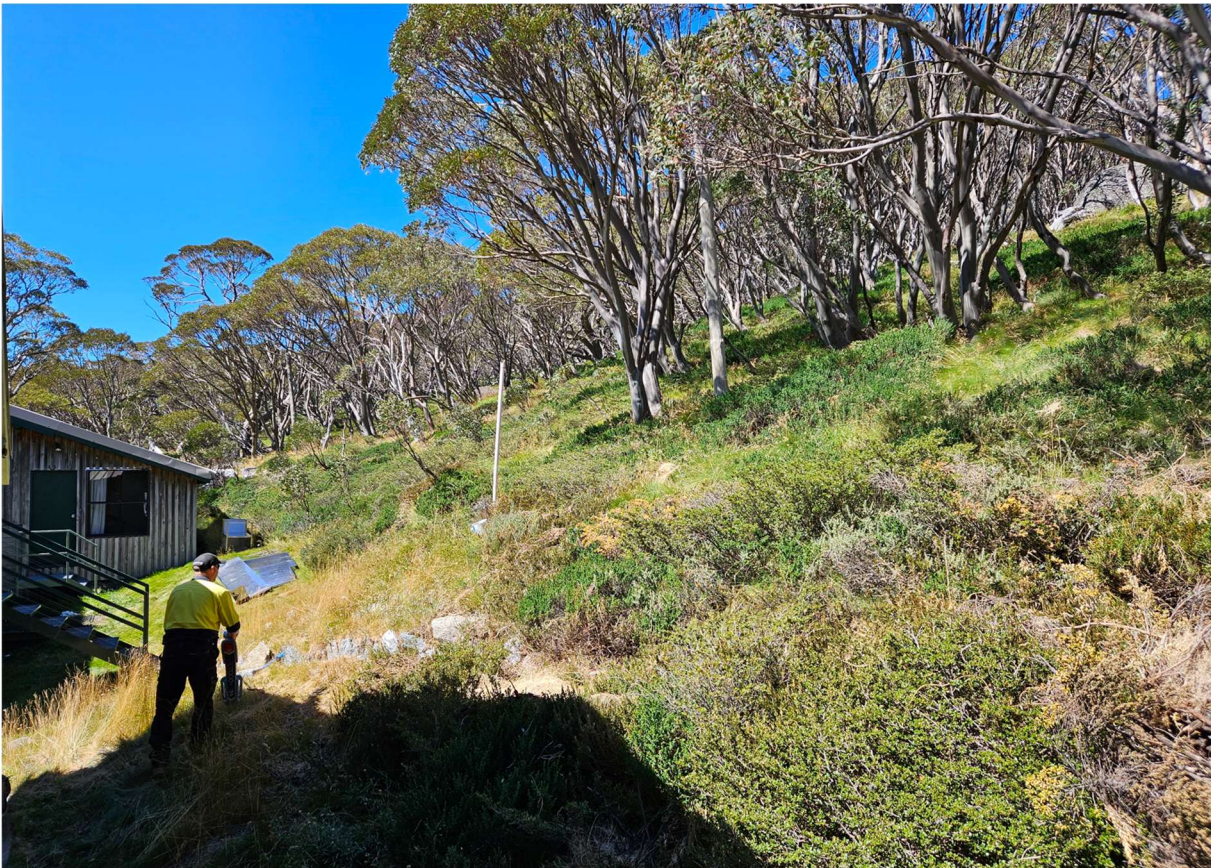
*Plate 14 – View south-east, of the slope above the property. Note eucalypt trees and typical downslope lean.*

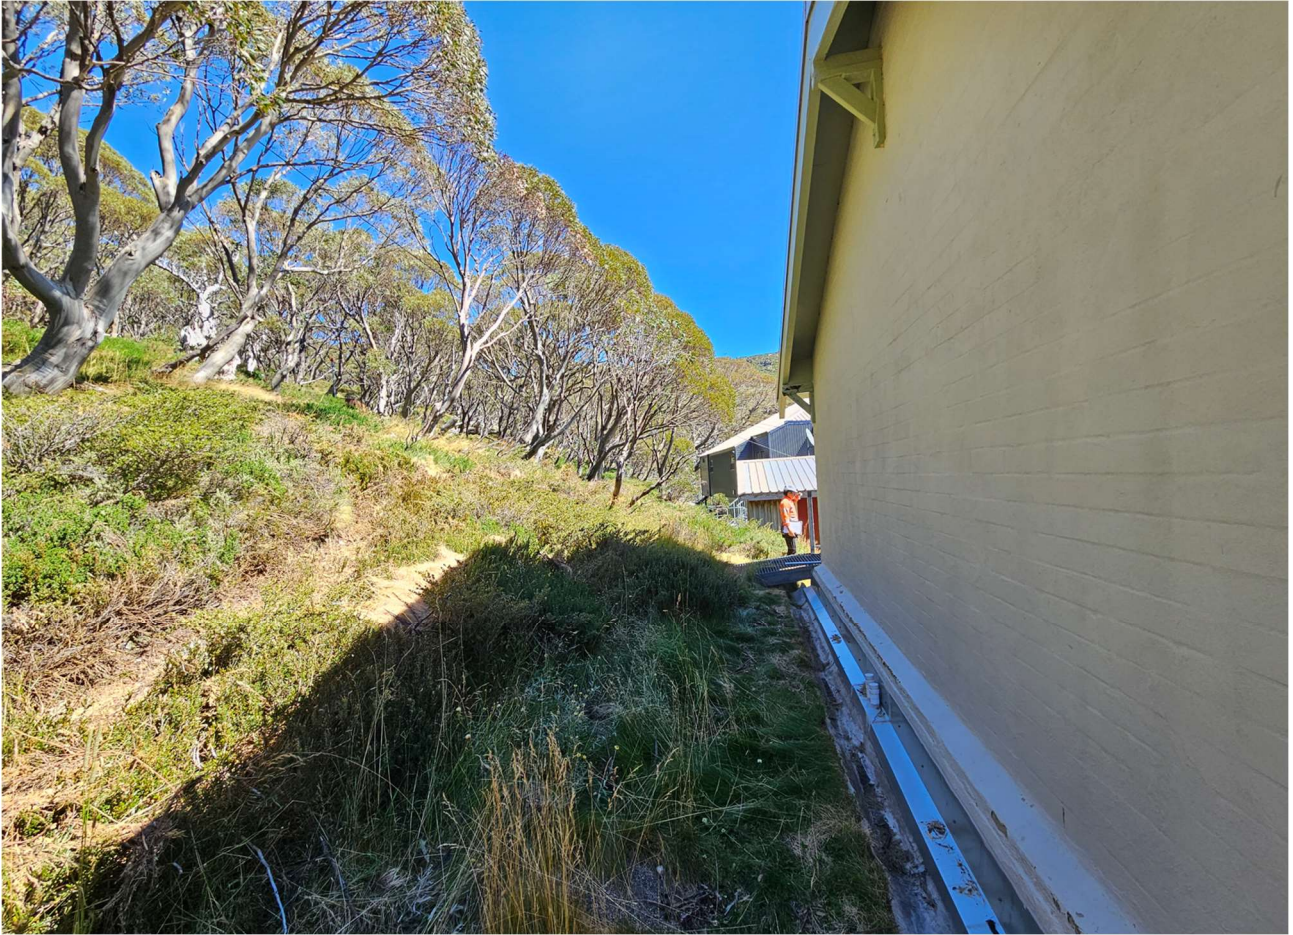
*Plate 15 – View west of the slope above the property. Note eucalypt trees and typical downslope lean, indicative of regional, slow colluvial mantle creep.*

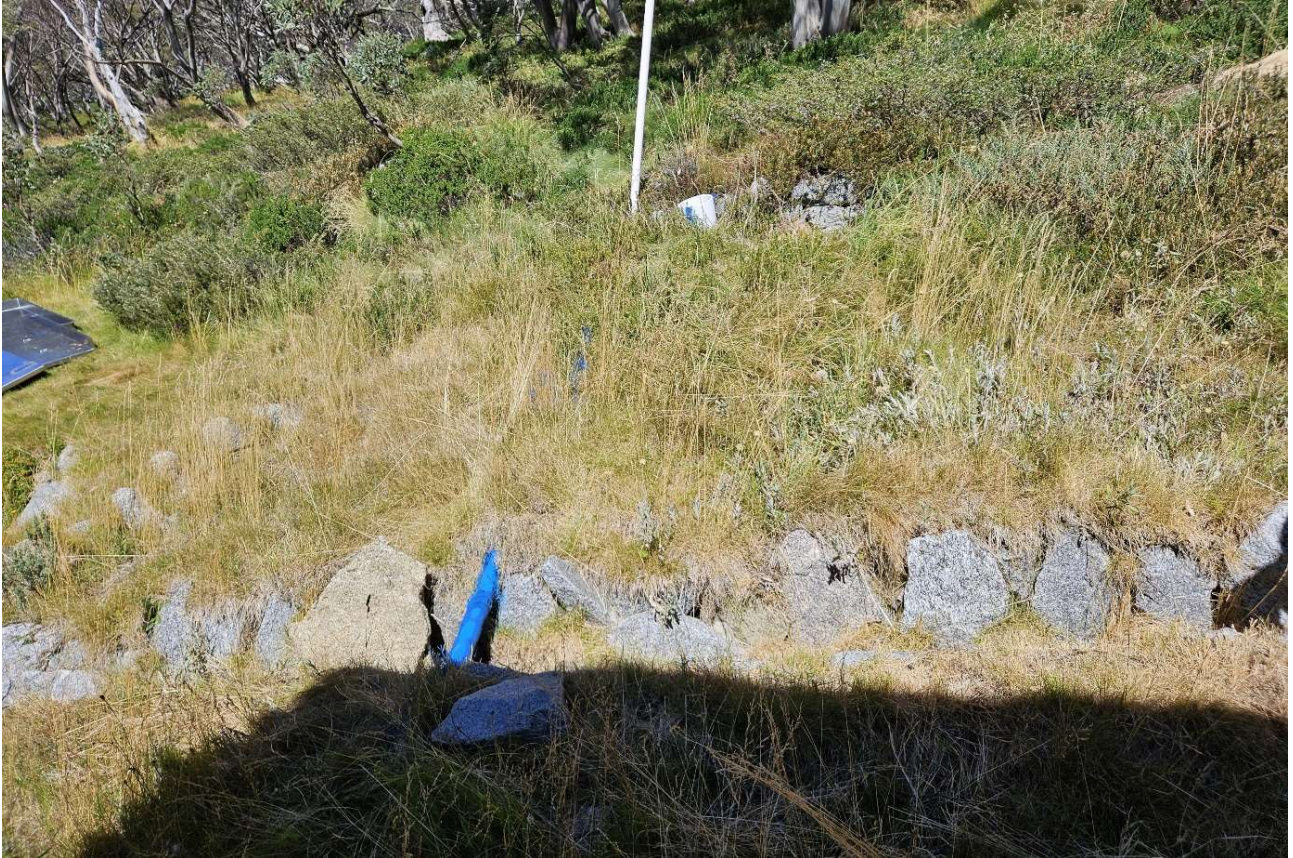
*Plate 16 – View of the water supply line at the south-eastern corner of the property. Note stone lined cutoff drain.*

The water supply line at the uphill south-eastern corner must be checked for integrity and that no leakage is occurring, as such leakage may increase the probability of landsliding at the structure or below any leaks.

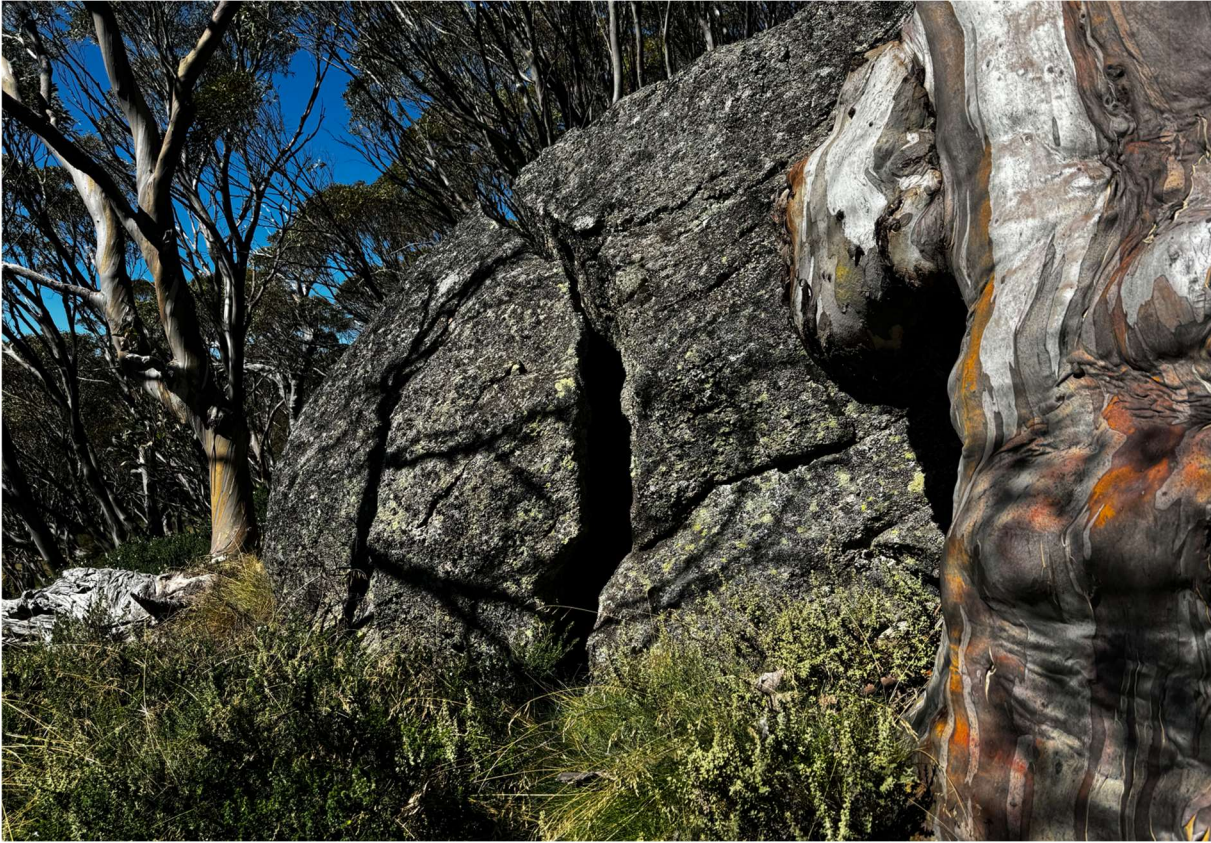
*Plate 17 – View east of a large boulder some 50 m laterally above the property. Note the split. The smaller section is not restrained and has been considered in the risk assessment.*

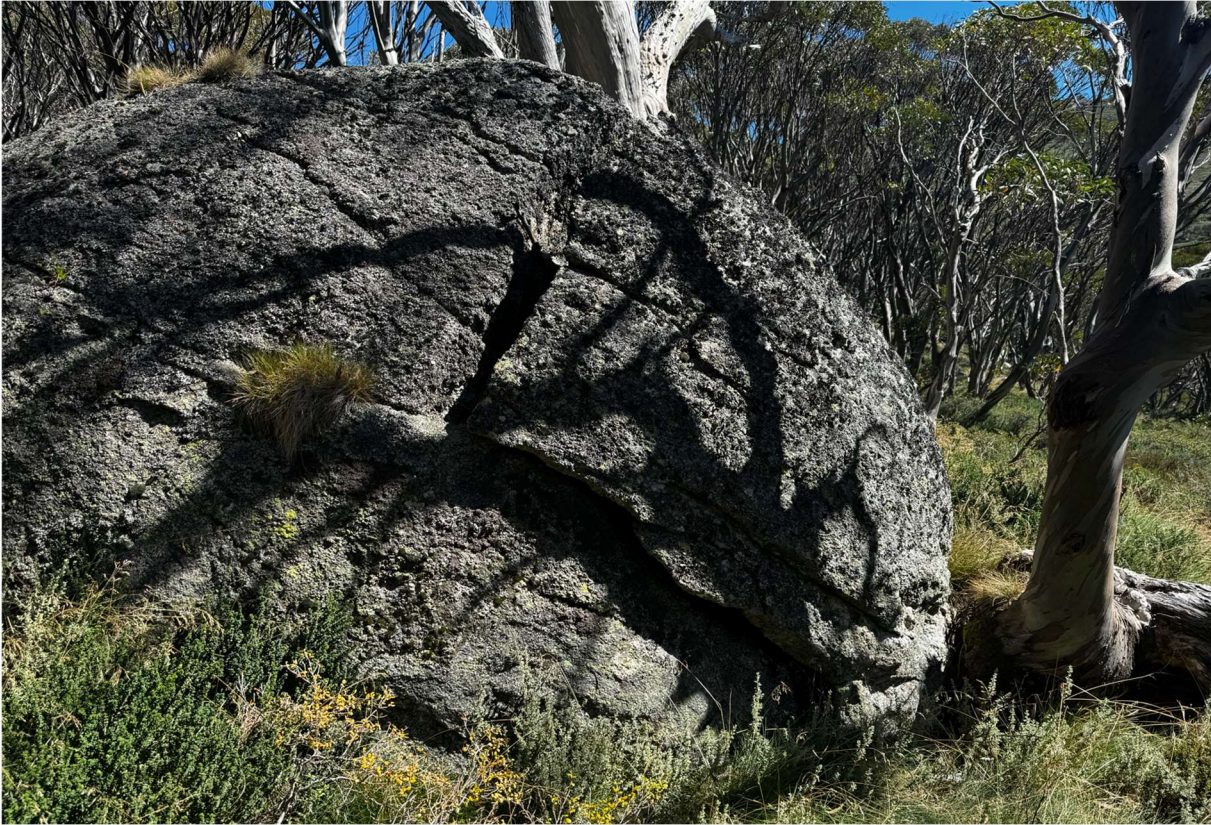
*Plate 18 – View west of a large boulder some 50 m laterally above the property. Note the split. The smaller section is not restrained and has been considered in the risk assessment. The tree to the right may provide some restraint should the split component separate and topple.*

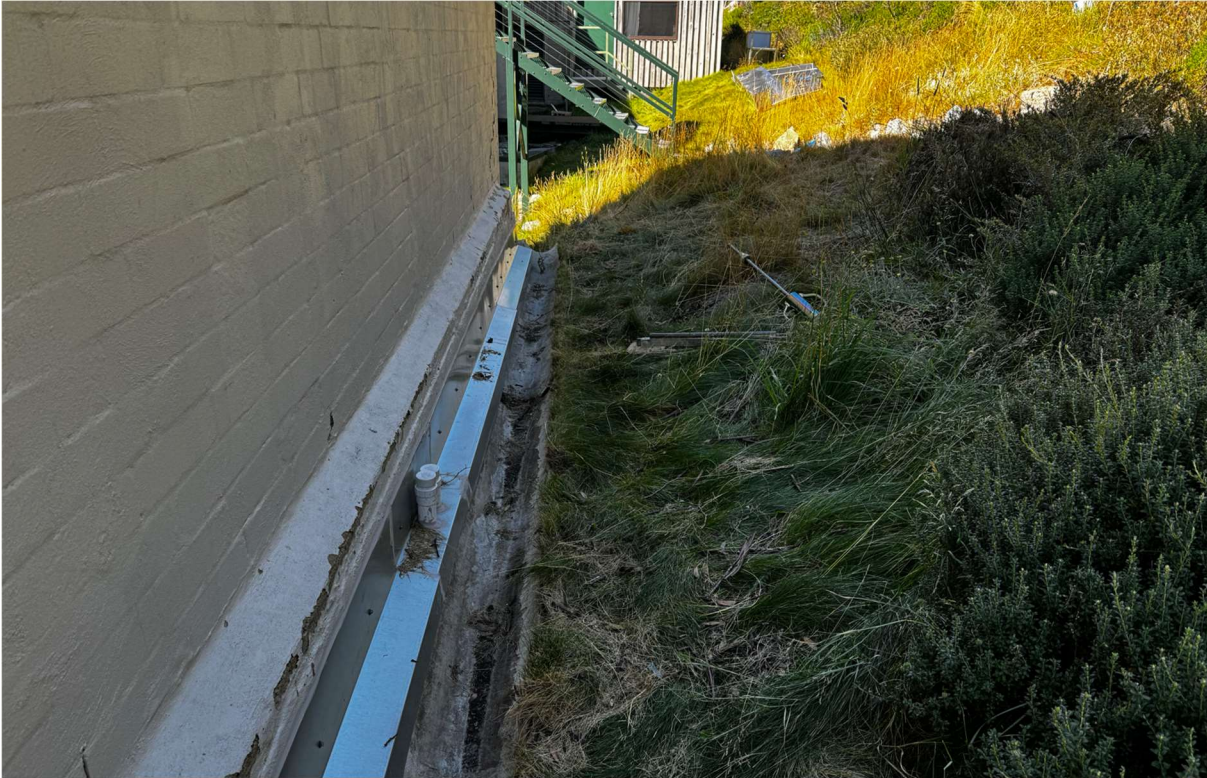
Minor indications of erosion were observed at the upper, southern corners of the structure, where a cut-off drain is present in the slope above the structure, and a collector (catch) drain is present immediately above the structure. The drains discharge either side of the structure (i.e. the eastern and western slopes alongside the structure). Joints between sections of the catch drain were dislocated and requires repair.

*Plate 19 – View east, above the southern wall of the property. Note existing catch drain at the structure, and cut-off drain at the right of the photograph, uphill of the structure.*

The erosion from flows from the catch drains at the upslope wall/corners must be repaired/infilled with cobble/rockfill armouring to reduce erosion which may cause geometric changes, increasing geohazard likelihoods.

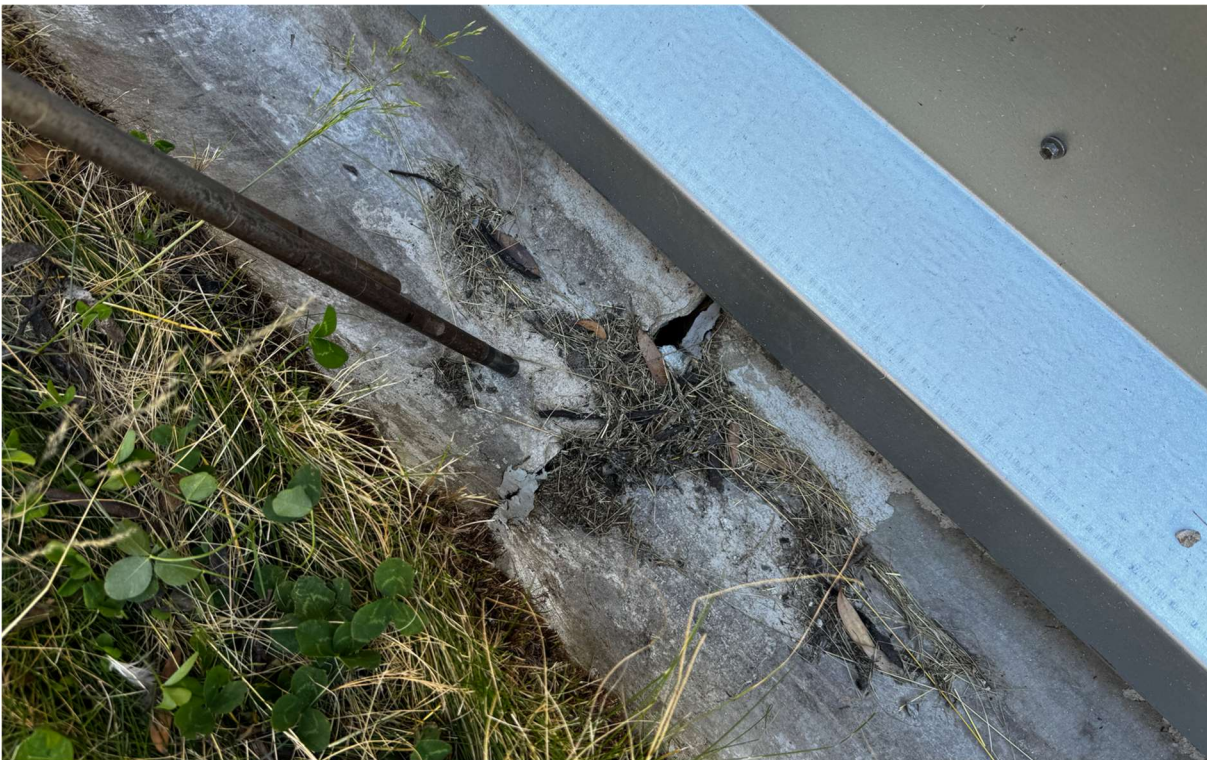
*Plate 20 – Condition of joints in the catch drain at the southern edge of the structure, which requires sealing/resetting to avoid ingress.*

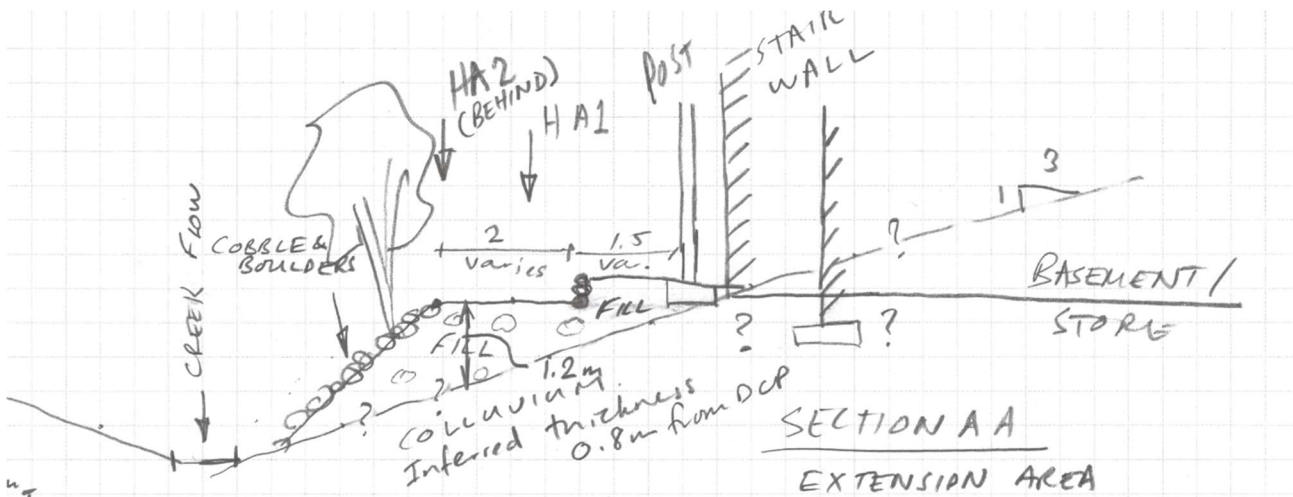
Plate 21 – Cross-section field sketch of the geotechnical model at the extension area (existing conditions). Note fill wedge overlying colluvial soil.

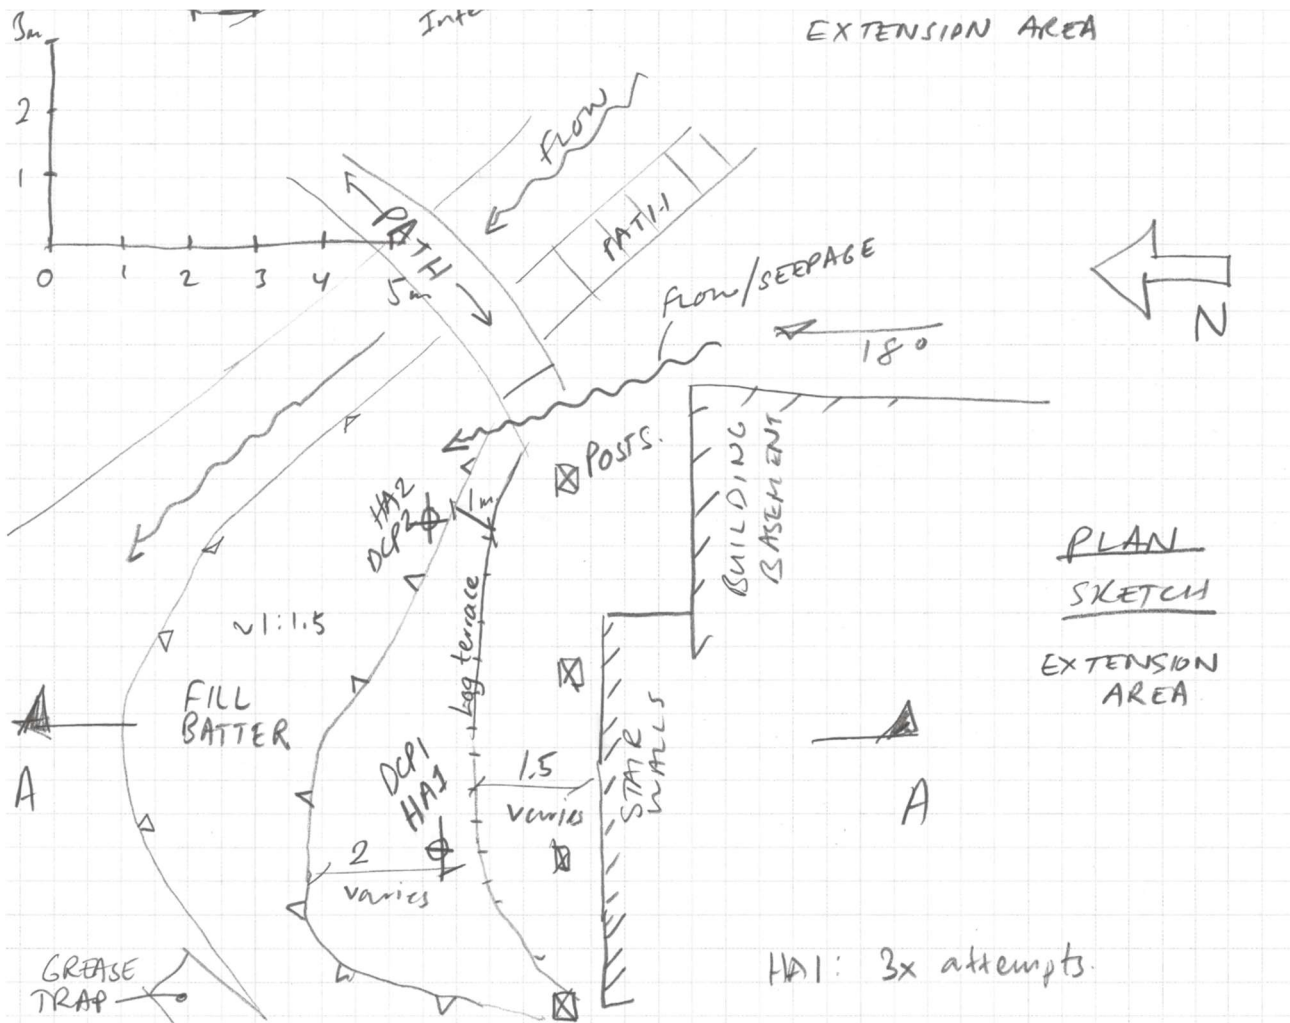
Plate 22 – Plan field sketch of the extension area (existing conditions). Note fill wedge overlying colluvial soil. Note drainage and seepage observation at the east of the extension area.
