Arborist Site Inspection Impact Assessment

Client:	Kosciuszko Thredbo, Mr. Euan Diver
Date of inspection	22 Oct 24
Address	Village Green, Friday Drive THREDBO NSW
Arborist completing inspection:	Andrew Downing Senior Arborist Assess Trees at AQF 5, QTRA Licenced User

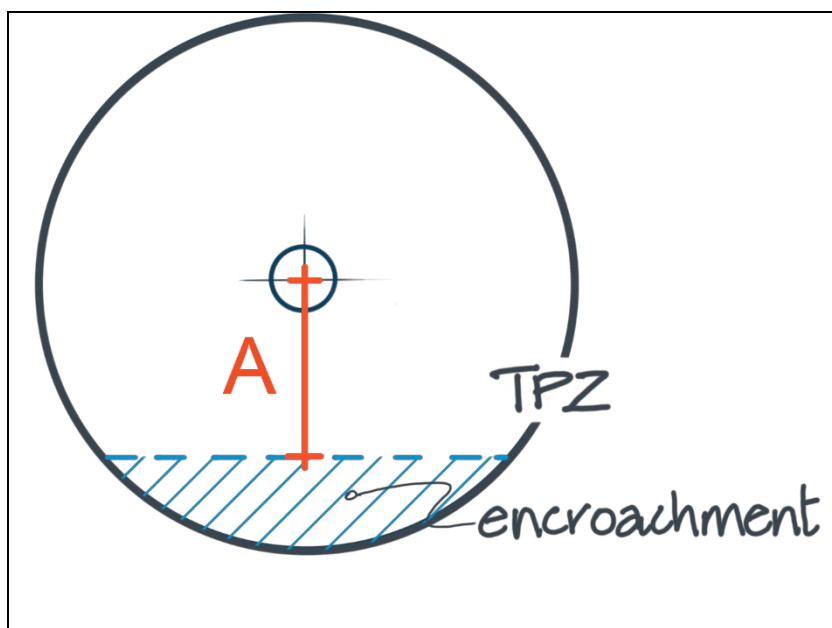
Typical TPZ and 10% encroachment detail

The proposed line of excavation through the TPZ of both trees exceeds the permissible encroachment allowance of 10 percent.

A solution to this should include planning for minimal impact excavation techniques such as Hydraulic Vacuum Excavation using high pressure water to cut through soil and vacuum suction to remove liquid debris or careful hand excavation. Any tree roots encountered must be avoided and left undamaged. Minor roots less than 20mm diameter may be cleanly cut using loppers or a hand saw.

Backfilling of trenches post works should be done using washed river sand and watered in to ensure any air pockets are completely filled.

The area beneath the trees and inside the TPZ should be mulched with organic mulch to a depth of 100-150mm.

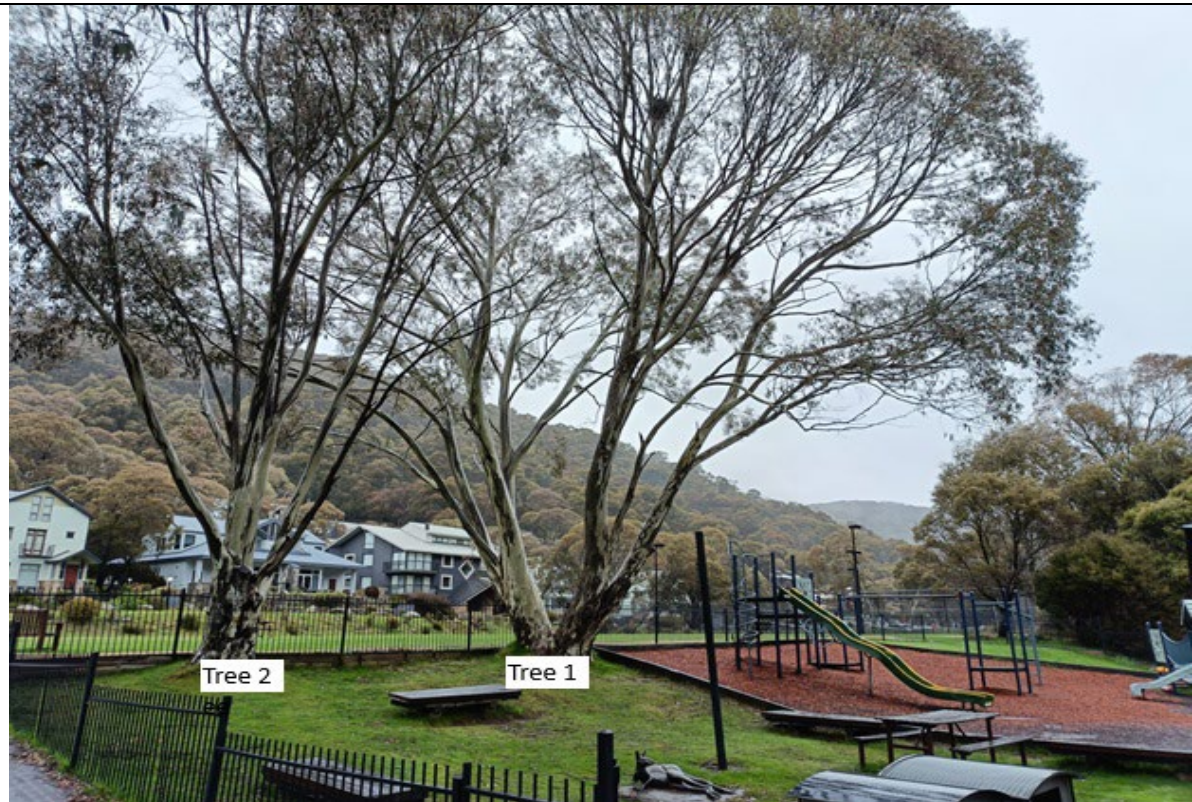
Trees 1 and 2

Comments: The tree vitality is good with large co dominant stems and healthy florescence. It has a large spreading canopy approx. 25m x 16m and over hangs the playground area. The tree provides excellent shade to the under storey and playground area.

There is minor dead wood evident which is typical for the tree species.

Comments: The tree vitality is average. It has a medium spreading canopy approx. 8m x 5m and overhangs the playground area. The tree provides excellent shade to the playground area.

There is dead wood >50mm diameter evident and minor decline over all.

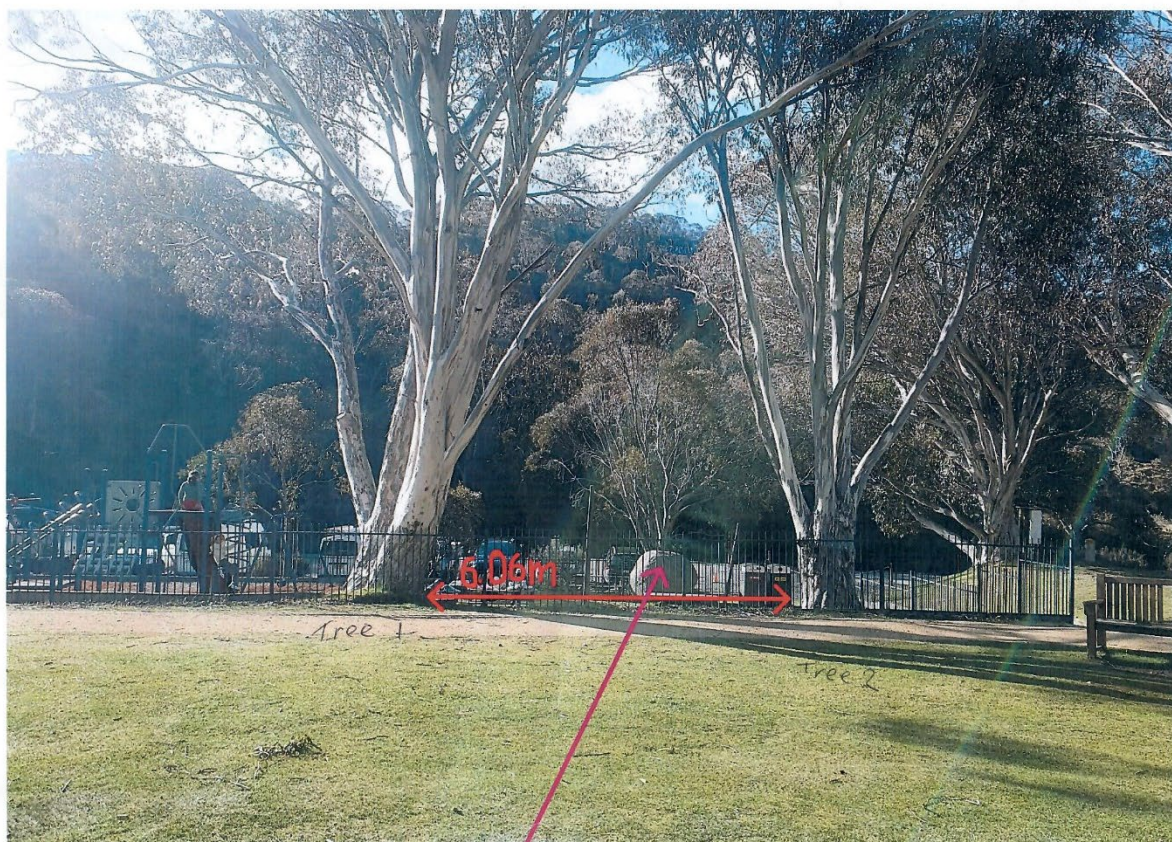
Proposed Trench

There are proposed trenching works planned to upgrade the storm water service from the village green that will be directed between the two trees and approx. 6m from both trunk bases. See attached image.
