## Arborist Site Inspection Impact Assessment

| <b>Client:</b> | Kosciuszko Thredbo, Euan Diver |
| <b>Date of inspection</b> | 28/01/25 |
| <b>Address</b> | Village Green, Friday Drive THREDBO NSW |

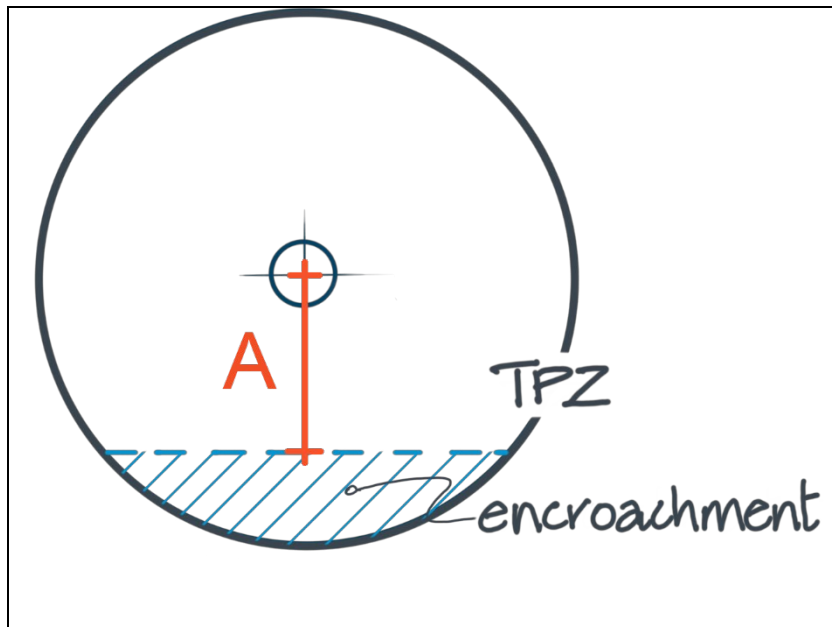
Typical TPZ and 10% encroachment detail

Any encroachment by mechanical trenching into the Tree Protection Zone (TPZ) that will cause damage to tree roots will have a negative impact on tree health and should be avoided. While a ten percent encroachment is permissible anything above this should be avoided. Any encroachment over thirty percent can cause partial decline or whole tree death.

Encroachment into the Structural Root Zone will cause instability and can lead to whole tree failure and risk of harm to any users of the target areas beneath the tree.

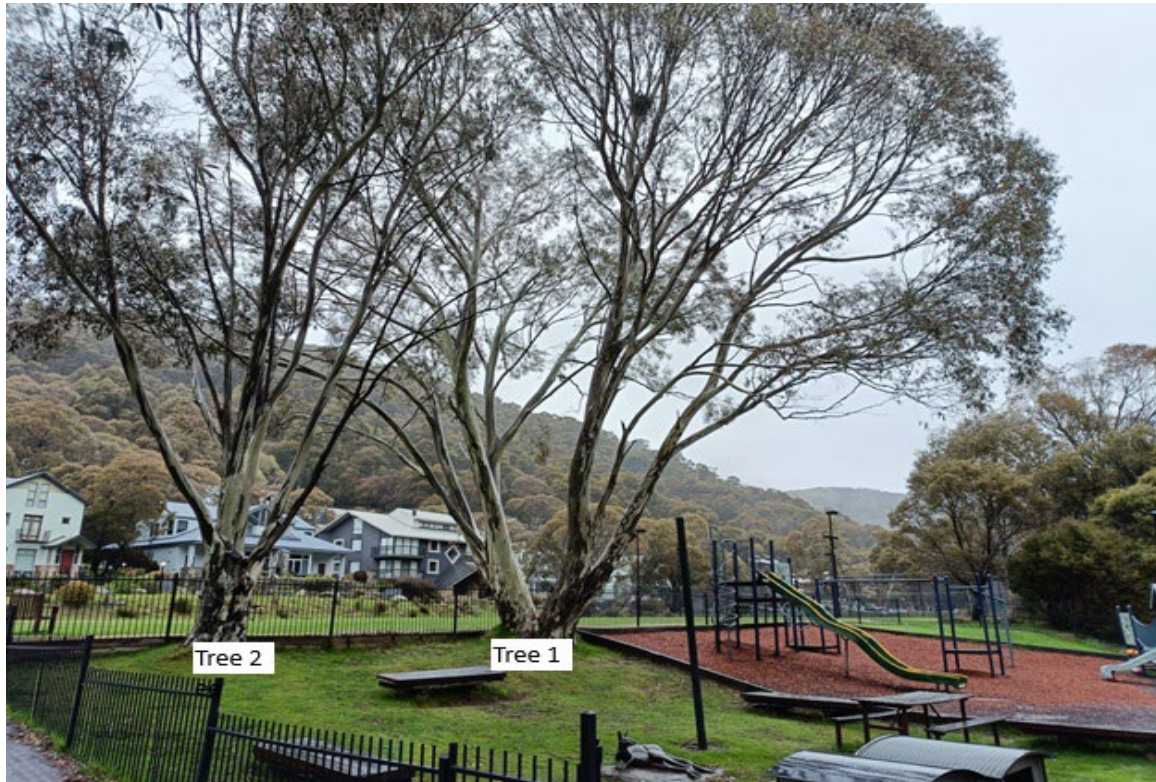
Image 1. Trees 1 and 2

**Comments:** The tree vitality is good with large co dominant stems and healthy florescence. It has a large spreading canopy approx. 25m x 16m and over hangs the playground area. The tree provides excellent shade to the under storey and playground area.

There is minor dead wood evident which is typical for the tree species.

There will be encroachment into the TPZ and SRZ from proposed trenching and fence relocation work. (See tables below).

**Comments:** The tree vitality is average. It has a medium spreading canopy approx. 8m x 5m and over hangs the playground area. The tree provides excellent shade to the playground area.

There is dead wood >50mm diameter evident and minor decline over all.

There are proposed trenching works planned to upgrade the storm water service from the village green that will be directed between trees one and two and approx. 6m from both trunk bases.

There is also a fence to be relocated within the TPZ and SRZ of trees one and two.

| Tree 1. TPZ and SRZ Trenching Calculation Table | |
|---|---|
| Encroachment area (m <sup>2</sup> ) | 208.6 |
| Encroachment (%) | 36.0 |

| Tree 2. TPZ and SRZ Calculation Table | |
|---|---|
| Encroachment area (m <sup>2</sup> ) | 53.8 |
| Encroachment (%) | 24.3 |

The proposed line of excavation through the TPZ of trees one and two exceeds the permissible encroachment allowance of 10 percent.

A solution to this should include planning for minimal impact excavation techniques such as Hydraulic Vacscavation using high pressure water to cut through soil and vacuum suction to remove liquid debris or careful hand excavation. Any tree roots encountered must be avoided and left undamaged. Minor roots less than 20mm diameter may be cleanly cut using loppers or a hand saw.

Backfilling of trenches post works should be done using washed river sand and watered in to ensure any air pockets are completely filled.

The area beneath the trees and inside the TPZ should be mulched with organic mulch to a depth of 100-150mm.

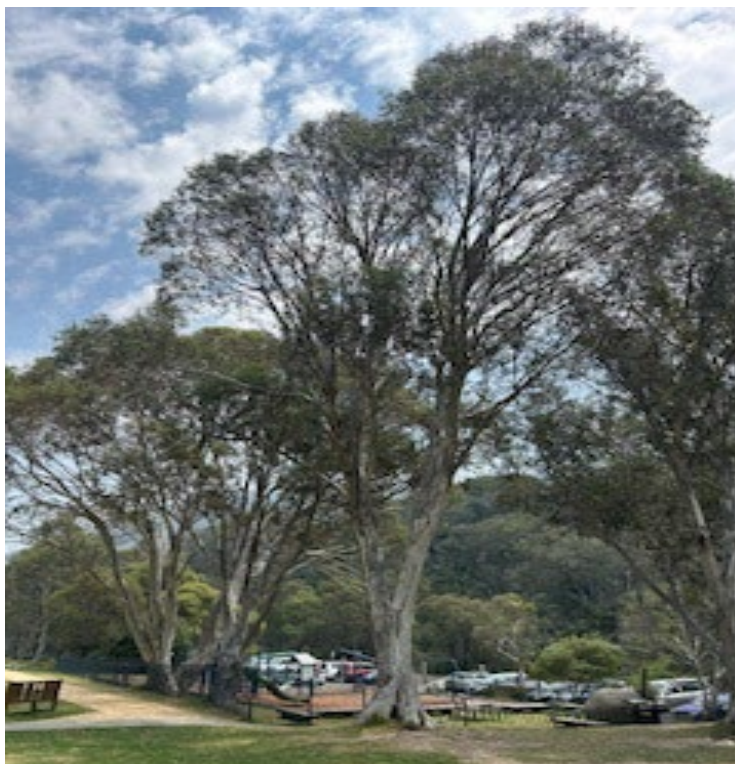
Image 2. Tree Three

**Comments:** The tree vitality is average with a crown spread of approx. 10m. There will be no encroachment into the TPZ or SRZ from proposed works.

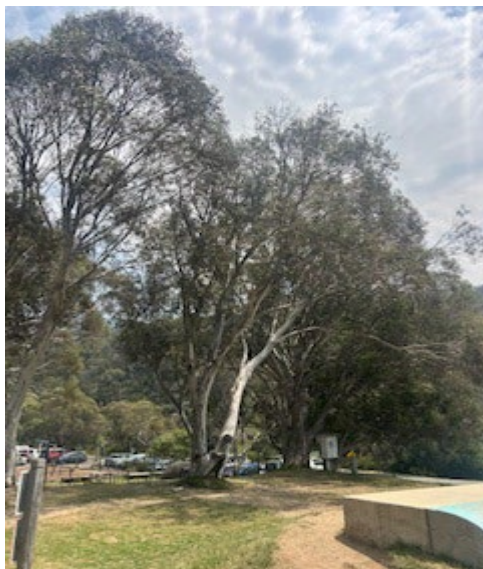
Image 3. Tree Four

**Comments:** The tree vitality is average with a crown spread of approx. 11m. There will be no encroachment into the TPZ or SRZ from proposed works.

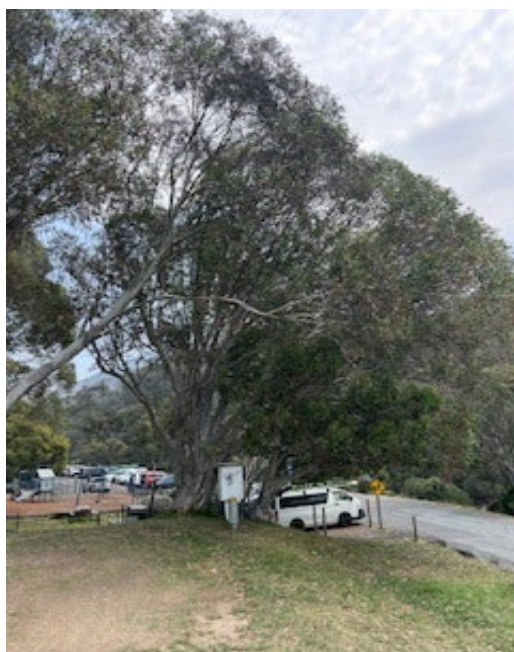
Image 4. Tree Five

**Comments:** The tree vitality is average with a crown spread of approx. 14m. There will be no encroachment into the TPZ or SRZ from proposed works.

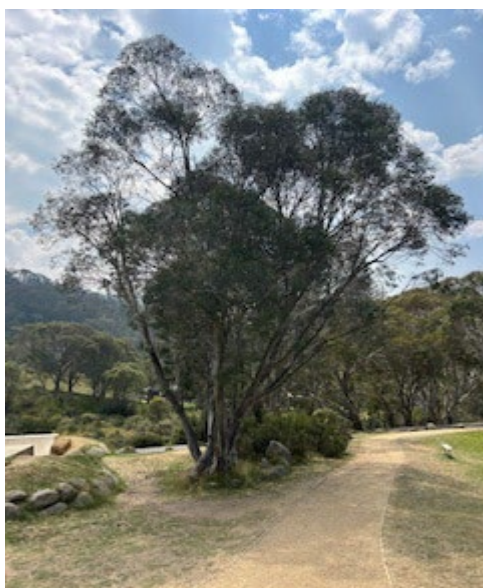
Image 5. Tree Six

**Comments:** The tree vitality is good with a crown spread of approx. 10m. There will be no encroachment into the TPZ or SRZ from proposed works.

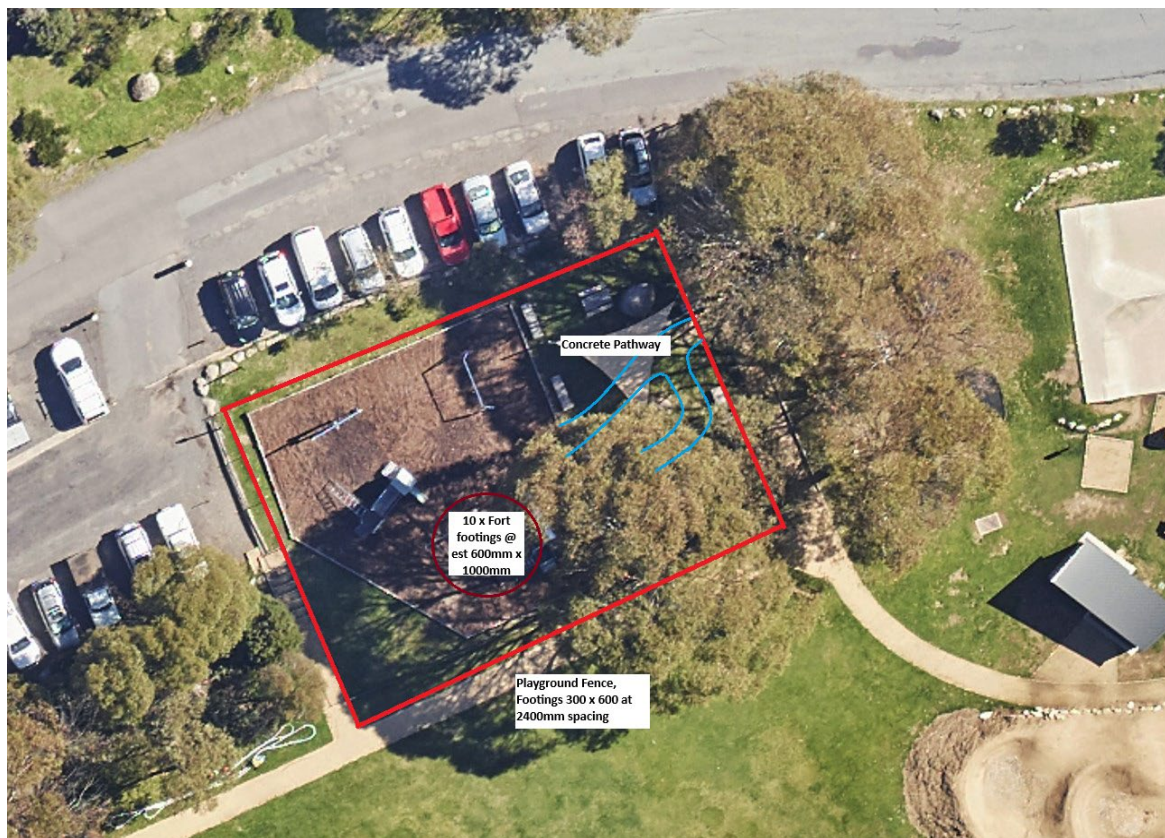
Image 7. Proposed New Features

A planned log slalom course will also encroach into the TPZ of tree 1. (See concept Plan)

This encroachment is 10 percent and is a permissible encroachment.

The proposed Log Slalom course must be redesigned so the line of encroachment does not come closer than 6.6m from the centre of the main trunk to minimise the encroachment area to 10% or less. The footing detail for the logs should be bored footings which will aid in avoiding continuous disturbance within the TPZ and limiting damage to sub soil roots.
