Our ref: 7471-R1 Rev3
13 February 2025

Proposed Playground Upgrade, Thredbo Village NSW Geotechnical Assessment

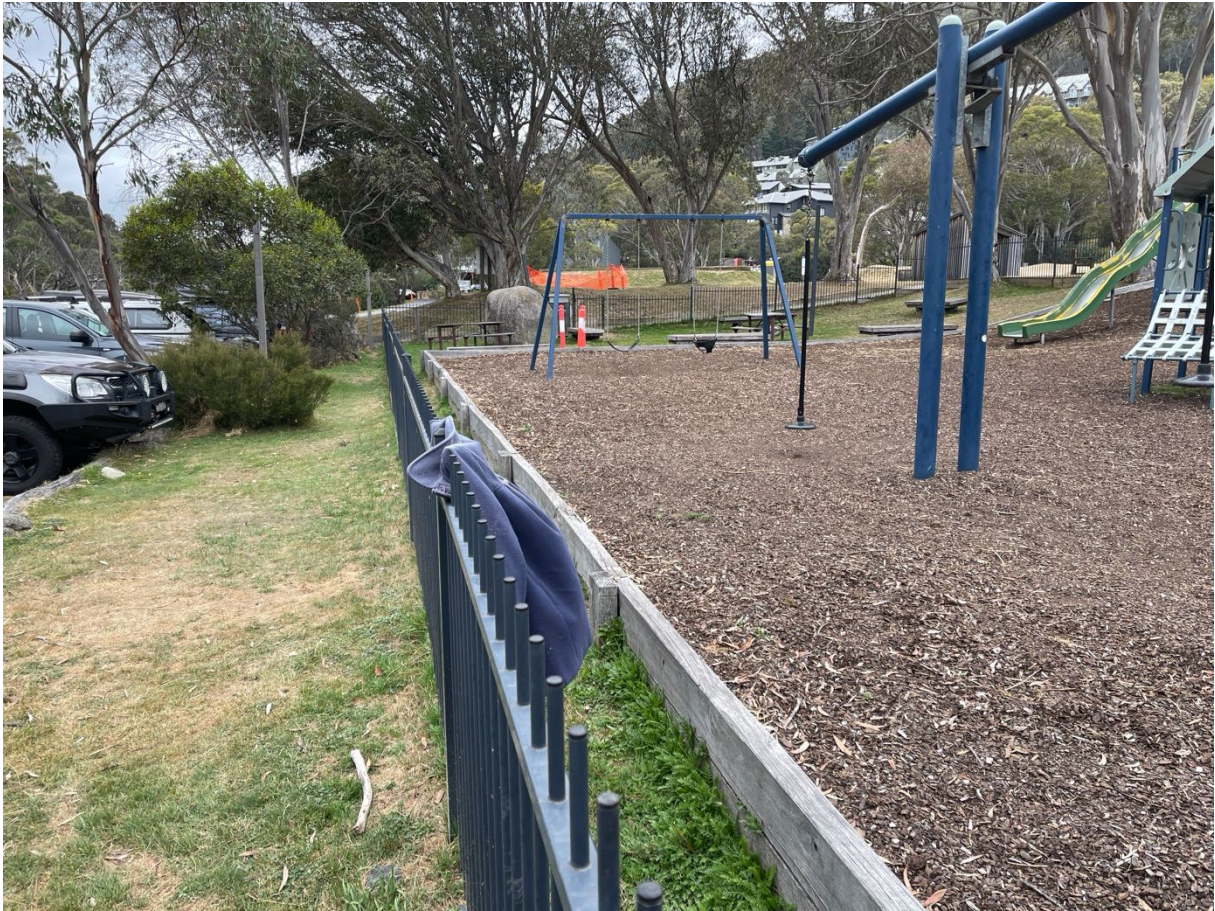
Photo 1: View of northern side of existing playground, looking northeast.

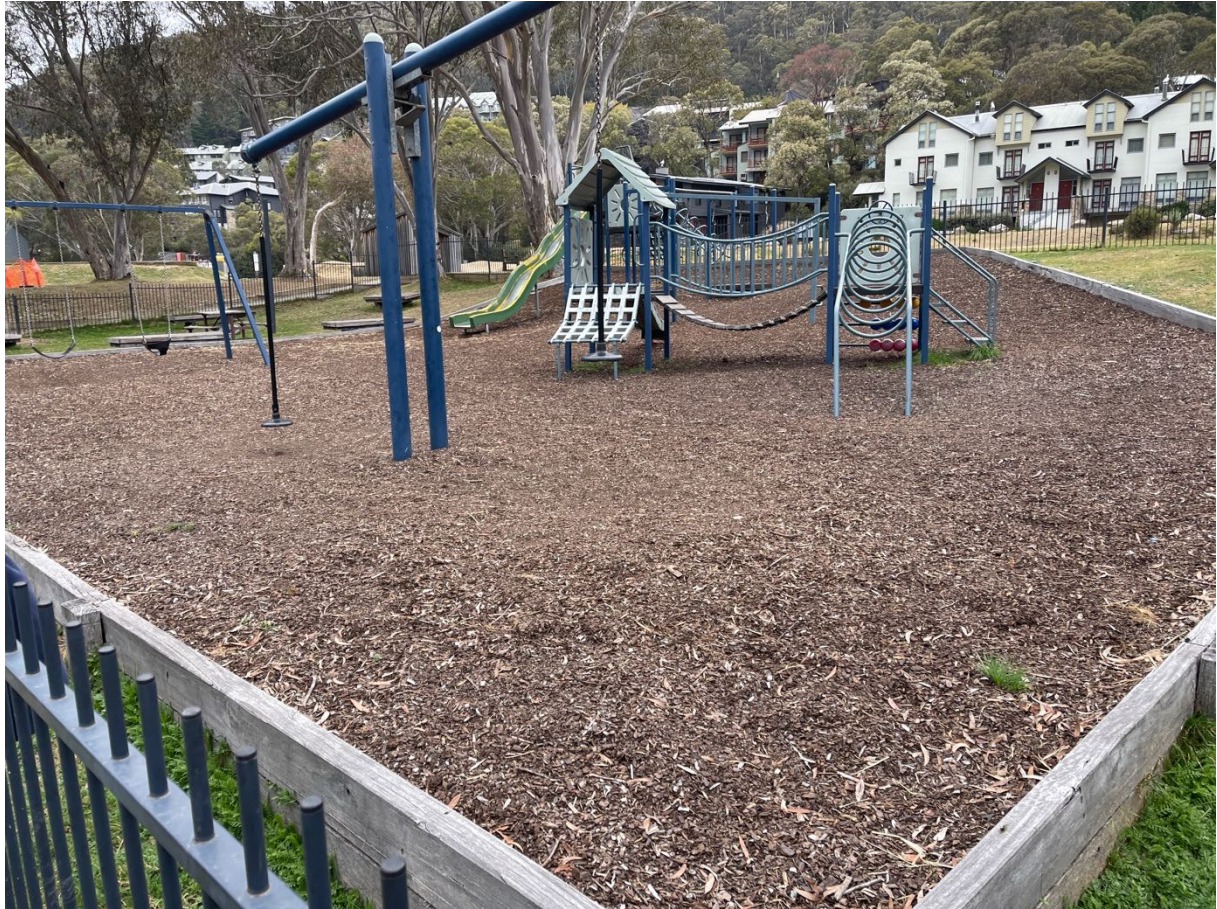
Photo 2: View of existing playground, looking southeast.

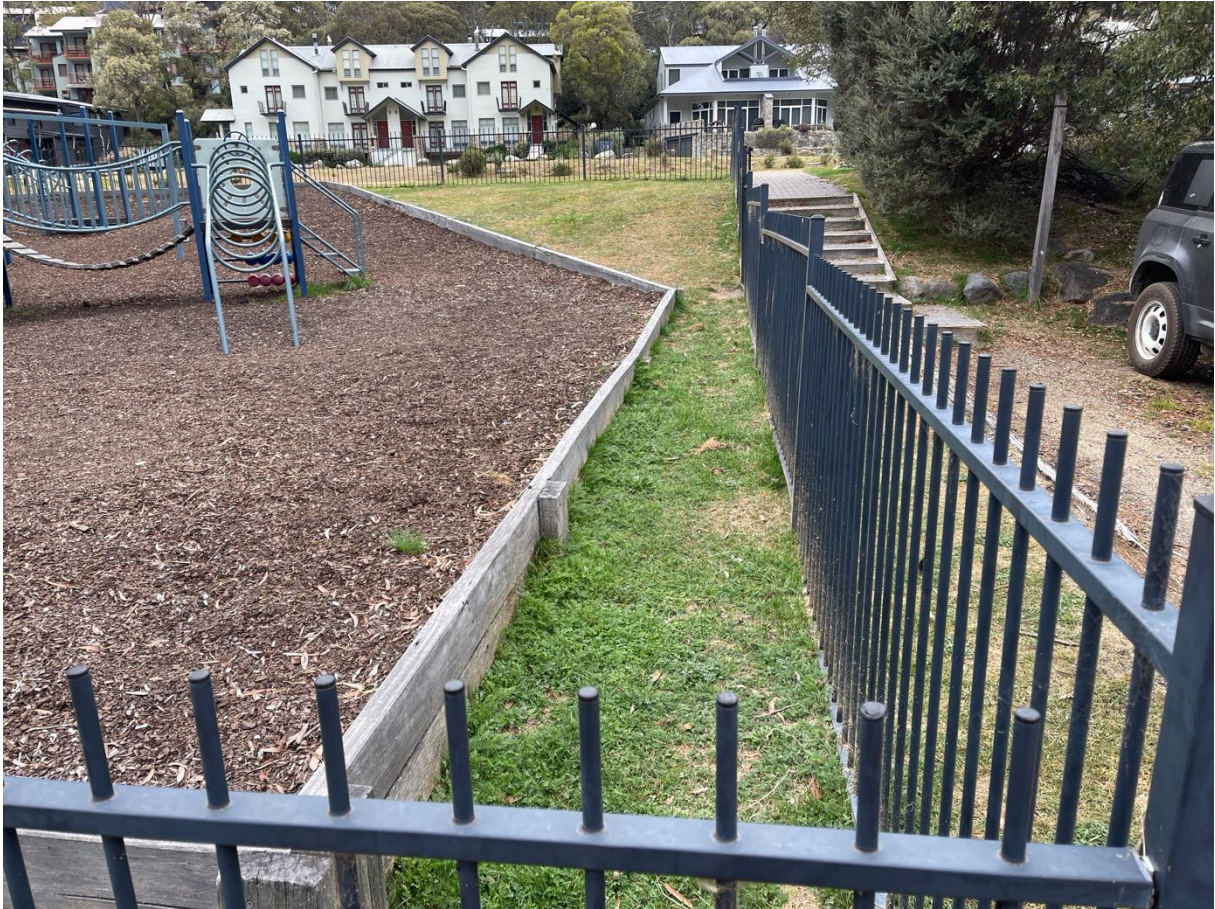
Photo 3: View of existing playground, looking south.

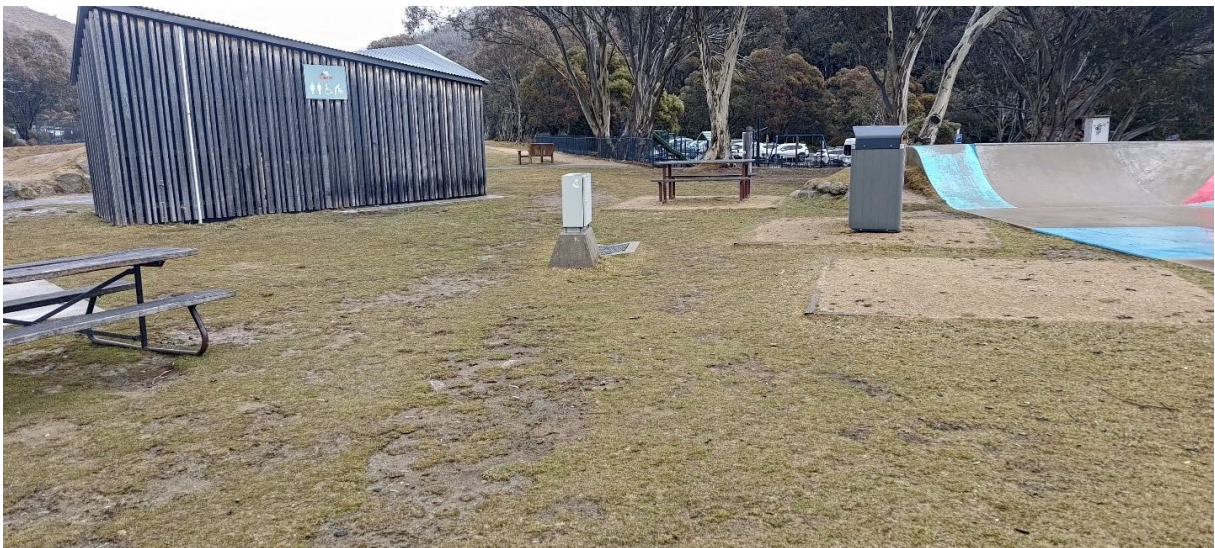
The existing plaza is located north of the pump track and primarily consists of landscaped grass, with a restroom to the south and seating benches to the east and west. A utilities distribution board and a rubbish bin are also present in the area.

Photo 4: Existing Plaza Area, looking south. Source: Kosciuszko Thredbo Pty Ltd.

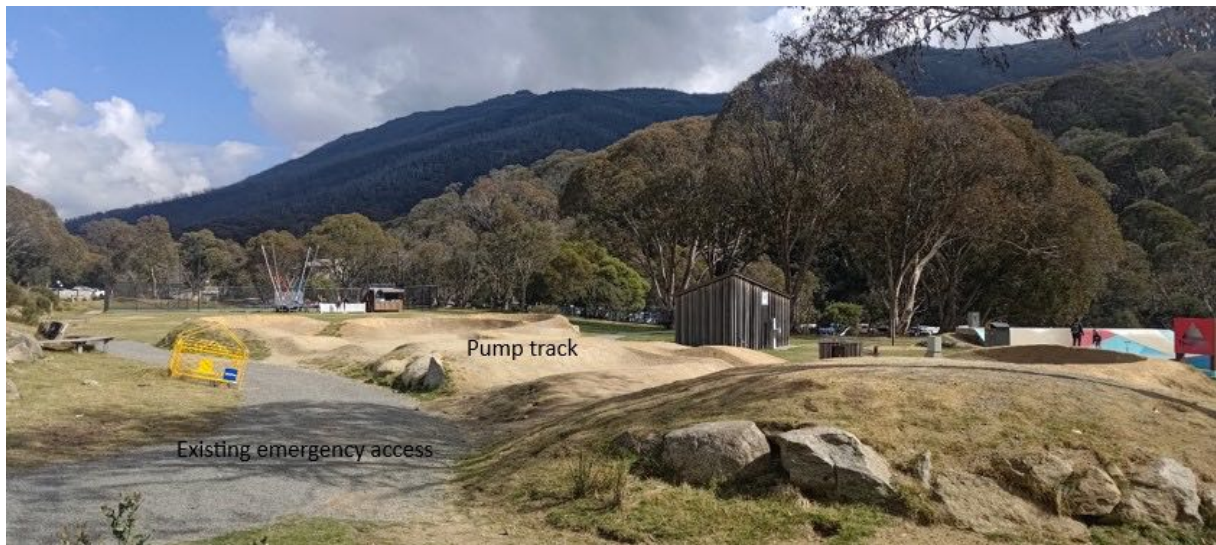
The pump track is situated east of the existing playground, bordered by the village green to the west, an emergency access path to the south, a walking track to the east, and the plaza to the north. It features an undulating surface forming a wavy path, with some rock boulders observed around its perimeter.

Photo 5: Existing Pump track Area, looking west. Source: Kosciuszko Thredbo Pty Ltd.

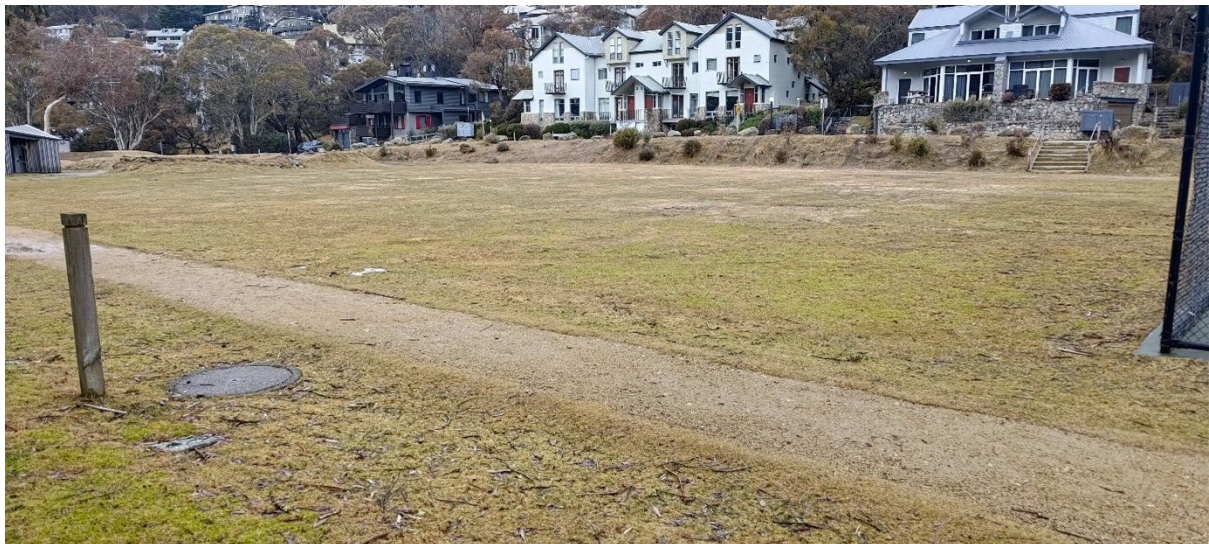
The existing water main is located north of Thyne Reid Drive, on the flat surface of the village green. To the west of the water main, there is a play court. The emergency exit is situated south of the pump track, connected to Thyne Reid Drive, and is paved with asphalt.

Photo 6: Existing Water Main and Emergency access area, looking east. Source: Kosciuszko Thredbo Pty Ltd.

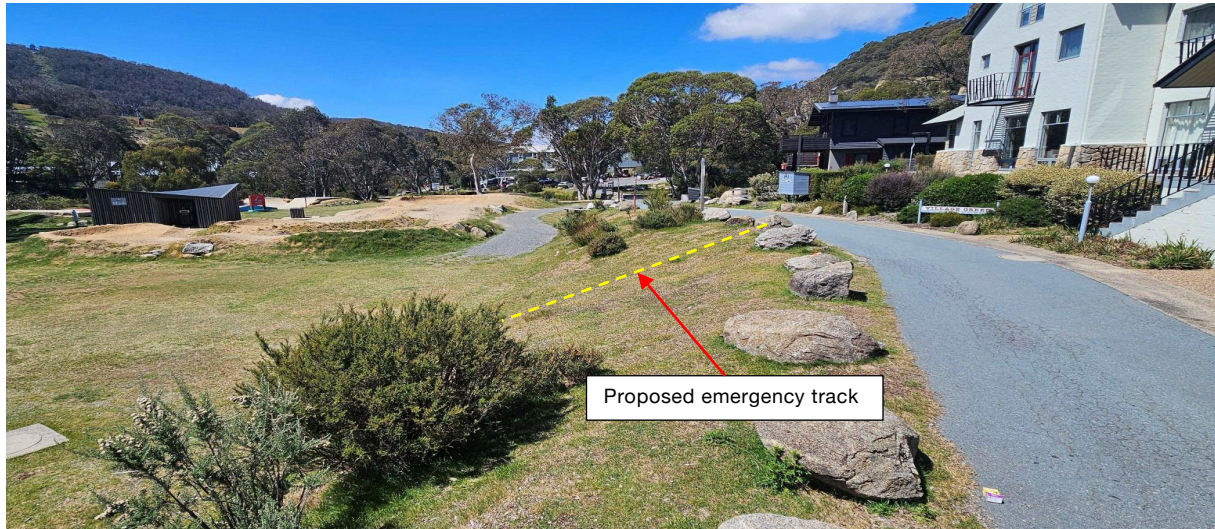
Pump track: The existing pump track (approximately 850 m²) will be demolished and rebuilt in the same location with a slightly larger footprint (approximately 1,000 m²). Bermed features reach up to 1.3 meters in height, and the entire surface will be asphalted. The current emergency access near Thyne Reid Drive will be removed, with a new emergency access lined with boulders for delineation as illustrated in Photo 7. It is noted that these boulders do not retain any soil.

Photo 7: Approximate location of proposed emergency access track. Boulders lining Thyne Reid Drive are proposed for lining new emergency access track. Source: Kosciuszko Thredbo Pty Ltd.

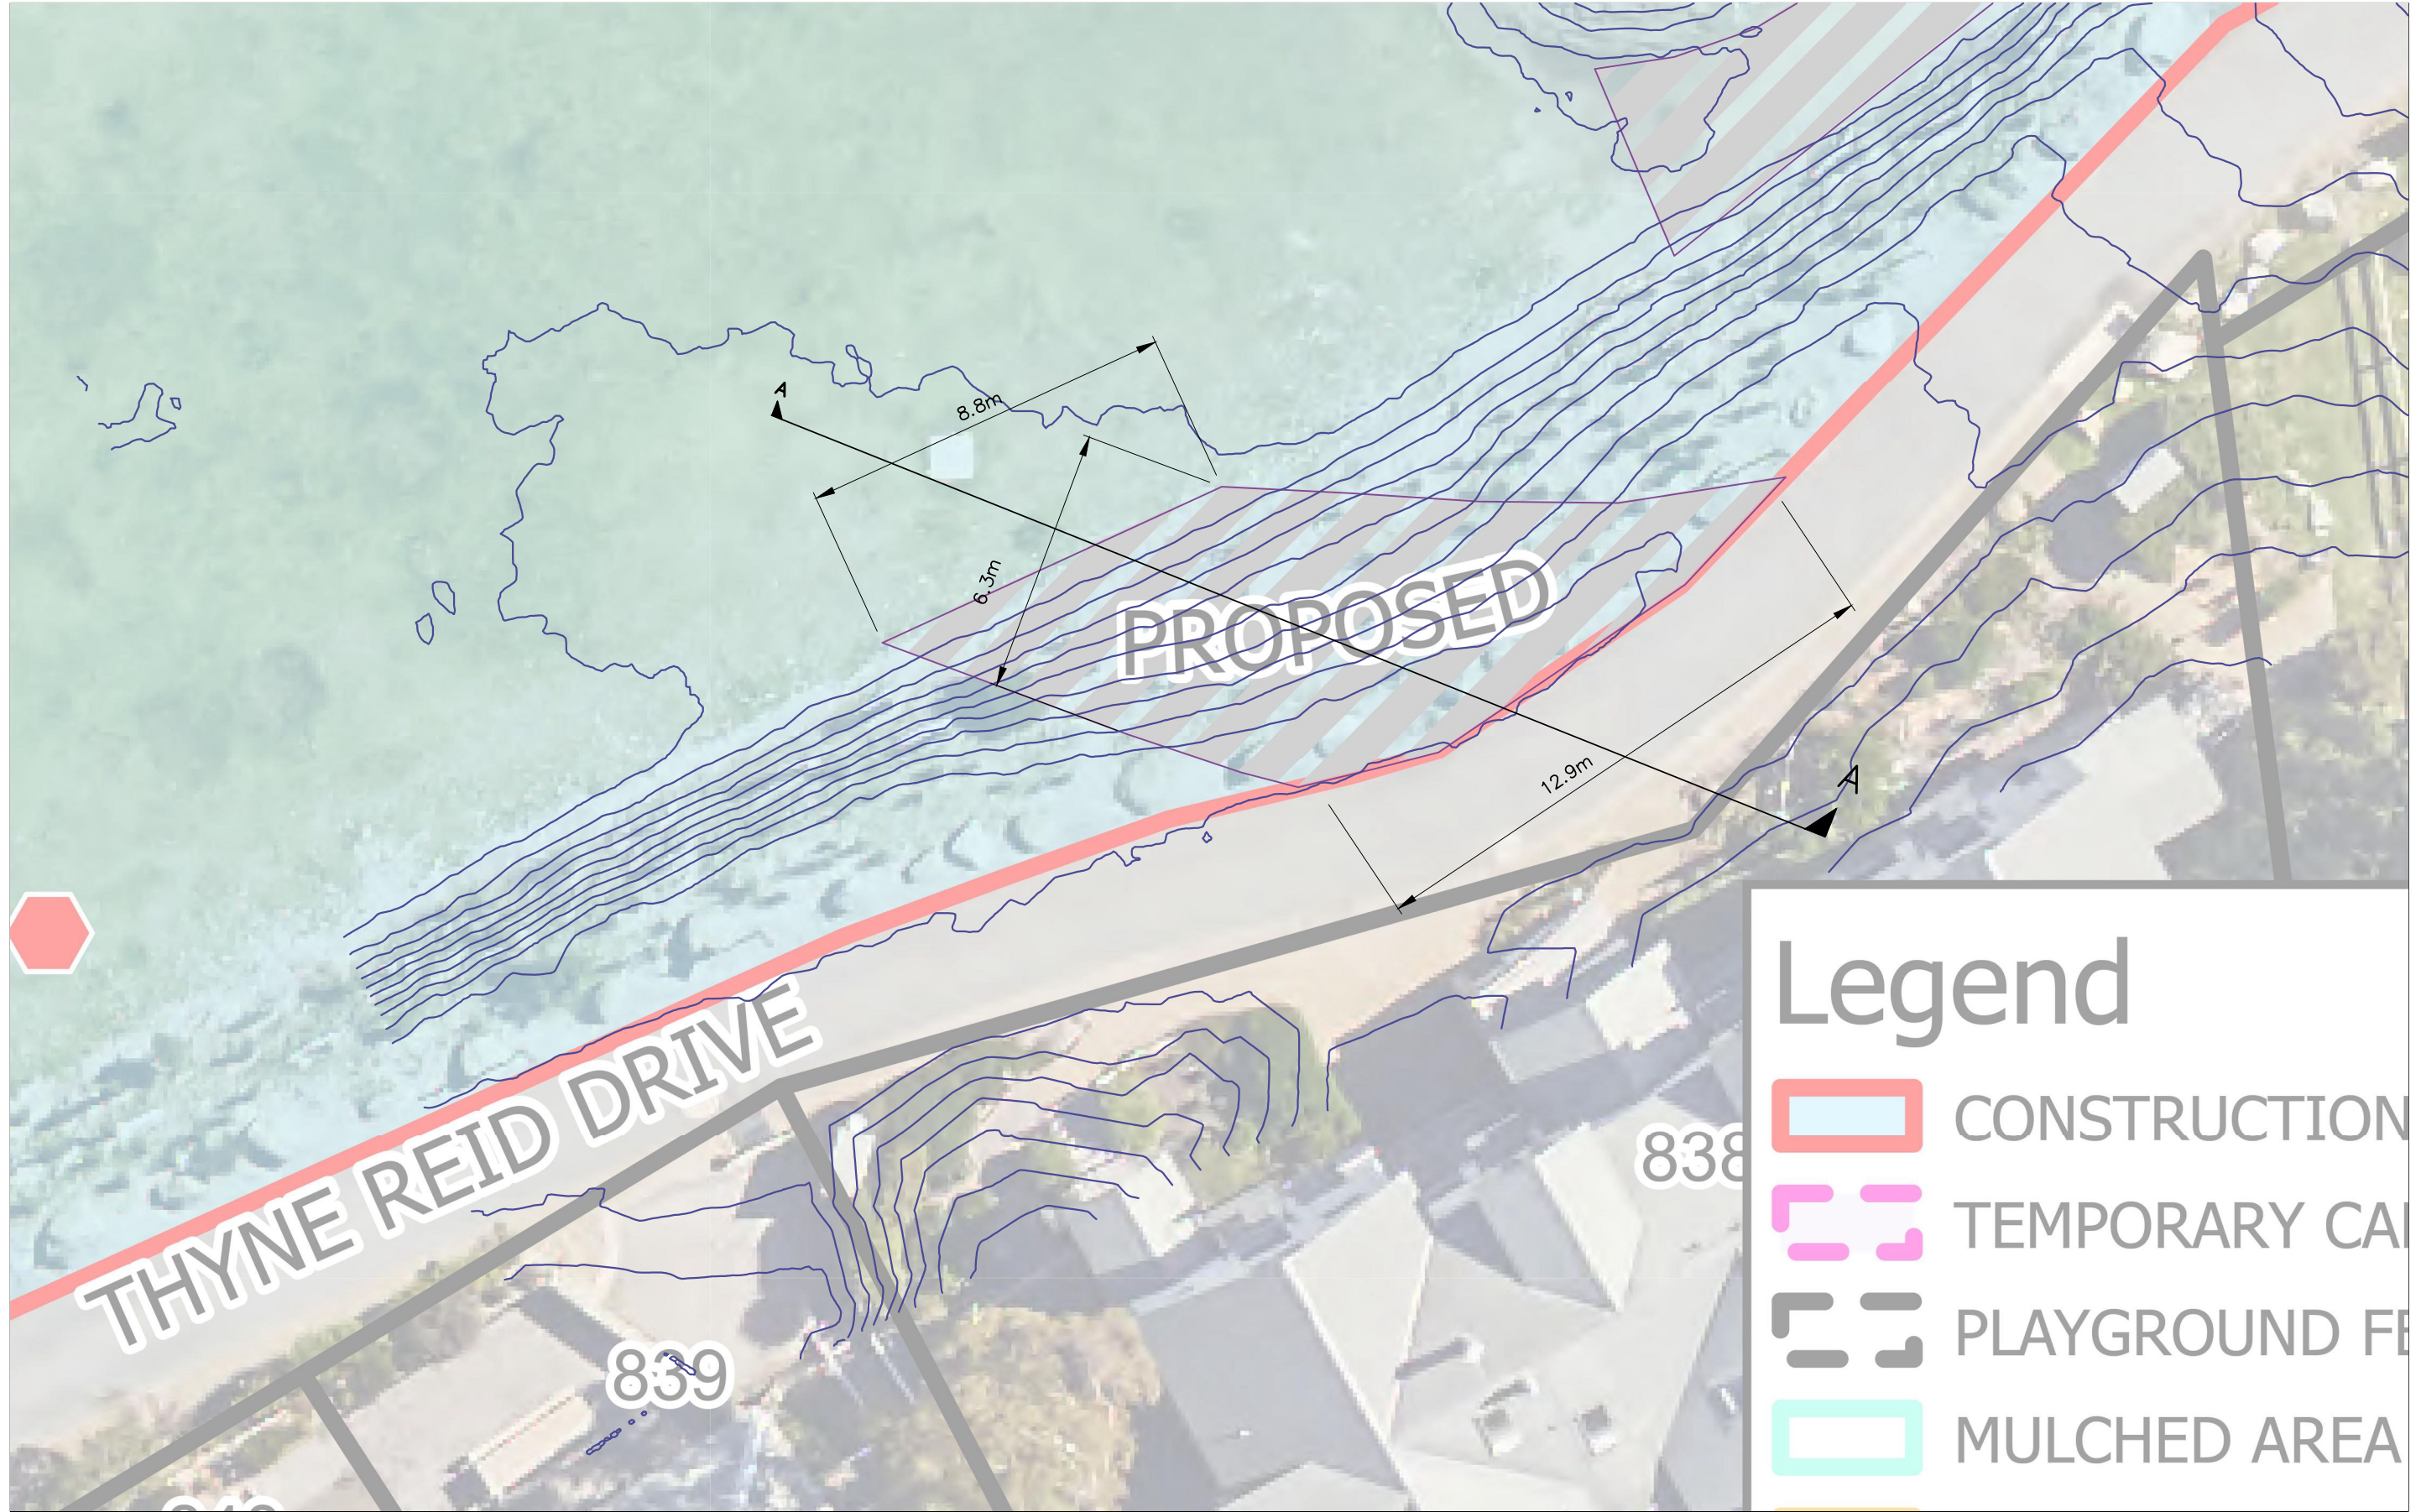
Site Plan with Surface Contours

The emergency access track will run off Thyne Reid Drive at the location indicated in Figure 1, at a maximum slope of 15° as shown in the long section in Figure 2. Based on a nominal 150mm thick gravel access track, minor cutting and filling are proposed to level out the track, with cutting expected to be less than 300mm deep and filling less than about 150mm. Widths of the track are shown on Figure 1. The entrance off Thyne Reid Drive is to be fitted with a suitable gate to prevent unauthorised vehicle access. Given the modest slopes and short lengths involved, no specific drainage measures are considered necessary.
